Agency of Agriculture Food & Markets

ARM Division – Water Quality
94 Harvest Lane
Williston, VT 05495

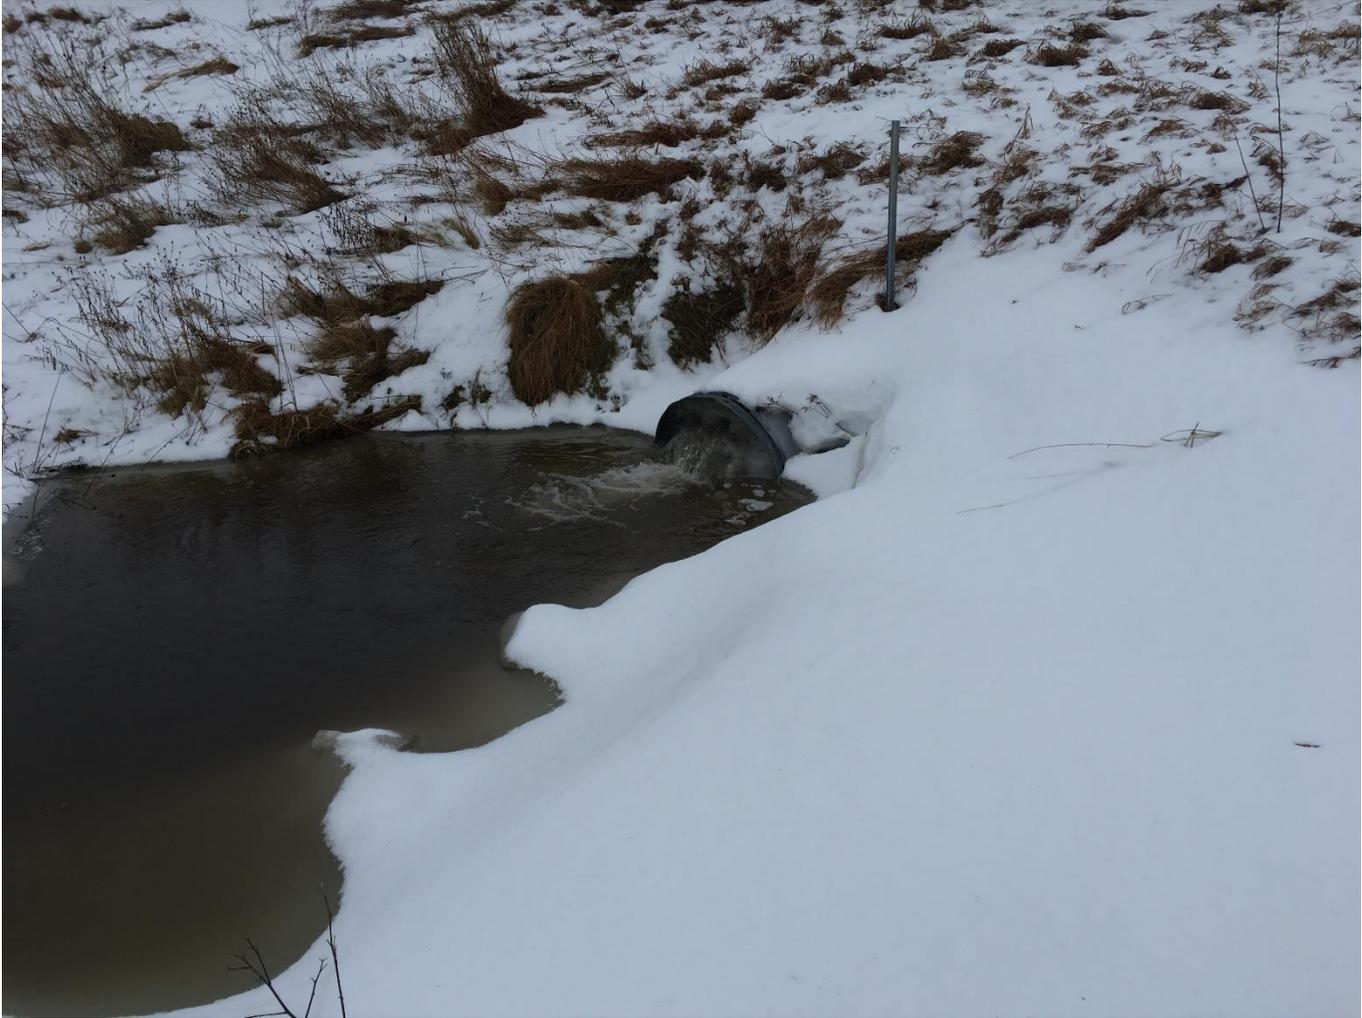
IMG_1732, Taken on 1-23-2018 by John D. E. Roberts . View of the 30” culvert under Route 236 that is frozen, except for two small holes

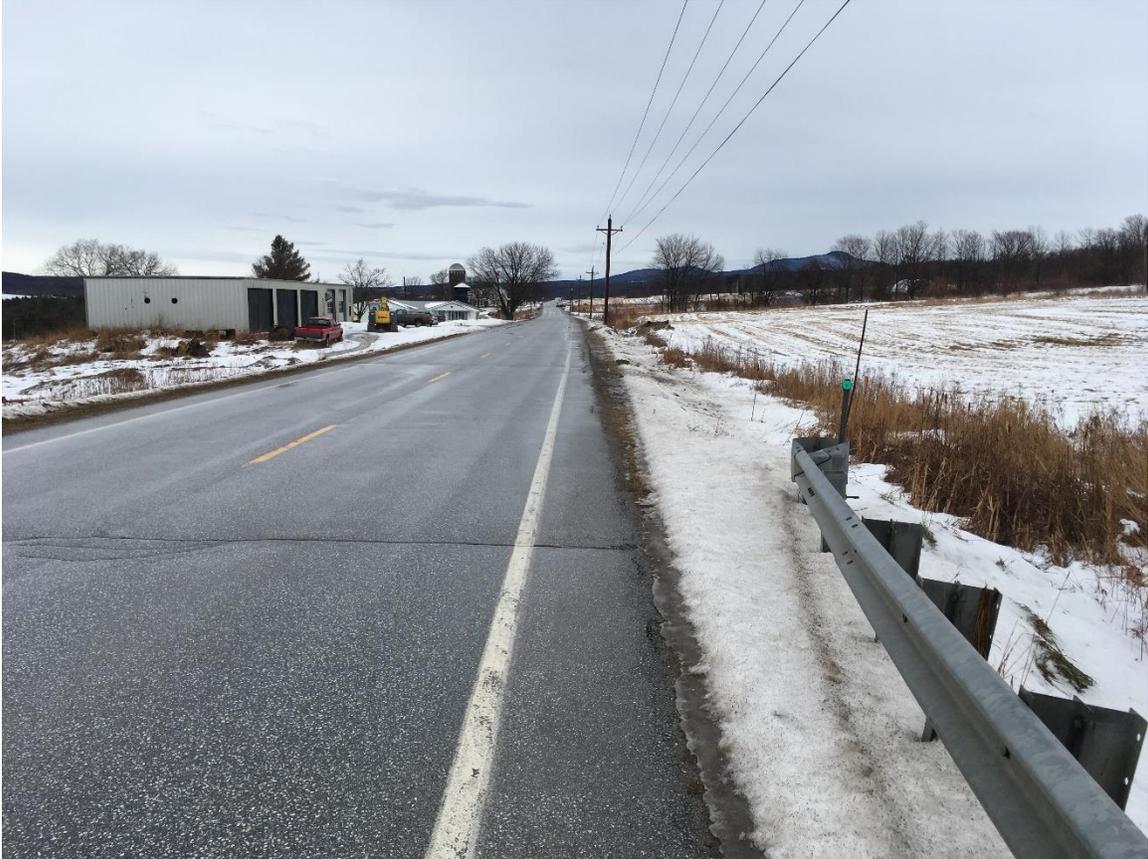
IMG_1731, Taken on 1-23-1028 by John D. E. Roberts. The view from the point where the frozen culvert passes under Route 236 looking north in the direction that the large amount of water flowed, then crossed 236 where the garage and red pick-up truck are on the left of the photo.

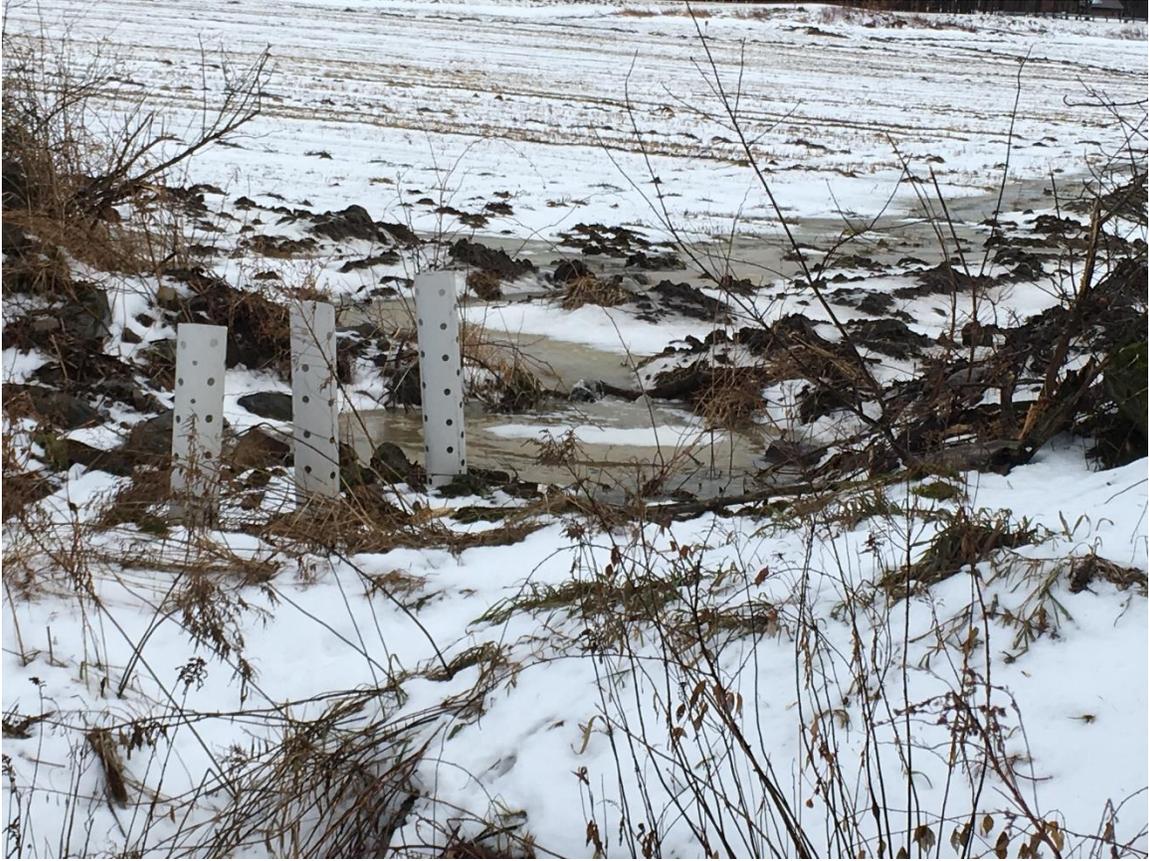
IMG_1719, Taken on 1-23-2018 by John D. E. Roberts. Showing the water flowing off the field where the tiling was done in the fall of 2017 with some mild sediment in the water on this day.

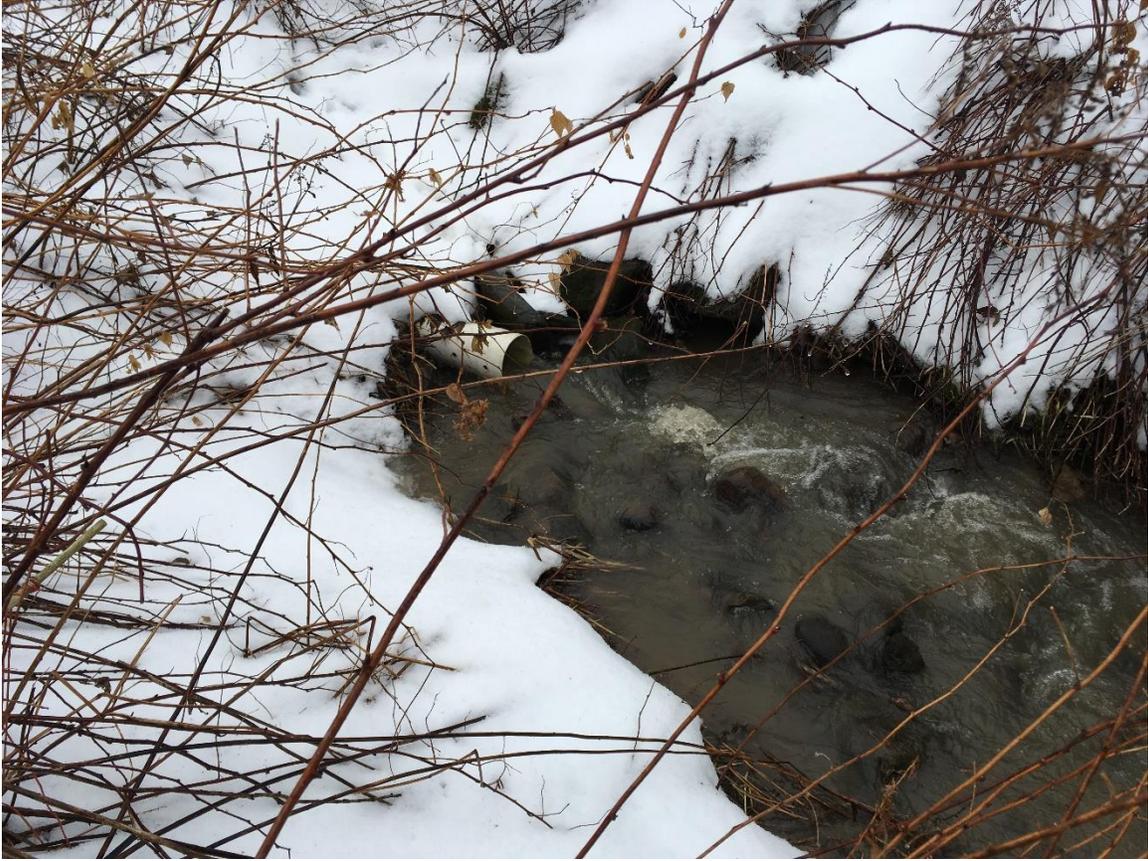
IMG_1722, Taken on 1-23-2018 by John D. E. Roberts. The photo depicts where the tile under the grassed waterway leading from the tiled field comes out by the cedar woods down near Lake Carmi. The water coming out of the tile has some mild sediment in it on this day.
