Vermont Department of Environmental Conservation

Water Investment Division – Dam Safety Program
1 National Life Drive, Davis 3
Montpelier, VT 05620
Phone: 802-622-4093

WATER CONTROL PLAN
April 12, 2021
AMHERST LAKE DAM, PLYMOUTH
State ID No. 156.05 / National ID No. VT00131

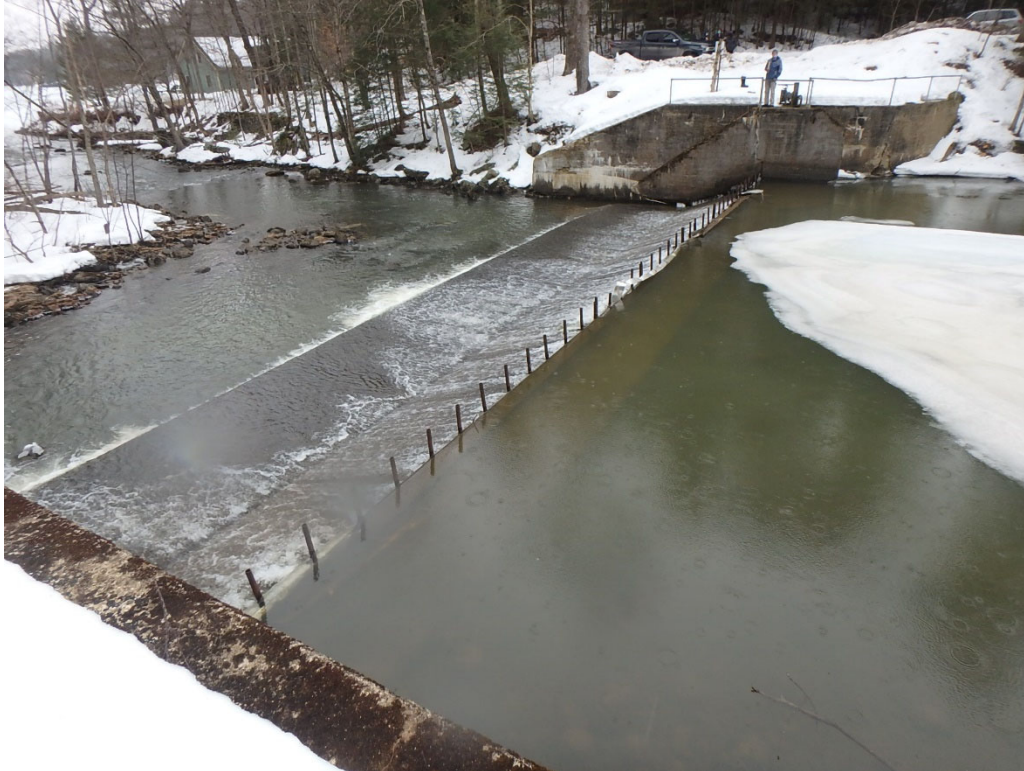
Photo 1: March 2021, an overview of the dam from the left abutment area

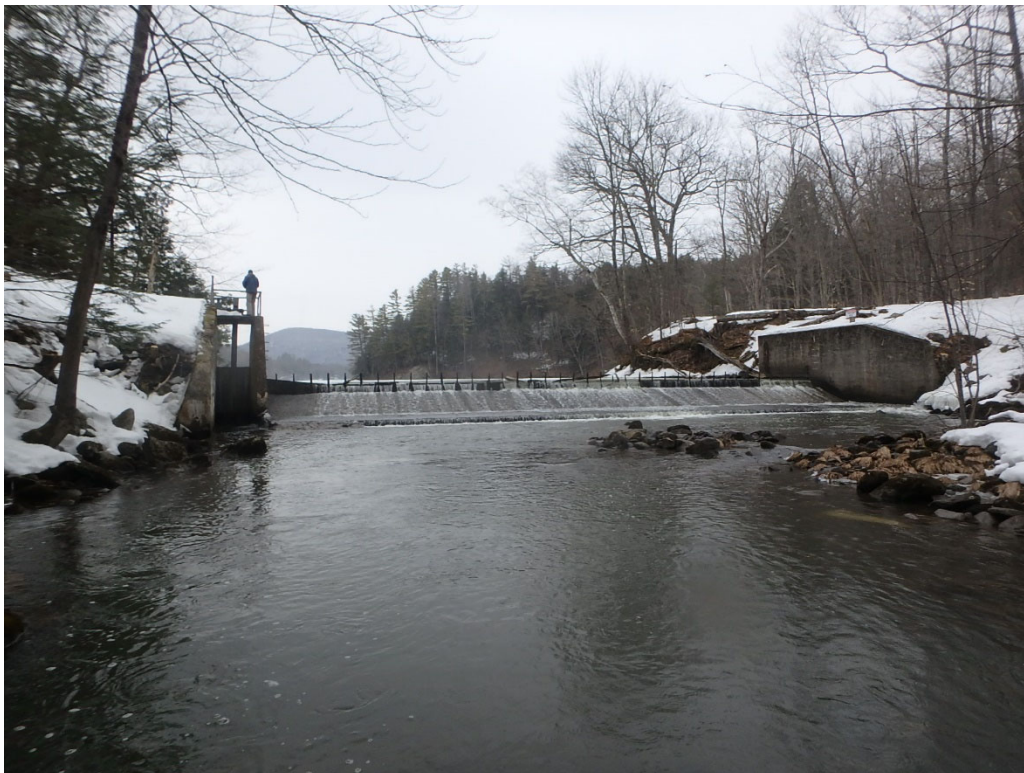
Photo 2: March 2021, an overview of the dam from the downstream area looking upstream.

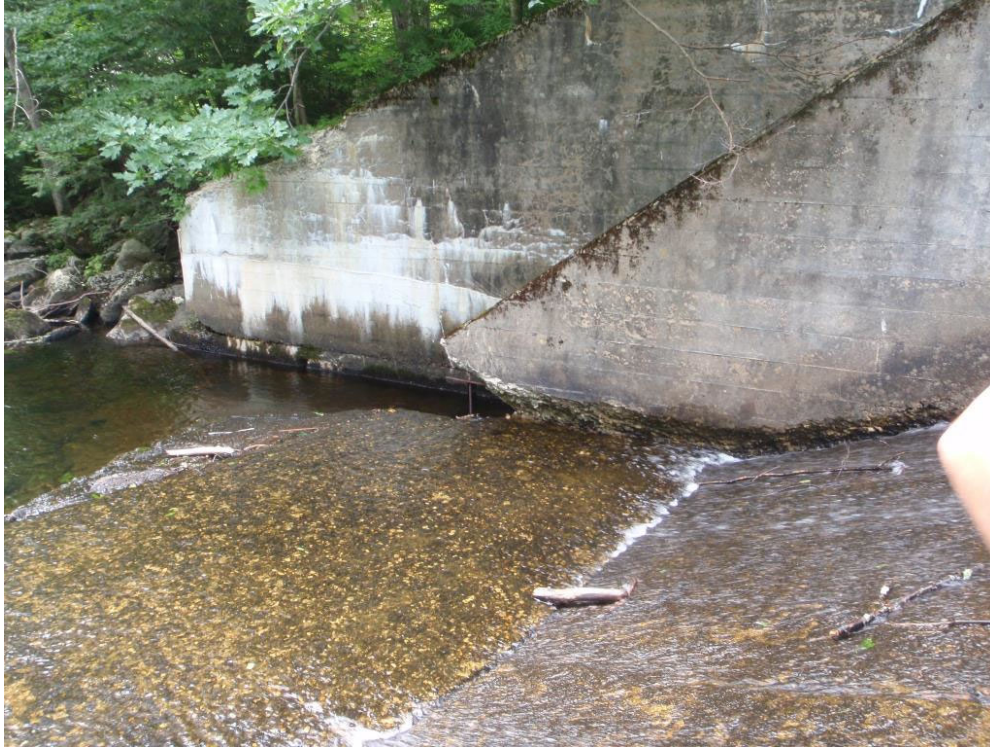
The right concrete training wall is also the dividing wall between the spillway and the gated outlet channel. The condition of this wall is poor as the downstream end of the wall is completely undermined with loss of support for approximately 10 feet laterally except for several corroded, 0.75-inch diameter rebar. The concrete is heavily deteriorated with exposed aggregate, delamination, and cracking. A horizontal crack extends on the gate side of the wall from the gate in the downstream direction and displacement towards the spillway along the crack was observed. The wall above the crack is tilted towards the spillway greater than 3 degrees past vertical. It should be noted that at the top of the wall is a short concrete bridge that supports the gate mechanism and ties the wall to the right abutment wall. The connection of the wall to this bridge appeared good, but it was noted that both the walls are similarly tilted (racked) towards the spillway. Based on review of past inspection report photographs, continued concrete section loss, cracking, and tilting was observed. The wall appears marginally stable under normal loading conditions.

Photo 3: August 2010, downstream end of concrete wall separating the spillway from the outlet works.

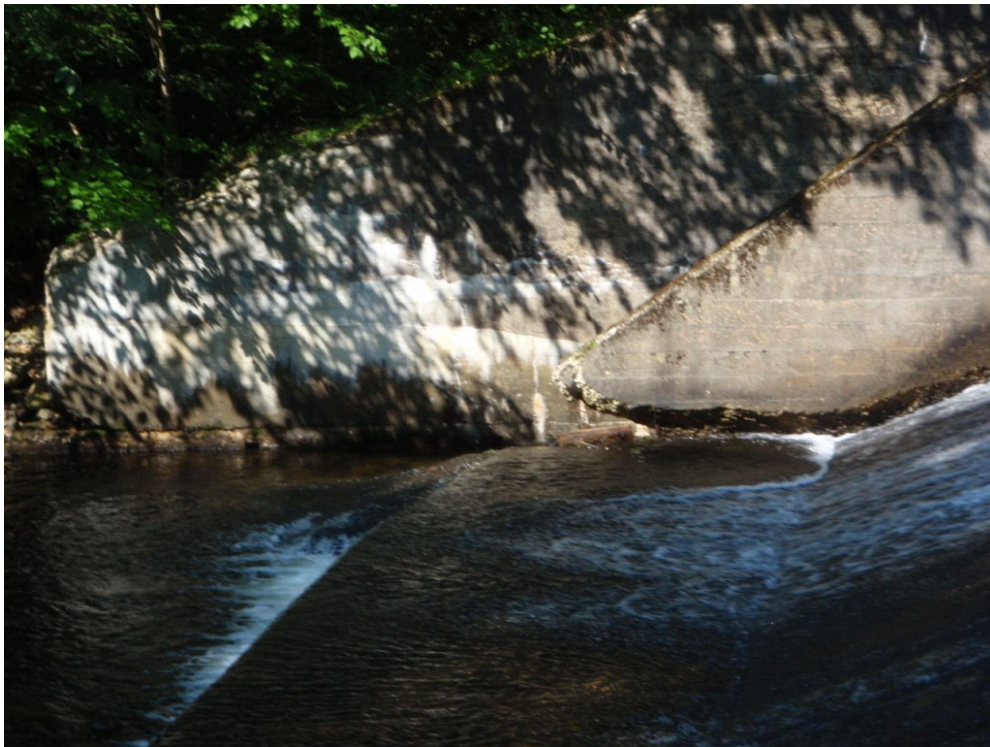
Photo 4: July 2014, downstream end of concrete wall separating the spillway from the outlet works, note continued section loss and deterioration.

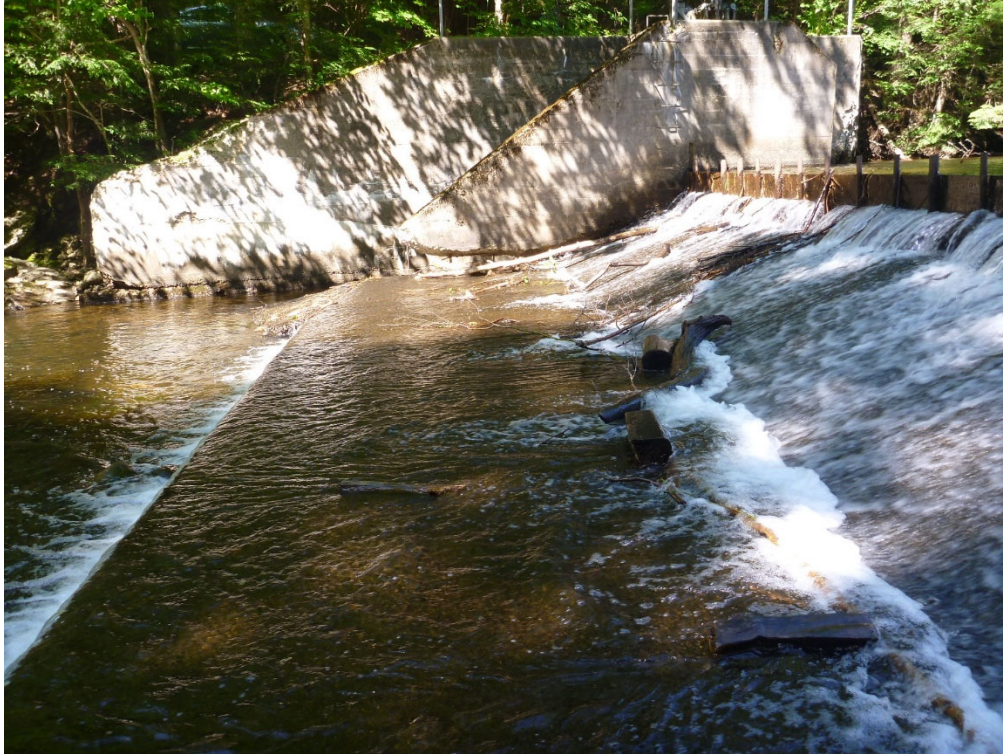
Photo 5: July 2019, downstream end of concrete wall separating the spillway from the outlet works, note continued section loss and deterioration.

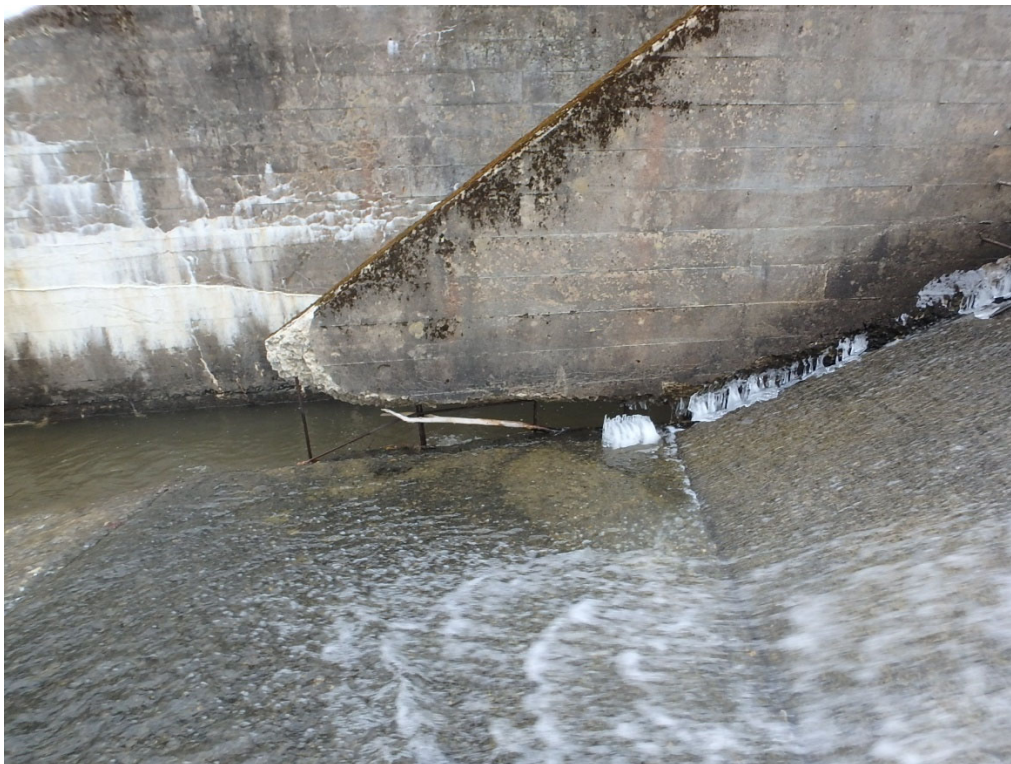
Photo 6: March 2021, downstream end of concrete wall separating the spillway from the outlet works, note continued section loss and deterioration.

3. Perform an assessment of the structural stability of the training walls and identify repair alternatives.
4. Investigate the undermining of the spillway apron and seepage/stability impacts.
5. Develop an Operations and Maintenance Manual for the dam.

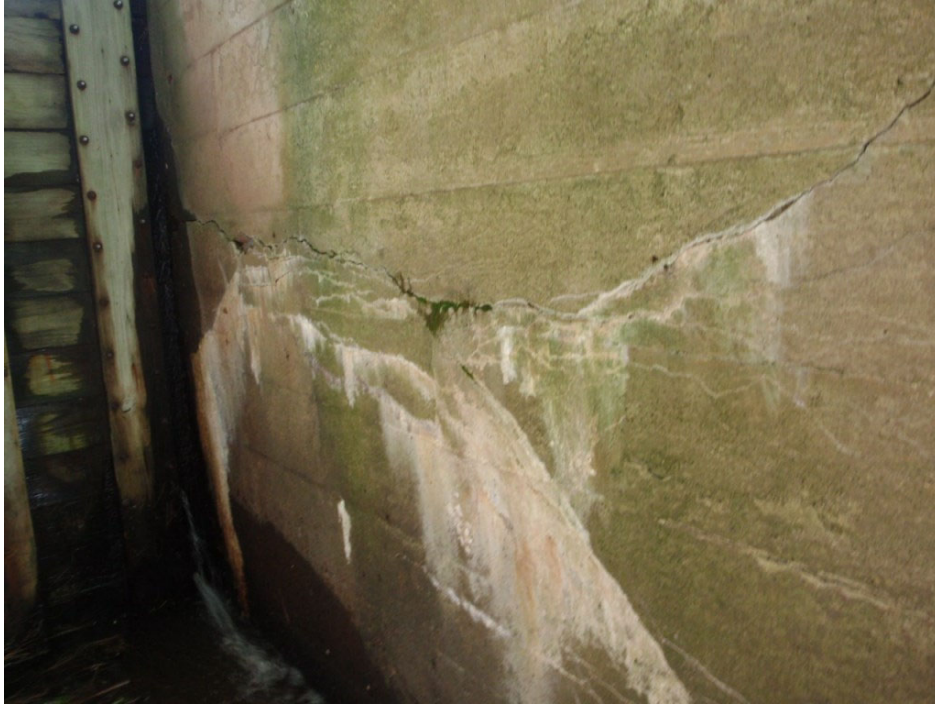
Photo 7: July 2014 looking upstream at the gate structure and wall separating the outlet from the spillway. Note the crack and deteriorated concrete.

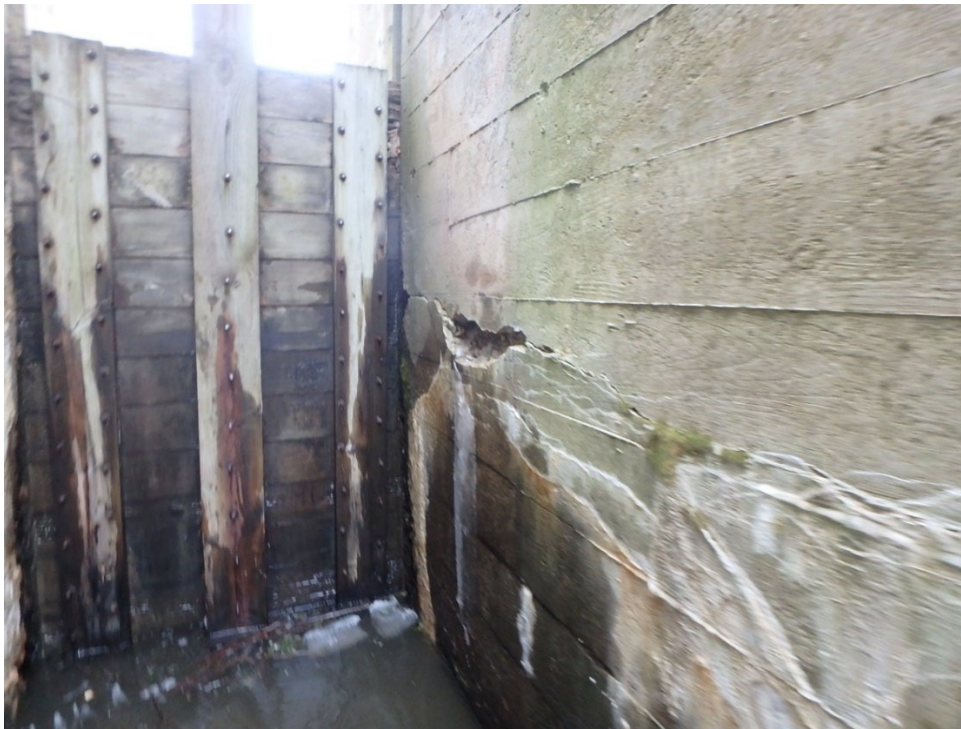
- **Auxiliary Spillway:** There is no auxiliary spillway at the dam.
- **Low Level Outlet/Drawdown Facility:** The outlet consists of a concrete channel and timber slide gate that can be opened to discharge flow/lower the impoundment. The gate was not test operated as part of the inspection, but the Owner reported the gate was last operated without issue in Fall 2020. The right concrete training wall of the outlet works is also the right abutment wall of the dam. The wall has a vertical crack between the main portion of the wall and the wing wall on the upstream side that has an opening up 2-inches. On the face of the wall at this location near the normal water level, an approximately 18-inch-deep section loss with exposed spalling concrete/aggregate was observed and appears to be worsening based on review of past inspection photographs. The wall appears to be tilted inwards towards the outlet/spillway on the order of 1 to 3 degrees, similar to the left wall dividing the outlet channel from the spillway. As noted above, the left wall is in poor condition, cracked at the gate contact, tilted towards the spillway, and undermined at the downstream end.

Photo 8: March 2021 looking upstream at the gate structure and wall separating the outlet from the spillway. Note the continued deterioration of concrete and displacement of the wall towards the spillway above the crack.

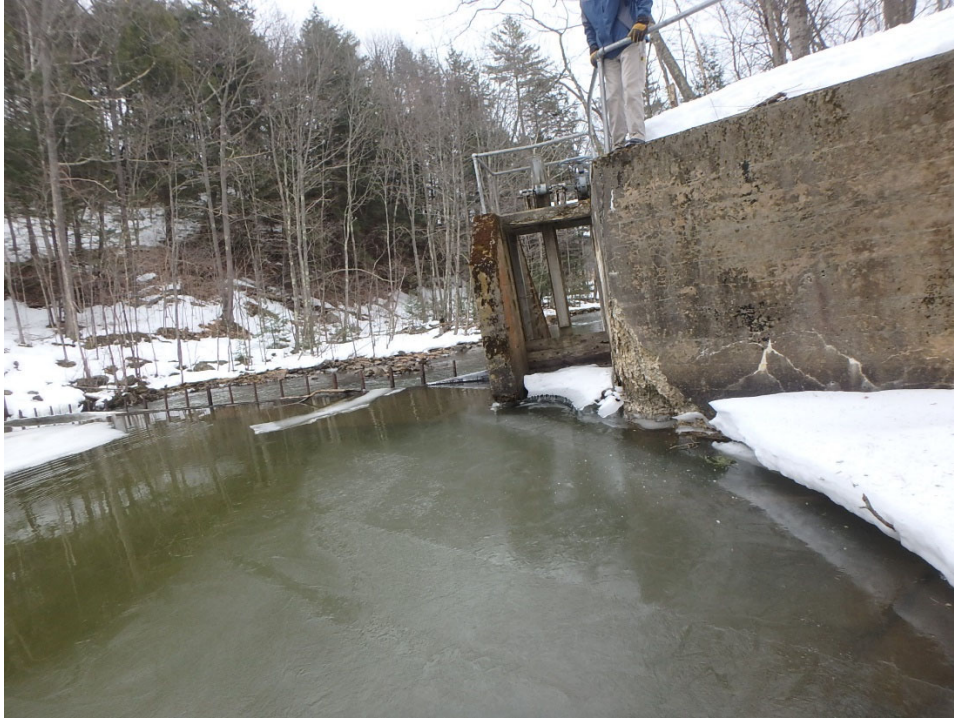
Photo 9: March 2021 looking downstream from the right abutment area. Note the section loss of the right training wall.
