MEMORANDUM

DATE: February 8, 2024

SUBJECT: Risk Reduction Measures
Prison Pond Dam, Windsor, Vermont
State ID No. 248.07
National ID No. VT00363

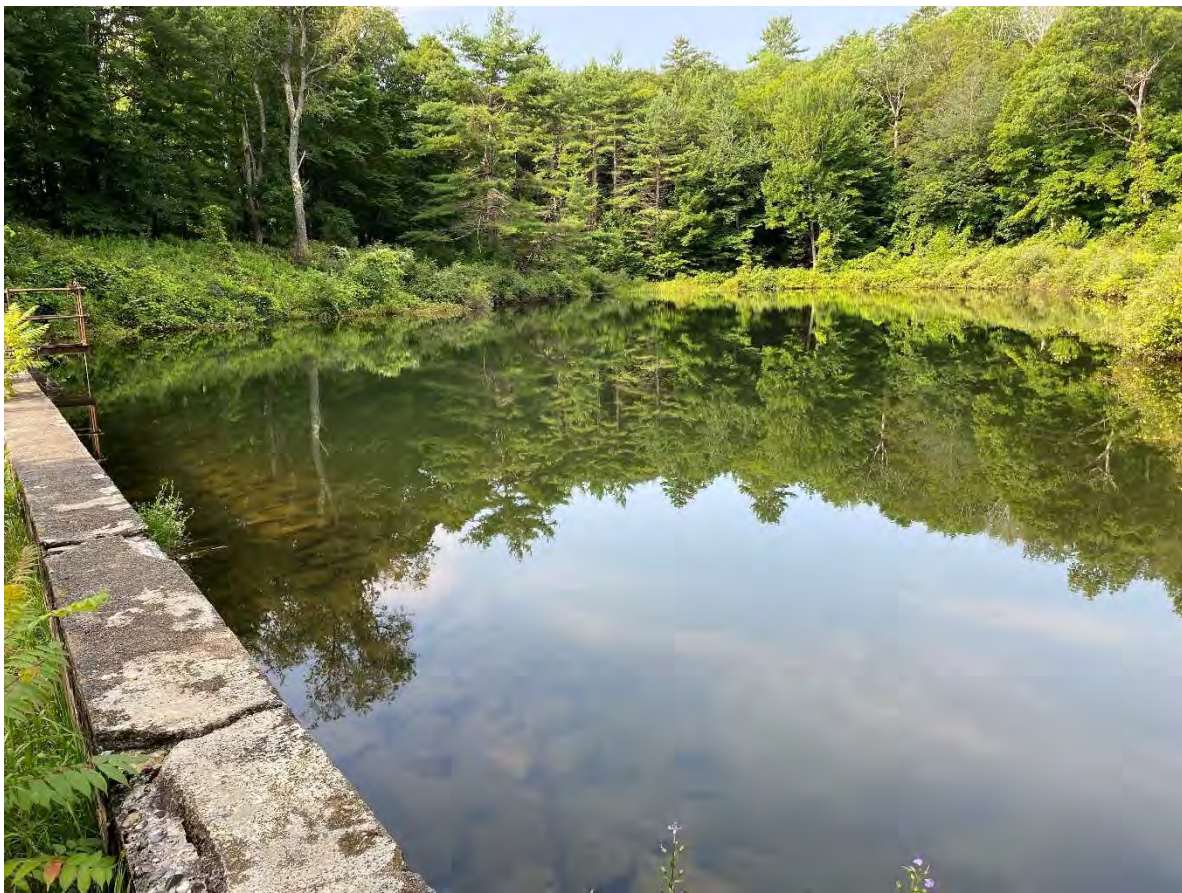
Upstream slope images

Upstream slope issues	Action
No upstream slope issues were observed during the inspection.	<input checked="" type="checkbox"/> None

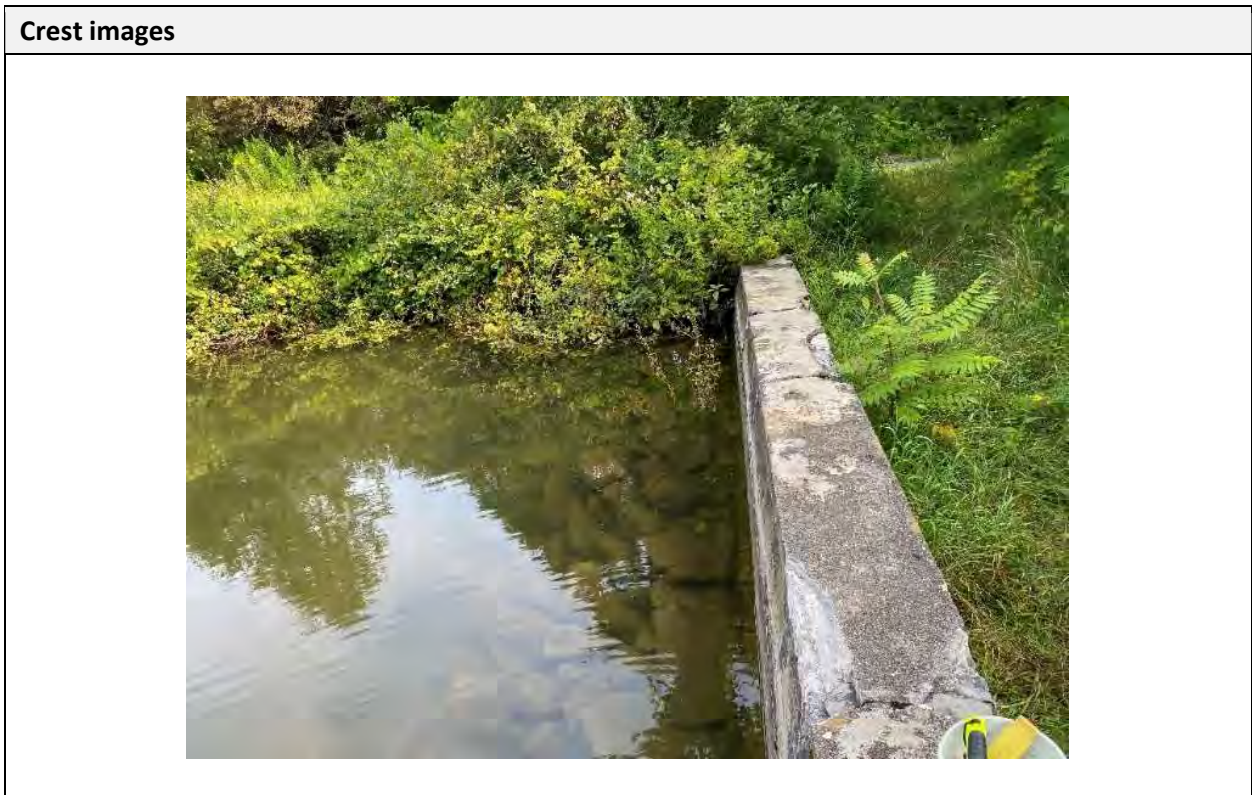
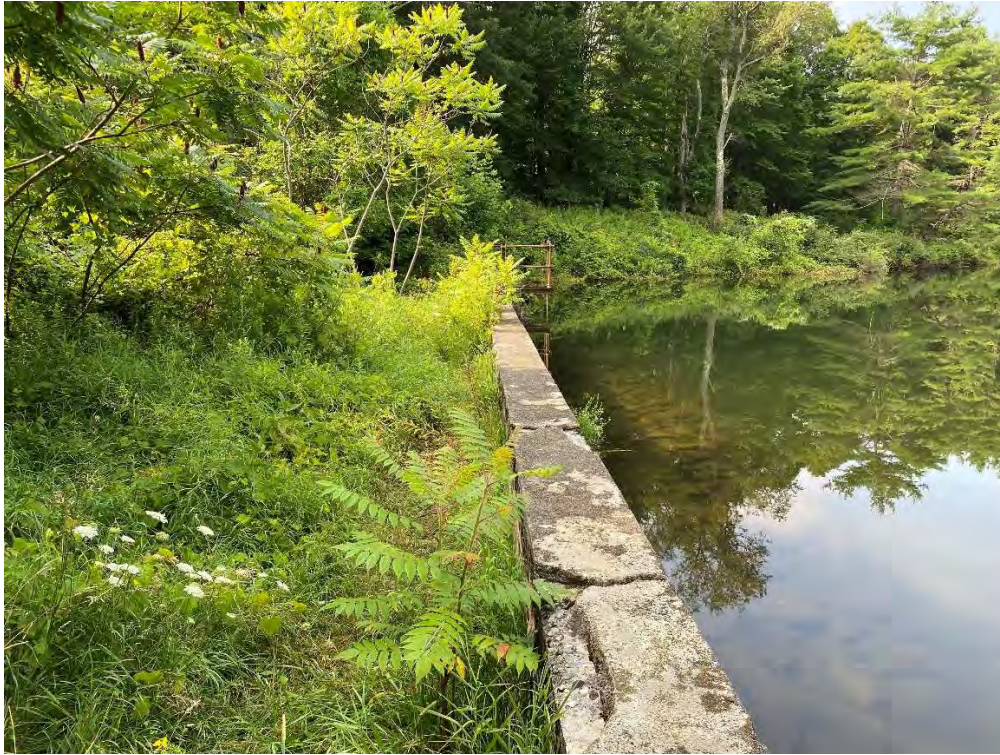
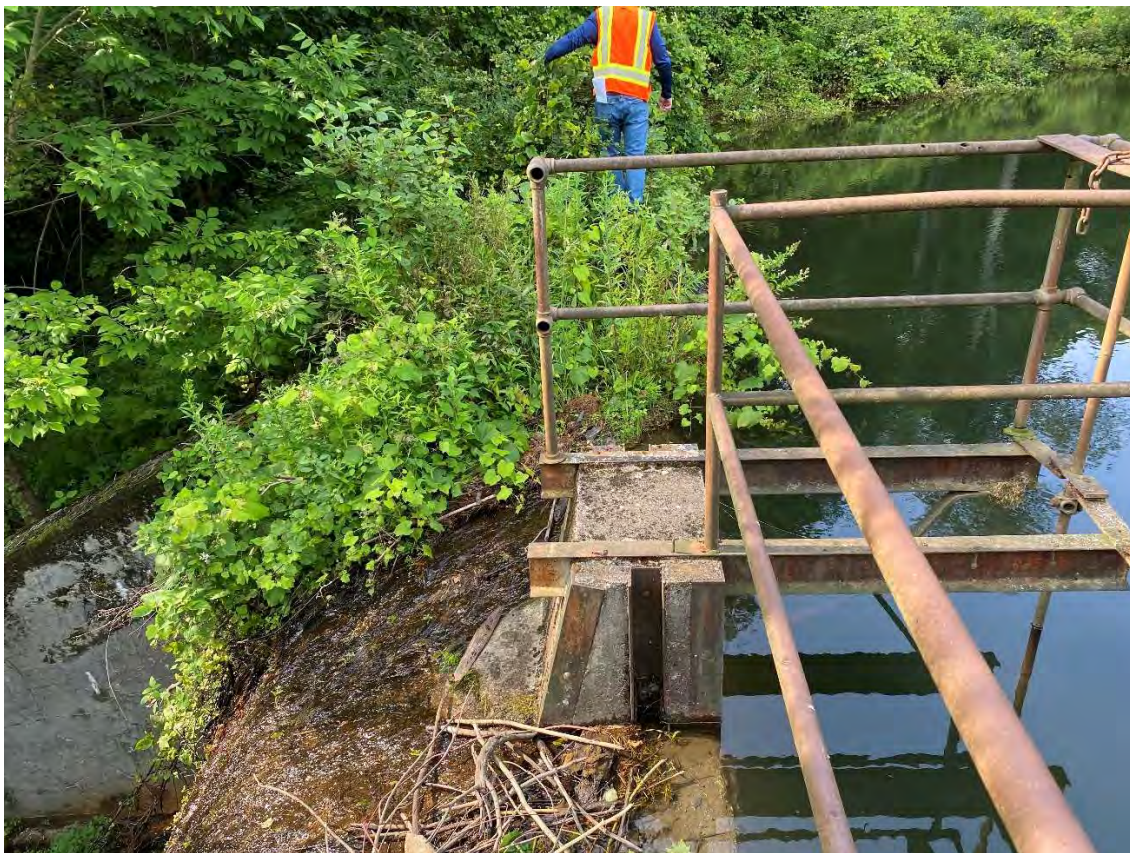
Crest images

Crest	
Length: 154 ft	Width: 1.5 ft
Freeboard: Principal spillway crest to dam crest: 2.3 ft	
Additional comments: It is unknown how far down the crest wall extends into the embankment. At the left abutment a concrete wing-wall extends upstream towards the impoundment. Reportedly this wingwall was installed to prevent the adjacent access road from being washed-out during rare flood events. Several joints along the top of the crest wall are deteriorating and missing material. There is evidence of past repairs made to address concrete spalling along the crest of the wall.

Crest issues	Action
Brush Coverage: Dense Location: Right End, Middle	<input type="checkbox"/> None <input type="checkbox"/> Monitor <input checked="" type="checkbox"/> Maintenance <input type="checkbox"/> Engineer
Missing Joint Material/Expansion of Joints Location: Entire Surface	<input type="checkbox"/> None <input checked="" type="checkbox"/> Monitor <input checked="" type="checkbox"/> Maintenance <input type="checkbox"/> Engineer

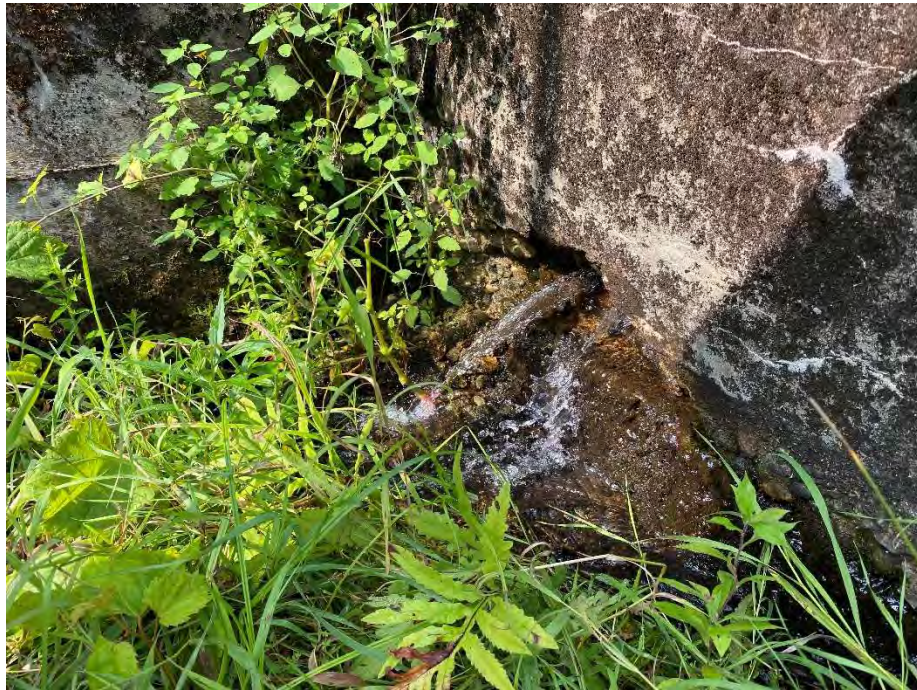
Concrete wall issues	Action
Concrete Deterioration While portions of the concrete seem solid based on sounding; there are areas of severe deterioration which result in leakage. These areas require an engineered repair solution.	<input type="checkbox"/> None <input checked="" type="checkbox"/> Monitor <input type="checkbox"/> Maintenance <input checked="" type="checkbox"/> Engineer
Leakage Flow rate: 8 GPM+ Location: To either side of spillway along concrete wall. Through deteriorating concrete joints and cracks in wall. Leakage resulting erosion of downstream slope along outsides of principal spillway training walls.	<input type="checkbox"/> None <input checked="" type="checkbox"/> Monitor <input type="checkbox"/> Maintenance <input checked="" type="checkbox"/> Engineer

Near intersection of left concrete wall with left spillway training wall.

<i>Structural/ Geotechnical</i>	<ul style="list-style-type: none"> Evaluate concrete deterioration, cracking, and leakage. Develop repair solution(s) to address leakage through the concrete crest wall and subsequent erosion of the downstream slope. Perform an engineered stability analysis of the dam and appurtenant structures such as the principal spillway training walls. Evaluate the appropriateness of either temporarily partially breaching the dam or buttressing the dam and its appurtenant structures until it is possible to proceed with removal/rehabilitation/replacement.

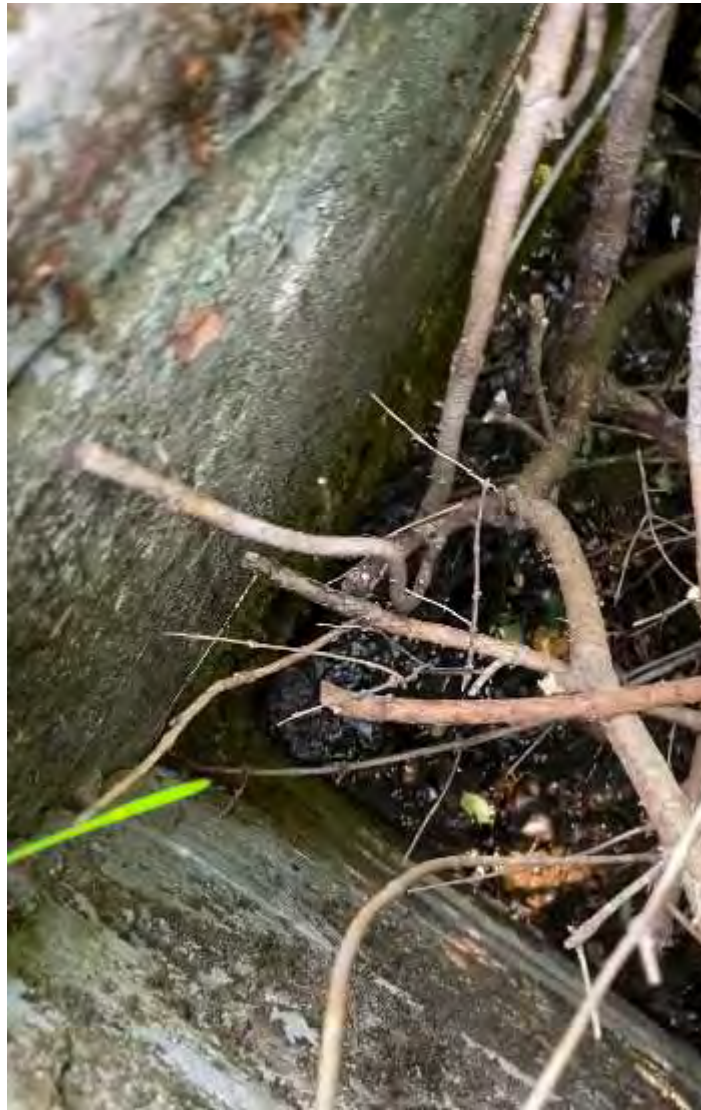
Near intersection of right concrete wall with right spillway training wall.

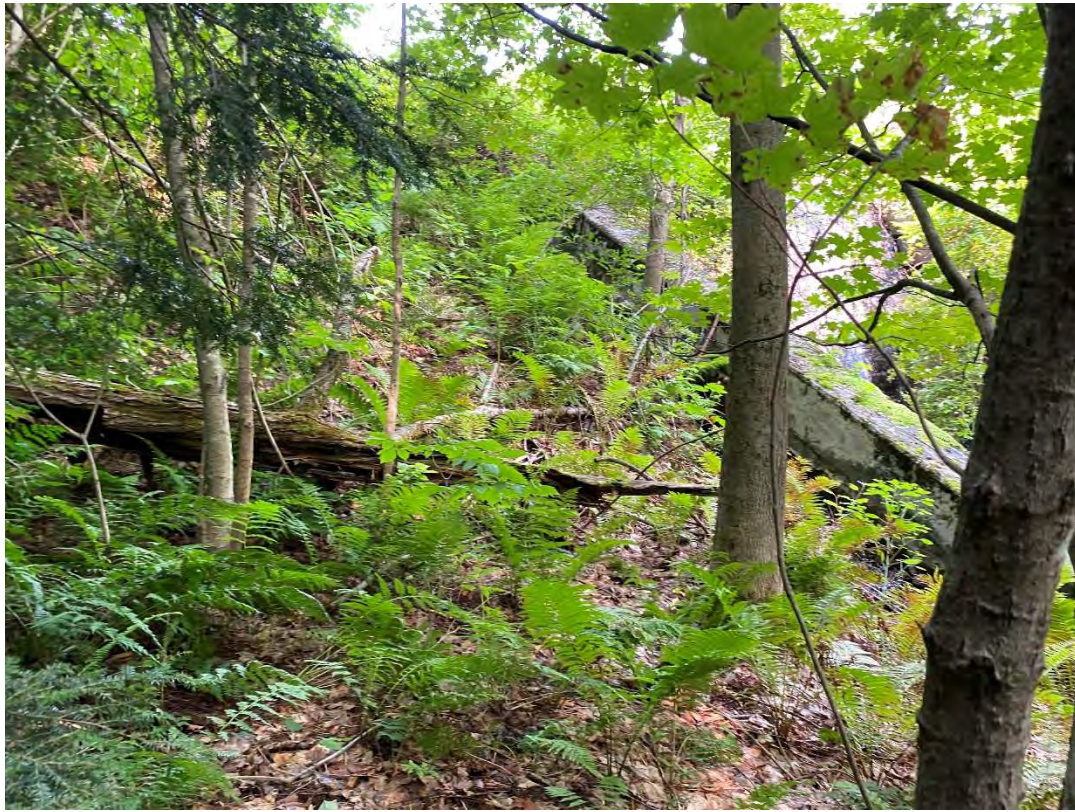
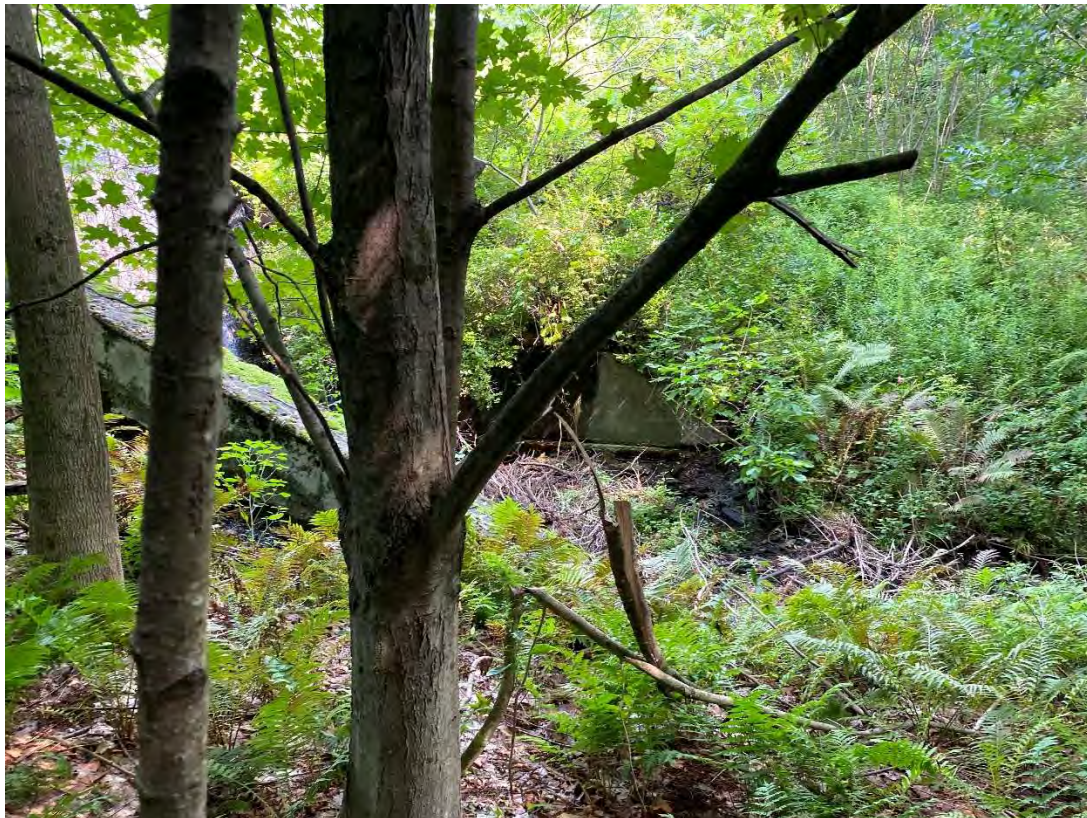
Downstream slope images

Additional comments: Downstream slope consists of earth fill located below the concrete wall portions of the dam. The downstream slope was densely vegetated which prevented thorough inspection. While no engineered stability analysis available exist on file, the presence of the downstream material is likely critical to the overall stability of the dam, and similarly the condition of the concrete crest wall and it is ability to function as a hydraulic cutoff is likely critical to the stability of the downstream slope.

Downstream slope protections	Action
<p>Vegetation Condition:</p> <p> <input type="checkbox"/> Adequate <input type="checkbox"/> Bare <input checked="" type="checkbox"/> Too tall <input type="checkbox"/> Improper <input type="checkbox"/> Sparse <input type="checkbox"/> Too short </p> <p>Comments: Overgrown, lack of maintenance.</p>	<p> <input type="checkbox"/> None <input type="checkbox"/> Monitor <input checked="" type="checkbox"/> Maintenance <input type="checkbox"/> Engineer </p>

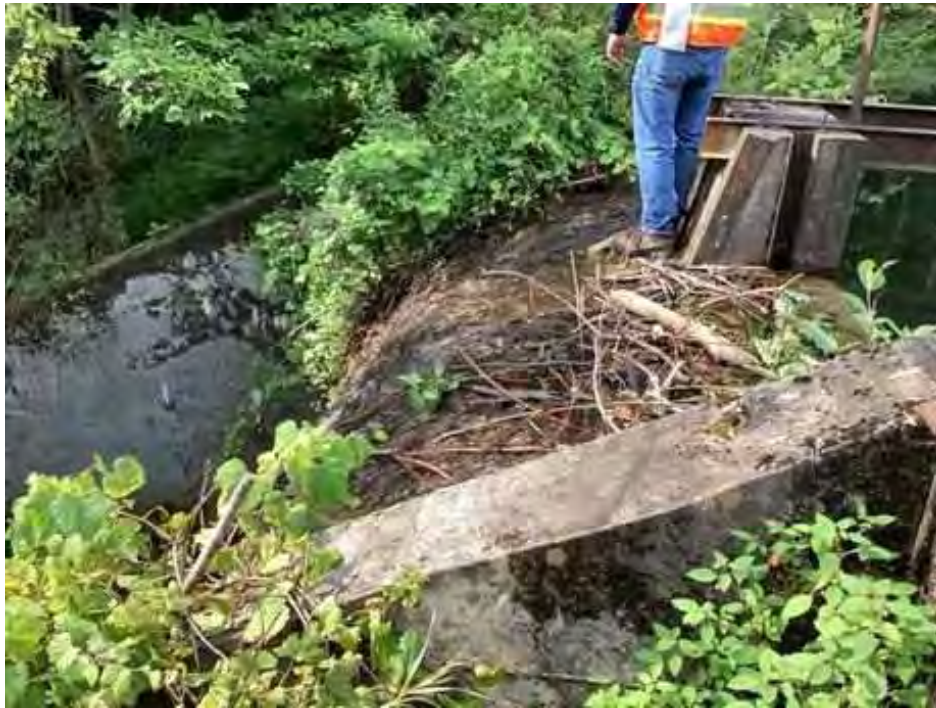
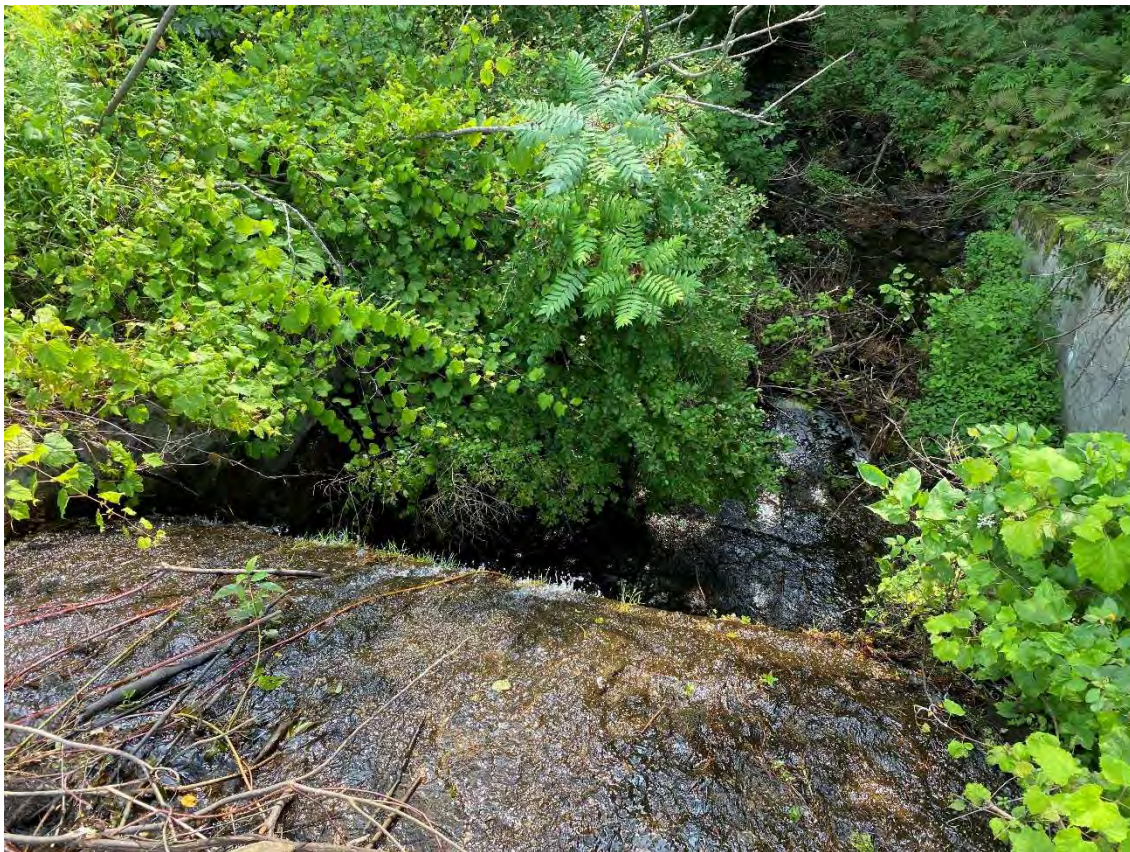
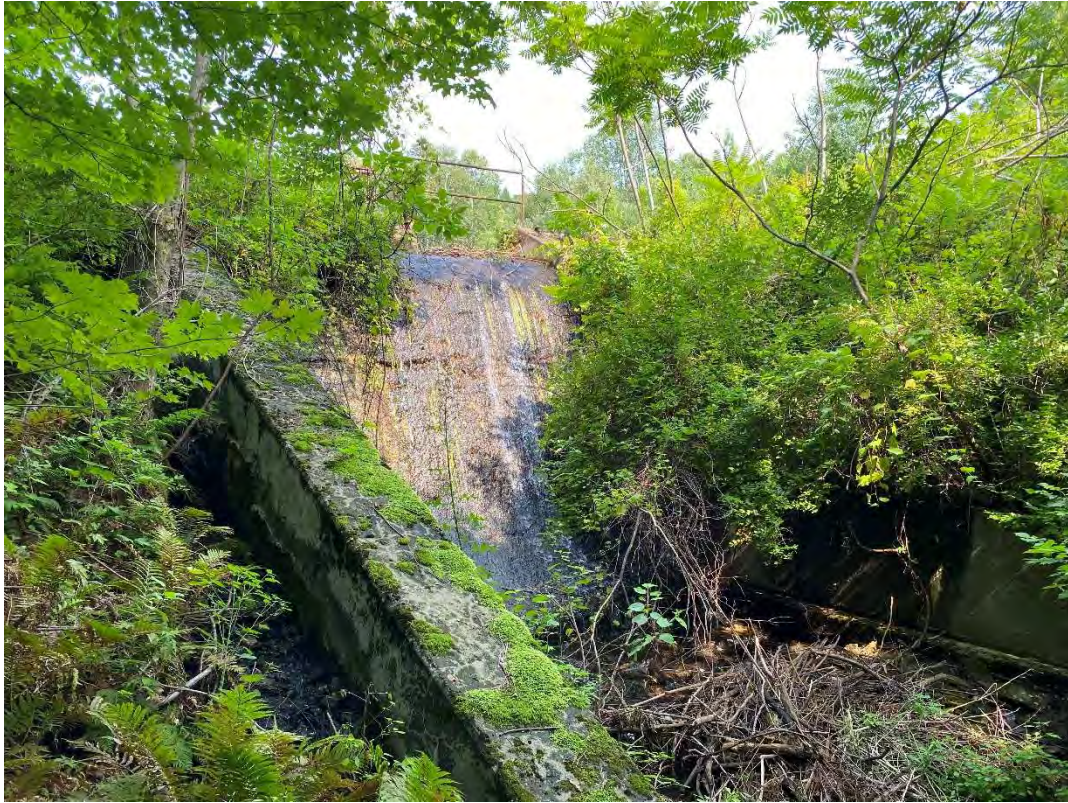
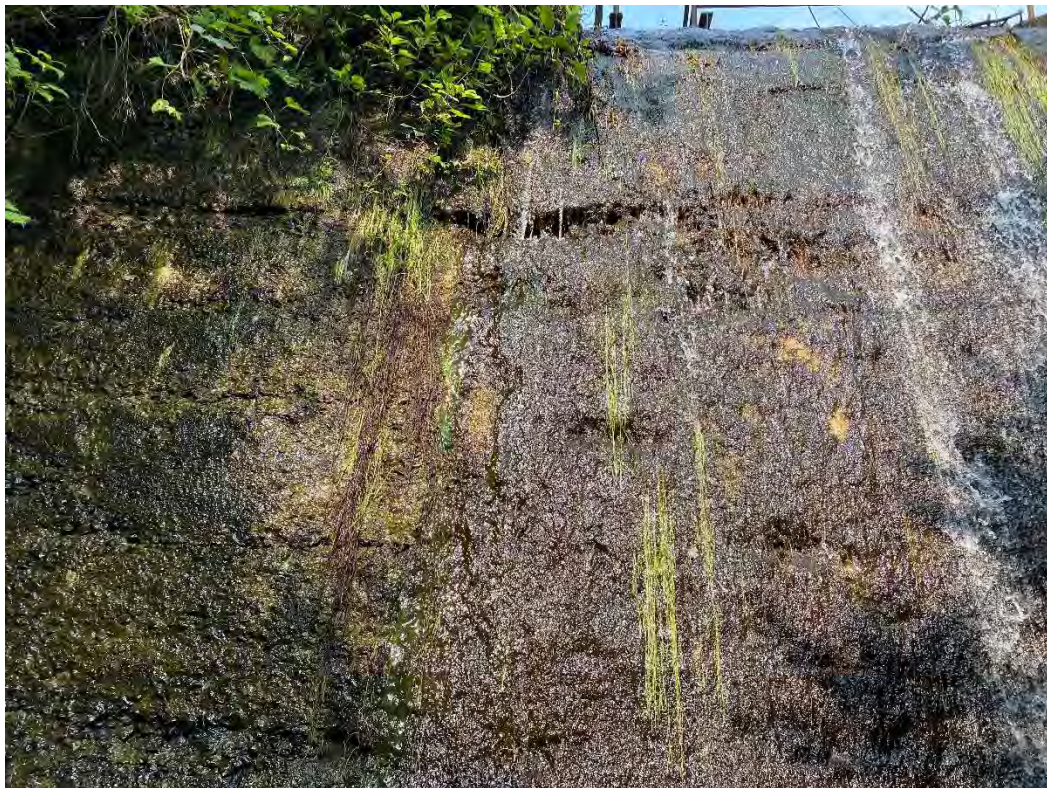
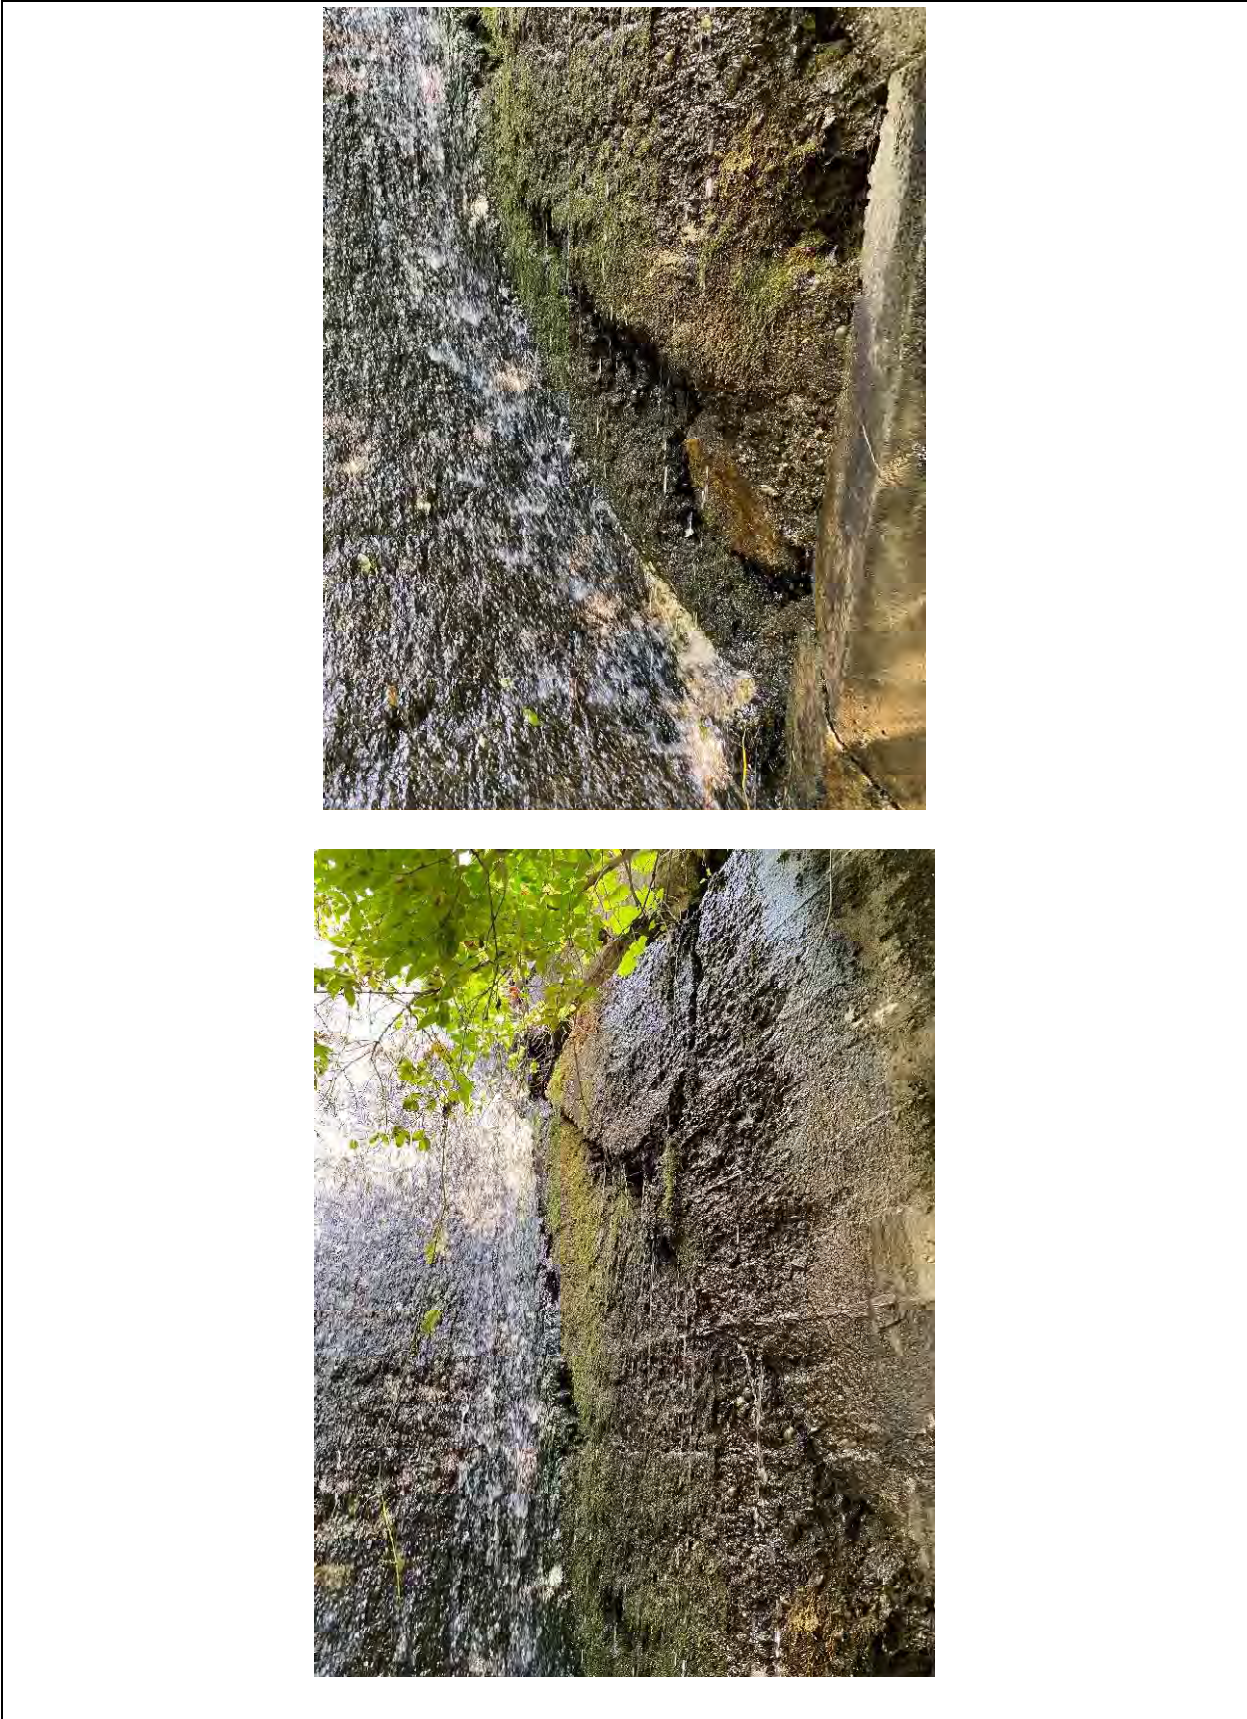
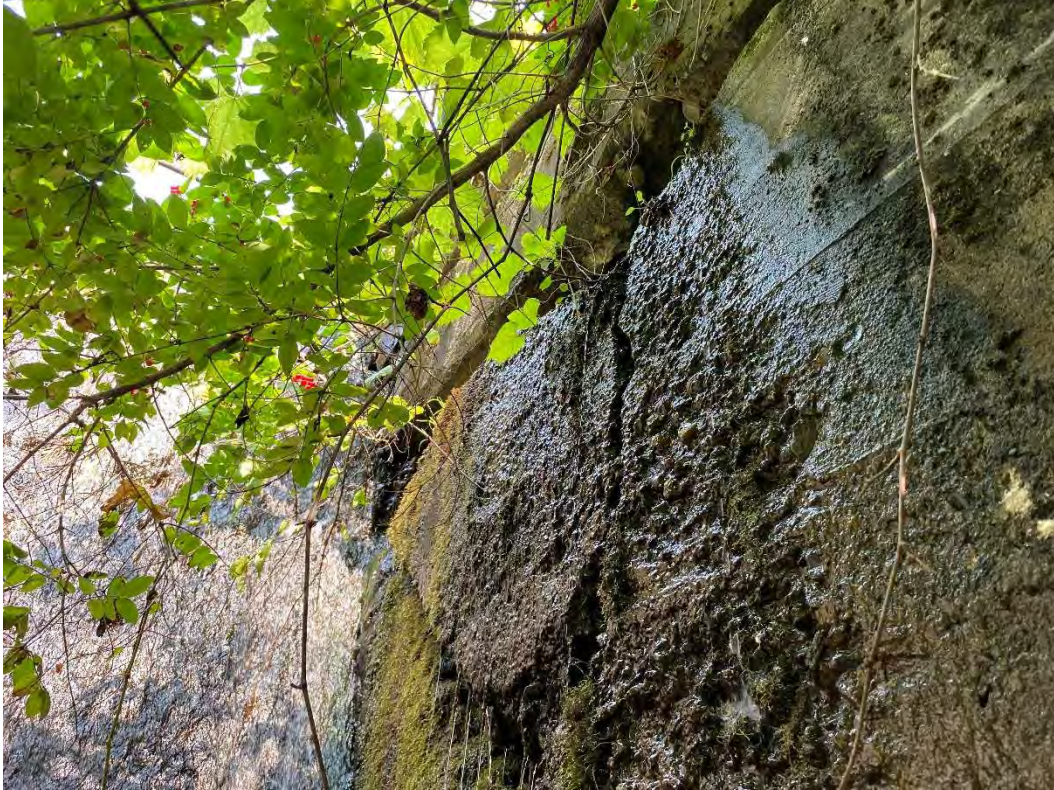
Principal spillway images

Principal Spillway	
Spillway type: Weir	Primary material: Concrete Weir: Ogee
Spillway location: Center of dam	Gate: Unknown
Water level measured against principal spillway crest: 1-inch above crest	Erosion control structures: Plunge Pool, Impact Basin, Rock-Lined Channel
Spillway components:	
<input type="checkbox"/> Anti-vortex plate	<input type="checkbox"/> Filter Diaphragm <input checked="" type="checkbox"/> Training Walls
<input type="checkbox"/> Flashboard	<input type="checkbox"/> Trash rack <input type="checkbox"/> Other:
<p>Additional comments: Water seeping through dam crest wall is running along the outside of the principal spillway training walls and eroding material. The base of the left concrete spillway training wall is being undermined. The left spillway training wall is more deteriorated than the right wall and has several cracks of considerable size. It appears the right wall was replaced or resurfaced more recently than the left wall. The surface of the spillway chute is slowly being eroded; deterioration is concentrating at vertical lift joints.</p>

<p>Location: Entire Surface</p>	<input type="checkbox"/> Bug holes	<input checked="" type="checkbox"/> Pop outs	<input type="checkbox"/> Isolated crack	<input type="checkbox"/> None	<input checked="" type="checkbox"/> Hairline crack	<input type="checkbox"/> Honeycombing	<input type="checkbox"/> Exposed rebar	<input checked="" type="checkbox"/> Monitor	<input checked="" type="checkbox"/> Efflorescence	<input checked="" type="checkbox"/> Scaling	<input type="checkbox"/> Disintegration	<input type="checkbox"/> Maintenance	<input checked="" type="checkbox"/> Spalling	<input type="checkbox"/> Crazed/Map cracks	<input type="checkbox"/> Other:	<input checked="" type="checkbox"/> Engineer	
<input type="checkbox"/> Bug holes	<input checked="" type="checkbox"/> Pop outs	<input type="checkbox"/> Isolated crack	<input type="checkbox"/> None														
<input checked="" type="checkbox"/> Hairline crack	<input type="checkbox"/> Honeycombing	<input type="checkbox"/> Exposed rebar	<input checked="" type="checkbox"/> Monitor														
<input checked="" type="checkbox"/> Efflorescence	<input checked="" type="checkbox"/> Scaling	<input type="checkbox"/> Disintegration	<input type="checkbox"/> Maintenance														
<input checked="" type="checkbox"/> Spalling	<input type="checkbox"/> Crazed/Map cracks	<input type="checkbox"/> Other:	<input checked="" type="checkbox"/> Engineer														
<p>Vegetation & Debris</p>	<input type="checkbox"/> None <input type="checkbox"/> Monitor <input checked="" type="checkbox"/> Maintenance <input type="checkbox"/> Engineer

<i>Spillways</i>	<ul style="list-style-type: none"> Maintain the spillway free of debris to ensure free-flow conditions. Monitor and repair minor concrete cracking and deterioration. Monitor the condition of the concrete chute and training walls.

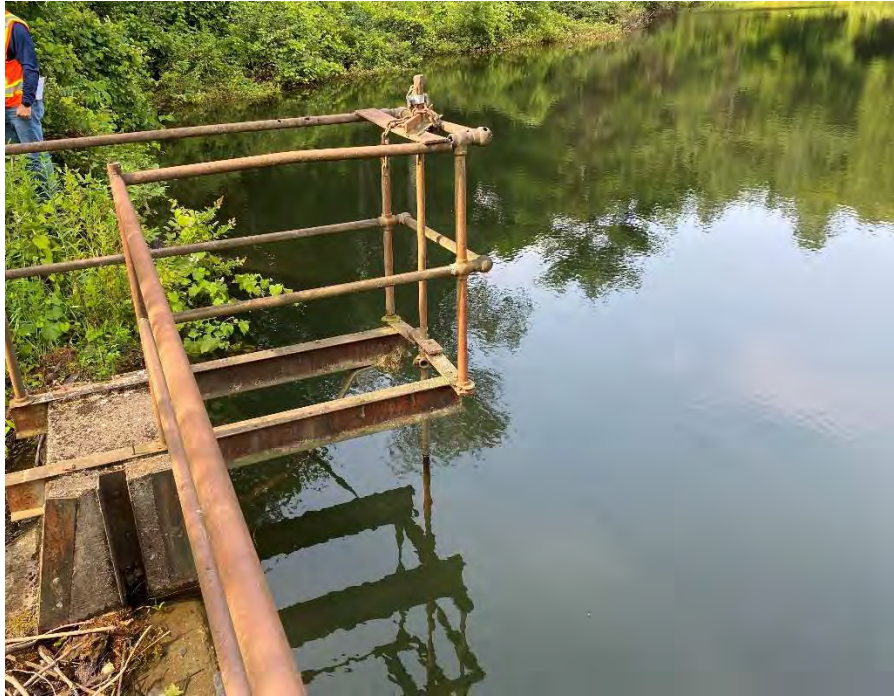
Outlet images

The dam reportedly includes a low-level-outlet which can be accessed from the middle of the principal spillway crest. The walkway which formerly provided access to this outlet has been removed and metal plates have been welded to the operator stem to “discourage vandalism”. The size of the pond drain is reportedly 15 to 18 inches in diameter. The dam also reportedly includes an 8-inch pipe which supplies water to the former prison facility. It is unclear if this pipe is also controlled by the same operating mechanism. Neither pipe was observable during the inspection, pipes are assumed to have been buried.
