Dam Safety Inspection Report

Name: **Prison Pond**
State ID: **248.07** NID ID: VT00363
Hazard Class: **Significant Hazard Potential**

Town: **Windsor**
Watershed: Mill Brook
Stream: Hubbard Brook-TR

Inspection date: 08/03/2023 14:18

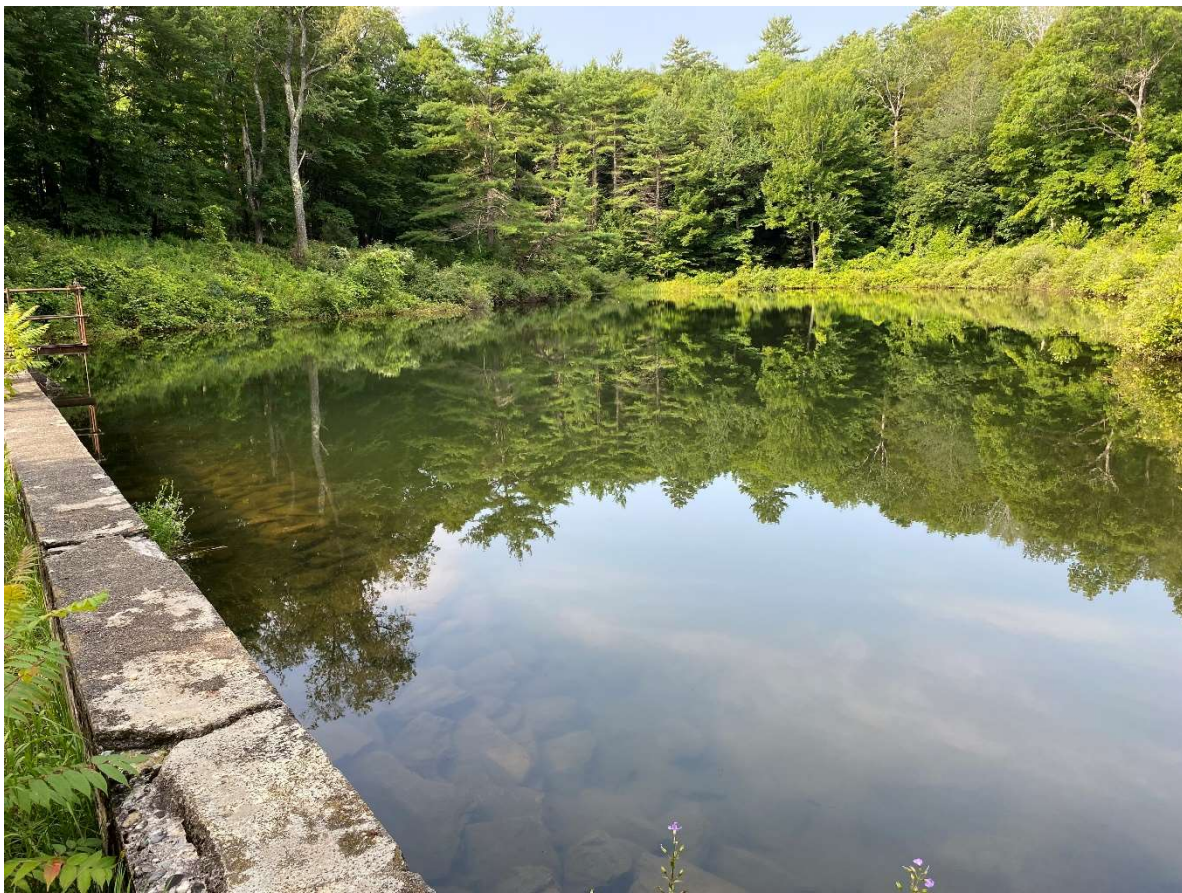
Upstream slope images

Additional comments: The upstream slope consists of stone fill which appears to include an approximately 5-foot-wide bench at the top of the slope. File records indicate the dam used to a stone fill structure. It is considered plausible that the current dam configuration may have been built on top of remaining portions of the original dam.

Upstream slope issues	Action
No upstream slope issues were observed during the inspection.	<input checked="" type="checkbox"/> None

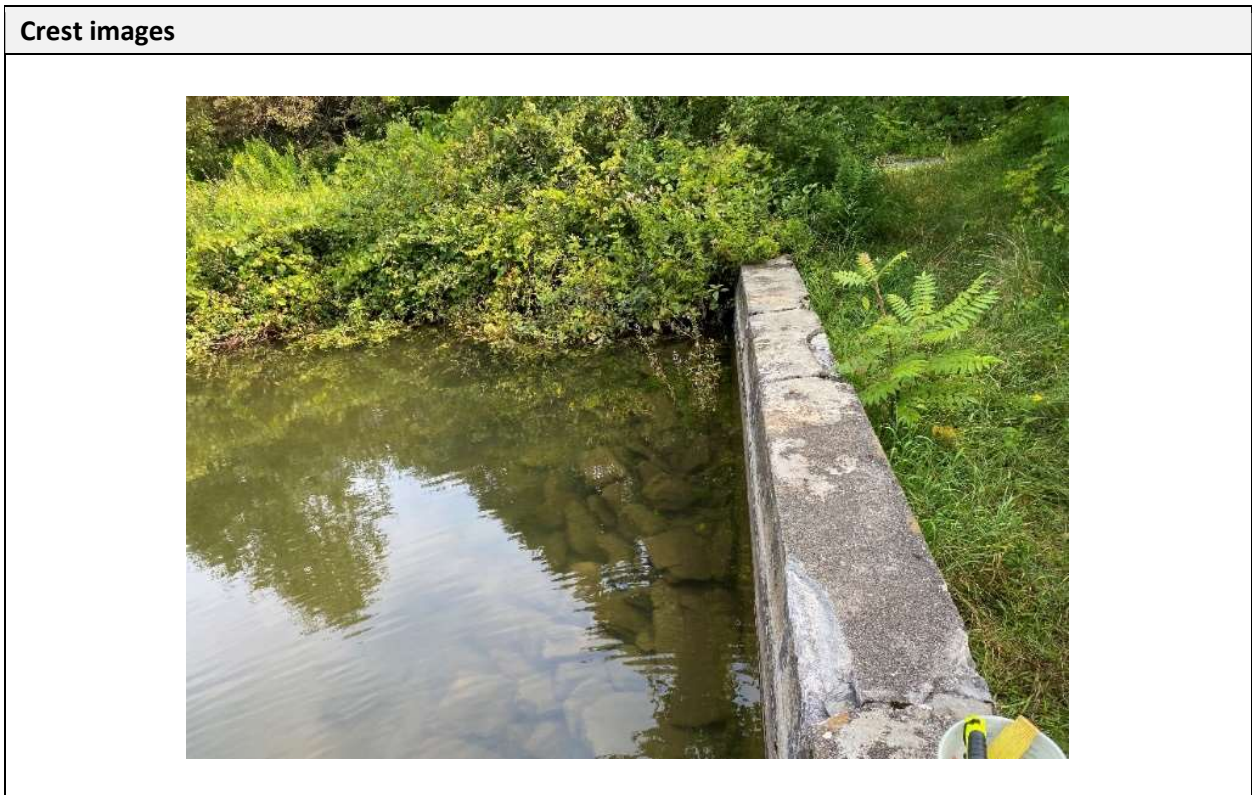
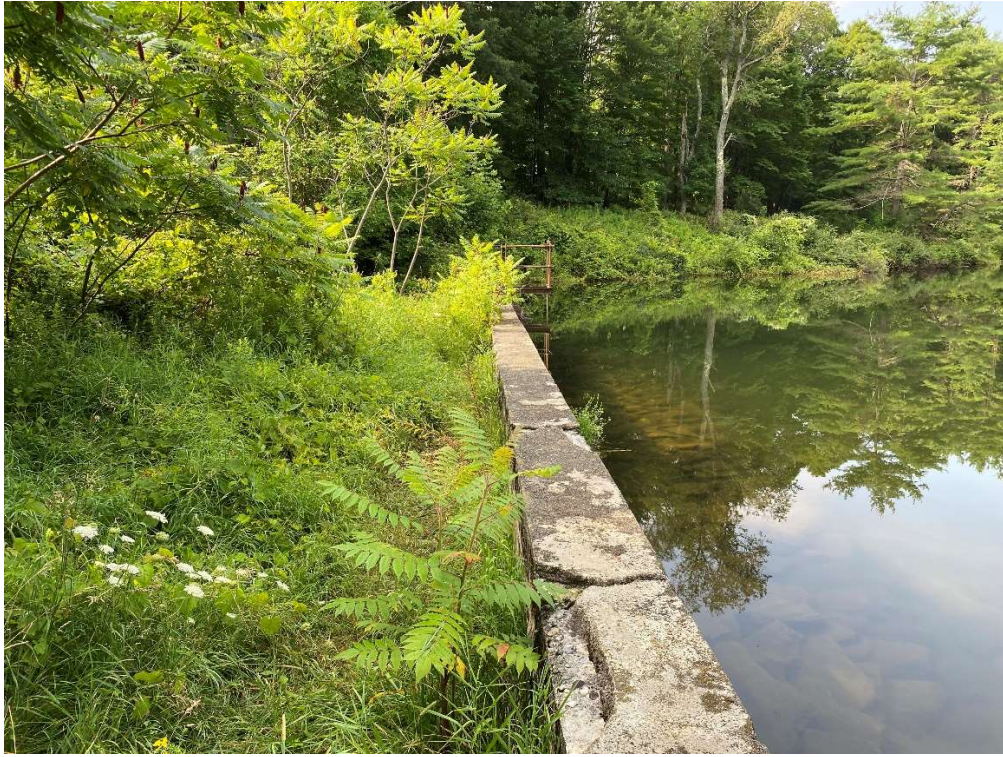
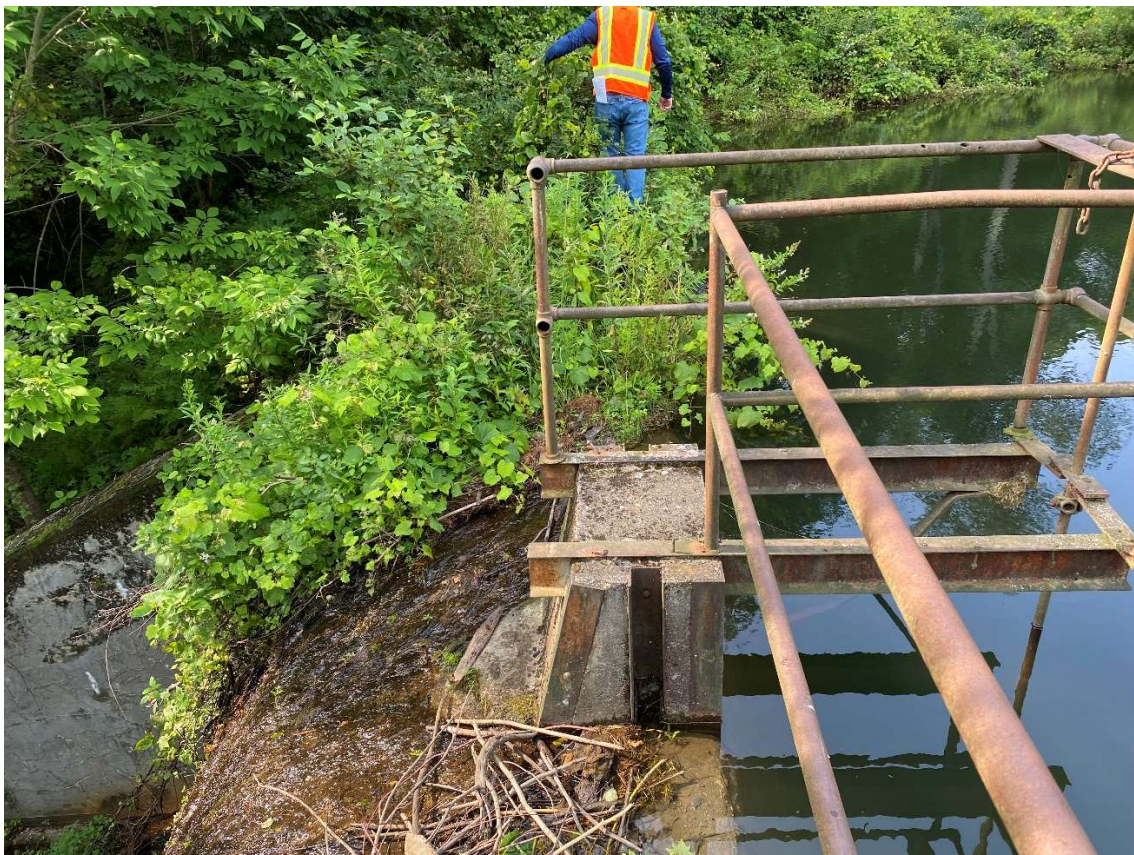
Crest images

Crest	
Length: 154 ft	Width: 1.5 ft
Freeboard: Principal spillway crest to dam crest: 2.3 ft	
Additional comments: It is unknown how far down the crest wall extends into the embankment. At the left abutment a concrete wing-wall extends upstream towards the impoundment. Reportedly this wingwall was installed to prevent the adjacent access road from being washed-out during rare flood events. Several joints along the top of the crest wall are deteriorating and missing material. There is evidence of past repairs made to address concrete spalling along the crest of the wall.

Crest issues	Action
Brush Coverage: Dense Location: Right End, Middle	<input type="checkbox"/> None <input type="checkbox"/> Monitor <input checked="" type="checkbox"/> Maintenance <input type="checkbox"/> Engineer
Missing Joint Material/Expansion of Joints Location: Entire Surface	<input type="checkbox"/> None <input checked="" type="checkbox"/> Monitor <input checked="" type="checkbox"/> Maintenance <input type="checkbox"/> Engineer

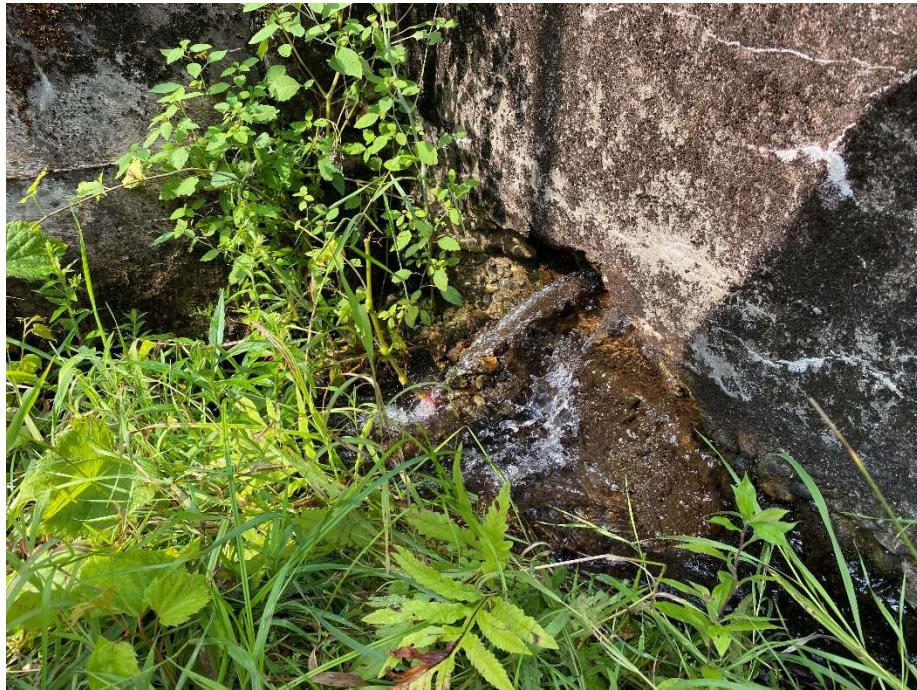
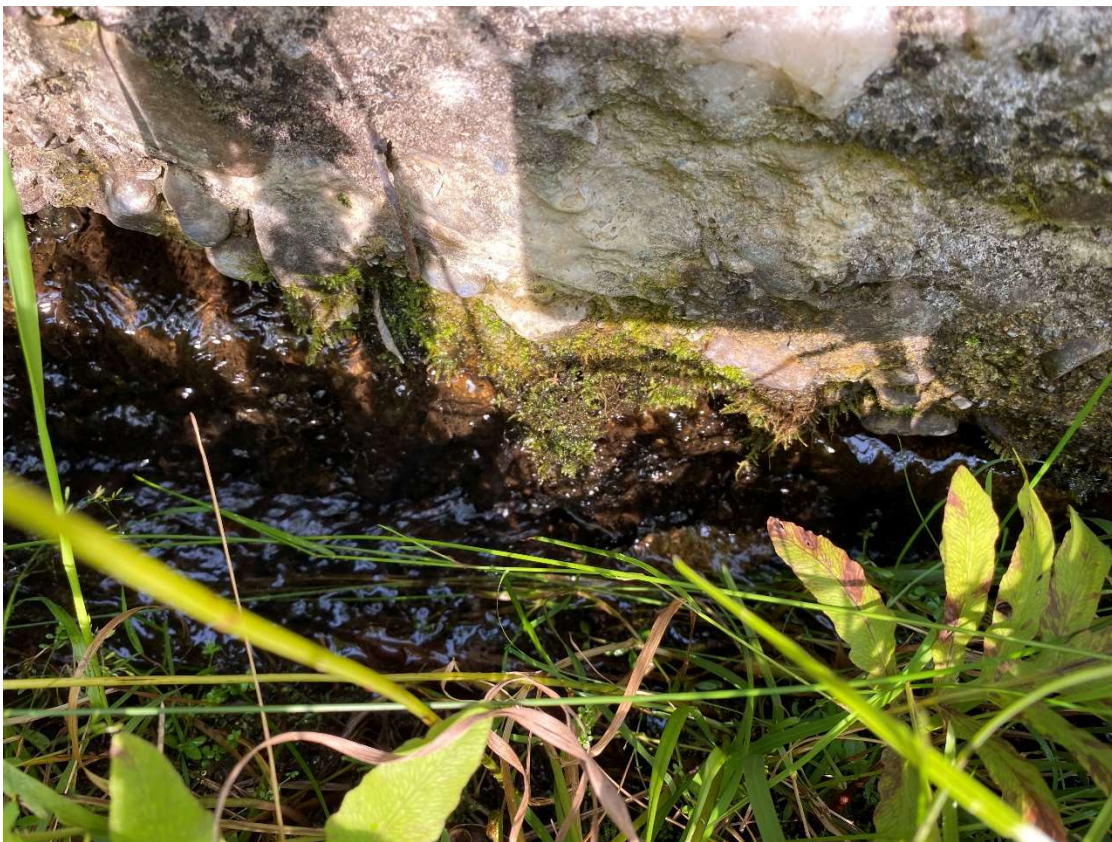
Concrete wall images

- The concrete crest wall to the left and right of the spillway is cracked resulting uncontrolled leakage. This is causing erosion of the downstream embankment and if left unchecked could potentially lead to dam failure. Additionally due to the deteriorated condition of this concrete wall, there is an elevated risk of the wall failing due to inadequate strength to resist loading conditions. A measure to maintain a lower water level which does not result in uncontrolled leakage under normal conditions should be implemented as soon as possible to mitigate the likelihood and potential risks of dam failure. The water level should be maintained at the lower level until remedial repairs are implemented and approved.

Concrete wall issues	Action
Concrete Deterioration While portions of the concrete seem solid based on sounding; there are areas of severe deterioration which result in leakage. These areas require an engineered repair solution.	<input type="checkbox"/> None <input checked="" type="checkbox"/> Monitor <input type="checkbox"/> Maintenance <input checked="" type="checkbox"/> Engineer
Leakage Flow rate: 8 GPM+ Location: To either side of spillway along concrete wall. Through deteriorating concrete joints and cracks in wall. Leakage resulting erosion of downstream slope along outsides of principal spillway training walls.	<input type="checkbox"/> None <input checked="" type="checkbox"/> Monitor <input type="checkbox"/> Maintenance <input checked="" type="checkbox"/> Engineer

Near intersection of left concrete wall with left spillway training wall.

<i>Structural/ Geotechnical</i>	<ul style="list-style-type: none"> • Evaluate concrete deterioration, cracking, and leakage. Develop repair solution(s) to address leakage through the concrete crest wall and subsequent erosion of the downstream slope. • Perform an engineered stability analysis of the dam and appurtenant structures such as the principal spillway training walls. • Evaluate the appropriateness of either temporarily partially breaching the dam or buttressing the dam and its appurtenant structures until it is possible to proceed with removal/rehabilitation/replacement.

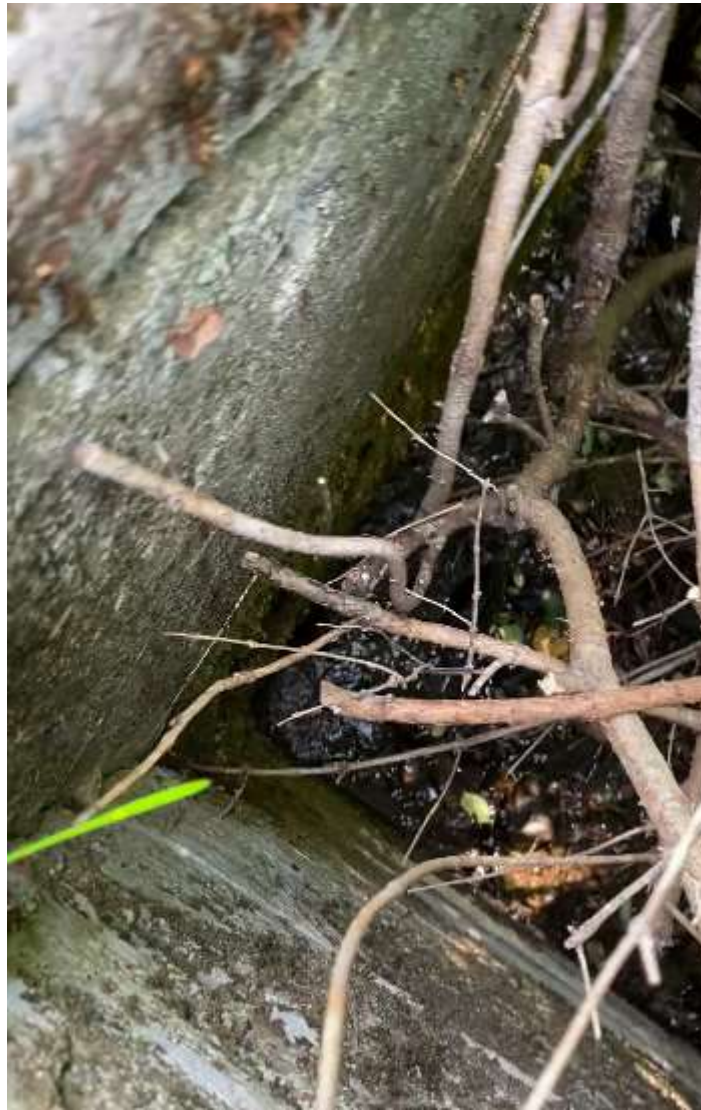
Concrete wall images

Near intersection of right concrete wall with right spillway training wall.

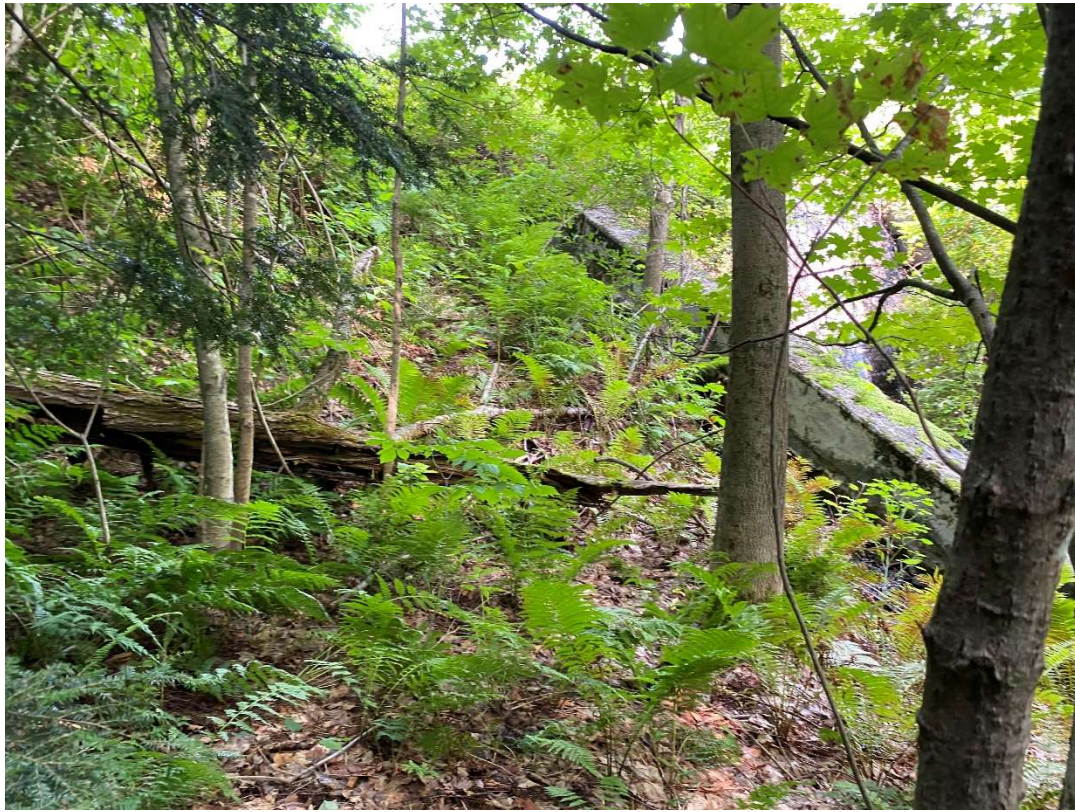
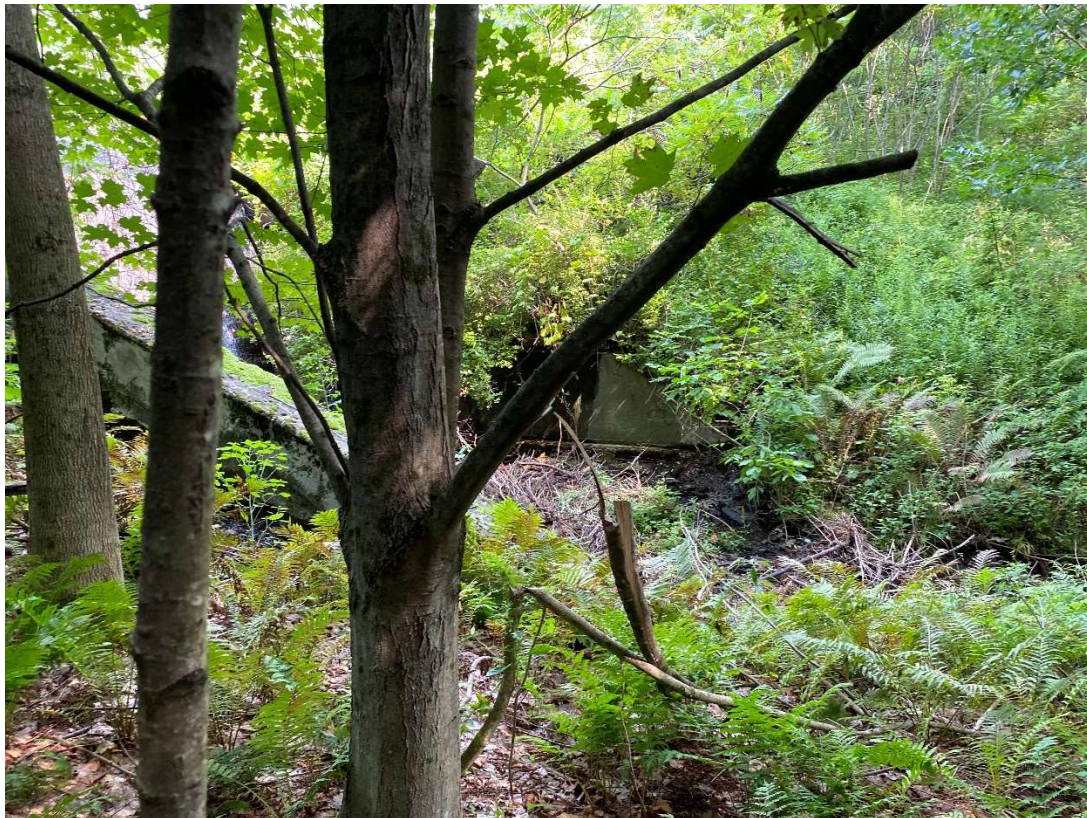
Downstream slope images

Additional comments: Downstream slope consists of earth fill located below the concrete wall portions of the dam. The downstream slope was densely vegetated which prevented thorough inspection. While no engineered stability analysis available exist on file, the presence of the downstream material is likely critical to the overall stability of the dam, and similarly the condition of the concrete crest wall and its ability to function as a hydraulic cutoff is likely critical to the stability of the downstream slope.

Downstream slope issues	Action
<p>Trees Location: Entire Surface</p>	<p> <input type="checkbox"/> None <input type="checkbox"/> Monitor <input checked="" type="checkbox"/> Maintenance <input type="checkbox"/> Engineer </p>
<p>Wet Areas Location: Toe of right downstream slope.</p>	<p> <input type="checkbox"/> None <input checked="" type="checkbox"/> Monitor <input type="checkbox"/> Maintenance <input type="checkbox"/> Engineer </p>

<i>Upstream Slope</i>	<ul style="list-style-type: none"> Monitor the condition of the stone fill on the reportedly over-steepened upstream slope.
<i>Crest area</i>	<ul style="list-style-type: none"> Monitor the dam crest for signs of settlement. Monitor the condition of the concrete joints. Remove debris from the joints and re-install sealant.
<i>Concrete Walls</i>	<ul style="list-style-type: none"> Monitor the concrete surface conditions. Perform minor surficial repairs as needed. Monitor the upstream/downstream concrete/stone masonry walls for unusual movement, and changes in leakage.
<i>Downstream Slope</i>	<ul style="list-style-type: none"> Monitor the reportedly over-steepened downstream slope. Monitor the area of erosion along the outside of the principal spillway training walls. Repair/temporarily stabilize erosion by placing stone. Monitor wet area below right downstream slope for changes.

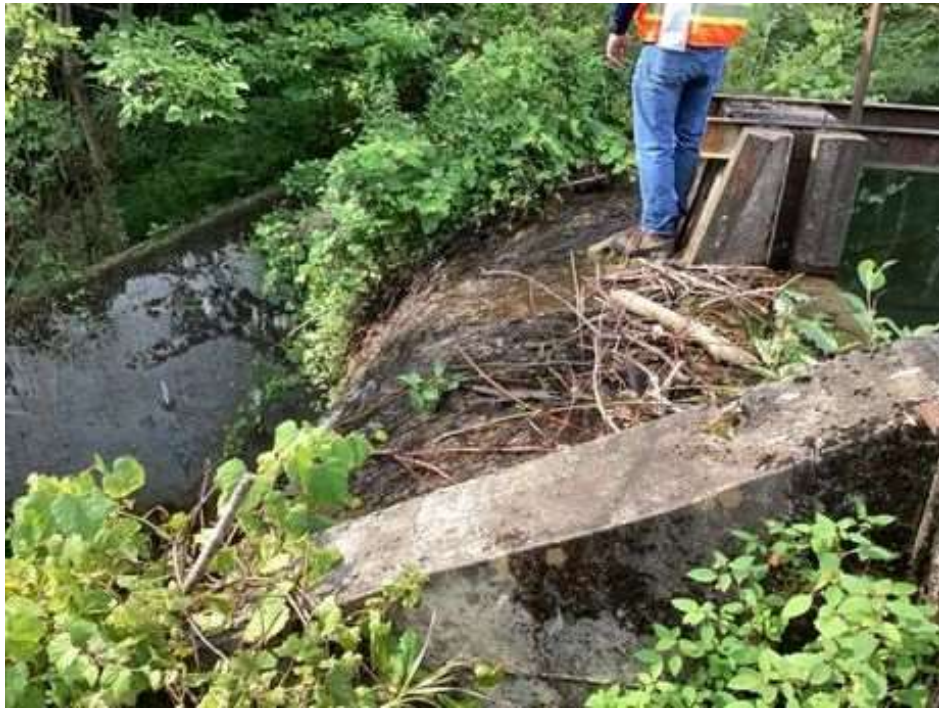
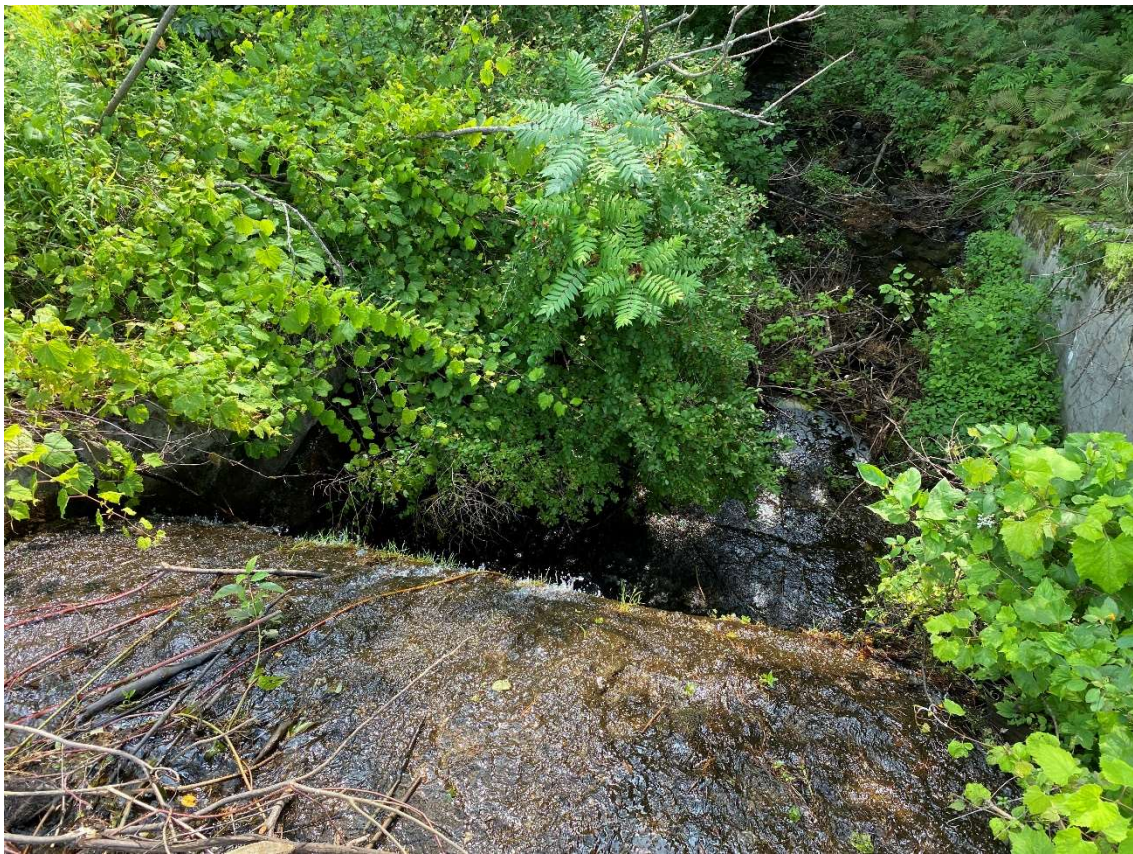
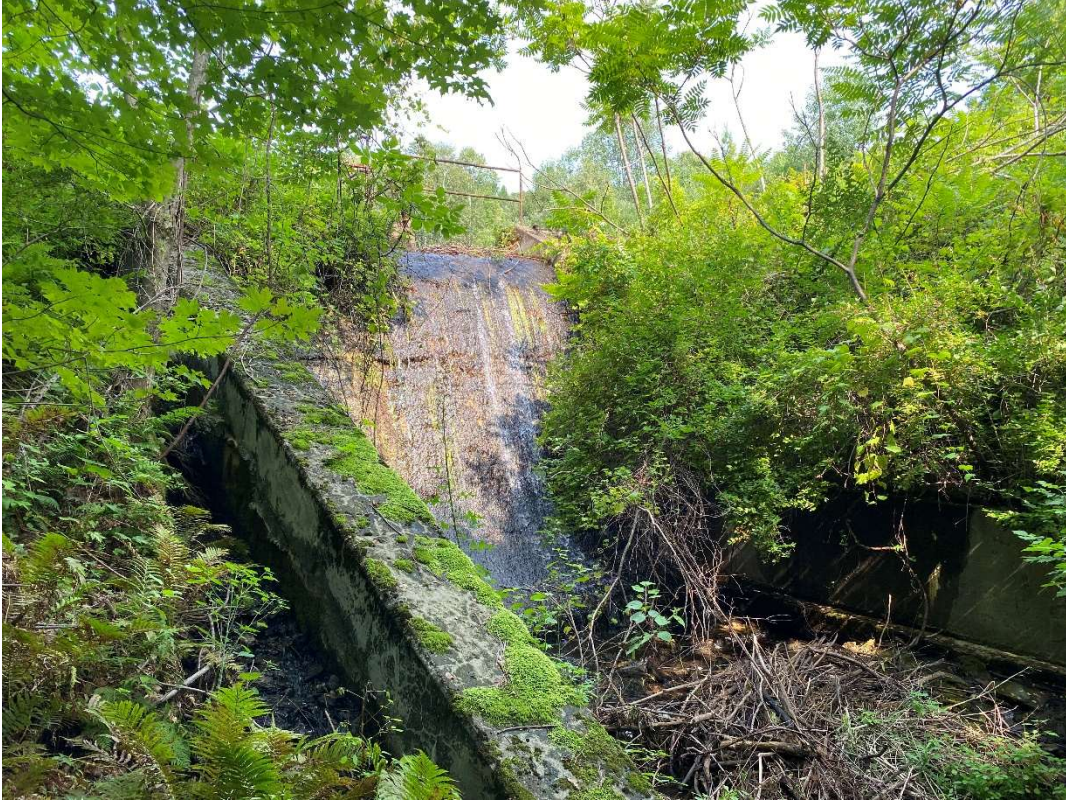
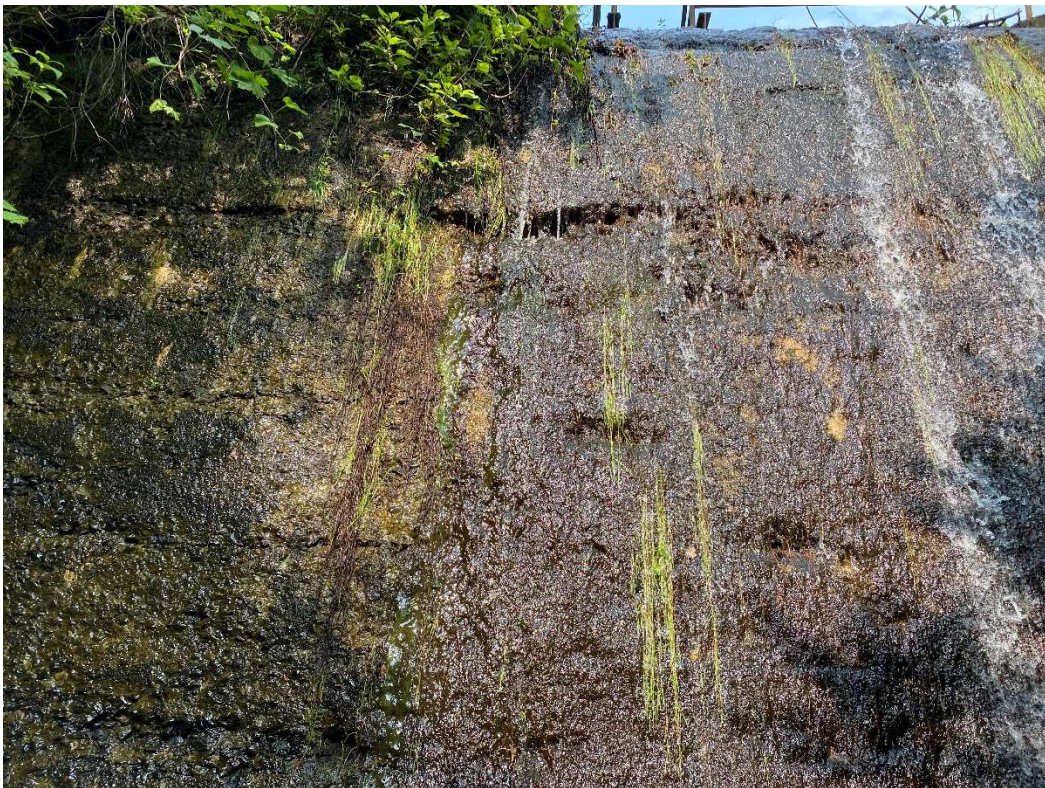
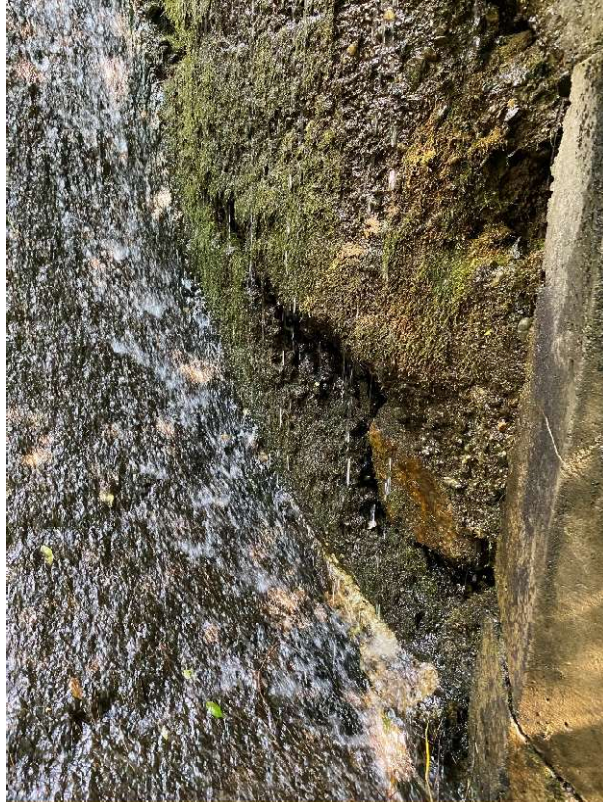
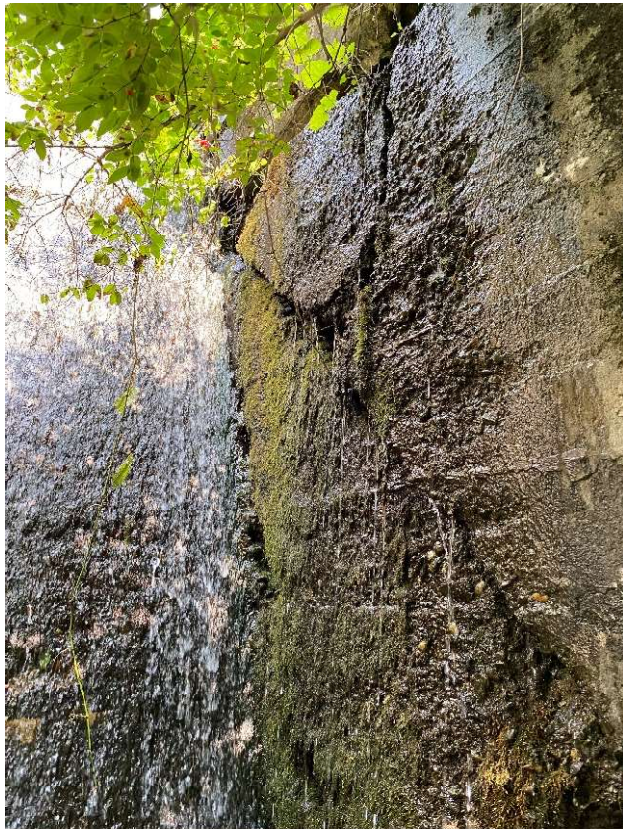
Principal spillway images

Principal Spillway	
Spillway type: Weir	Primary material: Concrete Weir: Ogee
Spillway location: Center of dam	Gate: Unknown
Water level measured against principal spillway crest: 1-inch above crest	Erosion control structures: Plunge Pool, Impact Basin, Rock-Lined Channel
Spillway components:	
<input type="checkbox"/> Anti-vortex plate	<input type="checkbox"/> Filter Diaphragm <input checked="" type="checkbox"/> Training Walls
<input type="checkbox"/> Flashboard	<input type="checkbox"/> Trash rack <input type="checkbox"/> Other:
<p>Additional comments: Water seeping through dam crest wall is running along the outside of the principal spillway training walls and eroding material. The base of the left concrete spillway training wall is being undermined. The left spillway training wall is more deteriorated than the right wall and has several cracks of considerable size. It appears the right wall was replaced or resurfaced more recently than the left wall. The surface of the spillway chute is slowly being eroded; deterioration is concentrating at vertical lift joints.</p>

<p>Location: Entire Surface</p>	<input type="checkbox"/> Bug holes	<input checked="" type="checkbox"/> Pop outs	<input type="checkbox"/> Isolated crack	<input type="checkbox"/> None	<input checked="" type="checkbox"/> Hairline crack	<input type="checkbox"/> Honeycombing	<input type="checkbox"/> Exposed rebar	<input checked="" type="checkbox"/> Monitor	<input checked="" type="checkbox"/> Efflorescence	<input checked="" type="checkbox"/> Scaling	<input type="checkbox"/> Disintegration	<input type="checkbox"/> Maintenance	<input checked="" type="checkbox"/> Spalling	<input type="checkbox"/> Crazed/Map cracks	<input type="checkbox"/> Other:	<input checked="" type="checkbox"/> Engineer	
<input type="checkbox"/> Bug holes	<input checked="" type="checkbox"/> Pop outs	<input type="checkbox"/> Isolated crack	<input type="checkbox"/> None														
<input checked="" type="checkbox"/> Hairline crack	<input type="checkbox"/> Honeycombing	<input type="checkbox"/> Exposed rebar	<input checked="" type="checkbox"/> Monitor														
<input checked="" type="checkbox"/> Efflorescence	<input checked="" type="checkbox"/> Scaling	<input type="checkbox"/> Disintegration	<input type="checkbox"/> Maintenance														
<input checked="" type="checkbox"/> Spalling	<input type="checkbox"/> Crazed/Map cracks	<input type="checkbox"/> Other:	<input checked="" type="checkbox"/> Engineer														
<p>Vegetation & Debris</p>	<input type="checkbox"/> None <input type="checkbox"/> Monitor <input checked="" type="checkbox"/> Maintenance <input type="checkbox"/> Engineer

<i>Spillways</i>	<ul style="list-style-type: none"> Maintain the spillway free of debris to ensure free-flow conditions. Monitor and repair minor concrete cracking and deterioration. Monitor the condition of the concrete chute and training walls.

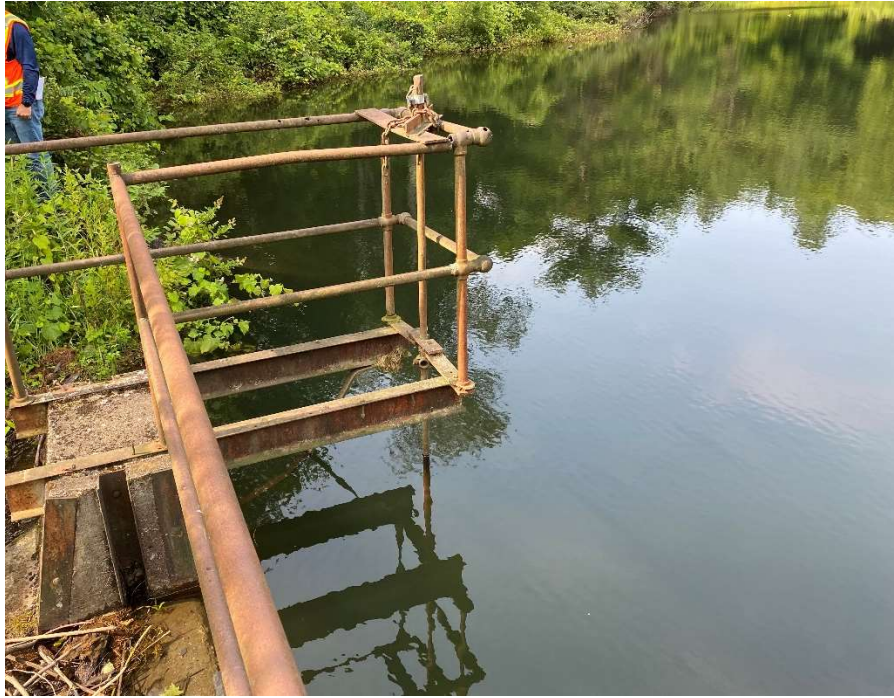
Outlet images

The dam reportedly includes a low-level-outlet which can be accessed from the middle of the principal spillway crest. The walkway which formerly provided access to this outlet has been removed and metal plates have been welded to the operator stem to “discourage vandalism”. The size of the pond drain is reportedly 15 to 18 inches in diameter. The dam also reportedly includes an 8-inch pipe which supplies water to the former prison facility. It is unclear if this pipe is also controlled by the same operating mechanism. Neither pipe was observable during the inspection, pipes are assumed to have been buried.
