Detecting and Eliminating Illicit Discharges in the Stevens Branch Watershed and Stowe

Final Report

February 19, 2016

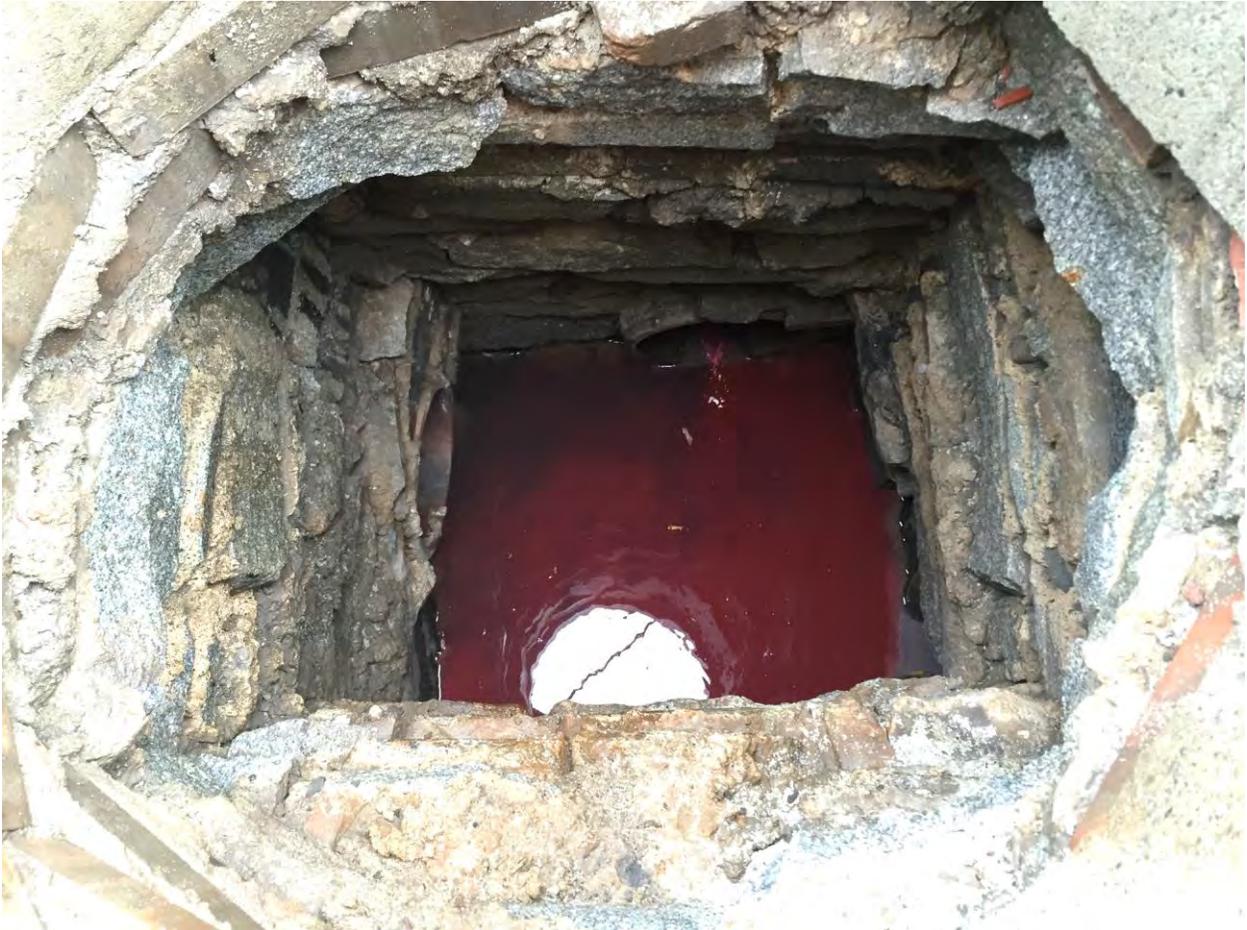
Dye (and wastewater) flowing from a leaking sewer main into a catchbasin on Hill Street in Barre, November 24, 2015. Two leaking sections of the sewer main were replaced in December, 2015.

- On November 24, 2015, Everett Hoyt (Barre Public Works) and Dave Braun (Stone) dye tested a toilet at 204 Hill Street and the Hill Street sanitary sewer main below Woodland Drive (by flushing dye at 2 Woodland Drive). In both tests, dye was observed in the storm sewer at manhole MH11. Using the City’s tracked camera (Figure 8), we determined that dye (and wastewater) were crossing into the storm sewer at a pipe joint 231 feet below MH12.

Conclusions: Wastewater was leaking into the storm drain from the sewer main on Hill Street between Woodland Drive and Nelson Street. Questions remain about the sewer connection for the house at 204 Hill Street.

section of broken pipe and a possible broken pipe bell were observed within the first 30 feet of pipe. Ultimately, two dilapidated sections of pipe on Hill Street between Nelson Street and Woodland Drive were excavated and replaced by Public Works. It is unclear whether the sewer service for 204 Hill Street was found. The connection may have been in a dilapidated section of pipe or the house sewer may in fact be directly connected to the storm line. The Department of Public Works has arranged with the owner of 204 Hill Street to have the sewer lateral replaced when conditions permit in the spring.

Resolution: Two sections of dilapidated sewer pipe were excavated and replaced to eliminate flow of wastewater to the storm drain. When conditions permit in the spring, the City has committed to working with the homeowner at 204 Hill Street to ensure a proper house sewer connection is constructed.

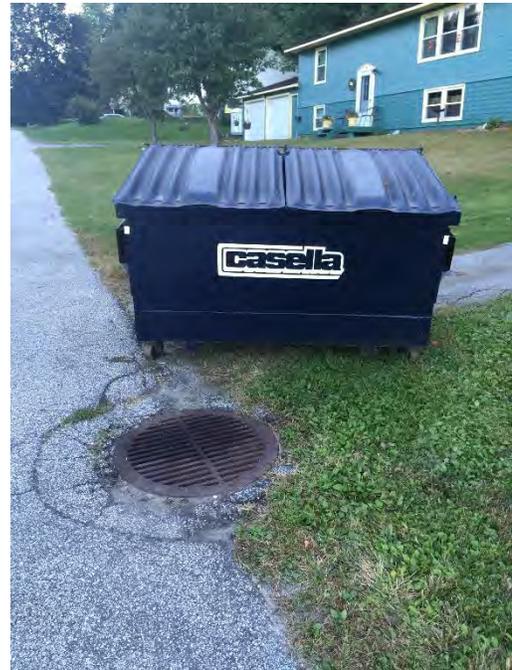
Figure 2. Oil on catchbasin grate

- On September 23, 2015, a petroleum odor was observed in catchbasin CB12 and oily residue was observed in catchbasin CB13 on Palmisano Plaza (Map BC-1). Note that CB13 is not mapped accurately; it is located in front of 31 Palmisano Plaza. The catchbasin grate had an oily appearance, indicating waste oil was recently dumped into the drain. A dumpster was located next to this catchbasin in front of 31 Palmisano Plaza (Figure 2).

- Mr. Micheli has spoken to the homeowners of 31 Palmisano Plaza advising them that discharging petroleum products or any other wastes to catchbasins is illegal. In our January 19, 2016 meeting, Mr. Micheli stated he would check on the issue periodically. If any further petroleum spill or dumping to the municipal drainage system occurs, Mr. Micheli will refer the matter to DEC enforcement.
- Stone recommends the City of Barre install placards on catchbasins on Westwood Parkway or a sign near the intersection of Westwood Parkway and Prospect Street advising residents not to dump wastes in catchbasins.
- Stone recommends dye testing of houses between catchbasins CB14 and CB15 to identify any possible graywater connections or leaking sewer laterals. Specifically, we recommend dye testing houses 8, 12, 16, and 20 Palmisano Plaza.

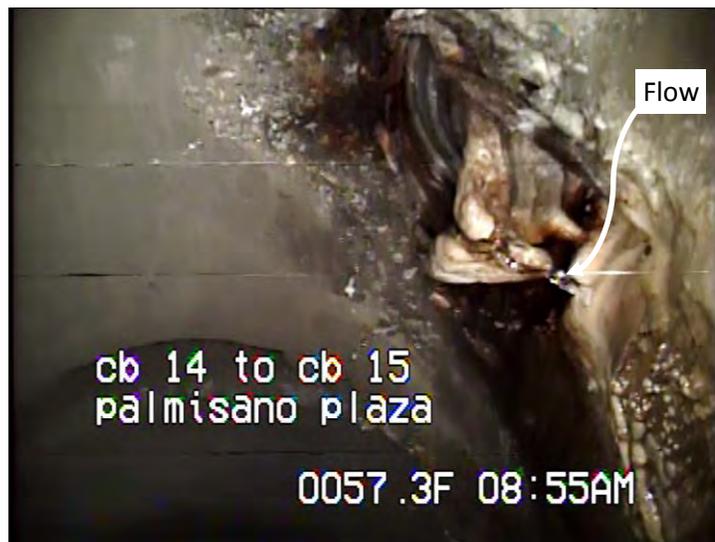
Figure 3. Flowing pipe 57 feet down storm sewer from CB14

- In mid-November, Everett Hoyt (City of Barre) TV'd the storm sewer from CB14 to CB15. There was clear flow the length of the pipe. There were pipe penetrations at 57 ft. (Figure 3), 87 ft., and 160 ft. and clear flow from the pipes at 57 and 160 ft.

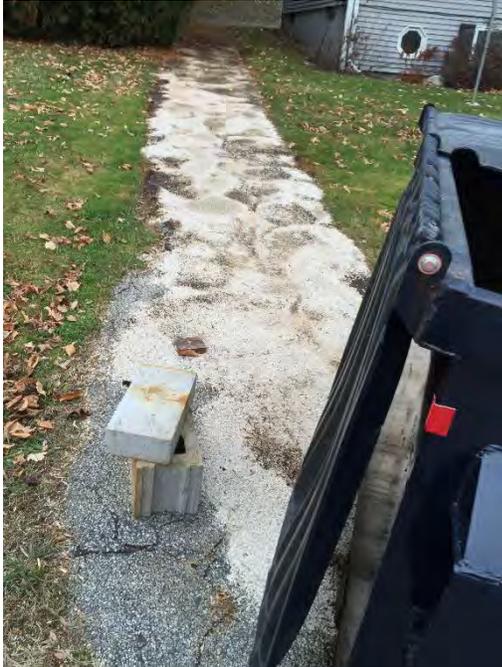
Figure 4. Path to 31 Palmisano Plaza; material apparently spread to absorb waste oil

- On November 24, 2015, Dave Braun (Stone) and Everett Hoyt (City of Barre) inspected catchbasins on Palmisano Plaza. At 31 Palmisano Plaza, a material had been spread on the side path and around the dumpster, apparently to absorb spilled waste oil (Figure 4).
- Shortly after November 24, 2015 Steve Micheli, Public Works Director, visited 31 Palmisano Plaza to advise the owners to dump no waste in the drain. Mr. Micheli stated he would also require them to move the dumpster away from catchbasin CB13.

Conclusion: Three apparently unrelated problems were identified in this system. Disposal of dog waste in catchbasins on Westwood Parkway presents both water quality and human health concerns. Disposal of waste oil in catchbasin CB13 on Palmisano Plaza is illegal. Finally, there appears to be washwater or sanitary wastewater entering the system above catchbasin CB15 on Palmisano Plaza (Map BC-1). The exact source is not known. The most likely explanation is a leaking sewer lateral at a house located between catchbasins CB14 and CB15, possibly discharging to the storm sewer via one of the three pipe connections observed in this section. Another explanation is that the observed petroleum contamination caused false positive optical brightener readings on the Palmisano Plaza line, although the absence of optical brightener in CB12, CB13, and CB14 is counter to this theory.

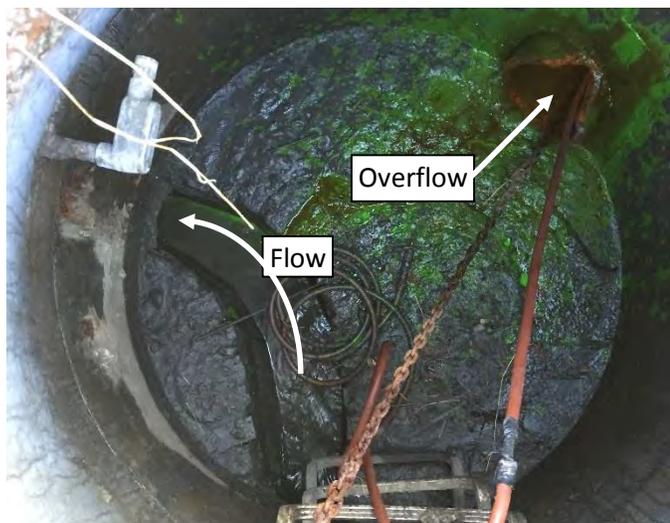
Figure 5. Sanitary manhole near North End pump station; sewer overflow pipe marked by dye

- Wastewater odor and pump sounds were consistently observed at the outfall. Optical brightener was detected at the outfall on both occasions it was monitored.
- There was no flow on September 22, 2015, the day *E. coli* samples were collected in Barre.
- On December 11, 2015, a sanitary manhole located directly west of the North End pump station was accessed. A pipe was found apparently connecting the sanitary manhole to the stormline, with an invert a few inches above the floor of the manhole (Figure 5). Dye poured into the pipe opening quickly flowed to the outfall (Figure 6).
- The Barre Department of Public Works determined that a valve intended to restrict sewer overflow from the pipe to the storm sewer was not working properly.

Conclusion: Based on wastewater odors and pump sounds repeatedly observed at the outfall, the gray appearance of water in the splash pool below the outfall, and the presence of optical brightener, a direct connection between the sanitary sewer and the stormwater system was suspected. A direct connection via a sewer overflow pipe was confirmed on December 11, 2015.

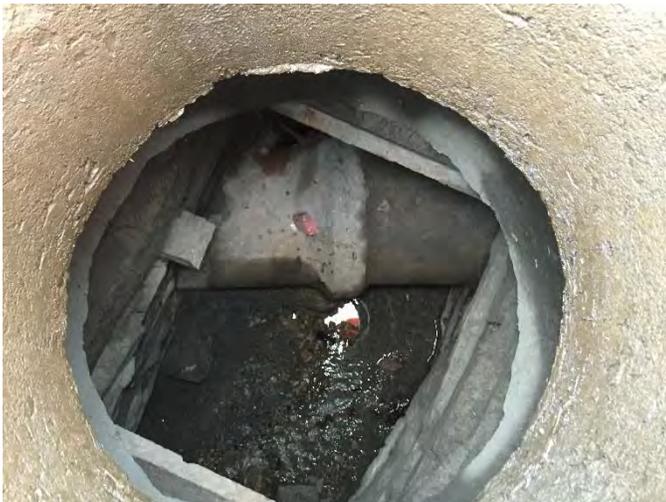
Figure 7. Stormwater manhole MH1 with concrete sewer main running through it

- The concrete sewer main flowing through stormwater manhole MH1 (Figure 7) has reportedly been repaired multiple times in the last decade. This pipe was found to be leaking badly when FWR and Stone performed the first Barre City IDDE project in 2006. According to the Department of Public Works, it was repaired in 2006 and again more recently. In a November 24, 2015 meeting, Everett Hoyt indicated he had recently inspected the pipe section and it was not leaking. Mr. Hoyt also explained that he had

found and cleared a major obstruction in the sewer main in the sanitary manhole immediately below this section of pipe. The obstruction has caused wastewater to surcharge but not overflow the sanitary manhole.

Conclusions: We suspect there are (or were) two sources of optical brightener—and wastewater—entering this system. One source is (or was) in the area where the sanitary sewer crosses the storm sewer (in or near catchbasin CB1, manhole MH1, or the storm line connecting the two structures). Water pressure in the sewer main resulting from obstruction in the sanitary manhole likely caused wastewater and sewer odors to infiltrate the underlying storm drain, either via an unknown direct connection or through gaps and cracks in the walls of the structures. Cleaning the sewer main appears to have eliminated or reduced this source. Because optical brightener was detected on the main line up to catchbasin CB9 on Howard Street, potentially masking sources lower in the system, we cannot say conclusively that the source near CB1 and MH1 was eliminated by cleaning the sanitary sewer.

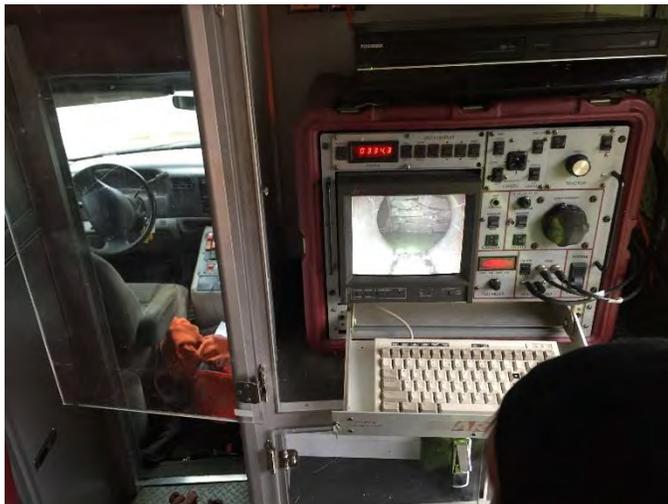
Figure 8. Inspection of Hill Street storm sewer, November 24, 2015

- On September 23, 2015, manholes MH11 and MH12 on Hill Street (Map BC-5) had a pronounced wastewater odor and flow was observed through the main storm line. There was no flow in manholes MH13 and MH14; however a wastewater odor was present, possibly venting up the pipe. The flow and wastewater odor appeared strongest at MH11.

- Monitoring pads deployed on September 23, 2015 indicated that the source of optical brightener is located on Hill Street between Nelson Street and Woodland Drive. Optical brightener was detected at the outfall and at all manholes on Hill Street except MH14 (at the intersection of Hill Street and Woodland Drive). No optical brightener was detected at MH5 on Berkeley Street.

• In early December, 2015, the Department of Public Works performed camera inspection of the 6-inch sewer main on Hill Street to identify possible leaks. Substantial root penetration was observed in the first 30 feet of pipe below the sanitary manhole nearest 204 Hill Street. Roots were cut out of the line. A

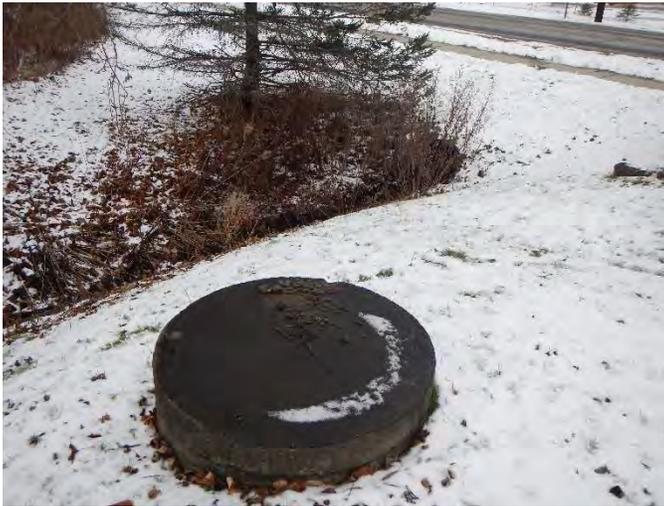
Figure 9. Concrete structure in side yard of 140 Websterville Road

- Monitoring pads deployed at the outfall on July 7, 2014 and September 22, 2015 indicated presence of optical brightener.
- A trickle of flow was observed from the outfall on October 1, 2015; otherwise the pipe has been dry.

- The alignment of the outfall pipe suggests it is connected to a round concrete structure (Figure 9) in the side yard of the house at 140 Websterville Road. This structure may be some type of graywater system.
- According to the Town Engineer, Harry Hinrichsen, 140 Websterville Road was unoccupied in recent months. New residents moved in to the house in early January, 2016. Mr. Hinrichsen has been in contact with the property owner, who agreed to work with the Town to determine if there is a pipe connection from the house to the concrete structure in the yard (or directly to the outfall).
- During the January 19, 2016 meeting, Mr. Hinrichsen stated that town staff would attempt to dye test a toilet in the house and inspect plumbing connections to ensure that all fixtures and appliances discharge to the municipal sewer.

Resolution: The Town of Barre intends to determine whether or not there is a plumbing connection from the house and, if found, will work with the property owner to correct the problem.
