MISSISQUOI BASIN IDDE STUDY

PROJECT NO. 13035

RE: Missisquoi Advanced IDDE Investigation – Town of St. Albans

HARTIGAN TRUNKLINE TV CAMERA LOGS
AND REPORT

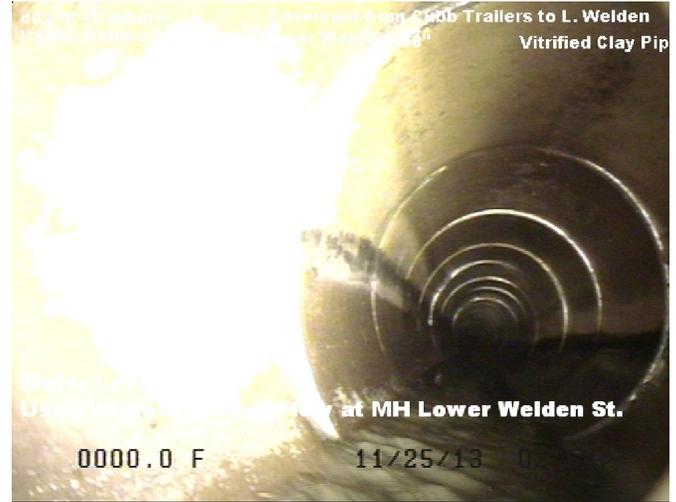
Distance: 0.0 ft. Grade: 0
 Condition: Water Level
 Remarks: Used Vector to lower Flow at MH Lower Welden St.

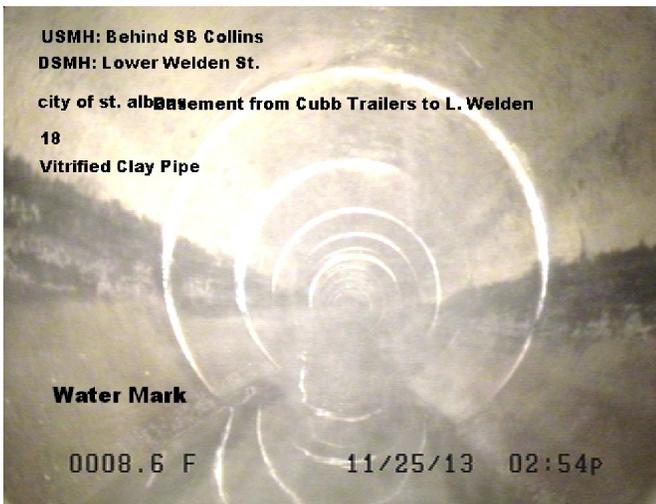
Distance: 8.6 ft. Grade: 4
 Condition: Water Mark
 Remarks: N/A

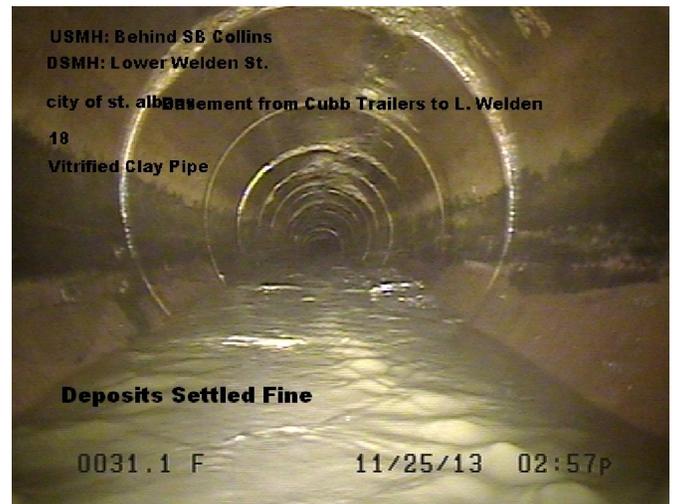
Distance: 31.1 ft. Grade: 3
 Condition: Deposits Settled Fine
 Remarks: N/A

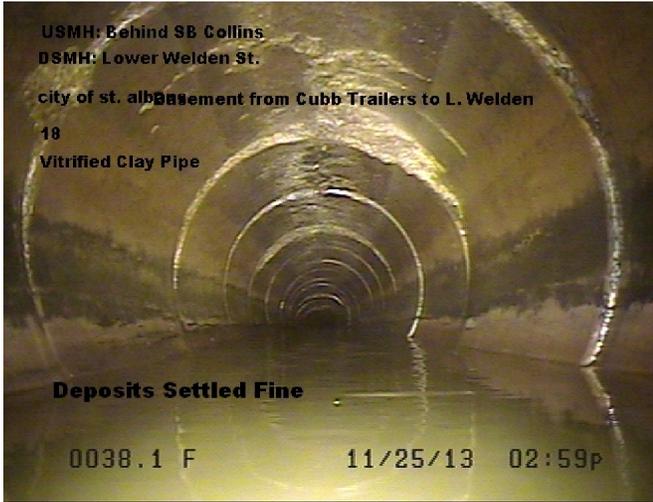
Distance: 38.1 ft. Grade: 3
 Condition: Deposits Settled Fine
 Remarks: N/A

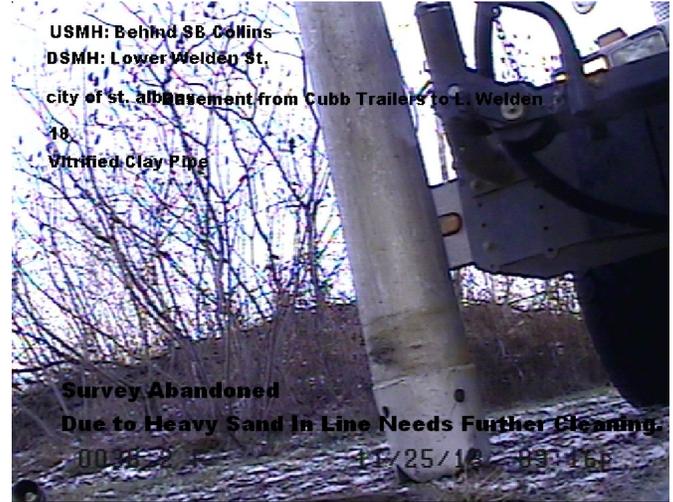
Distance: 38.2 ft. Grade: 0
 Condition: Survey Abandoned
 Remarks: Due to Heavy Sand In Line Needs Further Cleaning.

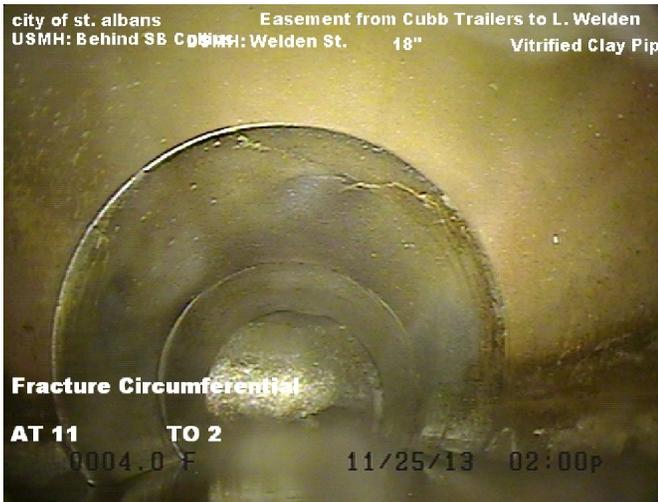
Distance: 4.0 ft. Grade: 2
 Condition: Fracture Circumferential
 Remarks: N/A

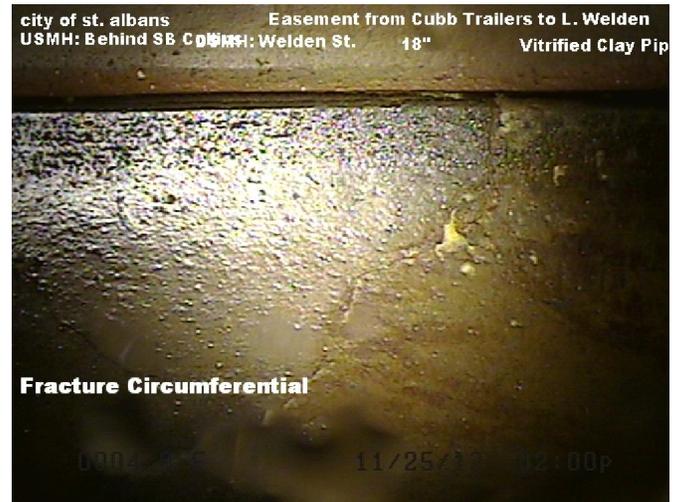
Distance: 4.0 ft. Grade: 2
 Condition: Fracture Circumferential
 Remarks: N/A

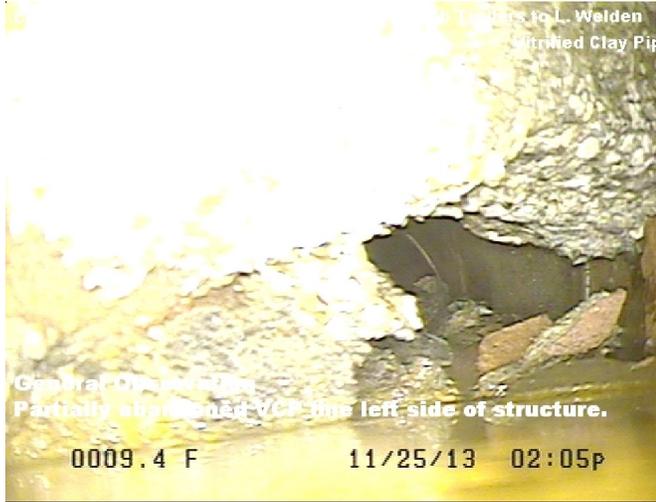
Distance: 9.4 ft. Grade: 0
 Condition: General Observation
 Remarks: Partially abandoned VCP line left side of structure.

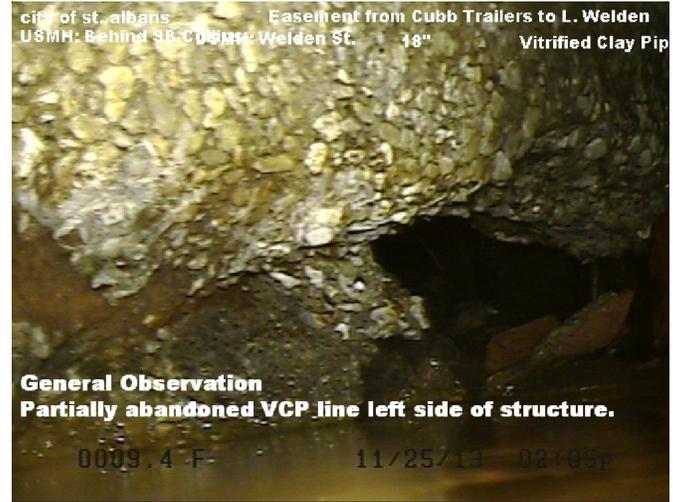
Distance: 9.4 ft. Grade: 0
 Condition: General Observation
 Remarks: Partially abandoned VCP line left side of structure.

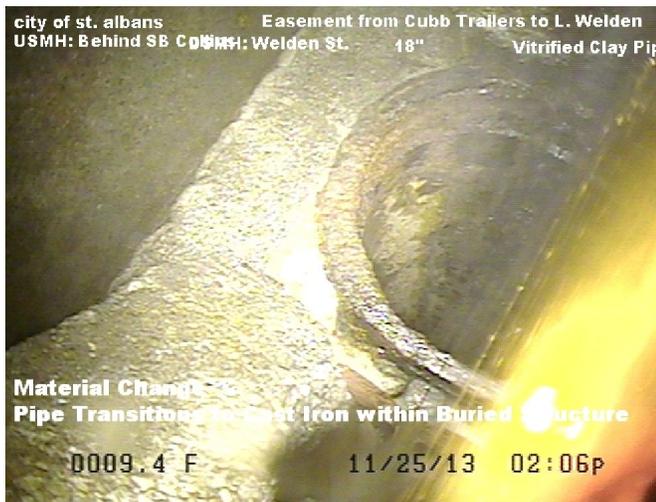
Distance: 9.4 ft. Grade: 0
 Condition: Material Change
 Remarks: Pipe Transitions to Cast Iron within Buried Structure

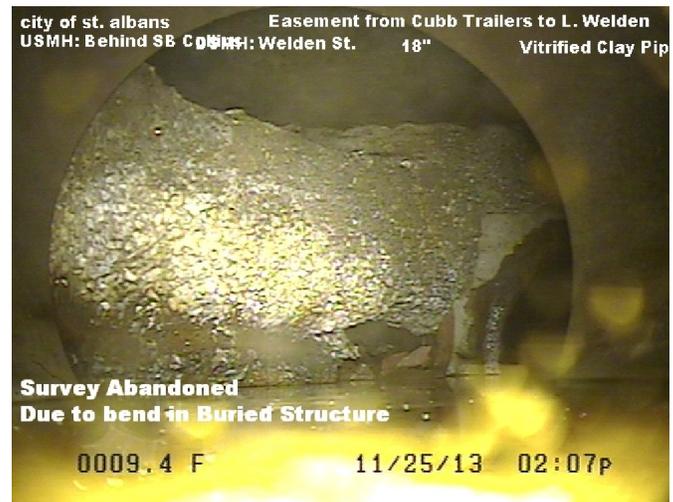
Distance: 9.4 ft. Grade: 0
 Condition: Survey Abandoned
 Remarks: Due to bend in Buried Structure

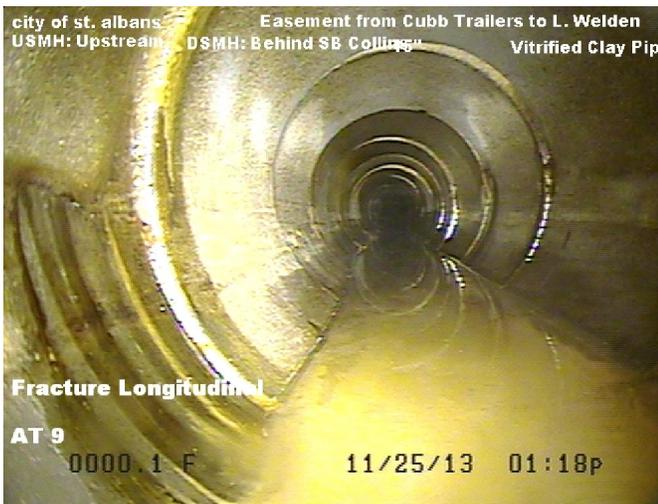
Distance: 0.1 ft. Grade: 3
 Condition: Fracture Longitudinal
 Remarks: N/A

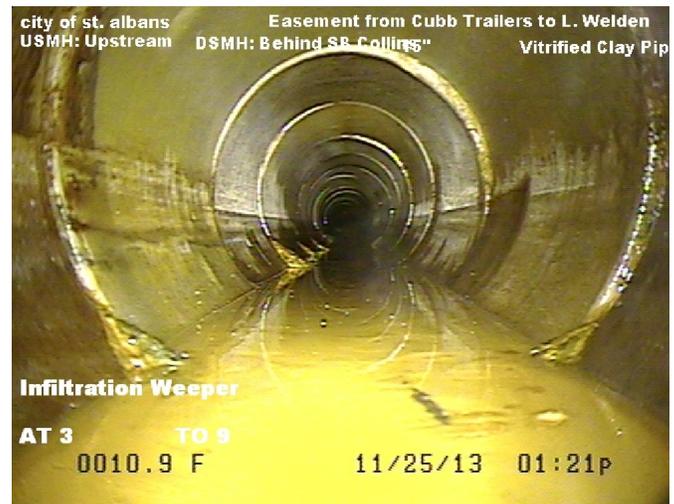
Distance: 10.9 ft. Grade: 2
 Condition: Infiltration Weeper
 Remarks: N/A

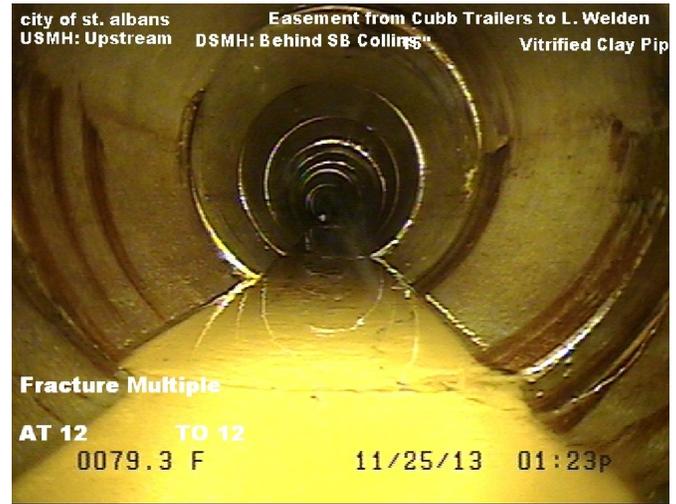
Distance: 79.3 ft. Grade: 4
 Condition: Fracture Multiple
 Remarks: N/A

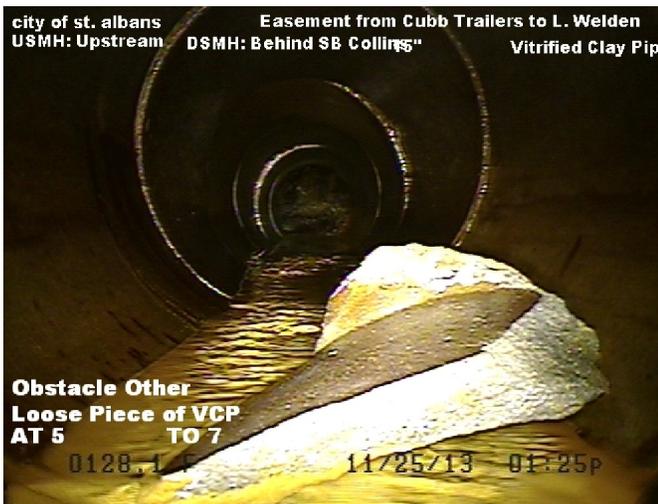
Distance: 128.1 ft. Grade: 3
 Condition: Obstacle Other
 Remarks: Loose Piece of VCP

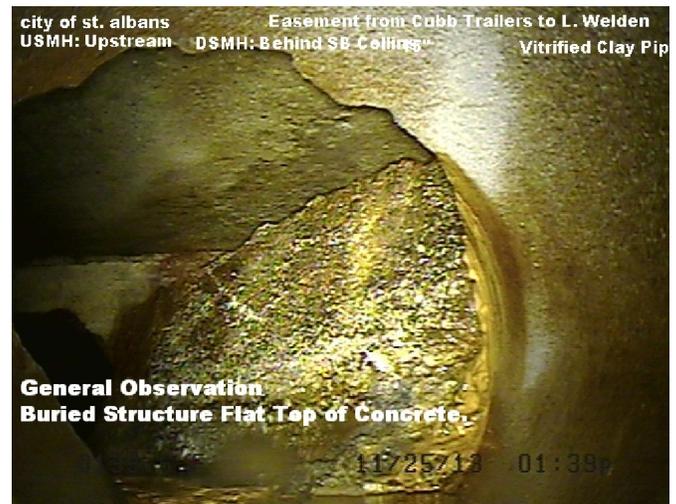
Distance: 139.6 ft. Grade: 0
 Condition: General Observation
 Remarks: Buried Structure Flat Top of Concrete.

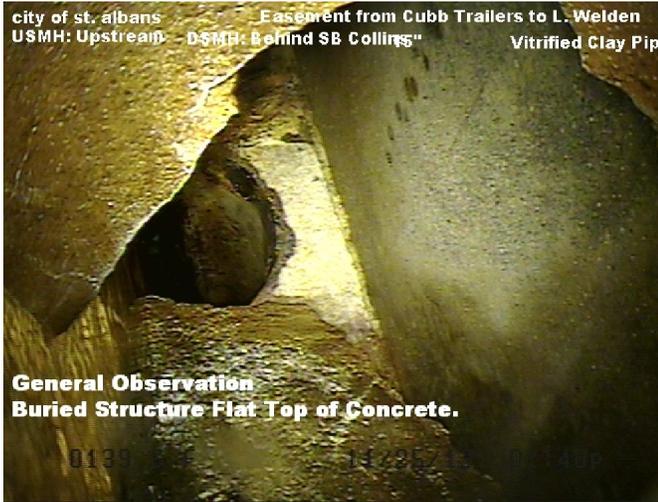
Distance: 139.6 ft. Grade: 0
 Condition: General Observation
 Remarks: Buried Structure Flat Top of Concrete.

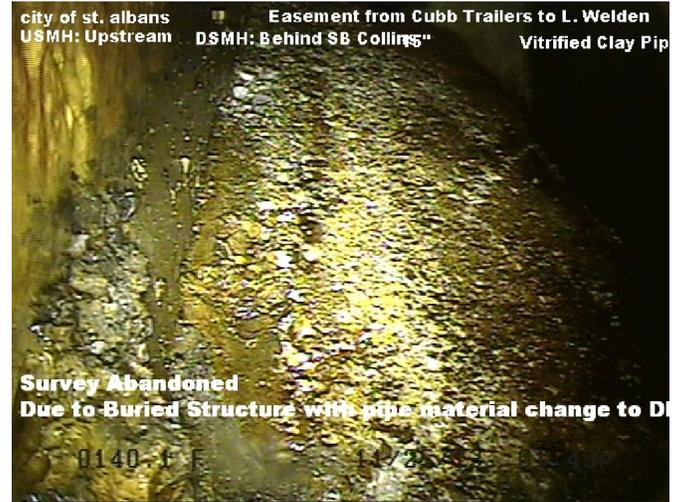
Distance: 140.1 ft. Grade: 0
 Condition: Survey Abandoned
 Remarks: Due to Buried Structure with pipe material change to DIP

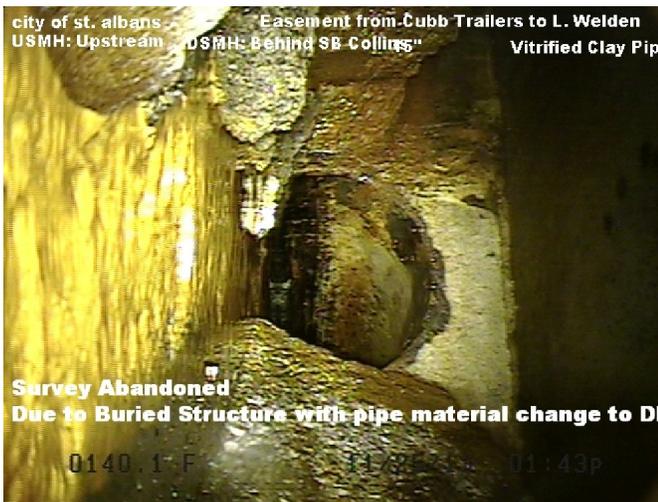
Distance: 140.1 ft. Grade: 0
 Condition: Survey Abandoned
 Remarks: Due to Buried Structure with pipe material change to DIP

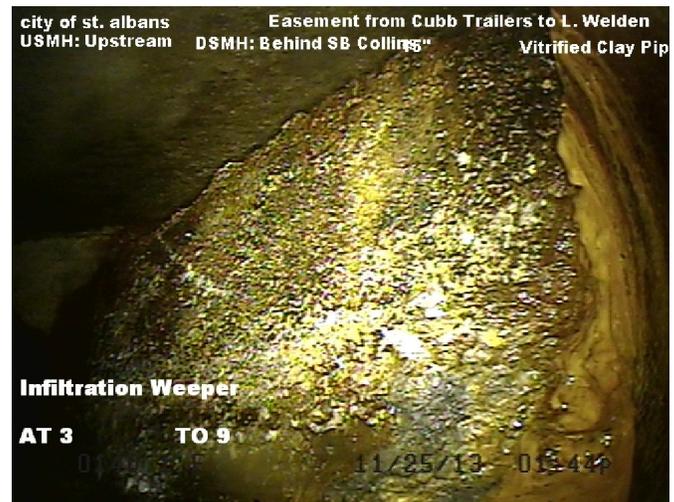
Distance: 140.1 ft. Grade: 2
 Condition: Infiltration Weeper
 Remarks: N/A
