Detecting and Eliminating Illicit Discharges to Improve Water Quality in the Lamoille River Basin

Final Report

Issued: January 31, 2014

Prepared for:	Prepared by:
Jim Pease	Dave Braun
VT Department of Environmental Conservation	Stone Environmental, Inc.
1 National Life Drive, Main Building, 2nd Floor Montpelier, VT 05620-3522	535 Stone Cutters Way Montpelier, VT 05602
Tel. / (802) 490-6116	Tel. / 802-229-5379
E-Mail / Jim.Pease@state.vt.us	E-Mail / dbraun@stone-env.com

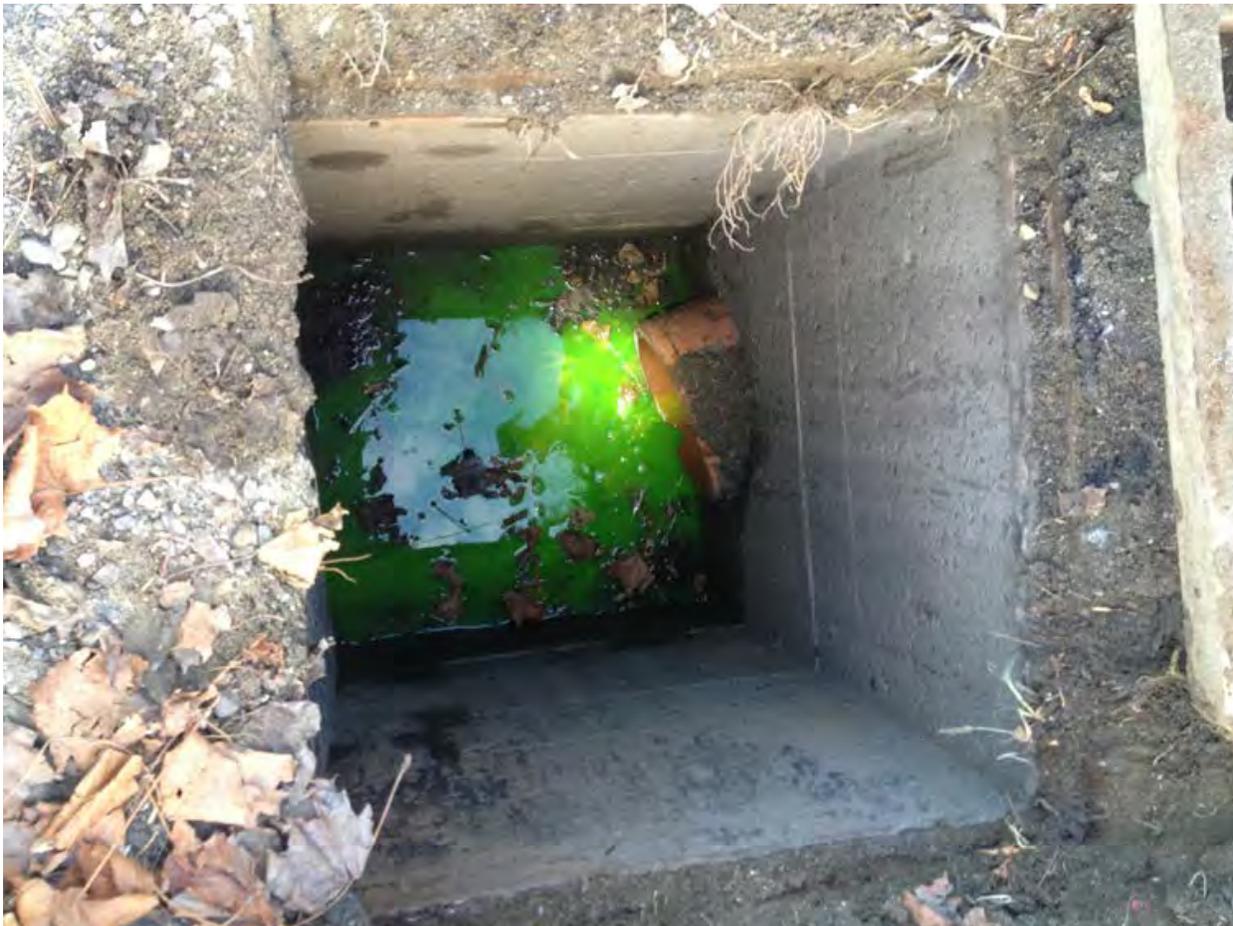
Dye flushed down a toilet in the Hardwick Elementary School appeared in this catchbasin on South Main Street, confirming a sanitary wastewater connection to the stormwater drainage system

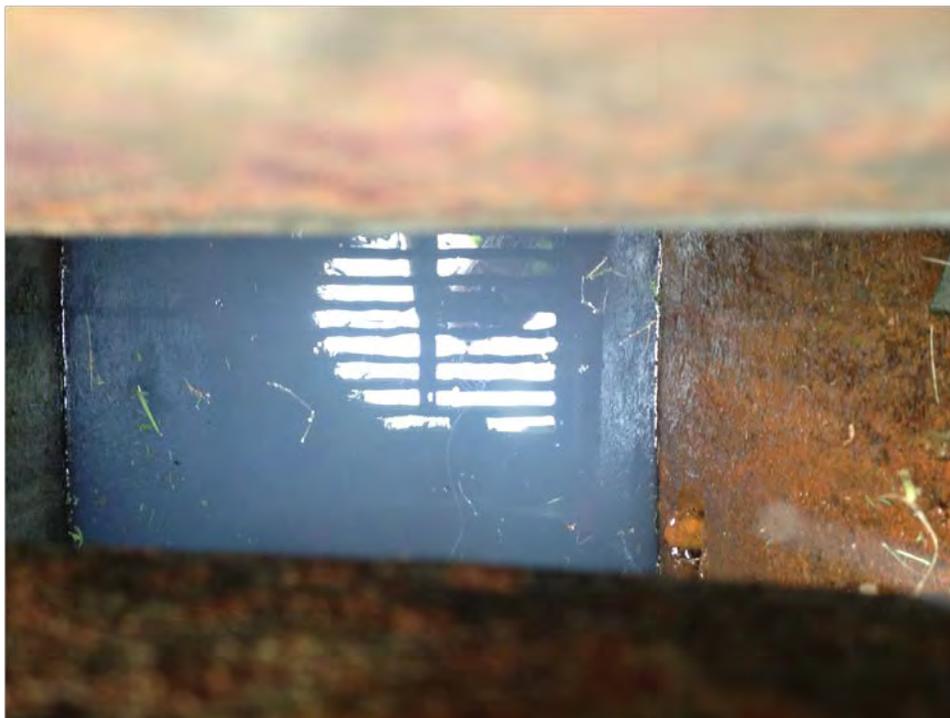
Figure 2. Laundry wastewater present in CB-B in system GA070

service station. A distinct laundry odor was observed in the first three catchbasins up-pipe from the outfall. The odor was strongest in the second catchbasin up-pipe from the outfall, CB-B. Water in the sump of CB-B was opaque and blue-gray in color (Figure 2). Ammonia and MBAS detergents were detected at low concentrations at the outfall and optical brightener was detected at the outfall and in the first three up-pipe catchbasins.

strongly suggested a laundry/graywater discharge to this system.

Optical brightener monitoring pads were placed in catchbasins CB-A, CB-B, and CB-C on August 13, 2013 to confirm the presence of laundry detergent. A marked laundry detergent odor was observed in catchbasins CB-B and CB-C when the pads were deployed and again when they were retrieved on

August 23, 2013. Pads placed in CB-A, CB-B, and CB-C showed strong optical brightener fluorescence. Because no pipes enter CB-B and CB-C, we suspect the source of the laundry detergent is infiltration from the onsite wastewater treatment system at the tan ranch house located on Route 7 in front of the bike shop and kitchen store. A second possible source is infiltration from the newly constructed (2011) mound system at the Franklin West Supervisory Union building at 4497 Highbridge Road.

Given the presence of laundry detergent and the location of the tan house relative to the storm drain, we suspect that the onsite wastewater treatment system serving this property is not providing adequate wastewater treatment. The question becomes: what level of treatment constitutes failure? *E. coli* levels measured at the outfall were low; therefore the system may provide adequate pathogen removal. The phosphorus concentration was also low, suggesting that phosphorus removal in the leachfield soils may be adequate. We expect mobile constituents such as nitrogen, chloride, and optical brighteners to pass from onsite wastewater treatment systems to groundwater. This is not necessarily a problem. In our view, the strongest basis for finding that the system was not providing adequate wastewater treatment was the bluish-gray color observed in catchbasin CB-B on July 27, 2012 and the laundry odor repeatedly observed in CB-B and CB-C.

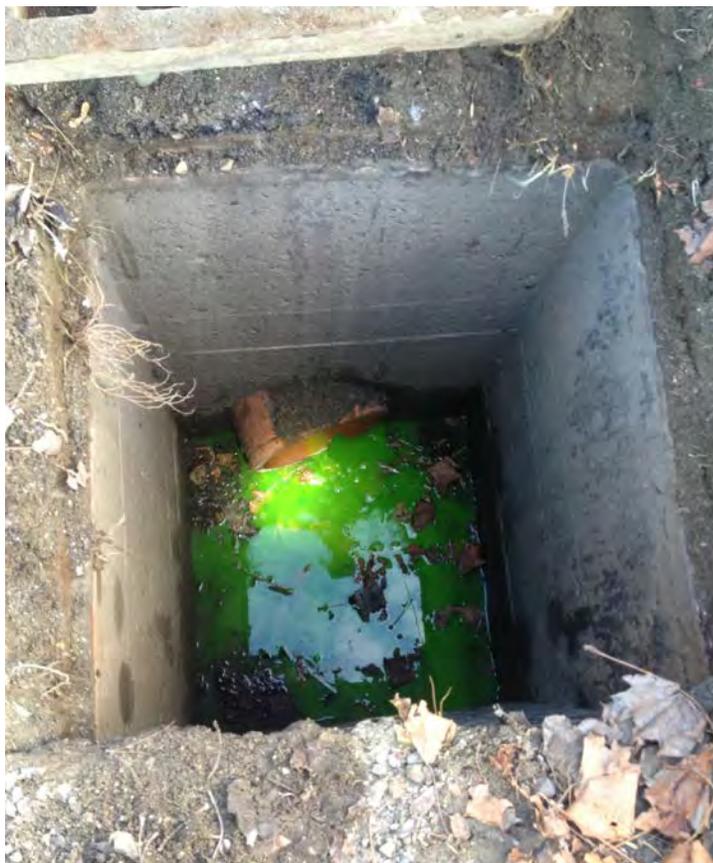
Figure 3. Dye flushed down a toilet at the elementary school appeared in catchbasin CB-C

On November 5, 2013, a meeting was held with the Town Manager, Jon Jewett, to discuss IDDE findings in Hardwick. With assistance from public works staff, all the kitchen drains in the elementary school were dye tested; none were found to be connected with the HA070 system. Investigations were started

in the kitchen due to the repeated observations of fish odors. A push camera was then deployed in catchbasin CB-C. Approximately 50 feet into the pipe a large diameter pipe intersected the line from the direction of the elementary school. Through sound checks, we confirmed the opposite end of the pipe, a ductile iron pipe that protruded through the basement wall and was sealed with a threaded cap. No visible building plumbing was connected to this pipe. Finally, toilets were dye tested in different areas of the elementary school building and a wing of the school with four bathrooms was determined to be connected to the HA070 system (Figure 3). The exact connection is unclear, but we suspect that the sanitary line from this wing of the building is plumbed to a roof downspout which intersects the ductile iron pipe just outside the basement wall.

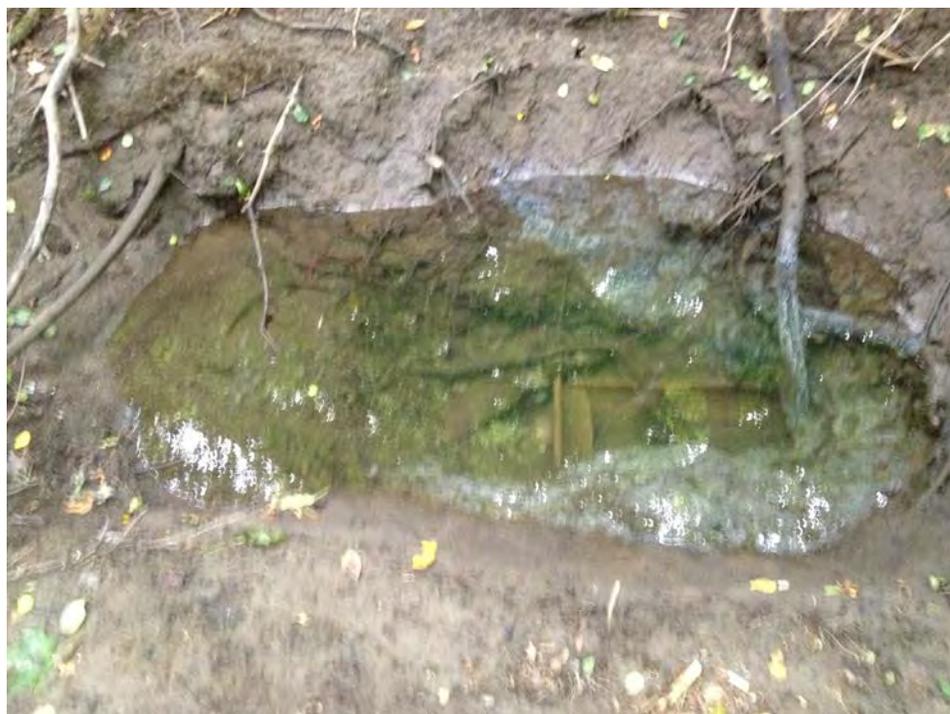
Figure 4. Sinkhole with gray film suggesting wastewater contamination

On November 13, 2012, we attempted to follow the path of the buried stormline up from the outfall. The vitrified clay line is broken in places, creating two sinkholes. The sinkhole pictured in Figure 4 had a wastewater odor and condoms were visible, indicating a wastewater source. Optical brightener monitoring pads were placed at the outfall, the sinkhole, CB-D, and MH-I. Optical brightener was

detected at the outfall, the sinkhole, and MH-I. Although the mapping of this system contained inaccuracies which confused interpretation of the data, the results indicated a direct sanitary wastewater connection somewhere within the system.

and Carol Robertson, the Village General Manager, to discuss the HP090 system. A site visit was made immediately following a rain storm and substantial flows were observed discharging from both the outfall and the sinkhole into the ephemeral stream running through the ravine. A wastewater odor was observed at both the outfall and the sinkhole. Because it was unclear what the broken pipe in the sinkhole was connected to, a plan was made to excavate the pipe to determine its connections and create access for sampling closer to Johnson Street Extension.

On October 31, 2013 excavation at the sinkholes quickly revealed that they were holes over breaks in the former combined sewer main. In the previously sampled sinkhole (closer to Johnson Street Extension), both ends of the broken vitrified clay line were exposed. Because the line was the main and not a broken lateral, attention shifted to finding the source of the contamination within the downtown area. All residences located on Main Street between Church Street and Johnson Street Extension were dye tested on October 31, 2013 and over the following weekend. In every case, dye was seen in the sanitary system and not the stormwater system (at MH-I).

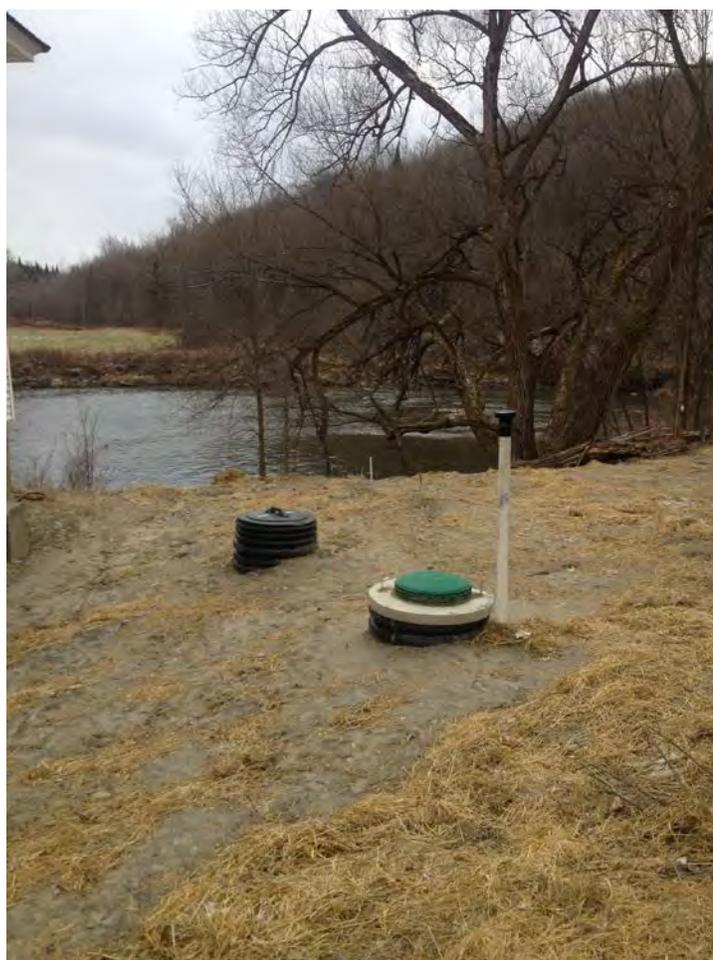
Figure 5. Replacement septic system at the Wolcott Town Hall

A meeting to discuss the IDDE results was held on September 12, 2013 with Wolcott Town officials (Linda Martin, Town Clerk and Belinda Clegg, Assistant Town Clerk and Select Board Chair) and Jim Ryan, the Lamoille River Basin Planner. Following the meeting, the Town Health Officer, Bernard Earle, determined that the septic system serving the Town Hall building was malfunctioning and was therefore a likely source of *E. coli* at the outfall. The Town constructed a new leach field and installed a pump vault to route septic tank effluent to the new leach field (Figure 5). The PVC pipe discharging at WO050 was routed around the septic system and the outfall was extended to the top of the river bank. When outfall WO050 was resampled on January 21, 2014, the *E. coli* concentration was low, 95 MPN/ 100 mL. This result suggests that replacement of the leach field may have reduced wastewater infiltration to the system.

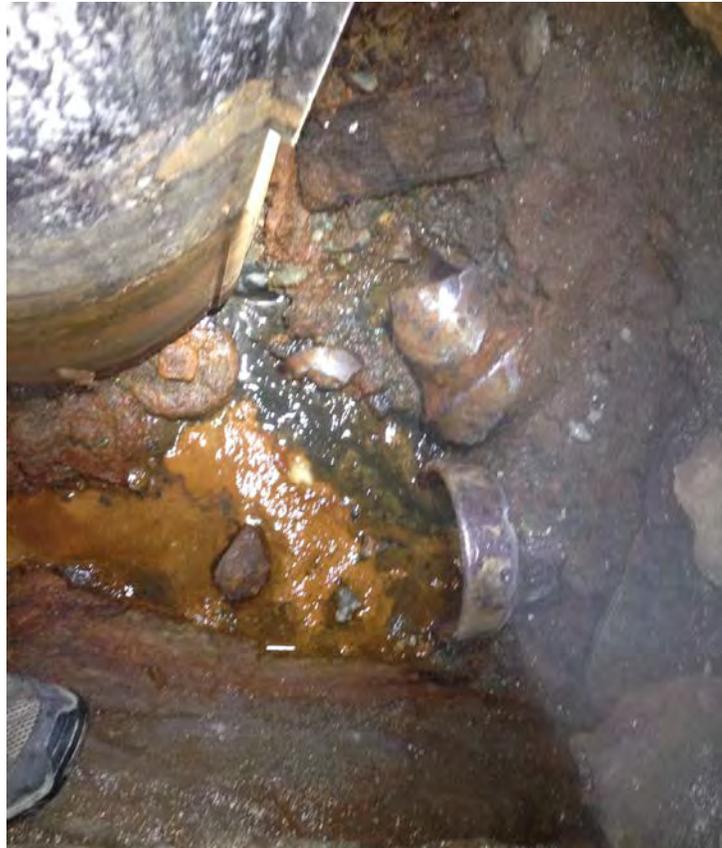
Figure 6. Leaking wastewater pump chamber next to perimeter drain

On November 19, 2013, an attempt was made to determine the source of the flow at the WO050 outfall. In the basement of the Buck’s Furniture showroom, a shallow trench dug along the perimeter of the basement wall conveys groundwater from the basement to a gravity drain in the southwest corner of the basement. This groundwater is believed to be the primary source of dry weather flow at the WO050 outfall. A wastewater pump chamber is located within two feet of this drain. While inspecting this interior drain a leak was noted in the corroded steel pump chamber, causing

wastewater to leak into the perimeter ditch and into the drain (Figure 6). According to our contact at Buck's Furniture, Ricky Fichtner, the owner indicated he would replace the leaking pump chamber expeditiously. However, six months after we notified the business this work still had not been performed. DEC is now pursuing its options to resolve the problem.
