Assessment of stormwater system outfalls in Marshfield, VT

September 2013

Friends of the Winooski River
P.O. Box 777
Montpelier, VT 05601

Stone Environmental
535 Stone Cutters Way
Montpelier, VT 05602

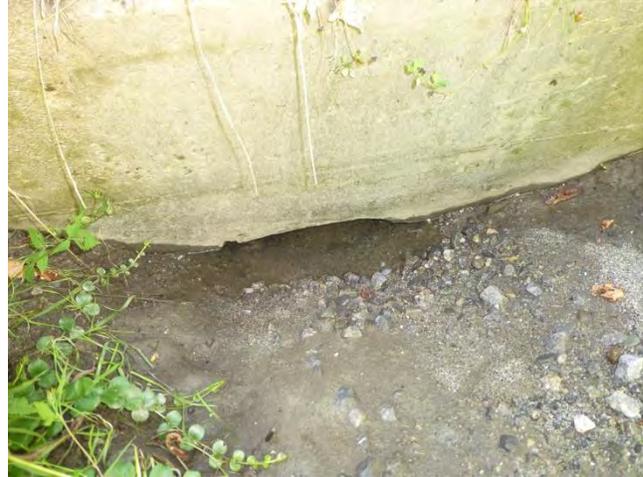
Marshfield outfall M-O-170 (Route 2 and Folsom Hill Road)

Description: Concrete header. Diameter of outfall not measurable due to sediment accumulation in front of the outfall. Drains Folsom Hill Road and the area southwest of the Folsom Hill Road/Route 2 intersection, where a large area has been cleared and remains bare. Probably state owned.

Damage: Header appears to be tipping over forwards. Because the outlet of the outfall pipe was almost completely covered by sediment, however, it was difficult to determine the extent of the damage.

- **Remove the sediment blocking outfalls M-O-160 and M-O-170 along Route 2 and take steps to reduce the amount of sediment and stormwater entering these outfalls. VTDEC will contact VTrans about these two outfalls.**

- **Revisit M-O-090 and M-O-170 to determine if reinforcement of the banks below is needed and feasible.**
- **Revisit the locations of the two outfalls that were overlooked in 2013 and assess.**

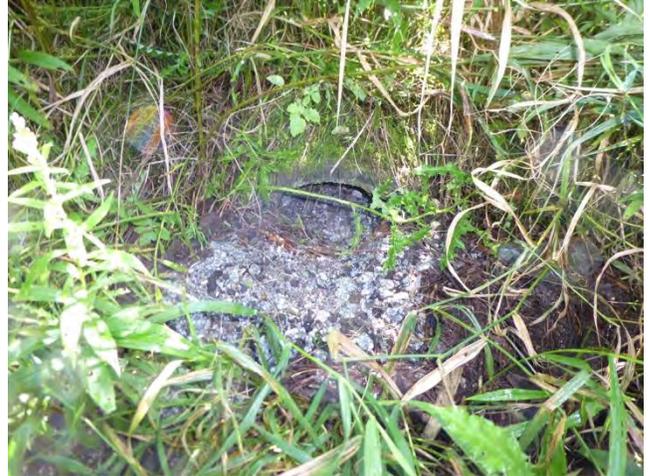
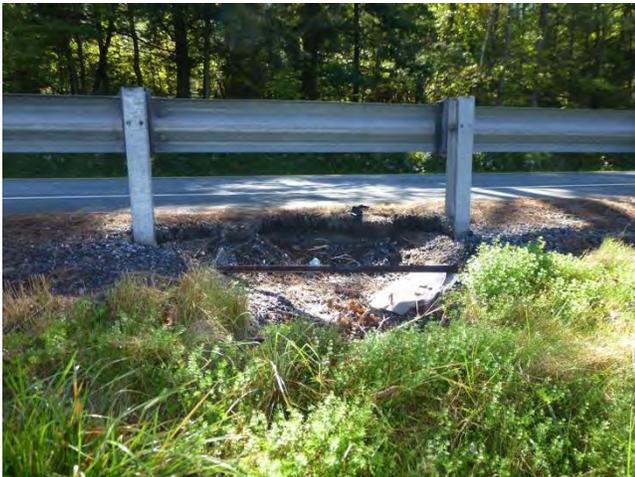
Marshfield outfall M-O-160 (Route 2, northeast of Marshfield Village)

Description: ~18 inch concrete pipe that drains the swale on the south side of Route 2. State owned.

Obstruction: The outfall pipe is completely full of sediment and very little stormwater, if any, appears to be making its way through this line. The catch basin above is obstructed with brush.

Significant erosion at the road shoulder across from this catch basin and above the outfall is evidence that the stormwater is bypassing this line and running over the bank.

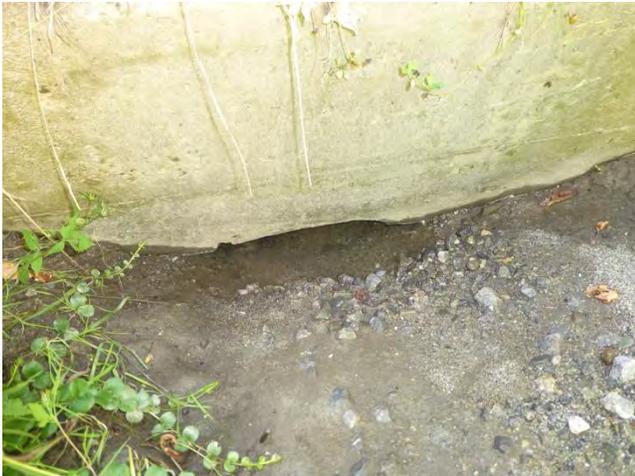
Marshfield outfall M-O-170 (Route 2 and Folsom Hill Road)

Description: Concrete header. Diameter of outfall pipe not measurable due to sediment accumulation in front of the outfall. Drains Folsom Hill Road and area southwest of the Folsom Hill Road/ Route 2 intersection, where a large area has been cleared and remains bare. Probably state owned.

Obstruction: Outfall is almost completely obstructed with the sediment that has accumulated in front of it. Only a small clearance remains.

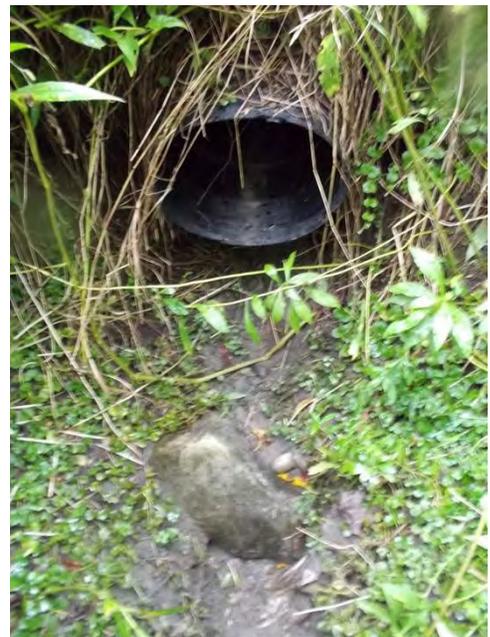
Marshfield outfall M-O-090 (Southeast side of Route 2)

Description: ~13 inch smooth plastic. Drains a small section of Route 2. State owned.

Erosion description: Incision below outfall.

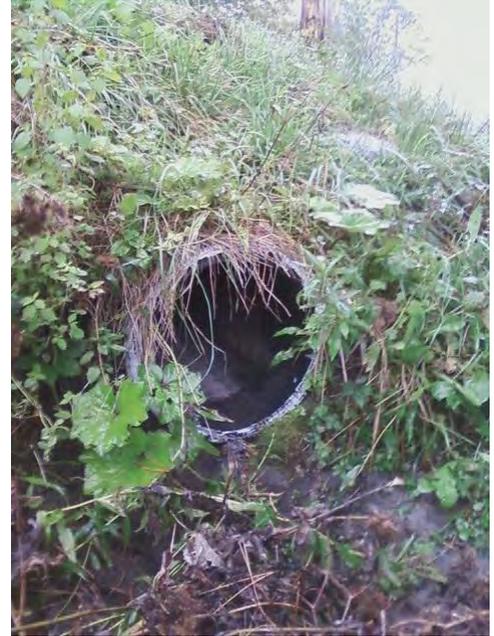
Marshfield outfall M-O-140 (Gillman Street/School Street)

Description: ~20 inch smooth plastic. Drains the south side of Gilman Street. Town owned.

Erosion description: Significant sediment below this outfall that seems to originate above the outfall.

M-O-140 (Marshfield)	Near the intersection of Gilman and School streets	Significant sediment has accumulated below this outfall.	Encourage nearby property owners to reduce stormwater runoff and erosion from their properties.
M-O-160 (VTrans)	North side of Route 2 east of Marshfield Village.	Outfall is full of sediment and line is unable to transport stormwater. Flow diverts across the road above and is eroding the road shoulder.	Clean out drain system along this line and remove brush on top of the catch basin immediately above this outfall. Take steps to locate the source of the sediment and reduce the sediment load and stormwater flow to this stormwater line.
M-O-170 (VTrans and Marshfield)	North of Route 2 east of Marshfield Village	Outfall is blocked by accumulated sediment and gully has formed below.	Remove accumulated sediment in front of the outfall and within the stormwater line above it if necessary. Take steps to locate the source of the sediment and reduce the sediment load and stormwater flow to this stormwater line.

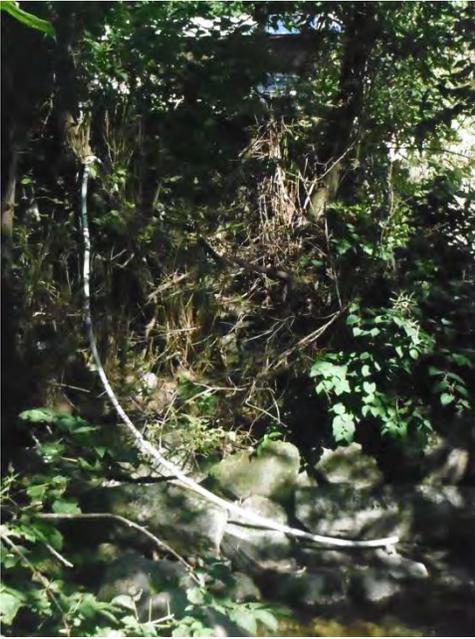
Drainage hose between outfalls M-O-040 and M-O-050

Location: Behind trailer on Creamery Road between outfalls M-O-040 and M-O-050 along Creamery Brook.

Reason for flag: Follow-up needed to determine what is being drained with this hose (grey water or condensation from an air conditioner are possibilities). Town responsibility.

- **Determine what is being discharged through the drainage hose behind the trailer near the intersection of Creamery and Main Streets.**
- **Encourage the community and property owner about ways to reduce stormwater flow, especially in areas drained by outfalls with erosion and sediment problems. Methods for reducing stormwater runoff involve increasing stormwater infiltration on individual properties. Examples of strategies to enhance infiltration are reducing bare and paved areas, converting lawn to perennial gardens or woody shrubs and trees, redirecting gutters away from bare or paved areas and toward vegetation, and disconnecting gutters from the stormwater system.**
