**DETECTION AND ELIMINATION OF
NON-STORMWATER DISCHARGES
TO THE
NORTH BRANCH, DOG RIVER AND THE STEVENS
BRANCH
IN
MONTPELIER, BERLIN AND NORTHFIELD**

July 2009

FRIENDS OF THE WINOOSKI RIVER
PO Box 777 Montpelier VT 05601

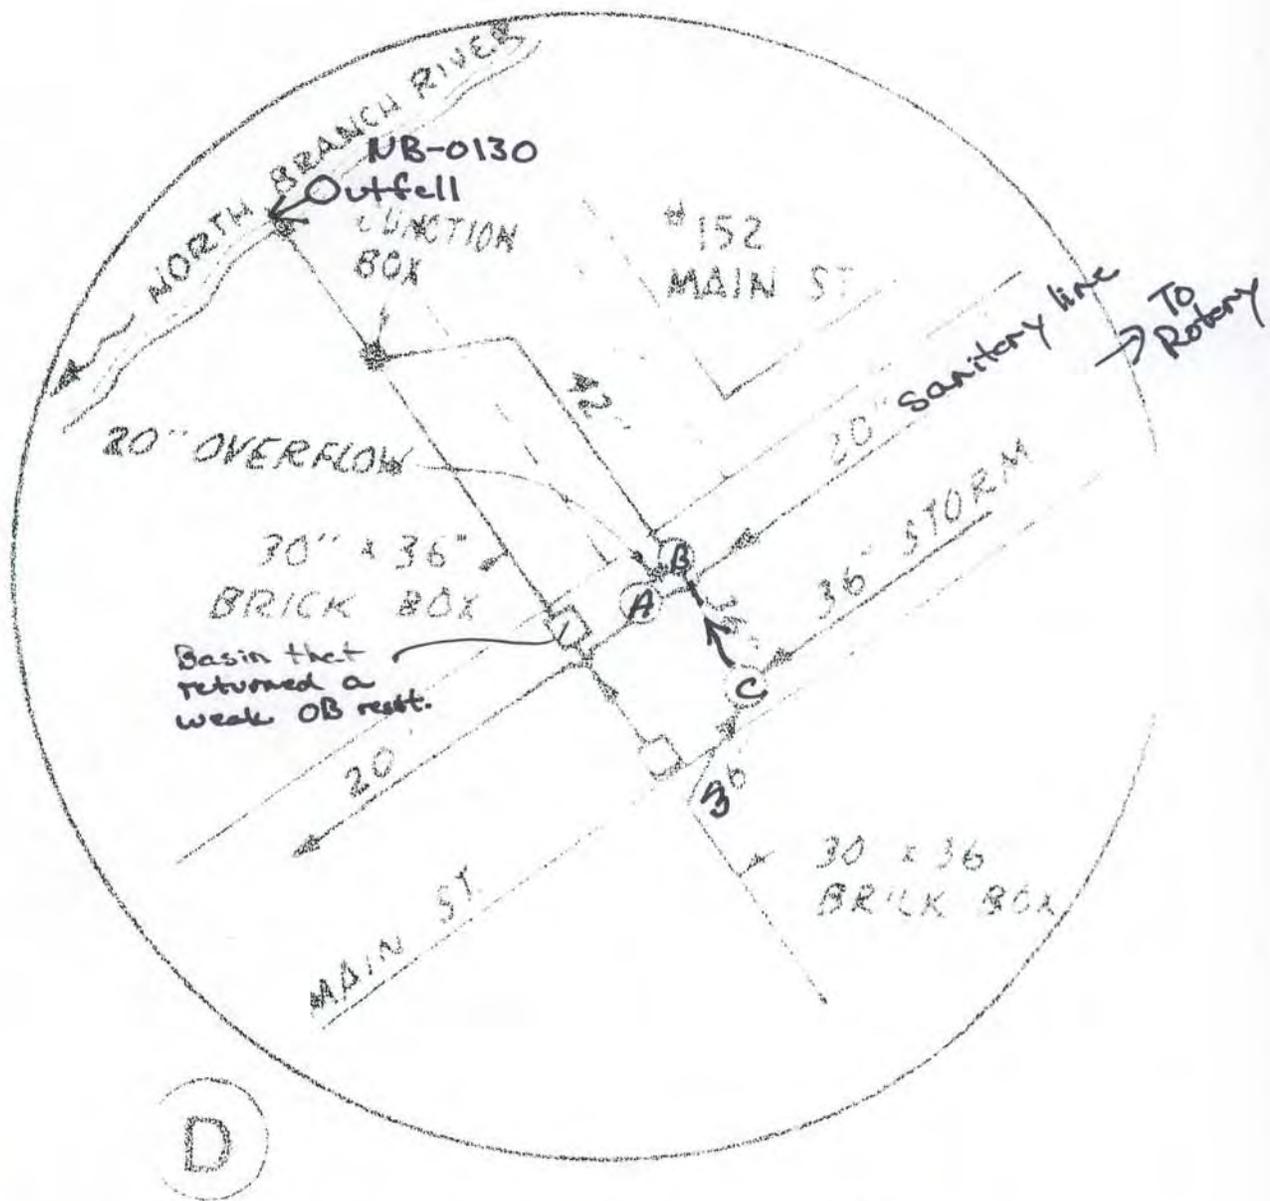
NB-0130

Based on the above information, we suspect that there is some infiltration of wastewater into the stormline crossing the sanitary sewer under Main Street.

- A - Manhole access to sanitary overflow
- B - Manhole access to storm water line
- C - Manhole access to stormwater line
At this point, flows are coming in from the direction of the Main Spring St rotary and a brick box culvert from the other side of Main St.

Due to the rainy weather, the level of the North Branch River has submerged this outfall and surcharged the stormwater line where we suspect the problem arises, precluding further investigation. The City of Montpelier is committed to inspecting the stormline when the water level drops.

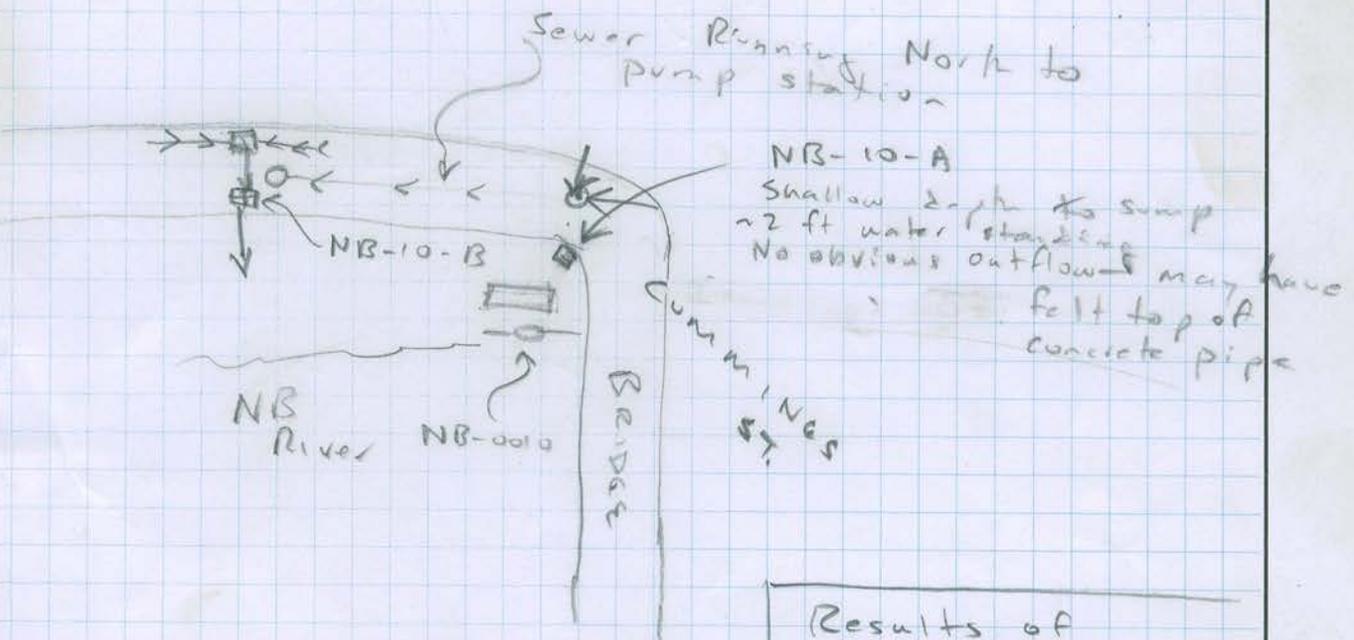
NB-10-B

Results of 11/12/08 08 readings

NB-0010 Retest (+)

Local source of WW
infiltrating pipe
likely - best guess

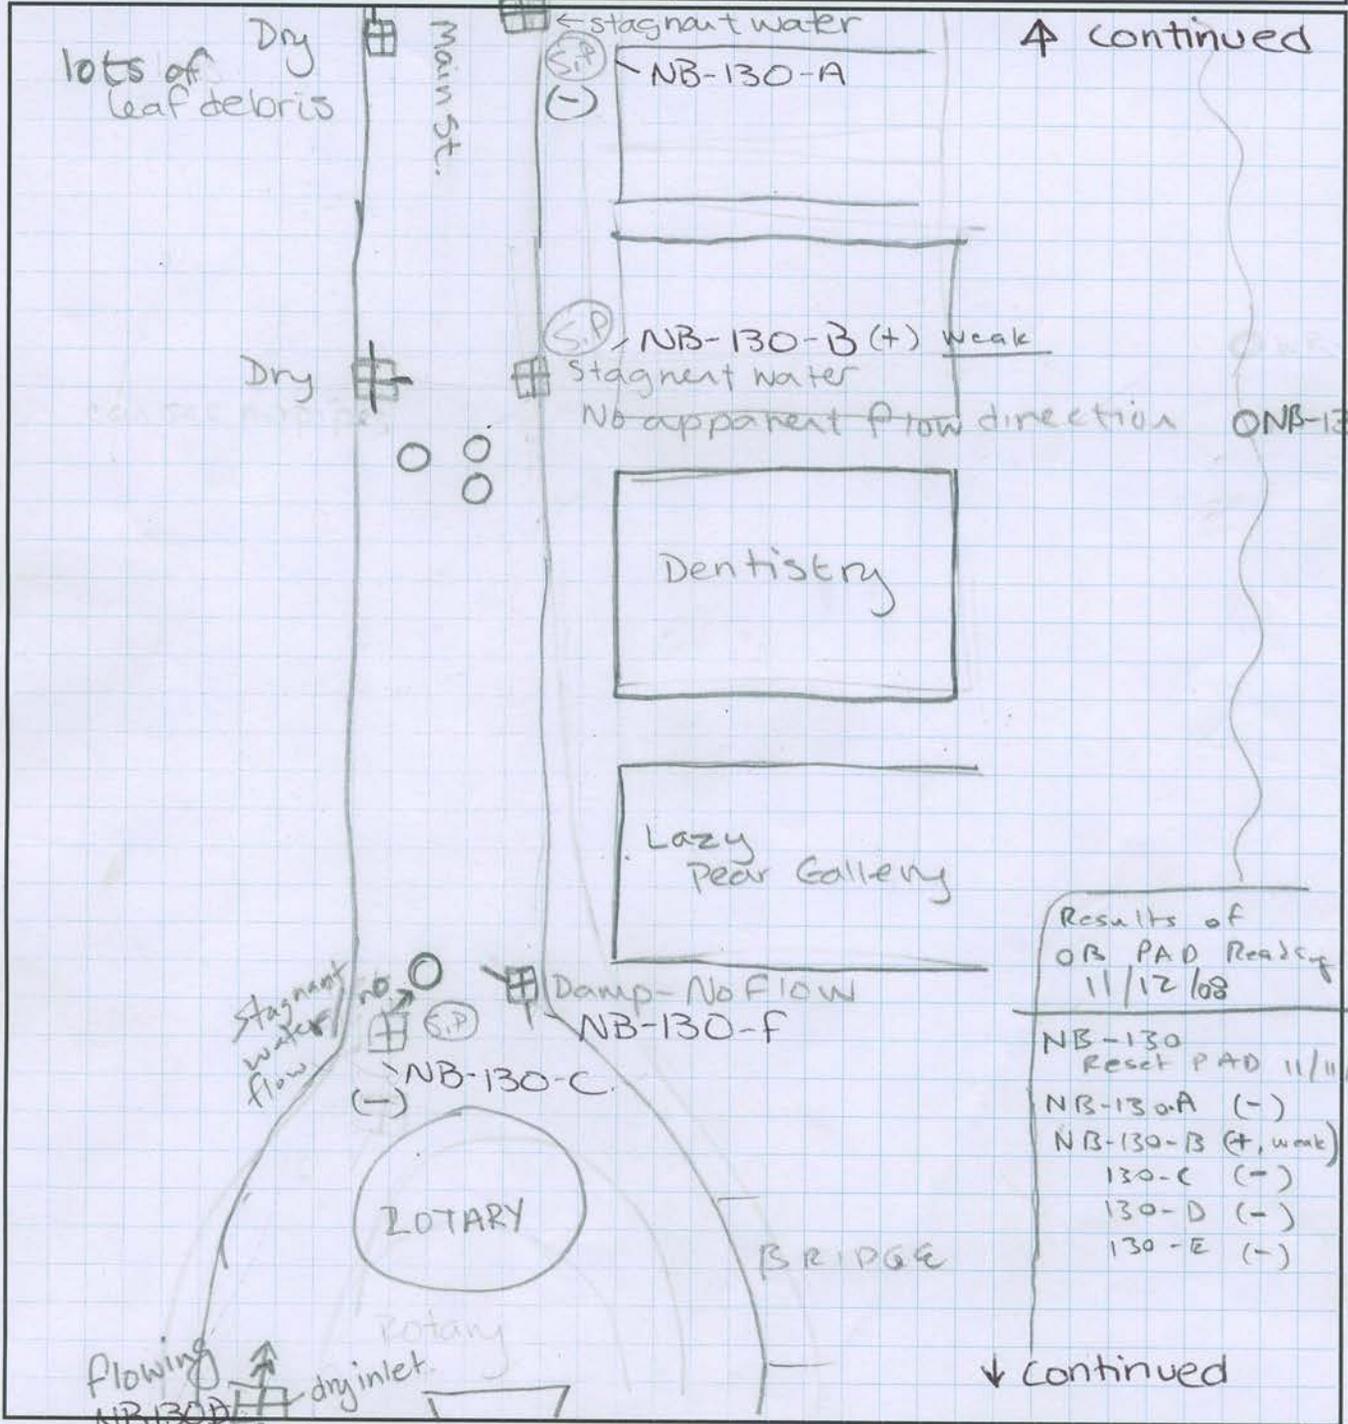
NB-130
Reset PAD 11/11/08

Results of
OB PAD Reading
11/12/08

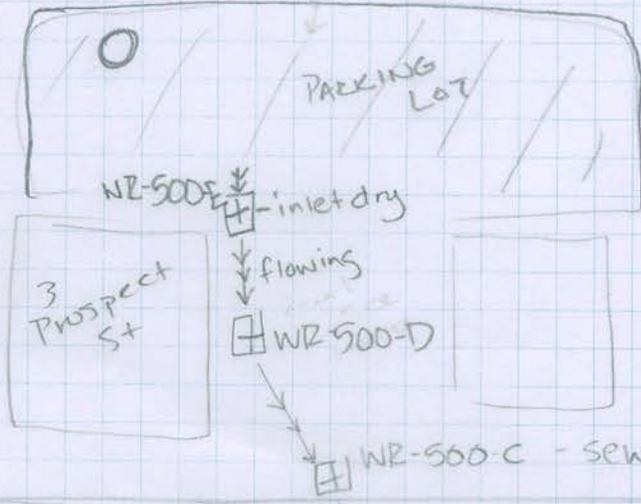
Results of
O.S. PAD Reading
11/12/08

- WR-500-A (-)
- WR-500-B (-)
- WR-500-D (-)
- WR-500-E (-)

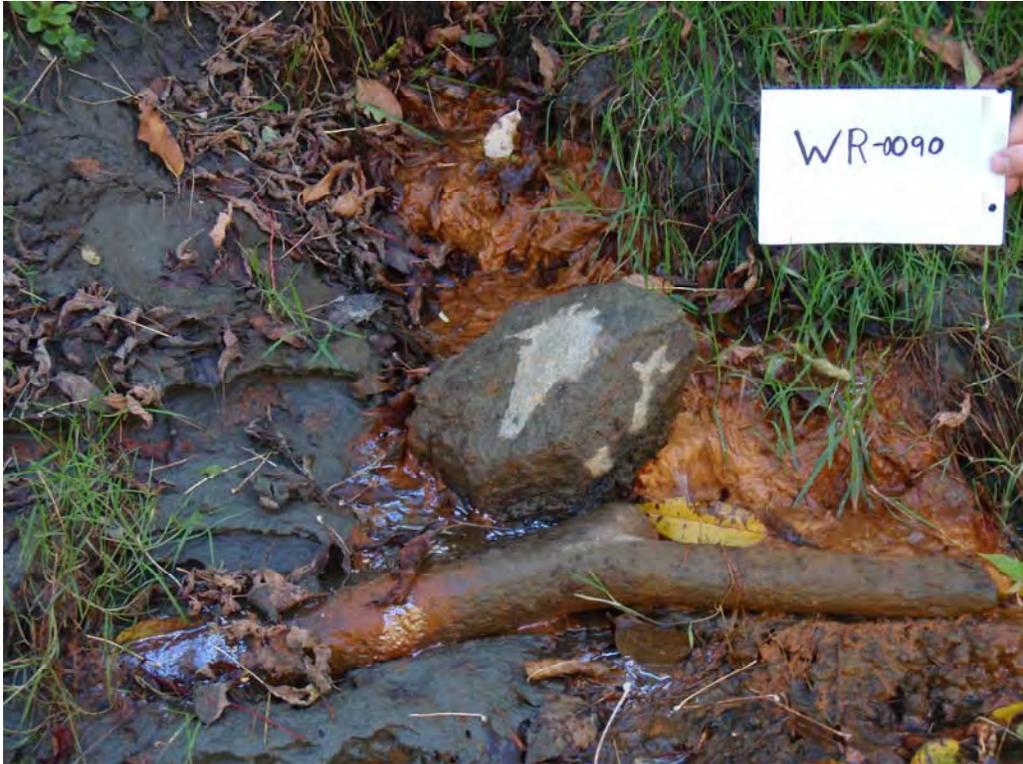
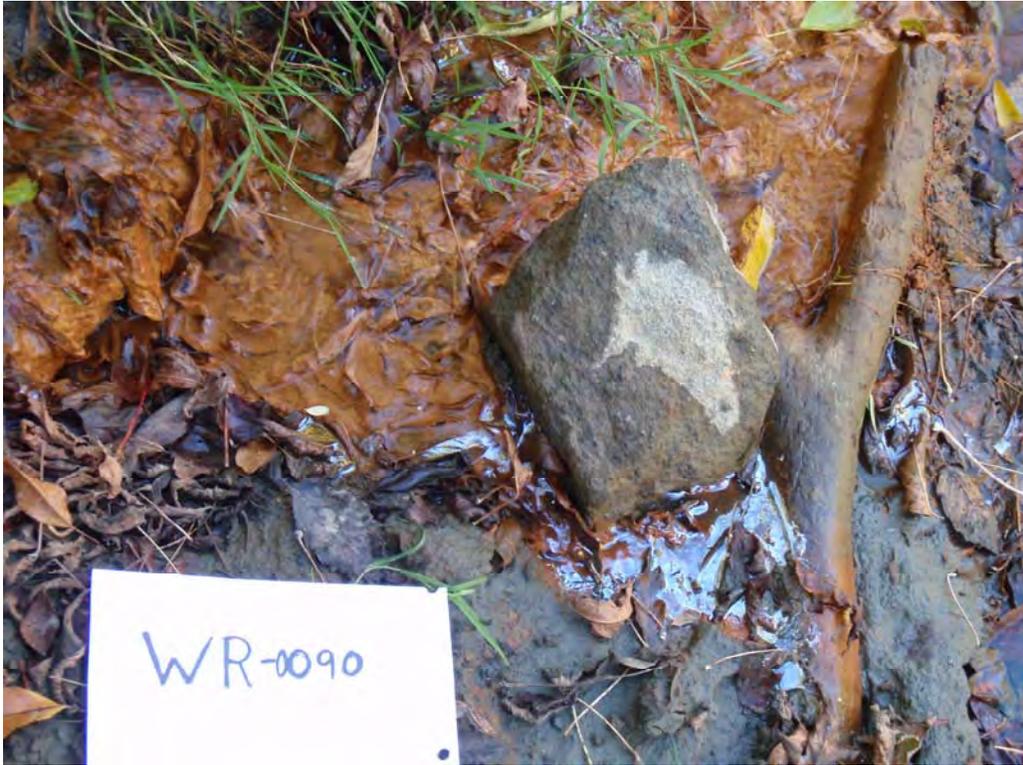
WR-0090. Smells strongly of organic chemical contaminants. Sheen is petroleum based.

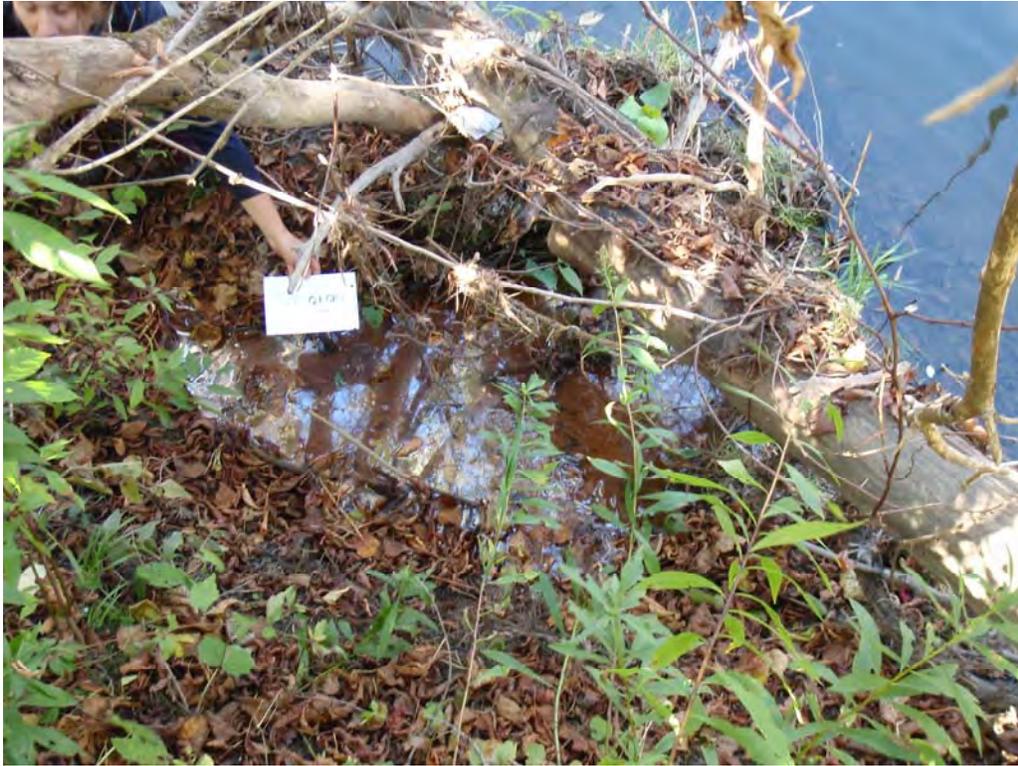
WR-0100. Smells strongly of organic chemical contaminants. Sheen is petroleum based

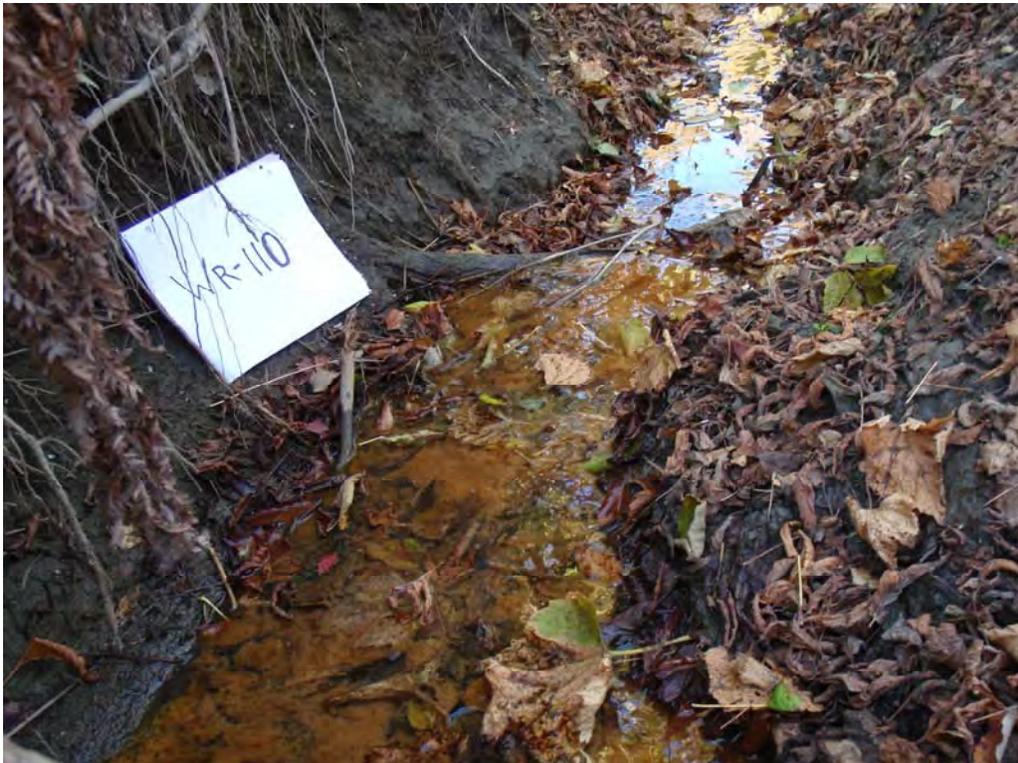
WR-0110. Faint smell of organic compounds. Iron staining suggests contamination
