City and Town of St. Albans Illicit Discharge Detection and Elimination (IDDE) Study

Final Report

Ecosystem Restoration Program
Contract #2012 ERP-1-01

12/13/2012

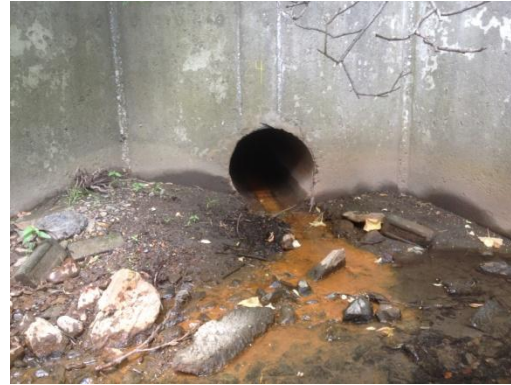
Figure 5: Outfall 24 on June 5th, 2012.

Outfall 24 is an 18" corrugated metal pipe with a concrete headwall connected to a series of catch basins in the Maple Pro Facility parking lot, located on Lemnah Dr. (Figure 5). Approximately 1/8th of the pipe was submerged upon inspection, with evidence of a steady trickle of dry weather flow. The outfall was initially surveyed on June 5th, 2012 at which time substantial iron oxide staining was present in the flow line.

Field Technicians sampled the discharge and tested for all the water quality parameters detailed in Section 3 of this report. The sample water contained extremely high levels of ammonia (3.2 mg/L) and phosphorus (1.88 mg/L), suggesting a possible chemical waste discharge (Table 7). The concentration of Potassium (11 ppm) was almost twice the threshold value and there was a detectable level of detergents (0.30 ppm). Based on the analytical results, the outfall was flagged for further investigation.

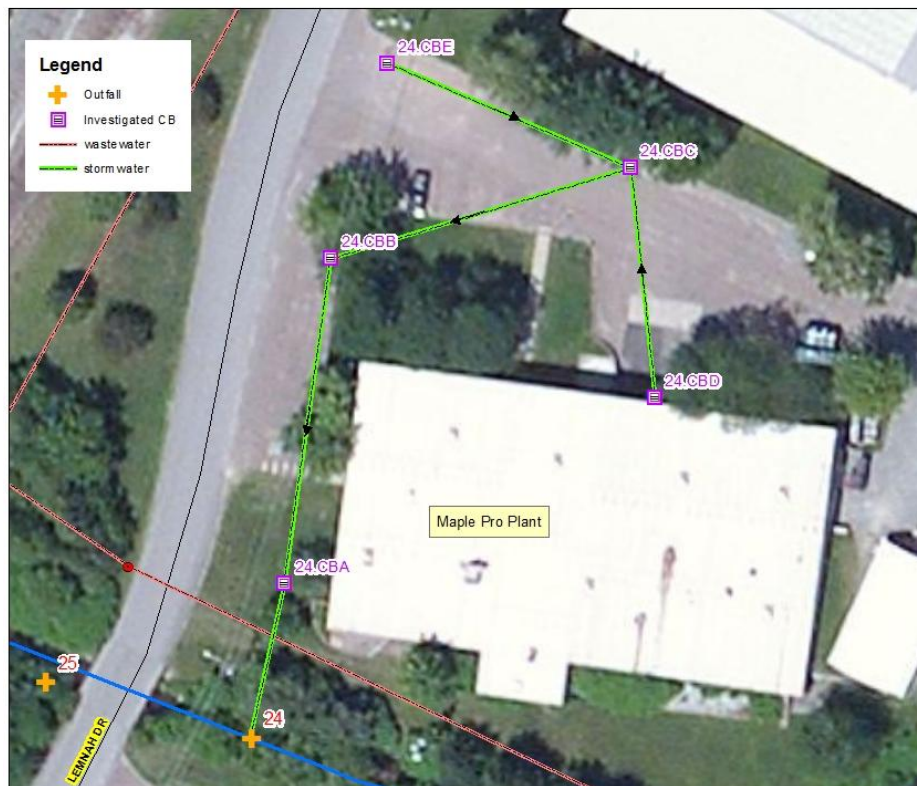
Figure 6: Outfall 24 Drainage System

On June 8th, field technicians inspected the drainage system so as to isolate the source of contamination. The drainage system was found to differ from the existing mapping data, with the addition of two unmapped catch basins and the outfall labeled “Outfall 1” could not be found. Figure 6 (full map provided in Appendix 5-1) shows the updated drainage system, including 5 catch basins (24.CBA-24.CBE) connected to Outfall

24. Flow into the first catch basin up the line from the outfall (24.CBA) tested extremely high for ammonia (4.57 mg/L). Catch basin 24.CBD (the catch basin in the loading dock area of the facility) also tested high for ammonia (2.49 mg/L) and had a strong chemical odor (Figure 7). Catch basin 24.CBE, which doesn’t receive drainage from 24.CBD and only drains the roadway had a low ammonia level of 0.27 mg/L, suggesting that the loading dock catch basin was the source of the contamination. The loading dock catch basin was found to also have 4 feet of sediment build up, therefore it was recommended to have the catch basins in the system vacuumed, particularly 24.CBD in order to detect any inflow pipes into the catch basin from the building.

One suggestion for the contamination, due to the proximity of 24.CBD to the facility, was from past spray down of the facility floors with ammonia and phosphate based cleaning fluids resulting in residual build up of the chemical in the catch basin. Team members spoke with the Owner of the Maple Pro Facility about possible past activities. The Owner said he did not know of any cleaning activities in the vicinity of the loading dock area. However, he did mention that they had acquired the space only a year ago, and that the

past occupants may have disposed of waste in the loading dock area. In addition, the system appeared to be relatively stagnant suggesting that the discharge observed at the outfall was a result of groundwater infiltration into the storm pipes and/or a slow drain of sump water from past rainfall events, and not direct continuous discharge into the system. However, the presence or lack of a floor drain needed to be confirmed.

DPW personnel cleared out the catch basins on June 21st, 2012. An inlet pipe was not found, therefore supporting the possibility of cleaning fluid contamination from washing activities near the loading dock area. Follow up monitoring of the outfall was conducted to assess if the contamination was residual waste from past dumping or current dumping activities. Monitoring results are summarized above in Table 7, which show that ammonia levels were high on June 29th (2.3 mg/L), but then declined substantially by July 13th to 0.48 mg/L. Upon observation, the amount of flow at the outfall declined throughout the summer as well, with no flow observed on August 27th, as base flow throughout the watershed decreased. In addition, the presence of excessive iron oxide was evident on June 8th, but no staining was observed on August 27th, when the outfall was dry (and base flow was low). Iron oxide is typically associated with groundwater flow, supporting the possibility of groundwater infiltration into the storm system.

On October 25th, 2012 field technicians returned to the outfall and found the flow amount to be similar to the observed flow in June, and again with substantial iron oxide build-up in the flow line. The ammonia level was found to be elevated again at 3.78 mg/L, above levels observed during the initial survey. Sump water from the loading dock catch basin, 24.CBD, was also tested and found to be elevated at 1.25 mg/L. The results suggested that new dumping activities had occurred. The outfall was again sampled on November 15th, and found to have a slightly decreased ammonia concentration of 2.47 mg/L. Flow was observed into and out of catch basins 24.CBA and CB.CBB. Sump water from both basins were sampled and found to have similar ammonia concentrations of 2.38 and 2.33 mg/L, respectively. Interestingly, sample water from the sump of the loading dock catch basin, 24.CBD, only had an ammonia concentration of 0.25 mg/L. One possible explanation for the ammonia test results is that dumping activities at 24.CBD occurred prior to October 25th, 2012 and were still actively being flushed through the system on November 15th as a result of groundwater infiltration and rainfall events.

Therefore, the overall conclusion for this site is that illicit dumping of cleaning product fluid due to cleaning activities is occurring periodically at the Maple Pro Plant, and the contamination is flushed through the system due to rainfall and groundwater infiltration.

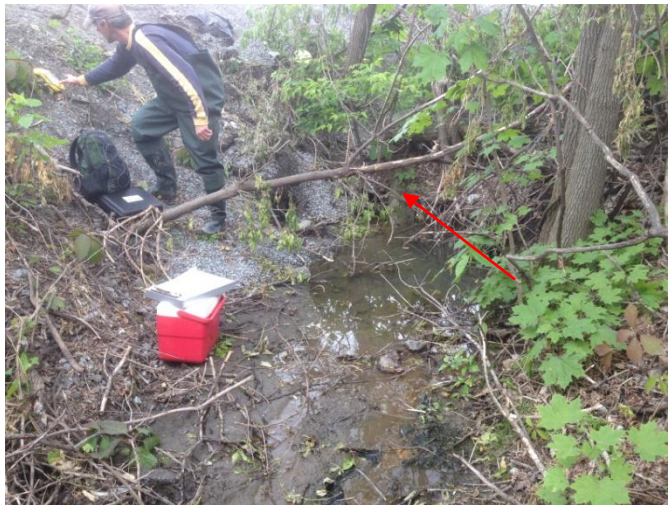
Figure 8: Outfall 26

Outfall 26 is a 24" corrugated metal pipe located near Lemnah Dr. that drains a series of catch basins. Dry weather flow was observed at the outfall on June 5th, 2012. The outfall is indicated in Figure 8 below by the red arrow.

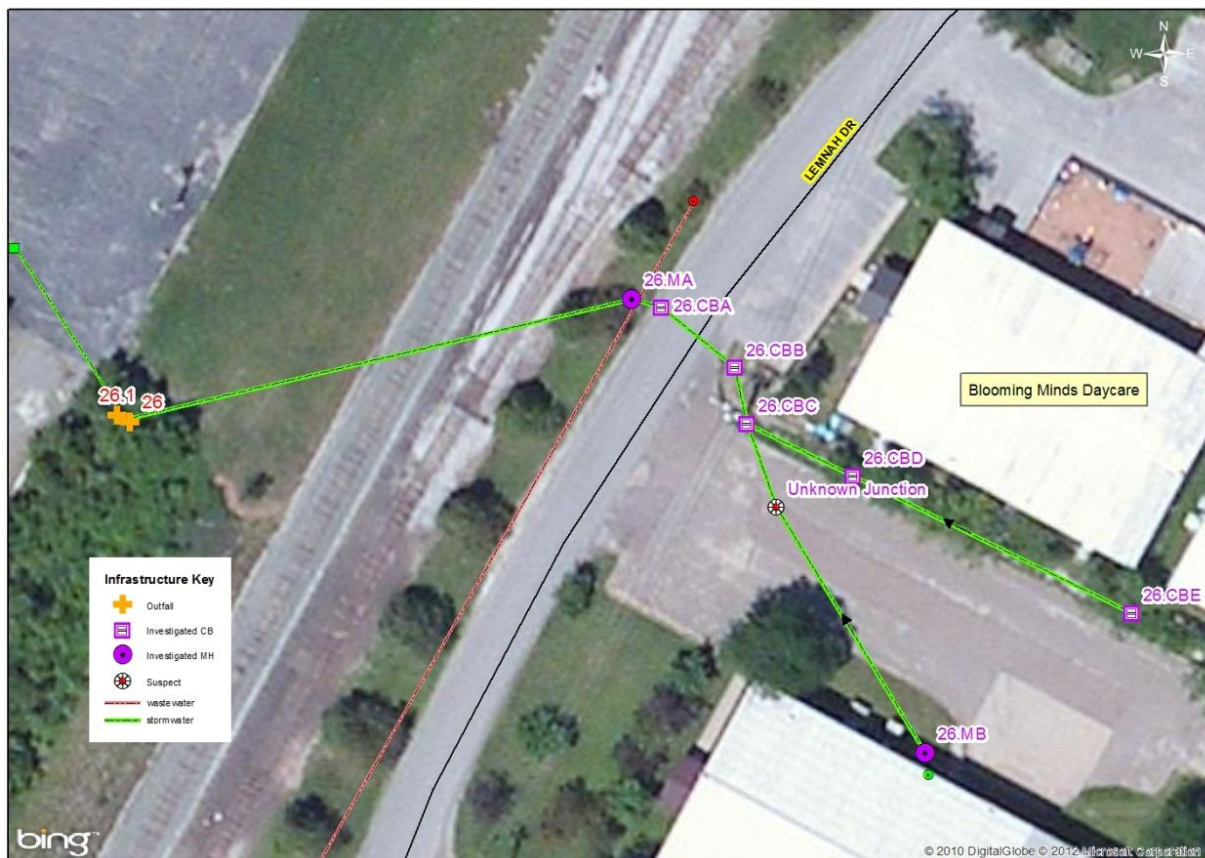
Figure 9: Outfall 26 Drainage System

and 26.CBA. Sump water in 26.MA was tested for E.coli and found to be only 50 cfu/100ml which reduced the likelihood of a wastewater cross-contamination. The structures along the drainage line were sampled and tested for ammonia in the following order, 26.MA, 26.CBA, and 26.CBB, with ammonia concentrations increasing from 2.37, 2.65, and 3.43 mg/L, respectively.

All samples had detectable levels of detergents as well (0.25 mg/L). The next mapped catch basin, 26.CBC was full of sediment with no standing water, however, there appeared to be a trickle of flow into 26.CBB in the direction of 26.CBC. A manhole across the parking lot, mapped as a direct connection to 26.CBC, was sampled and only had an ammonia concentration of 0.48 mg/L, isolating the problem to 26.CBB. In 26.CBB (Figure 10) there appeared to be a submerged 4" metal pipe coming from the direction of Blooming Minds Daycare. Active flow could not be detected because the pipe was submerged. Sump water of 26.CBB was sampled for E.coli and found to have an elevated concentration of 1600 cfu/100 mL. The combination of ammonia and E.coli made the structure suspect for a wastewater discharge, although there was no trace odor of sewage. To determine if the submerged pipe was a possible illicit connection, DPW personnel dyed the sewer system at Blooming Minds. However, no dye was observed in 26.CBB.

Additionally, on November 15th, 2012, sump water from catch basins 26.CBB, 26.CBC, 26.CBD, and 26.CBE were sampled and found to have ammonia levels of 2.74, 1.56, 1.09, and 0.15 mg/L respectively. The inflow into 26.CBC from pipe 26.P (from the direction of the parking lot) was sampled and contained a concentration of 2.58 mg/L suggesting a possible source for the high ammonia. The flow from 26.P was also tested for detergents but only had a concentration of 0.1 ppm common of natural sources. The elevated ammonia level in 26.CBD could possibly be due to back flow into the basin from 26.CBC, as the inflow pipe from 26.CBD was completely submerged. Since the catch basins were vacuumed the day before, it is likely that the source of ammonia is from an active discharge and not residual from past activity.

It was recommended that the catch basins be cleaned so as to clear out any residual contamination and to be able to detect any pipes entering 26.CBC. The catch basins were vacuumed out by DPW Personnel on November 14th, 2012. The next day, field technicians revisited the site and discovered there was an active inflow into 26.CBC from a 6" metal pipe (26.P), but the inflow pipe did not look to be in line with 26.MB as previously mapped. The inflow appeared to be clear, but there was substantial iron

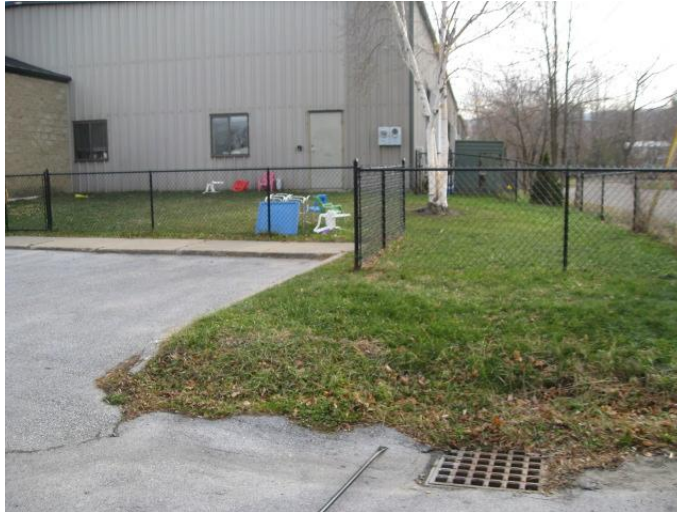
Figure 10: Catch basin, 26.CBB, located in parking lot of Blooming Minds Daycare

Samples were also tested for E.coli from 26.CBB, 26.CBD, and 26.P, all of which had 0 cfu/100ml. These results did not comply with the previous E.coli test from 26.CBB on June 21st, indicating that the E.coli on June 21st could have been from pet waste (or some other natural source) entering the catch basin, or a transient wastewater leak.

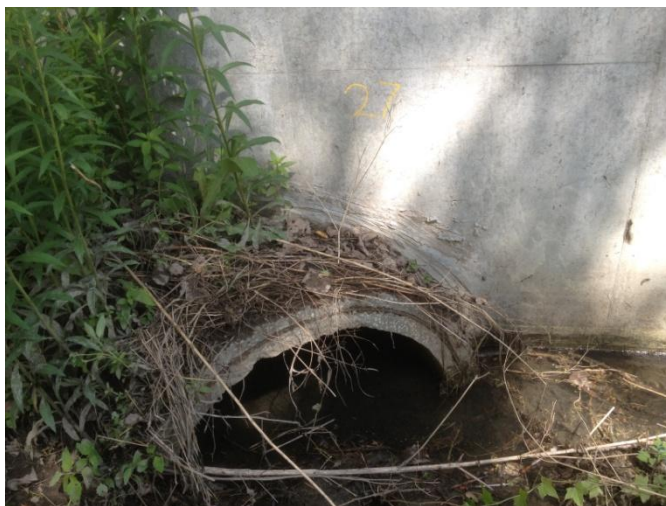
Figure 11: Outfall 27 on June 6th, 2012.

Outfall 27 is a 24" concrete pipe located along Lower Welden St. (Figure 11). The outfall was halfway submerged, with a steady flow evident. The pool in front of the outfall appeared turbid, with sediment build up within the pipe.

Samples were collected from inside the pipe in the center of the flow line and tested according to the methods previously outlined. Results from water quality testing are summarized in Table 9 below. One of the samples was tested for ammonia in the field, and found to have an elevated ammonia concentration of 0.98 mg/L. Discharge had a detectable level of detergents (0.40 ppm) and a high E.coli concentration of 1000 cfu/100mL. Due to the steady flow, large drainage area and elevated phosphorus concentration, the phosphorus loading estimation was high at 6.27 lb/yr. The analytical data for the outfall were indicative of a possible wastewater discharge, and therefore warranted further investigation.

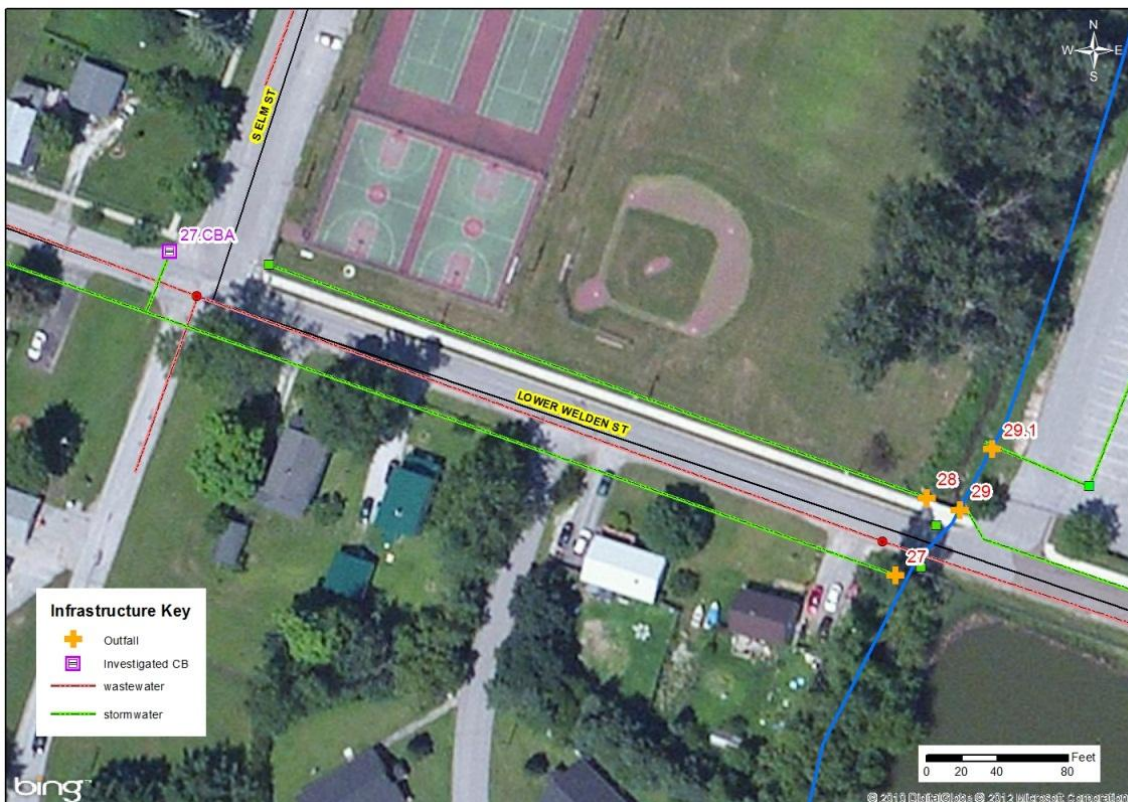
Figure 12: Outfall 27 Problem Site Investigation

The team spoke with the DPW about the possibility of a wastewater leak, and it was discovered that the intersection of S. Elm St. and Lower Welden St. is a low point in the wastewater system, and has a history of combined sewer overflows (CSOs). The sewer manhole is located in the middle of the intersection, and there is a catch basin, marked as 27.CBA in Figure 12 (full map in Appendix 5-3) connected to the storm system of outfall 27 directly North East of the manhole. On June 21st, 2012, the sump of this catch basin appeared stagnant and turbid. The sump water was sampled and testing revealed an exceedingly high concentration of ammonia (3.18 mg/L) and very high detergents (2.0 ppm). The testing results suggest that the catch basin 27.CBA and therefore the rest of the storm line contains residual wastewater from recent CSOs. It was recommended that the DPW clean all catch basins within the drainage system of

In order to address the continual occurrence of CSOs, implementation of stormwater BMP's in the watershed is recommended, so as to reduce stormwater flows entering the system. The CSOs are contributing a large point source of E.coli and phosphorus to Steven's Brook via the outfall, and therefore need to be minimized.

- ✓ Document history of CSOs and set up regular cleaning schedule of catch basins near the intersection of Lower Welden St. and S. Elm St., as well as a mandate to clean catch basins after all CSO events.
- ✓ Continue to evaluate and implement stormwater/wastewater separation projects, as well as green infrastructure projects in the City to reduce stormwater entering the sewer system during large rainfall events and promote groundwater infiltration.

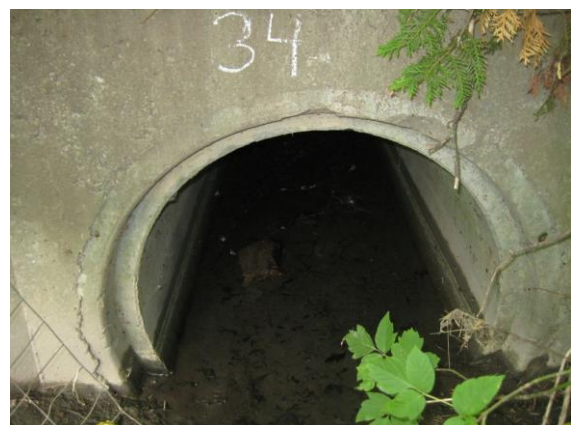
Figure 13: Outfall 34 on June 6th, 2012

Outfall 34 is a 34" concrete outfall located along LaSalle St that drains a large primarily residential drainage network (Figure 13). On June 6th, the outfall was observed to be partially submerged with a substantial amount of sediment build up in the bottom of the pipe, and a slow moving flow through the pipe. There was also an easily detectable odor of sulfide.

The outfall was sampled and tested on June 6th, 2012 revealing slightly elevated levels of ammonia (0.39 mg/L) and high E.coli (800 cfu/100ml), as summarized in Table 10. While the phosphorus concentration was not noticeably high, the moderate flow rate resulted in a substantial annual phosphorus loading estimate of 4.6 lb/yr. The water quality results suggested a possible diluted wastewater source and or chemical waste disposal somewhere further up in the drainage system.

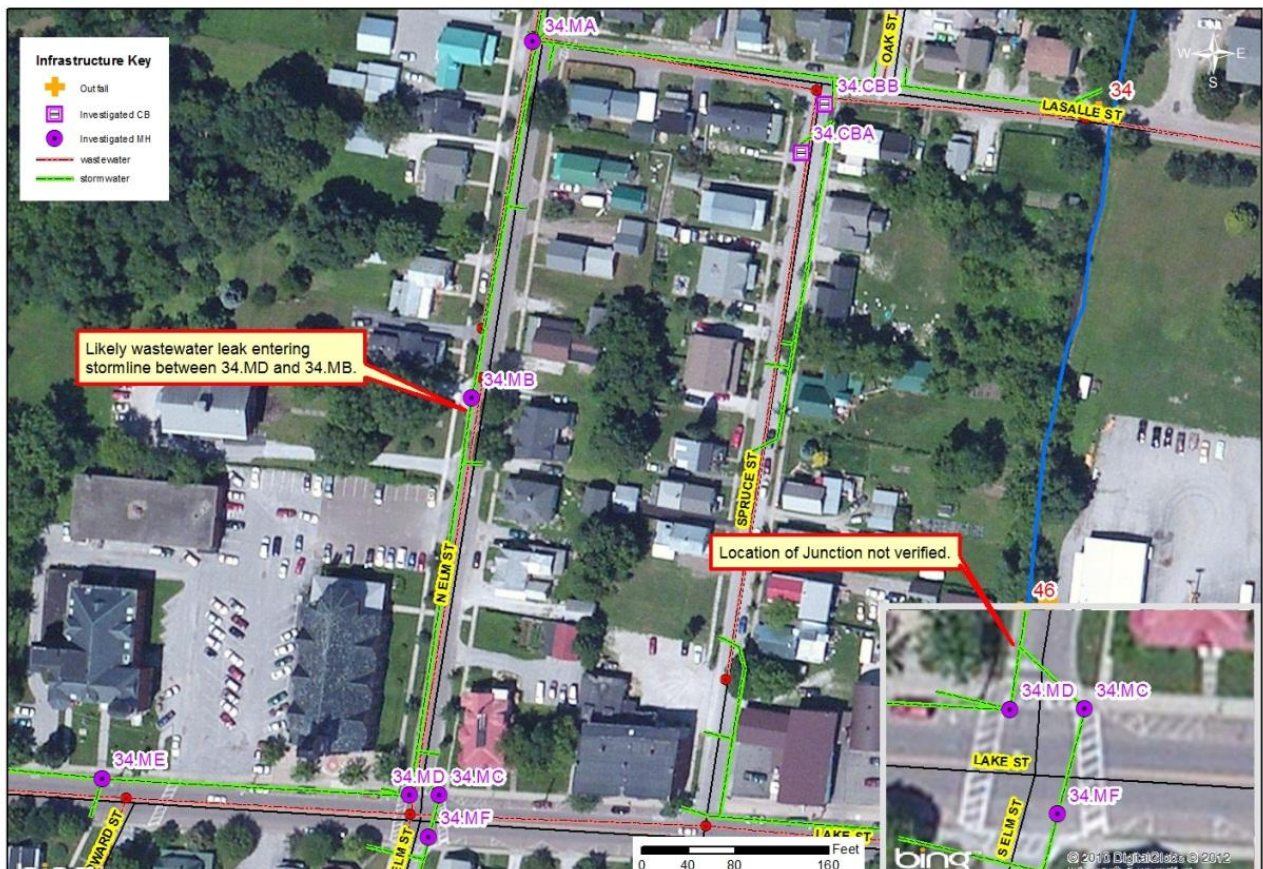
Figure 14: Outfall 34 Problem Site Investigation

The drainage network for outfall 34 was investigated on June 30th, starting with the catch basins along La Salle St, as mapped in Figure 14 (full map in Appendix 5-4). The first catch basin at the intersection of LaSalle and Spruce contained an ammonia concentration of 0.53 mg/L, but a minor E.coli concentration of 78 cfu/100ml. Sump water in the next catch basin in the line contained an ammonia level of 0.6 mg/L and a slightly higher E.coli concentration of 186 cfu/100ml. Inlet pipes were submerged in both catch basins so an active dry weather flow was not detectable. The manhole (34.MA) along the main stormline connected to outfall 34, located at the end of LaSalle St. was inspected and appeared to have a small flow from the south and no flow from the north along N. Elm St., therefore concluding that the source was likely coming from the south. Sump water from the manhole contained an ammonia concentration of 0.4 mg/L and a high level of E.coli (748 cfu/100 ml).

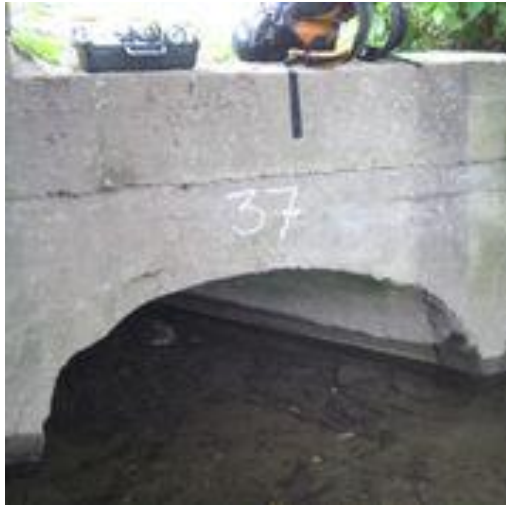
Figure 15: Outfall 37

Outfall 37 is a concrete elliptical shaped pipe on Pearl St. that is connected to a large drainage network (Figure 15). Dry weather flow from the outfall was estimated to be approximately 0.14 cfs on June 6th, 2012.

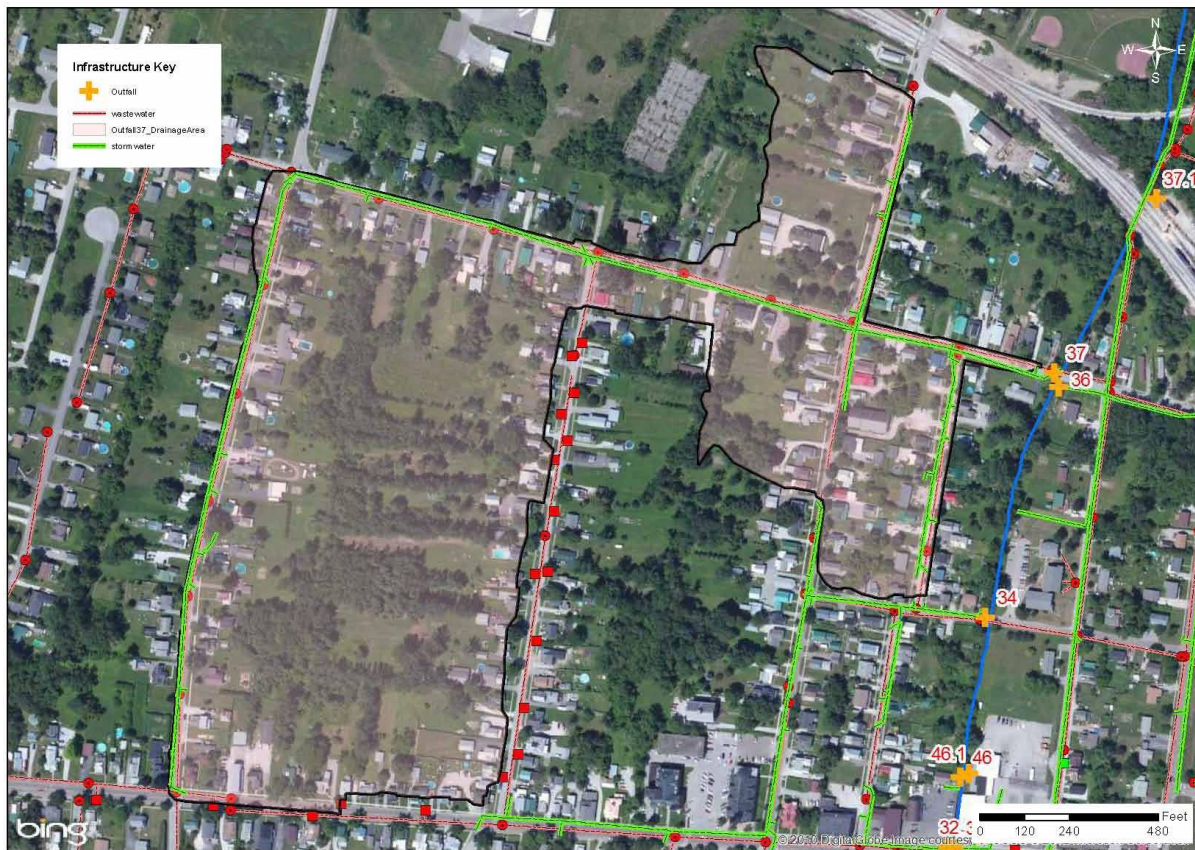
Figure 16: Outfall 37 Drainage Area

The drainage area was not investigated further due to time constraints, and the large size of the drainage area (Figure 16 - full map in Appendix 5-5). While the loading estimate may not be accurate, the estimate does demonstrate that this outfall may contribute a substantial amount of phosphorus on an annual basis. Due to the potential contribution of phosphorus pollution to

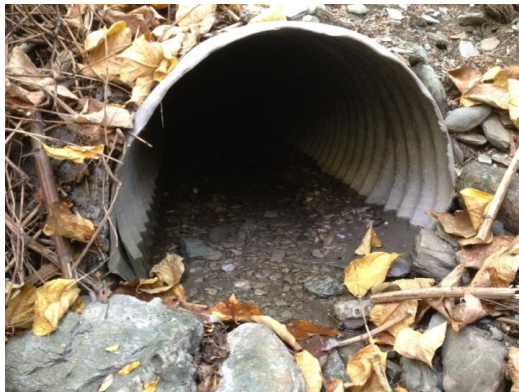
Figure 17: Outfall 43A on October 25th, 2012

Outfall 43A is a 24" corrugated metal pipe located across Main Street from the St. Albans Messenger. The outfall was surveyed on June 7th, 2012 from which a trickle of flow was present. Figure 17 below, taken on October 25th, 2012, depicts the buildup of sediment in the pipe that was present on the initial survey.

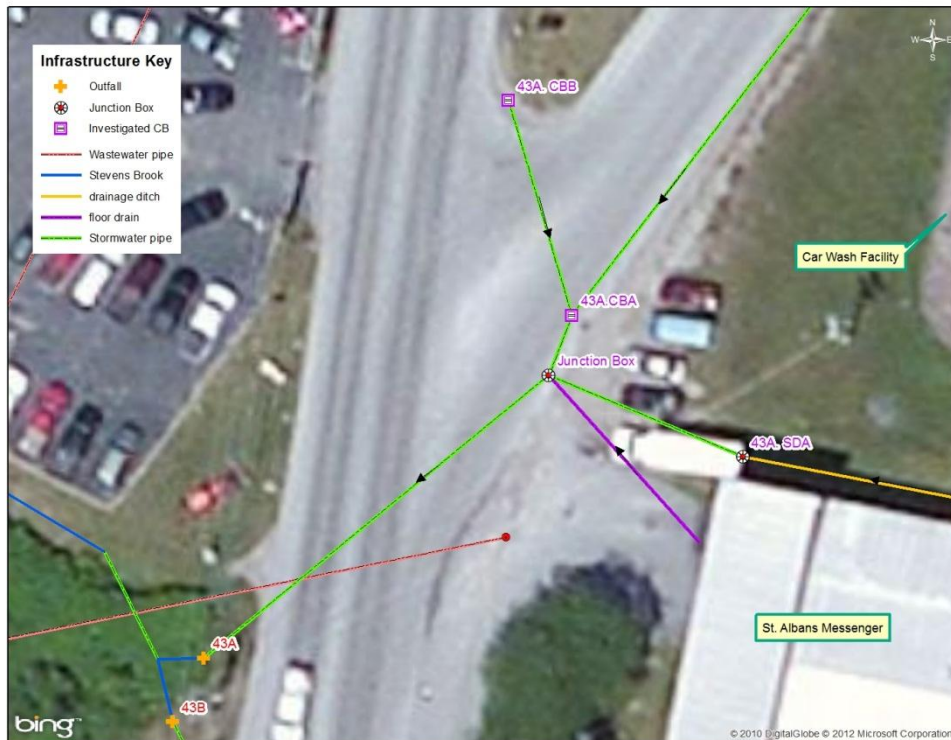
Figure 18: Outfall 43A Drainage Area

The drainage system investigation began with an inspection of the next mapped structure up the line from the outfall; catch basin 43.CBA as marked in Figure 18 (full map provided in Appendix 5-6). On June 21st, 2012 water from the sump of catch basin (43A.CBA) was tested for

runoff from a Car Wash facility up the hill from the catch basin. The source of the high E.coli level was still not confirmed.

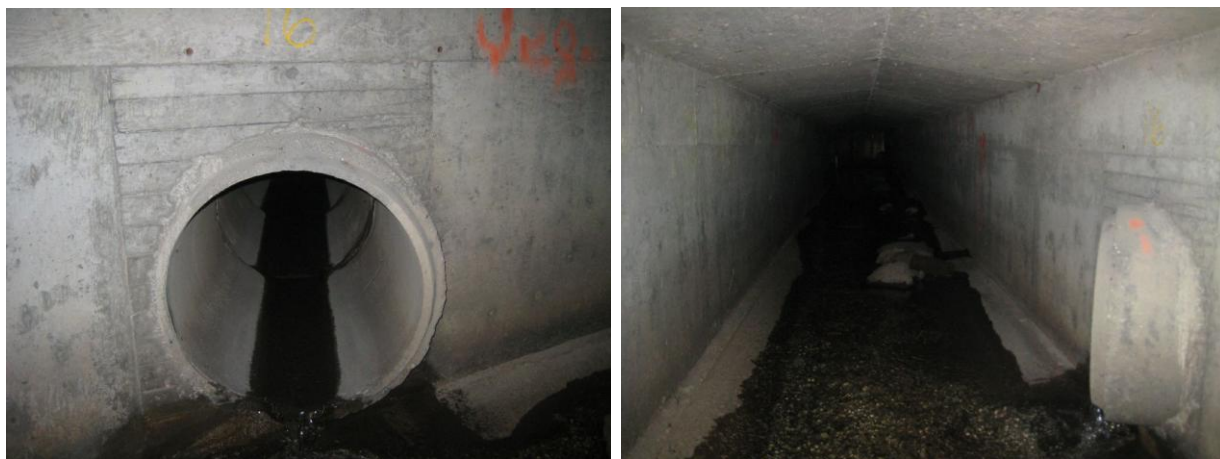
One June 5th, outfall 16 was observed to have a substantial amount of dry weather flow (Figure 20-Left). Outfall 16 is a 30" concrete pipe that exits from the side of the culvert (looking downstream) at the intersection of Upper Welden St. and Main St (Figure 20-Right). The outfall drains a large commercial and residential area, North of the intersection, including runoff from Main St.

Figure 20: Left - Outfall 16 on June 5th, 2012, Right- Side View of Outfall 16 Looking Through Culvert Under Upper Welden St./Main St.

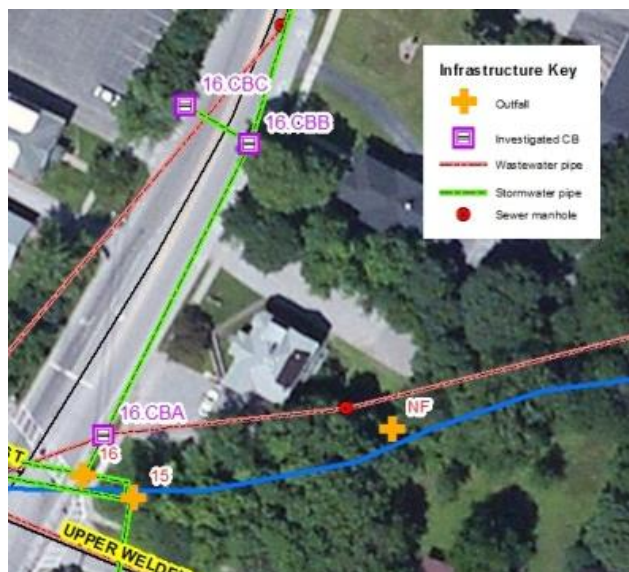
Figure 21: Outfall 16 Problem Site Investigation

On August 2nd, 2012 three catch basins, 16.CBA, 16.CBB, and 16. CBC, located along Main St. directly up the line from Outfall 16, were inspected Figure 21 (see full map of drainage area in Appendix 5-7). The outfall at the time had only a trickle of flow, as opposed to the flow observed on June 5th, 2012. A small trickle was evident leaving the first structure from the outfall (catch basin 16.CBA). The flow was sampled and found to have an ammonia concentration of 0.23 mg/L, which was similar to that observed at the outfall. The next structure, 16.CBB had standing water with both inlet and outlet pipes submerged. The next catch basin in the system, 16.CBC, located across the street was dry and therefore determined to not be a source for the discharge. The investigation was discontinued due to time constraints.

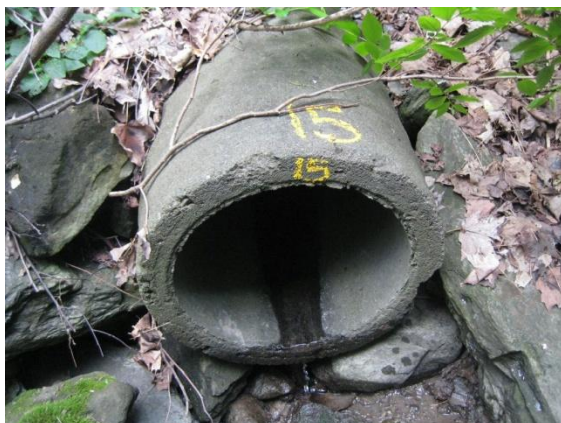
Figure 22: Outfall 15 on June 5th, 2012.

Outfall 15 was investigated after an initial suspicion of an intermittent illicit discharge (Figure 22) due to a low hit for ammonia, and high level of potassium (18 ppm), as summarized in Table 14.

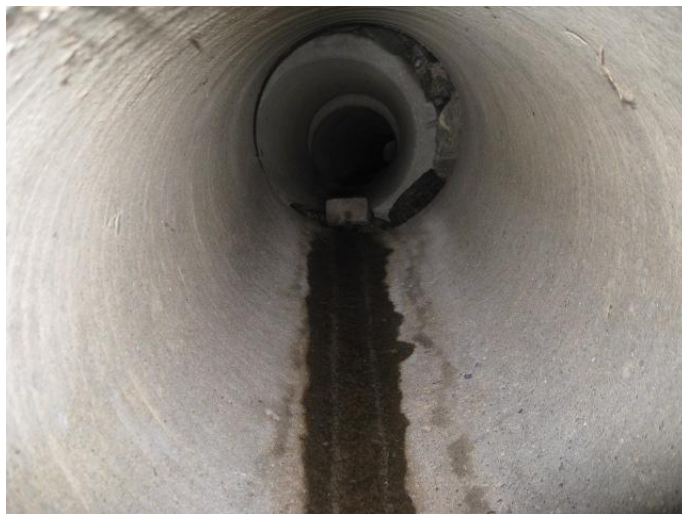
An Optical Brightener Monitoring Pad (OBM) was deployed for 12 days, from August 16th – 27th 2012. The OBM had a False Positive reading due to the presence of specks of dust that appeared to be optical brighteners, but were determined to be from contamination of the OBM after collection. The pipe was found to have a large crack about 10 ft from the outlet. The pipe and the fact that the pipe exits from the side of a steep slope, suggests that the dry weather flow was a result of groundwater infiltration (Figure 23). Due to the presence of high potassium and phosphorus levels in discharge from Outfall 15 but a lack of optical brighteners, the discharge was determined to be groundwater infiltration into the pipe contaminated by non-point source pollution from the use of fertilizers in the drainage area Figure 24 (see full map in Appendix 5-8).

Figure 23: View Looking up Outfall 15 on August 27th, 2012 (Disconnection in pipe visible 10 ft up pipe from outfall)

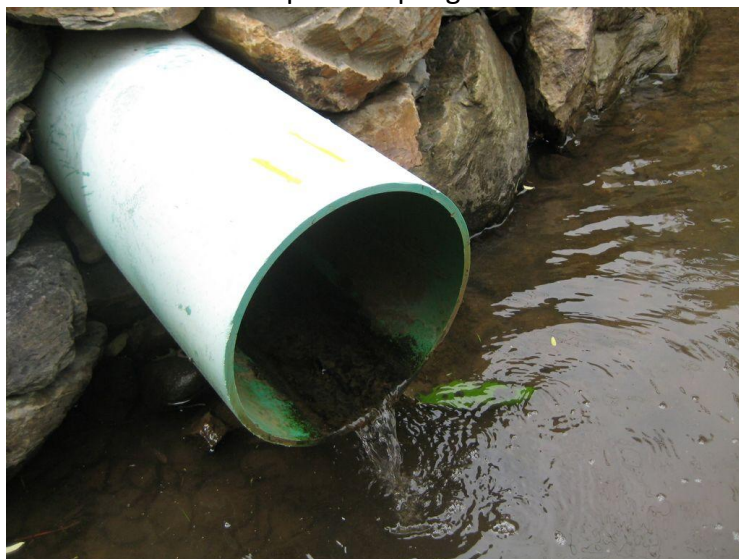
Figure 25: Outfall 11 on June 4th, 2012

On June 4th, 2012 Outfall 11 was surveyed, and found to have about 0.005 cfs of flow (Figure 25). The outfall pipe, a 10" pvc pipe, appeared to exit out of the side of the stream bank. No other structures up the pipe could be located, suggesting the pipe was a floor or foundation drain. The pipe had brown-green benthic growth in the flow line and a very slight sulfide odor. The water was clear upon sampling.

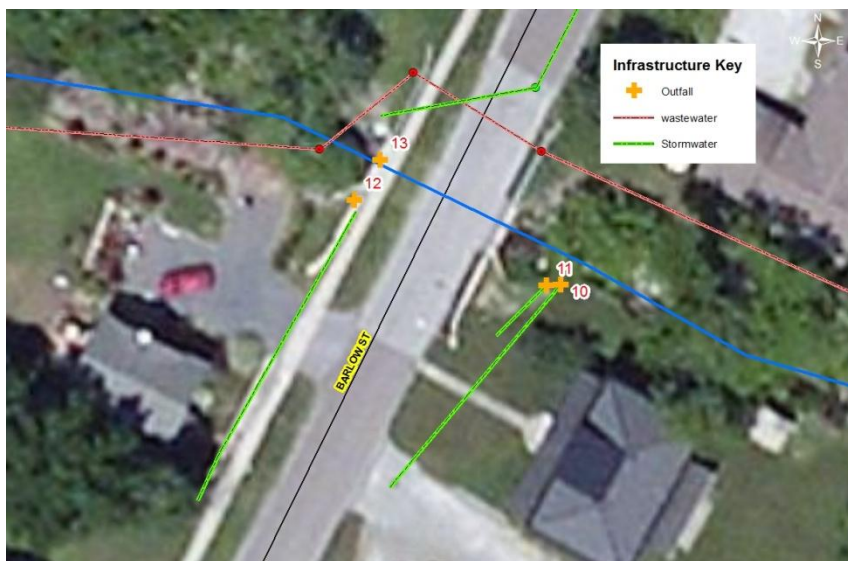
Figure 26: Outfall 11 Drainage System

On August 8th, 2012 Drummac Septic Service conducted a camera investigation of the pipe, and found that the pipe only extended about 10 feet into the side of the bank (Figure 26-full map provided in Appendix 5-9). The pipe appeared to be an underdrain for the bank, but was not connected to any other pipeline. The following investigation results suggested the source of the elevated parameters was groundwater contamination from a minor wastewater leak or spilled washwater and/or fertilizer onto the lawn above the outfall pipe. The presence of detergents is not natural, indicating that there had been past washing activities and/or an intermittent septic leak in the area of the outfall.

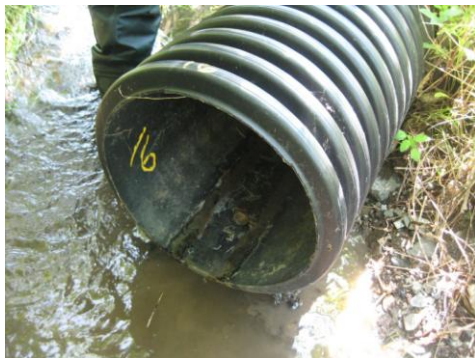
Figure 27: Outfall T16 on June 7th, 2012.

Outfall T16 is a 15" HPDE drainage pipe that connects to a catch basin located in the loading dock area behind Hannafords Store, within the Highgate Shopping Center (Figure 28-see full map in Appendix 5-10). On June 6th, outfall T16 was surveyed and found to have approximately 0.0001 cfs of dry weather flow (Figure 27). Benthic growth and discoloration were present in the flow line suggesting a possible illicit discharge.

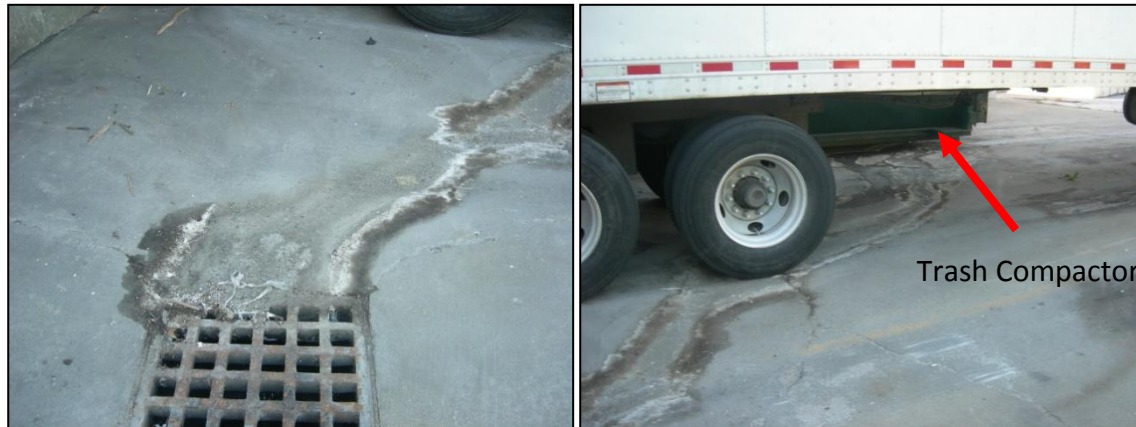
from T16.CBA, suggesting a possible source for the elevated WQ indicator levels (Figure 29). However, the waste stream was dry and did not explain the presence of dry weather flow.

Figure 29: T16.CBA, located in Hannaford Loading Dock. Seepage from trash compactor evident on June 21st, 2012.

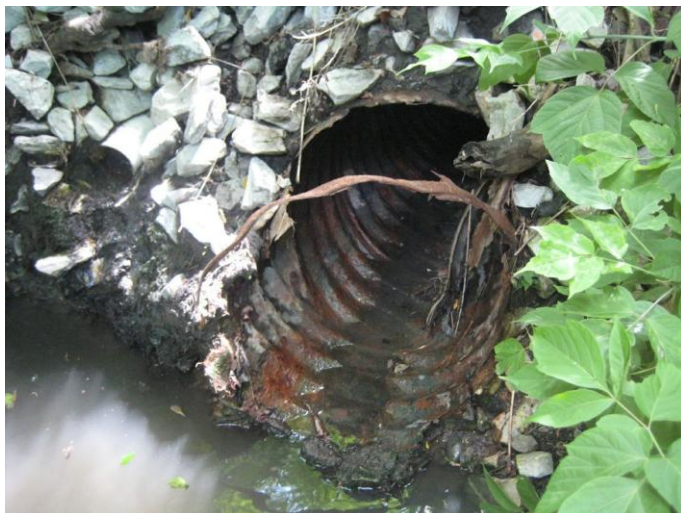
Figure 31: Outfall T123 on June 7th, 2012.

The outfall is an 18” corrugated metal pipe that appears to be in disrepair as displayed in Figure 31 below.

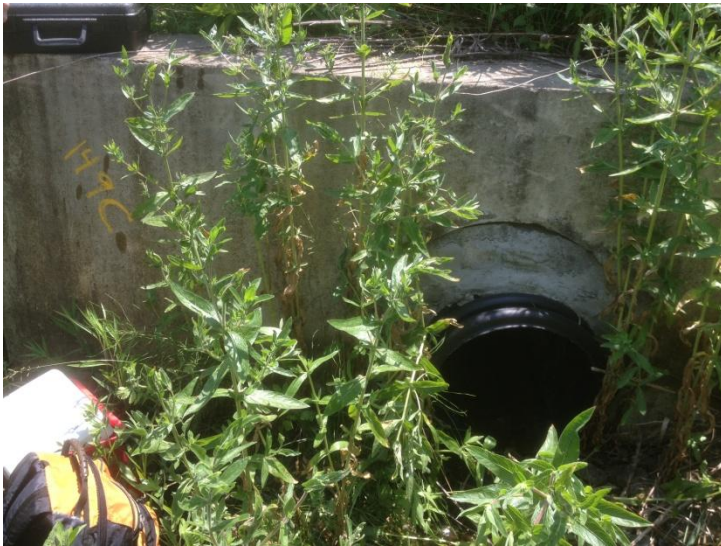
Outfall T149C is a drainage outlet for a catch basin (T149.CBA) located in the loading dock of the nearest industrial building (occupant unknown). The outfall is located at the end of Industrial Park Extended Road, within the St. Albans Industrial Park as marked in Figure 32 (Full map in Appendix 5-12). On June 20th, 2012 dry weather flow was observed coming from the 15" HDPE outfall pipe (Figure 33).

Figure 33: Outfall T149C; Slight trickle observed on June 20th, 2012.

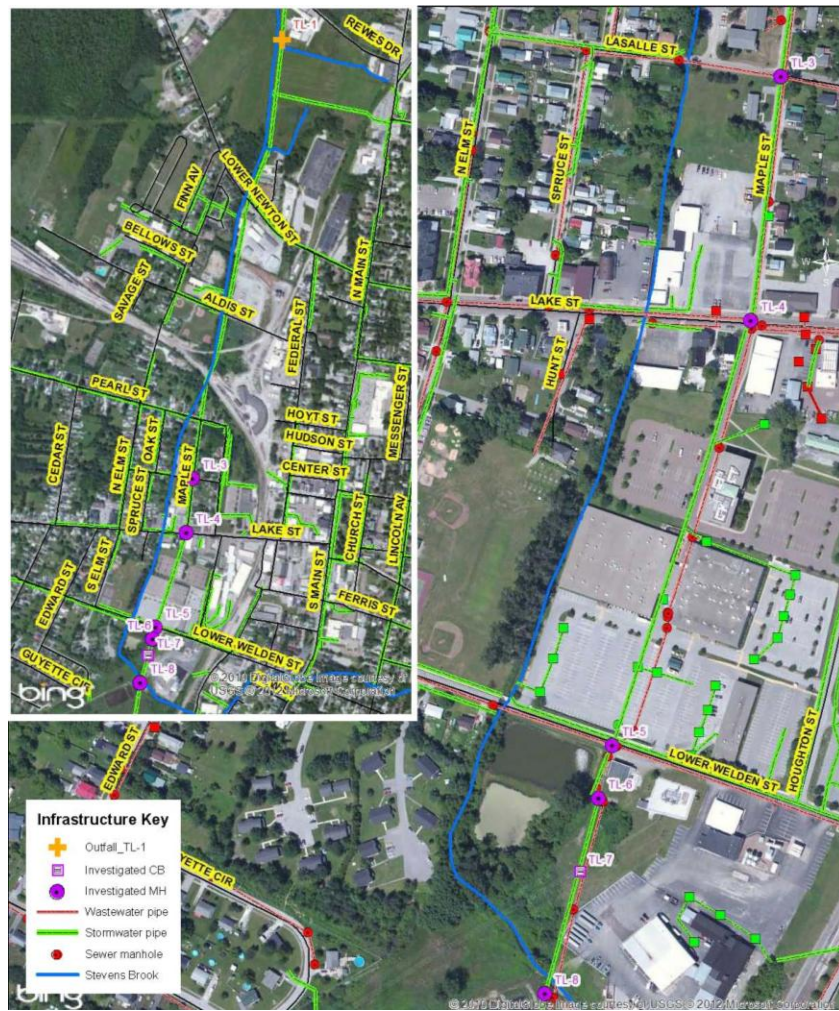
Figure 34: Trunkline Investigation

Investigation of the trunk line began on October 25th, 2012 at structure TL-3, as marked in Figure 34 and working up the pipe. The manhole (TL-3) was suspect given that a wastewater pipe crosses through the structure (Figure 35). Upon inspection, there appeared to be a buildup of iron oxide along the wastewater pipe and the sump of the basin, as well as thick brownish-orange foam. There was a steady flow visible from the partially submerged inflow pipe. In addition, a strong petroleum odor was evident. After mentioning this issue to DPW personnel, they noted that petroleum based manufacturing activities had historically occurred in the adjacent lot, and that the site had been a known source of groundwater contamination. Samples were collected at the inlet pipe, and revealed a high concentration of ammonia (1.46 mg/L) and a detectable level of detergents (0.25 ppm). E.coli was also elevated above the VT water quality standard for fresh waters, at 92 cfu/100 ml.

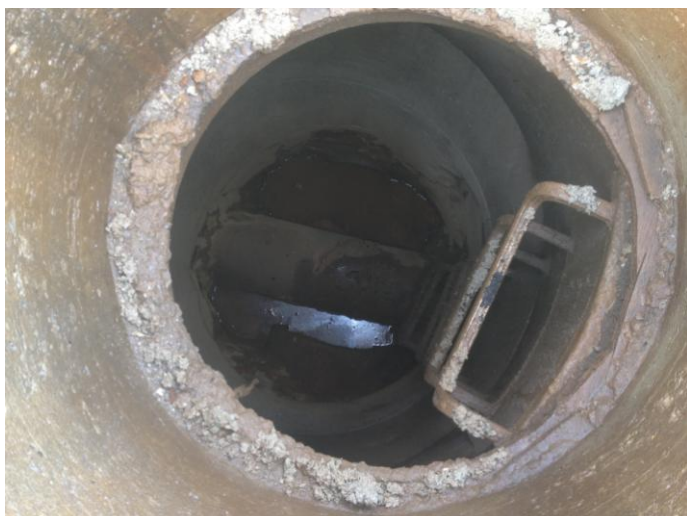
Figure 36: Structure TL-5 on October 25th, 2012.

On the next cross street (Lower Welden St.), structure TL-5, was suspect due to a wastewater pipe crossing through the structure (Figure 36 below), as was the case for TL-3. The inflow pipe to the structure was partially submerged, and flow was evident. Sample water had a pronounced rusty tinge. The ammonia concentration was 1.58 mg/L. While the detergents level was below the benchmark (0.1 ppm), the E.coli concentration was high at 600 cfu/100ml. Fluoride could not be measured due to interference from a high amount of iron in the sample resulting in an erroneous negative reading.

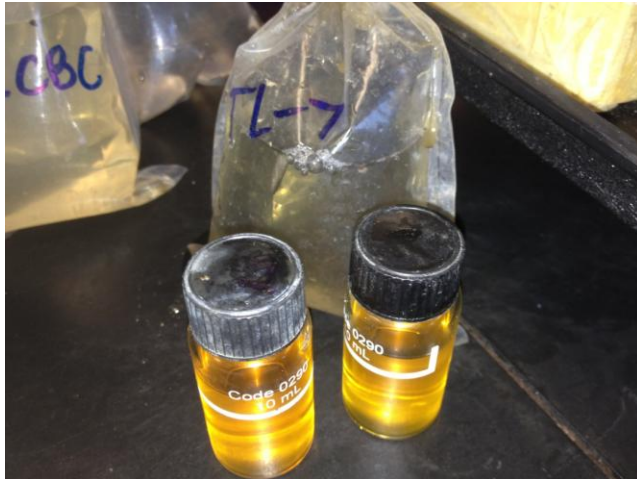
The next structure, TL-7, is a catch basin that appeared to connect directly to the trunk line. However, all pipes were submerged upon inspection and the water was turbid, so the exact connection is unknown. There was a strong odor of sulfide coming from the basin, and the sump water appeared yellowish when sampled. In the process of testing the sample for ammonia, the bulb in the Lamotte Colorimeter burned out. However, the reagents were added to the sample, revealing qualitative evidence for an exceptionally high ammonia concentration based on the deep golden yellow color (Figure 37). The E.coli test revealed 0 cfu/100 ml. The high ammonia and lack of E.coli suggest the possibility of an ammonia-based chemical spill.

**Figure 37: Reacted Samples from TL-7
Indicates High Concentration of Ammonia (> 5.0 mg/L)**
