Detecting and Eliminating Illicit Discharges to Improve Water Quality in the Lake Memphremagog Basin

Final Report

August 14, 2015

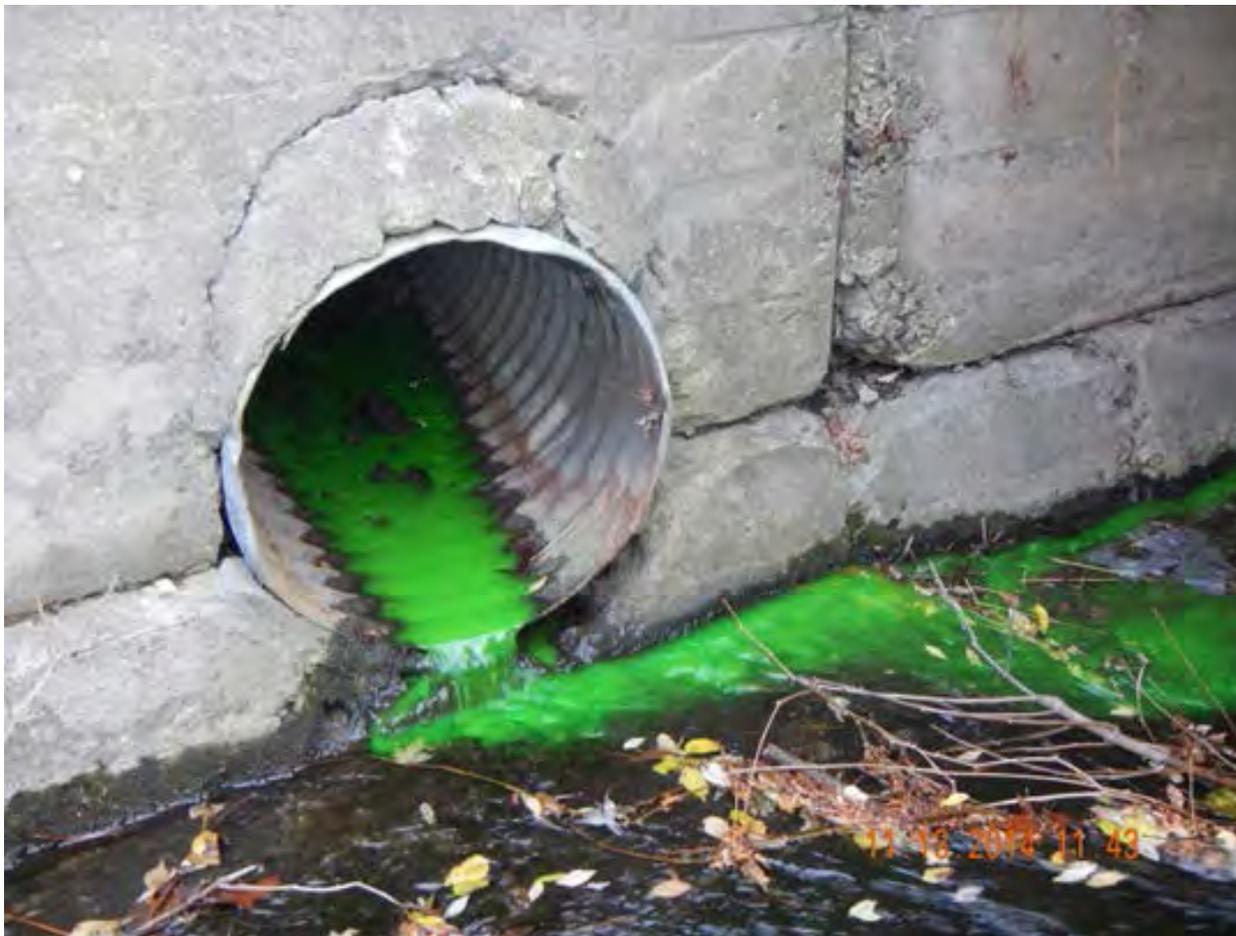
Dye (and wastewater) entering a stream in Barton from a direct sanitary connection on Porter Lane. This connection is scheduled for elimination in 2015.

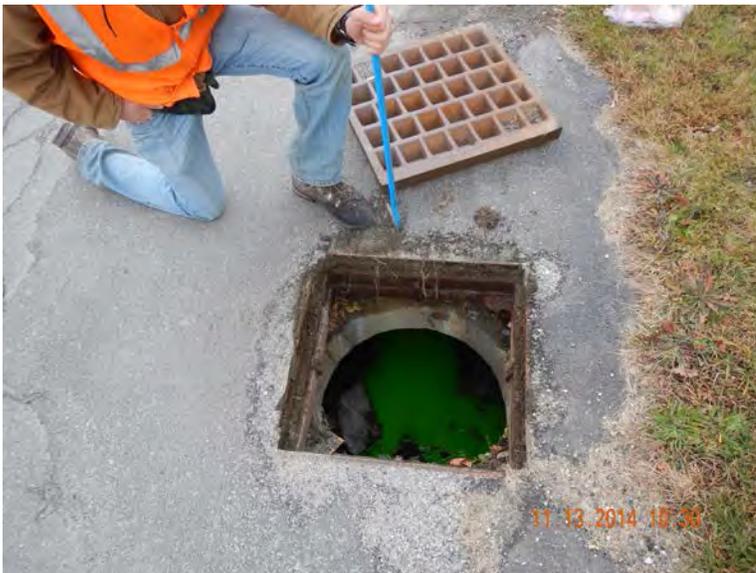
- Optical brightener and ammonia results suggested that sanitary wastewater was entering the system between CB9-A and CB10-A on High Street, possibly via an abandoned sanitary line connected to the storm line.
- On November 13, 2014, dye flushed down a toilet at the house at 112 High Street was observed at catchbasin CB9-A (Figure 2 and Map BA-4), confirming a sanitary connection. No dye appeared in the stormwater system after three other buildings on High Street (between #112 and the intersection with Eastern Avenue) were tested.

Figure 2. Dye observed at catchbasin CB9-A after it was flushed at 112 High Street.

Conclusion: A direct sanitary connection existed between 112 High Street and Branch A of the BA270 stormwater drainage system.

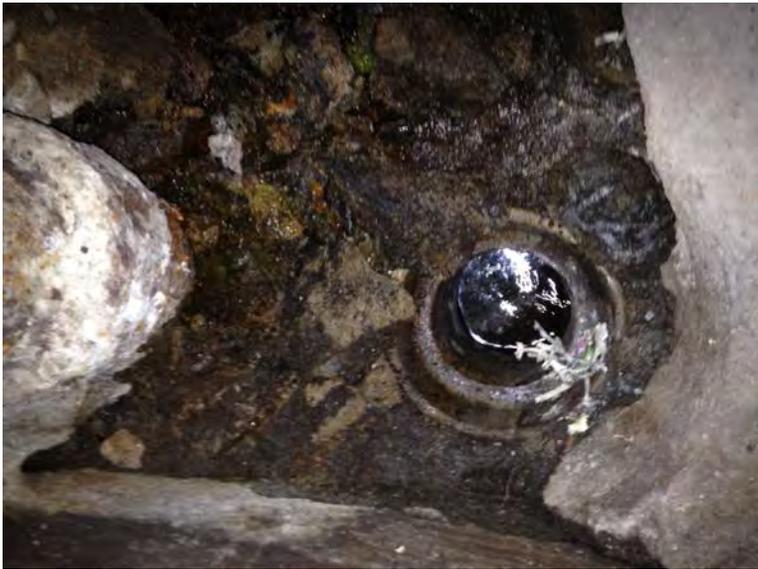
- Optical brightener results suggested that sanitary wastewater or washwater is entering Branch B of the BA270 system above CB7-B.
- Dye testing revealed that the sewer main on Hubbard Avenue is not a source of contamination.
- On November 12, 2014, inspection of the plumbing facilities in the house at 72 Hubbard Avenue revealed a corroded sanitary elbow that appears to be slowly leaking into an opening in the perimeter drain beneath it (Figure 3). We expect that the perimeter drain is connected to catchbasin CB7-B.

Figure 3. Rusted sanitary elbow found slowly leaking to a perimeter drain

Conclusion: We believe the source of the optical brightener detected at catchbasin CB7-B is a leaking sewer pipe fitting in the basement of 72 Hubbard Avenue. This fitting is above a perimeter drain.

Resolution: Written notice was sent to the Village of Barton on November 13, 2014. In June 2015, the Village of Barton sent the homeowner a letter describing Stone's findings. The homeowner reportedly retained a plumber who did not see a problem. On July 18, 2015 a member of the Barton public works staff inspected the sanitary connection and found it deteriorated but not leaking. Apparently the Village

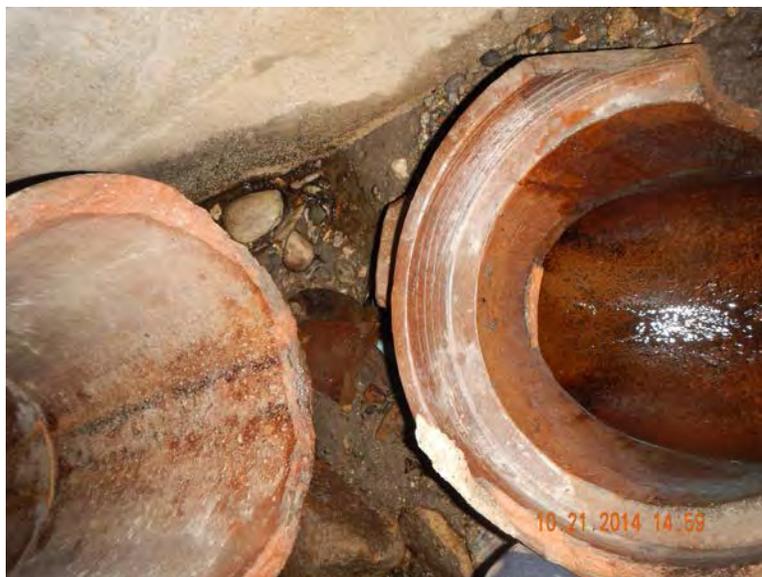
- Dye testing of the sewer main up Porter Lane did not reveal any sewer leaks entering the stormwater main.

Figure 4. Drop structure located at the end of the stormwater tunnel.

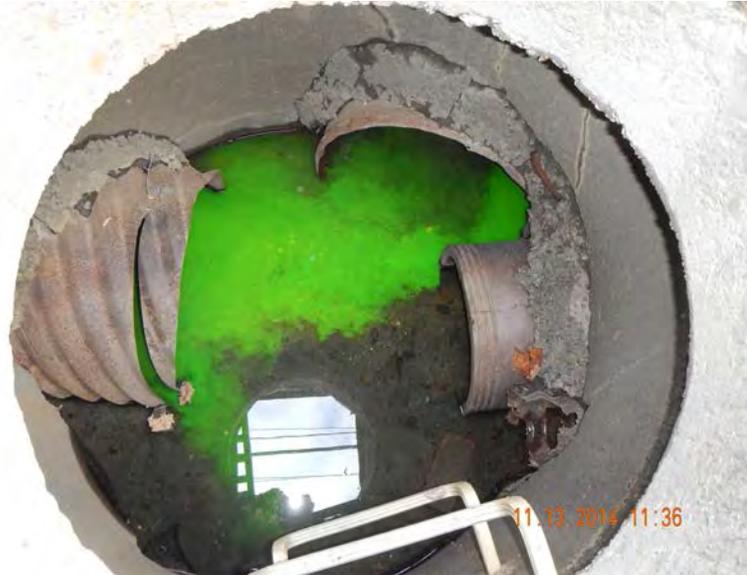
- On October 30, 2014, inspection of catchbasin CB2 revealed a definite wastewater odor and gray material (likely fungal growth) in the sump and in the outlet of Pipe A, which drains the Porter Lane line. MBAS and ammonia were slightly elevated in flow from Pipe A and a corn kernel was present in the sample.
- On November 12, 2014, all accessible buildings on lower Harrison Street and Porter Lane were dye tested. No dye appeared in the stormwater system.
- On November 13, 2014, we gained entry to the house at the end of Porter Lane (79 Porter Lane). This house appeared to be the most likely source based on its proximity to the stormwater line. Dye flushed at the house was observed at catchbasin CB2 (Figure 5) and not in the sanitary sewer, confirming a wastewater connection.

Figure 5. Catchbasin CB2 at the intersection of Main Street and Porter Lane.

Conclusion: A direct sanitary wastewater connection existed between 79 Porter Lane and the BA360 stormwater drainage system.

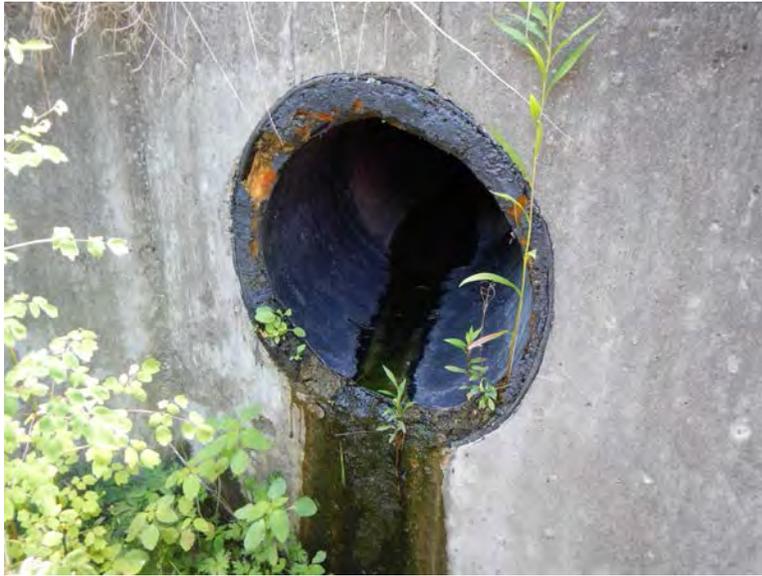
Figure 6. DT030 outfall

- Optical brightener was detected at the outfall and in catchbasin CB1. Low concentrations of ammonia, MBAS, and chlorine have also been detected at the outfall.
- A steady flow of water was observed seeping from the yard on the northern end of the property at 31 Hinman Settler Road and discharging into CB1. This water has a wastewater odor.
- *E. coli* and total phosphorus concentrations in samples collected at the outfall on May 14, 2015 were surprisingly low considering that a wastewater odor was observed (Table 79).

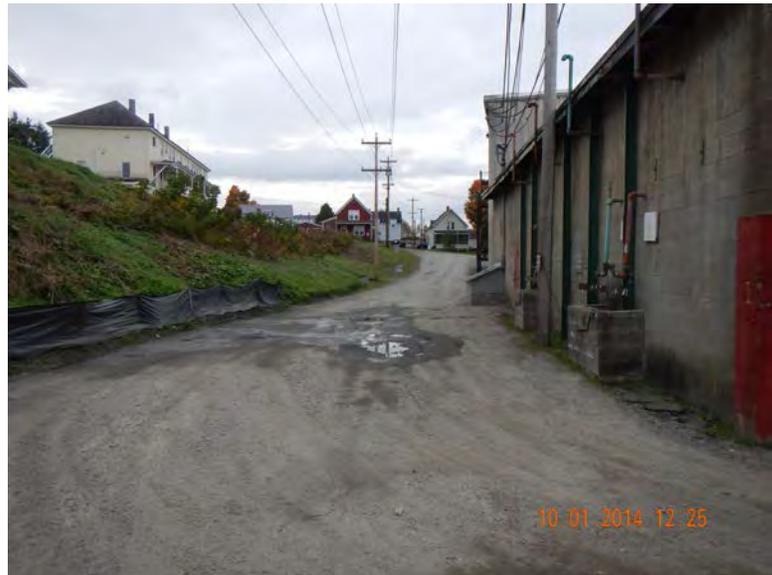
Figure 7. Eastern side of Ethan Allen facility in area drained by OR220

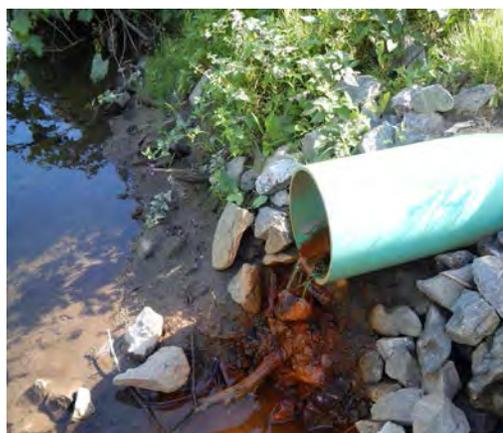
Figure 8. OR320 outfall

The OR320 system discharges to the Barton River at the northern end of the Ethan Allen property (Map OR-3). There do not appear to be any connected stormwater inlets. The outfall pipe (Figure 8) was reportedly replaced sometime between May 2013 and August 2014 after a sinkhole developed nearby due to an old tile drain.

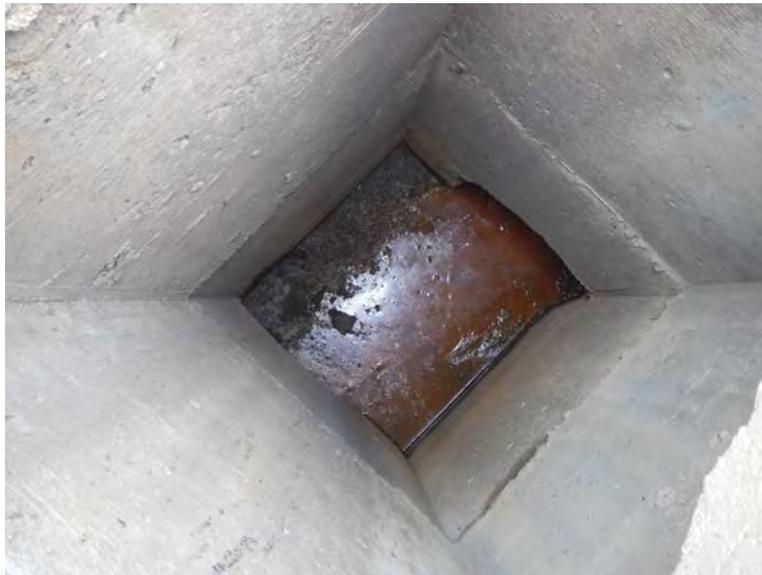
Figure 9. Catchbasin NC470 CB1 at the corner of Causeway Road and Route 191.

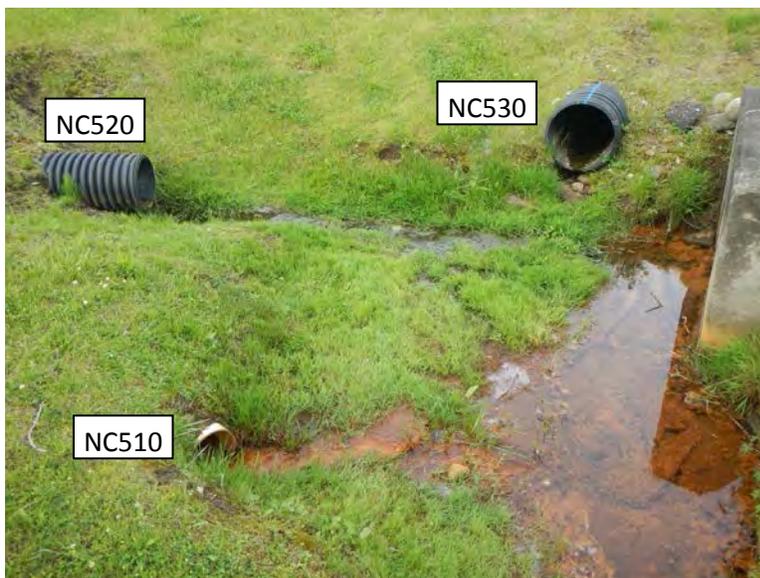
Figure 10. Petroleum contaminated discharge evident at outfall NC510

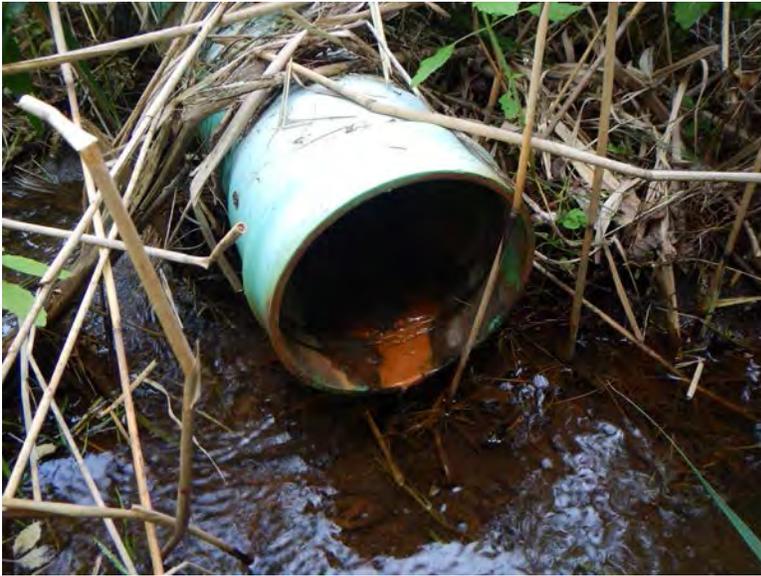
Figure 11. NC1490 outfall

Conclusion: This structure is an identified combined sewer overflow. However the presence of dry weather flow requires explanation. One possible explanation that fits these data is that there is a municipal water leak that infiltrates the pipe (contributing chlorine) and flushes out wastewater residues from past overflow events.

Resolution: We recommend Newport City identify the source of the dry weather flows in this structure and correct any leaks in the pump station or municipal water system that may be contributing these flows.
