# Stormwater Master Plan Town of Rupert, Vermont

December 4, 2015

**Fitzgerald Environmental Associates, LLC.**  
18 Severance Green, Suite 203  
Colchester, VT 05446

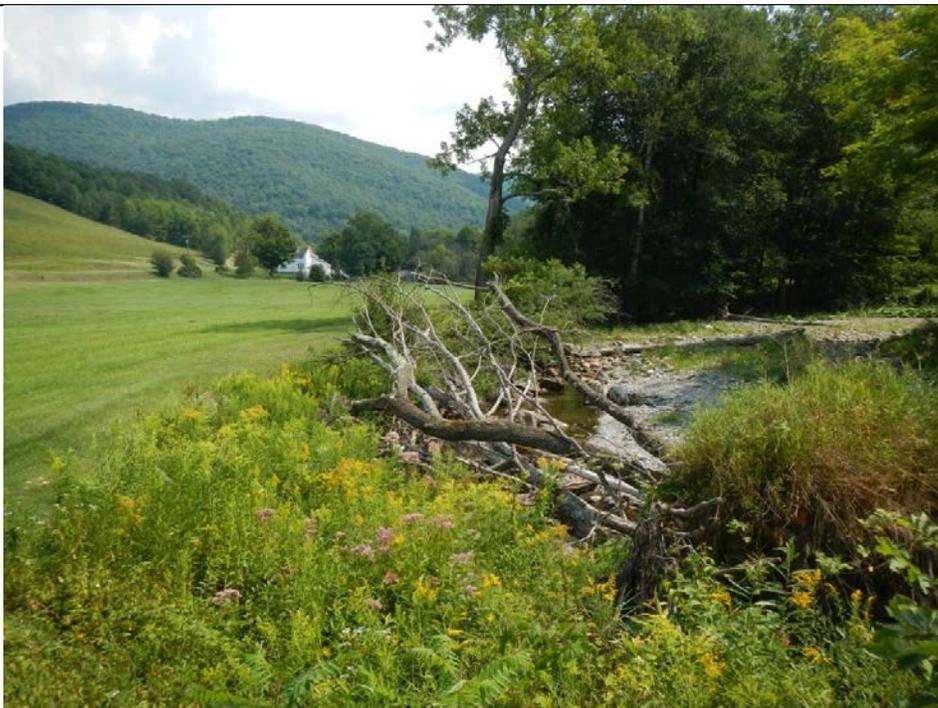
**Site Description:** Project #4 in White Creek/Mill Brook RCP. Bank erosion into the farm field initiated during Tropical Storm Irene and is continuing as the channel adjusts planform. Recommend planting the bank and buffer with native woody vegetation and establishing an unmanaged buffer area in hay field. Woody debris in channel should remain undisturbed.

**Photo 1:** Bank erosion into hay field. Woody debris accumulation along toe of bank is temporarily slowing erosion, however no woody vegetation was present along the bank. Recommend establishing a vegetated buffer extending at least 25 feet from the top of the bank.

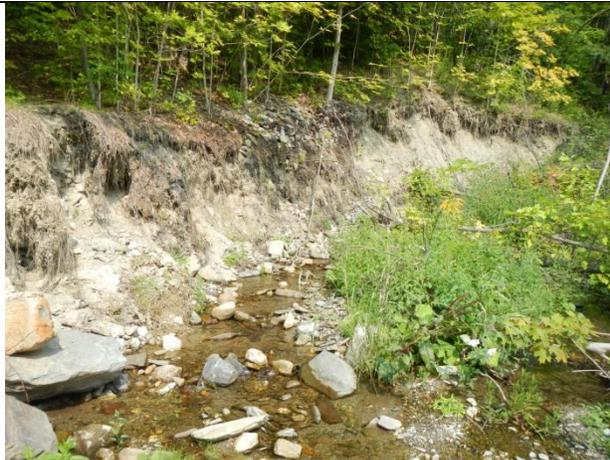
**Site Description:** Two areas of bank erosion/mass failure along the right bank (north) where the stream channel is pushing into the steep valley wall. The downstream section of active bank erosion is approximately 6-8' tall and 75' long. The large mass failure is slowly revegetating and the toe of the failure is somewhat protected by sediment accumulation. Recommend low cost approach of protecting trees along top of mass failure slope. Another low cost option is to revegetate the lower-middle mass failure slope. Bank stabilization would be costly given the length and height (photo 1).

**Photo 1:** Severe bank erosion approximately 100' downstream CR2 and 400' downstream of the mass failure

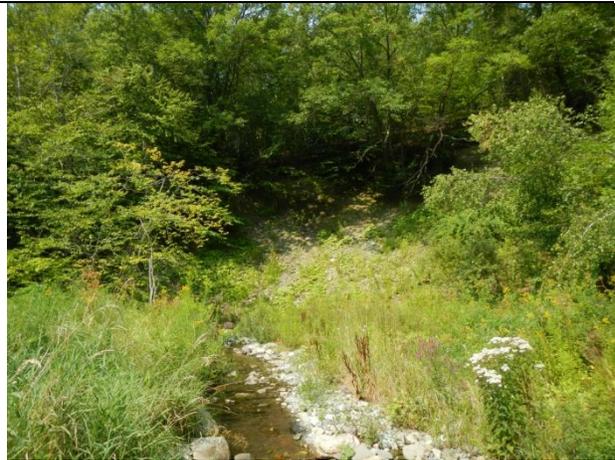
**Photo 2:** Somewhat stable mass failure area on sharp bend in the stream channel (located just upstream of barn which is being undermined by bank erosion on the south bank).

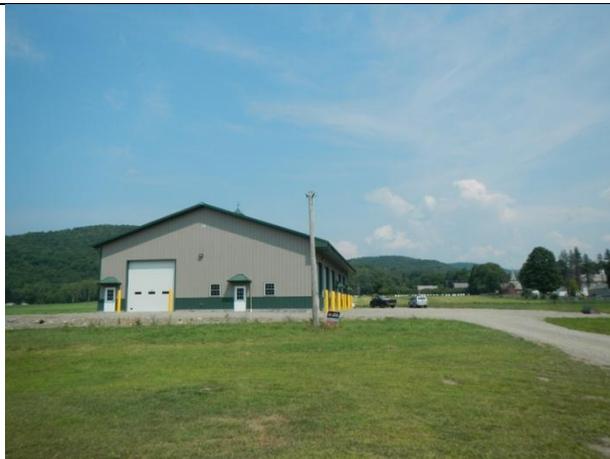
**Site Description:** The newly constructed town garage building and the scheduled construction of the sand/salt storage shed will result in a large area of impervious surfaces generating stormwater runoff. The roof drains are connected to a pipe that directly outlets to a ditch along the rail bed. Recommend directing runoff from the parking area, road, and sand/salt storage shed to a green stormwater infrastructure collection system where possible, otherwise disperse runoff to grassed areas to encourage infiltration.

**Photo 1:** Town garage building and future sand/salt storage building area (foreground)

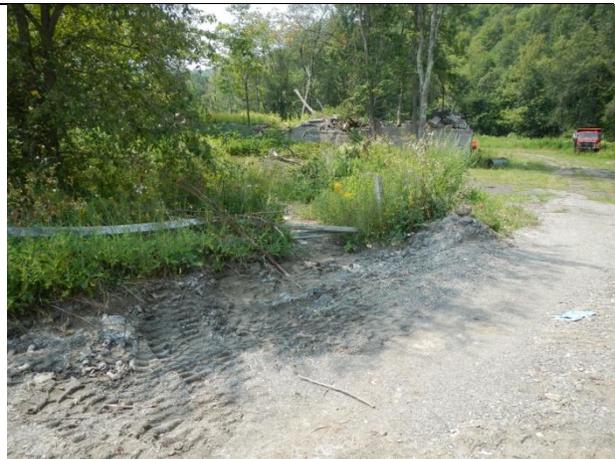
**Photo 2:** Existing drainage pathway for current sand pile and access road.

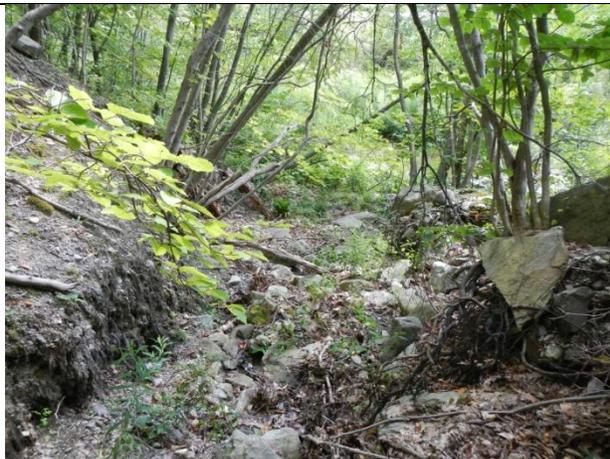
**Site Description:** A large and active gully has formed in an area of concentrated runoff draining from 41 acres of forest, pasture, and residential lands. The lower portion of the gully has numerous head cuts and active bank erosion. The upper portion of the gully is moderately stable, however the headcuts will advance upslope. Recommend stabilizing the gully with log and stone check dams to mitigate sediment load to Mill Brook. The upslope contributing drainage should be reviewed in the field to identify potential stormwater diversion opportunities.

**Photo 1:** Raw eroding banks and numerous headcuts in the lower portion of the gully

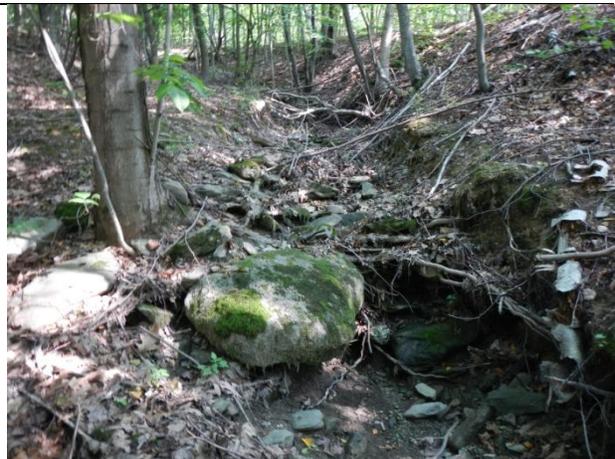
**Photo 2:** Headcut at the transition to the somewhat more stable upper portion of the gully

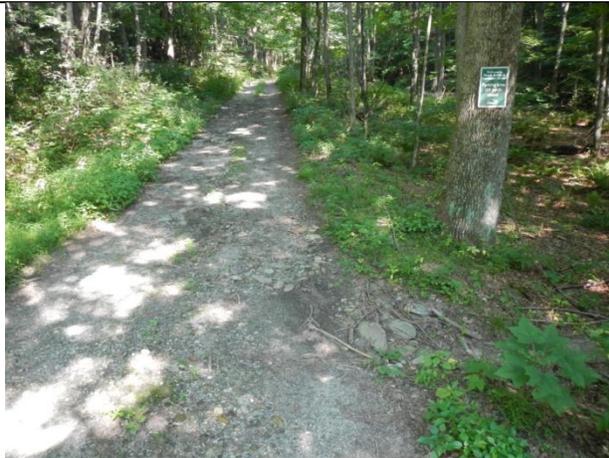
**Site Description:** A small area of parking lot and access road drain from the road to a narrow strip of forested floodplain. A moderate volume of sediment is being generated from these surfaces and the edge of the road is eroding. Recommend armoring the edge of the road and adding log check dams and natural roughness (brush matting) to the floodplain to trap sediment in the area shown in photo 2.

**Photo 1:** Concentrated runoff from parking area and road causing erosion of road edge

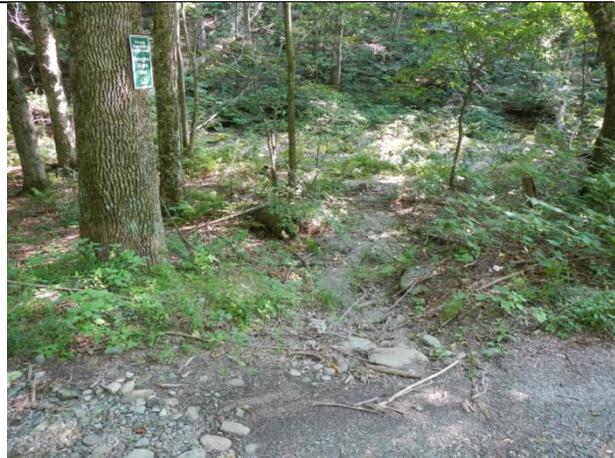
**Photo 2:** Sediment deposition on forested floodplain

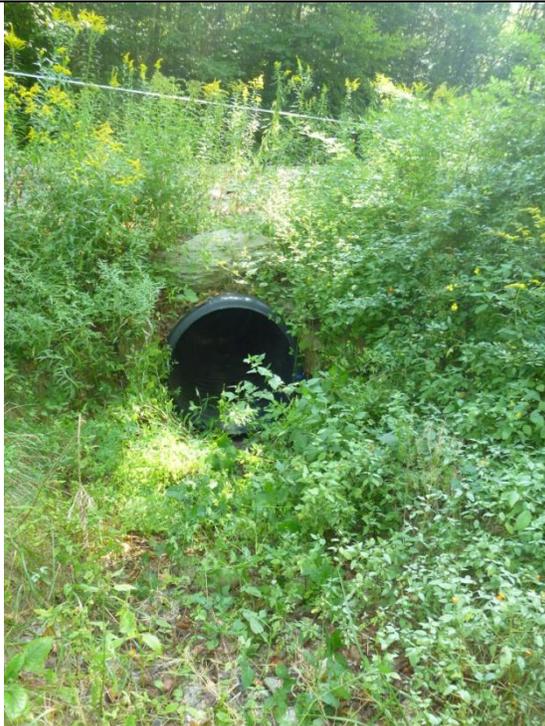
**Site Description:** 36" diameter corrugated HDPE culvert under Sandgate Road delivers sediment and stormwater to Sandgate Brook. The culvert has appropriate hydraulic capacity for the 7.7 acre forested watershed and the downstream swale is stable. No immediate action is recommended, however the Town should monitor the outlet and the swale for erosion and add armor if needed.

**Photo 1:** Culvert outlet

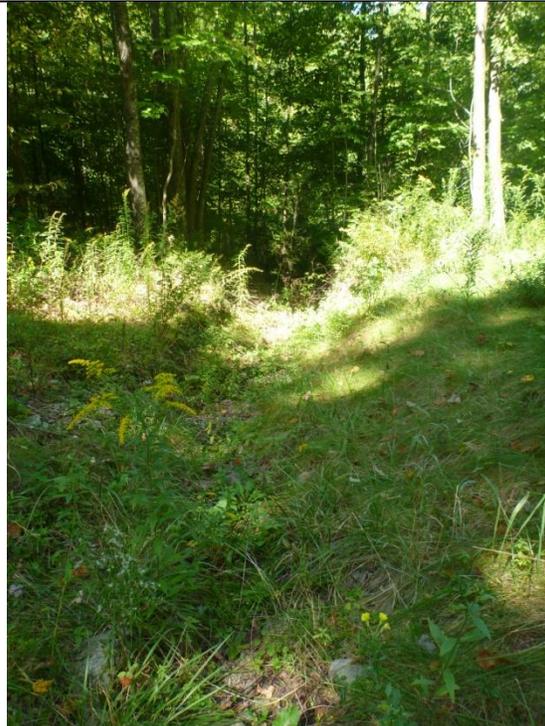
**Photo 2:** Stable and vegetated swale downstream to Sandgate Brook

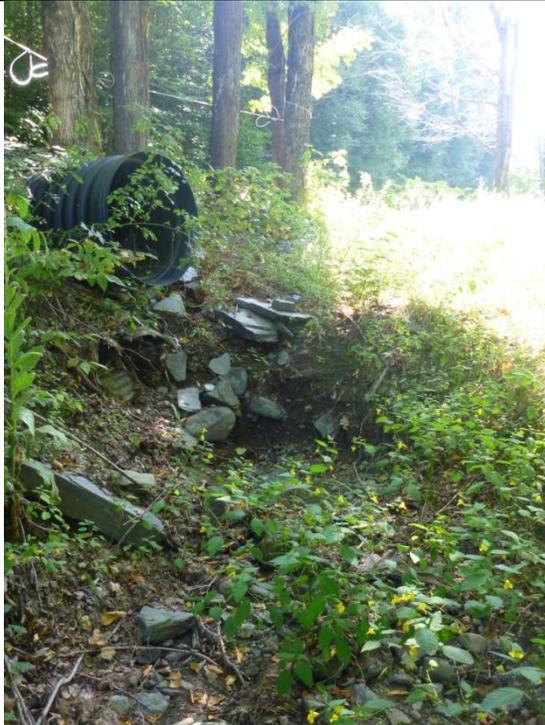
**Site Description:** 36" diameter corrugated HDPE culvert under Sandgate Road delivers sediment and stormwater to Sandgate Brook. The culvert has appropriate hydraulic capacity for the 17.6 acre forested watershed, however the outlet is perched leading to scour below, and scour continues down the outlet swale to the stream. Recommend improving armor at the culvert outlet to reduce scour and installing stone check dams to stabilize the downstream swale.

**Photo 1:** Culvert outlet with scour below

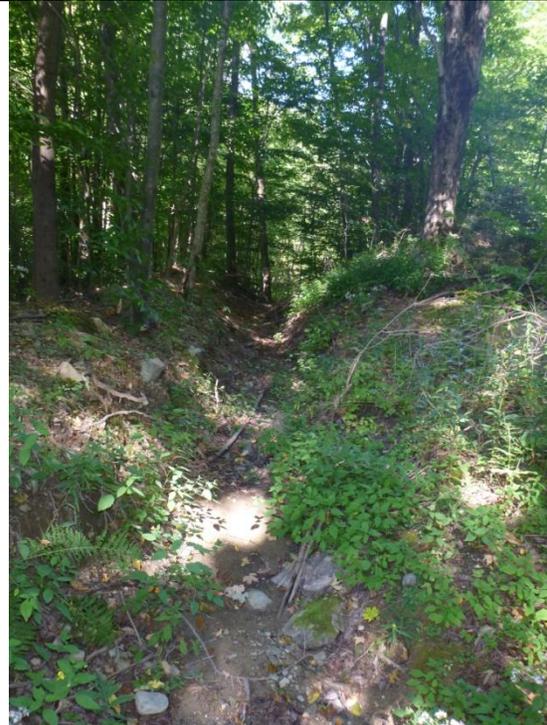
**Photo 2:** Incised outlet swale to Sandgate Brook

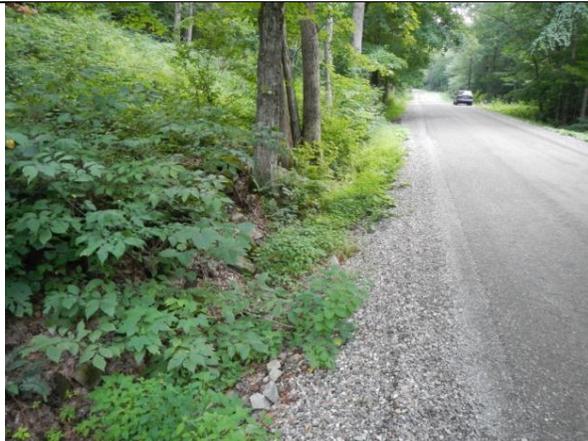
**Site Description:** 12" diameter corrugated HDPE culvert under Sandgate Road delivers sediment and stormwater to Sandgate Brook. The culvert is hydraulically undersized for the 9.5 acre forested watershed and the upstream ditch along the road is somewhat incised. Recommend installing stone check dams to stabilize road ditch and consider the culvert for replacement with a larger structure (18 to 24" diameter).

**Photo 1:** Somewhat incised ditch along Sandgate Road

| Project ID | Location | Description | Water Quality Risk | Flood and Erosion Risk to Infrastructure | Site Ranking | Recommendations | Ballpark Cost |
|---|---|---|---|---|---|---|---|
| DC-3 | Sandgate Road | 12" HDPE culvert with sediment clogging | Low | Moderate | 2 | Install stone check dams to stabilize road ditch and consider the culvert for replacement with a larger structure (18 to 24" diameter). | 2-5K |

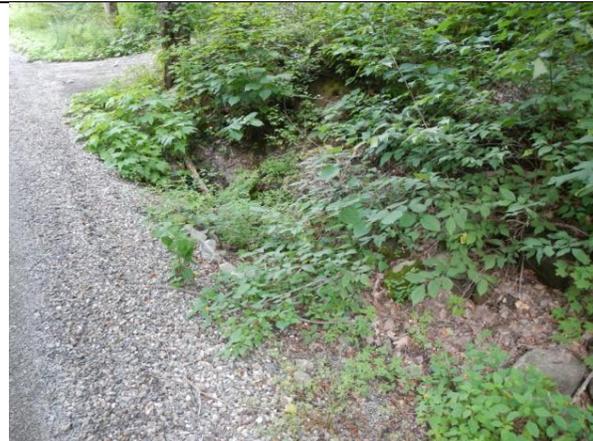
**Photo 2:** Culvert inlet is partially filled with gravel and leaves

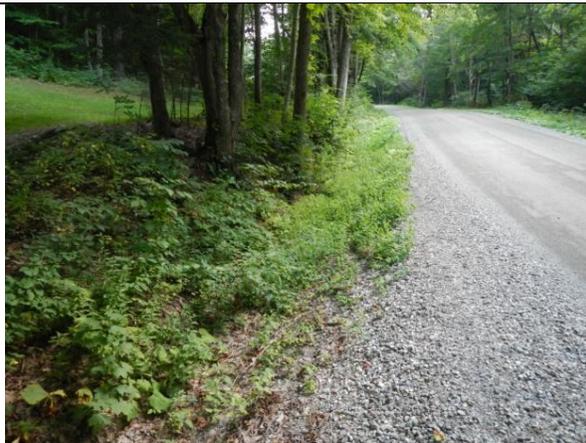
**Site Description:** 18" Corrugated HDPE culvert under Sandgate Road delivers sediment and stormwater to Sandgate Brook. The culvert is appropriately hydraulically sized for the 8.8 acre forested watershed and the upstream ditch along the road is somewhat incised. Recommend installing stone check dams to stabilize road ditch.

**Photo 1:** Somewhat incised ditch along Sandgate Road

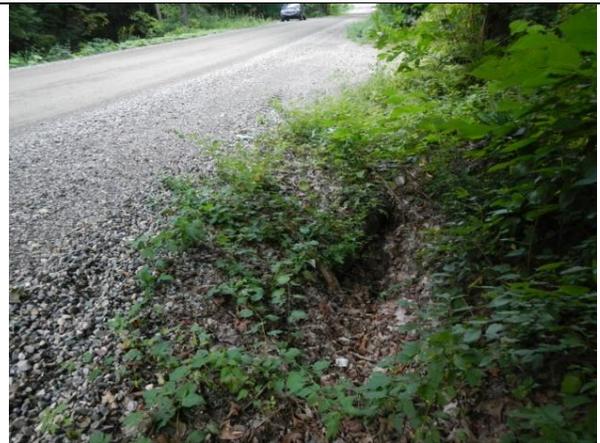
**Photo 2:** Culvert inlet is partially filled with gravel and leaves

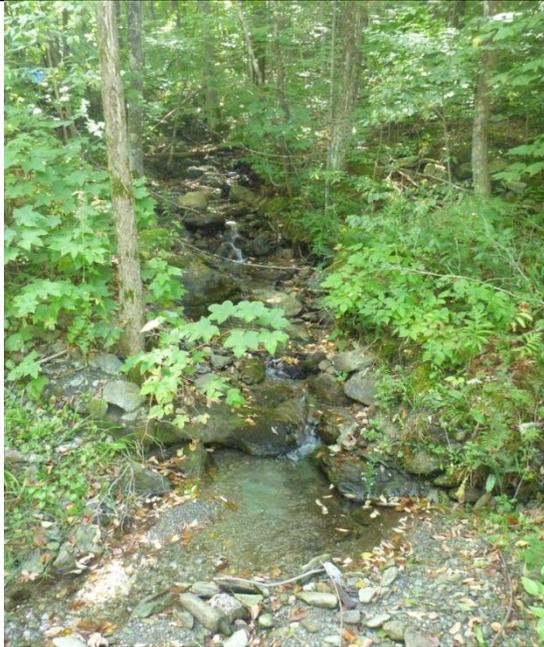
**Site Description:** 2' X 3' Squash CMP under Kent Hollow Road delivers sediment and stormwater to White Creek. The culvert is hydraulically undersized for the 197 acre forested watershed (i.e., cannot handle 10-year flow) leading to significant gravel and cobble deposition near the culvert inlet. Recommend replacing with a larger structure to obtain sufficient capacity for larger storm events and improve sediment transport through the culvert.

**Photo 1:** Upstream channel is steep and stable

| Project ID | Location | Description | Water Quality Risk | Flood and Erosion Risk to Infrastructure | Site Ranking | Recommendations | Ballpark Cost |
|---|---|---|---|---|---|---|---|
| DC-5 | Kent Hollow Road | 2'x3' squash CMP culvert with significant sediment clogging | Low | Moderate to High | 3 | Replace existing culvert with larger culvert. | 25-30K |

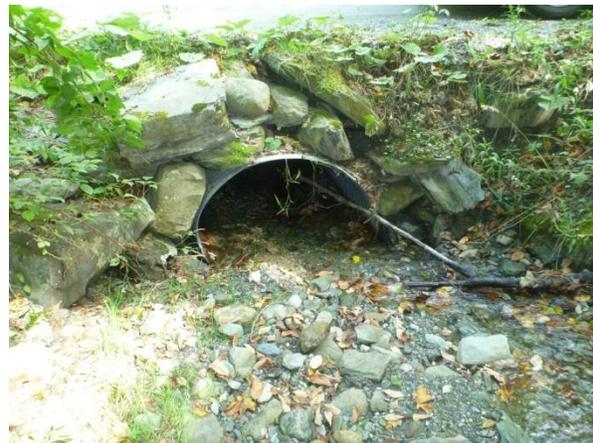
**Photo 2:** Culvert inlet is partially filled with gravel and cobble deposits

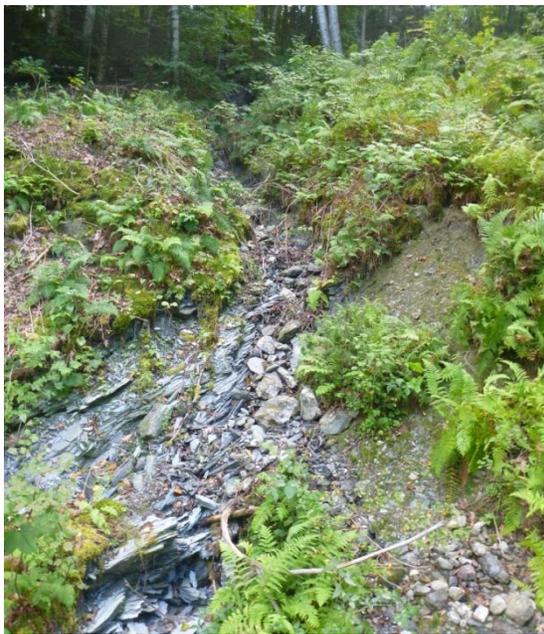
**Site Description:** 18" diameter HDPE culvert under Kent Hollow Road delivers sediment and stormwater to a tributary of Oven Brook. The culvert is appropriately hydraulically sized, however the upstream swale is deeply incised and is generating large volumes of sediment, causing the culvert to be partially plugged. Recommend installing stone check dams immediately upstream of the culvert inlet to stabilize the channel and reduce sedimentation.

**Photo 1:** Upstream channel steep and incising to underlying shale

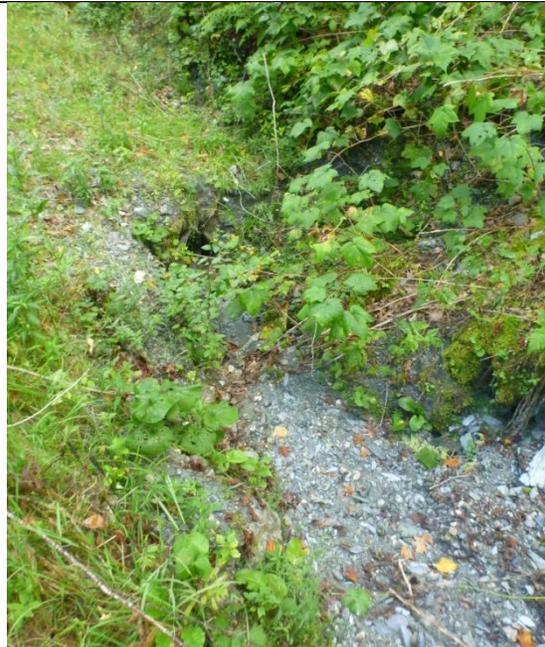
**Photo 2:** Significant gravel deposits partially filling culvert inlet

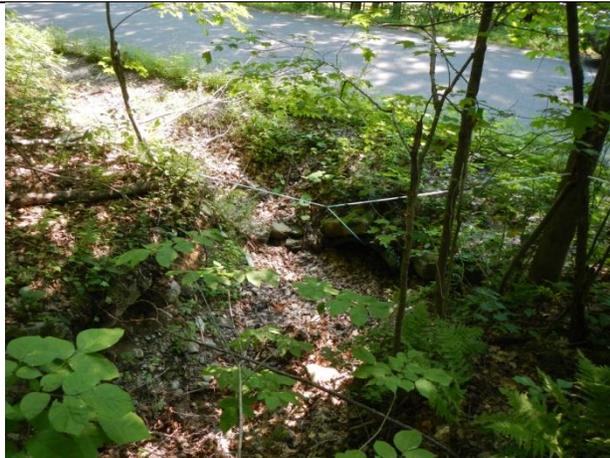
**Site Description:** 3' diameter HDPE culvert under Pawlet Mountain Rd is half filled with gravel and the upstream channel is severely eroded with an active headcut. Recommend stabilizing upstream channel with rock check dams and grade control structures as needed.

**Photo 1:** Culvert inlet half filled with sand/gravel

| Project ID | Location | Description | Water Quality Risk | Flood and Erosion Risk to Infrastructure | Site Ranking | Recommendations | Ballpark Cost |
|---|---|---|---|---|---|---|---|
| DC-7 | Pawlet Mountain Road | 3' diameter HDPE culvert is half filled with gravel and the upstream channel is severely eroded with an active headcut. | Moderate to High | Moderate | 3 | Recommend stabilizing upstream channel with rock check dams and grade control structures as needed. | 2-5K |

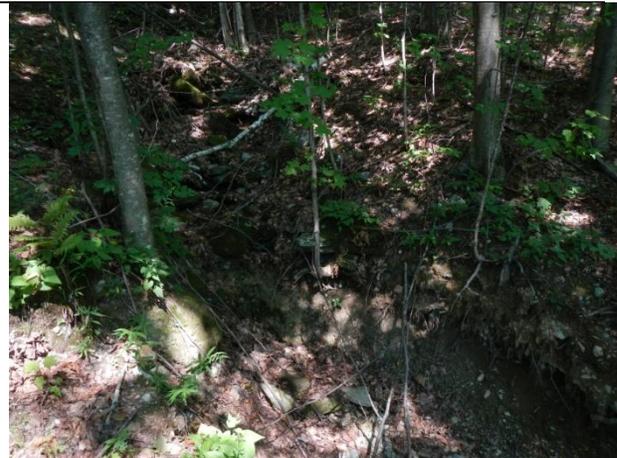
**Photo 2:** 2' tall headcut upstream of culvert, bad bank erosion to inlet

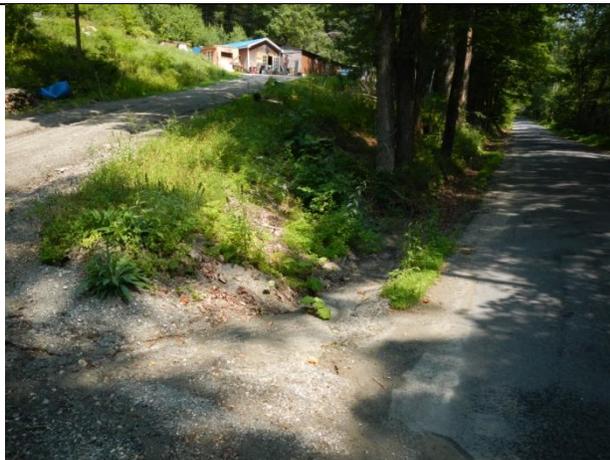
**Site Description:** 18" diameter HDPE culvert under Pawlet Mountain Rd is fully filled with fine sediment upstream, causing water to pond and flow over the road. Road ditch and adjacent driveway are both carrying large volumes of sediment to culvert inlet. Recommend replacing with a larger structure or adjusting culvert slope, and stabilizing ditch with rock check dams. Work with landowner to stabilize driveway erosion.

**Photo 1:** Sediment deposits filling road ditch and base of driveway

| Project ID | Location | Description | Water Quality Risk | Flood and Erosion Risk to Infrastructure | Site Ranking | Recommendations | Ballpark Cost |
|---|---|---|---|---|---|---|---|
| DC-8 | Pawlet Mountain Road | 18" diameter HDPE culvert is filled with fine sediment upstream, causing water to pond and flow over the road. | Moderate to High | High | 4 | Recommend replacing with a larger structure or adjusting culvert slope, and stabilizing ditch with rock check dams. Work with landowner to stabilize driveway erosion. | 10-15K |

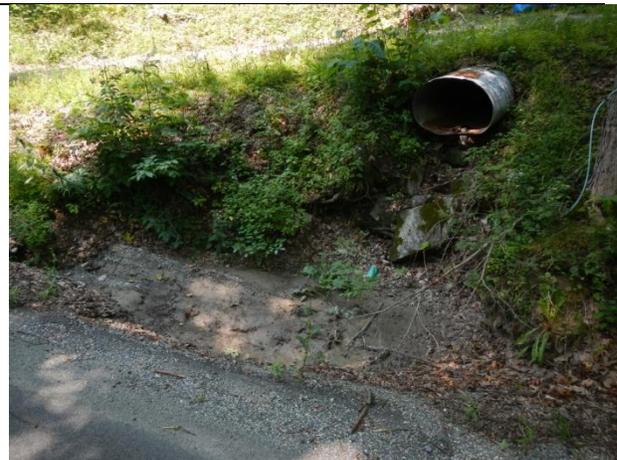
**Photo 2:** Culvert inlet is buried in fine sediment

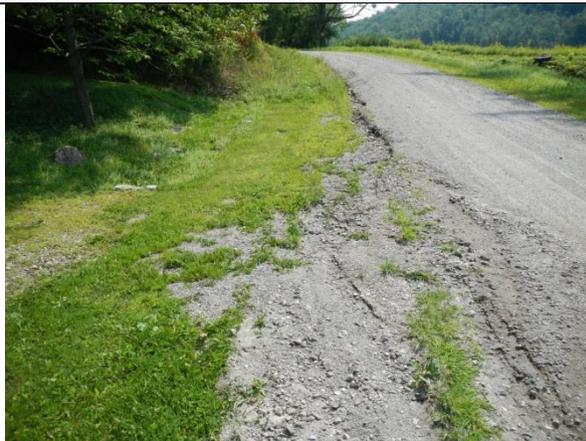
**Site Description:** Ditches on both sides of Youlin Road are filled in and have reduced capacity. The east edge of the road does not fully drain to the ditch causing erosion and sediment deposition on the road. A cross culvert is set near the road surface and is damaged (photo 2). Recommend raising the road bed to shed runoff to the north and cleaning out ditches to better direct runoff and reduce erosion. Replace damaged culvert as necessary.

**Photo 1:** Erosion and deposition along edge of road, runoff is not directed towards ditch

| Project ID | Location | Description | Water Quality Risk | Flood and Erosion Risk to Infrastructure | Site Ranking | Recommendations | Ballpark Cost |
|---|---|---|---|---|---|---|---|
| RD-1 | Youlin Road | Ditches on both sides of Youlin Road are filled in and have reduced capacity. The east edge of the road does not fully drain to the ditch causing erosion and sediment deposition on the road. A cross culvert is set near the road surface and is damaged. | Moderate | Moderate | 3 | Recommend raising the road bed to shed runoff to the north and cleaning out ditches to better direct runoff and reduce erosion. Replace damaged culvert as necessary. | 5-10K |

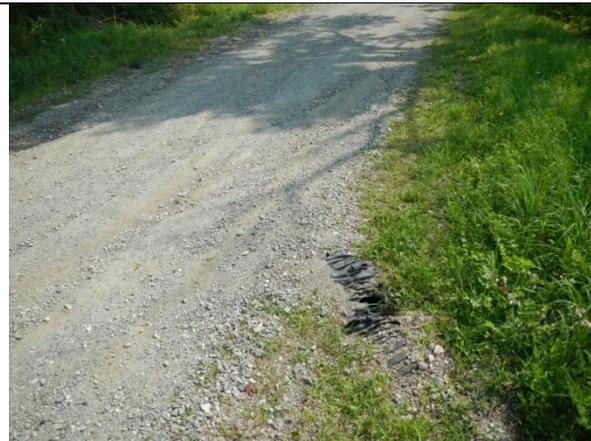
**Photo 2:** Exposed and damaged culvert crossing road

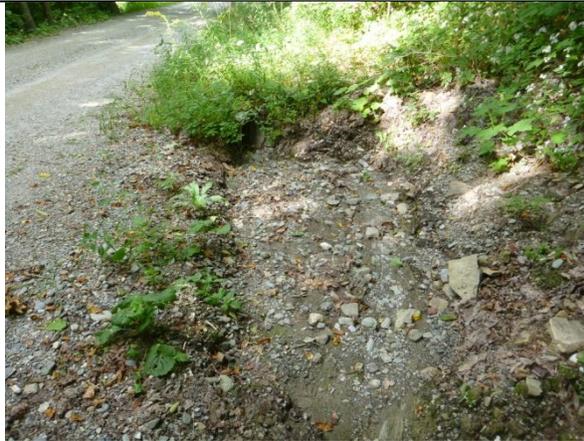
**Site Description:** Ditch along steep section of Youlin Road is eroding and generating large volumes of sand/gravel, clogging a drainage culvert. Recommend stabilizing ditch using stone check dams.

**Photo 1:** Sediment deposition and a clogged 16" CPP culvert under Youlin Road

| Project ID | Location | Description | Water Quality Risk | Flood and Erosion Risk to Infrastructure | Site Ranking | Recommendations | Ballpark Cost |
|---|---|---|---|---|---|---|---|
| RD-2 | Youlin Road | Ditch along steep section of Youlin Road is eroding and generating large volumes of sand/gravel, clogging a drainage culvert. | Low to Moderate | Moderate | 2 | Recommend stabilizing ditch using stone check dams. | <2K |

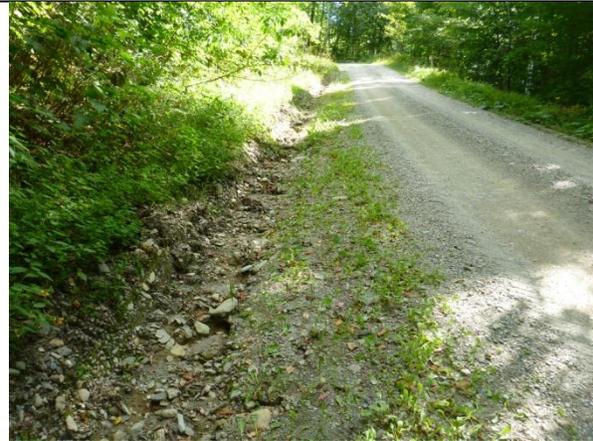
**Photo 2:** Ditch is eroded and generating large volumes of sediment

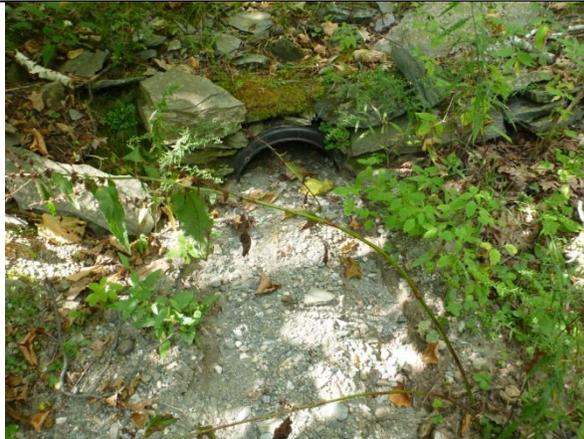
**Site Description:** Ditch along moderately steep section of Lang Road is eroding and generating large volumes of sand/gravel, clogging a drainage culvert. Recommend stabilizing ditch using stone check dams.

**Photo 1:** Sediment deposition and a clogged 12" CPP culvert under Lang Road

| Project ID | Location | Description | Water Quality Risk | Flood and Erosion Risk to Infrastructure | Site Ranking | Recommendations | Ballpark Cost |
|---|---|---|---|---|---|---|---|
| RD-3 | Youlin Road | Ditch along moderately steep section of Lang Road is eroding and generating large volumes of sand/gravel, clogging a drainage culvert. | Low to Moderate | Moderate | 2 | Recommend stabilizing ditch using stone check dams. | <2K |

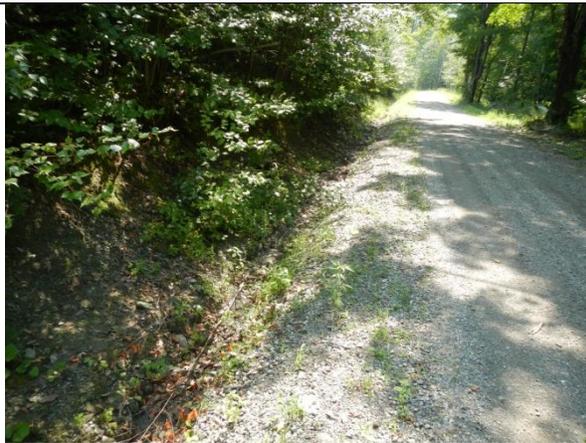
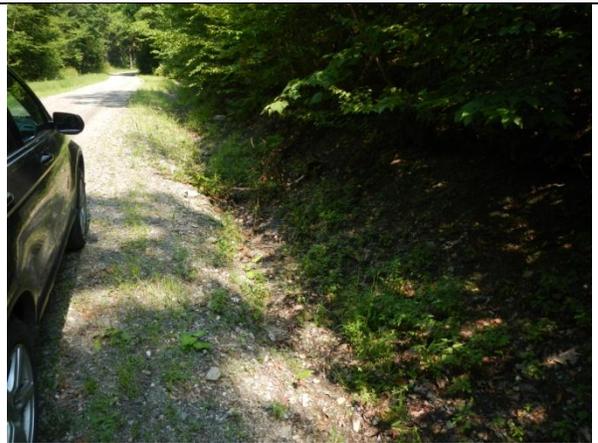
**Site Description:** Ditch along an approximately 1000' long and steep section of Dole Road is eroding and exposing raw sediment along the opposite bank. Recommend stabilizing the ditch with stone check dams.

**Photo 1:** Steep roadside ditch with moderate erosion

| Project ID | Location | Description | Water Quality Risk | Flood and Erosion Risk to Infrastructure | Site Ranking | Recommendations | Ballpark Cost |
|---|---|---|---|---|---|---|---|
| RD-4 | Dole Road | Ditch along steep section of Dole Road is eroding and generating large volumes of sediment. | Moderate | Low to Moderate | 2 | Recommend stabilizing ditch using stone check dams. | 2-5K |

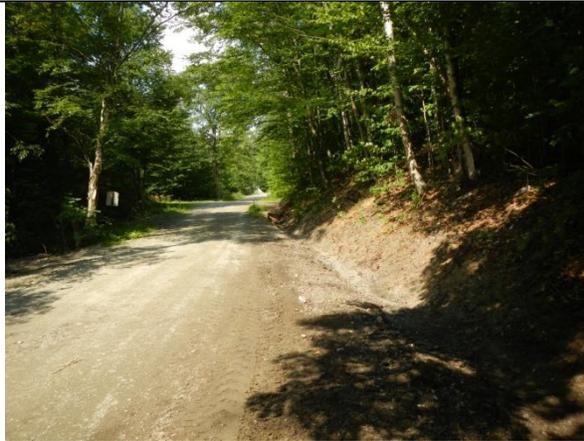
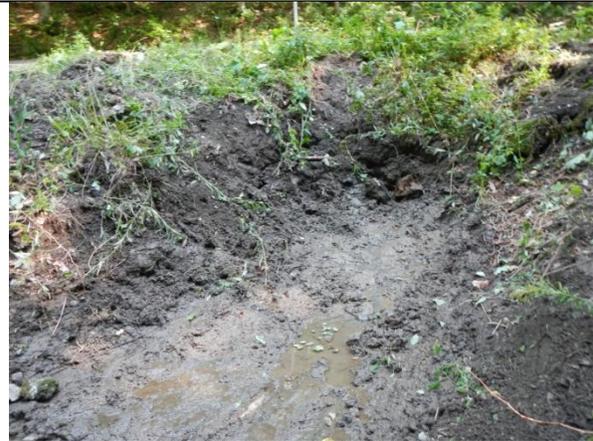
**Site Description:** Roadside ditches recently cleaned by Sandgate highway department were left with large areas of exposed raw soil and cross culverts were fully blocked. Large volumes of fine sediment were observed entering tributary. Recommend stabilizing ditch with coarse material and stone check dams, and working with highway department to improve ditch maintenance practices.

**Photo 1:** Recent ditch cleanout left behind exposed raw sediment and blocked culverts

| Project ID | Location | Description | Water Quality Risk | Flood and Erosion Risk to Infrastructure | Site Ranking | Recommendations | Ballpark Cost |
|---|---|---|---|---|---|---|---|
| RD-5 | Snow Road | Roadside ditches recently cleaned by Sandgate were left with large areas of exposed raw soil and cross culverts were fully blocked. Large volumes of fine sediment were observed entering tributary. | High | Moderate to High | 4 | Recommend stabilizing ditch with coarse material and stone check dams, and working with highway department to improve ditch maintenance practices. | 2-5K |

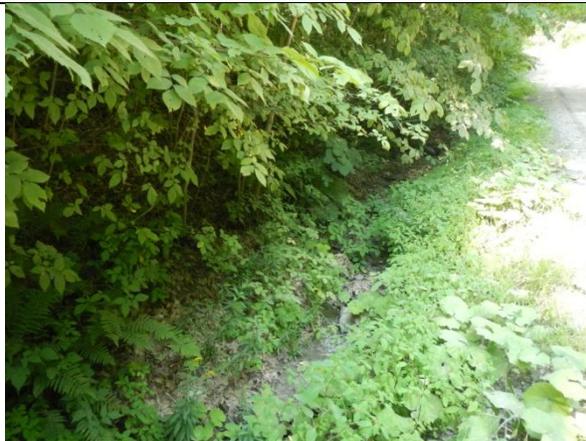
**Site Description:** Roadside ditches along a very steep portion of Hebron Road are incised. Exposed bedrock underlies some of the ditch and the road edge is eroding in areas. Recommend installing stone check dams to trap sediment and reduce ditch incision and rilling of the road edge.

**Photo 1:** Deeply incised ditch with exposed bedrock

| Project ID | Location | Description | Water Quality Risk | Flood and Erosion Risk to Infrastructure | Site Ranking | Recommendations | Ballpark Cost |
|---|---|---|---|---|---|---|---|
| RD-6 | Hebron Road | Roadside ditch along a very steep portion of Hebron Road is deeply incised. Exposed bedrock underlies some of the ditch and the road edge is eroding in areas. | Moderate | Moderate | 3 | Recommend stabilizing ditch using stone check dams. | <2K |

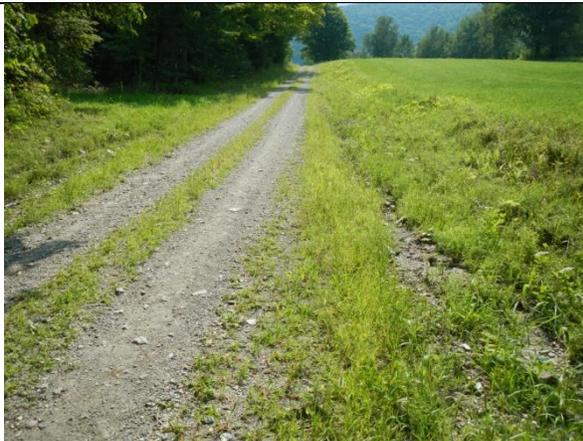
**Site Description:** Roadside ditch along a steep portion of Clarke Road is filled in with sediment and partially blocking a culvert crossing under the road to the stream. Stormwater flows across the road leading to erosion and rilling. Recommend cleaning out the ditch and installing stone check dams for easier future maintenance.

**Photo 1:** Road side ditch is filled with sediment and gravel

| Project ID | Location | Description | Water Quality Risk | Flood and Erosion Risk to Infrastructure | Site Ranking | Recommendations | Ballpark Cost |
|---|---|---|---|---|---|---|---|
| RD-7 | Clark Road | Roadside ditch along a steep portion of Clark Road is filled in with sediment and partially blocking a CPP crossing under the road to the stream. Stormwater flows across the road leading to erosion and rilling. | Moderate | Low | 2 | Recommend stabilizing ditch using stone check dams. | <2K |

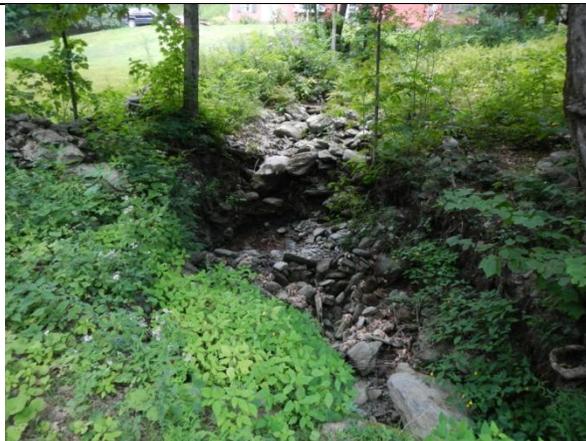
**Site Description:** 4' x 6' squash CMP culvert under the road has significant sediment deposition upstream and material throughout the culvert. The culvert is appropriately sized hydraulically for the 174 acre forested watershed. A large 4' tall headcut was observed immediately upstream of the inlet. The culvert slope is lower than the tributary channel slope, leading to increased deposition upstream. Recommend resetting the culvert to better match channel slope and improve sediment transport and aquatic organism passage.

**Photo 1:** Headcut and deposition upstream of culvert inlet

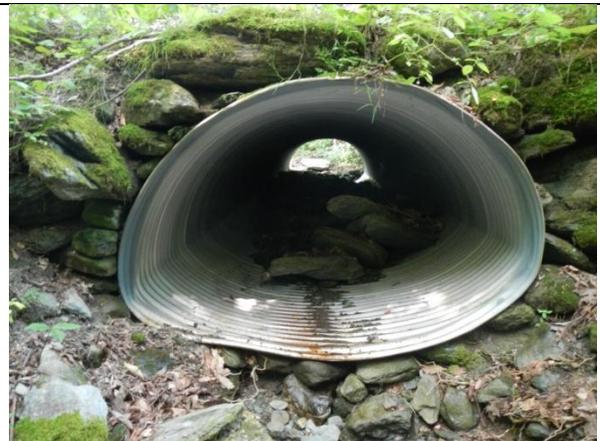
**Photo 2:** Large cobbles deposited in culvert, outlet is stable

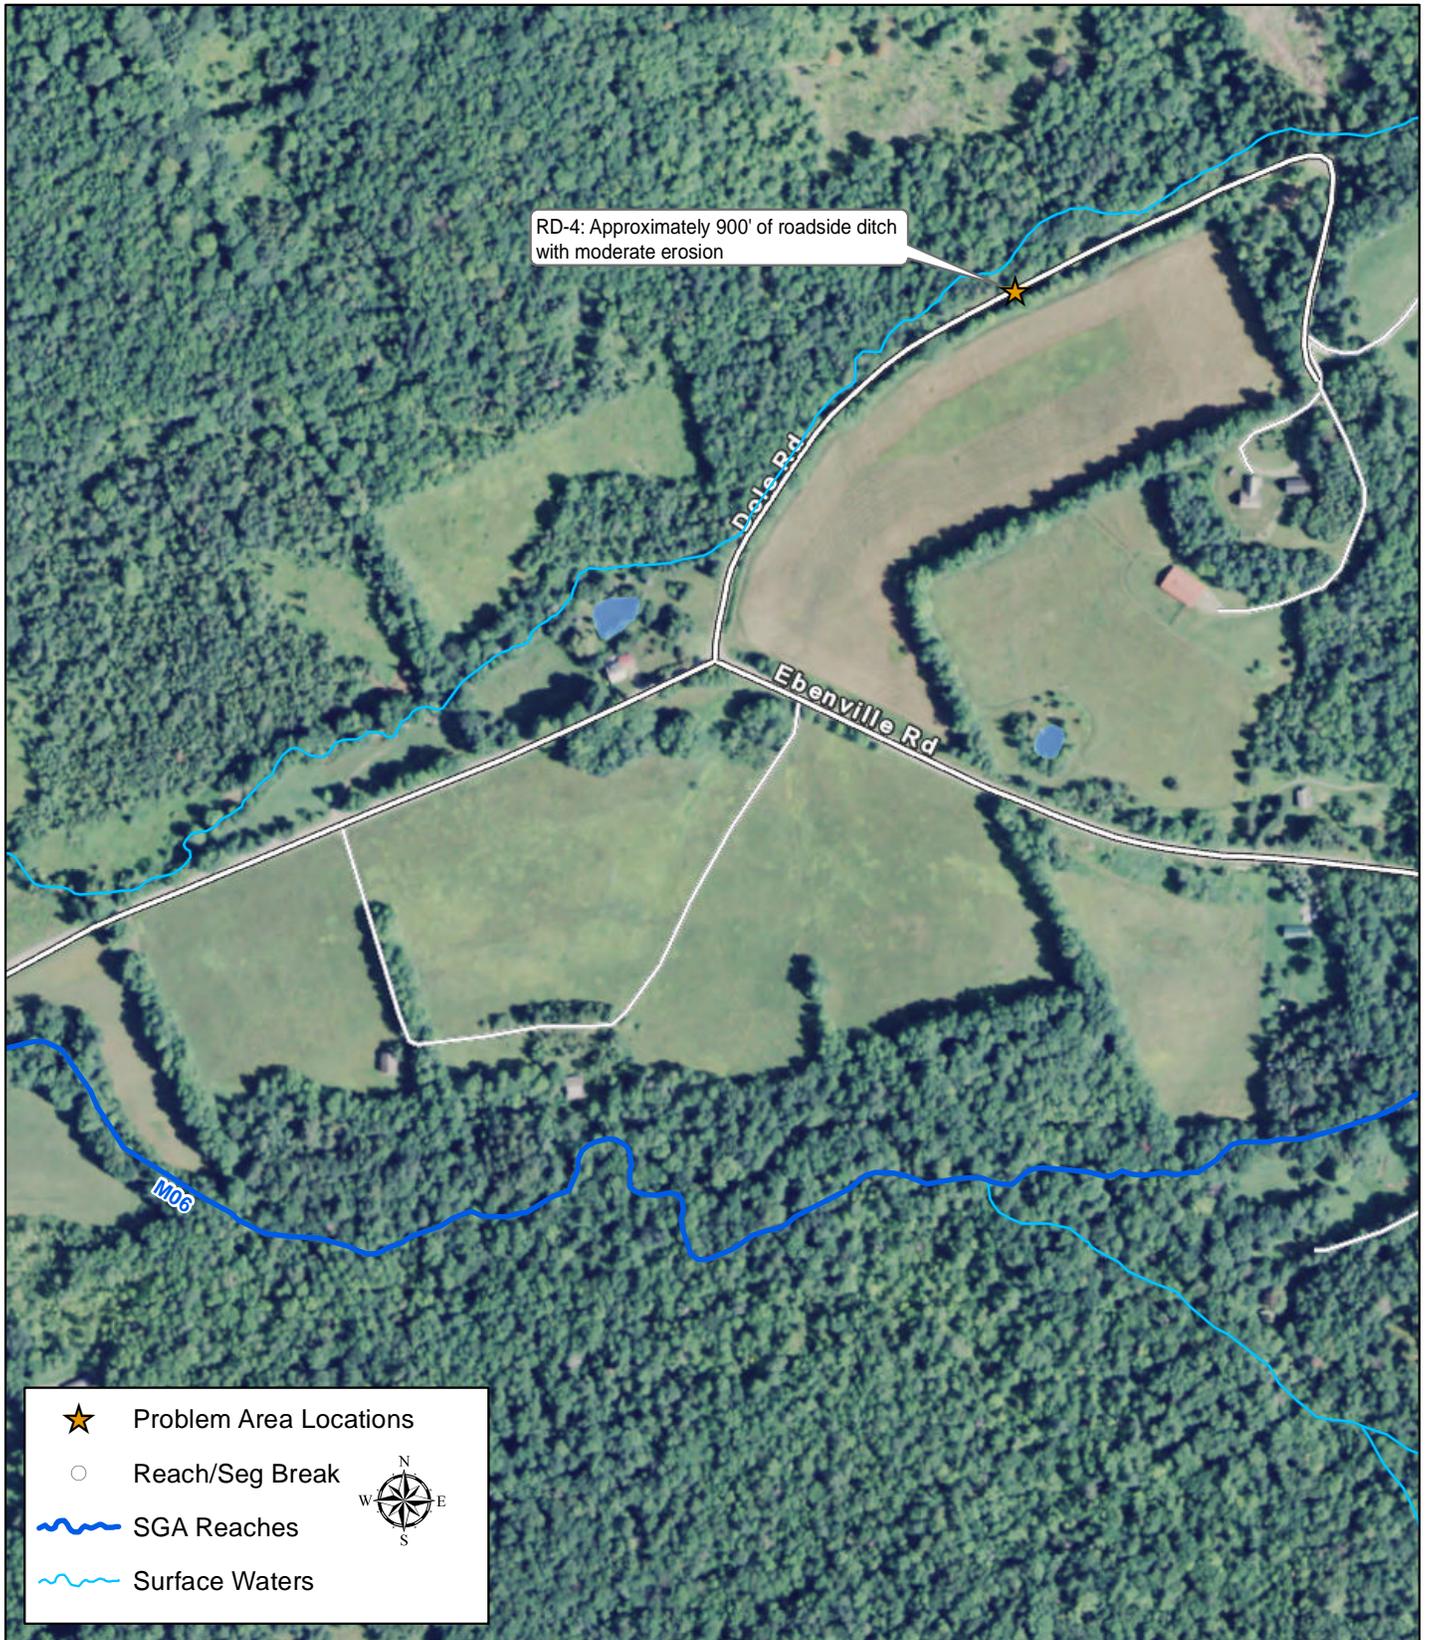
RD-4: Approximately 900' of roadside ditch with moderate erosion

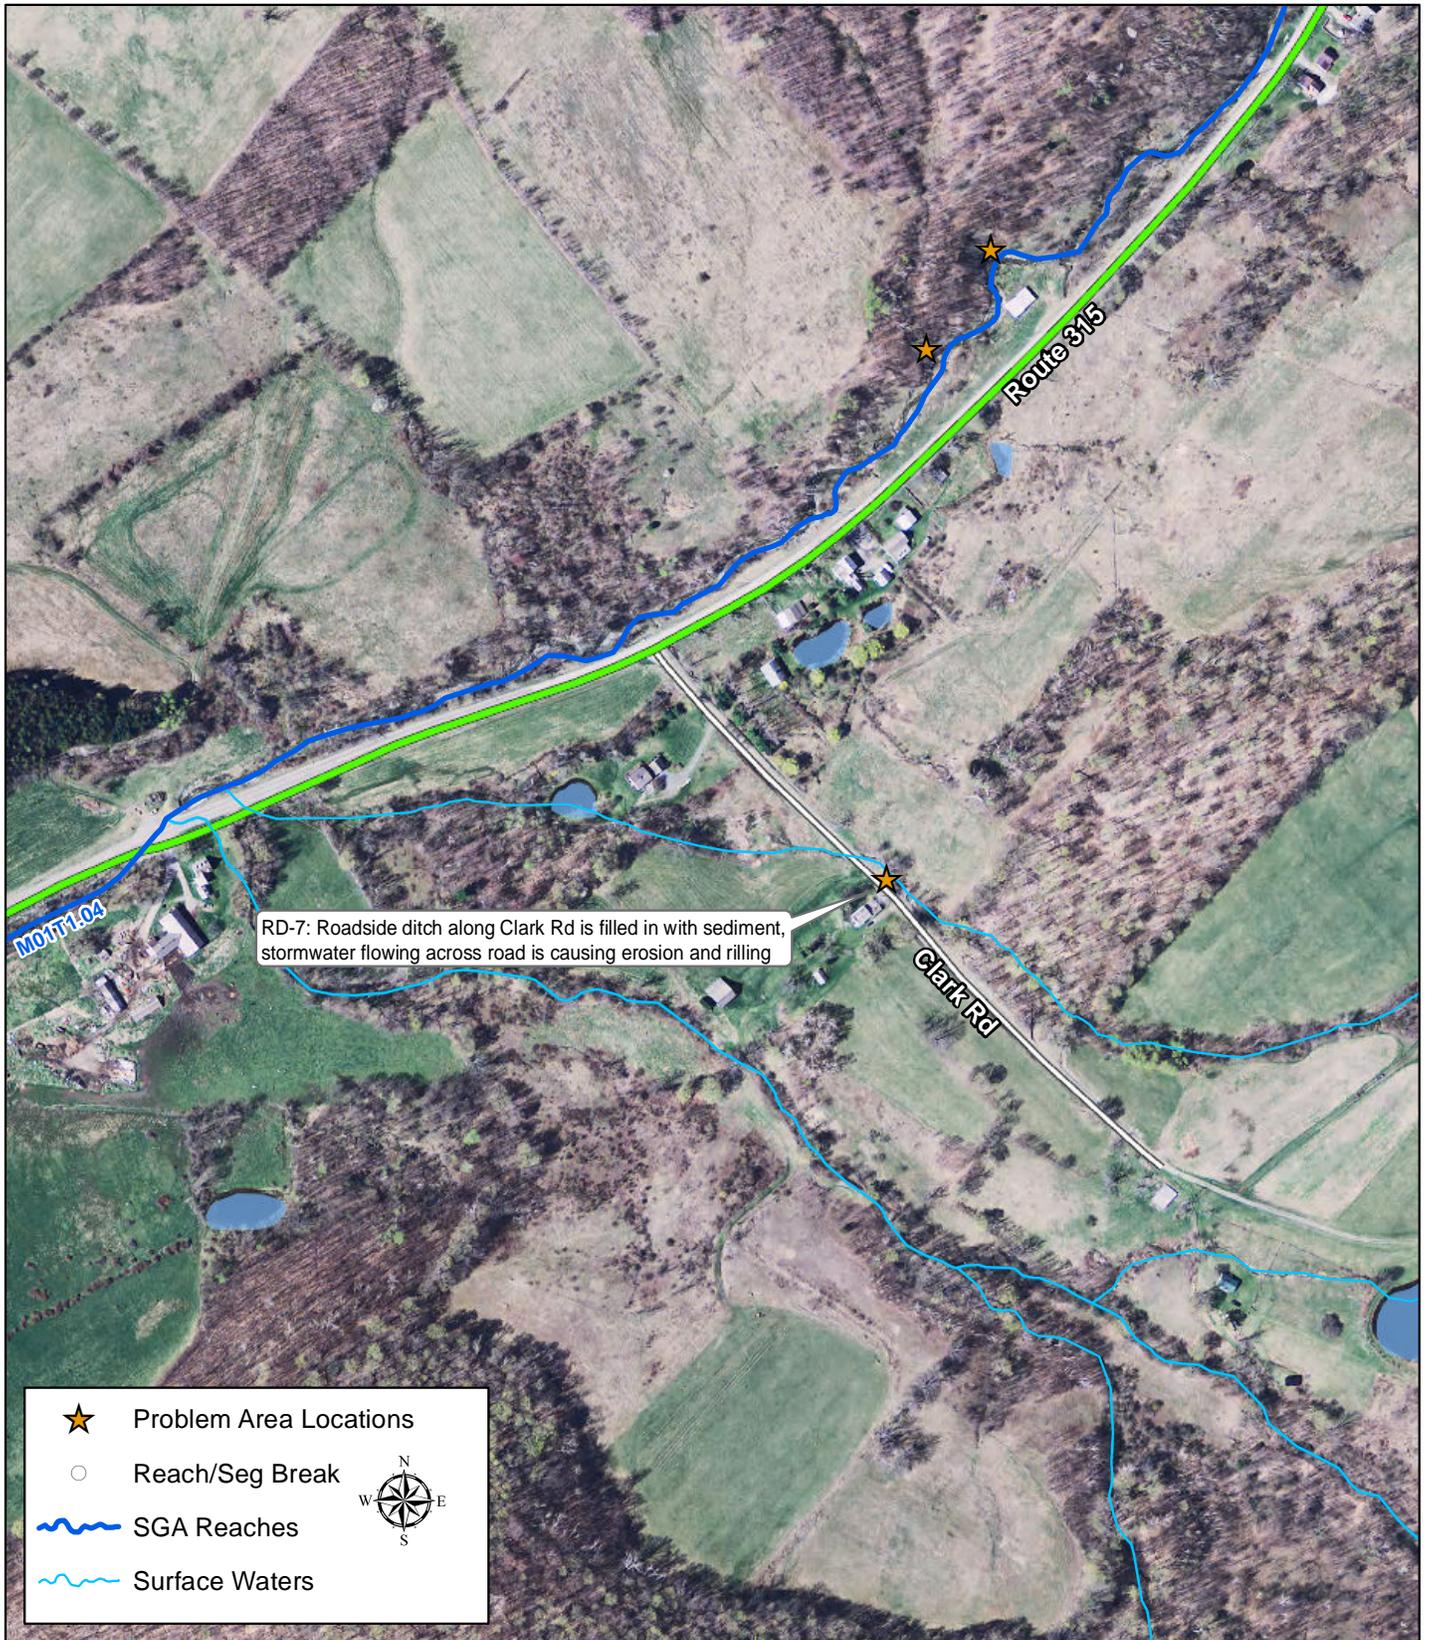
RD-7: Roadside ditch along Clark Rd is filled in with sediment, stormwater flowing across road is causing erosion and rilling

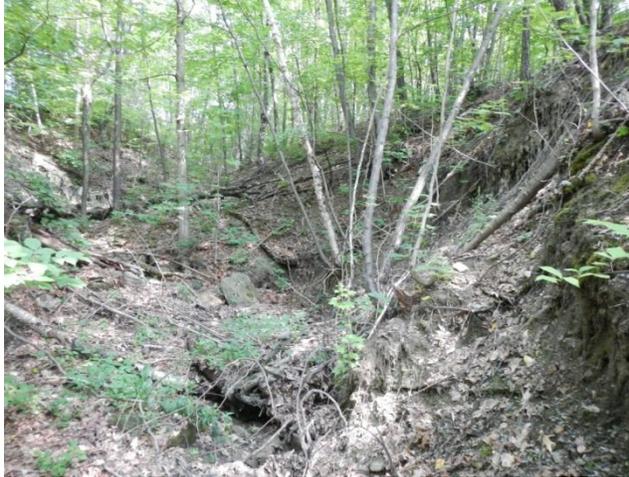
Steep failing banks and several headcuts in the lower portion of the gully

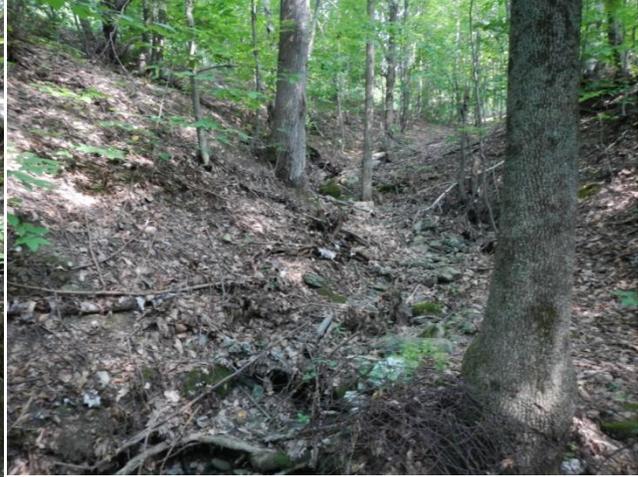
Stable banks and less incised gully in the upper portion

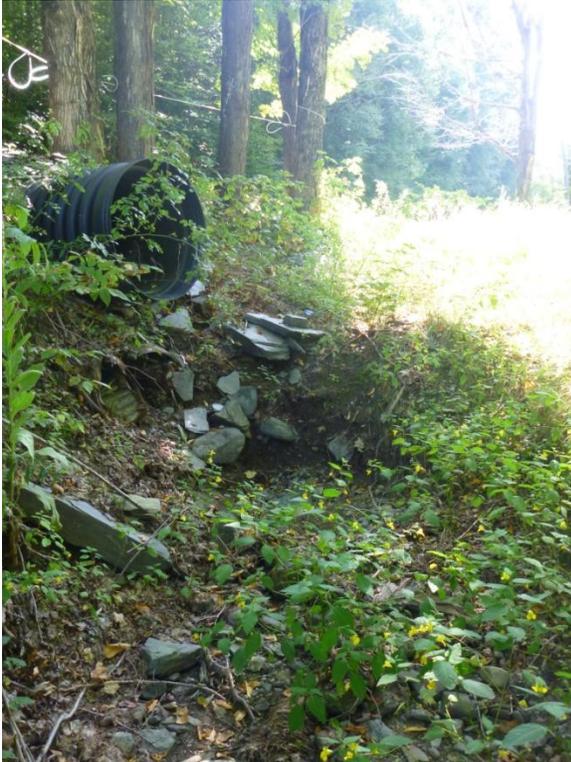
Perched culvert outlet and scour in swale

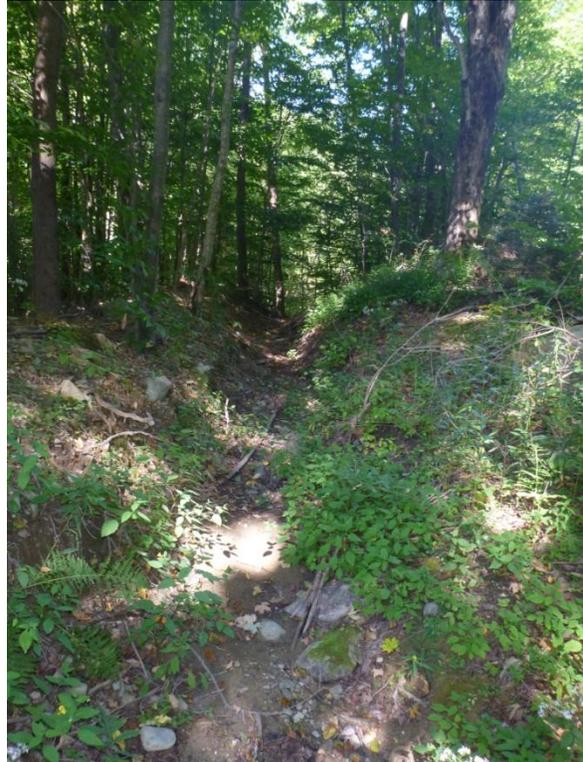
Incised swale leading to stream bank
