# Stormwater Master Plan Town of Rupert, Vermont

December 4, 2015

**Fitzgerald Environmental Associates, LLC.**  
18 Severance Green, Suite 203  
Colchester, VT 05446

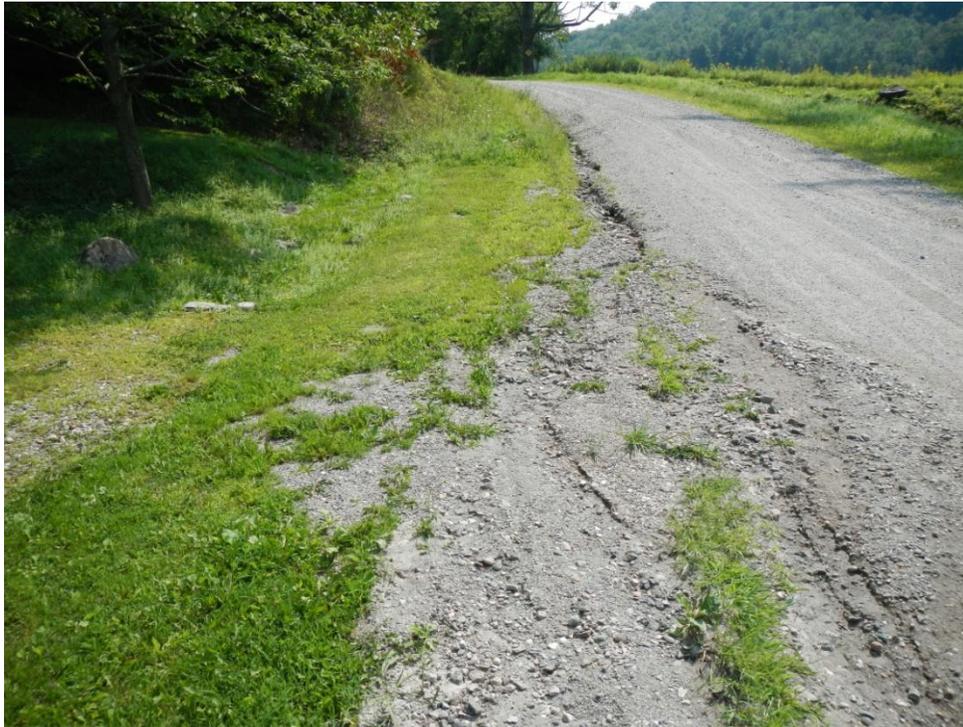
Rilling of road edge from stormwater runoff along lower Youlin Road.

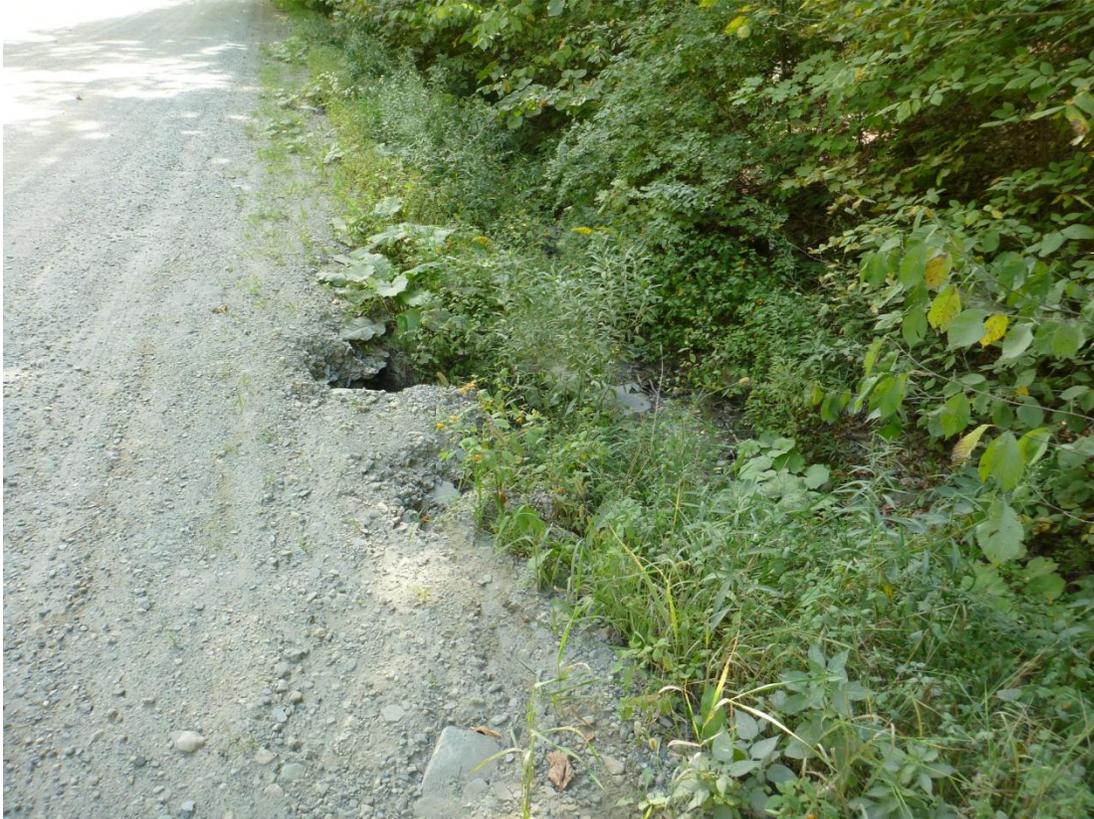
Rilling of road edge from stormwater runoff along upper Hebron Road.
