# STORMWATER MANAGEMENT PLAN FOR FRANKLIN

FINAL REPORT

Stone Project ID 14-053

March 11, 2015

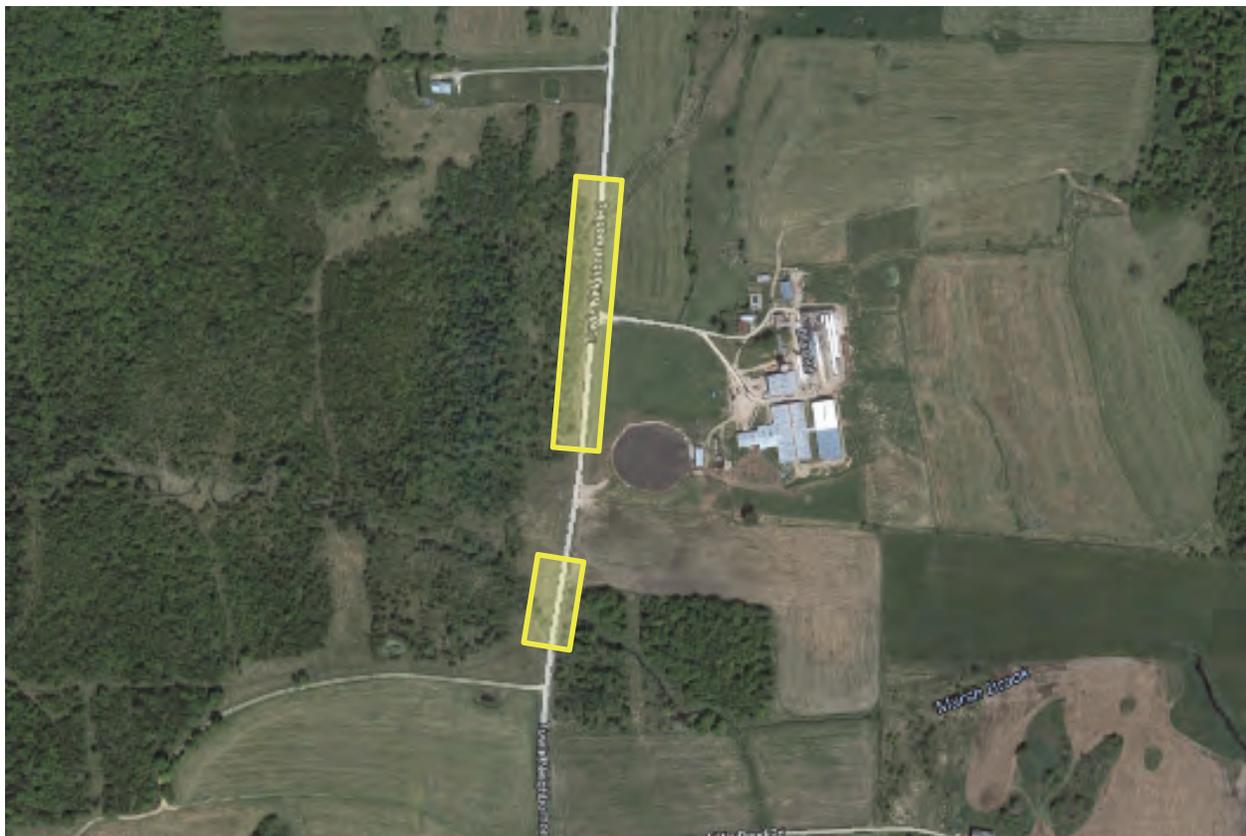
Roadside ditches in the highlighted areas shown in Figure 1, below, are in poor condition. Banks above the culvert inlets and outlets in both locations are over-steepened and are actively collapsing. The farm (also visible in Figure 1) appears to allow animals direct access to areas where both culverts outlet, exacerbating the problems.

Figure 1. Towle Neighborhood Road Problem Areas. Significant roadside erosion was observed in both areas highlighted in yellow; problems appear to be exacerbated by animal access to the streams in both areas.

Conditions along Towle Neighborhood Road could be improved by installing headwalls at the inlets to both culverts, and providing rock-lined splash pools at both culvert outlets. In addition, there is an approximately 300-foot section of roadside ditch that carries water from the outlet of the more northern culvert to the south that needs to be stabilized. Without animal exclusion from these areas, however, efforts to stabilize the outlets and ditch are likely to be overwhelmed.

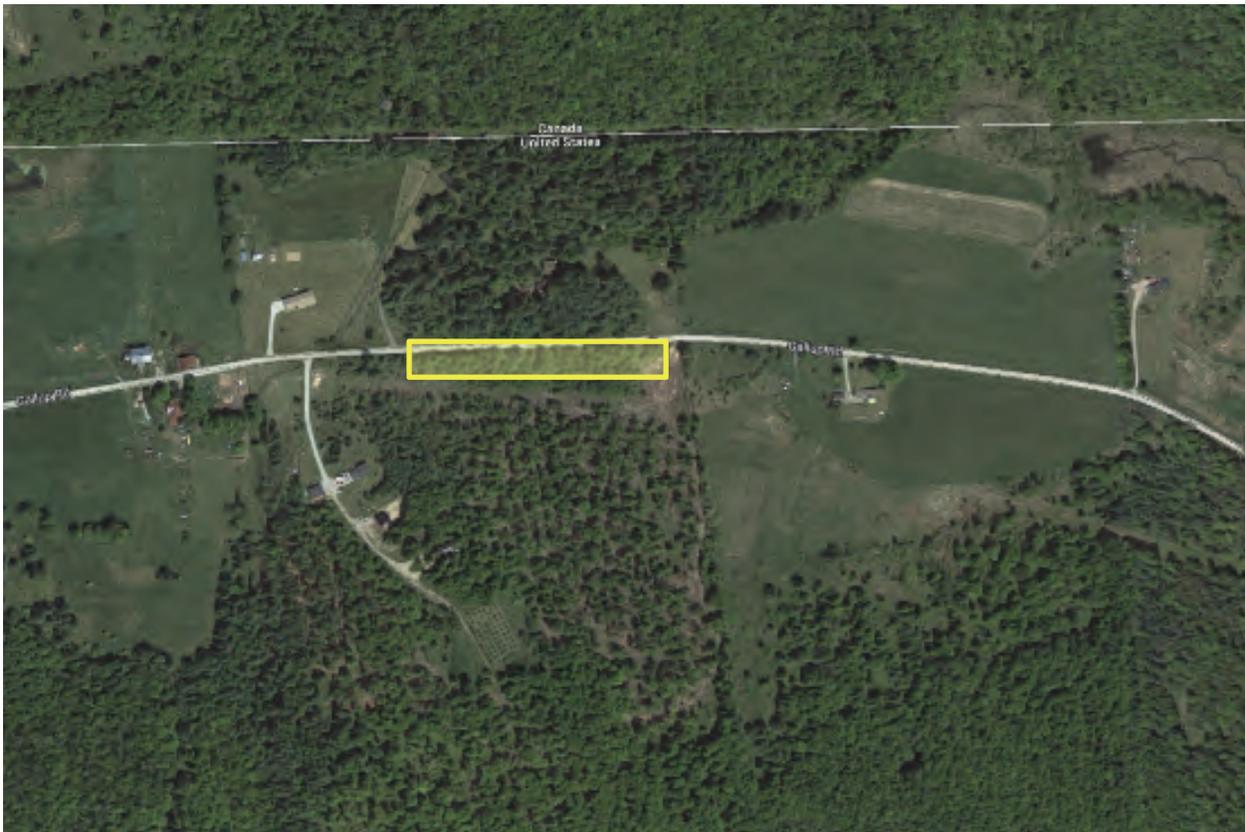
Gallup Road is a gravel road that runs roughly parallel to the Canadian border, east from Richard Road. A 600-foot section of roadside ditch, along the southern edge of the road and highlighted in Figure 2, was observed to be bare and actively eroding. In addition, the ditch has a steep back slope that is leading to slumping. Significant evidence of sediment transport was observed.

Figure 2. Gallup Road Problem Area. Highlighted location indicates the ditch improvement opportunity.

The ditch could be stabilized by making it wider, with a parabolic-shaped bottom. The ditch may need to be stone lined in sections where it is not possible to achieve a sustainable back slope. Stone check dams could also be employed in order to reduce flow velocities, limit sediment transport, and potentially create opportunities for infiltration in the ditch.

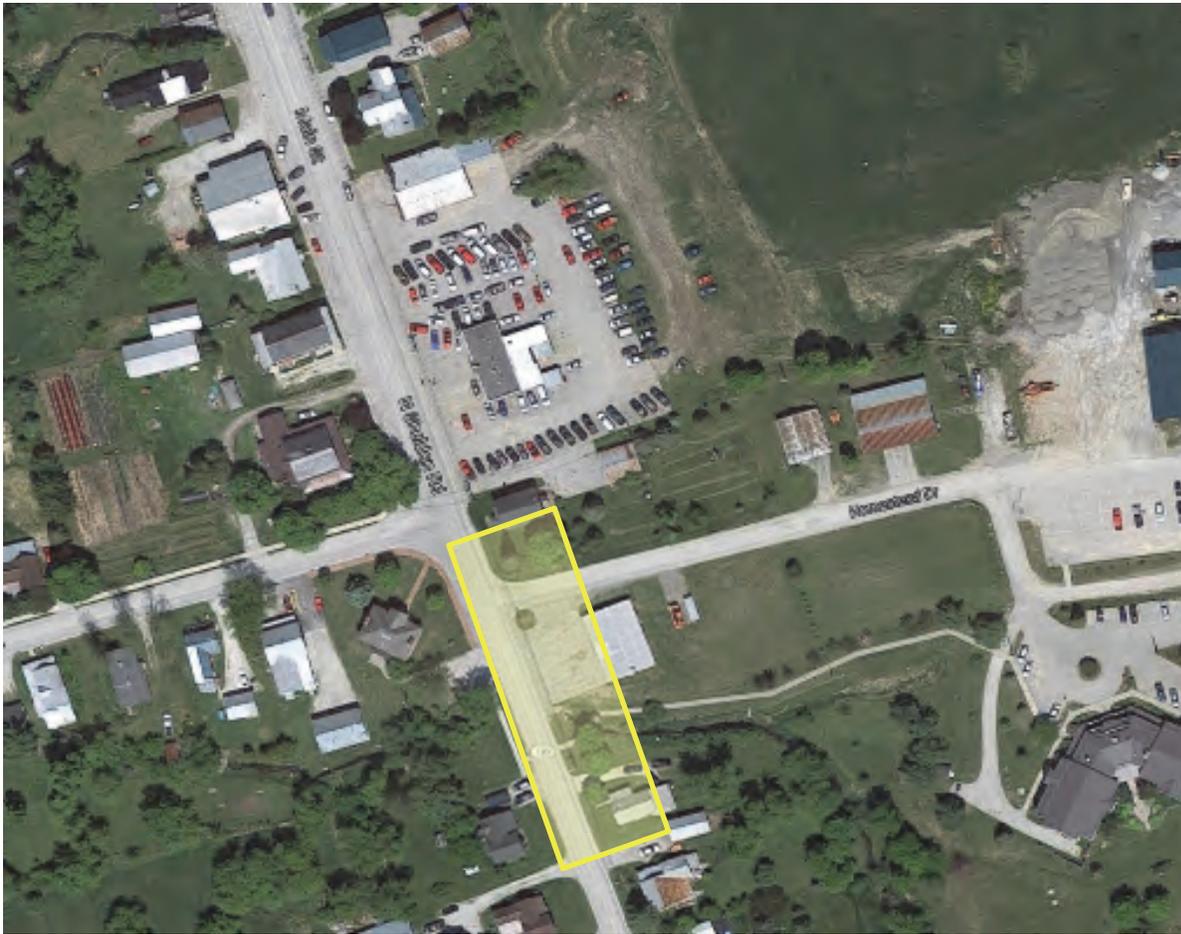
Figure 3. Franklin Fire & Rescue Problem Area. A priority area for stormwater retrofits is highlighted in yellow.

Although it may be difficult to fully capture and treat the runoff from the highlighted area, there are a number of opportunities to better manage the runoff. One of the easiest would be to redirect the roof leader from the Fire & Rescue building, which currently discharges onto the parking lot, to a cistern. The Town has indicated that Fire & Rescue regularly washes their emergency service vehicles, and the roof runoff could be harvested for this use. Additional opportunities include creating storage in the green space north of Homestead Drive, as well as working with the owner of the Ford dealership to identify unneeded impervious surface that could be removed, and/or locations to manage stormwater on-site. The NRCS soil survey indicates that both Homestead Drive and the Ford dealership are located in an area of loamy fine sand with moderate infiltration capacity, but high groundwater, so opportunities for stormwater infiltration may be limited.

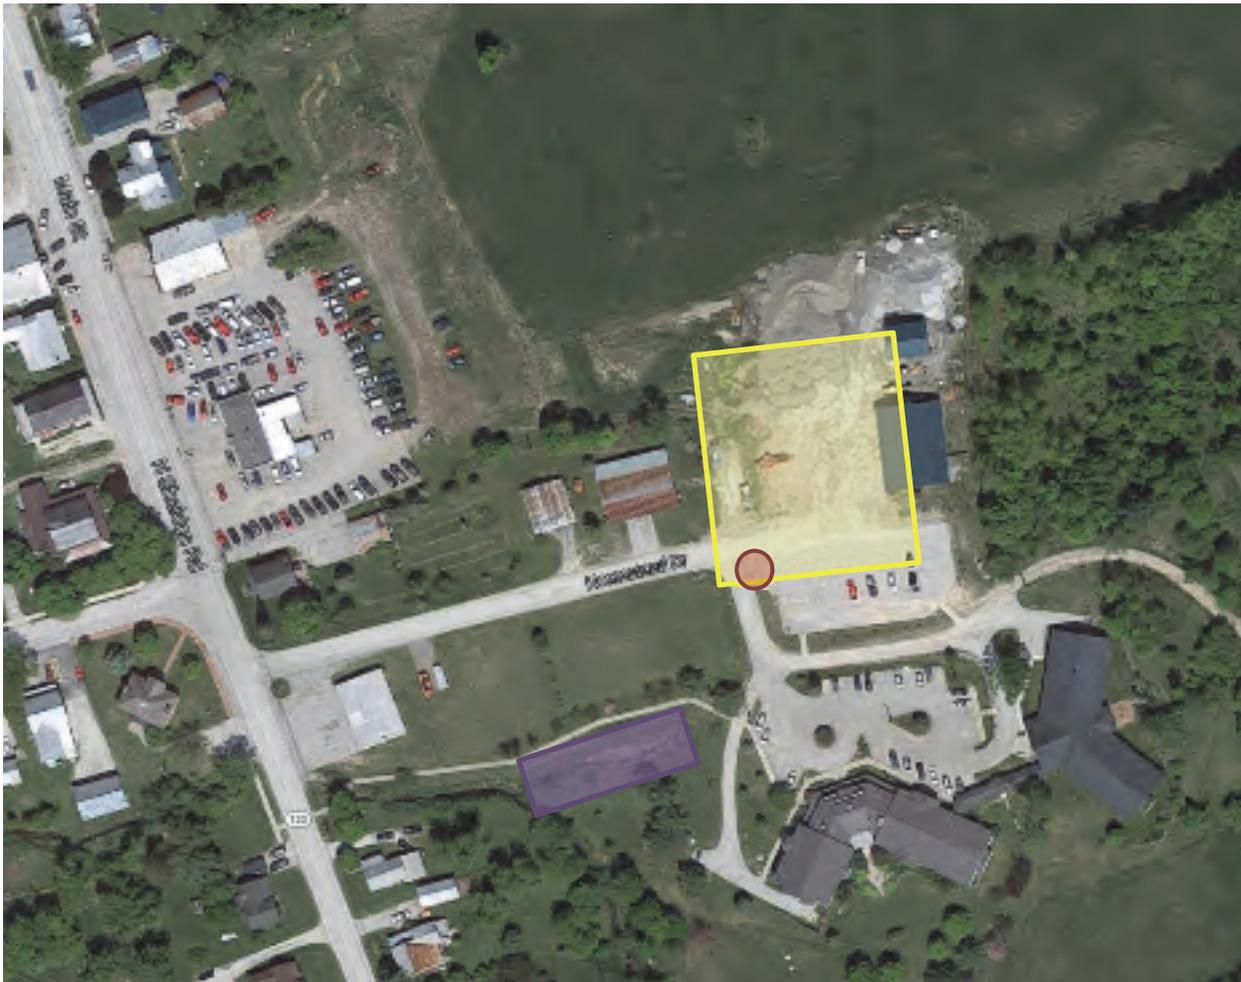
Figure 4. Franklin Town Garage Problem Area. A priority area for stormwater retrofits is highlighted in yellow; an existing catch basin is highlighted in red; and the open channel portion of conveyance from the catch-basin to the stream is highlighted in purple.

Although it may be difficult to fully capture and treat the runoff from the highlighted area, it may be possible to redirect a portion of the runoff from the Town Garage to the green space that separates the Park & Ride facility from Homestead Drive. The NRCS soil survey indicates that the green space is likely located in an area of stony loam soils that may have some capacity for infiltration-based practices, depending on the depth to groundwater. Additionally, the open channel portion of the conveyance could be retrofitted to improve management of stormwater runoff from the Town Garage.

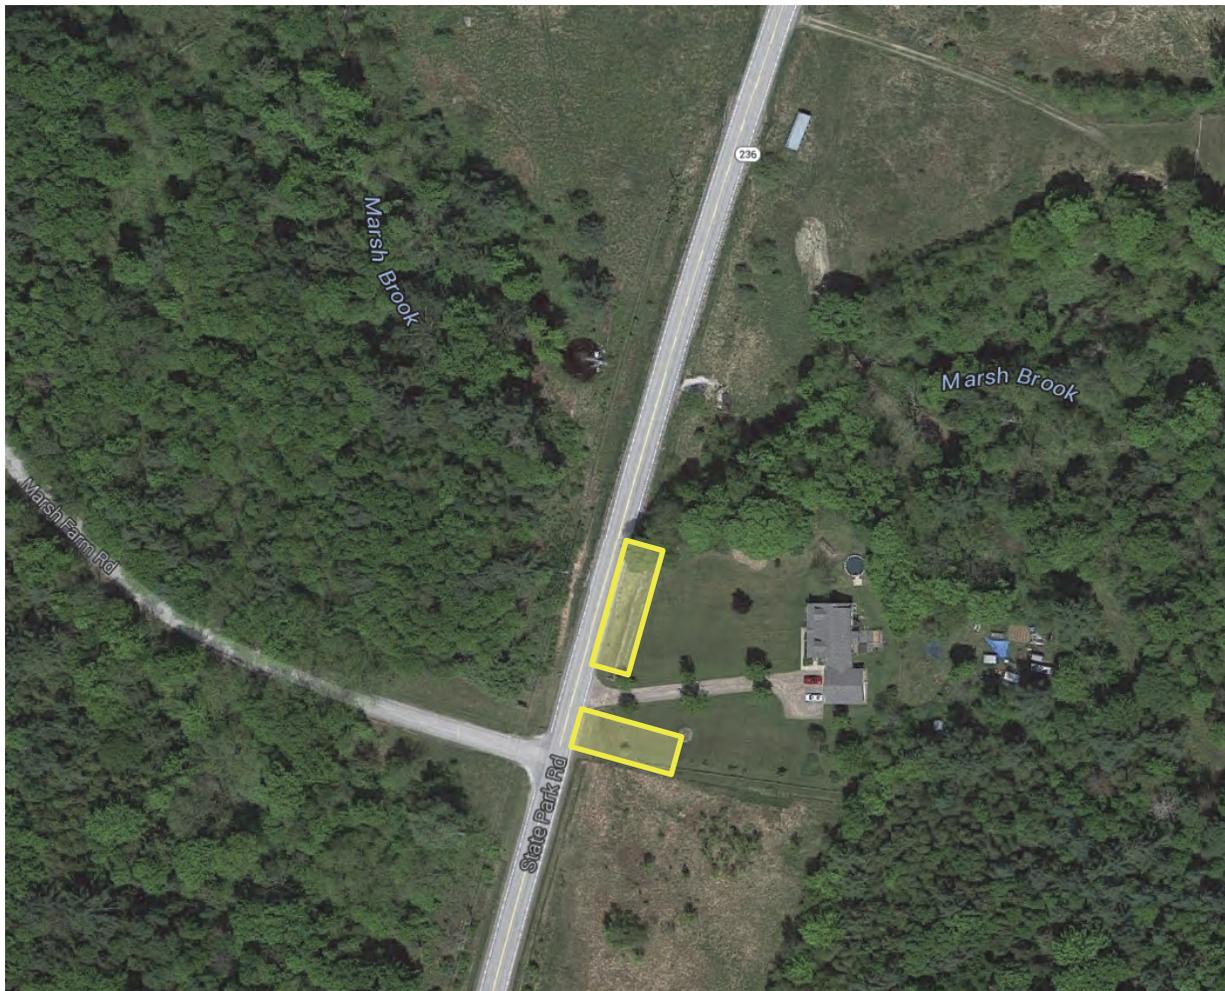
Recent construction along State Park Road has resulted in significant erosion in an area immediately adjacent to Marsh Brook. Photos of the area in 2009, available thru Google Maps, suggest that a stone retaining wall which ran parallel to State Park Road has been removed. Although the landowners appear to have attempted basic erosion control measures (e.g., seed and mulch), the measures have failed and the area is actively eroding. If allowed to continue, the erosion will likely impact State Park Road.

Although the removal of the stone retaining wall likely explains, at least in part, the erosion parallel to State Park Road, it is unclear what may have triggered the erosion south of the driveway. In the 2009 aerial photos, available from Google Maps, this area appears well-vegetated and stable. It will be important to involve the landowner, in addition to the Town, in devising a strategy for addressing this problem area.

Figure 5. Area of active erosion near the intersection of State Park Road and Marsh Farm Road.

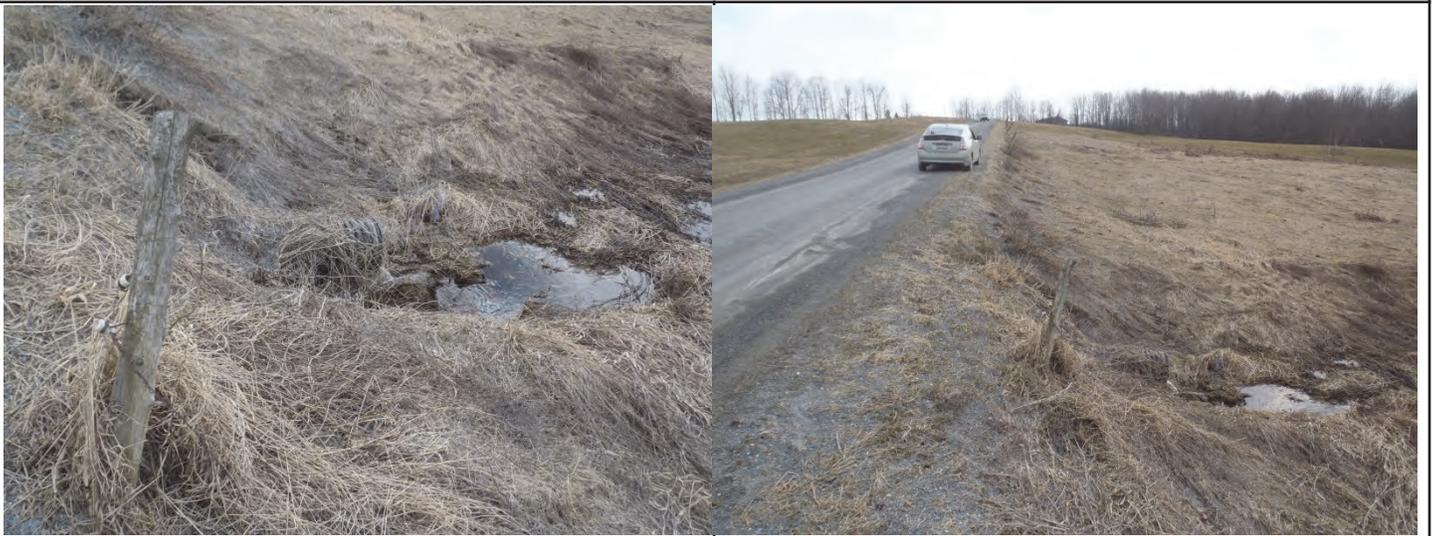
**Description of Observed Conditions:**  
 Culvert is too short for current road width. Banks above the culvert inlet and outlet are over-steepened and actively eroding.

Photo 1. Perched culvert outlet      Photo 2. Downstream bank erosion

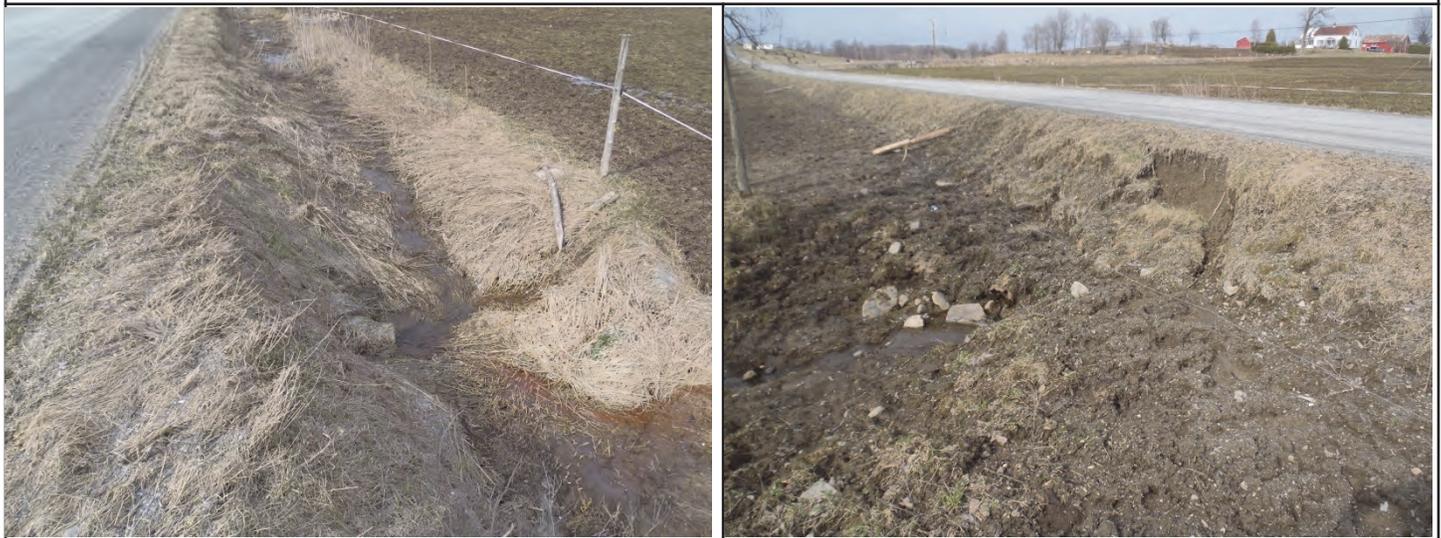
Photo 1. Bank above culvert inlet      Photo 2. Culvert outlet and bank collapse

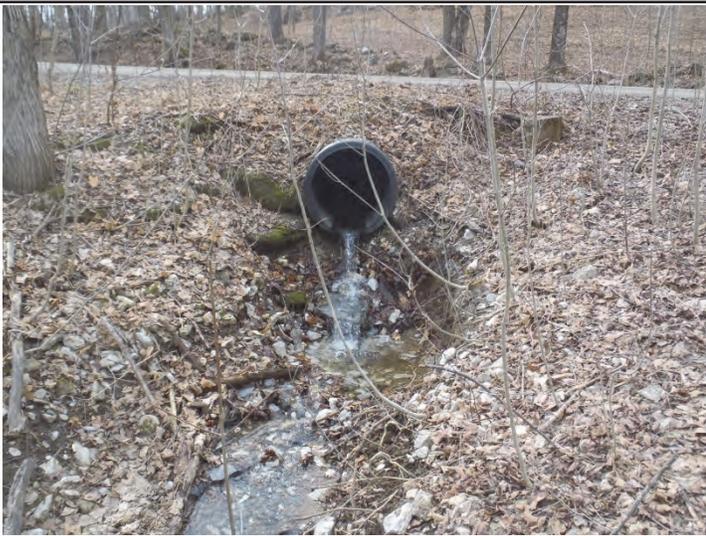
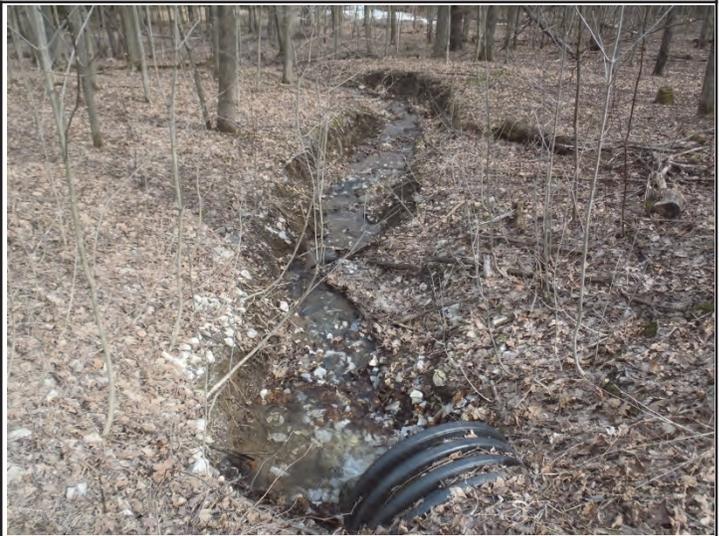
Photo 1. Perched culvert outlet

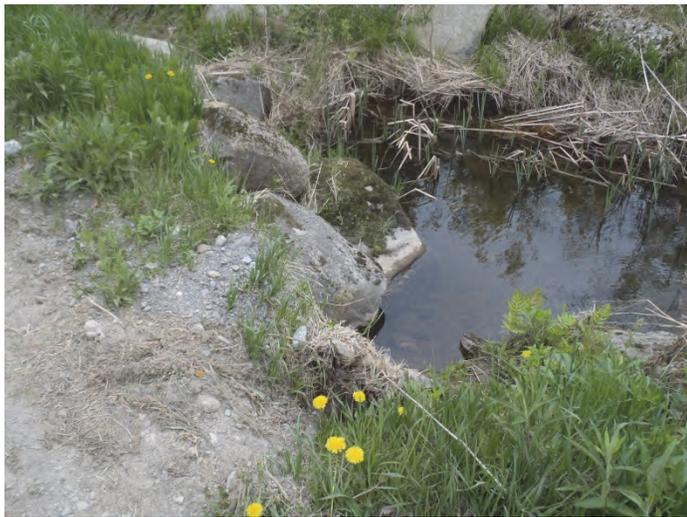
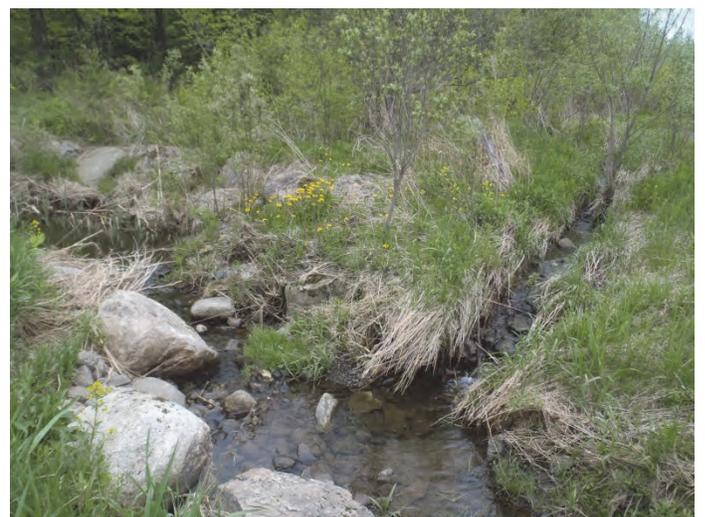
Photo 1. Culvert inlet, with visible sediment load from road surface

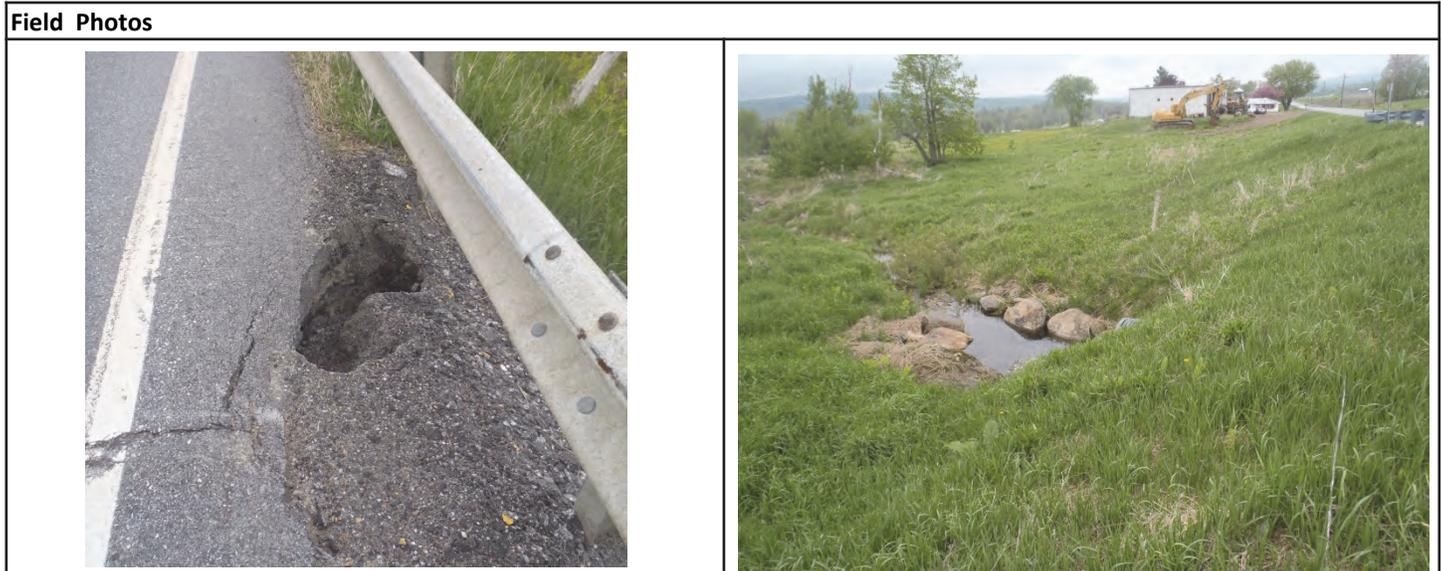
**Description of Observed Conditions:**  
 Sinkhole in the road shoulder has formed above the upstream end of the culvert; rocks have been installed in an effort to stabilize the scour pool at the downstream end of the culvert.

Photo 1. Sinkhole in east shoulder of State Park Rd, above culvert      Photo 2. Stabilization measures at downstream end of culvert

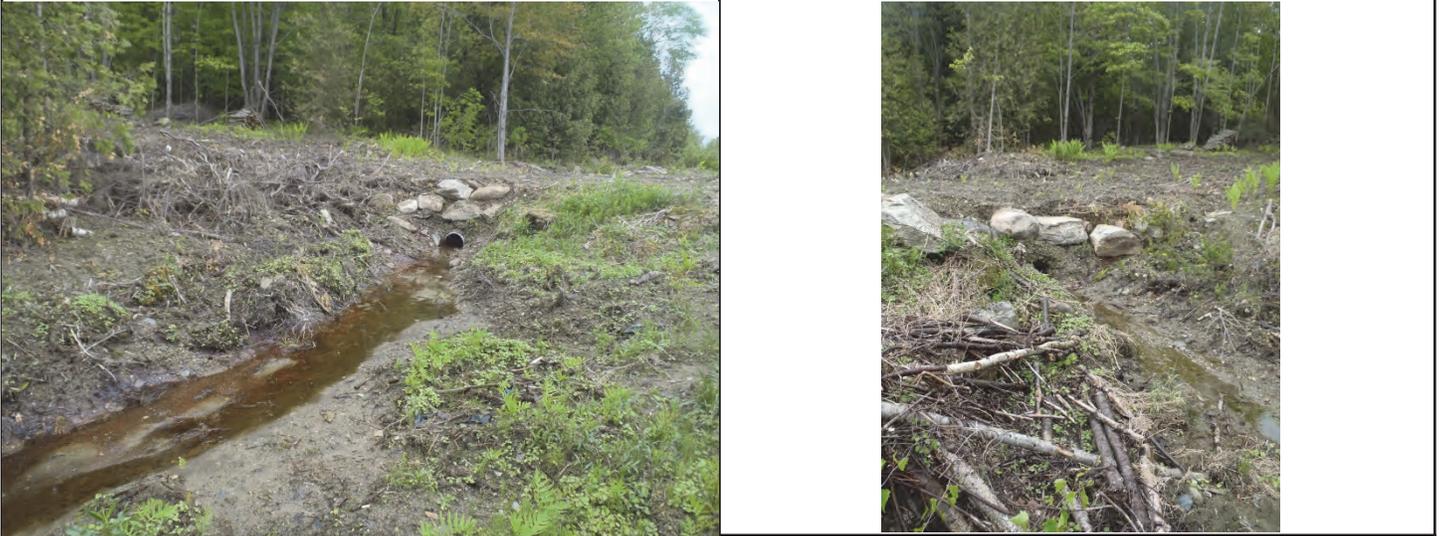
Photo 1. Logging road and landing      Photo 2. Log landing

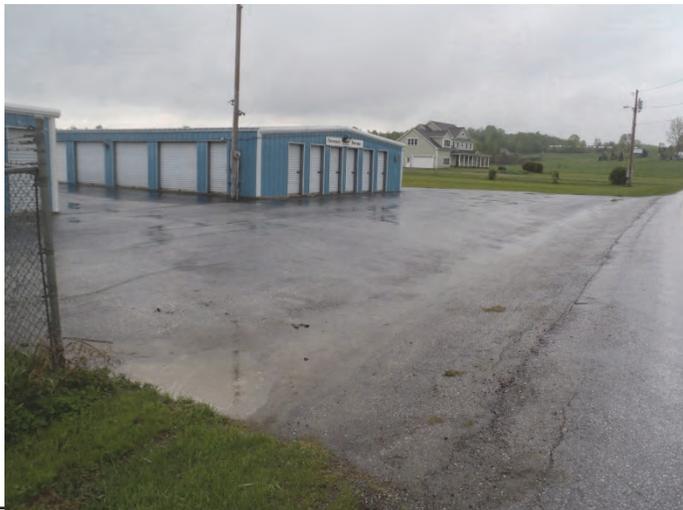
Photo 1. Uncontrolled runoff from self-storage facility

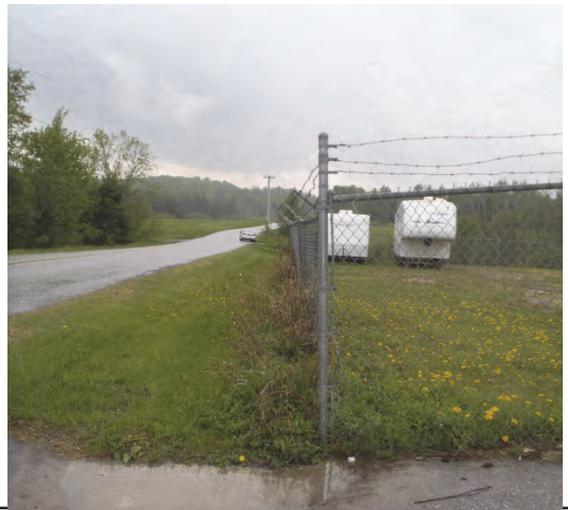
Photo 2. Runoff flows along fence to tributary

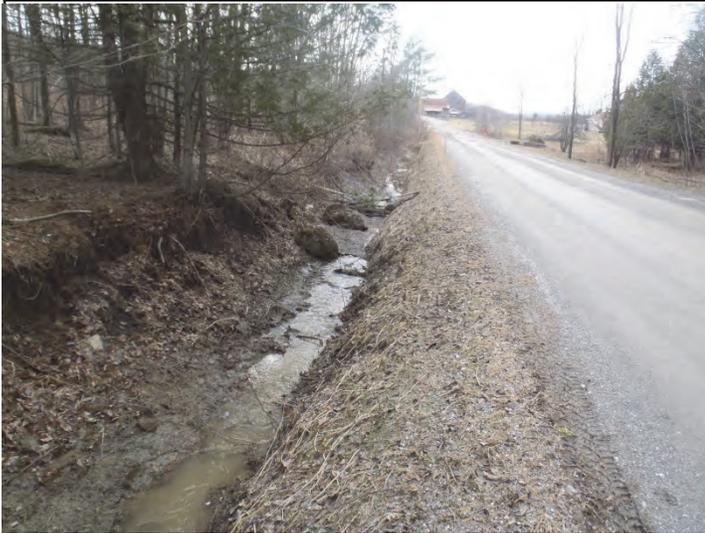
Photo 1. Steep back slope

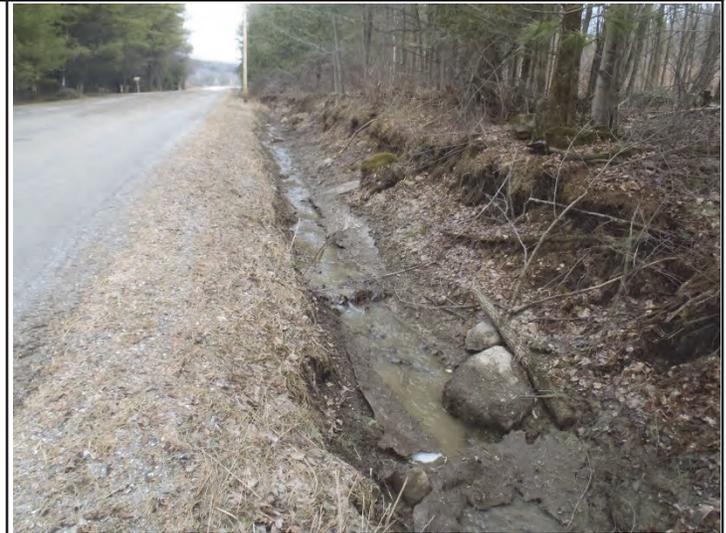
Photo 2. Bare ditch bottom showing evidence of significant sediment transport

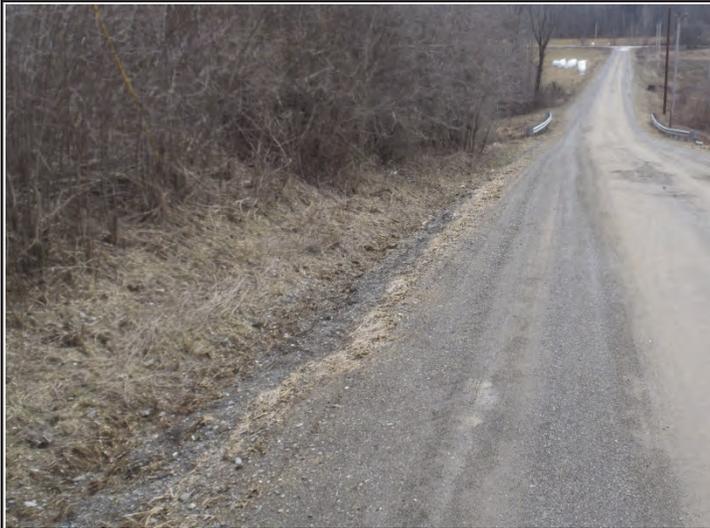
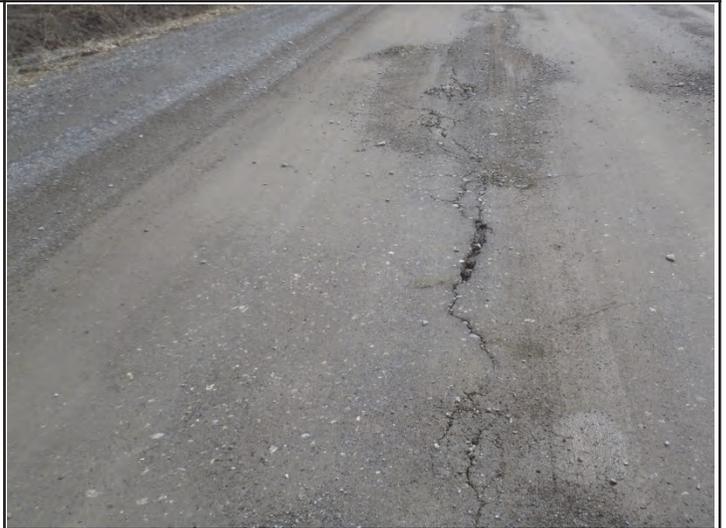
Photo 1. Shallow ditch

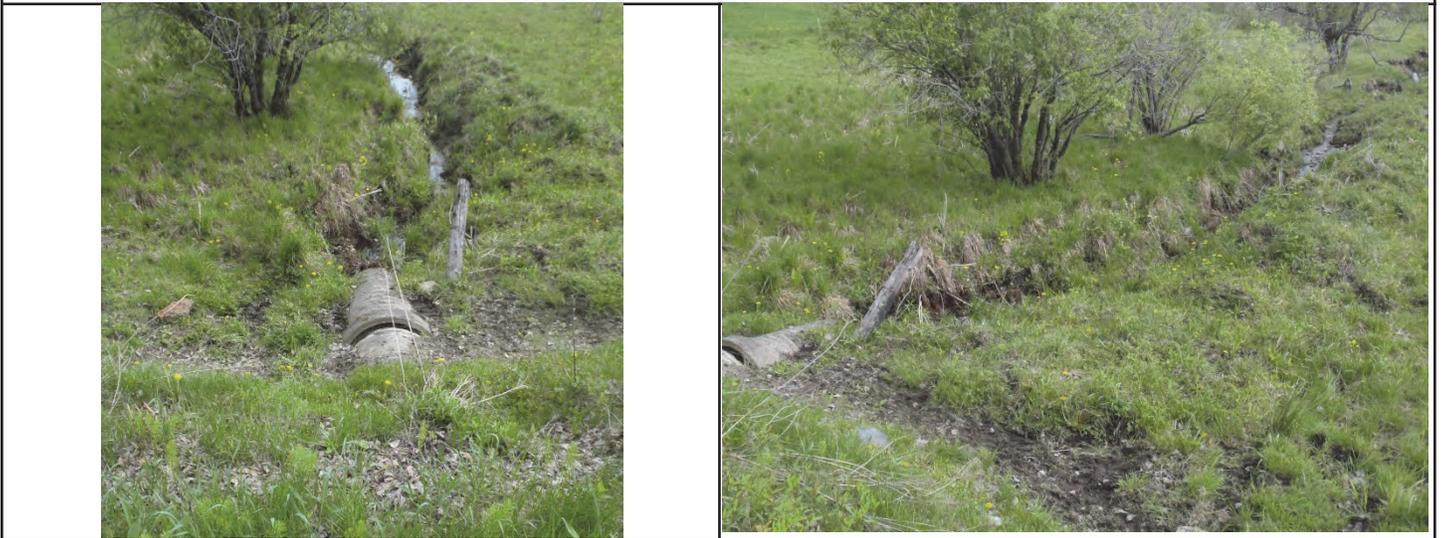
Photo 1. Culvert outlet

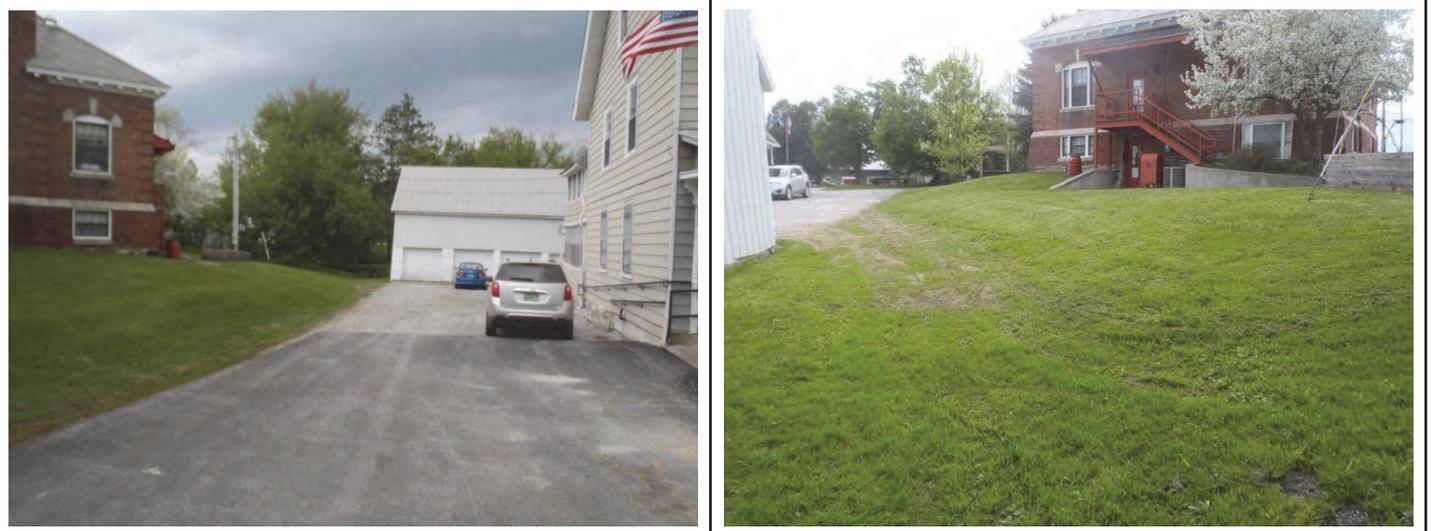
Photo 1. Looking toward stream between Post Office and Library, standing on Hanna Rd.  
 Photo 2. Looking back toward Hanna Rd from the stream bank; some evidence of minor erosion in yard.

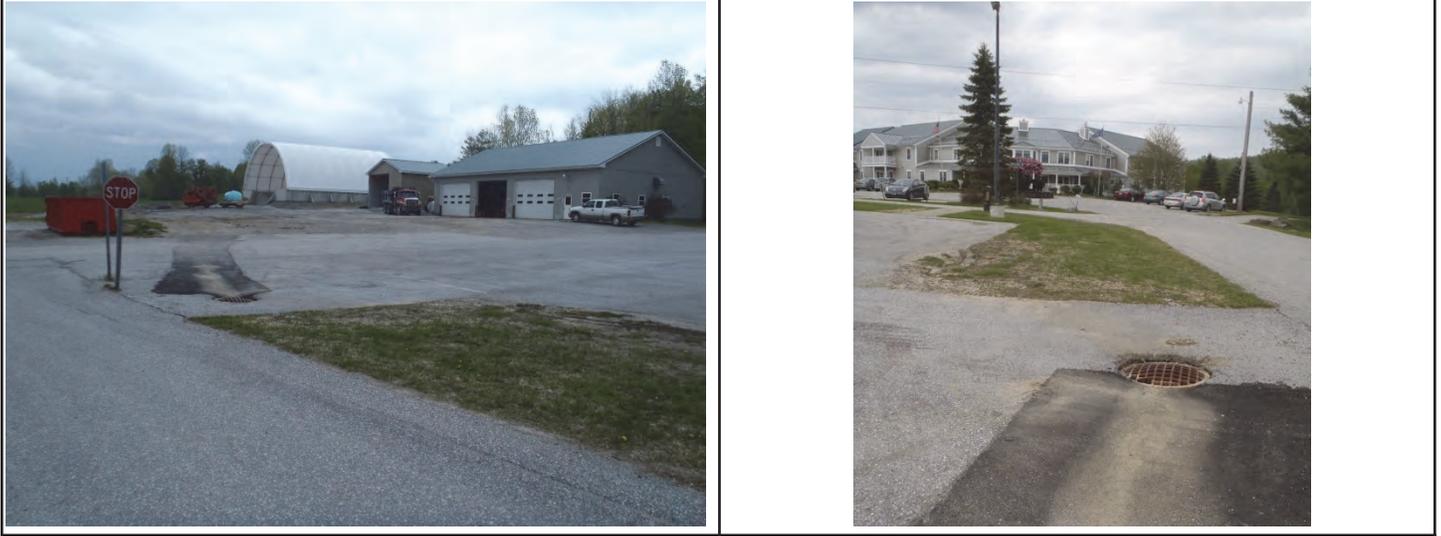
Photo 1. Town Garage draining to single catch basin near the stop sign  
 Photo 2. Evidence of sediment from the Town Garage reaching the catch basin; possible retrofit location shown in background

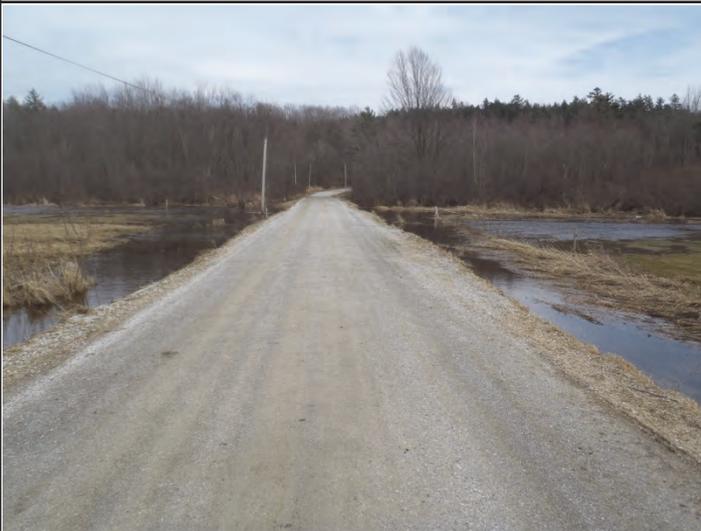
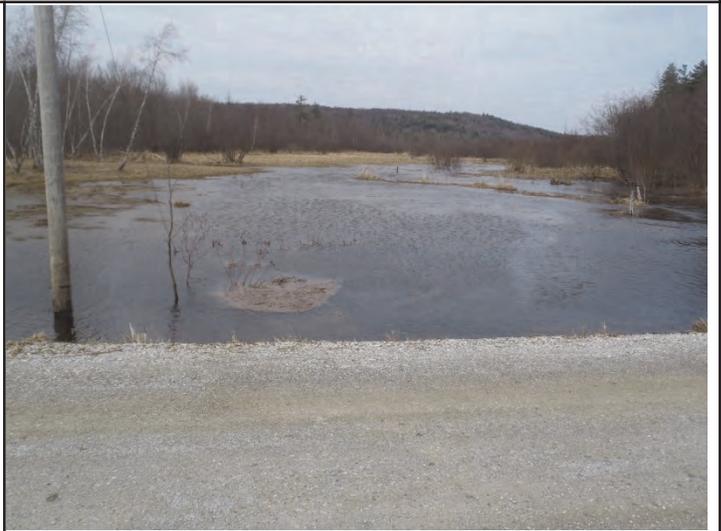
Photo 1. Water on either side of Beaver Meadow Rd.
