Wardsboro Brook Watershed Corridor Plan

Wardsboro & Jamaica, Vermont
October 27, 2014

Prepared by:
Bear Creek Environmental, LLC
149 State Street, Suite 3
Montpelier, Vermont 05602

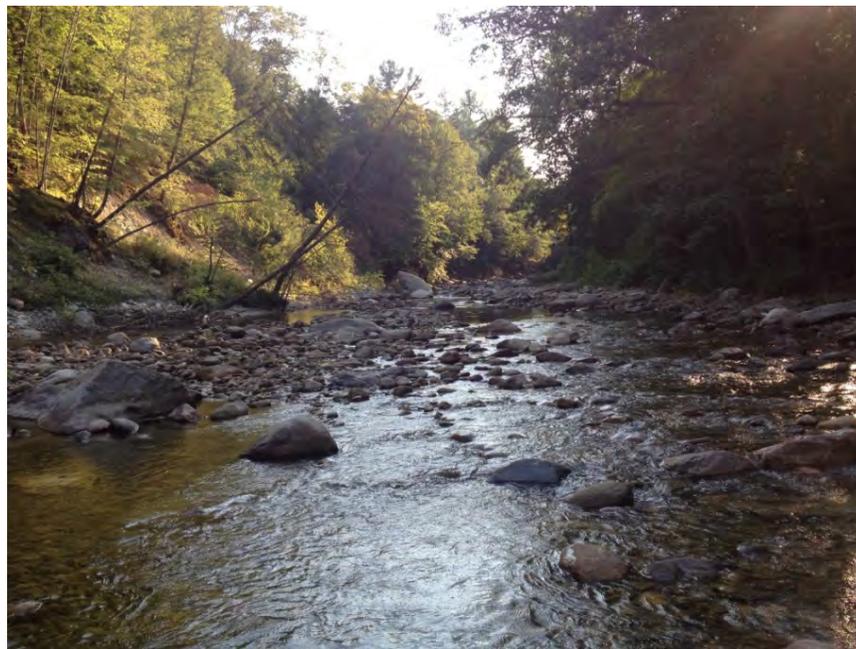
This segment begins at the confluence with the West River and continues approximately 900 feet upstream until the valley narrows. This segment is an *alluvial fan*, where the channel slope drops and the valley opens up as Wardsboro Brook meets the West River. Floodplain access is limited throughout the segment and bedform has been lost. A riffle-pool channel by reference has been converted to featureless plane-bed channel in this segment, as seen in Figure 5.4. This segment is in **fair** geomorphic condition, with major historic degradation, major recent widening, and significant bar formation. The segment is also in **fair** habitat condition due to lack of diverse habitat features and floodplain access, as well as impacted buffers. There is one stream crossing in this segment (Eaton Road), but it is not a channel constriction.

Figure 5.4. Lack of riffle-pool bedform and habitat features in T8.01A.

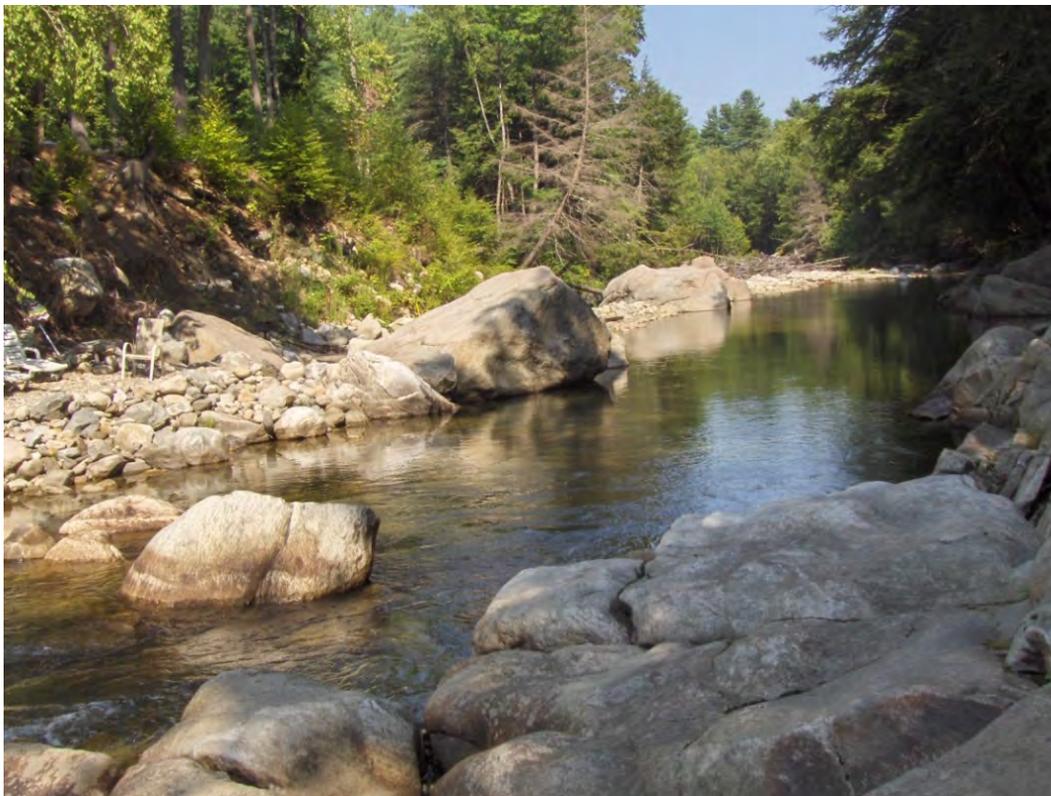
Figure 5.5. Good habitat features characteristic of segment.

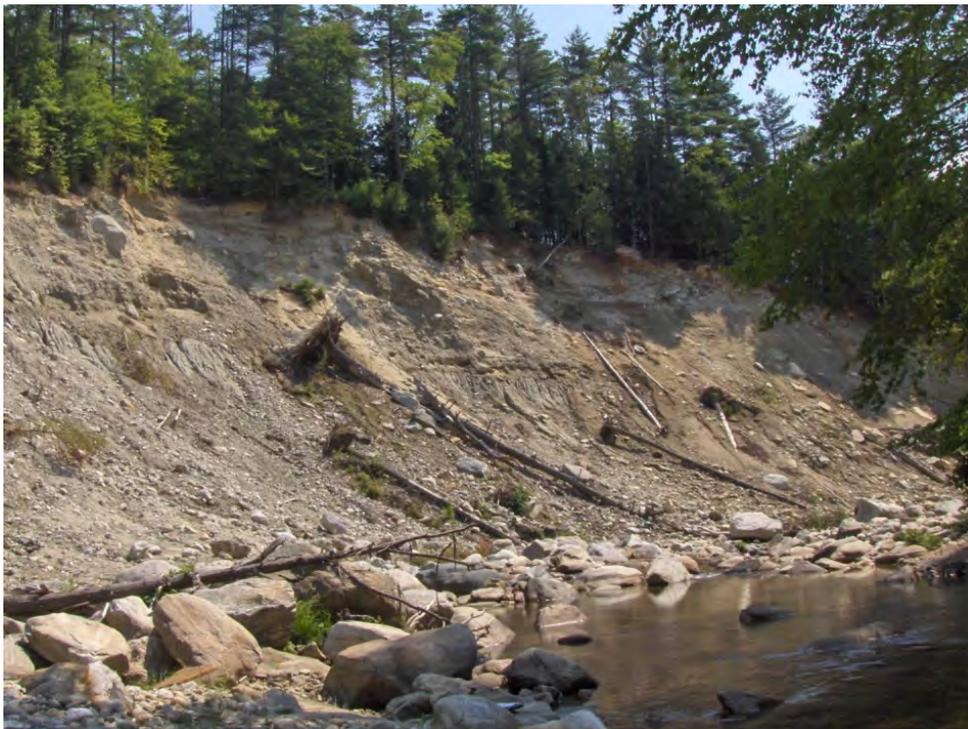
Windrowing and dredging are present in this segment, particularly in areas where the brook is close to the road. Due to these channel alterations, corridor encroachments, and loss of riparian buffer, this segment was placed in **fair** habitat condition. The channel has undergone extreme widening, and is in active planform adjustment, as evidenced by continuous erosion, mass failures, and large flood chutes behind very large bars. Due to these factors, this segment is in **poor** geomorphic condition. An example of the frequent mass failures present in this segment is shown in Figure 5.6.

Figure 5.6. One of many mass failures present in this segment.

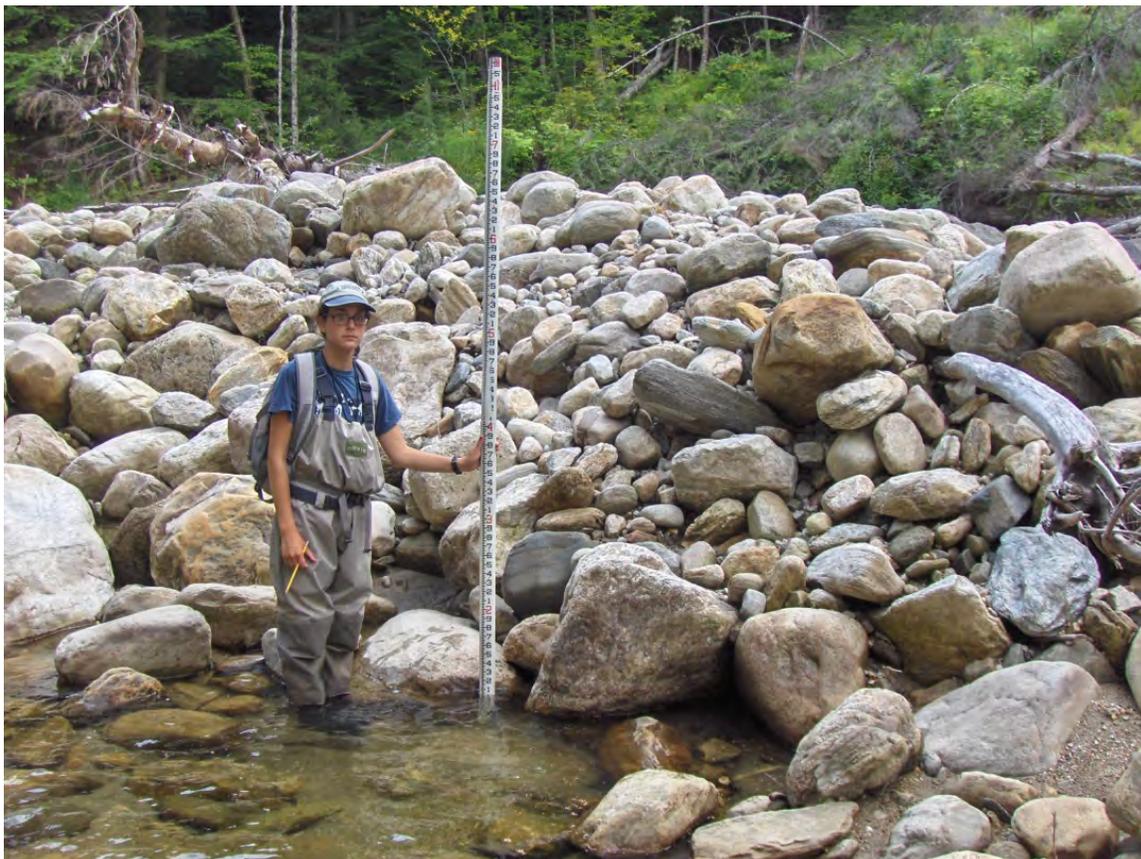
Figure 5.7. Very large bars are forming a juvenile floodplain in T8.01-D.

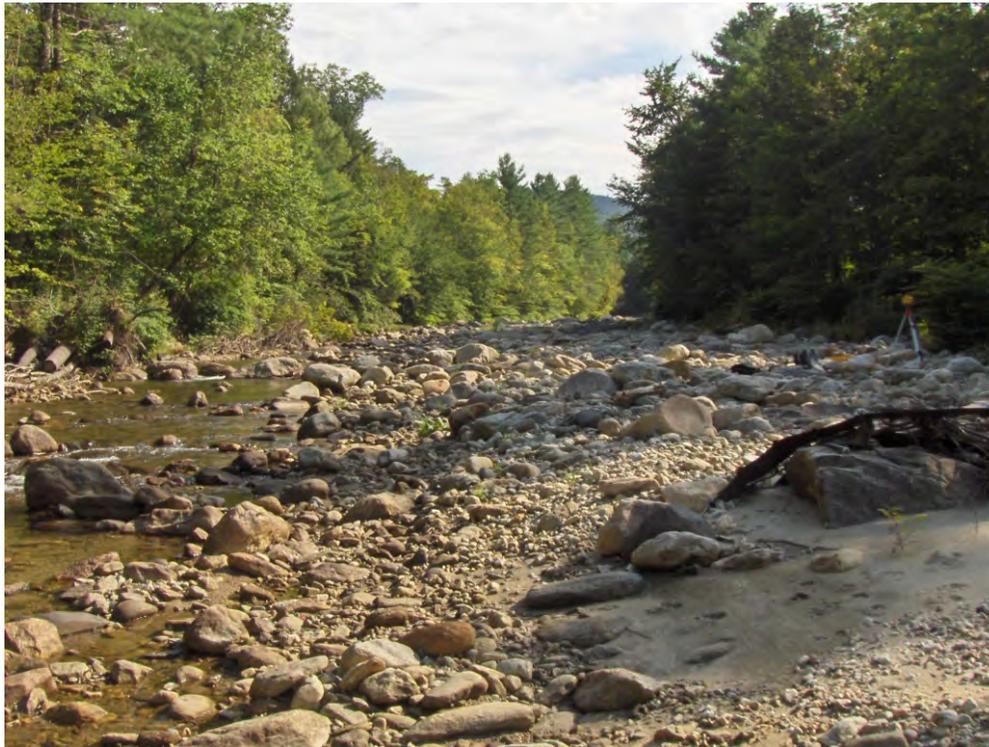
Figure 5.8. Large bar characteristic of T8.02-A.

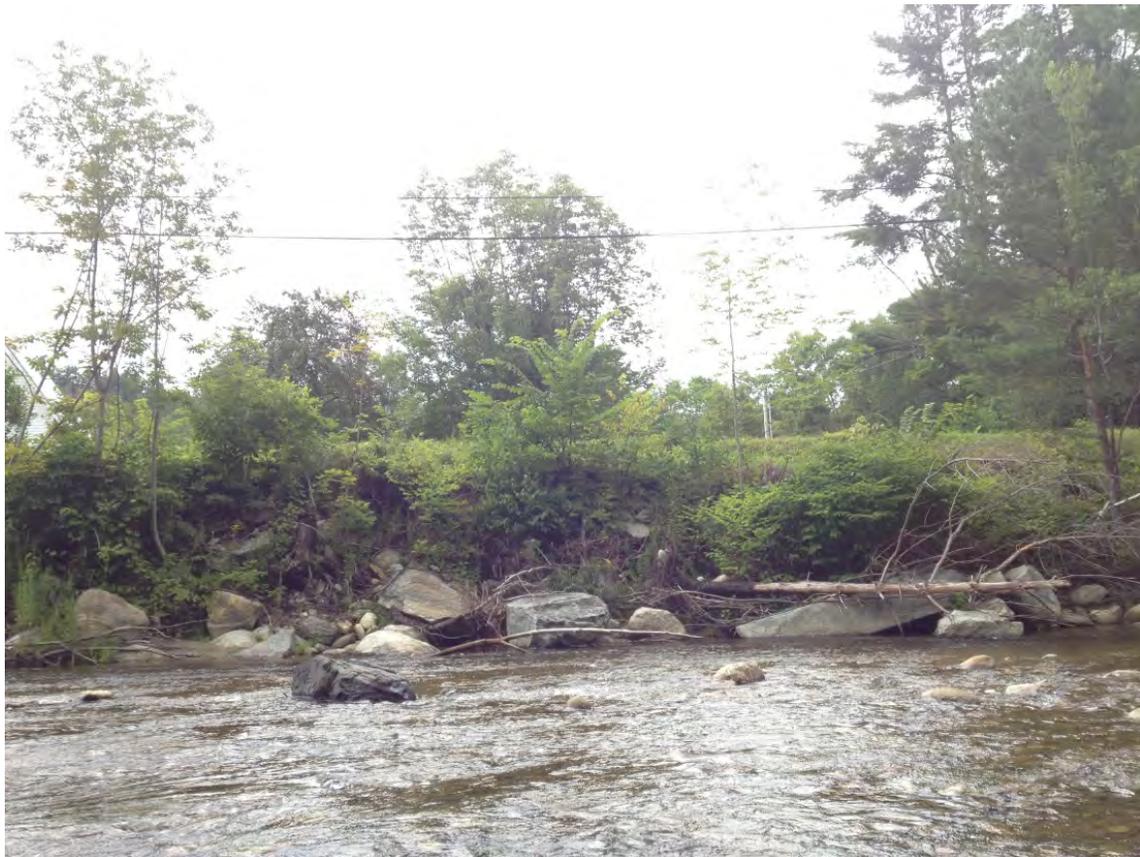
Figure 5.9. Impacted buffer where segment T8.02-B has been straightened along Rt. 100.

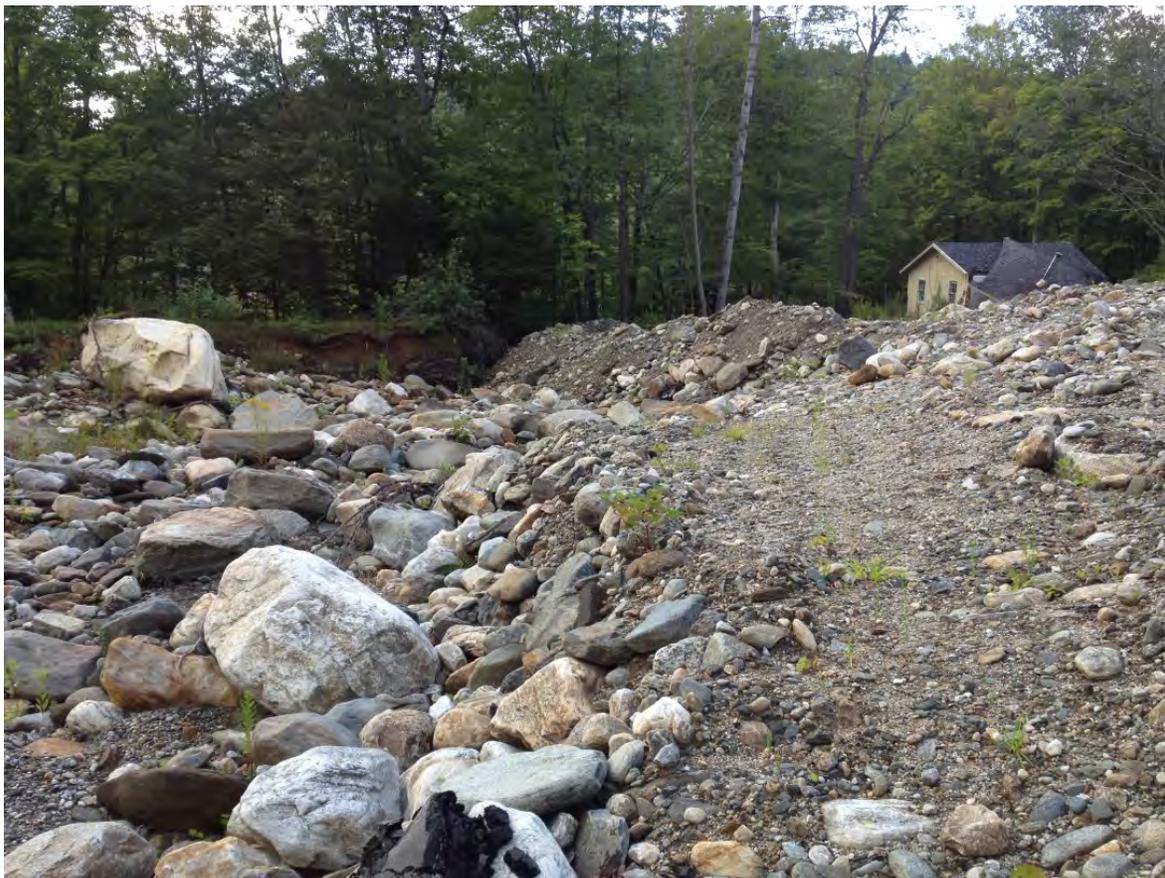
Figure 5.10. Location of three buyouts in T8.02-C

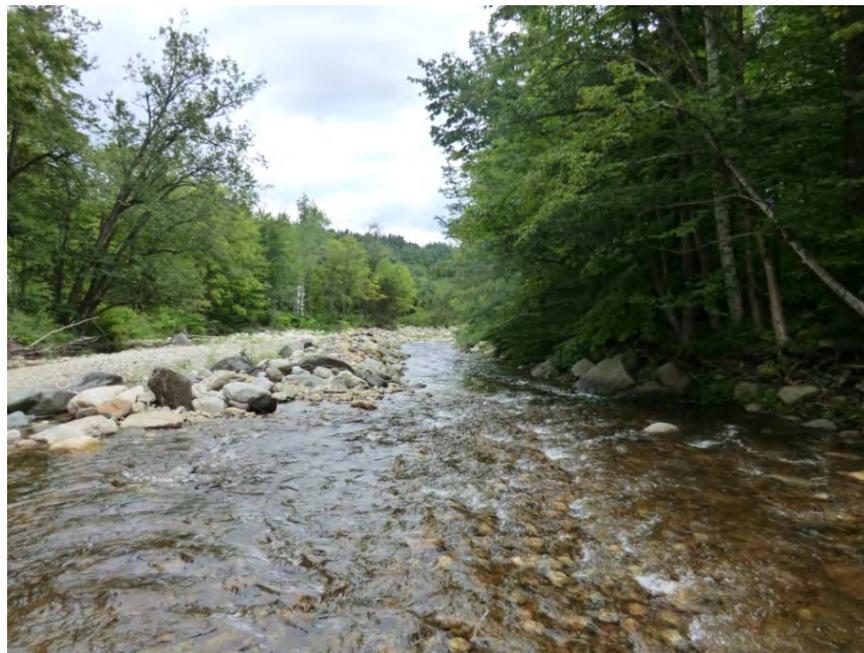
Figure 5.11. Post-TSI channel work to reposition flow in an over-widened channel.

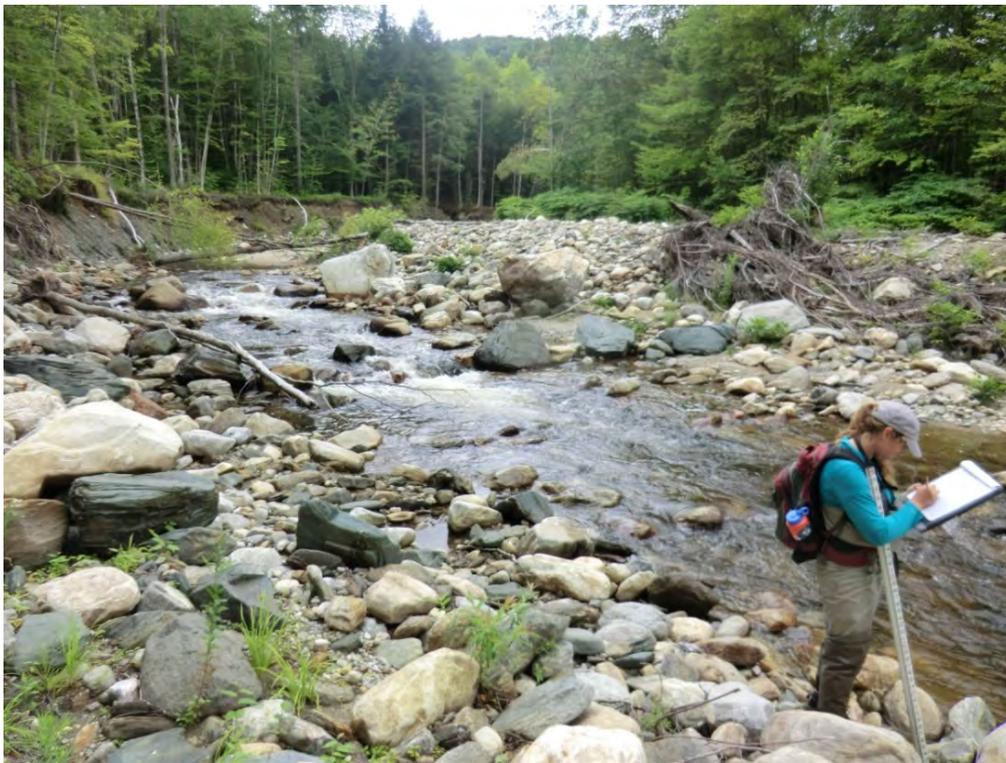
Figure 5.12. Channel avulsion with active headcut and erosion.

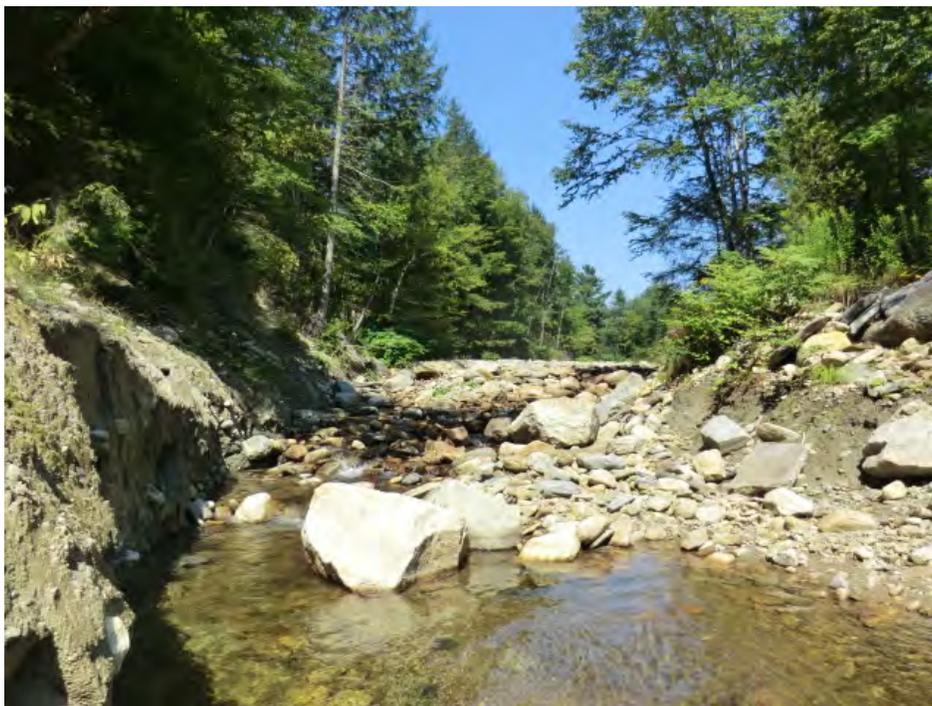
Figure 5.13. Headcut below sediment plug and high stream banks in T8.05-A.

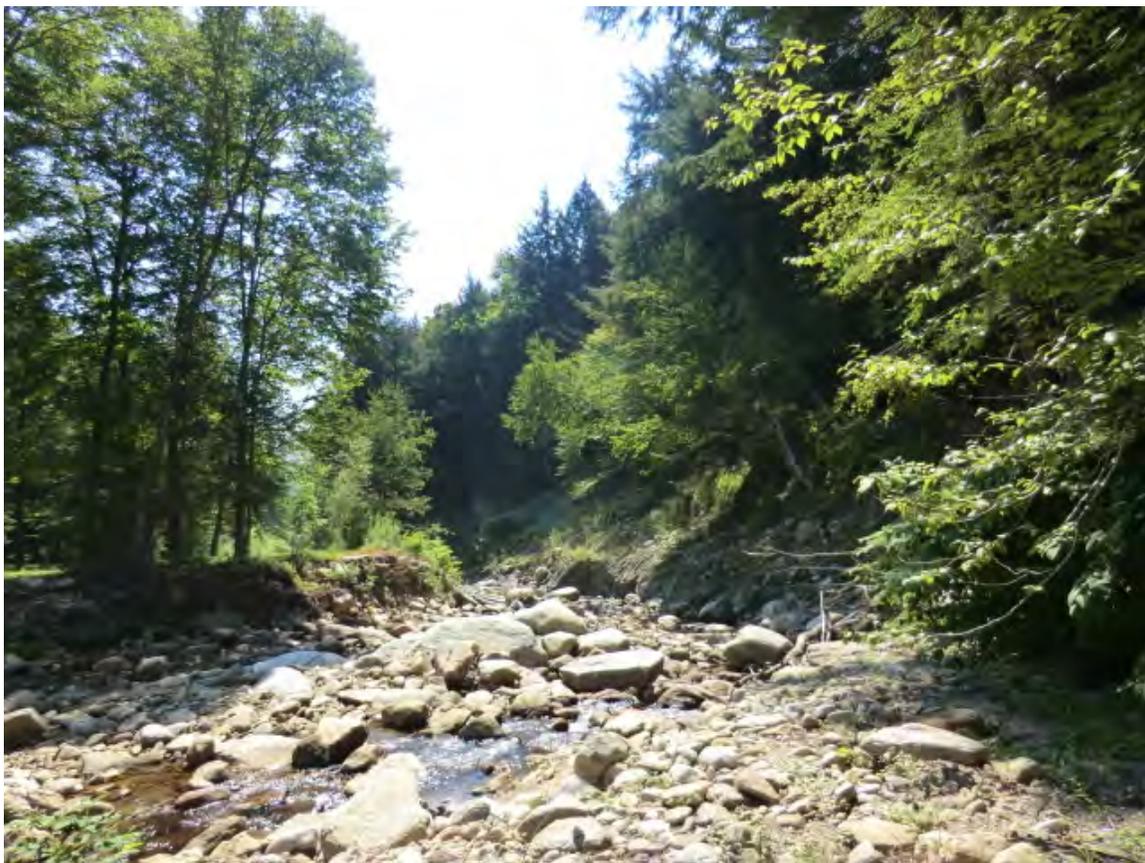
Figure 5.14. Major aggradation and floodplain access in T8.05-B.

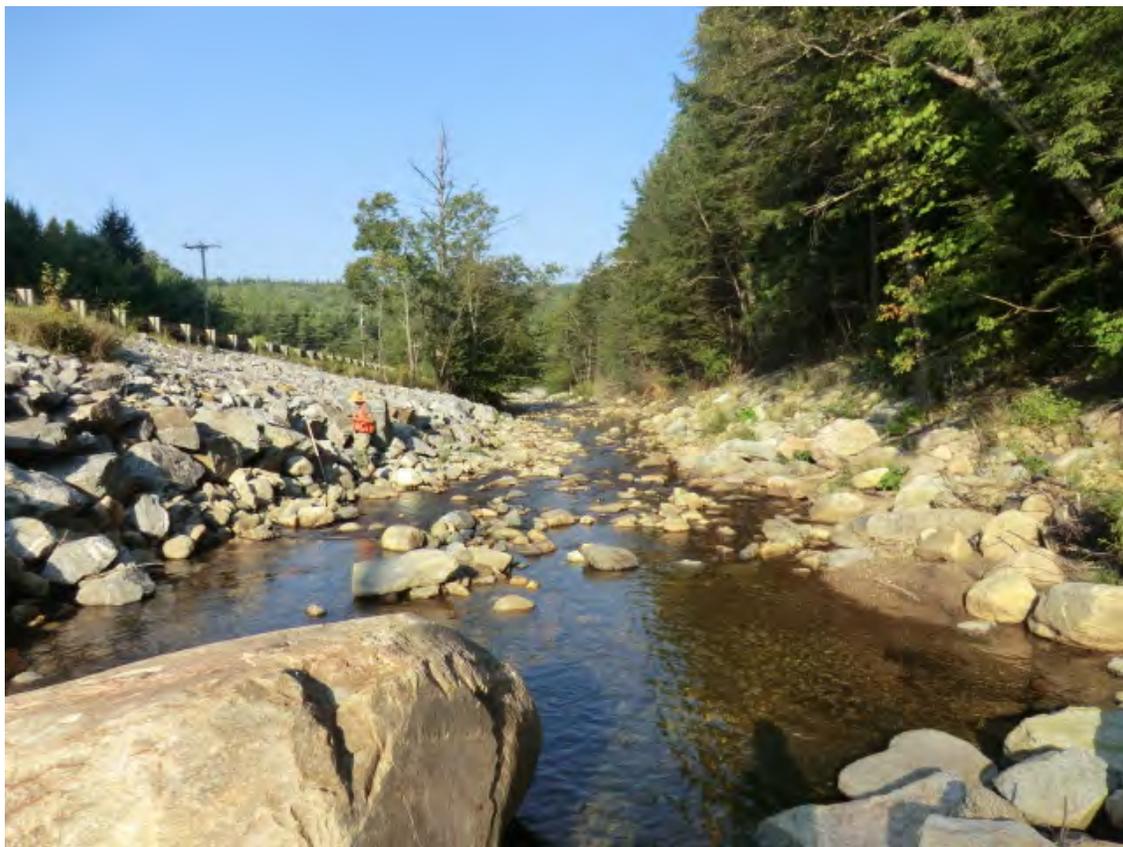
Figure 5.15. A straight, featureless channel with poor buffers dominates in T8.05-C.

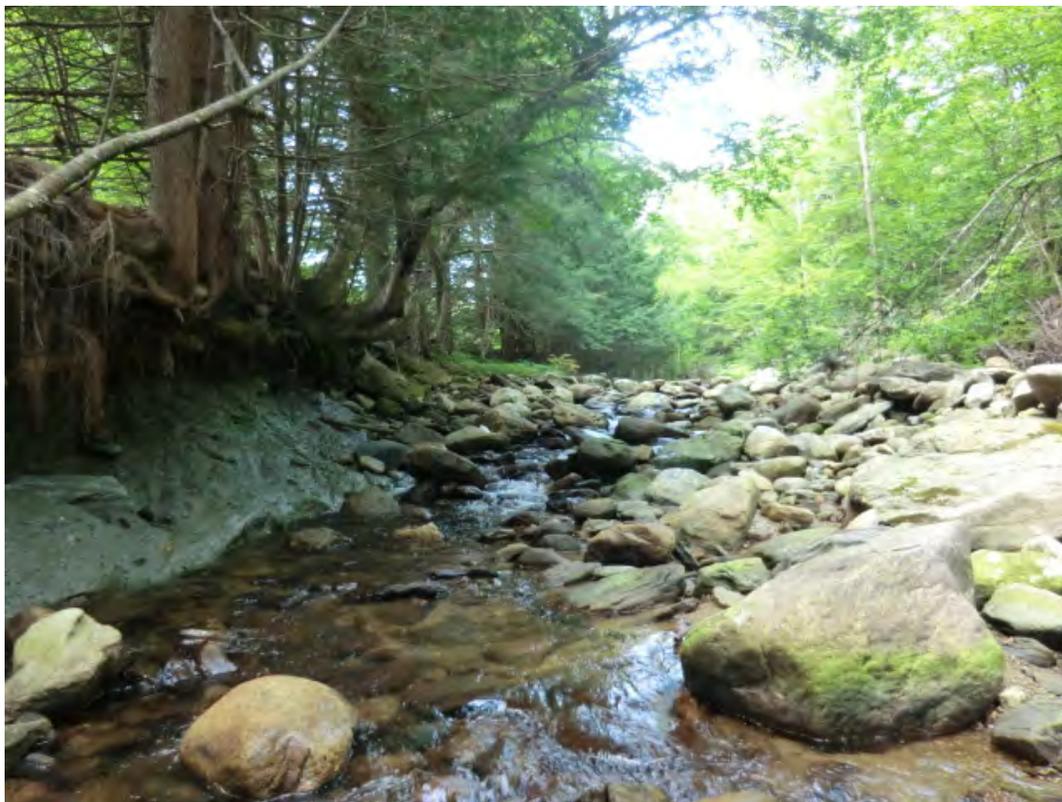
Figure 5.16. One of two active headcuts in T8.06-A.

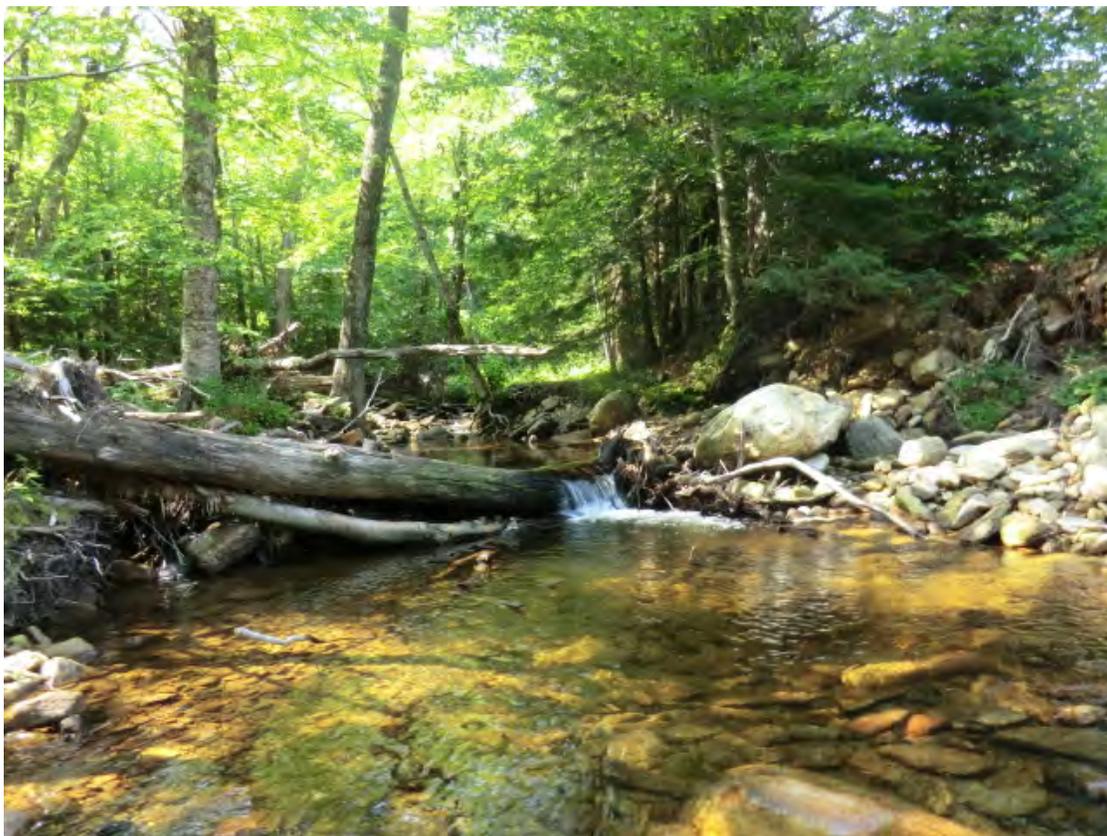
Figure 5.17. Debris jam creating plunge pool for good habitat conditions in T8.06-B.

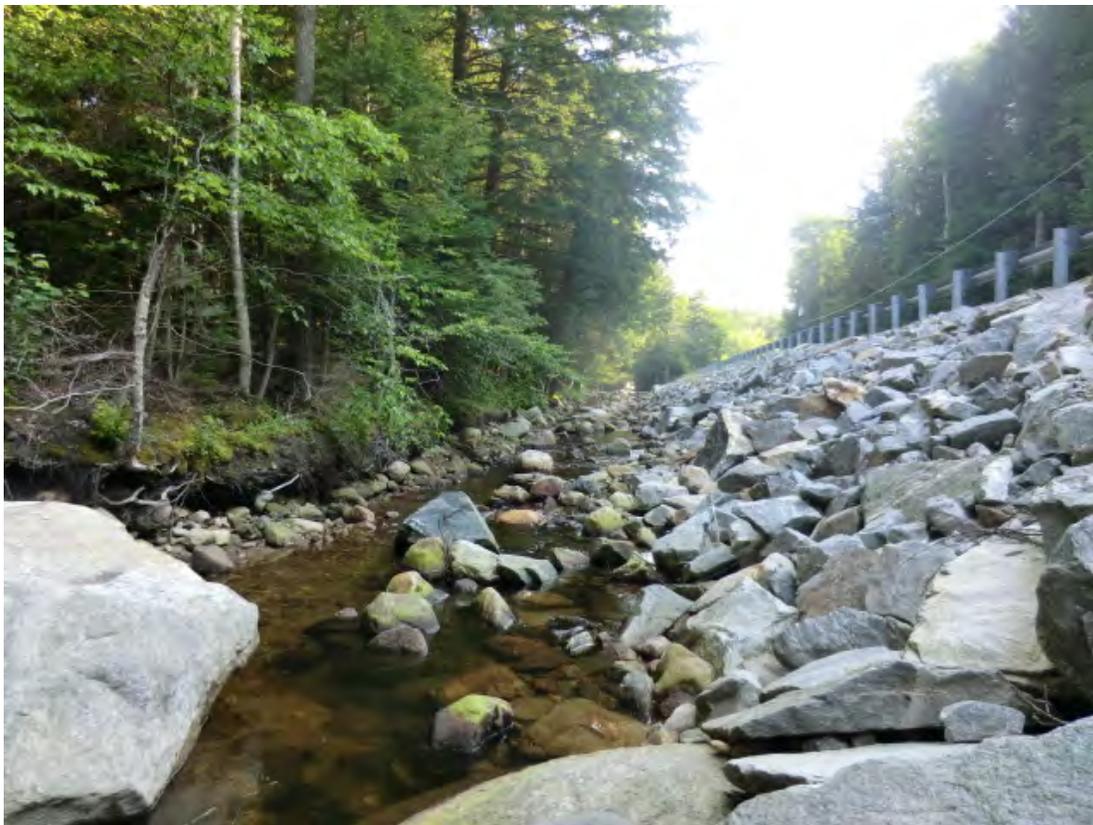
Figure 5.18. Straightened and rip rapped along the road, T8.06-C has been converted to a plane bed bedform.

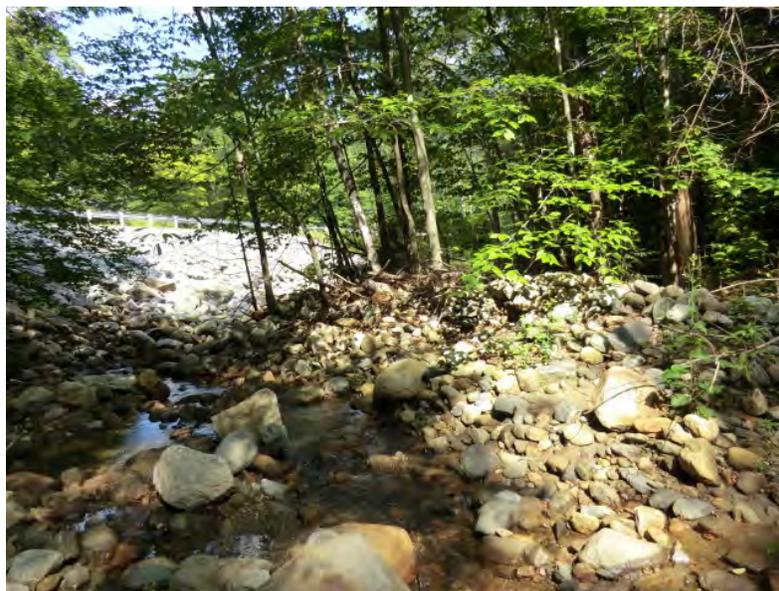
Figure 5.19. Windrowing and corridor encroachment of Rt. 100 common in T8.S3.01.

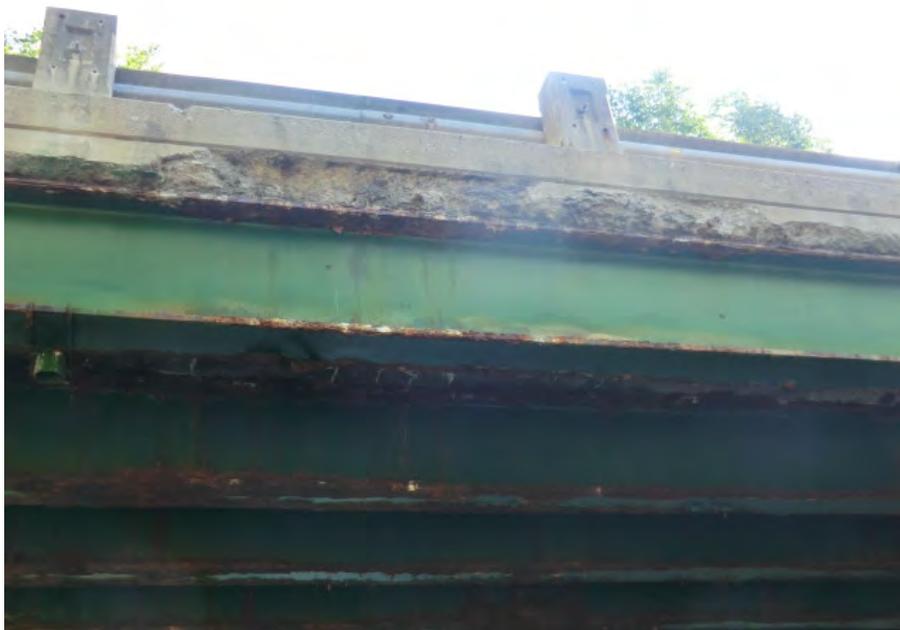
The downstream-most crossing recommended for replacement was a Rt. 100 bridge in T8.05-C. Significant scour around the structure occurred during TSI and the bridge could have been undermined during the next major flow event. The bridge ranked mostly compatible; however, due to its poor condition (cracked abutments, rusting beams, and deteriorating decking) and the potential for the bridge to be undermined, it was recommended for replacement with a moderate priority. According to John Bennett of the Windham Regional Commission, this bridge was replaced by the Vermont Agency of Transportation during 2014.

Figure 5.20. Deteriorating decking and rusting beams of Rt. 100 bridge in segment T8.05-C.

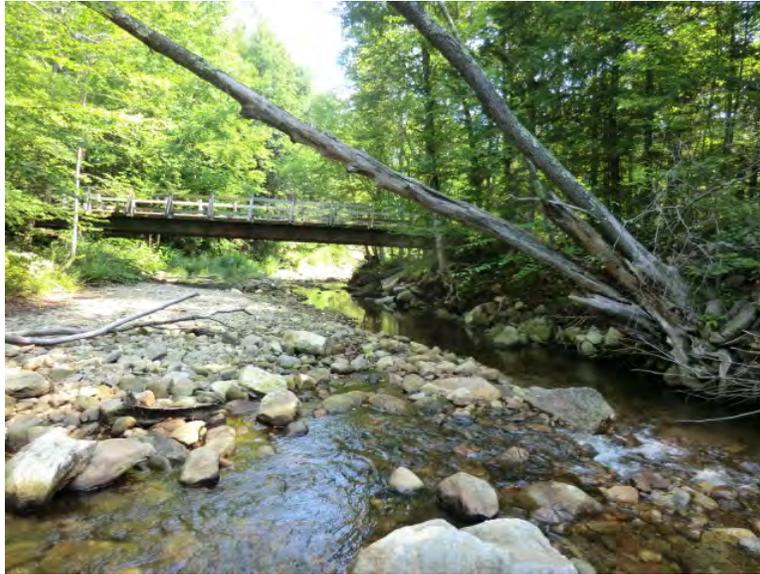
The bridge on Temple Road in segment T8.06-B is ranked as mostly incompatible and is recommended for replacement. This bridge has poor alignment, abutment scour, and was likely overtopped during TSI. Channel avulsions are present directly upstream of the structure.

Figure 5.21. Temple Road bridge in segment T8.06-B recommended for replacement.

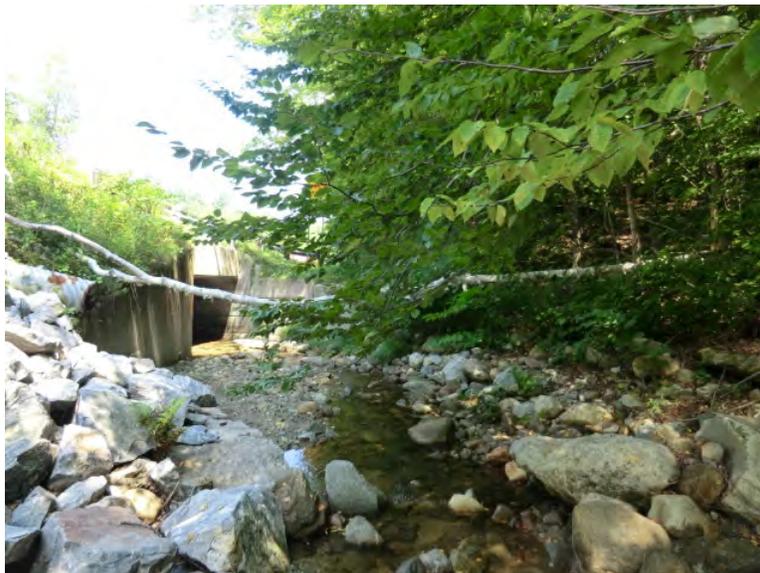
On reach T8.S3.01 of Dover Brook, the most downstream crossing recommended for replacement is the box culvert under Rt. 100 and Cross Road. It is recommended for replacement due to its poor alignment with the channel, reduced aquatic organism passage (AOP), and scour around the structure. Under typical low flows, the depth of water in the culvert is very shallow and it contains no sediment, which could create a barrier for fish and other wildlife.

Figure 5.22. Poor alignment of Dover Brook culvert under Rt. 100 and Cross Rd.

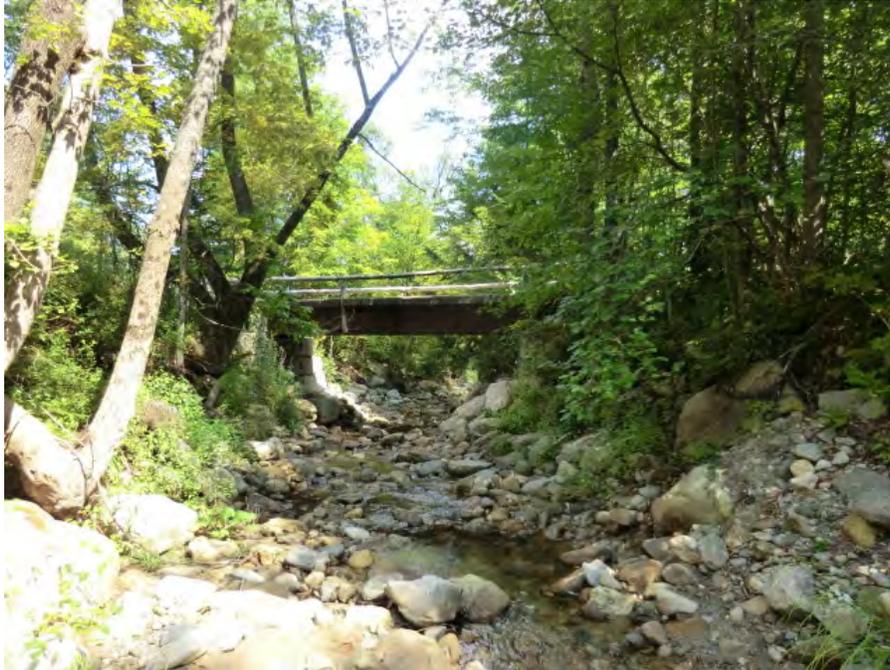
Farther upstream in T8.S3.01, a private driveway bridge is recommended for replacement with a low priority. This structure is a slight channel constriction, and has scour around its footers and failing rip rap.

Figure 5.23. Private driveway bridge in T8.S3.01 recommended for replacement.

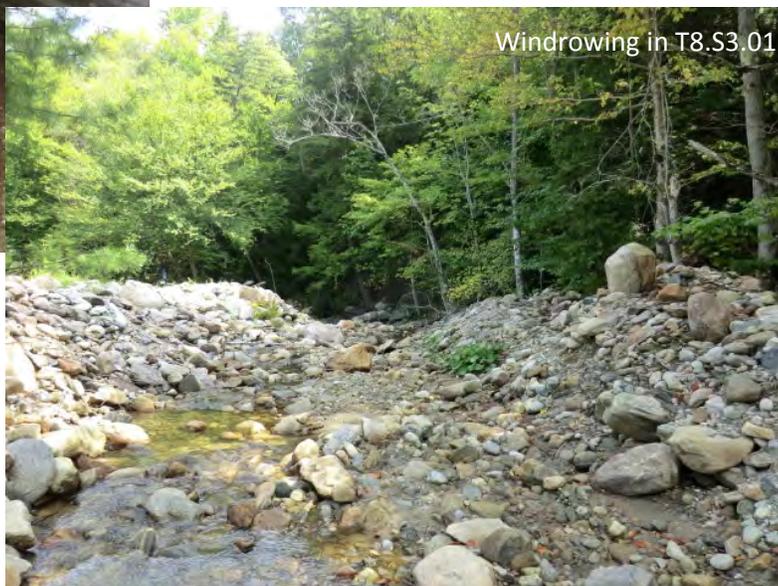
Windrowing in T8.S3.01
