# River Corridor Plan for the Saxtons River Watershed Windham County, Vermont

September 30, 2010

**Fitzgerald Environmental Associates, LLC.**  
316 River Road  
Colchester, VT 05446

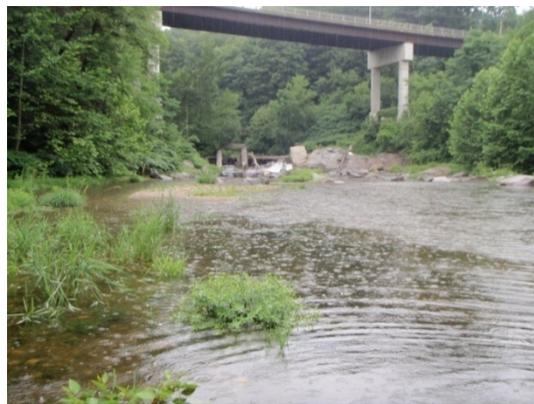
Figure 4.2 Several mid-channel bars in the widened channel

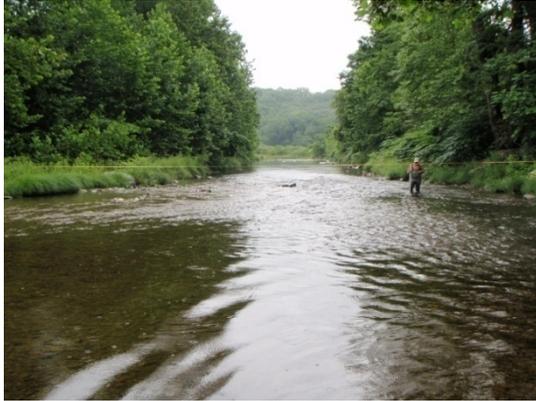
It should be noted that the high incision ratio in the reach may be exaggerated by the height of a glacial terrace (not a recently abandoned floodplain) above the current bankfull channel. Although the soils surrounding this reach are mapped by NRCS as “alluvium”, it is unclear whether this apparent floodplain was formed by recent river processes (hundreds of years old), or whether it is a relict of older, glacial processes (thousands of years old).

Figure 4.5 M02 cross-section location w/ F-type geometry

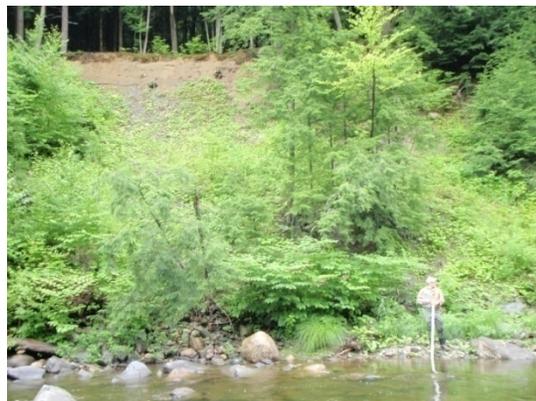
Figure 4.8 Mass failure located on right bank

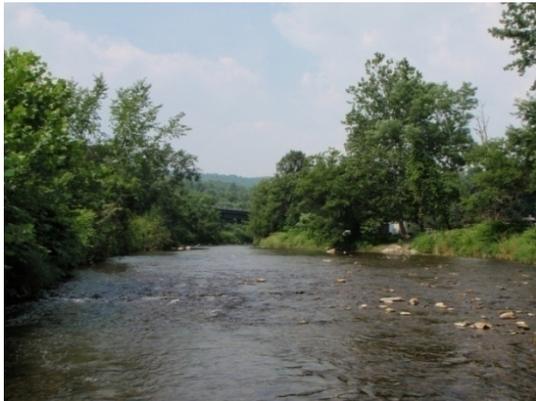
Figure 4.9 Widening looking upstream at cross-section location

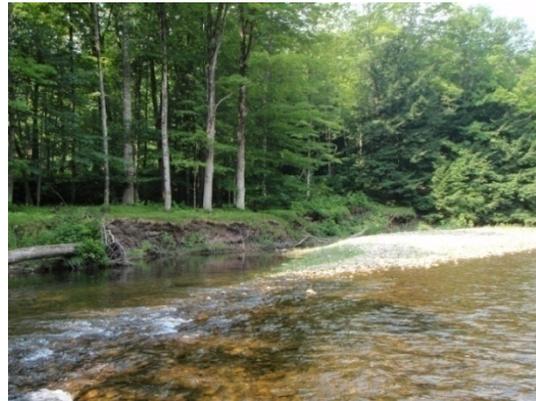
Segment M03-B begins just upstream of the Covered Bridge Road crossing and extends upstream about 1.1 miles to the reach break about 800 feet upstream of the I-91 crossing. The channel geometry is indicative of C-type morphology and the bedform is plane bed. The bed slope is approximately 0.5% and the confinement type is narrow. The bed substrate is predominately cobble (46%) and coarse gravel (28%) with gravel median substrate (55mm). The width-to-depth ratio observed at the cross-section seems to be slightly lower than widening observed in other parts the segment (WDR = 30.8; Figure 4.9). The entrenchment ratio is characteristic of C-type channel morphology (ER = 2.9) and the incision ratio suggests moderate degradation (IR = 1.5). The lower end of this segment has significant aggradation upstream of the grade control at the road crossing. There, the sediment has formed several large bar features suggesting past incision, widening, and now a shift in planform (Figure 4.10).

Figure 4.10 Diagonal bar upstream of segment break

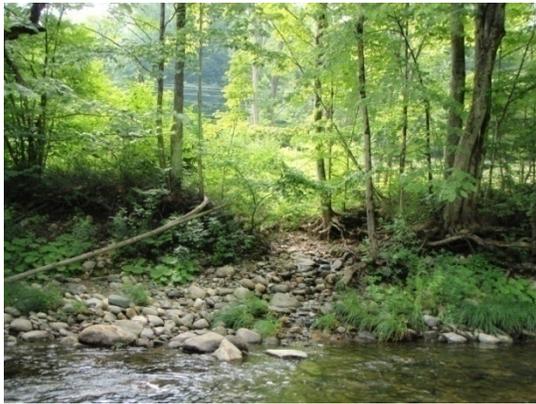
Figure 4.11 Rejuvenating tributary located mid-reach

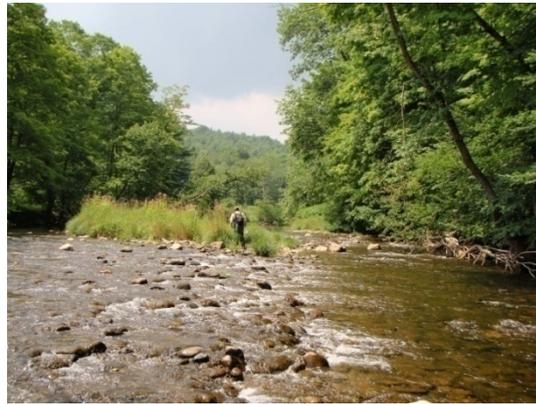
Figure 4.12 Diagonal riffle located mid-reach

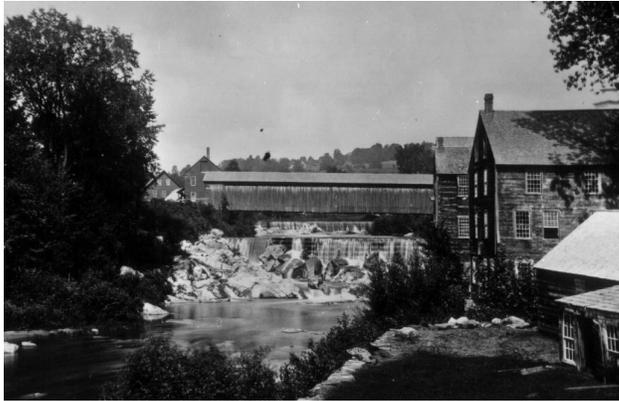
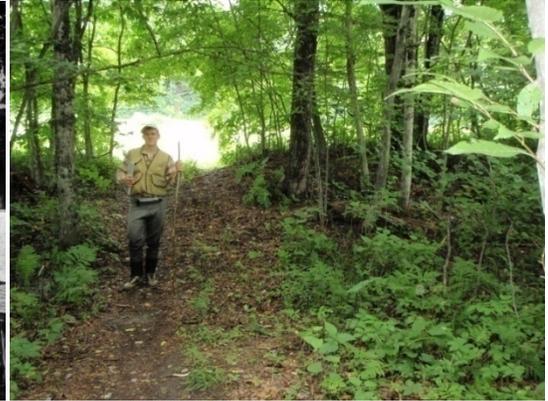
The channel is developed and encroached upon on both banks for a large portion of its length. Encroachment and development spans 90% and 75% of the channel's length, respectively. There are also several areas that have been straightened historically. The impacts associated with anthropogenic activities on this channel are very evident. Historical photographs indicate that at least 3 crib dams were once located in this reach (Figure 4.15). These dams caused significant aggradation of sediment which may explain why this reach has such a high width-to-depth ratio. Following the removal of the dams the channel most likely down-cut, leading to some incision observed in all cross-sections. The primary adjustments in this reach widening and aggradation (RGA score = "Fair"). The grade controls observed on this reach offer considerable vertical stability to the channel and have halted any further down-cutting that may have occurred after the crib dams were removed. Two berms can be found on the left bank at the upstream end of the channel. These features protect the hay field along Route 121 from flooding and prevent the channel from fully accessing its floodplain (Figure 4.16). A cursory Phase 3 survey was completed at the berm area to explore the possibility of removal. This is discussed in detail in Appendices E and F. Two road crossings at Main Street and Westminster West Road both have some deposition upstream of the structures, which led to a decreased aggradation score for the RGA. The channel is currently in stage III of the CEM and it is unlikely that evolution will continue until substantial planform adjustments take place. Woody debris was observed at a density of 17 LWD/mile and pools were infrequent (pools/mile = 6). The habitat condition rating was considered to be "Fair".

Figure 4.15 Crib dams located at the old Westminster Street crossing      Figure 4.16 Berm observed along the left bank in upper reach

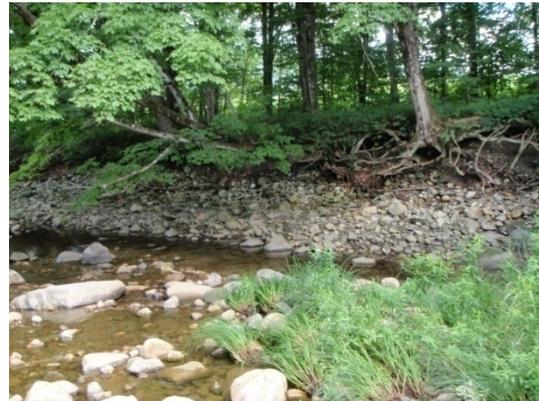
Figure 4.18 Bank erosion on the right bank

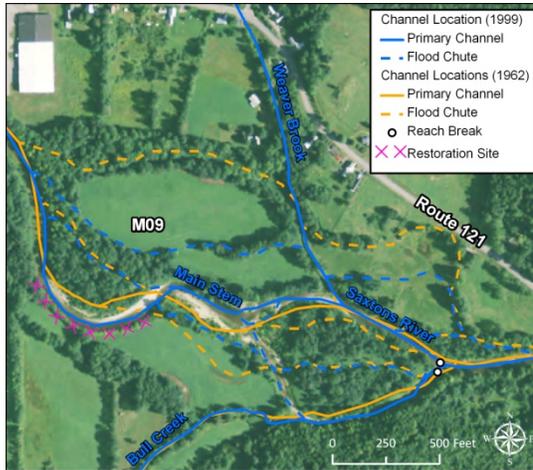
The multiple flood chutes present, along with aggradation and side bar development indicates widening and planform changes. The geomorphic condition is highly unstable and the lack of grade controls has likely led to the advanced stage of the CEM (RGA score = "Fair"; CEM stage = IId, D-model). Some restoration efforts were made on the right bank (Figure 4.21). There, willow plantings and rip-rap were installed to prevent further channel migration and potential avulsions out into the hay field to the southeast. The habitat was influenced by the shallow nature of the channelized flow (Figure 4.22). Pools were limited (pools/mile = 9), and the channel was often too shallow to support a diverse assemblage of aquatic species. Woody debris was quite low (LWD/mile = 17) and the habitat condition seemed to reflect the geomorphic condition (RHA score = "Fair").

Figure 4.21 Channel migration and braiding in the last 50 years

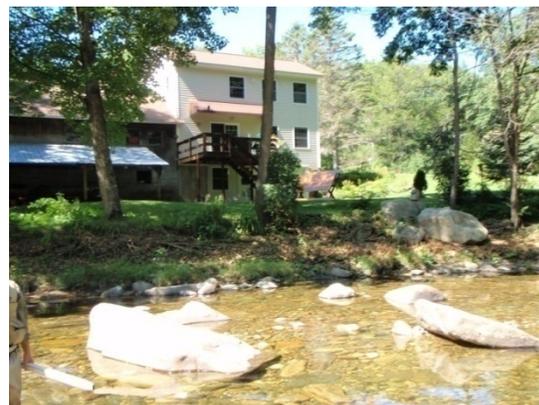
Figure 4.24 Buffer width <25ft and development on right bank

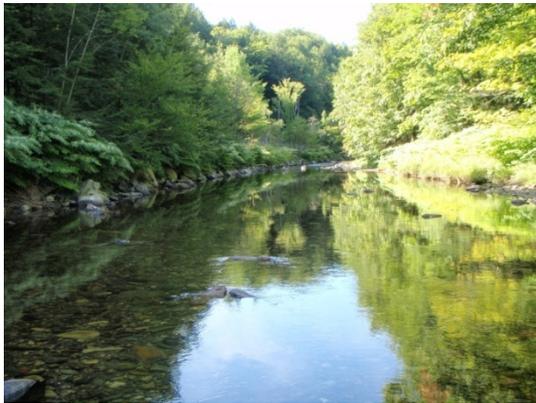
The channel is encroached upon entirely by Route 121, which has led to substantial changes in the natural geomorphic adjustment processes. Incision caused by road encroachment has caused a stream type departure, from C to B<sub>c</sub> due to lack of extensive floodplain (RGA score = "Fair"). The stream is in stage II of the F-model of CEM. Some meandering profile and habitat formation was noted in the lower reach, but extensive historical channel encroachment has led to a simplified form with limited habitat. Fine sediment deposition also reduces the viable habitat (RHA score = "Fair"; Figure 4.28).

Figure 4.27 Plane bed, featureless channel along Route 121

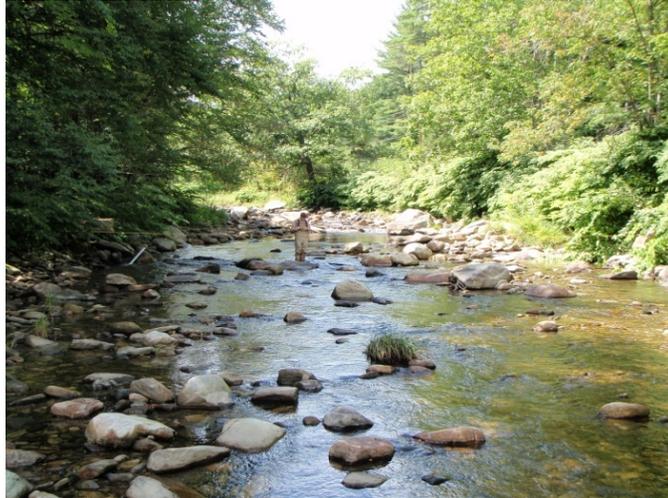
Figure 4.29 M13 cross-section with human elevated floodplain on right

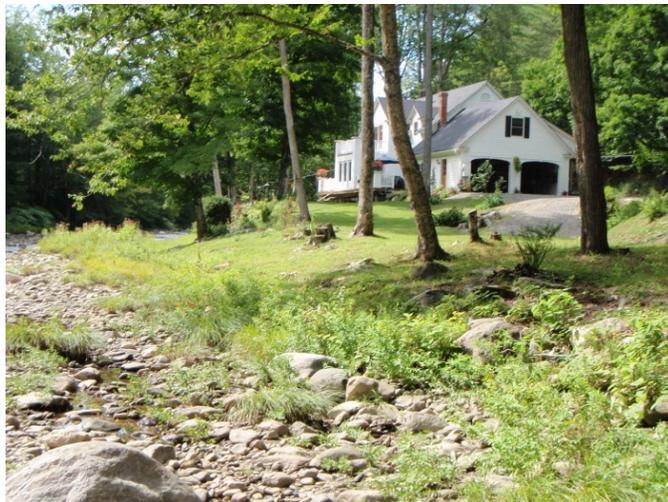
The encroachment from Route 121 has reduced the floodprone width and led to channel incision and loss of habitat. The reach is primarily adjusting by degradation and the channel is in stage II of the CEM (RGA score = "Fair"). Additional clearing in the buffer and along the left bank has further reduced LWD recruitment potential (LWD/mile = 29; Figure 4.30). Two large mass failures on right bank are supplying a moderate amount of sediment downstream. Also, a road ditch/tributary input off the left bank is rejuvenating and causing significant sediment to be washed downstream. Fine sediment in pools (pools/mile=22) and the loss of bank and buffer stability through encroachment and development has led to a decrease in the habitat quality (RHA score = "Fair").

Figure 4.30 Buffer clearing and development in the left corridor

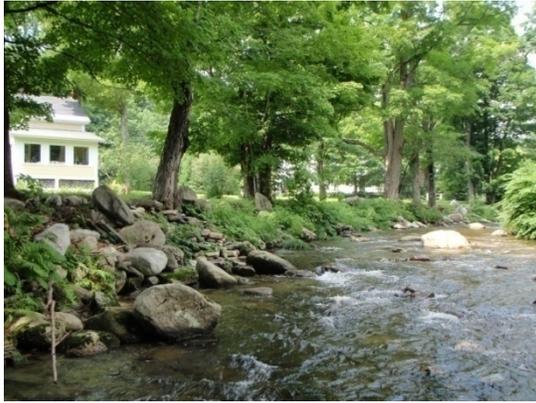
median particle size of 68mm. Rip-rap and hard bank armoring were observed from the reach break to about 200 feet upstream of the Main Street crossing (Figure 4.31). The total armoring spanned 46.5% and 17.5% of the channel length for the right and left banks, respectively (Figure 4.32). The armoring has limited the channel from its floodplain in some places natural floodplain is slightly raised (IR = 1.3). The Main Street crossing in Grafton Village is constricting the channel and causing some fine sediment to deposit upstream in a steep riffle.

Figure 4.31 Rip-rap on the right bank downstream of Main St

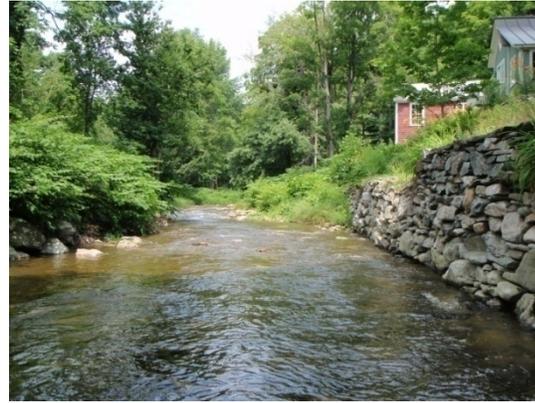
Figure 4.32 Hard bank upstream of the Main Street

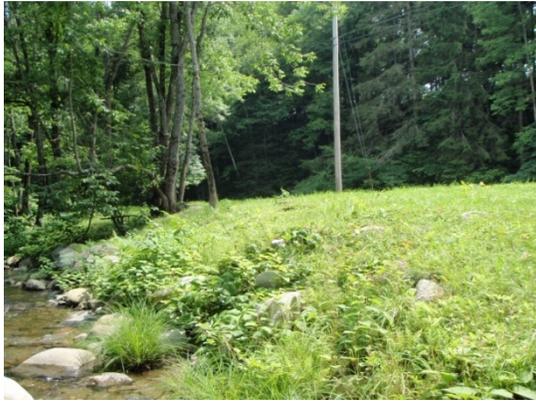
sediment downstream that has been deposited as bar features. The habitat could improve in the future as more pool features form (pools/mile = 4) and more woody debris attenuates along the bar features (LWD/mile = 10; RHA score = "Fair").

Figure 4.33 No buffer and encroachment on the left bank

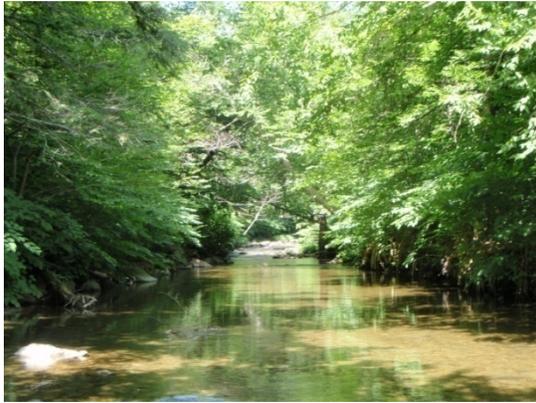
amount of fine sediment depositing upstream with very high embeddedness (Figure 4.36; Figure 4.37). Limited pools (pools/mile = 10) and woody debris (LWD/mile = 12), along with the encroachment reduced the habitat condition (RHA score = "Fair").

Figure 4.36 Looking upstream at area with aggradation

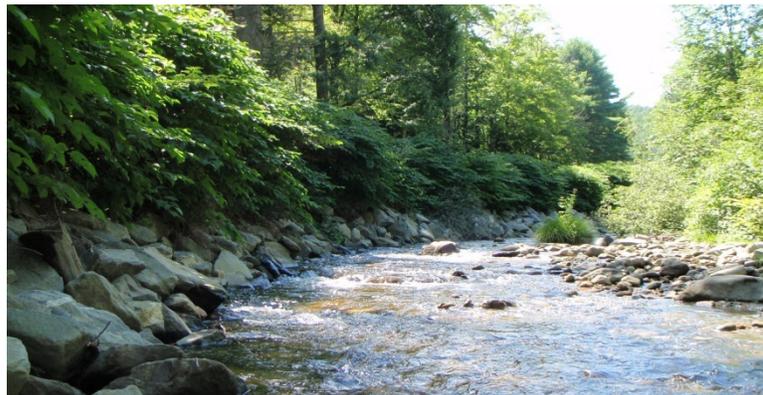
Figure 4.38 Rip-rap and road fill on the right bank

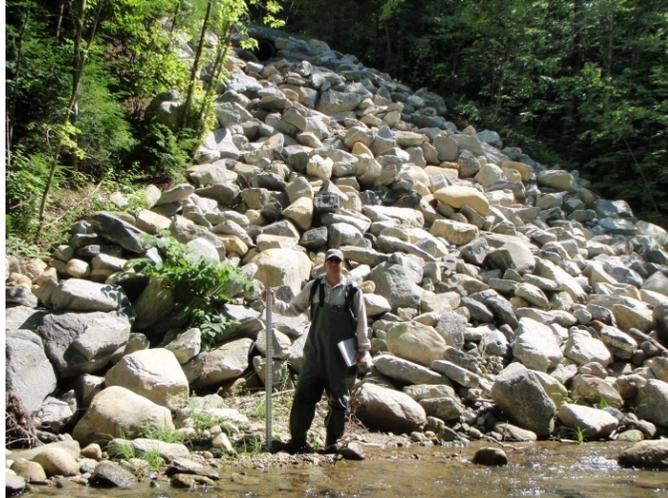
road to the north. The chosen stream type and stream sensitivity of “extreme” reflect this future erosion hazard. The habitat has also been influenced by the anthropogenic impacts in this reach (RHA score = “Poor”). Pools are almost non-existent (pools/mile = 2) and woody debris is scarce (LWD/mile = 17).

Figure 4.39 Mass failure on the right bank that has been heavily armored

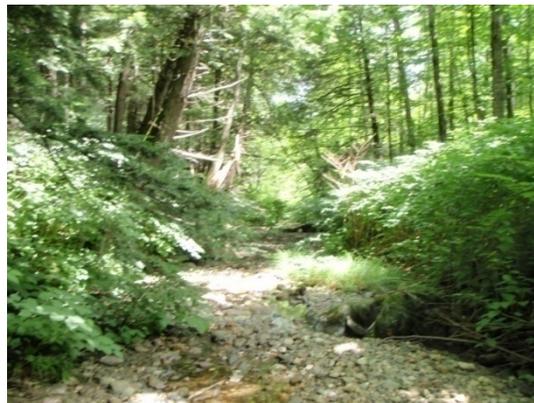
Figure 4.41 Flood chute off left bank that parallels Rt 121

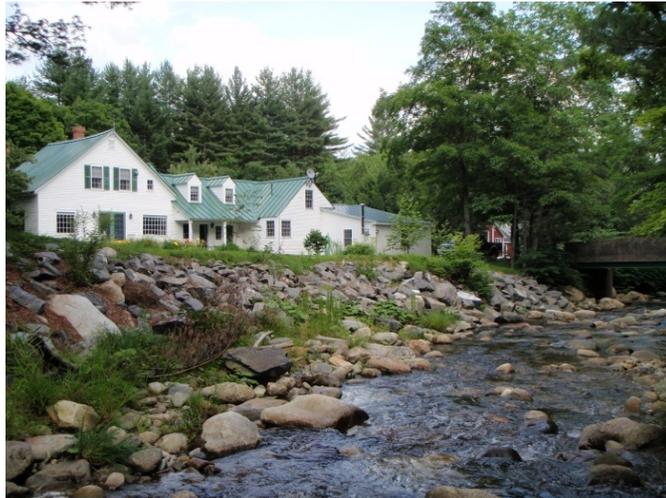
M19 is 1.1 miles long, with an average channel slope of about 3.4%. This reach begins at the change in confinement near the open field and continues along Route 121. Although the reach follows the road, the channel is not encroached heavily like most of the reaches downstream. The channel exhibits B-type morphology with step-pool bedform. The width-to-depth and entrenchment ratios are both indicative of the stream type, with no incision observed (WDR = 21.9; ER = 1.3; IR = 1.0). The dominant substrate is cobble (44%), with a median particle size of 63mm. There seems to be more of a plane bedform and a shallower slope on the downstream end of this reach, however, no segmentation was made because the downstream channel shared the same geometry as the area where the cross-section was taken upstream. The crossing at Cabell Road acts as a constriction to both the bankfull and the floodprone channel width and it is causing sediment to deposit upstream. The left bank both up and downstream of the structure is heavily rip-rapped and the buffer width is less than 25 feet (Figure 4.42).

Figure 4.42 Armoring and no buffer upstream of the Cabell Road Crossing on the left bank

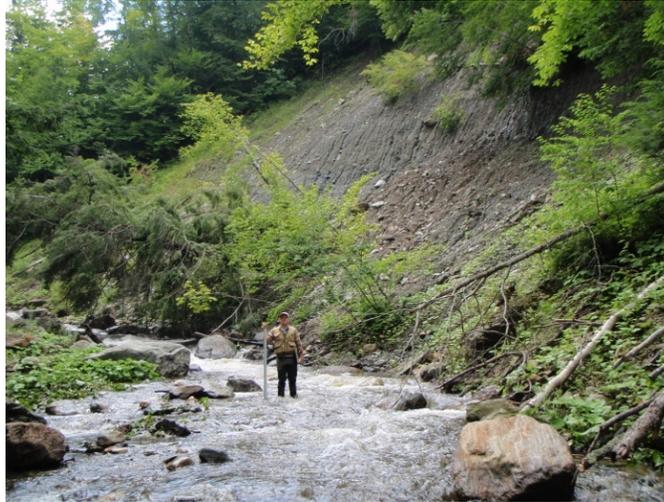
Figure 4.46 Large slope failure on the left valley wall

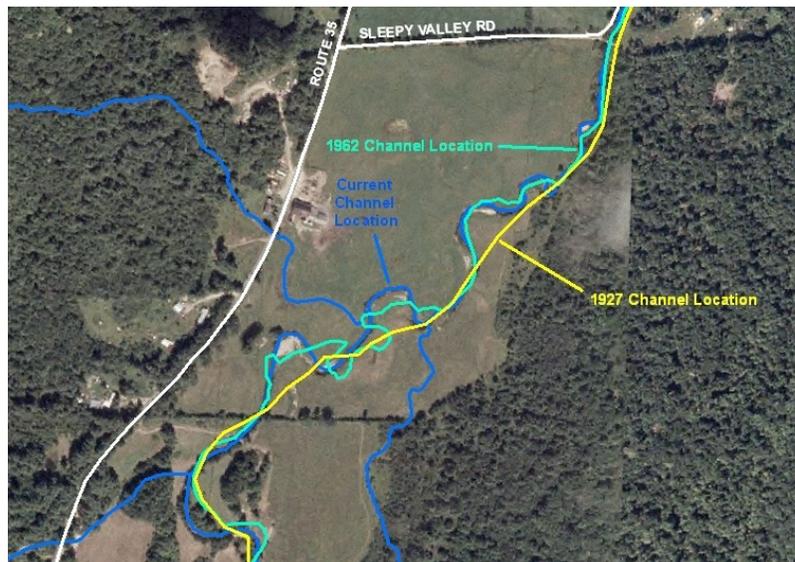
Figure 4.49 Historical channel straightening and redevelopment of meanders in T4.01-A, lower Bull Creek

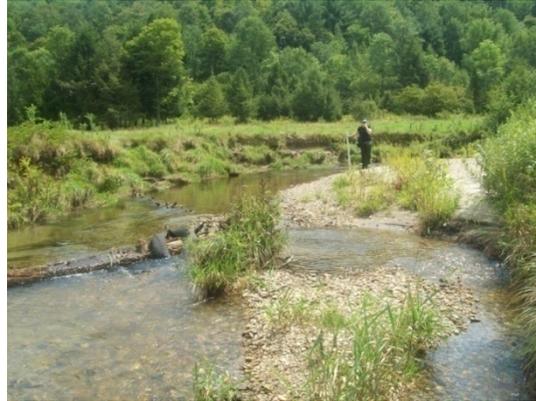
Figure 4.51 Bank erosion and widening in lower T4.01-A

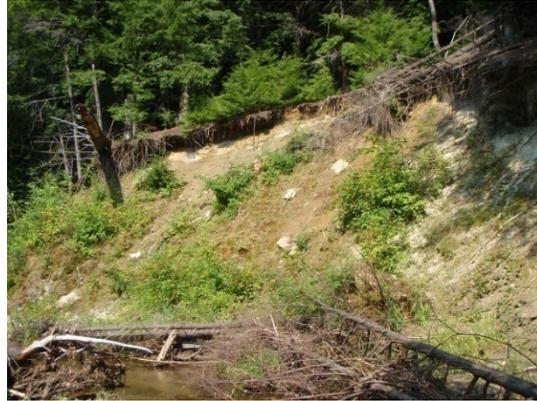
Figure 4.56 Looking downstream at the mass failure

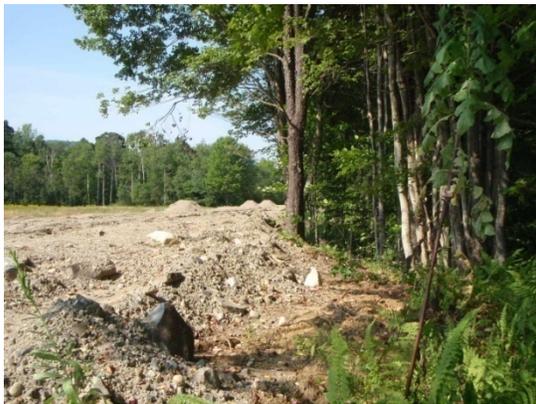
Figure 4.57 Exposed surficial material with no sediment BMPs

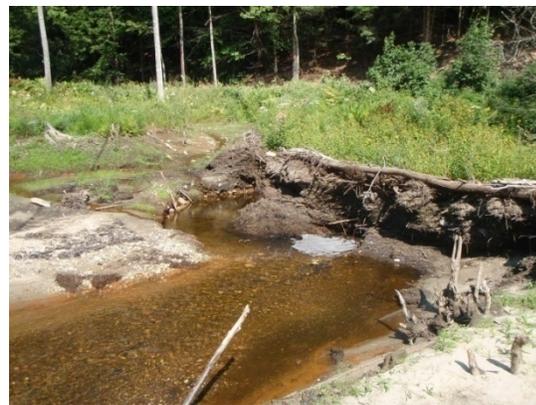
Figure 4.63 Looking downstream at the second breached dam

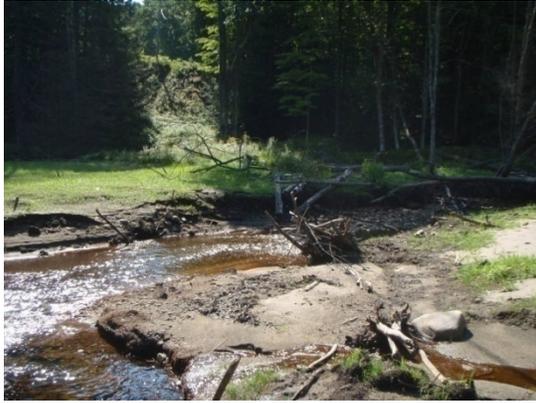
Figure 4.64 Widening channel upstream of the second dam

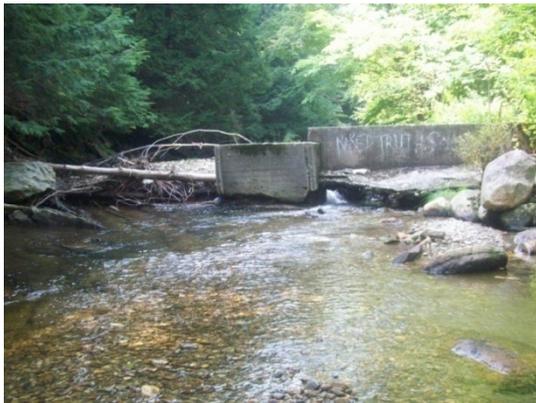
Figure 4.68 Breached dam upstream of Kidder Hill Road

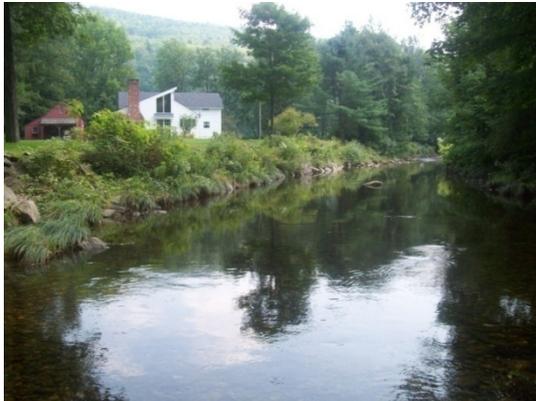
Figure 4.70 Bank armoring and development in the upper reach

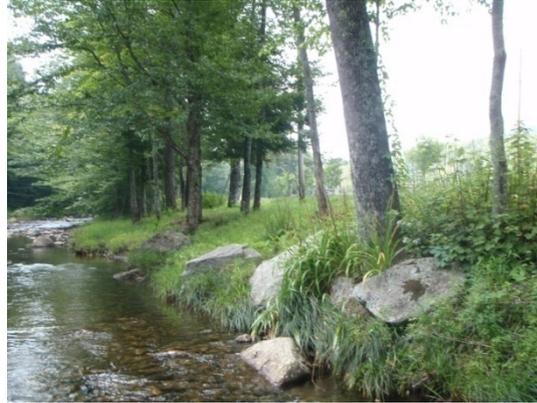
Figure 4.73 Townshend Rd. encroachment with HEF and B<25ft

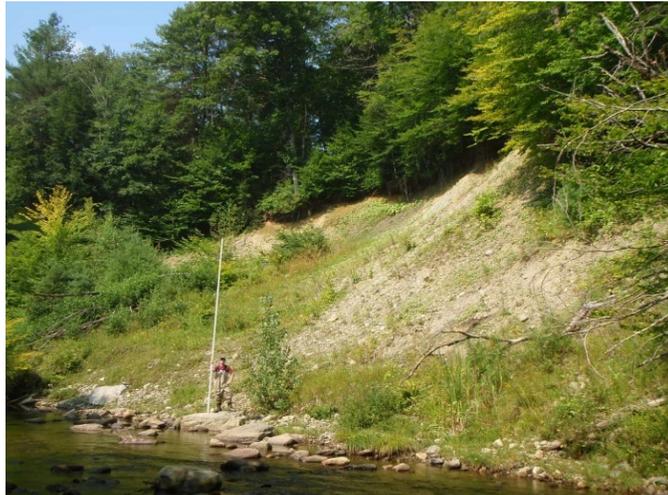
Figure 4.74 Large mass failure located in the lower reach on the left valley wall

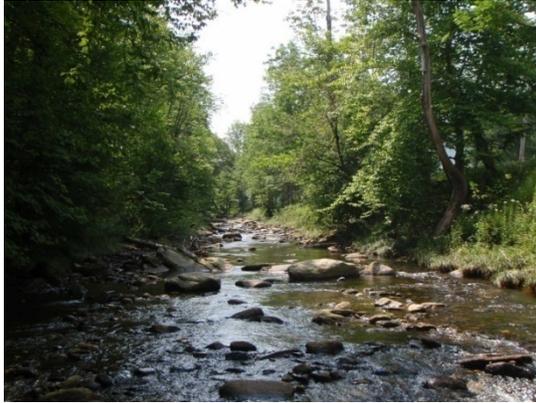
Figure 4.75 Straightened channel with encroachment

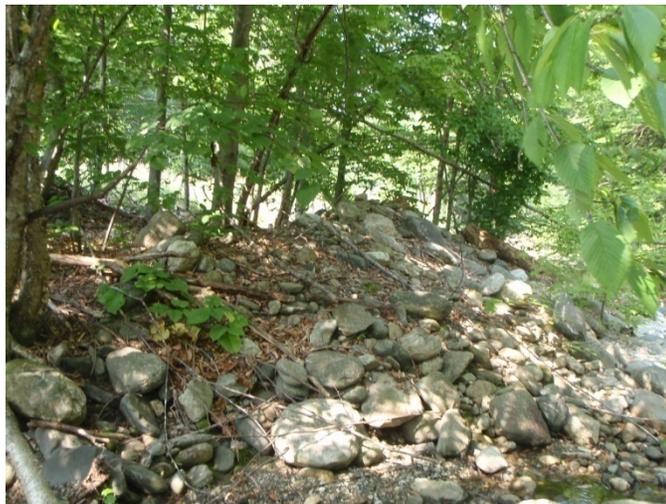
Figure 4.77 Dredged materials on the left bank near the confluence with Willie Brook in the upper reach

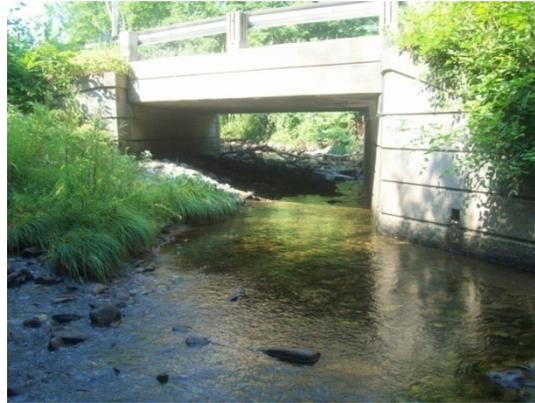
Figure 4.79 Sediment deposition within undersized bridge

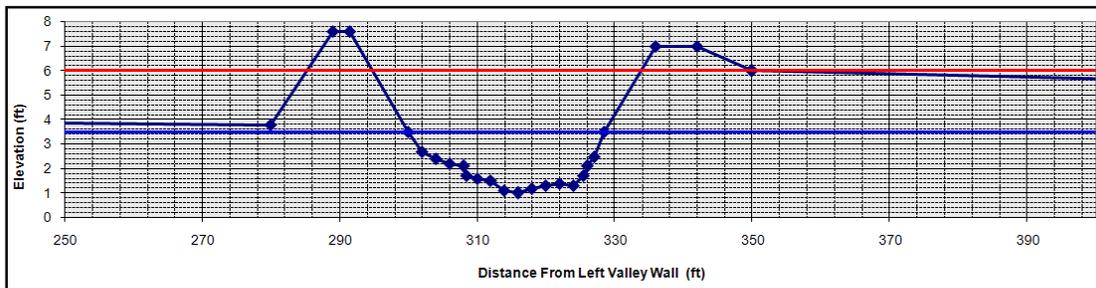
Figure 4.82 Cross-section of Willie Brook, showing berms along both channel banks

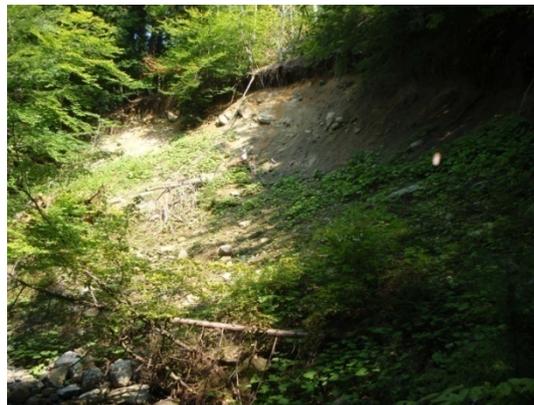
**Figure 4.85** Mass failure on the left bank

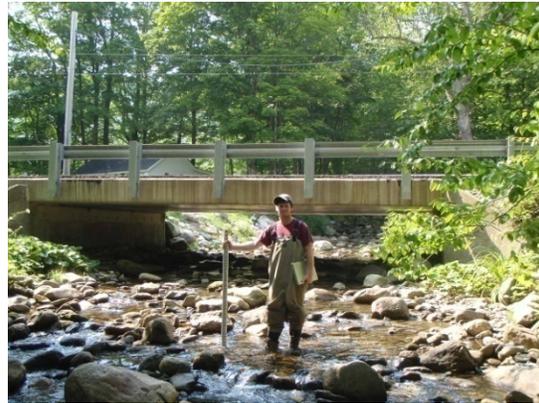
**Figure 4.89** Undersized crossing at Townshend Road
