TOWN OF GEORGIA

STORMWATER MANAGEMENT PLAN

FINAL REPORT

Stone Project ID 112475-W
February 20, 2013

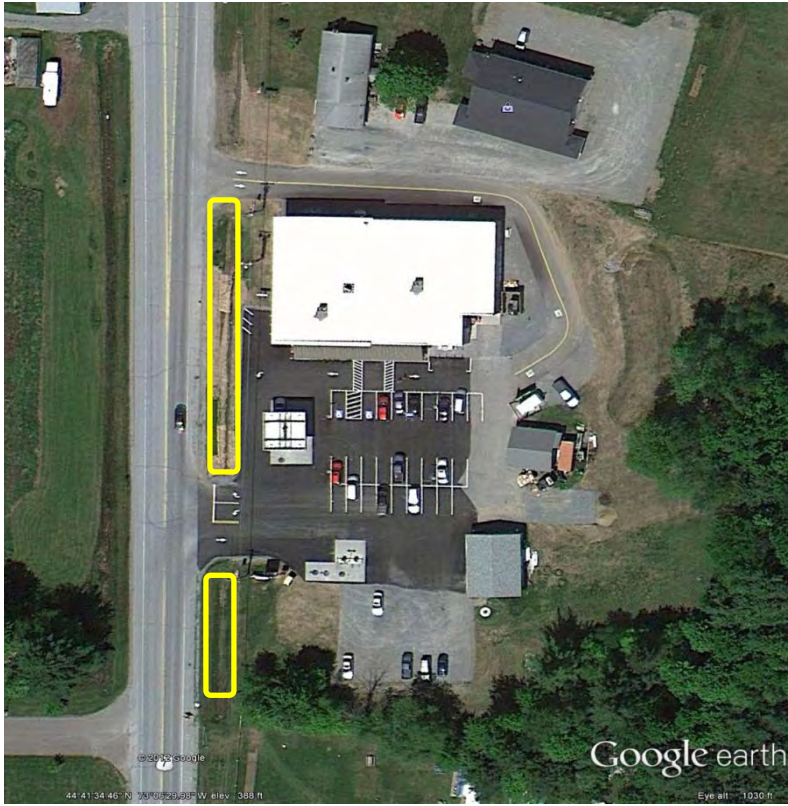
Figure 1. Treatment opportunities along U.S. Route 7 near the Georgia Market Property.

Multiple treatment opportunities exist along U.S. Route 7. The roadside ditches along this stretch of road are rather deep. Existing catch basins and driveway culverts could be retrofitted with flow-control devices; the roadside ditches, given their depth, could provide significant storage of stormwater. Further gains could be achieved by enhancing infiltration capabilities in these areas. Potentially suitable locations for retention and infiltration practices along Route 7 are shown below in Figures 1, 2 and 3.

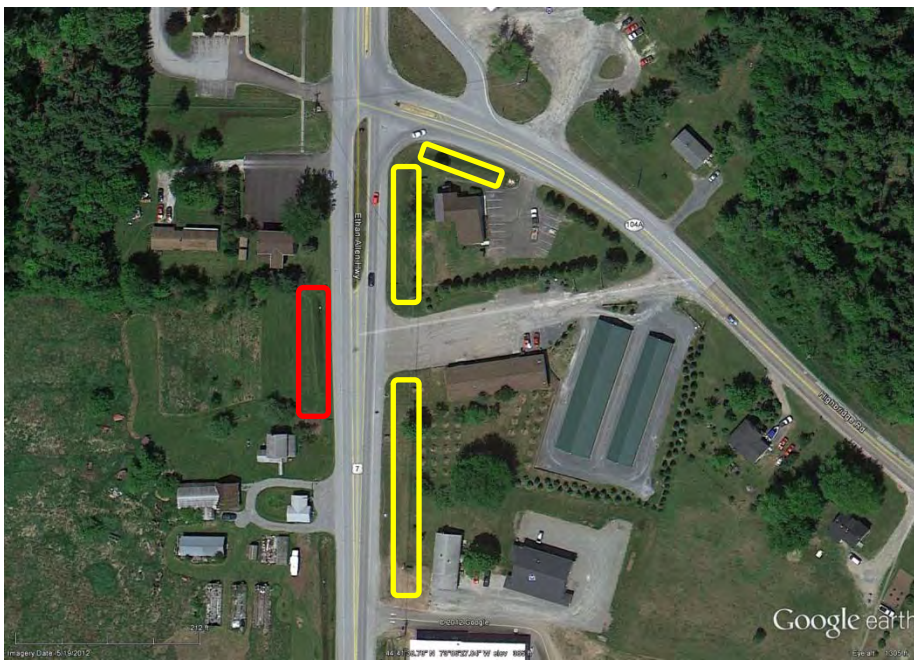
Figure 2. Potential stormwater treatment areas along U.S. Route 7 and VT Route 104A north of the Georgia Market property.

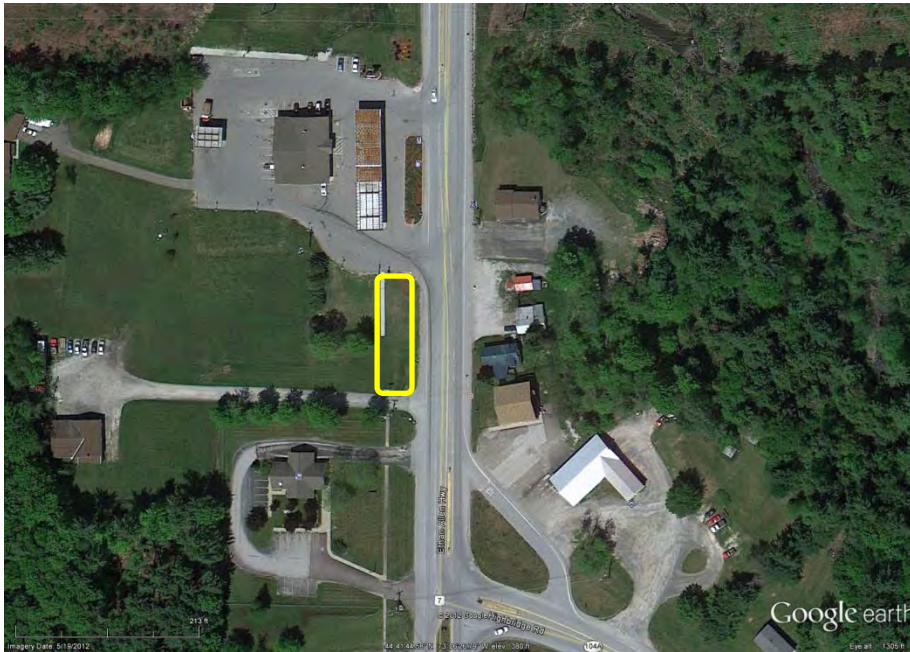
Figure 3. Potential location for stormwater treatment along the west side of Route 7, north of VT Route 104A, between the People's Trust Bank and the Mobil gas station.

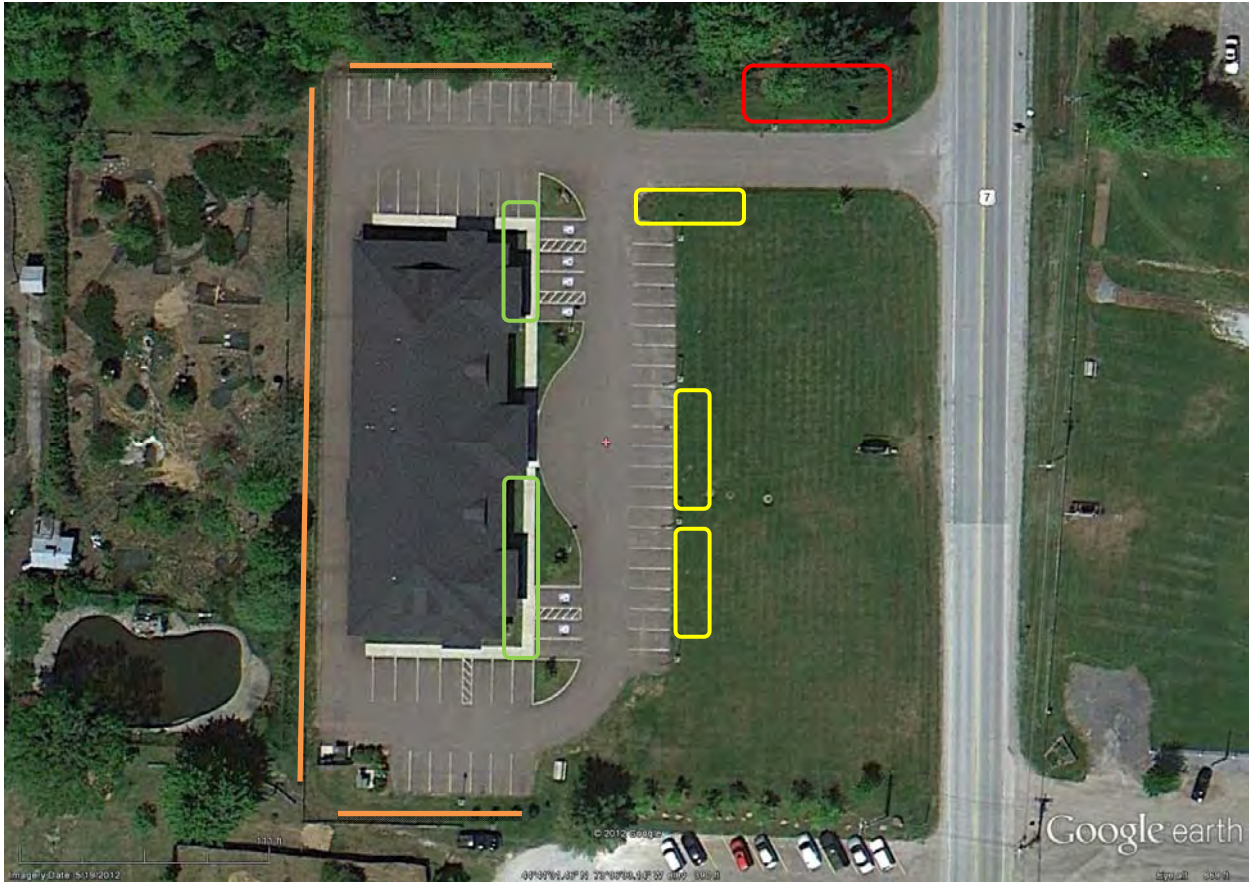
Figure 4. Potential treatment opportunities at the Georgia Eye Center / Northwest Occupational Health Building.

- Roof runoff could be treated by redirecting the existing downspouts to route stormwater through rain gardens or similar soak-away practices (shown in green on Figure 4).
- Runoff from the parking lot could be treated with bioretention basins designed to encourage infiltration (shown in yellow on Figure 4).
- The grass swale which flows clockwise from the southern end of the parking lot to the roadside ditch at the northeast corner of the property could be retrofitted with concrete weirs or check dams, and flow control apparatus to enhance infiltration (shown in orange on Figure 4).
- An additional or alternative stormwater treatment option would be to create a bioretention/infiltration basin or similar structure at the north end of the property between the

existing stormwater outfall and the existing roadside ditch along the west side of Route 7 (shown in red on Figure 4).

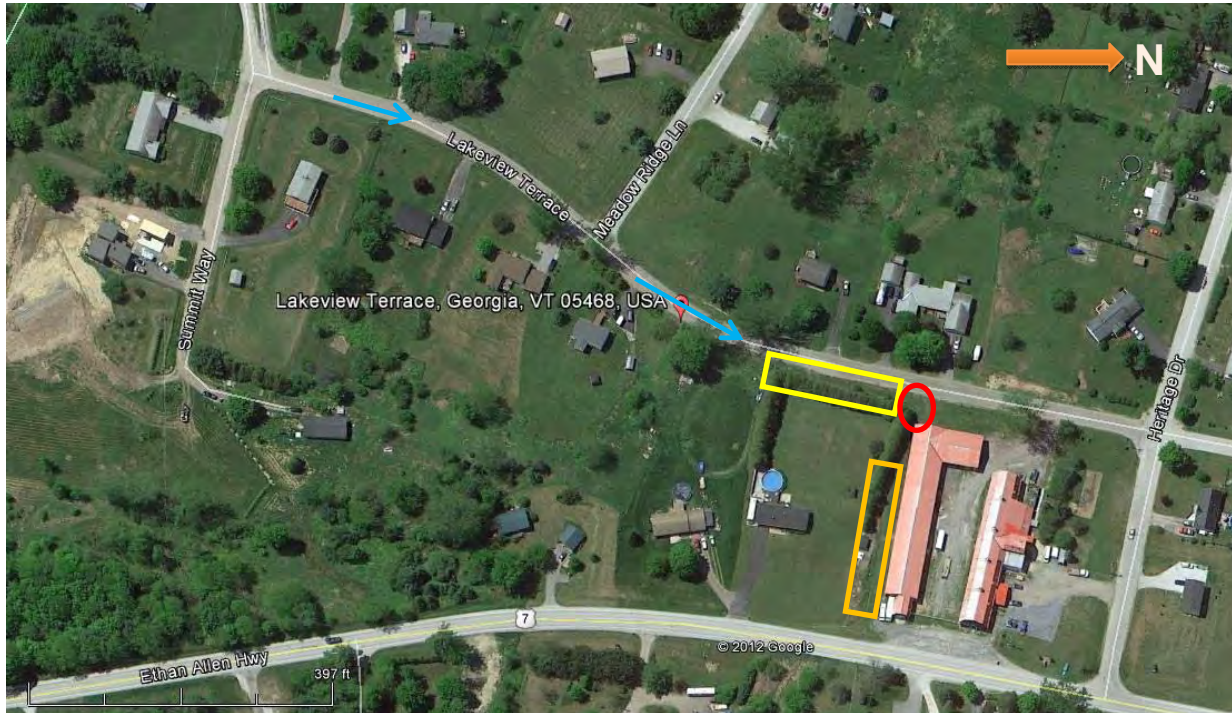
Figure 5. Red Barn property and surrounding neighborhood. Location of existing scour hole shown in red. Potential STP locations shown in yellow and orange.

- Repair and reinforcement of the scoured channel would reduce sediment loads downstream. Installation of a STP such as a bioretention basin, in the existing roadside ditch along the hedge row (upstream of the scour hole) would improve water quality and also prevent future erosion or scouring of the channel.
- An alternative or addition to a solution along Lakeview Terrace is to locate a treatment practice encouraging infiltration along the southern border of the Red Barn Storage property. Locating the treatment practice here would increase the land area potentially available for infiltration.

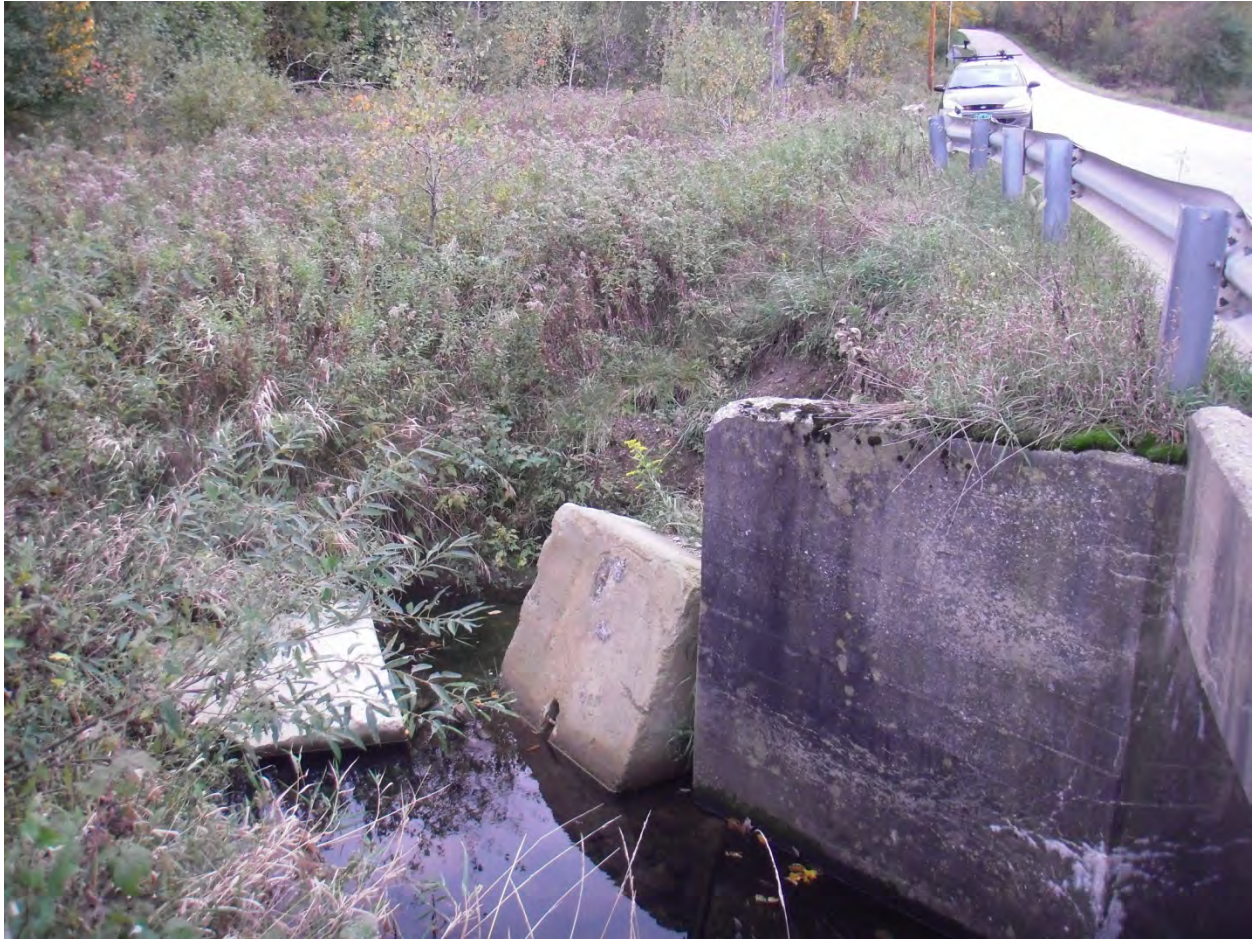
Significant streambank erosion is occurring at the Oakland Station Road- Mill River crossing. Mill River crosses under Oakland Station Road via a concrete box culvert just south of Conger and Loomis Roads. Unmanaged road runoff is causing erosion behind the southeast wingwall (Figure 6), and past stabilization attempts appear to be failing. Erosion from this source could be minimized with improved management of road runoff coupled with bank stabilization that includes properly sized riprap keyed-in below the scour depth of the stream bed.

The outlet of the box culvert drops steeply to a scour pool. This appears to be a barrier to aquatic organism passage. If this blockage is truly blocking the passage of fish and other aquatic organisms, retrofit options should be considered to improve the connectivity of the stream by lessening or removing the drop between the box culvert and the scour pool below. A tail-water control structure, such as a rock weir at the end of the scour pool, can raise the pool surface to create better passage conditions.

This structure appears to be in serviceable condition. However, when this box culvert reaches the end of its service life, it should be replaced with a structure that meets current State of Vermont design standards. This will help ensure sediment transport equilibrium, reduce erosion hazards, and maximize the ecological integrity of this road-stream crossing.

Figure 6. Failing slope near inlet to box culvert over Mill River on Oakland Station Rd.

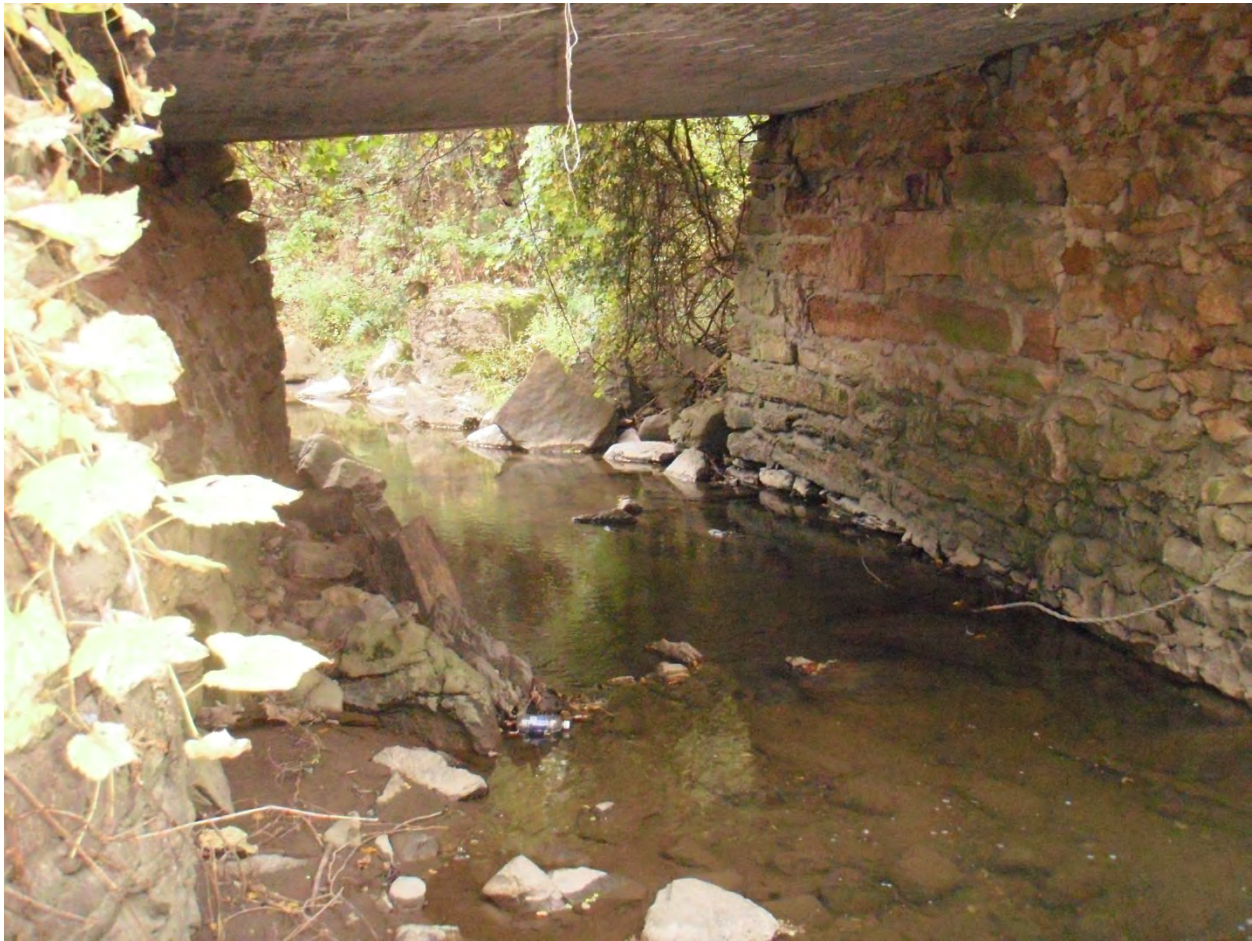
The Rugg Brook-Mill River Road bridge, just east of Bronson Road, consists of a concrete slab resting on two stone-masonry abutments (Figure 7). The span between abutments is narrower than the bankfull width of the stream. At elevated flow rates, this causes increased velocities, leading to erosion of the stream bed and banks, as evidenced by a large scour pool that has formed downstream of the structure. The existing structure appears to be approaching the end of the service life, with undercutting apparent beneath the abutments and deterioration of the stone masonry. When the structure is replaced, the new structure should be constructed with sufficient length to allow unimpeded flow of the stream at bankfull conditions. Designing the bridge with adequate length ensures sediment-transport continuity and maximizes ecological integrity of the road-stream crossing, while creating a flood resistant structure that requires reduced maintenance over its service life.

Figure 7. Deteriorating stone abutments of Mill River Rd. bridge over Rugg Brook.

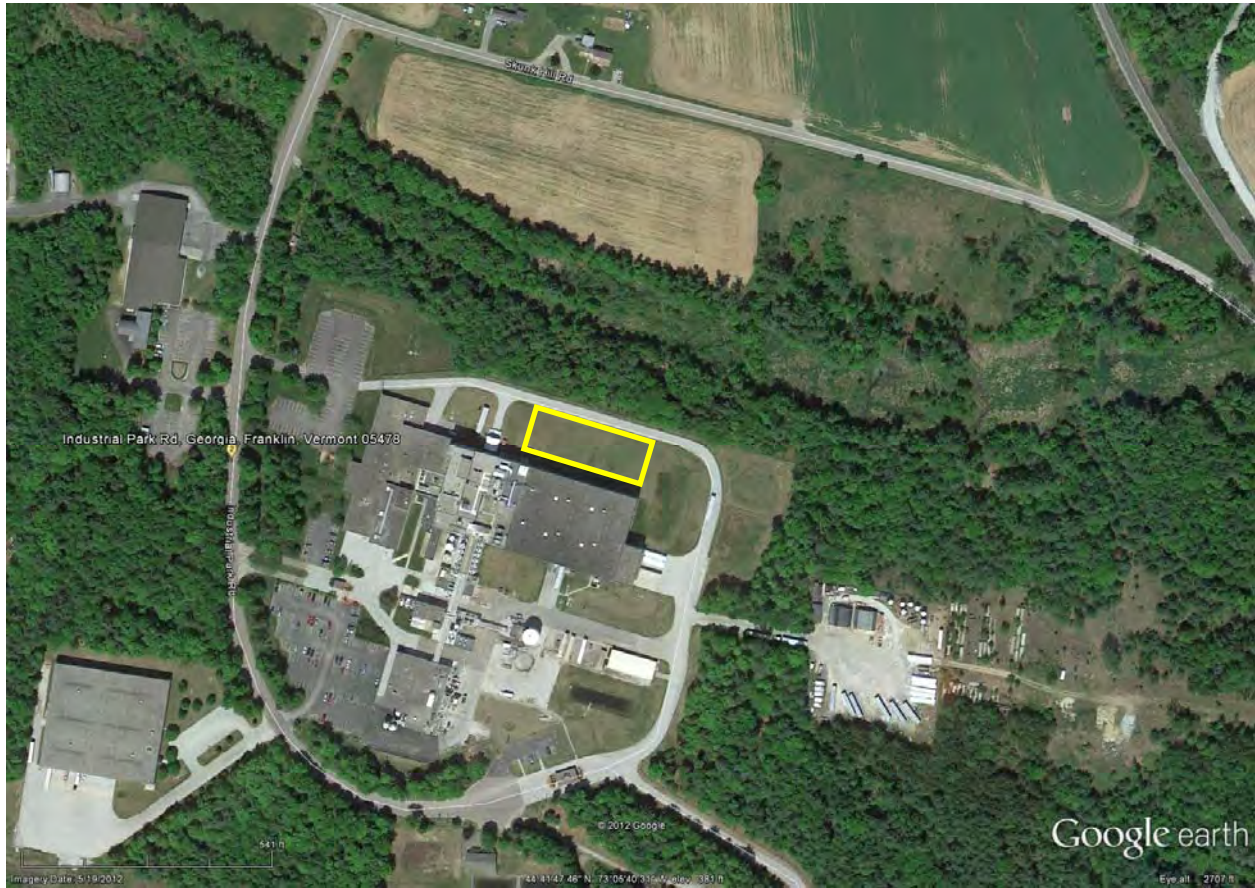
The Georgia Industrial Park contains a large amount of impervious area. This property is served by permitted stormwater treatment facilities that include dry wells and dry ponds. Soils at the Industrial Park are dominated by sands (hydrologic soil group A), so any stored runoff is likely to quickly infiltrate. Although it would be relatively straightforward to retrofit these facilities, it is unclear whether they routinely discharge or if any stored water simply infiltrates. Before proceeding with retrofits, the facility should be monitored to evaluate the frequency of discharge following storm events, with particular attention given to the detention pond highlighted in Figure 8. There are several low cost/low-tech means for evaluating whether an overflow event occurs, including placing small wood blocks in the outfall that would be washed away during an overflow event. If evidence of significant discharge is found, opportunities can then be assessed to improve treatment by modifying the existing facility, or by slowing or infiltrating stormwater closer to the source.

Figure 8. Georgia Industrial Park off Skunk Hill Rd. Detention area is highlighted in yellow.

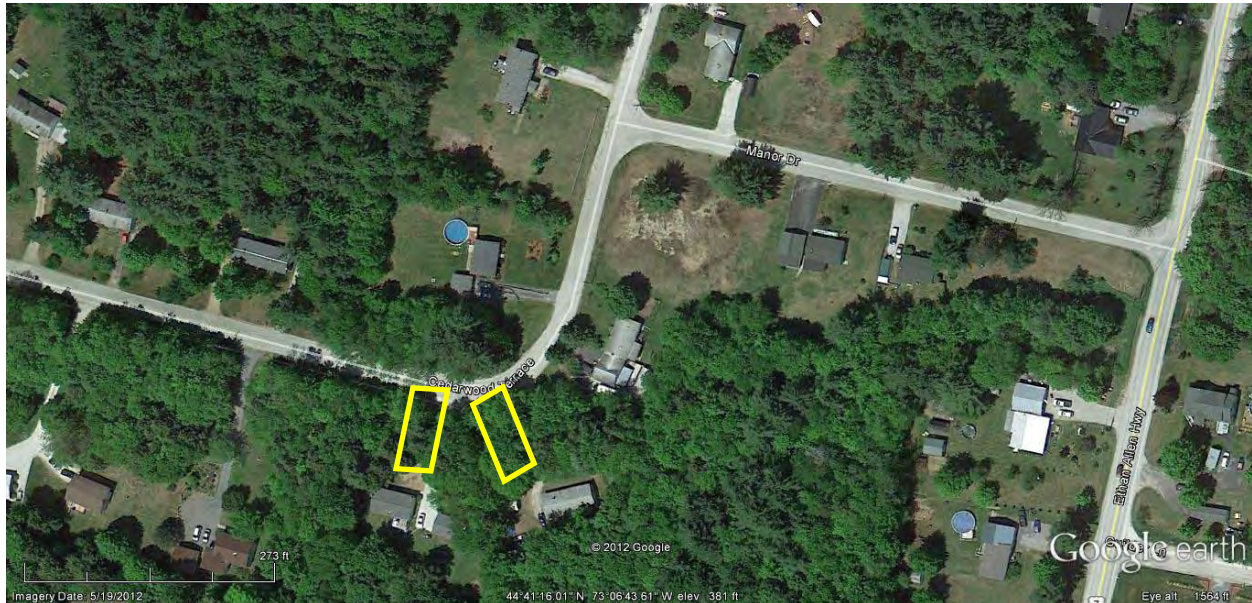
Stormwater-related issues reported during the March 7 kick-off meeting were investigated in the area of Cedarwood Terrace (Figure 9). While on site, one local land owner cited significant erosion of the road shoulder, claiming there was once enough room to park a vehicle where there is now only a few feet of space between the road and channel side-slope. Two compromised culverts were found under driveways providing access to two abutting private residences; there is some evidence of on-going erosion around the culverts.

The root cause of stormwater issues in this neighborhood is increased volume and flow attributable to increased impervious surfaces associated with development. Opportunities for stormwater treatment practices on public land or rights-of-way in the Cedarwood Terrace and Manor Drive neighborhoods are limited. Participation from private homeowners through implementing practices such as rain gardens or pervious pavement would help reduce stormwater impacts and improve water quality.

Figure 9. Compromised culverts conveying stormwater under private drives on Cedarwood Terrace, highlighted in yellow

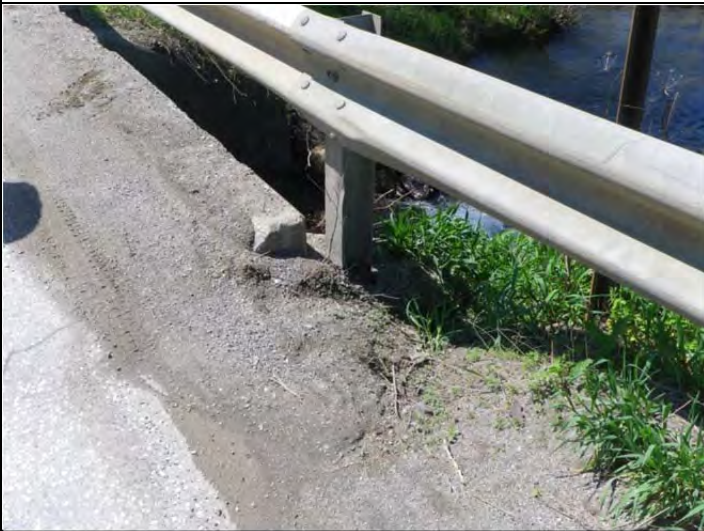
Photo 1. Road runoff

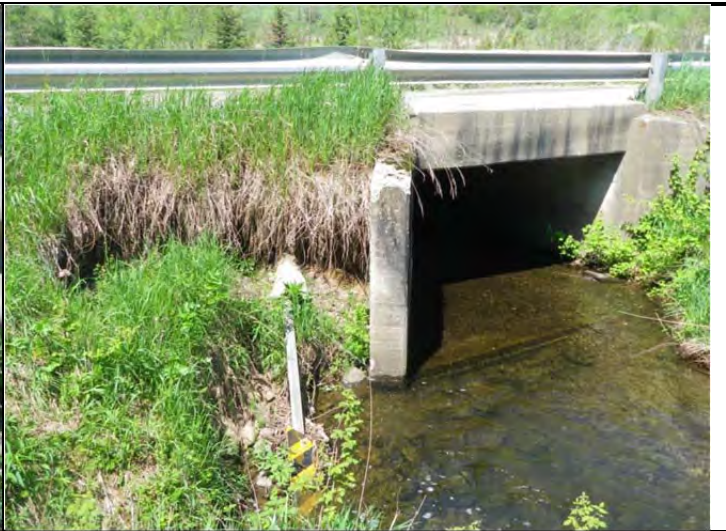
Photo 2. Looking downstream at bank erosion

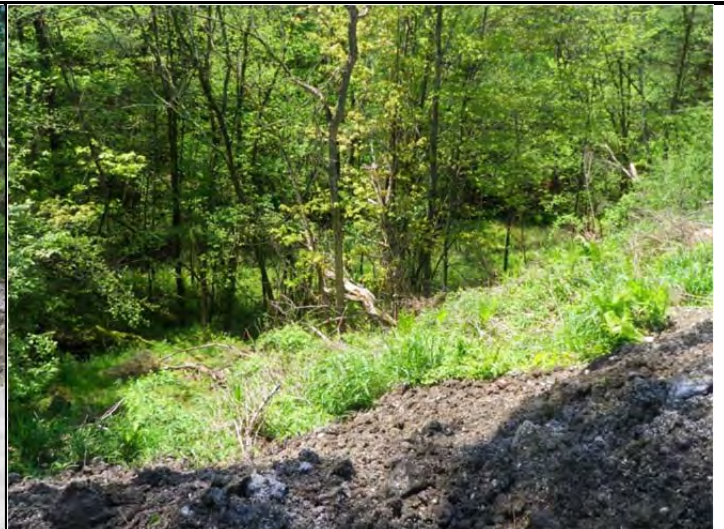
Photo 2. Natural area below placed fill

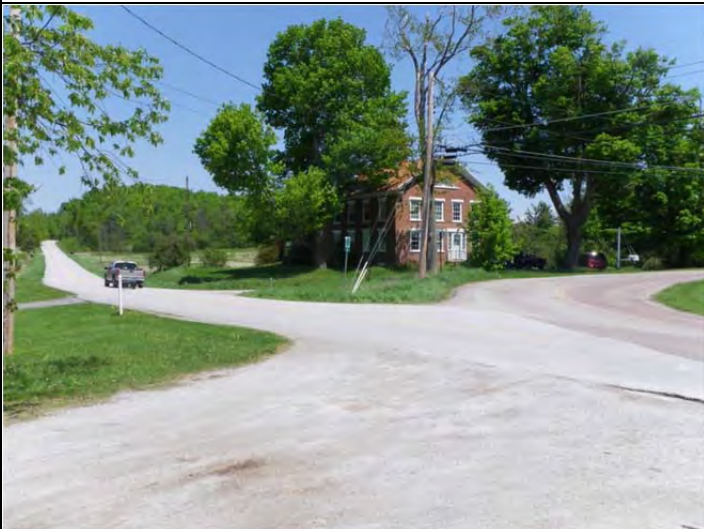
Photo 1. "Y" intersection

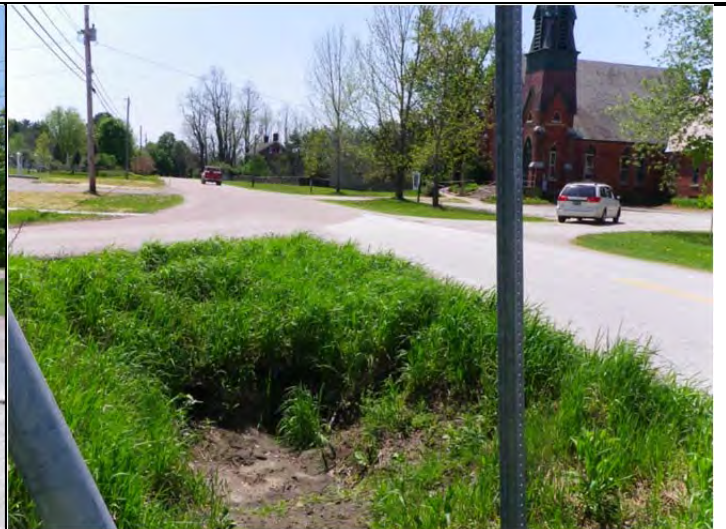
Photo 2. Sediment build up in the "Y" median

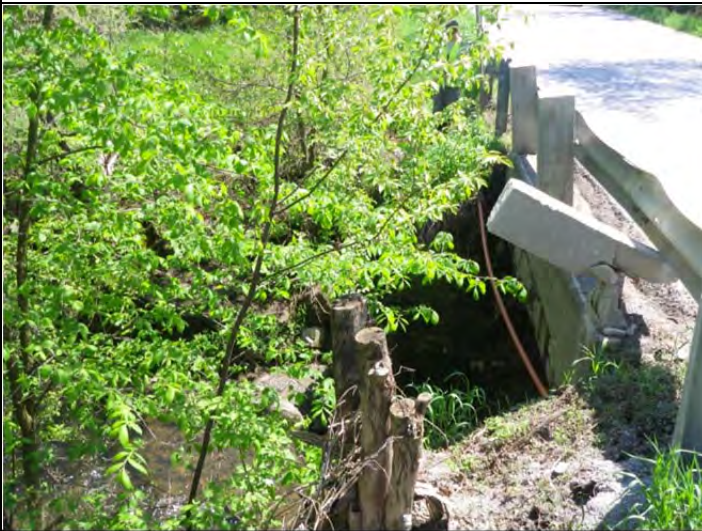
Photo 1. Erosion caused by road runoff

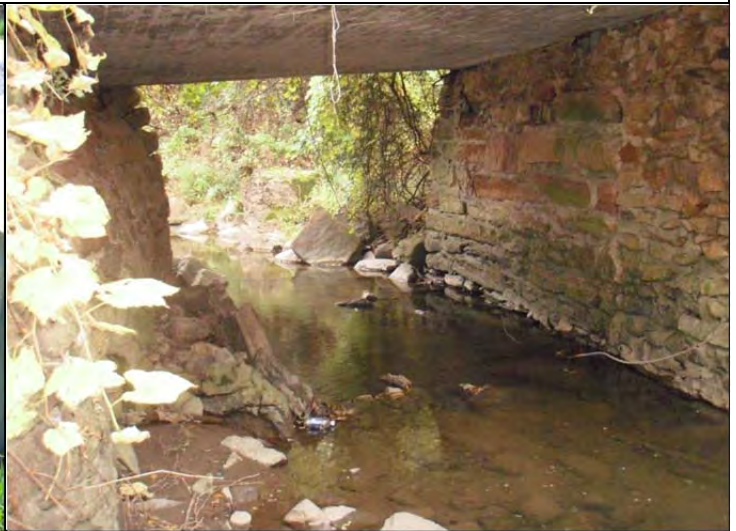
Photo 2. Falling rip-rap at outlet

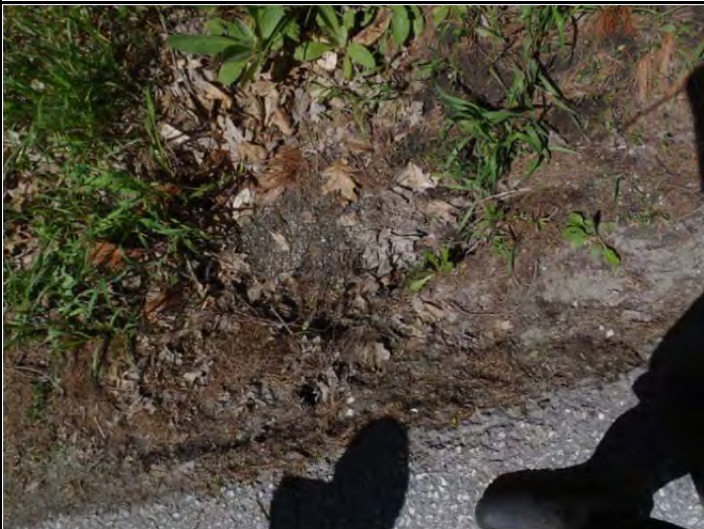
Photo 1. Clogged catch basin inlet, road undermining

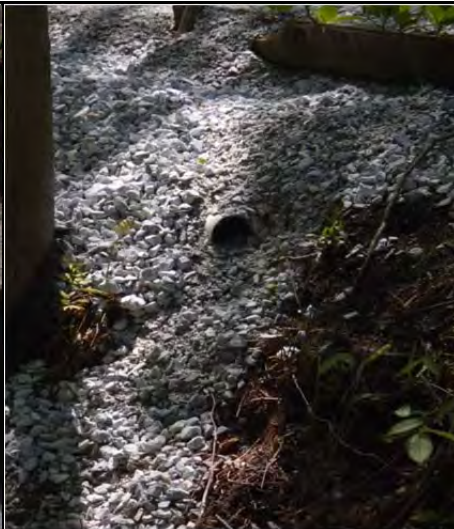
Photo 2. Recently repaired driveway

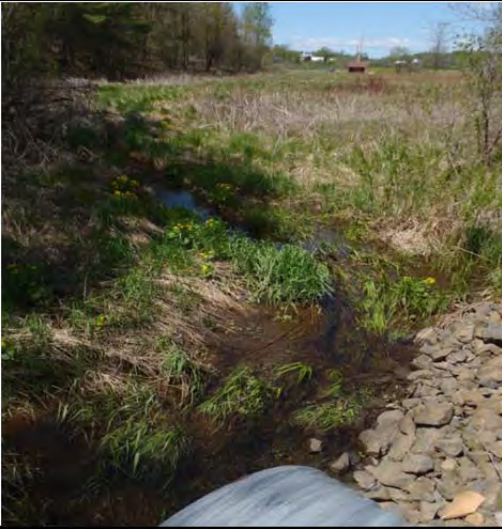
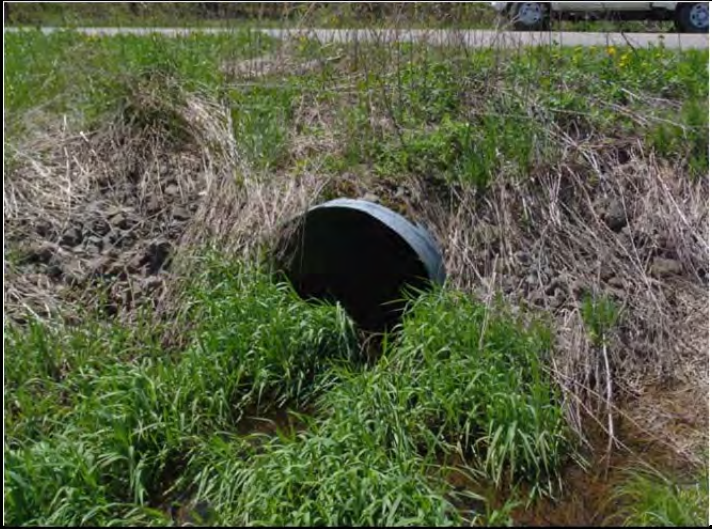
Photo 1. Looking upstream, "L" forms @ culvert	Photo 2. Outfall

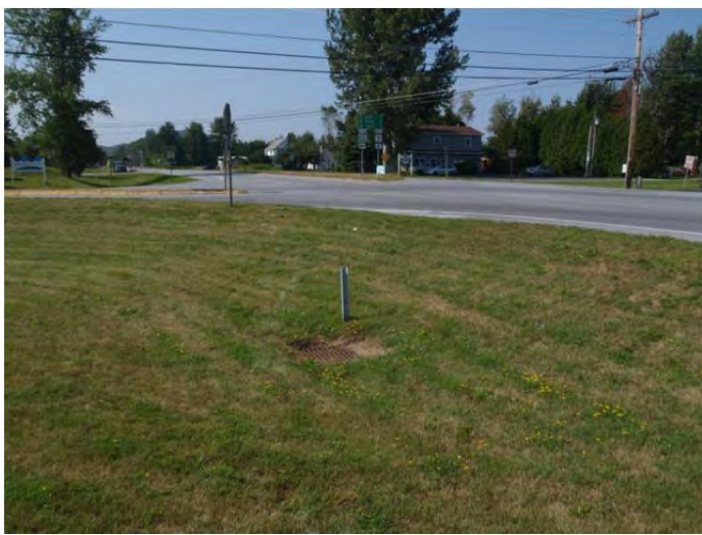
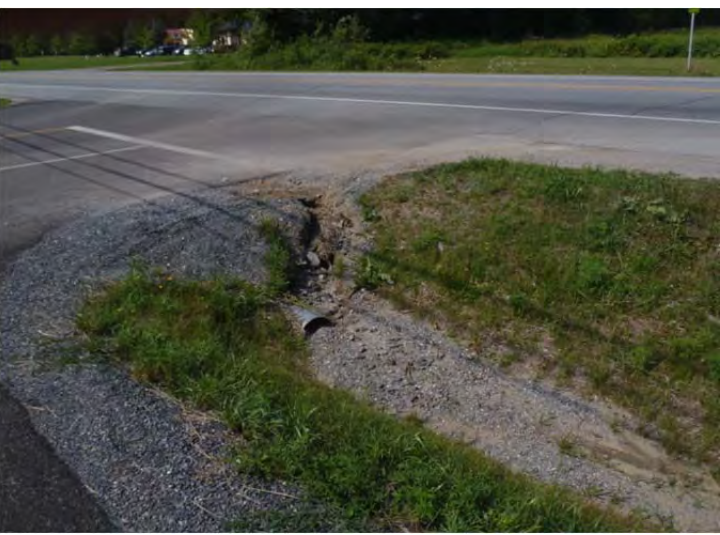
Photo 1. Catchbasin in 104A/Rt 7 triangle median	Photo 2. Plugged culvert at Georgia Market driveway

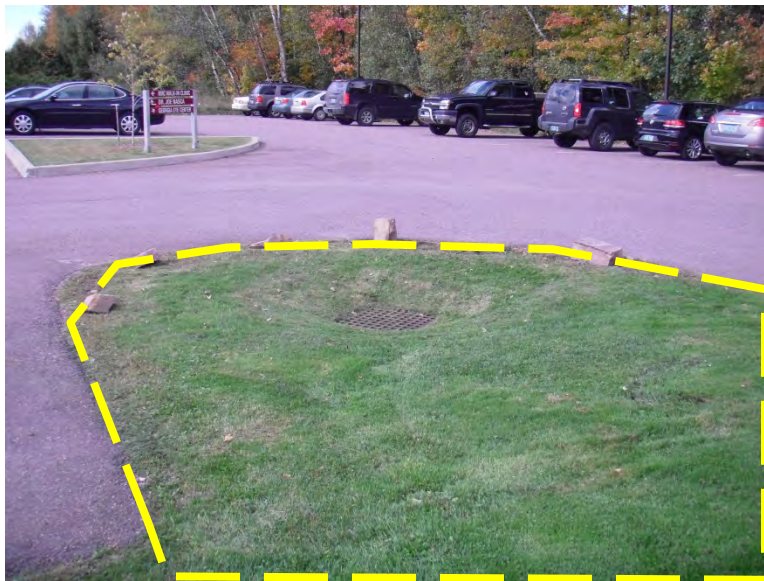
Figure 4. Existing catch basin that could be retrofitted and integrated into a stormwater treatment practice.

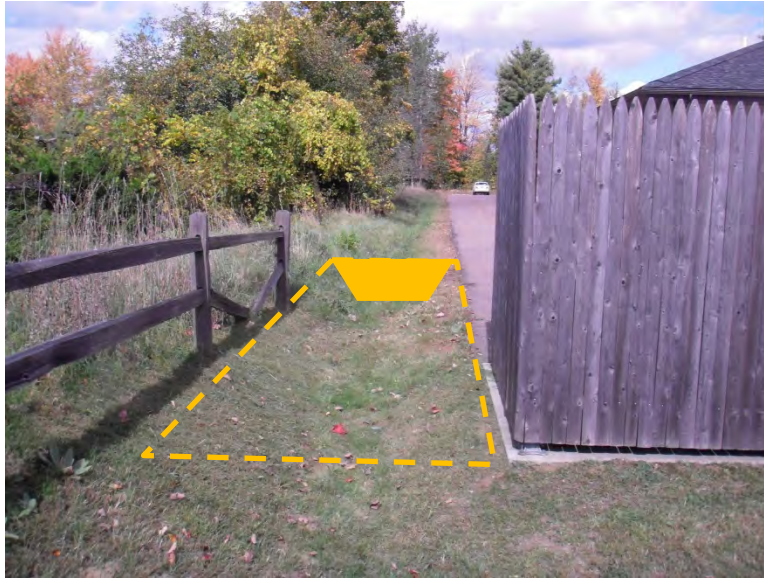
Figure 5. Existing grass swale could be modified to encourage infiltration.

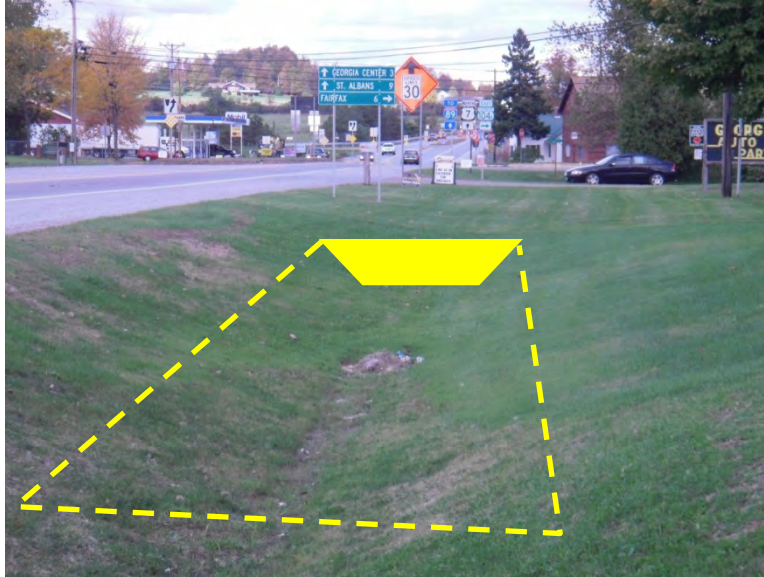
Figure 10. Looking north along Route from the Georgia Market property. The existing stormwater catch basin (center of photo) and ditch could be modified to provide temporary storage and increase infiltration.

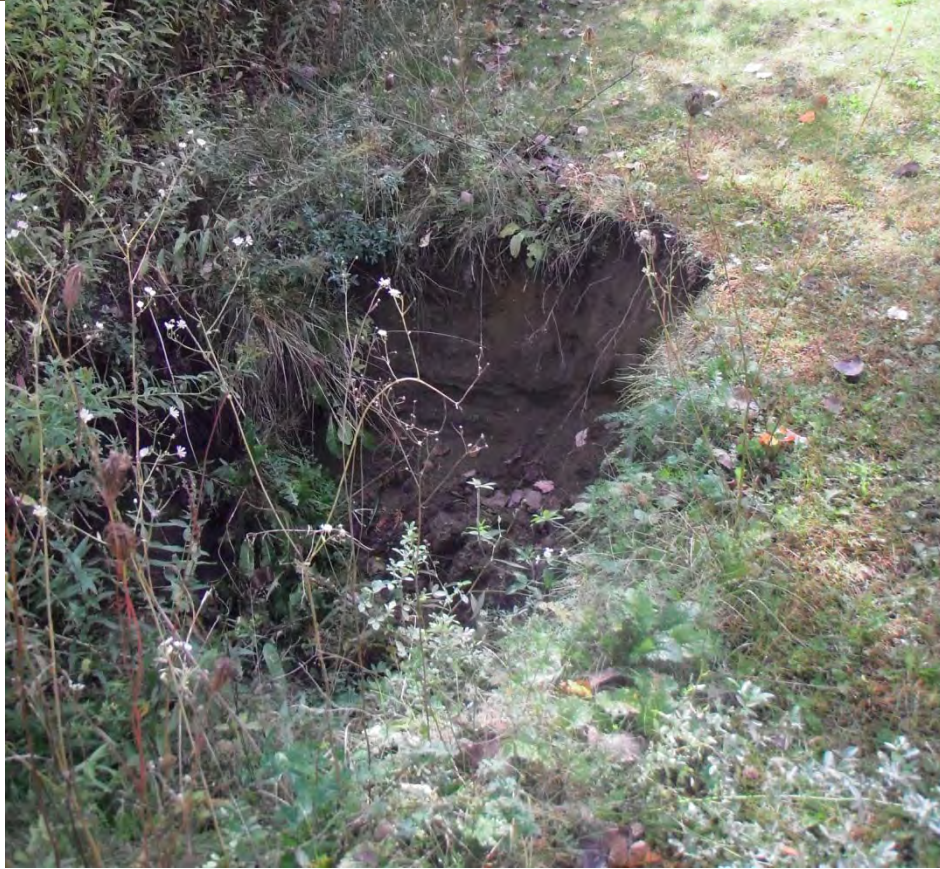
Figure 16. Headcut in road side ditch at the bottom of Lakeview Terrace.

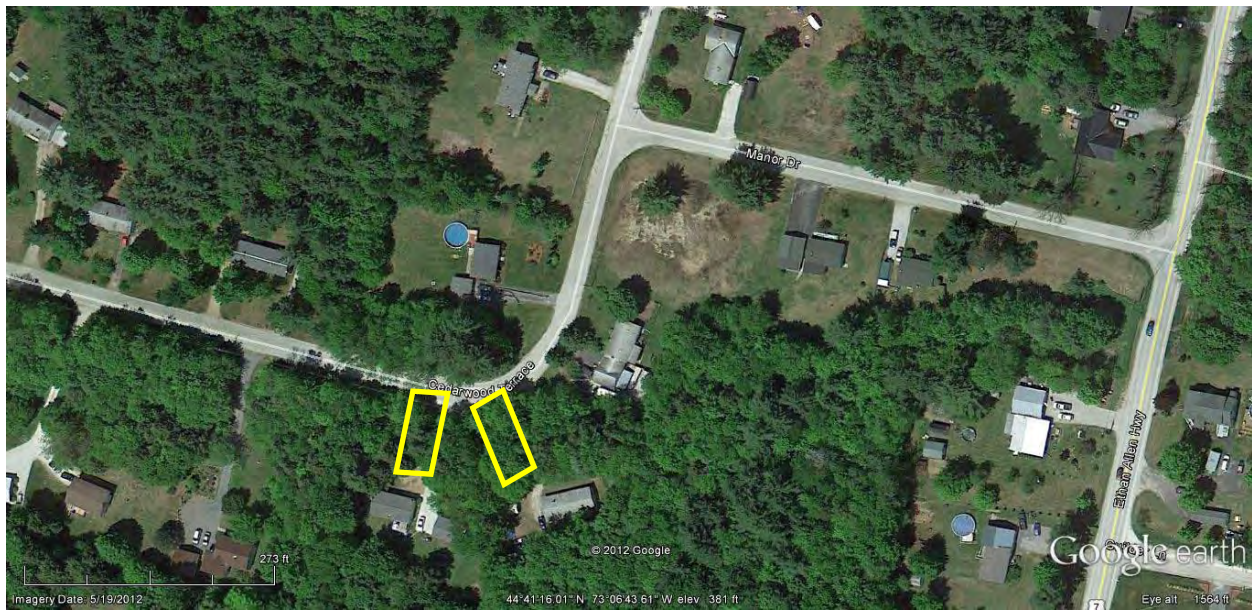
Figure 19. Two compromised culverts conveying stormwater under private drives on Cedarwood Terrace (highlighted in yellow).

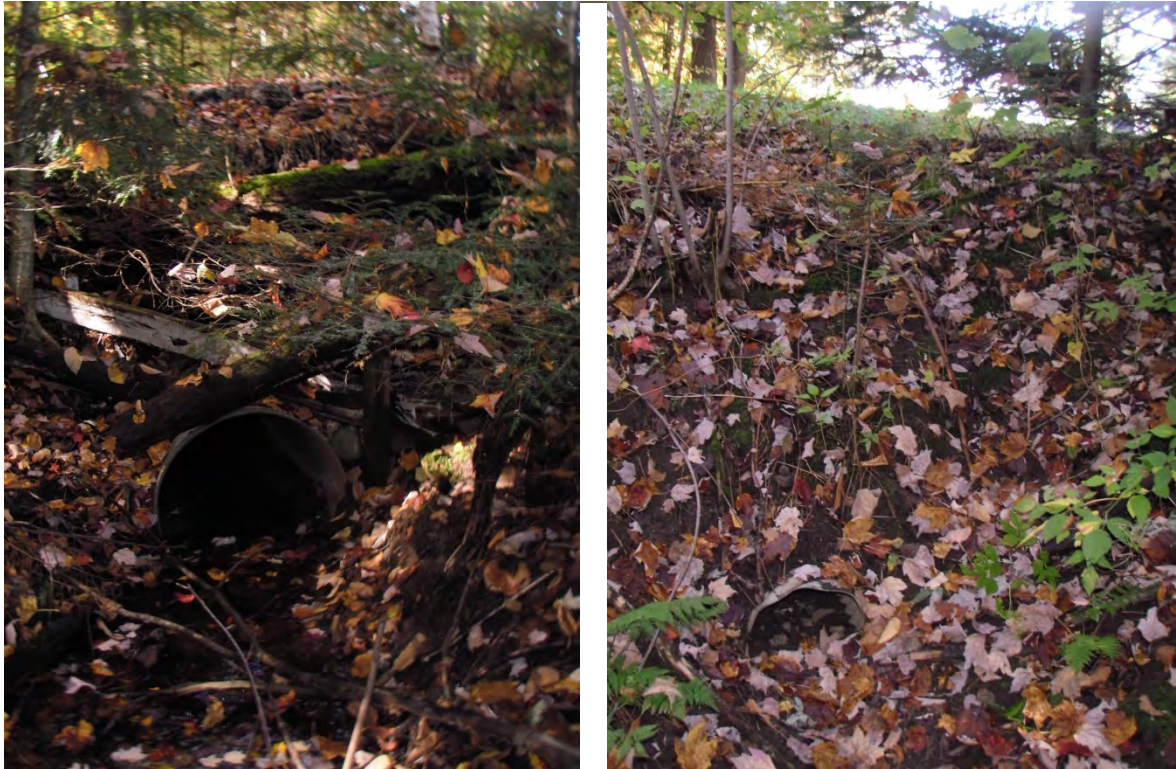
Figure 20. Partially clogged culverts with unstable cover slopes.

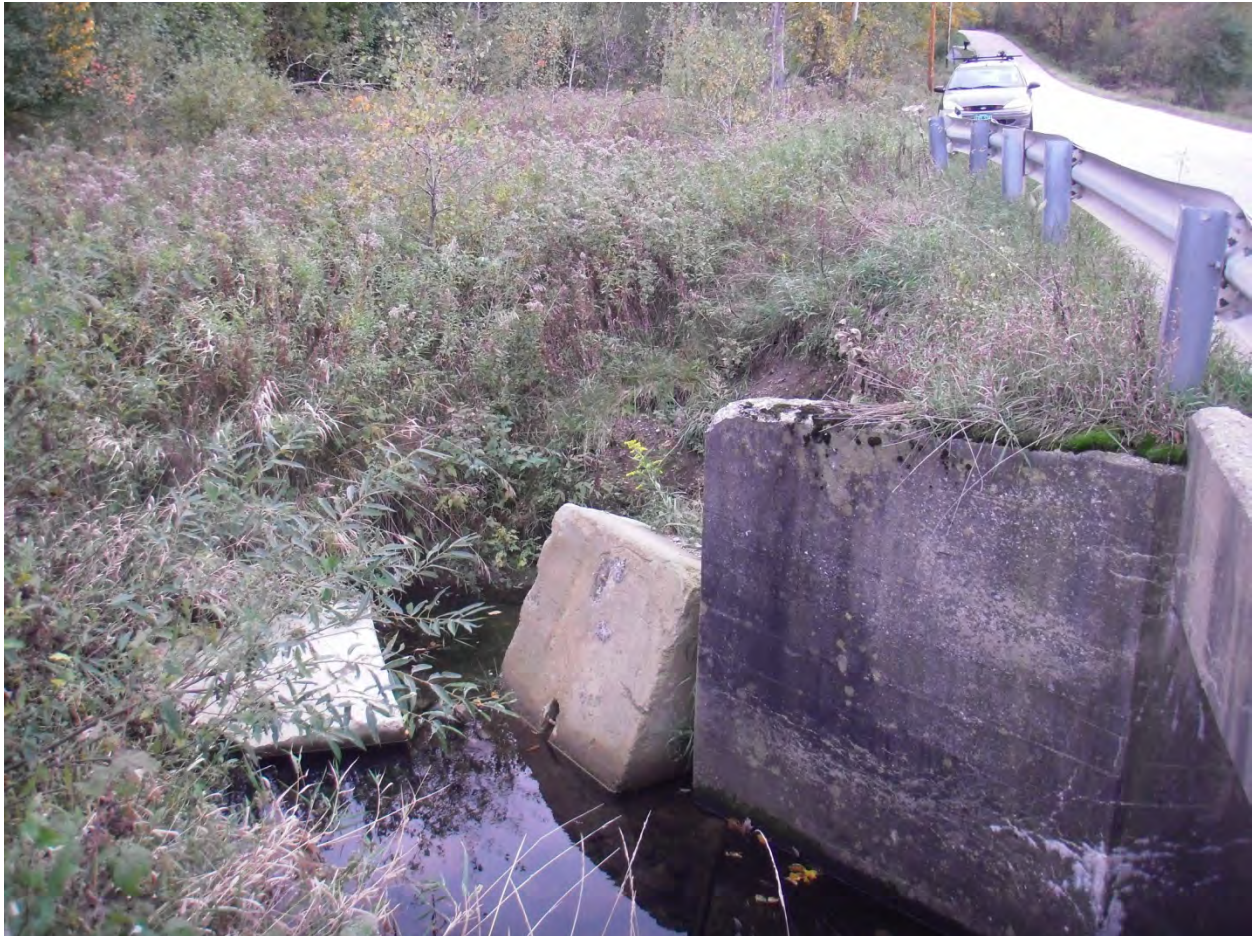
Figure 21. Failing slope near inlet to box culvert over Mill River on Oakland Station Rd.

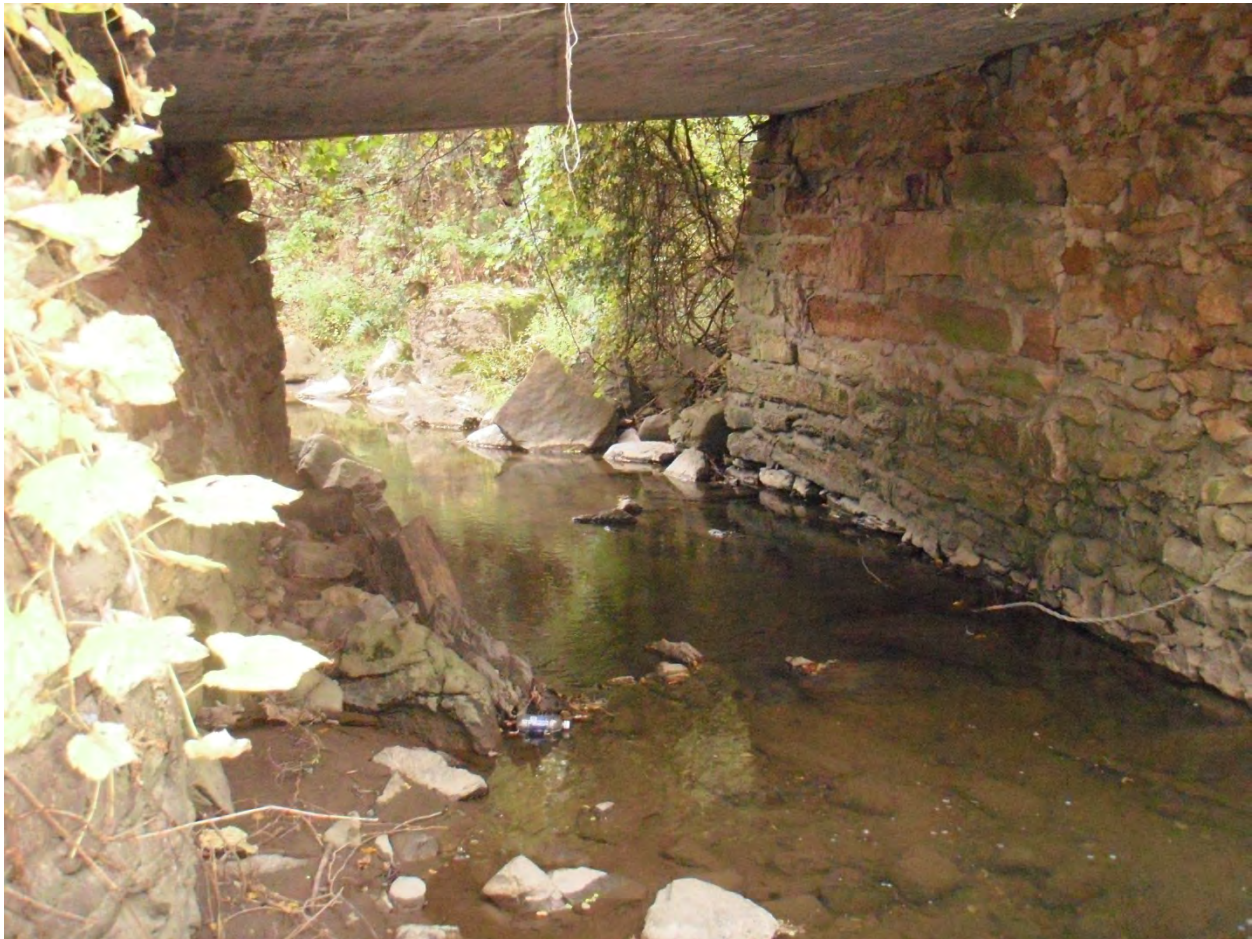
Figure 22. Deteriorating stone abutments of Mill River Rd. bridge over Rugg Brook.
