STORMWATER MANAGEMENT PLAN FOR HIGHGATE

FINAL REPORT

Stone Project ID 112475-W

March 1, 2013

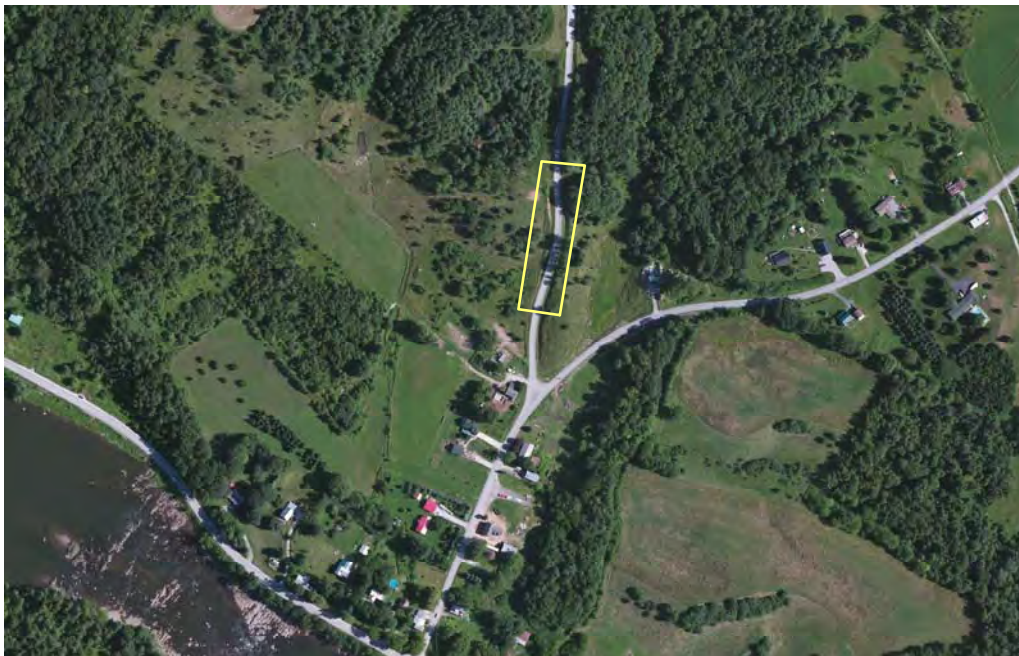
Recent roadway improvement work along Durkee Road in Highgate Center has resulted in over-steepened banks, causing erosion of sections of the ditch backslopes along both sides of the road. The section of road affected is fairly steep, and is located only about a third of a mile from the Missisquoi River. Approximately 300 feet of road side ditch is affected, with the backslope reaching a maximum approximate height of 10 feet. Appropriate grading of ditch side slopes and re-seeding to establish a stable channel are recommended practices. If a stable grade cannot be achieved, armoring the ditches would also help to stop the erosion.

Figure 1. An area of eroding slopes along Durkee Road is highlighted in yellow.

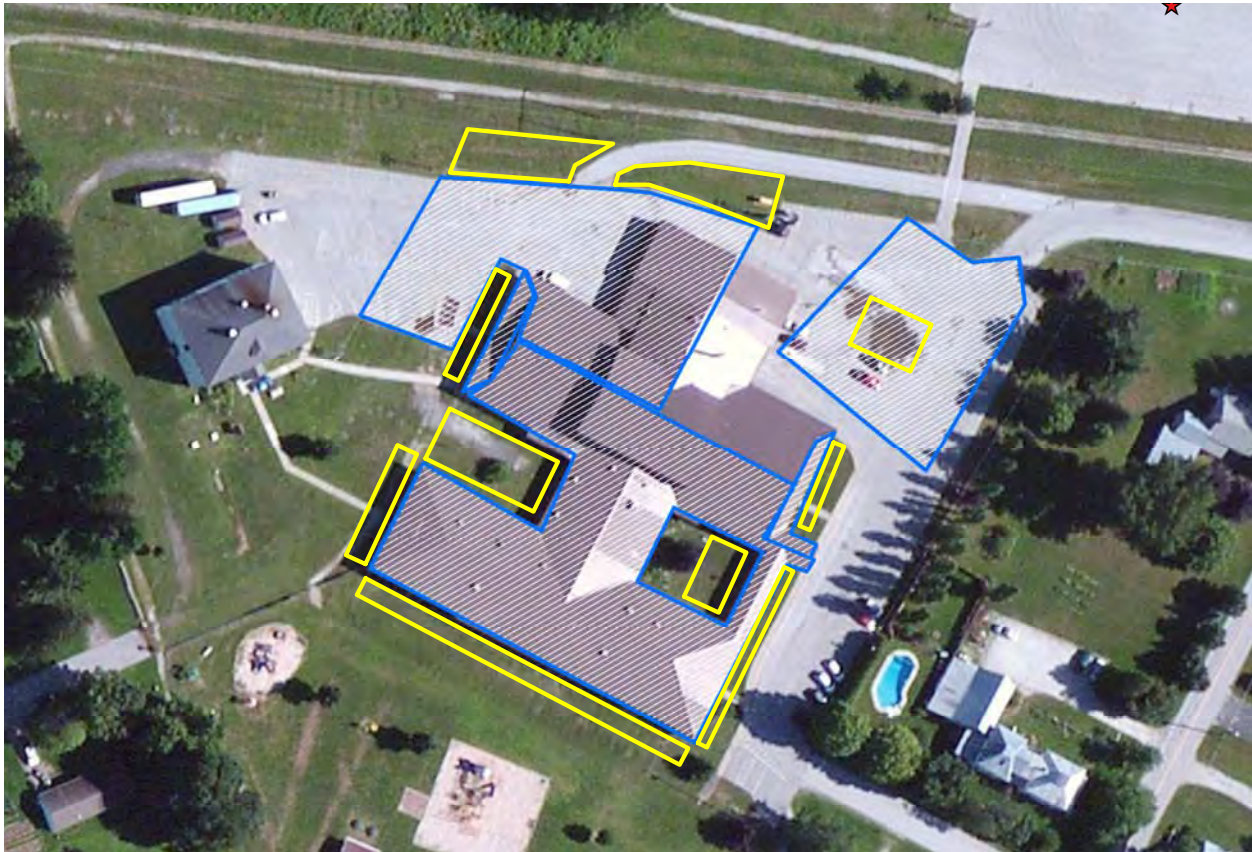
The soils at the school campus, from the west edge of the building to the east edge of the parking lot, appear to be well-drained Windsor loamy fine sands (Hydrologic Soil Group A) with no seasonal high water table limitations identified within the first five feet below ground surface. Infiltration practices are expected to be very effective in these conditions.

There is no closed drainage storm sewer infrastructure on or near the property, and little change in grade to accommodate underdrain outlets to the ground surface. Thus, any STPs constructed at this site would rely on the natural capacity of the underlying soils to infiltrate stormwater. Careful analysis of infiltration rates at proposed STP locations would be essential to insure the development of a properly functioning design.

Figure 2. Highgate Elementary School. Treatable impervious surface is highlighted in blue, and potential treatment practice locations are shown in yellow.

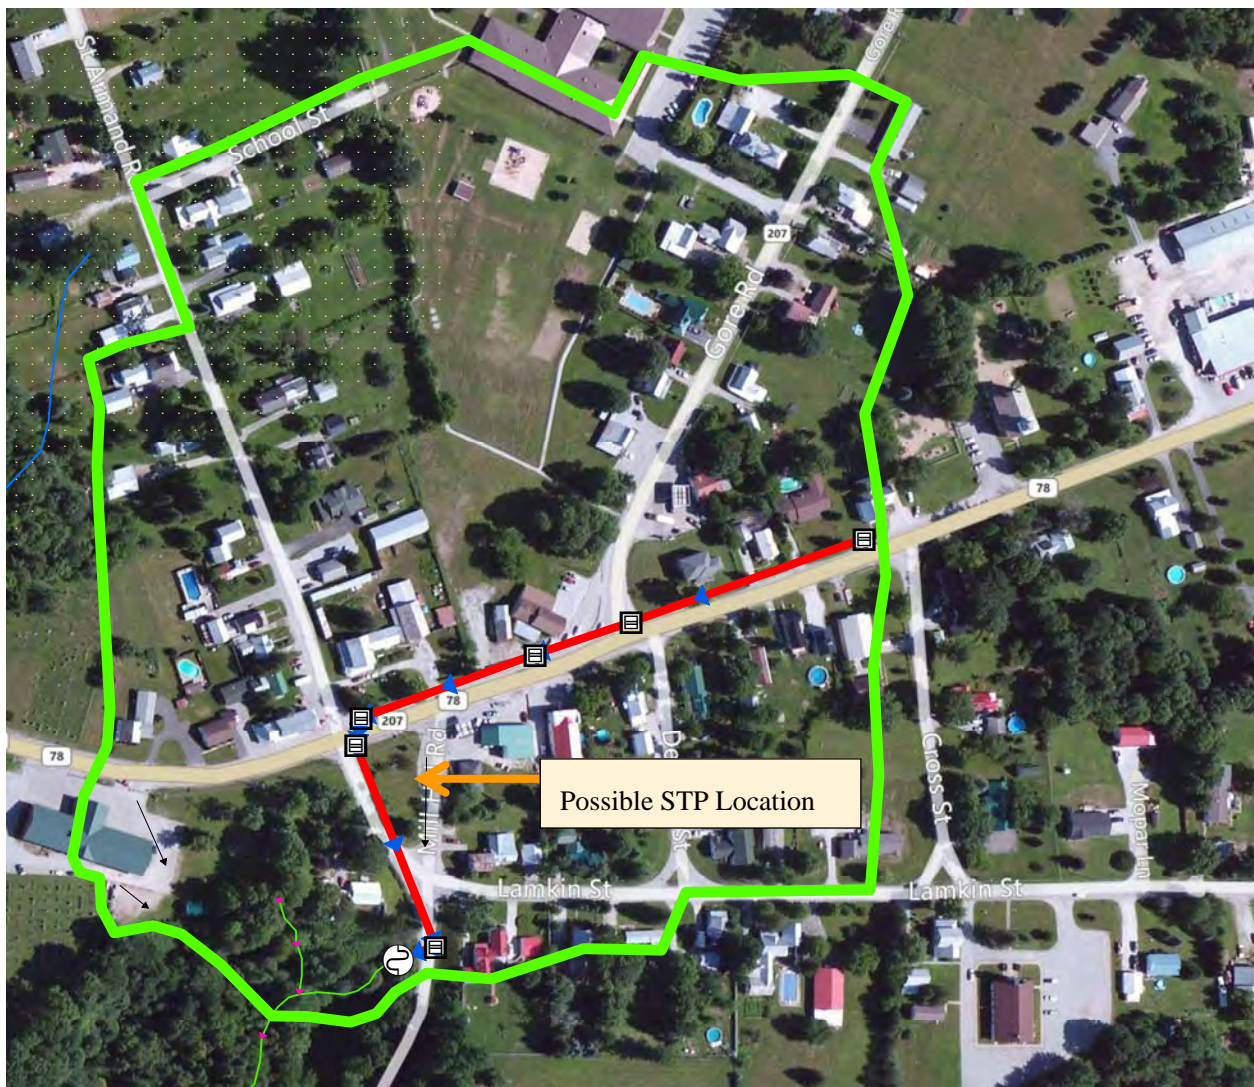
Nearly all of the village area of Highgate, a 32 acre catchment, drains south to a swale located along Mill Hill Road. A closed drainage system that collects stormwater along a section Vermont Route 78 discharges directly to this swale (Figure 3). Direct drainage from the street surfaces and this storm sewer are causing localized erosion at the outfall. Armoring this outfall with riprap is recommended—and to achieve more substantial improvements, source control is recommended to reduce the volume of runoff reaching the outfall. A “green street” approach could be employed, to turn out stormwater runoff from the road (particularly along St. Armand Road) into a series of small soak-away areas. Another treatment practice option could include a more centralized STP in the triangle median at the intersection of St. Armand Road, Vermont Routes 207 and 78, and Mill Hill Road. Much of this catchment area is underlain by well-drained Windsor loamy fine sand (HSG A), meaning the soils have a high infiltrative capacity and few seasonal high groundwater or shallow bedrock limitations.

Figure 2. The downtown area of Highgate is shown in this figure. Storm sewer is shown flowing from east to west, then to an outfall south of town on Mill Hill Rd. The contributing watershed is shown in green.

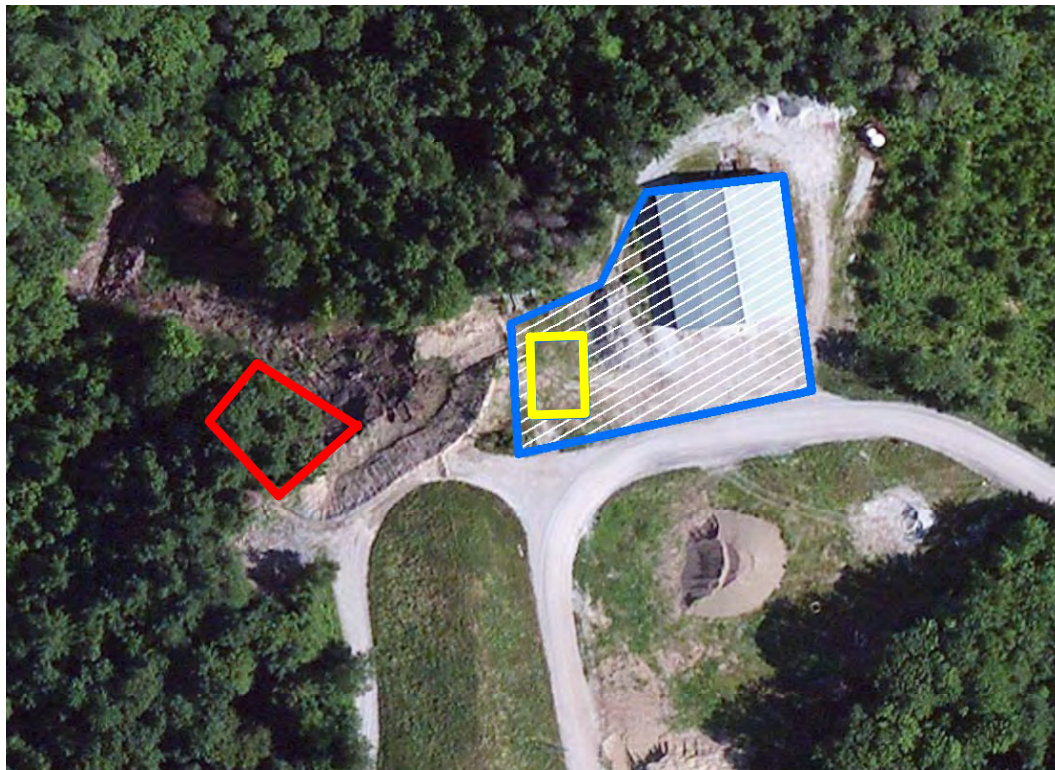
The Town of Highgate’s sand shed property (Figure 4), located on Transfer Station Road, is a potential source of sediment to an unnamed tributary of the Missisquoi River. This property was the site of a slope failure that occurred in the spring of 2011; the orthophoto below shows the slope failure clearly. The failed slope was repaired and stabilized, but stormwater is concentrating and leaving the site west of the repaired slope, and a gully is evident at this location (outlined in red). Stabilization measures should be considered to prevent propagation of the gully. In addition, during a December 2012 inspection, a catch basin (located near the western edge of the proposed STP, outlined in yellow) was found to be filled with sediment to the point where it did not function. It was not clear whether this catch basin drained to a dry well or to a conventional outlet.

Soils at the site appear to be well-drained Windsor loamy fine sand (HSG A), with a seasonal water table more than five feet below ground surface. Infiltration-based STPs will be effective if the native soils have not been overly compacted by grading or heavy equipment movement over the site. An infiltration-based STP could be constructed that used the existing catch basin as a high-flow outlet. The STP would keep sediment on-site, reduce impacts to water quality, and reduce the need to frequently clean out the catch basin.

Figure 4. Highgate town sand shed property. 0.65 acres of treatable impervious area is shown in blue, proposed STP location in yellow, and erosion gully shown in red. Note: slope damage shown in photo has been repaired.

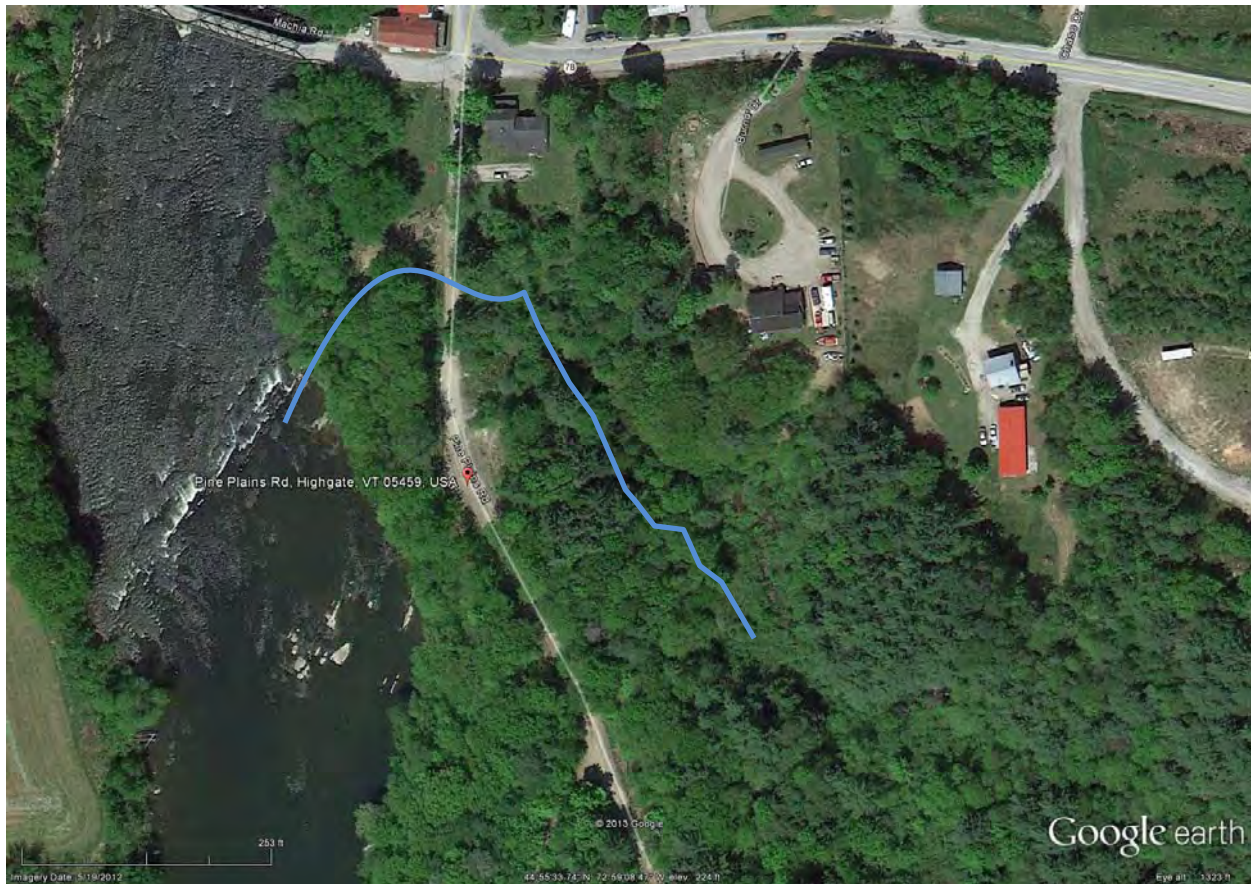
Pine Plains Road was found to be in poorly maintained condition (Figure 6). Only a short section of the road is maintained by the Town of Highgate, with the steepest sections maintained by private interests. Roadside ditches are in need of maintenance or do not exist. The lack of maintenance of the private section of the road is impacting the town-operated section. Poor ditch condition, coupled with poor grading, has resulted in substantial erosion of the road surface, which is turned out into the adjacent woodland and eventually deposited in a small tributary stream just upstream of its confluence with the Missisquoi River (Figure 6).

Figure 6. Pine Plains Rd. (south of Vermont Route 78) is poorly maintained. Eroding sediment from the road is impacting an unnamed stream near its confluence with the Missisquoi River.

The problems associated with Pine Plains Road could be remedied by excavating roadside ditches and properly grading the road. In steeper sections, road grade dips may be required to direct water off of the road surface. Roadside ditches in steeply sloping locations may need to be rock-lined. Ultimately, however, it is unclear what authority the Town has to require correction of drainage issues located on the privately-maintained section of Pine Plains Road.

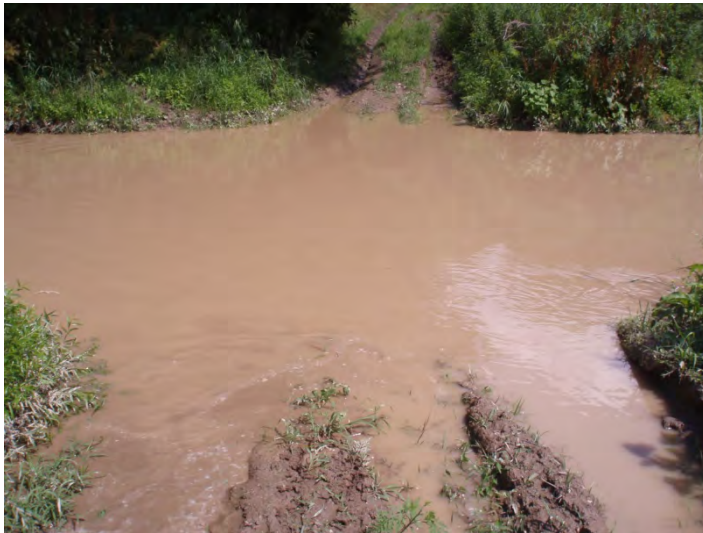
Unimproved or poorly constructed farm road stream crossings are a significant source of sediment to the Rock River and its tributaries in the Town of Highgate. During this project, landowners granted access to and provided Project Team staff the opportunity to observe four specific crossings; an example of the conditions observed is provided in Figure 7 below. While these crossings are on private land and thus are not directly within the purview of the Town, they have a significant and on-going impact on stream water quality. Implementation of best management practices for agricultural road crossings will also improve property owners' ability to access their land. State and federal programs may be available to aid with implementing these improvements.

Figure 7. Unimproved farm road crossing, shown during high flow conditions. Significant ruts suggest the landowner is often challenged to ford the river.

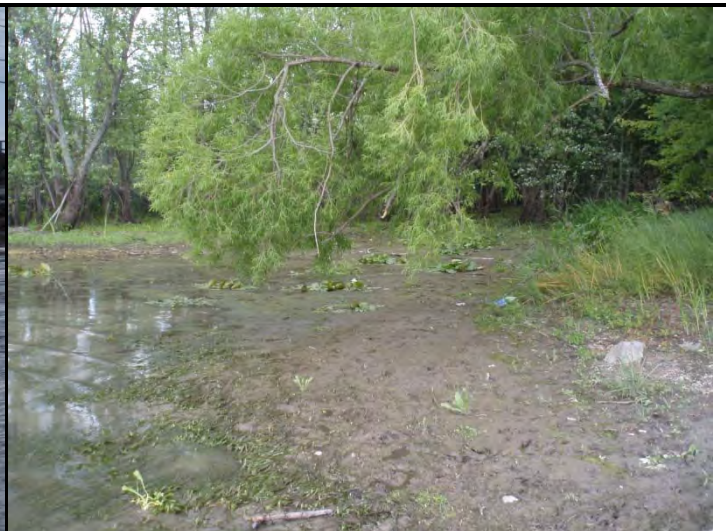
Photo 2. Evidence of flooding upstream of bridge

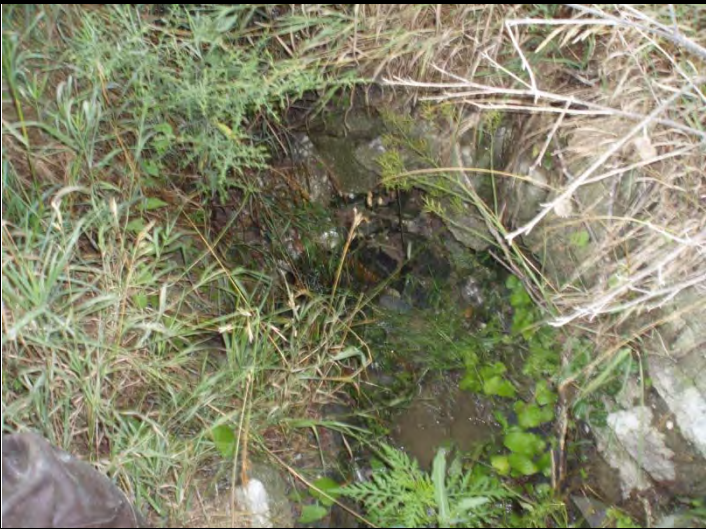
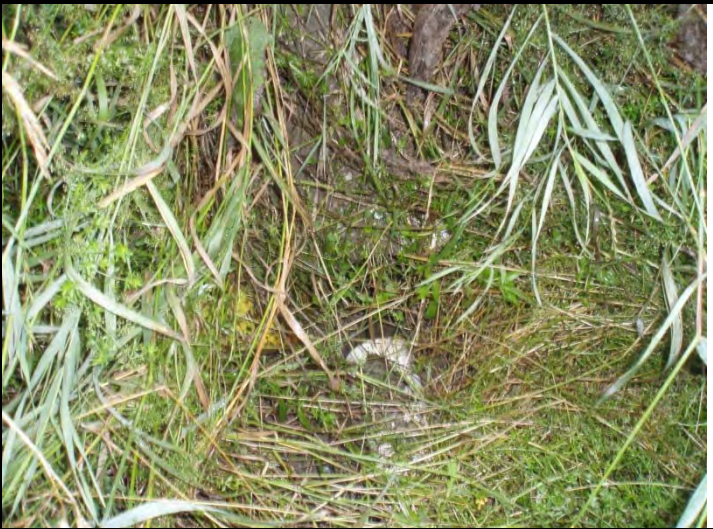
Photo 1. Under-road culvert outfall	Photo 2. 4" white pipe downstream of culvert

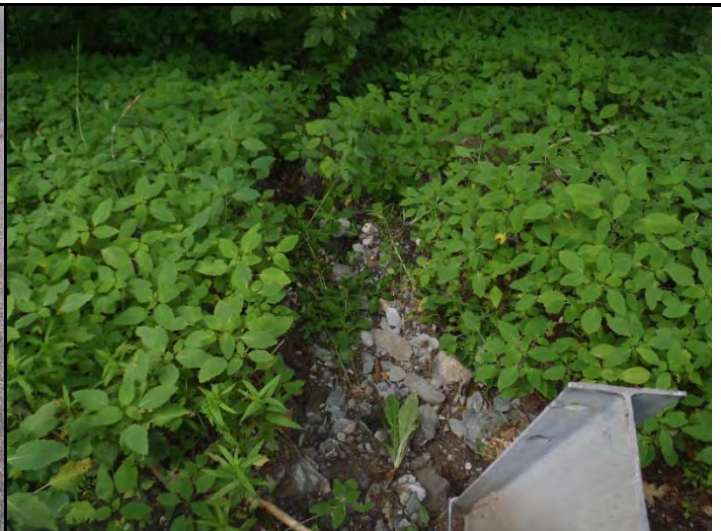
Photo 2. Blowout at the end of guardrail

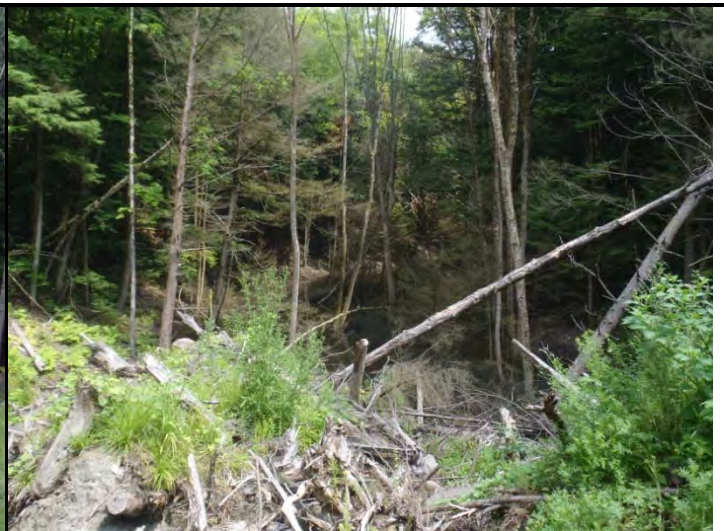
Photo 2. Debris obstructing waterflow at bottom

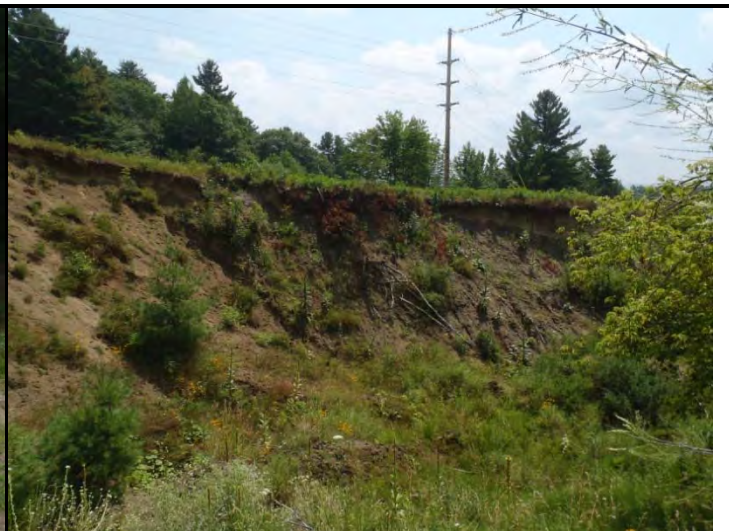
Photo 2. Eroded bank

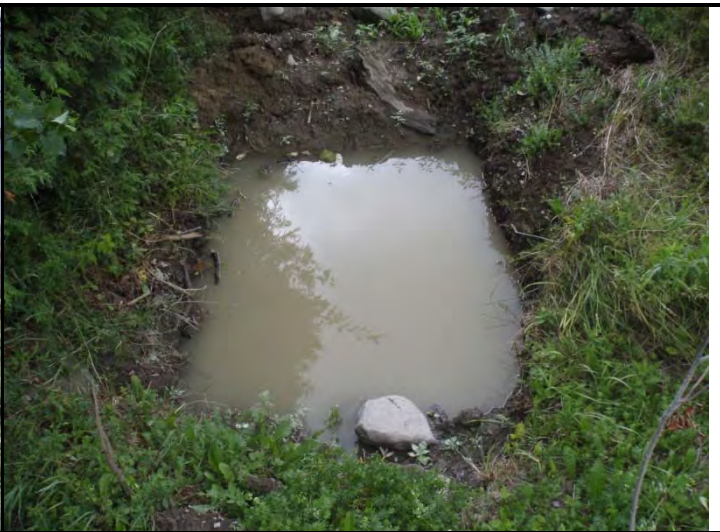
Photo 2. Close-up of submerged outfall

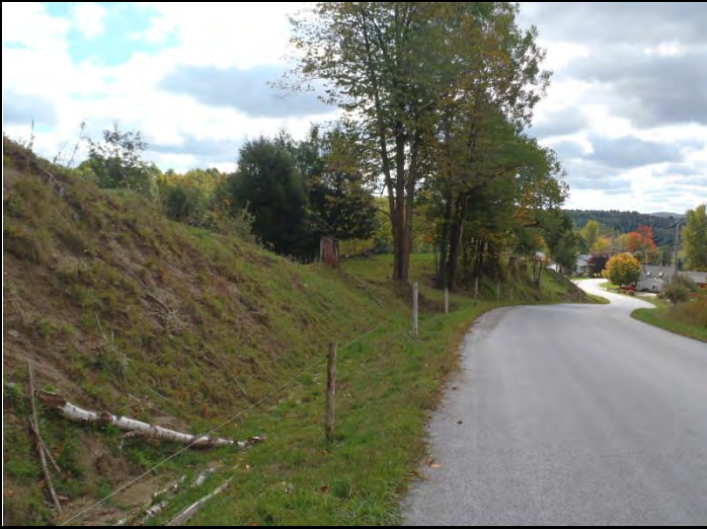
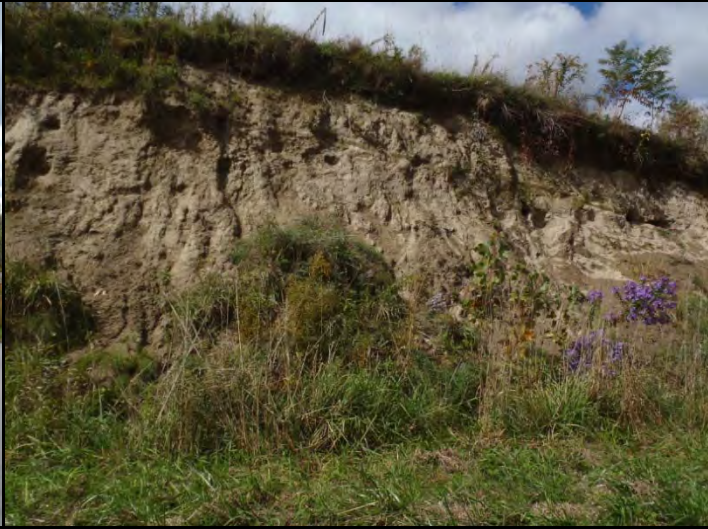
Photo 1. Ditching on East side of Durkee Rd	Photo 2. Erosion on West side of Durkee Rd

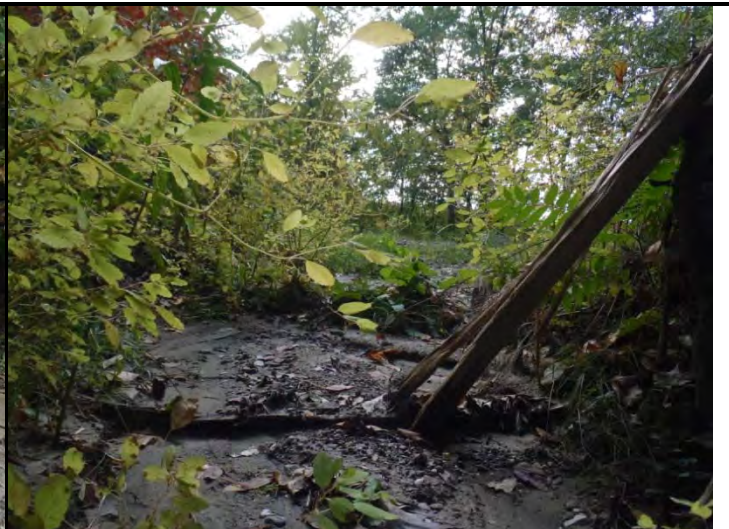
Photo 2. Separate instance of overland flow

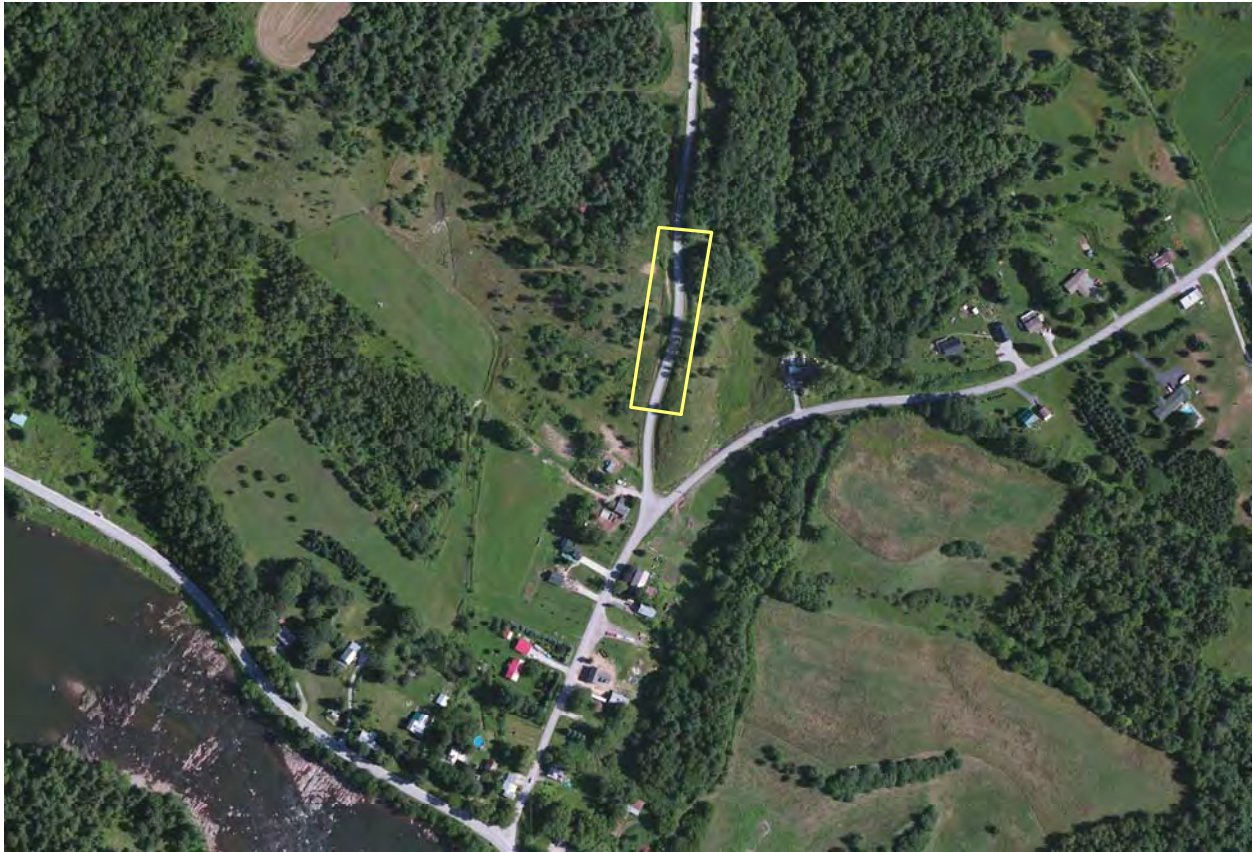
1.1 Durkee Rd. Highgate Center

Figure 1. Area of eroding slopes highlighted in yellow.

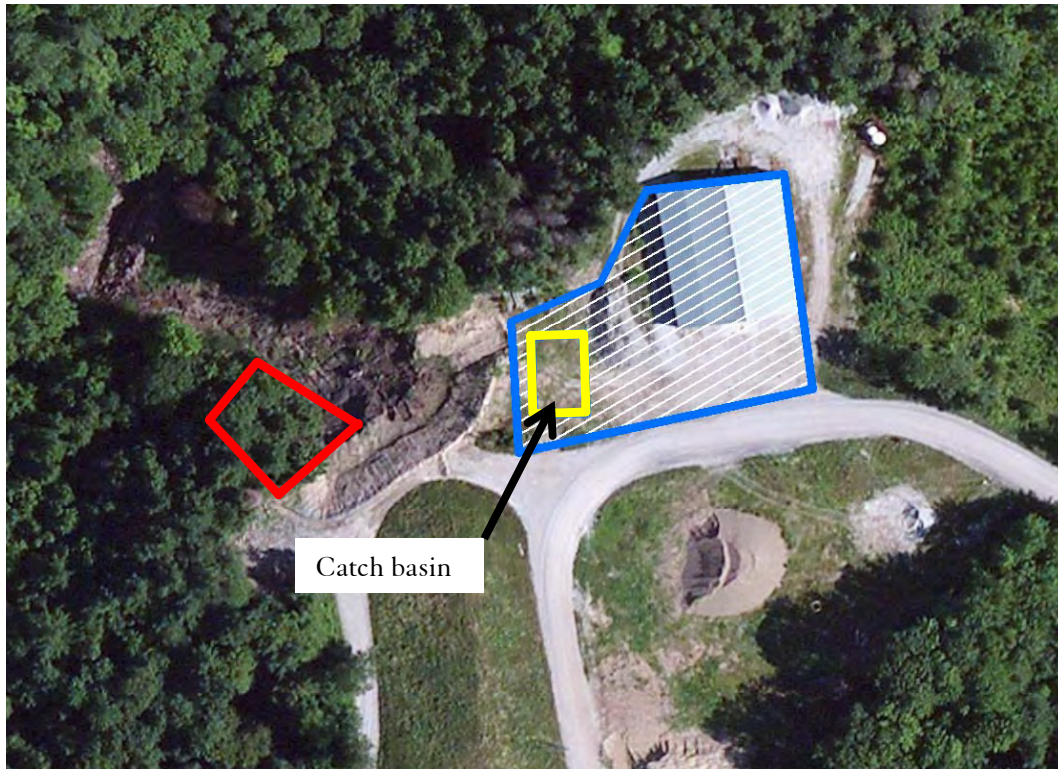
Figure 10. Highgate town sand shed property. 0.65 acres of treatable impervious area is shown in blue, proposed STP location in yellow, and erosion gully shown in red. Note: slope damage shown in photo has been repaired.

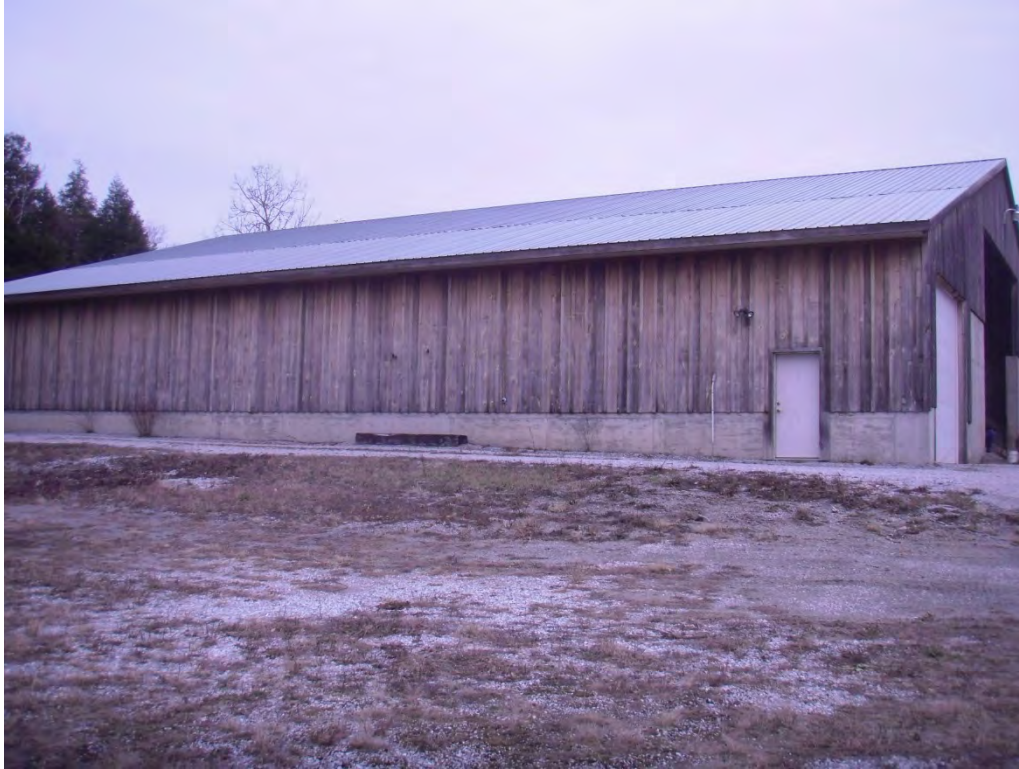
The Highgate town sand shed property (Figure 11), located on Transfer Station Road, is a potential source of sediment to a tributary of the Missisquoi River. This property was the site of a slope failure that occurred in spring of 2011 (visible in Figure 10). The failed slope has since been repaired and stabilized but some lingering issues remain. A catch basin was found to be completely filled with sediment during a December 2012 inspection (see Figure 12). It was not apparent whether this catch basin drained to a dry well or to a conventional outlet. Regardless, the catch basin is filled to a point where it does not function. Stormwater is also concentrating and leaving the site west of the repaired slope. A gully is evident at this location. Stabilization measures should be considered to prevent propagation of the gully.

Figure 11. Town sand shed and adjacent gravel lot includes more than 0.5 acres of potentially treatable impervious surface.

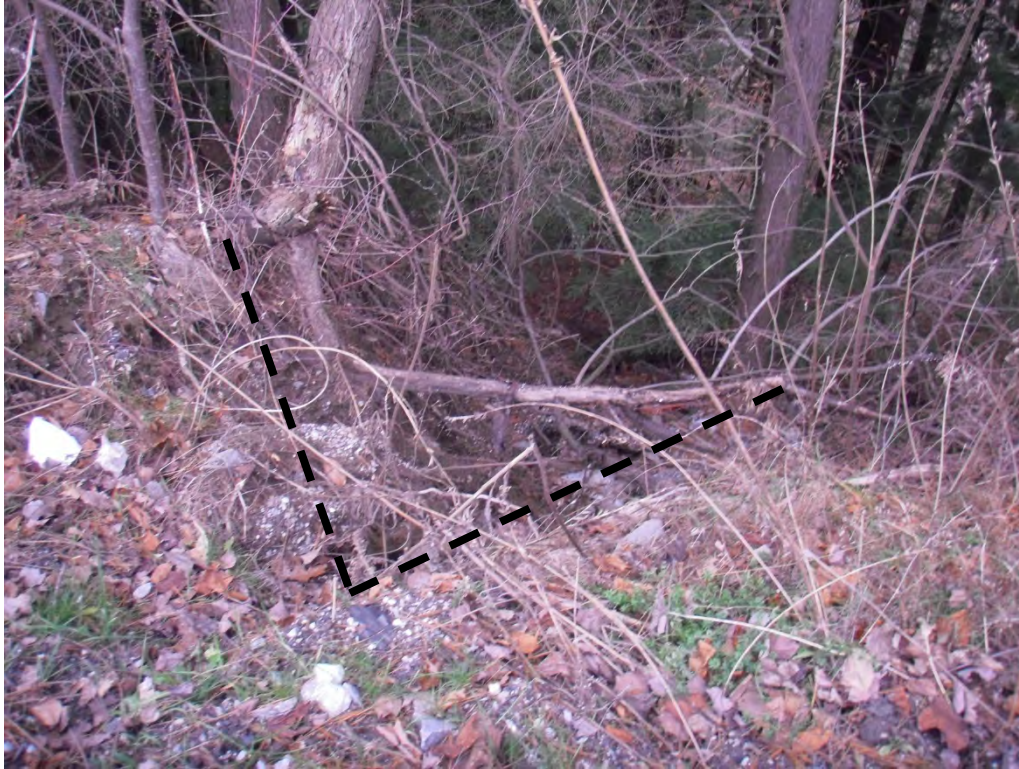
Figure 13. Erosion gully forming near repaired landslide at Highgate town sand shed.

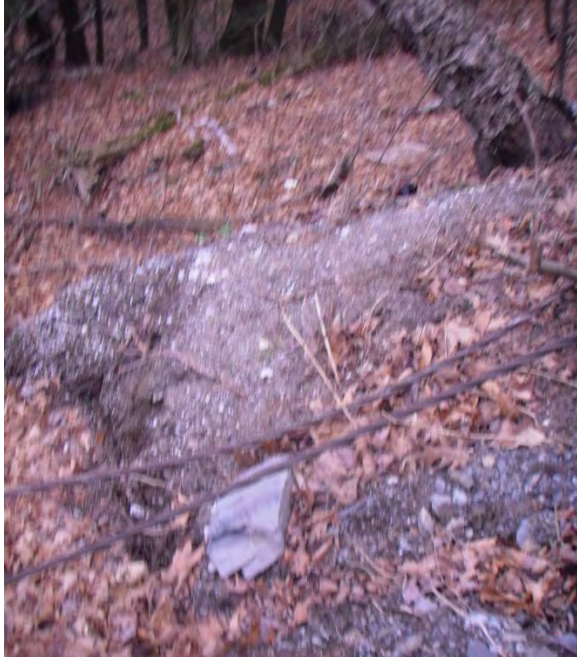
Figure 16. Erosion at the Mill Hill Rd. storm sewer outfall.

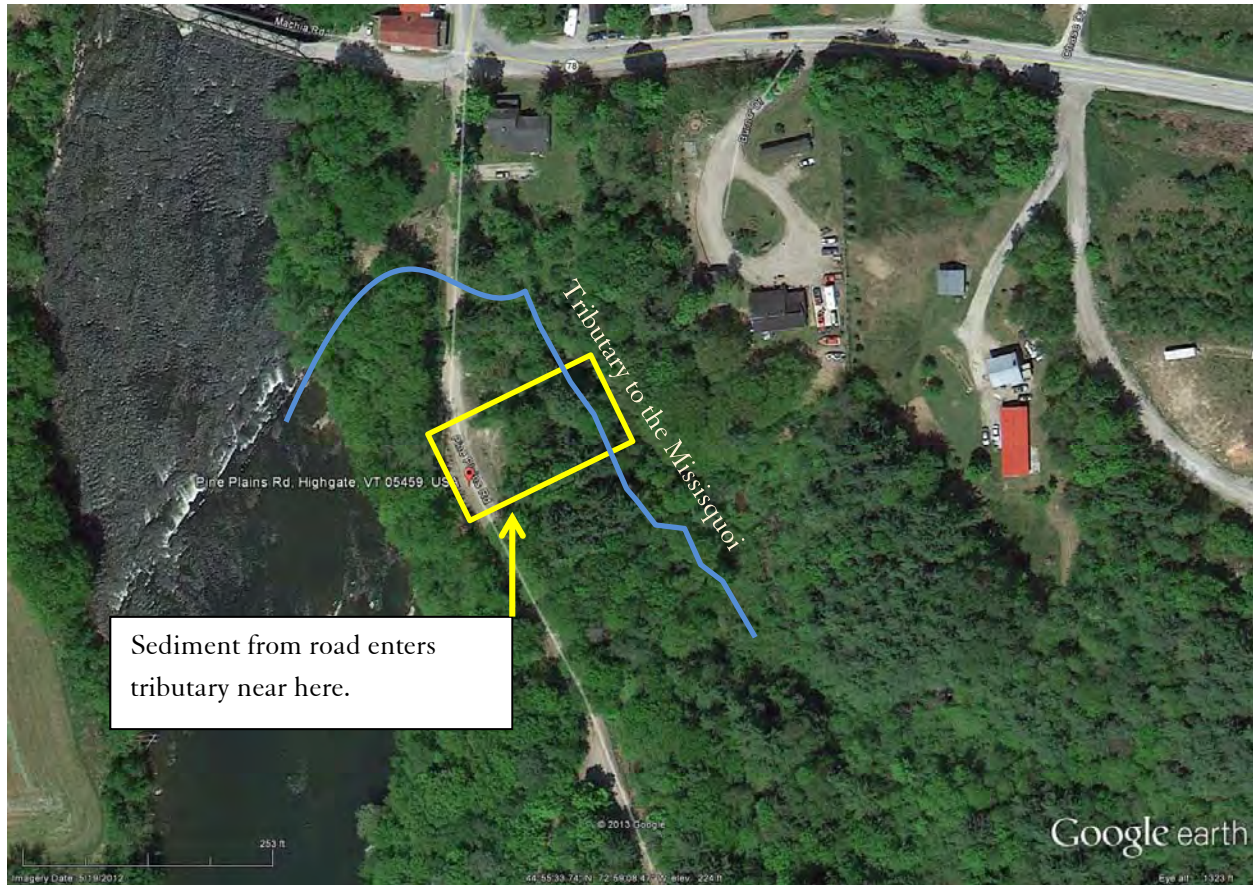
Figure 17. Pine Plains Rd. (south of VT-78) is poorly maintained. Eroding sediment from the road is impacting a tributary near the confluence with the Missisquoi River.

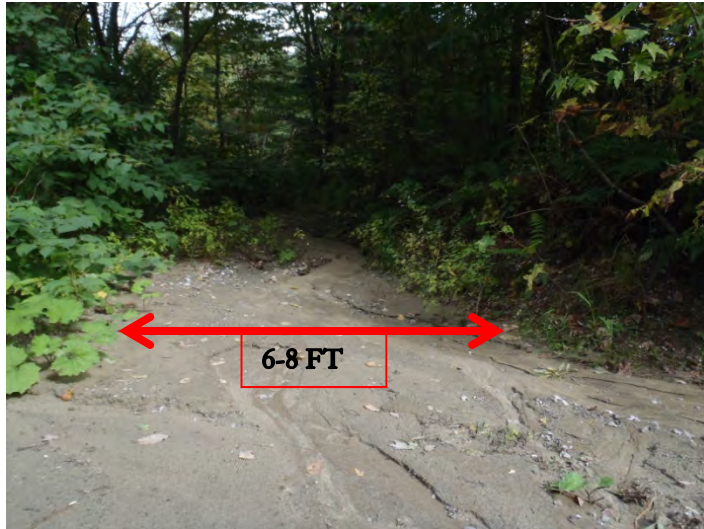
Figure 18. Eroding sediment from the road entering tributary to Missisquoi River.

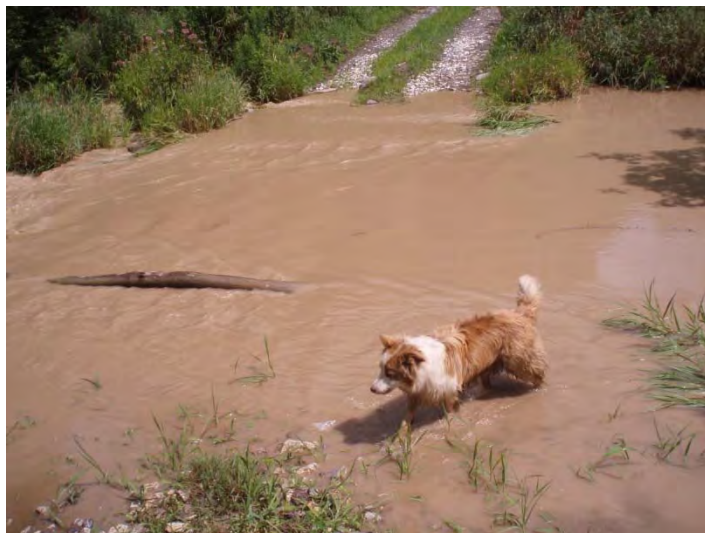
Figure 25. Unimproved farm road crossing, shown during high flow conditions. Bank erosion evident on both sides of the stream.

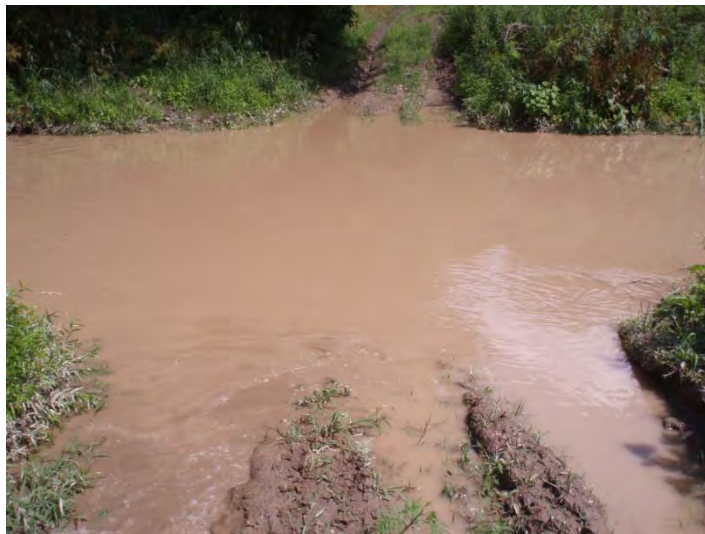
Figure 25. Unimproved farm road crossing, shown during high flow conditions. Significant ruts suggest landowner challenged to ford river during certain flow regimes.
