# LAKE MEMPHREMAGOG BASIN ADDITIONAL ADVANCED INVESTIGATIONS

## FINAL REPORT

FEBRUARY 21, 2016

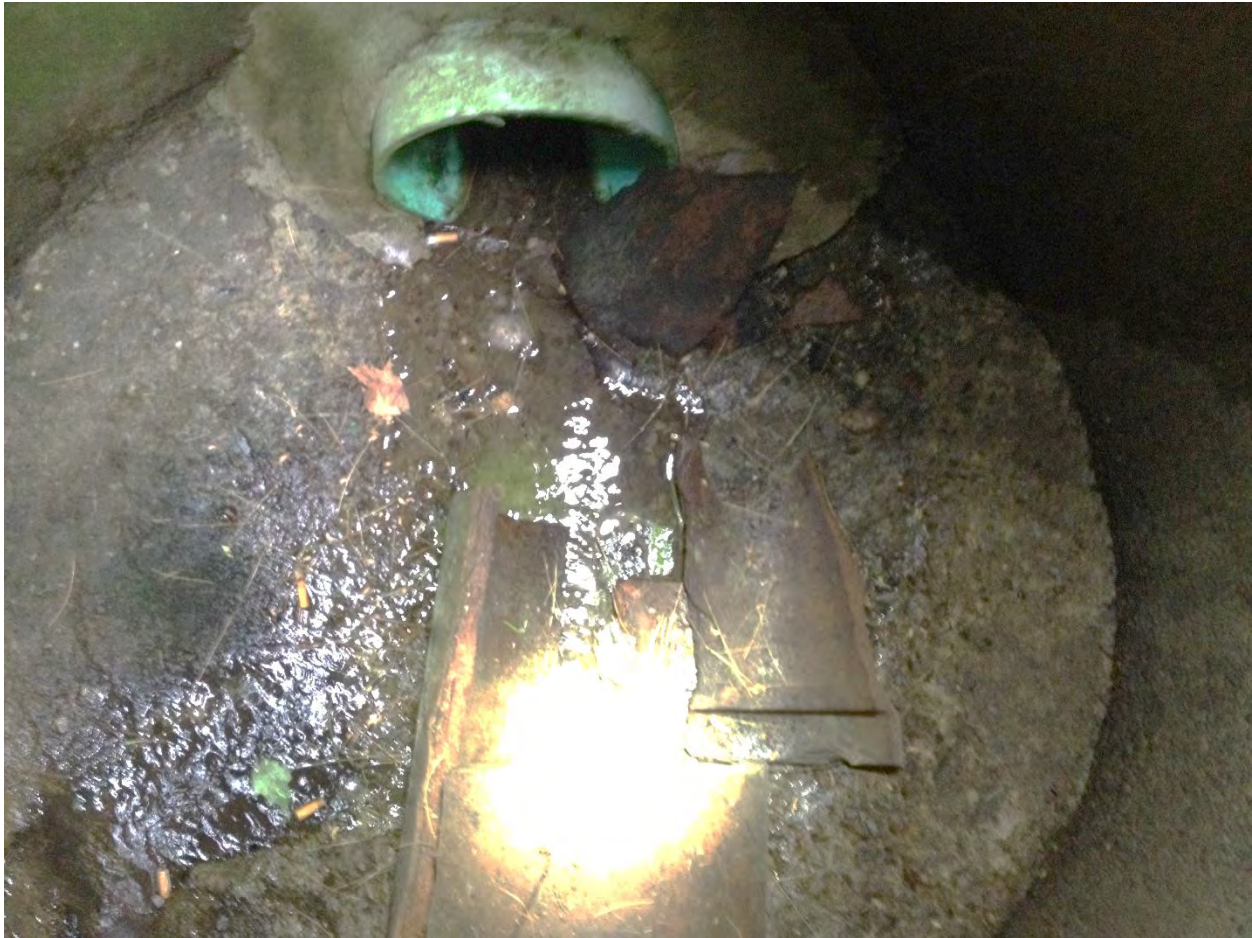
*Stormwater manhole at the Newport Elementary School with visible wastewater solids, June 16, 2015*

- On June 16, 2015, the storm drainage system around the school was inspected and mapped connections were verified or corrected. Toilet paper and feces were observed in a manhole (labelled CB3 on Map 8) south of the school building (see cover photo). An unmapped vitrified clay pipe discharges to this manhole. From its appearance, location, and alignment, we suspected the vitrified clay pipe was the source of wastewater entering the system and that it originates in the old wing of the elementary school. Dye testing was therefore performed in every lavatory in the old wing of the school. The toilet in one classroom (Room 108) was found to be connected via a cross connection to a roof leader. Dye added to the toilet quickly appeared in the unmapped vitrified clay pipe discharging to the manhole. We do not believe there are any other connected toilets. The sink in the lavatory and a project sink in the classroom were presumed to be connected incorrectly also, as there appeared to be a single pipe connection to the roof leader.

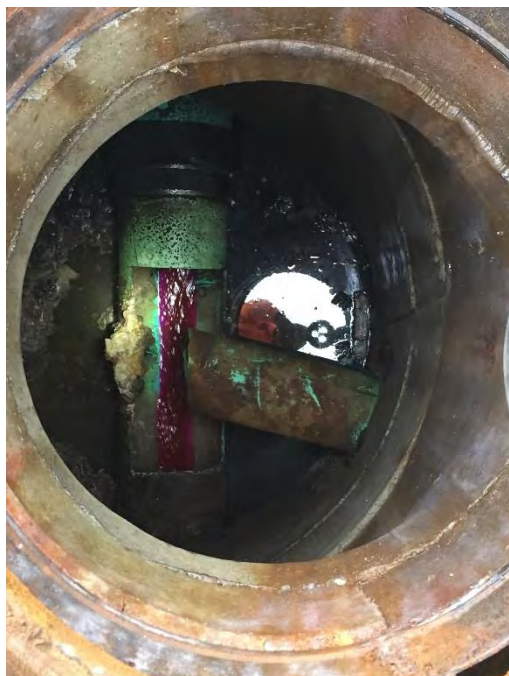
**Figure 1. Sanitary manhole showing dye from service station pit drain**

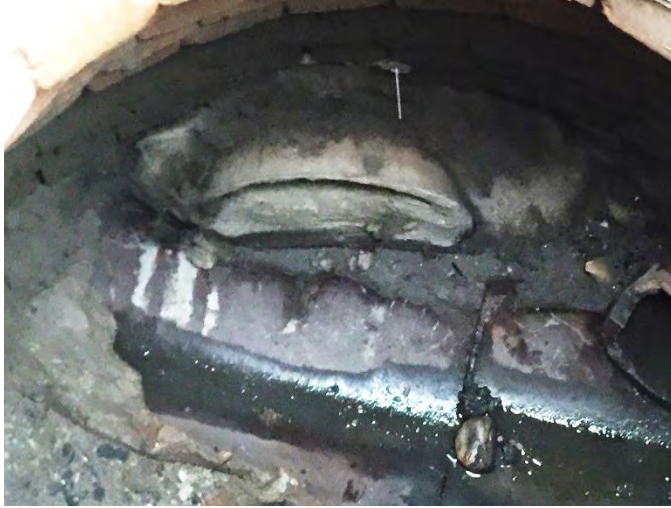
**Figure 2. Manhole MH1—a gap in the plug is visible in the pipe in the 11:00 position**

- On December 16, 2015, a push camera was used to view manhole MH1 and the pipes entering and exiting the structure. The nearby sanitary manhole was also inspected. The inspection revealed that a grout plug on a cross connection between the sanitary manhole and stormwater manhole MH1 was not properly sealing the pipe. A gap was visible at the top of the pipe opening (the grout apparently settled) (Figure 2). This gap in the plug was believed to be the source of the wastewater odor in MH1. Under surcharged conditions in the sanitary sewer, this gap would have allowed wastewater to flow into manhole MH1.

**Conclusion:** A direct connection between the sanitary sewer and stormwater manhole MH1 was identified. A faulty plug on a cross connecting line appears to have been responsible for wastewater odors in manhole MH1. When the sanitary sewer was surcharged this may have caused wastewater to enter MH1. Conversely, at high flows MH1 may have been a source of inflow to the sanitary sewer.

**Resolution:** The Newport City Public Works Department sealed the cross connection pipe in early February, 2016.

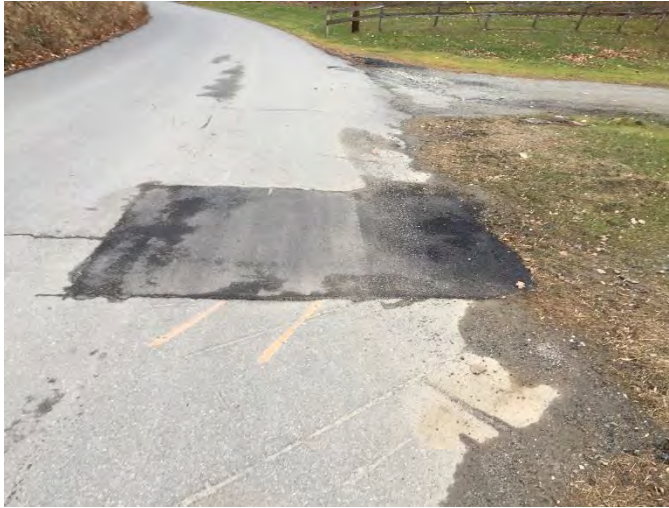
**Figure 3. Pavement patch on Fern Street over apartment building's new sewer service connection**

- The Director of Public Works, Tom Bernier, visited the property in late summer 2015 and observed wastewater solids in catchbasin CB4. Apparently, an excavator working on the septic system tied the building sewer for the two apartments on the north side of the building into the perimeter drain which discharges to CB4. Mr. Bernier required the building owner to make a proper connection to the municipal sewer on Fern Street (Figure 3). This repair was made in the fall of 2015.

**Conclusion:** Although some of the details are unclear, it appears that Pipe A in catchbasin CB4 is a perimeter drain that conveyed partially renovated wastewater from a saturated septic system leachfield to CB4. Over the summer of 2015 a contractor tied a sewer line serving two units into this drain, resulting in discharge of raw wastewater to CB4.

**Resolution:** The Newport City Public Works Department required the owner of the apartment building at 20 Fern Street to connect the building to the municipal sewer on Fern Street.

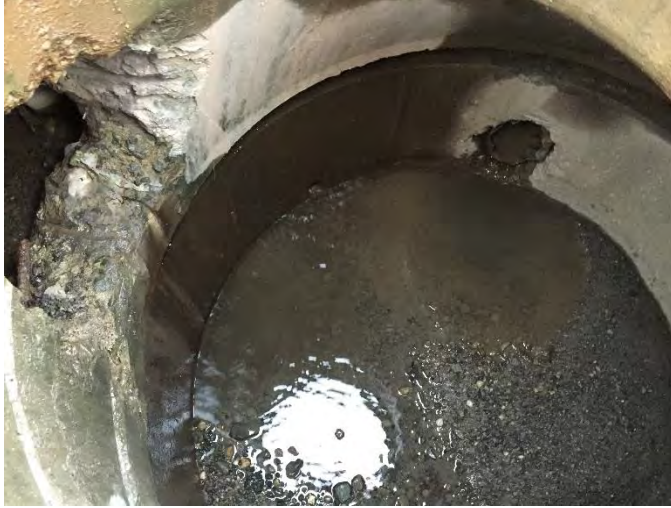
**Figure 4. Deteriorated pipe penetrations in catchbasin CB1**

- Remnants of clay and steel pipes were found in three locations along the toe of the slope between CB1 and CB2. At these and other locations, water was seeping from the ground onto the gravel drive below.
- On December 16, 2015 catchbasin CB1 was inspected. Water was observed flowing from Pipe A into voids around the outside of the structure and emerging at the Pipe B penetration (Figure 4). A low ammonia concentration was measured in samples collected at both penetrations. Samples collected from the Pipe B penetration were turbid.
