MEMORANDUM

SUBJECT: Visual Dam Safety Inspection of Amherst Lake Dam, Plymouth, Vermont
State ID No: 156.05, National ID No: VT00131

Amherst Lake Dam

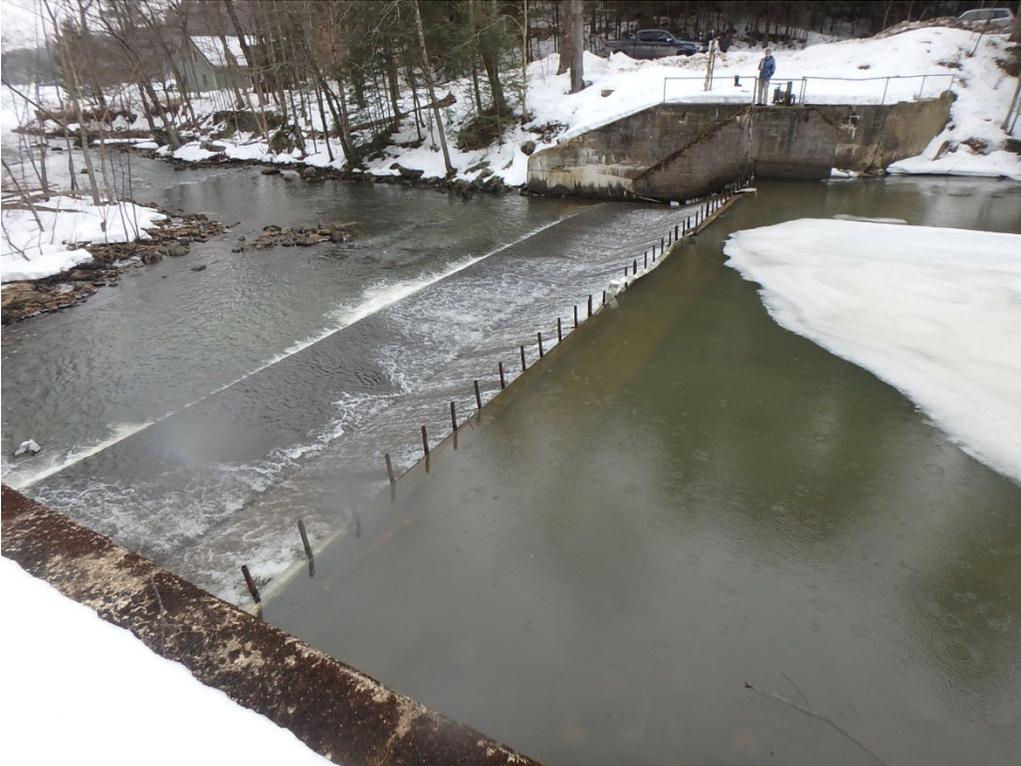
Photo 1: March 2021, an overview of the dam from the left abutment area

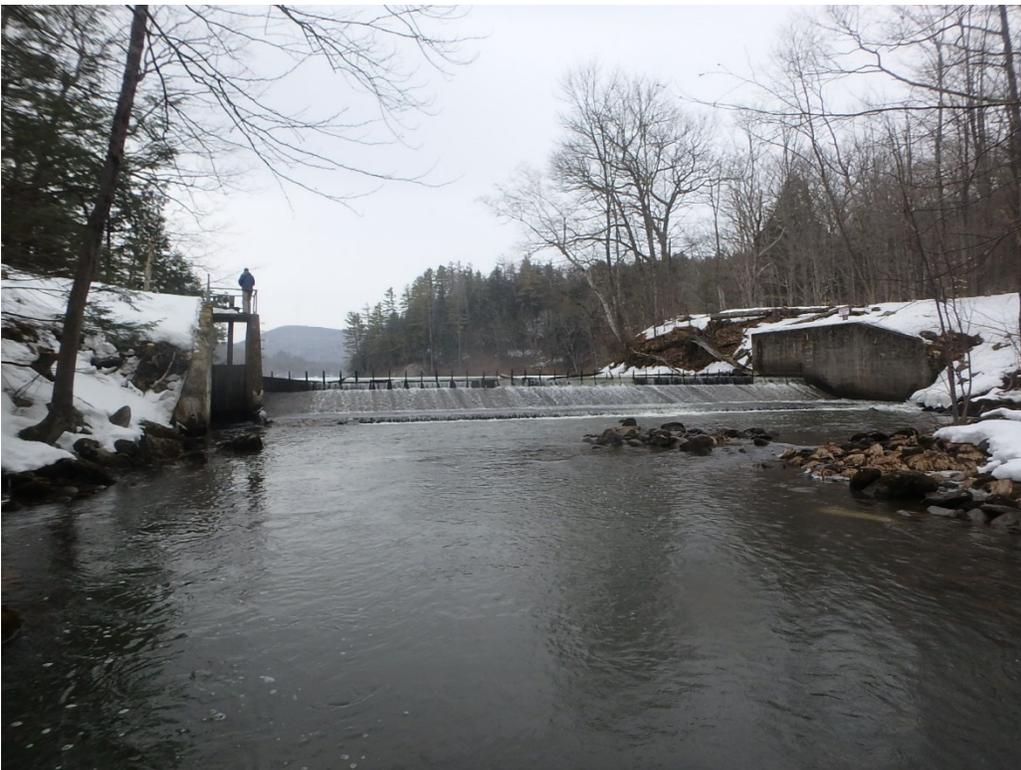
Photo 2: March 2021, an overview of the dam from the downstream area looking upstream.

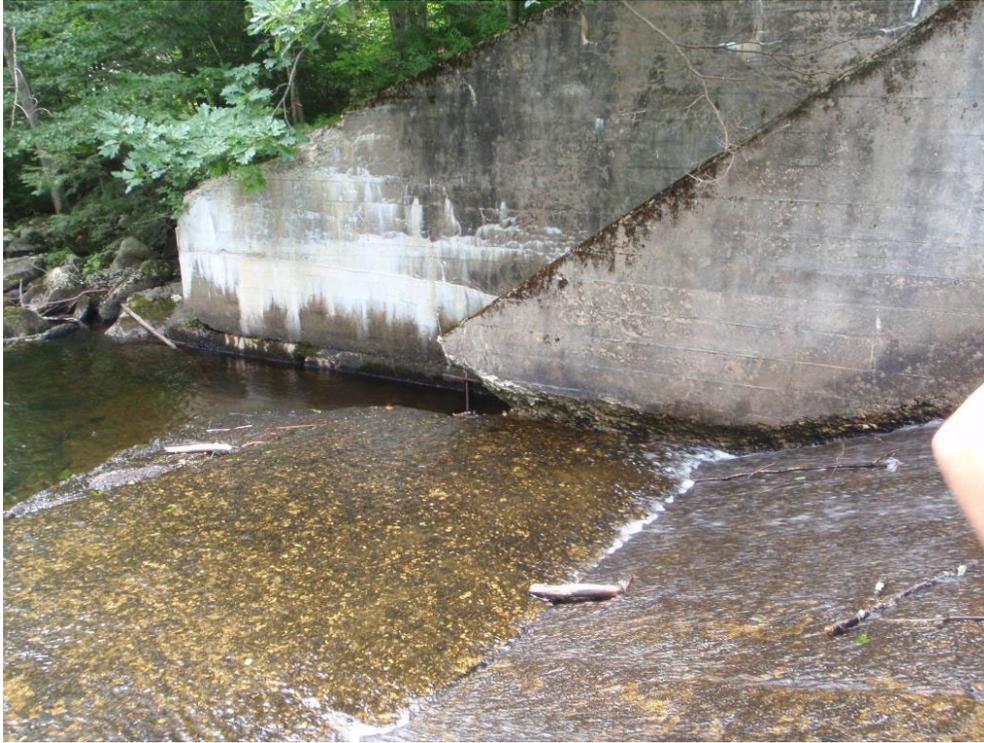
Photo 3: August 2010, downstream end of concrete wall separating the spillway from the outlet works.

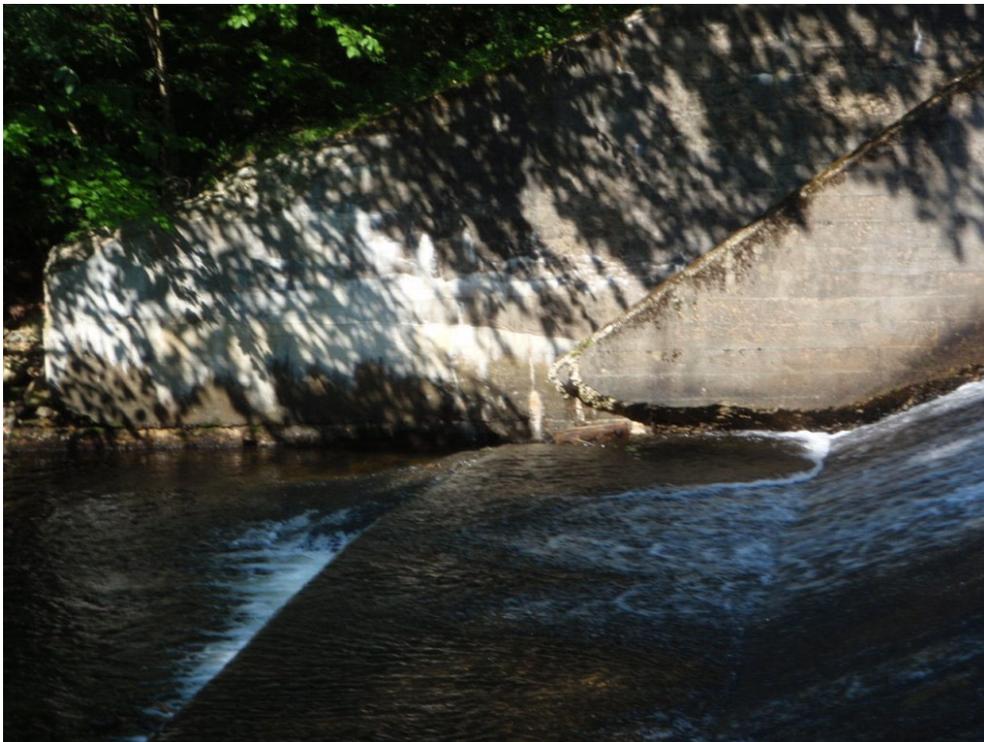
Photo 4: July 2014, downstream end of concrete wall separating the spillway from the outlet works, note continued section loss and deterioration.

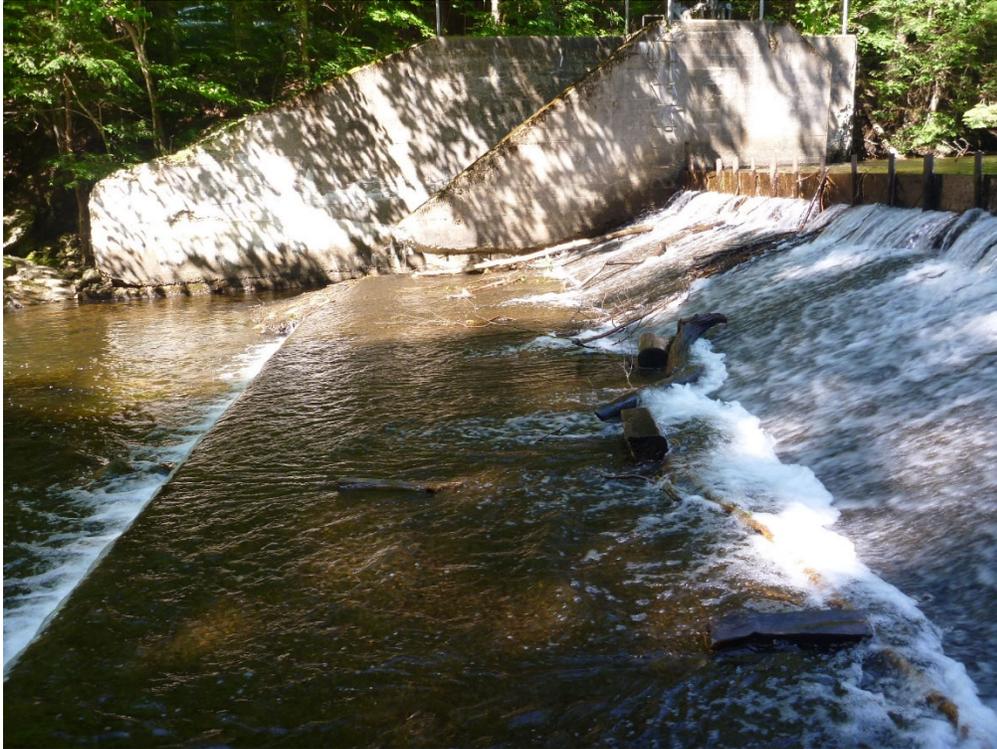
Photo 5: July 2019, downstream end of concrete wall separating the spillway from the outlet works, note continued section loss and deterioration.

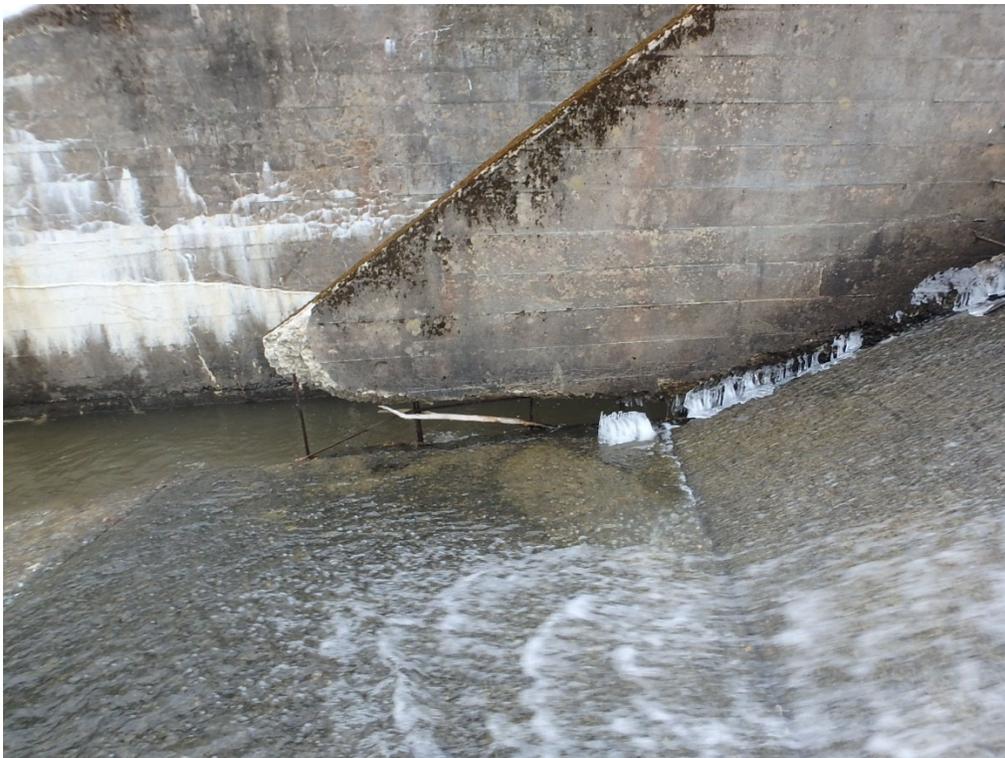
The right concrete training wall is also the dividing wall between the spillway and the gated outlet channel. The condition of this wall is poor as the downstream end of the wall is completely undermined with loss of support for approximately 10 feet laterally except for several corroded, 0.75-inch diameter rebar. The concrete is heavily deteriorated with exposed aggregate, delamination, and cracking. A horizontal crack extends on the gate side of the wall from the gate in the downstream direction and displacement towards the spillway along the crack was observed. The wall above the crack is tilted towards the spillway greater than 3 degrees past vertical. It should be noted that at the top of the wall is a short concrete bridge that supports the gate mechanism and ties the wall to the right abutment wall. The connection of the wall to this bridge appeared good, but it was noted that both the walls are similarly tilted (racked) towards the spillway. Based on review of past inspection report photographs, continued concrete section loss, cracking, and tilting was observed. The wall appears marginally stable under normal loading conditions.

Photo 6: March 2021, downstream end of concrete wall separating the spillway from the outlet works, note continued section loss and deterioration.

3. Perform an assessment of the structural stability of the training walls and identify repair alternatives.
4. Investigate the undermining of the spillway apron and seepage/stability impacts.
5. Develop an Operations and Maintenance Manual for the dam.

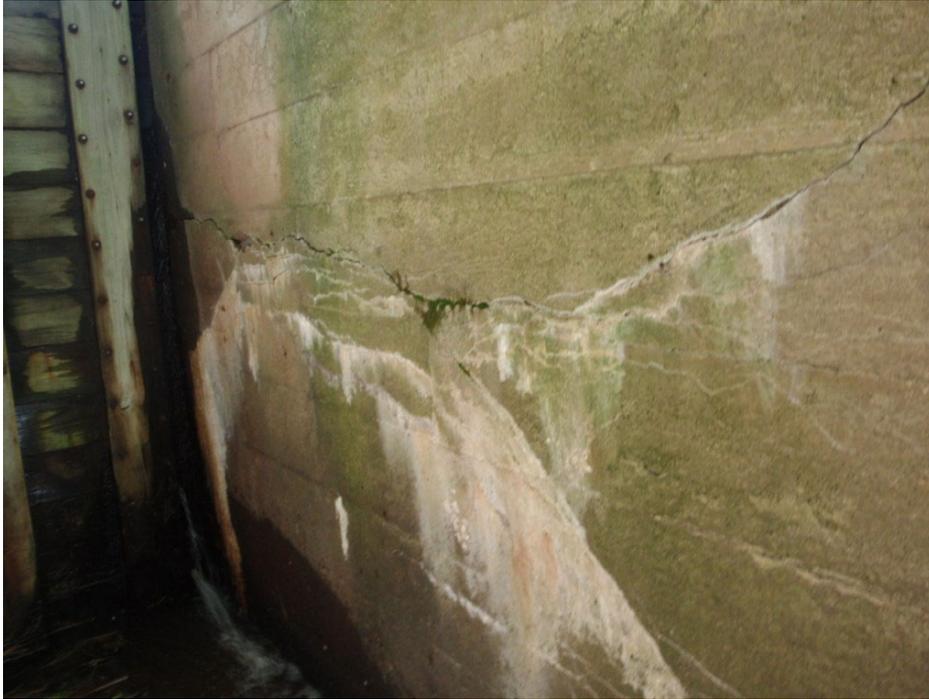
Photo 7: July 2014 looking upstream at the gate structure and wall separating the outlet from the spillway. Note the crack and deteriorated concrete.

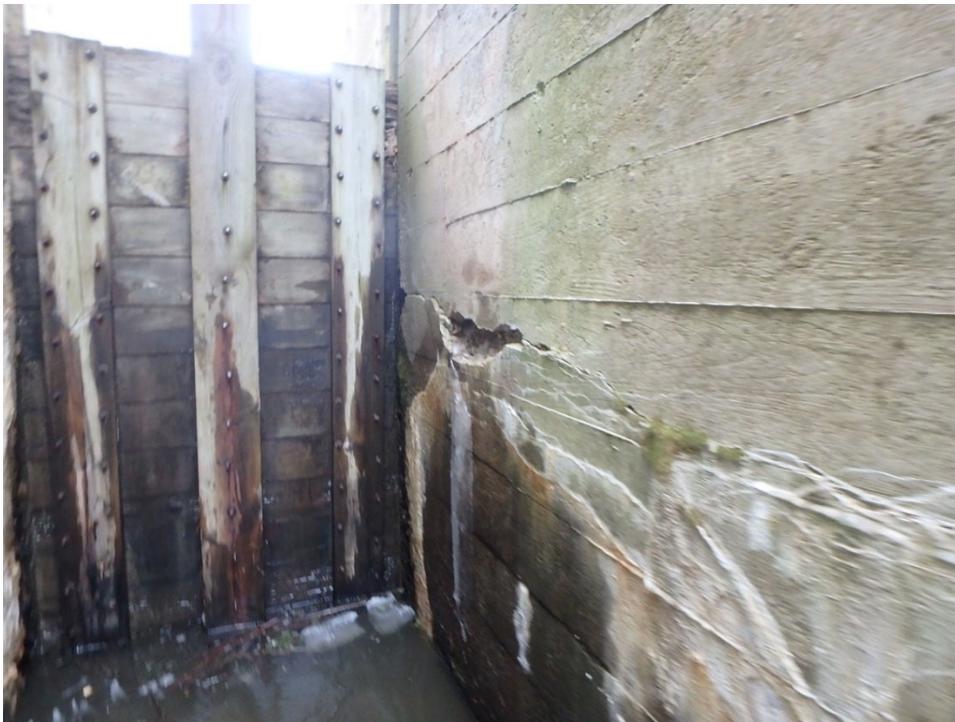
- **Auxiliary Spillway:** There is no auxiliary spillway at the dam.
- **Low Level Outlet/Drawdown Facility:** The outlet consists of a concrete channel and timber slide gate that can be opened to discharge flow/lower the impoundment. The gate was not test operated as part of the inspection, but the Owner reported the gate was last operated without issue in Fall 2020. The right concrete training wall of the outlet works is also the right abutment wall of the dam. The wall has a vertical crack between the main portion of the wall and the wing wall on the upstream side that has an opening up 2-inches. On the face of the wall at this location near the normal water level, an approximately 18-inch-deep section loss with exposed spalling concrete/aggregate was observed and appears to be worsening based on review of past inspection photographs. The wall appears to be tilted inwards towards the outlet/spillway on the order of 1 to 3 degrees, similar to the left wall dividing the outlet channel from the spillway. As noted above, the left wall is in poor condition, cracked at the gate contact, tilted towards the spillway, and undermined at the downstream end.

Photo 8: March 2021 looking upstream at the gate structure and wall separating the outlet from the spillway. Note the continued deterioration of concrete and displacement of the wall towards the spillway above the crack.

- Cut out the top timbers of the slide gate (not the frame) so that the top approximately matches the crest of the principal spillway to reduce loading on the marginally stable structure.

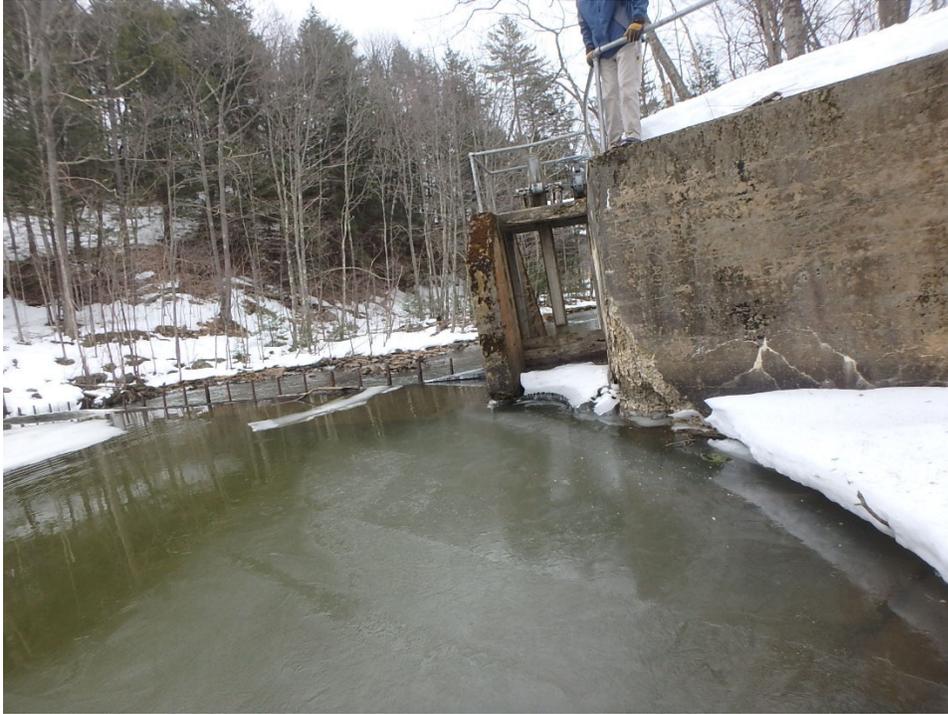
Photo 9: March 2021 looking downstream from the right abutment area. Note the section loss of the right training wall.
