To Laurence Becker, Vermont State Geologist
From: George Springston, Research Associate, Norwich University
Date: August 15, 2012
Subject: Slope Stability Issues in Barre City, May, 2011

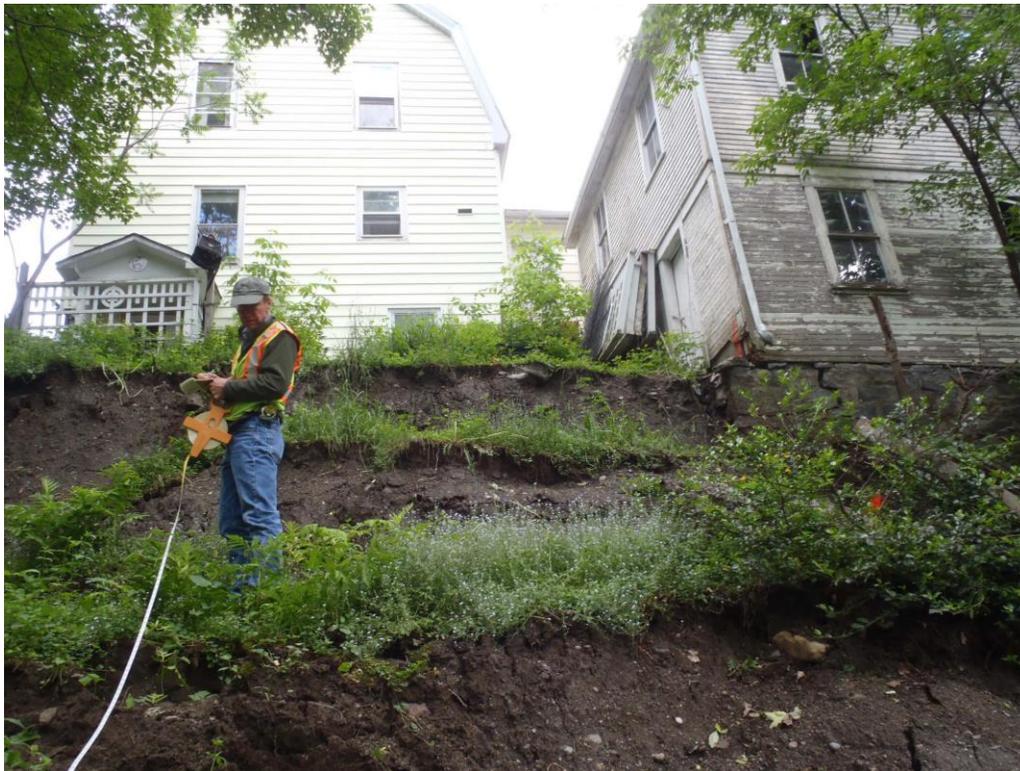
We examined three properties on Hilltop Avenue (Numbers 15, 17, and 21). Active, shallow, translational sliding has occurred at the top of slope, severe ground fracturing is visible behind each of these houses. The ground is pulling away and dropping down from the back sides of foundations and some foundation cracks are visible. This slope instability is threatening the stability of the houses and associated outbuildings. See the photos below.

Landsliding behind houses at Hilltop Avenue Three fresh fault scarps are visible, indicating recent and ongoing slope failure.

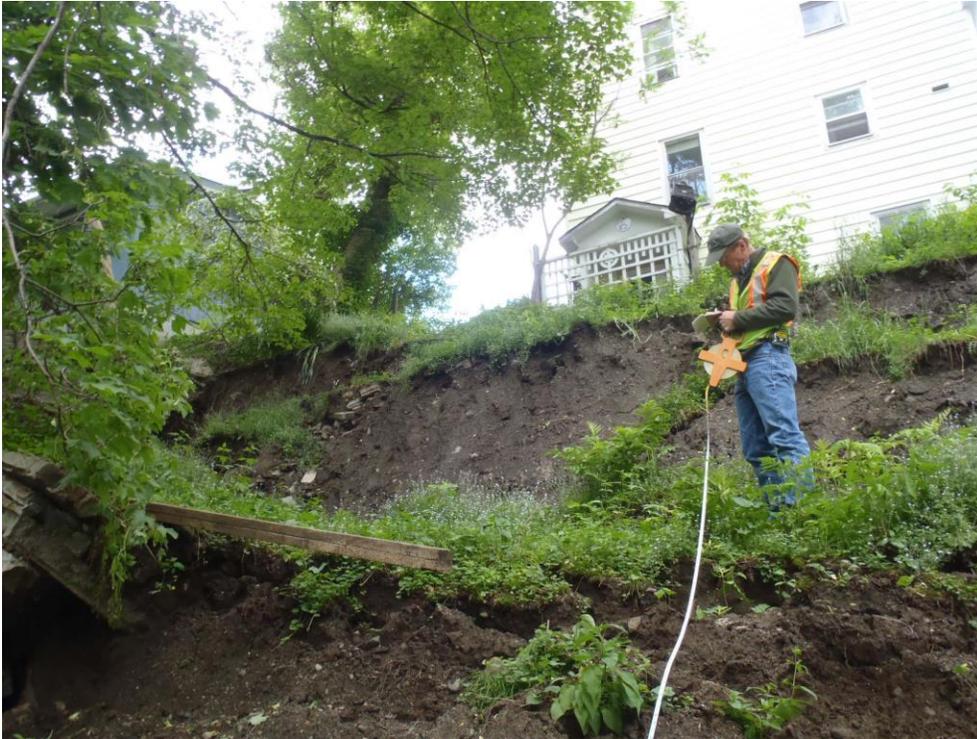
Another view of the active slope failures at Hilltop Avenue.

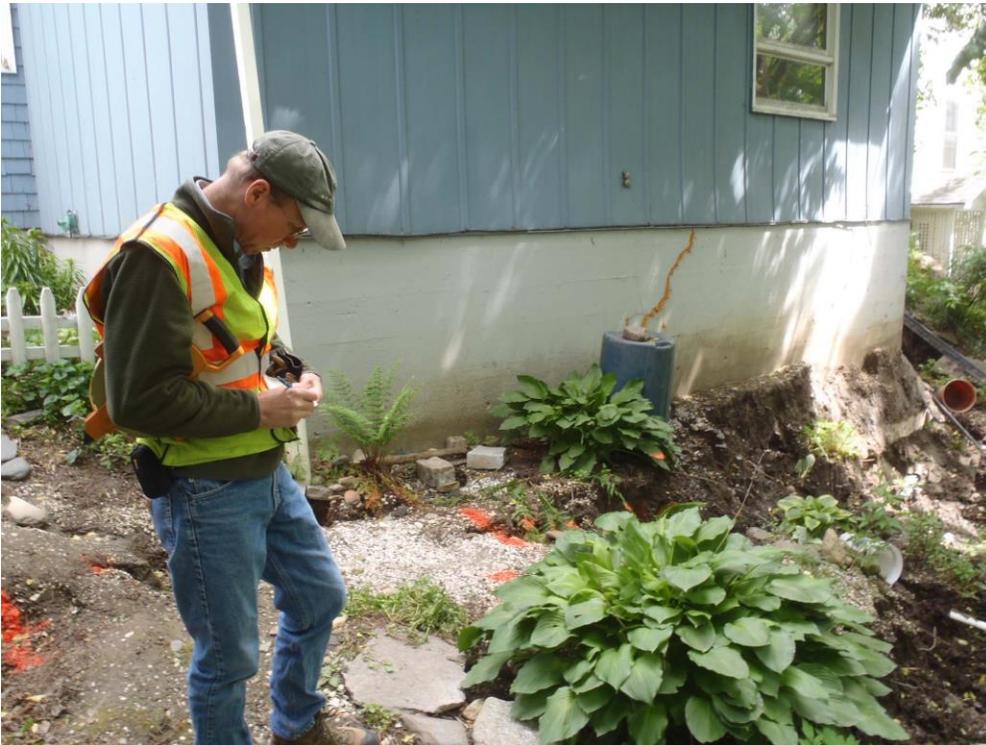
Soil pulling away from the rear of a foundation at Hilltop Avenue.

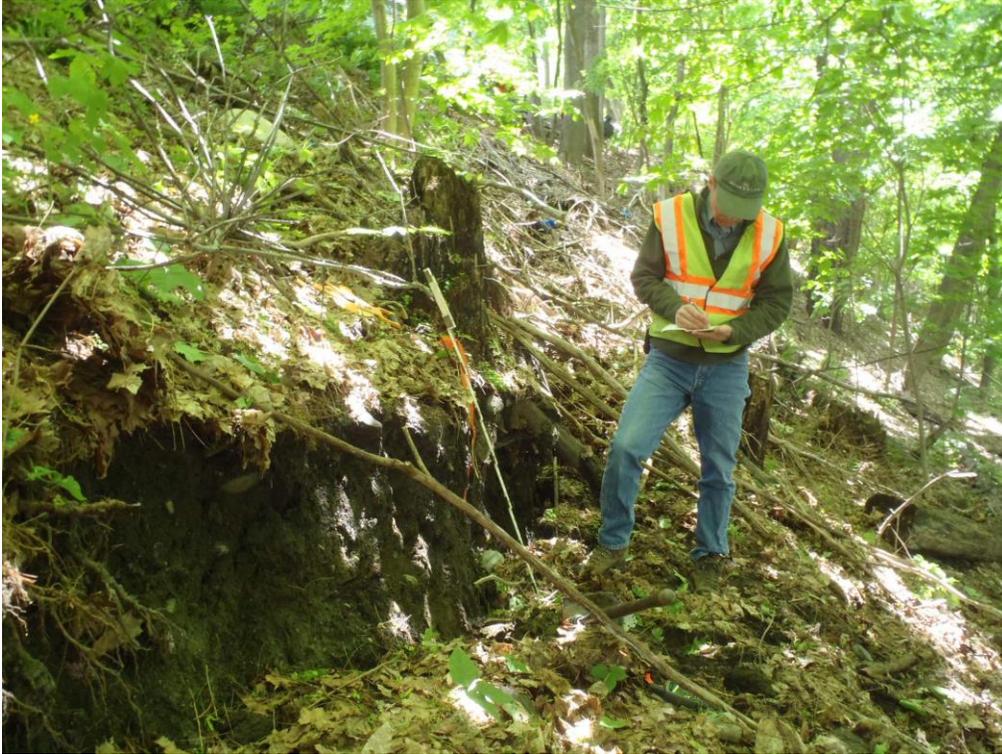
A fracture in soil in the woods below Hilltop Terrace.

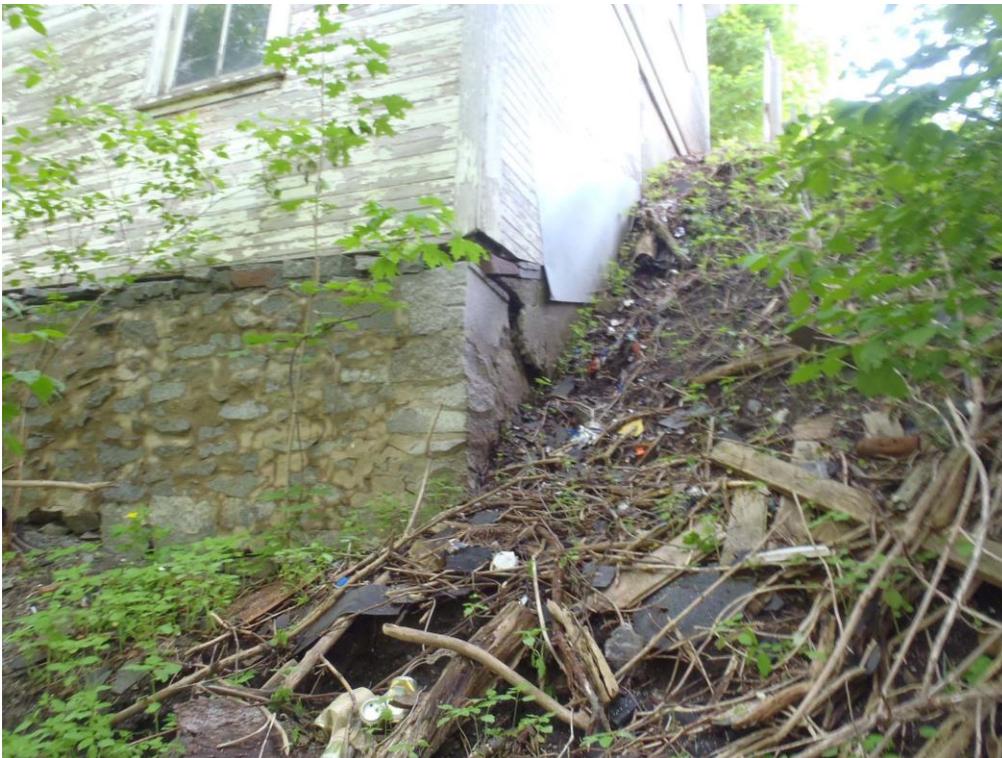
View from below looking up at cracked foundation of garage, Hilltop Avenue.

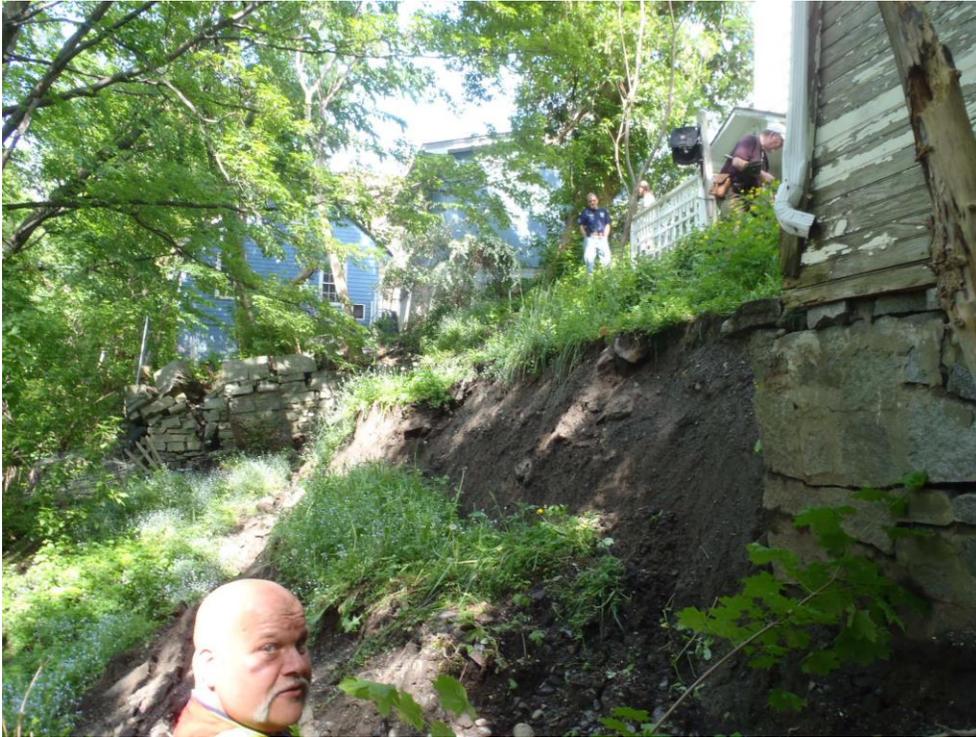
Slope instability behind houses at top of slope behind houses on Hilltop Avenue. Note landslide scarp to left of stone foundation.

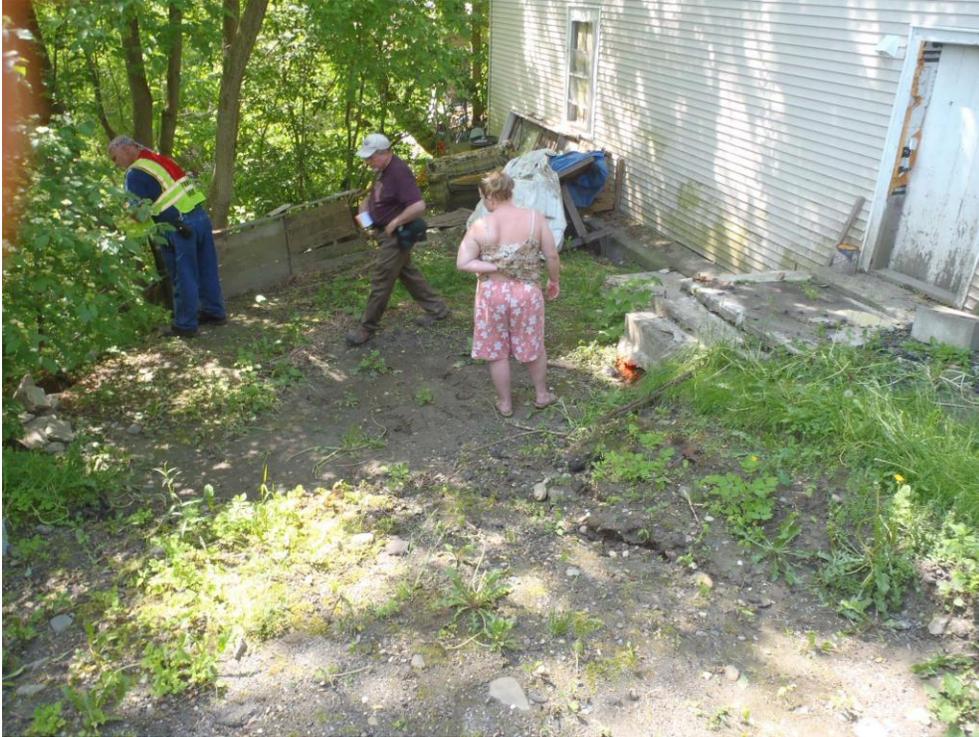
A translational landslide approximately 41 feet high has developed on the back side of Number 13, Foster Street. River Street runs along the base of this slope. Note that the base of the slope is reinforced with a retaining wall, indicating that slope stability has been a problem here in the past. The foundation of the house did not, however, appear to be immediately threatened. To the east of this house the soil shows indications of cracking, and further evaluations should be undertaken. A house on River Street below this site could possibly be at risk. Surface water runoff from Bassett Street could be adding to the wetness of the main slope failure at this site.

Cracks in soil behind #13 Foster Street. Main scarp is to the left.

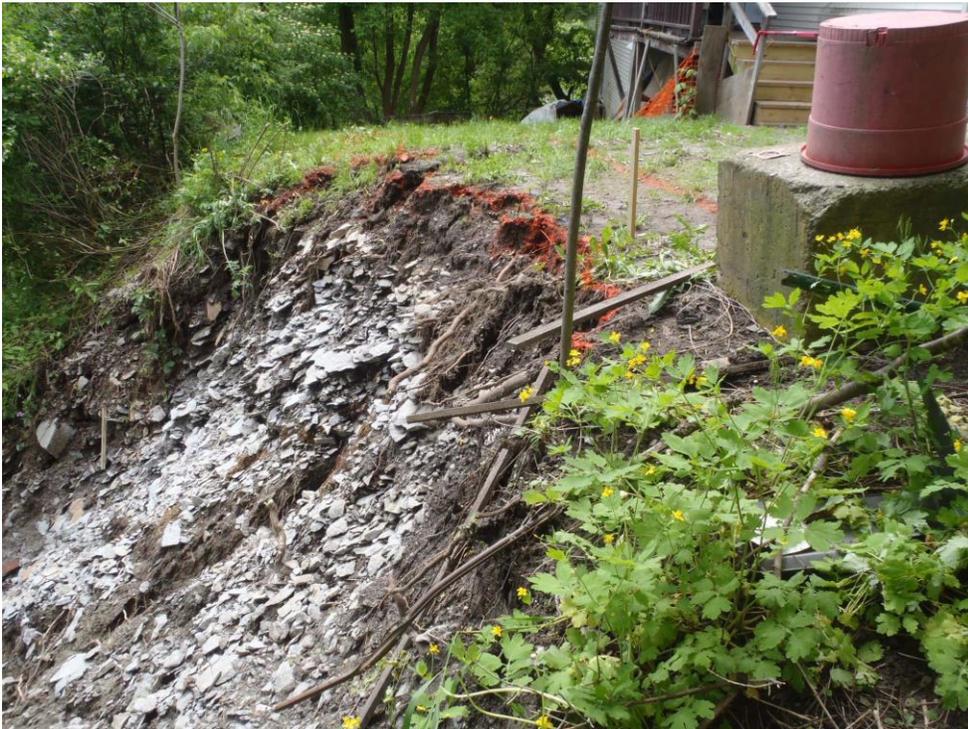
Top of main scarp at #13 Foster Street.

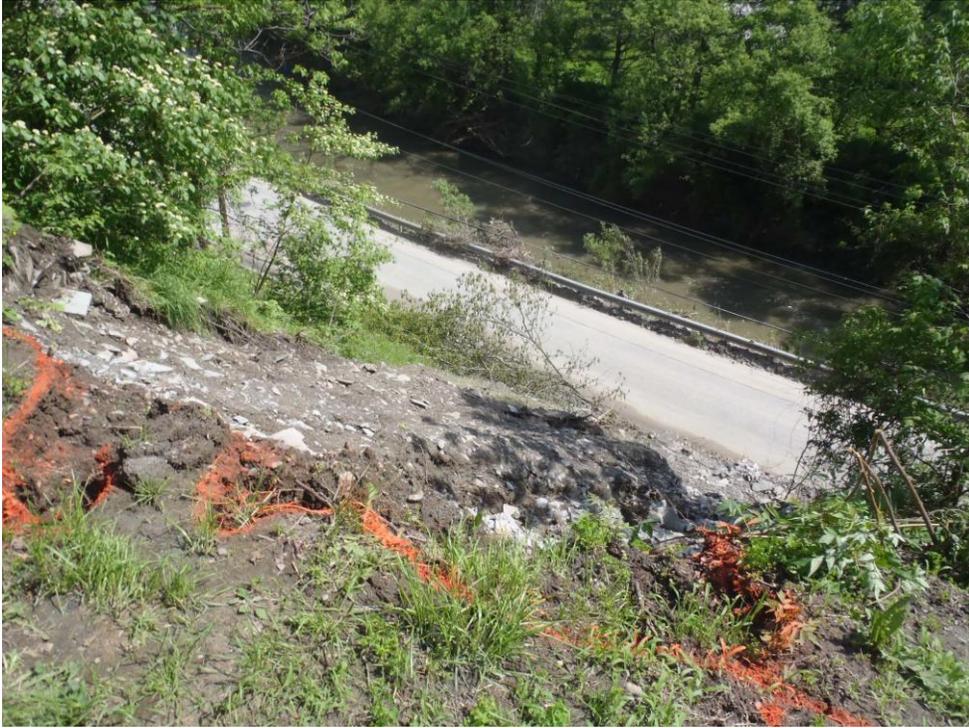
Looking down onto River Street at the main translational slide at #13 Foster St.

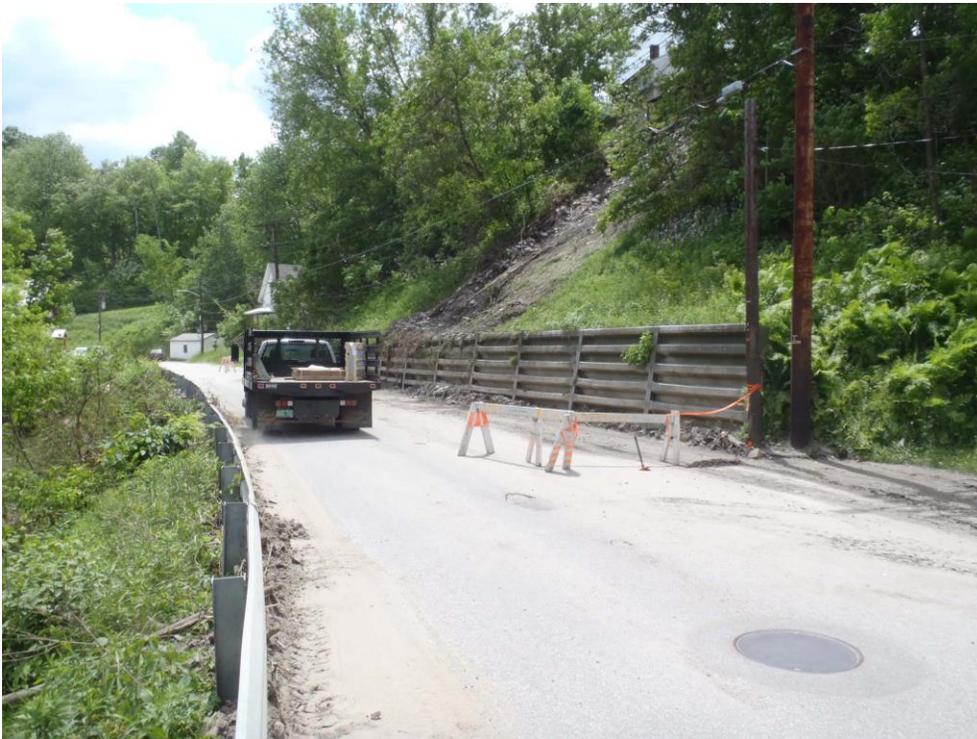
View from River Street of the retaining wall at the base of the slide behind #13 Foster Street.

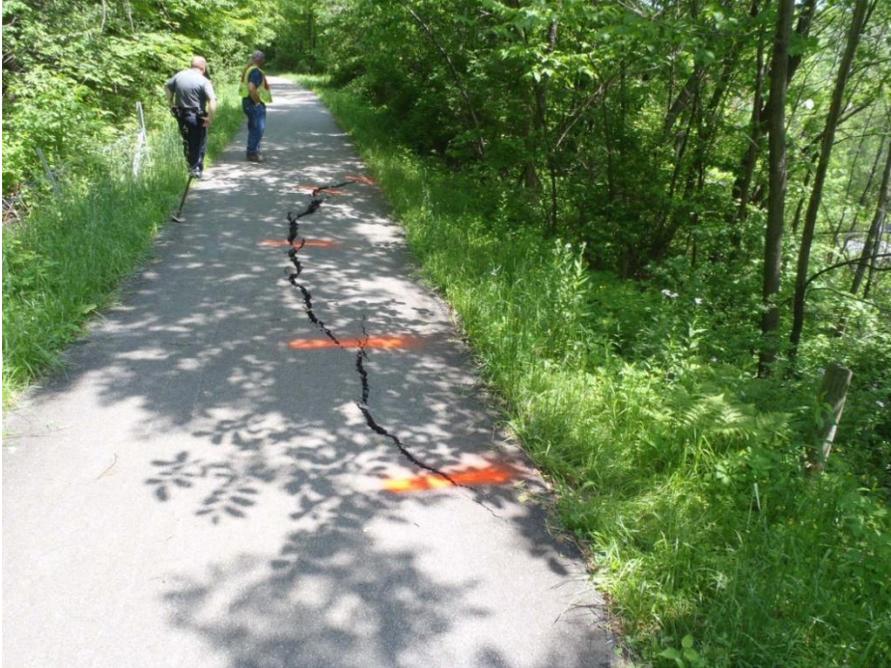
Fresh fractures in the paved recreation path indicate active subsidence. Water appears to be piping around the culvert below this spot, thus removing soil and leading to collapse. The site may actually be in Barre Town rather than Barre City.

Fractures in Recreation Path. These appear to be resulting from subsidence due to piping of water around the culvert under the site.

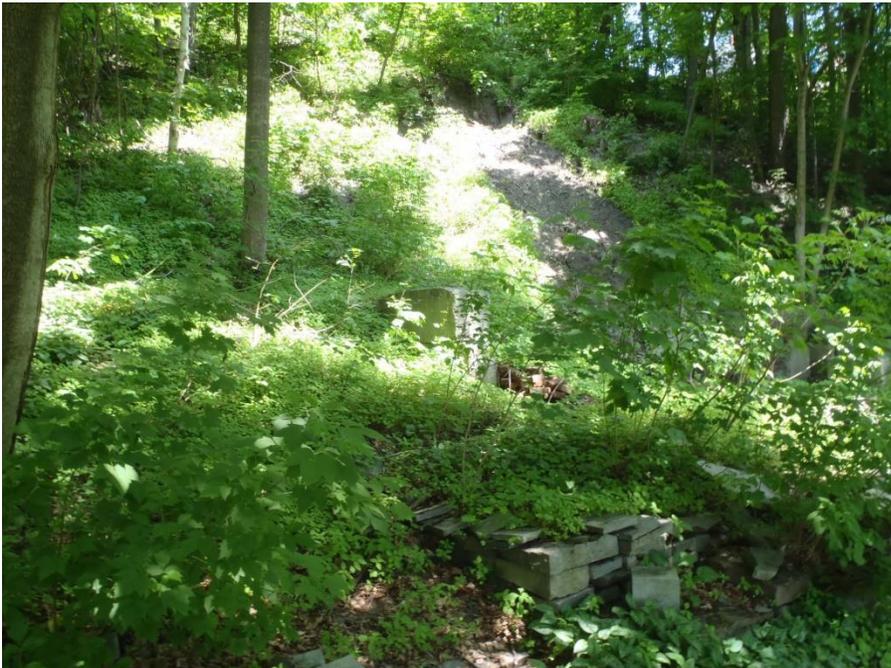
Outlet to the culvert on the recreation path.

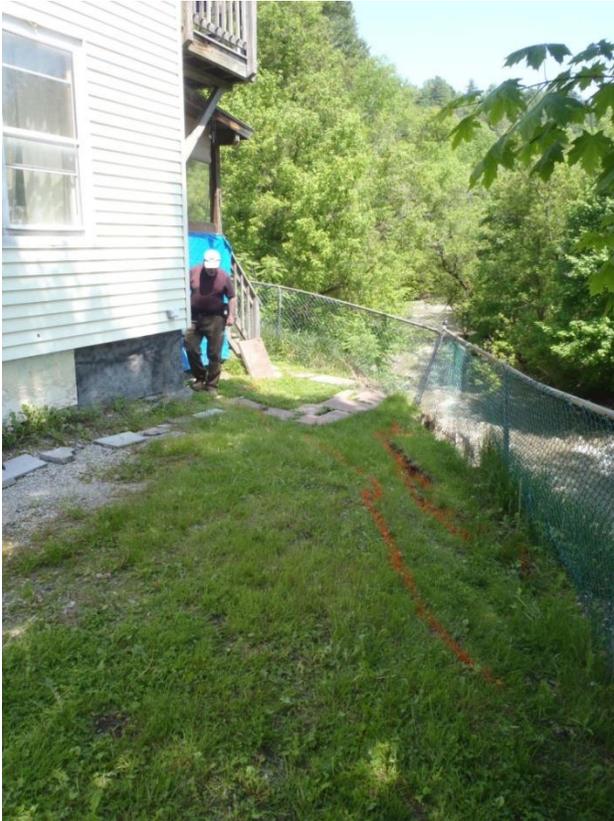
Severe bank erosion was observed behind a house on West Patterson Street (I did not get the house number). This site is on a steep bank above Gunner Brook. The bank is about 23 feet high, with an angle of 48 degrees from horizontal. An episode of stream erosion several years ago resulted in slope failure at the site. In the week since the May26 storm, renewed fracturing of the soil at the top of the slope has occurred. The fractures are within 7 feet of the house and pose a severe risk to the future stability of the building.

Fracturing of soil behind the West Patterson Street house. Gunner Brook in the background.

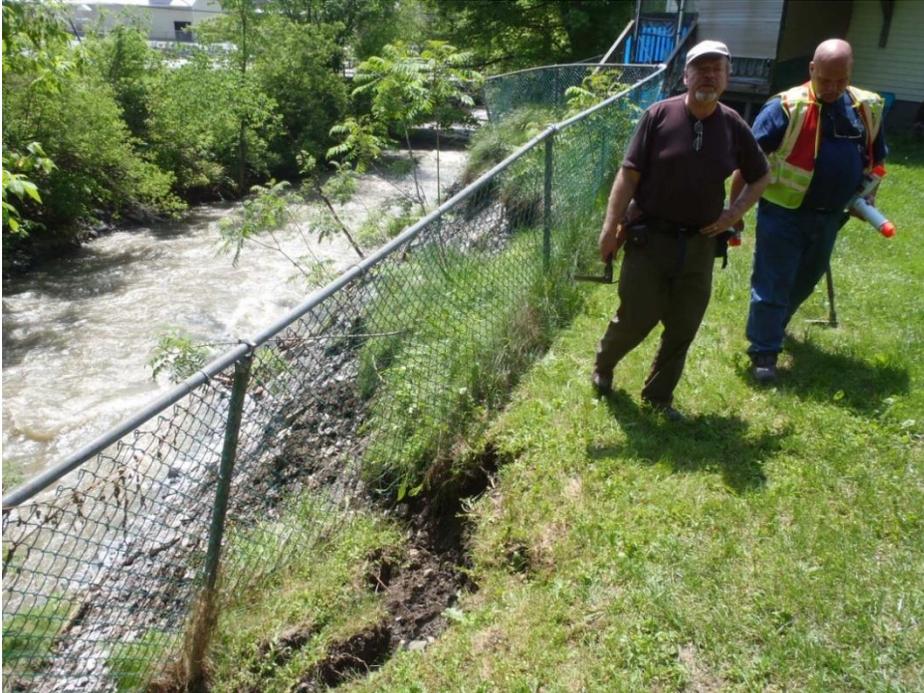
The top of the slope at the West Patterson Street house. Note that the bank at the fence is failing.

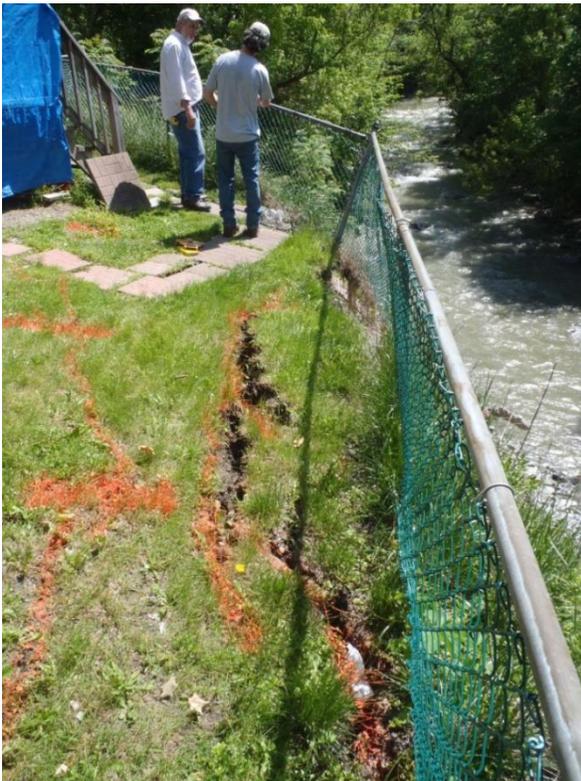
Fractures at the top of the slope at the West Patterson Street house. The house is immediately to the left. Looking upstream on Gunner Brook.

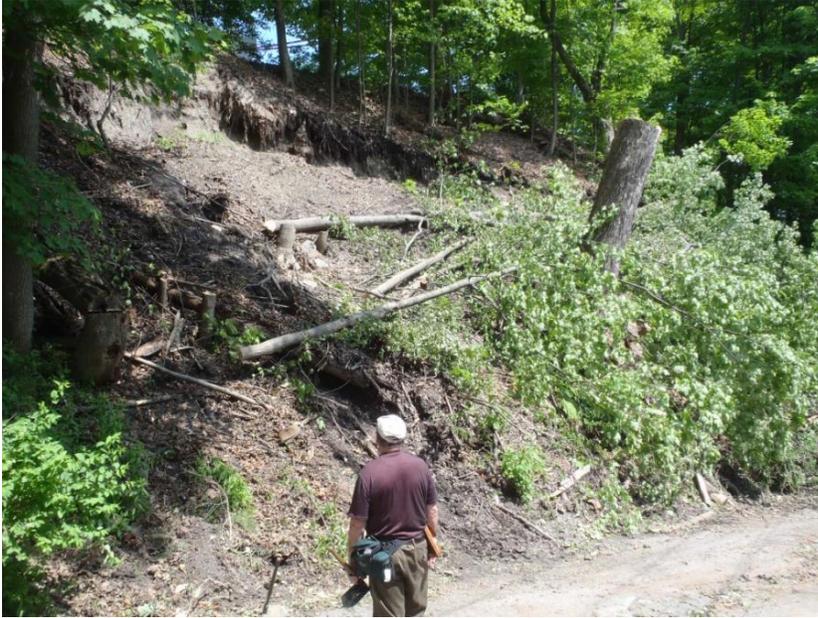
An active rotational slump-flow type of landslide is located on West Patterson Street. A crack in the soil was observed about 6 feet behind the existing scarp, indicating a strong likelihood of future movement.

Rotational slump landslide above West Patterson Street. Looking up at scarp (in shadow).

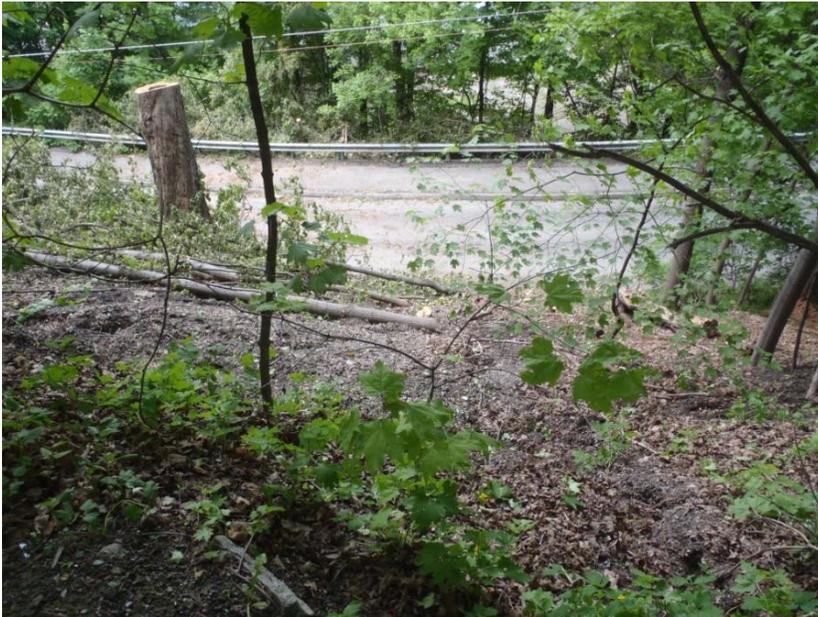
West Patterson Street landslide viewed from above.
