To: Laurence Becker, Vermont State Geologist

From: George Springston, Research Associate, Norwich University

Date: 9/3/2007

Subject: Erosion along Crosby Brook in Brattleboro

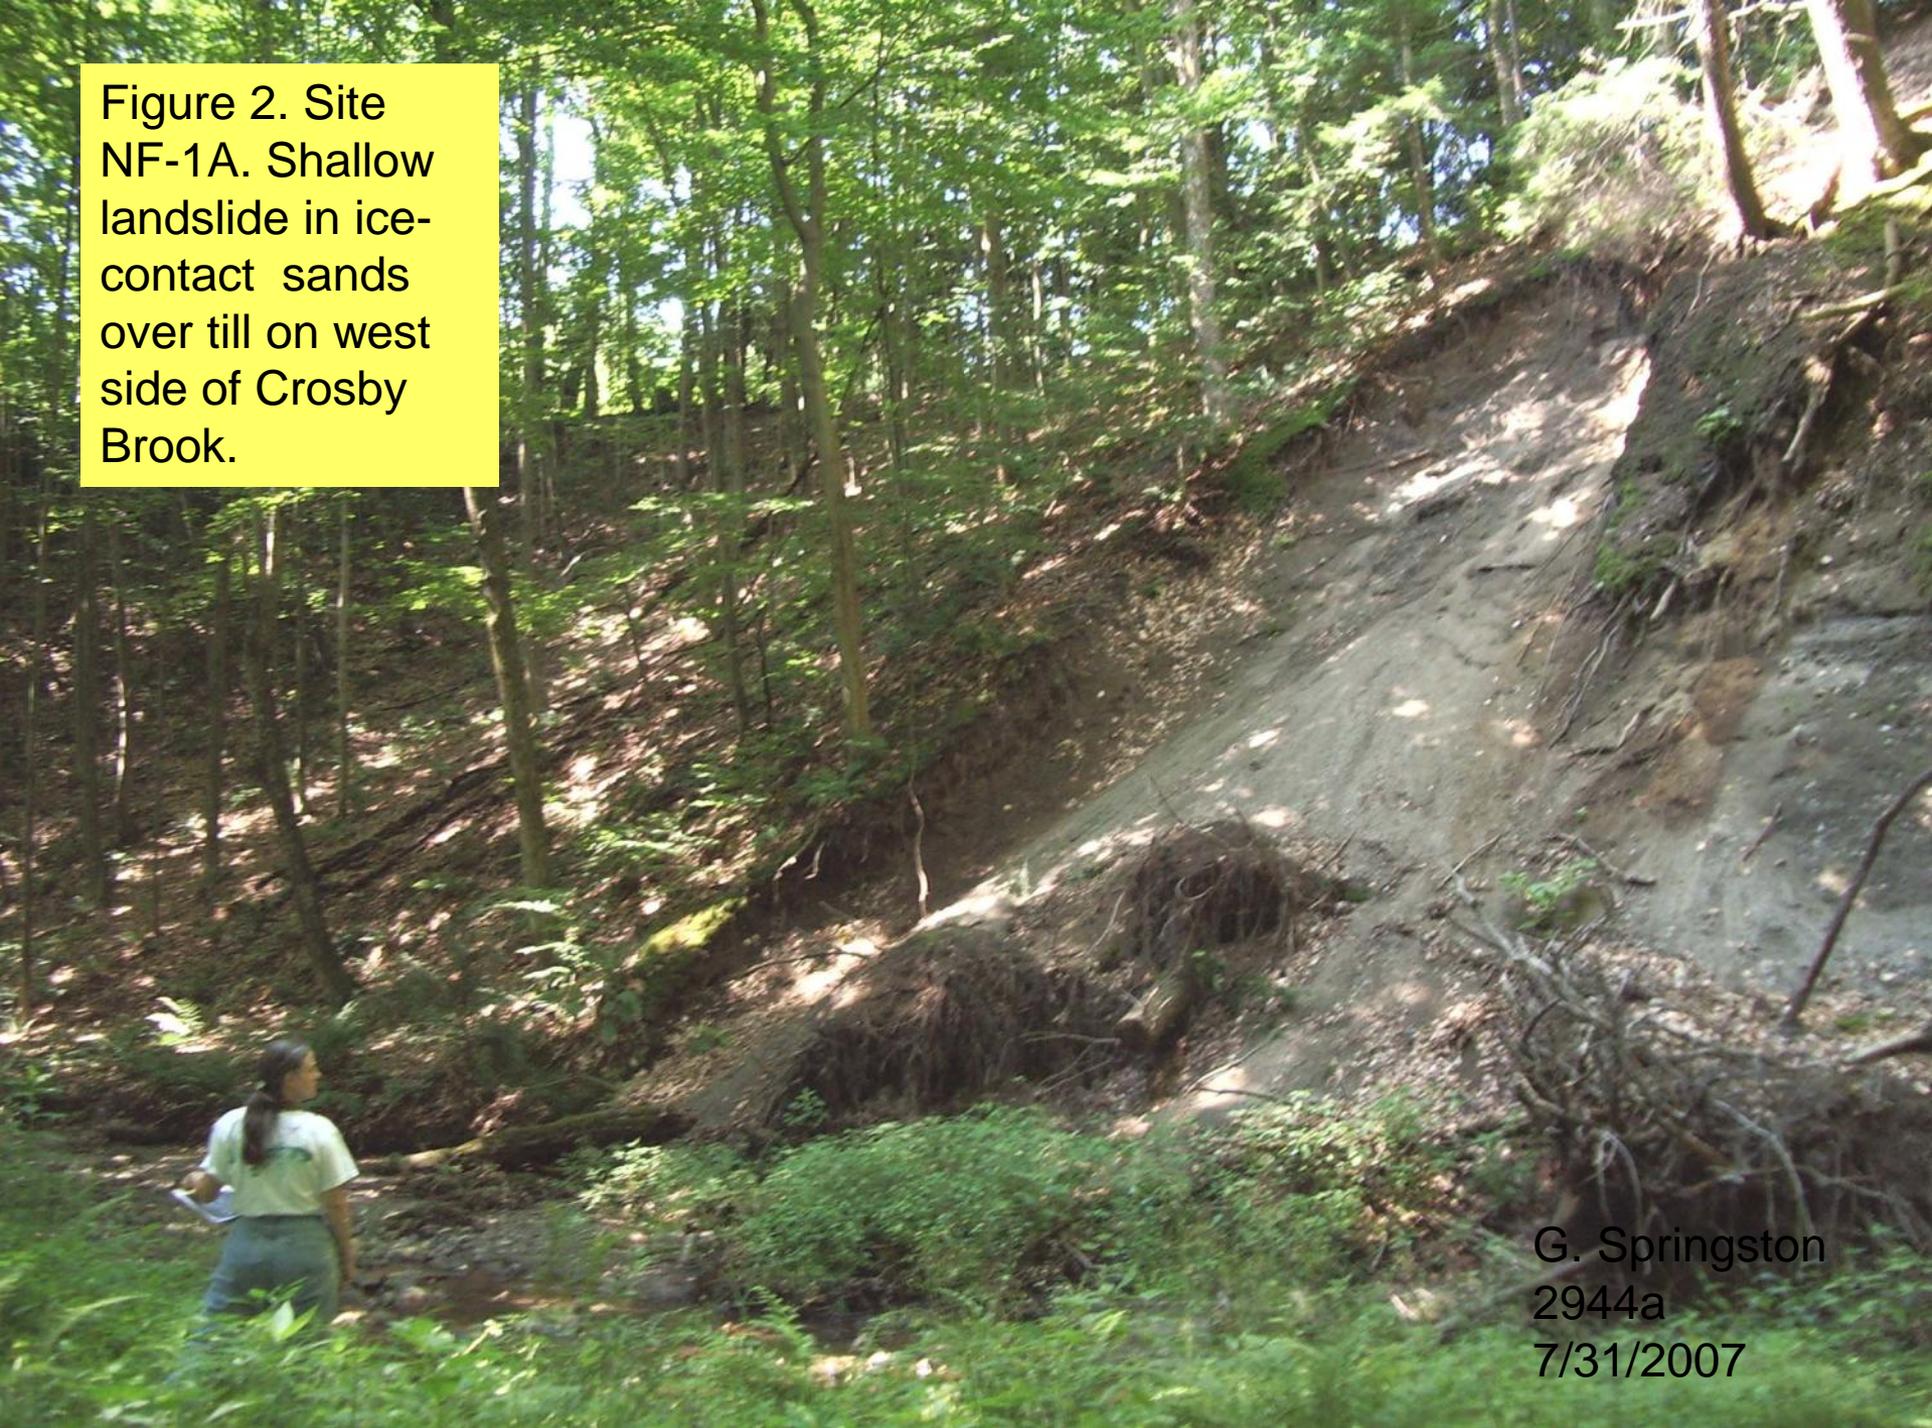
Site NF-1A is a 40-foot-high landslide on the outside of a bend on the west (right) bank of the brook (Figure 2). The materials consist of 30 feet of pebbly coarse sand, overlying 8 feet of sands, ranging from coarse to very fine, with minor silt and silty clay (Figure 3), overlying 2 feet or more of dense, silt-matrix till. Given the variable bedding orientation and the rapid variations in grain size, it appears that the materials overlying the till have formed in an ice-contact setting (something like an esker or kame terrace deposit). The east (left) bank at this bend is composed of alluvial materials.

Downstream of the slide we observed at least two headcuts, one of which appeared to have cut through recent alluvium and was incising into sands (ice-contact?) below. In order to understand the long-term stability of the slopes at this site it will be important to understand the extent of downstream grade control and whether or not incision is a dominant process at this site. Even a small amount of incision (1 to 2 feet) at site NF-1A may lead to increased landsliding.

Figure 2. Site NF-1A. Shallow landslide in ice-contact sands over till on west side of Crosby Brook.

The likelihood of incision should be evaluated at NF-1A. Incision would lead to an increase in the effective bank height and further loss of floodplain access and would be very likely to lead to increased landsliding at this site. Although only of moderate severity at the moment, the slide at NF-1A could become much larger.

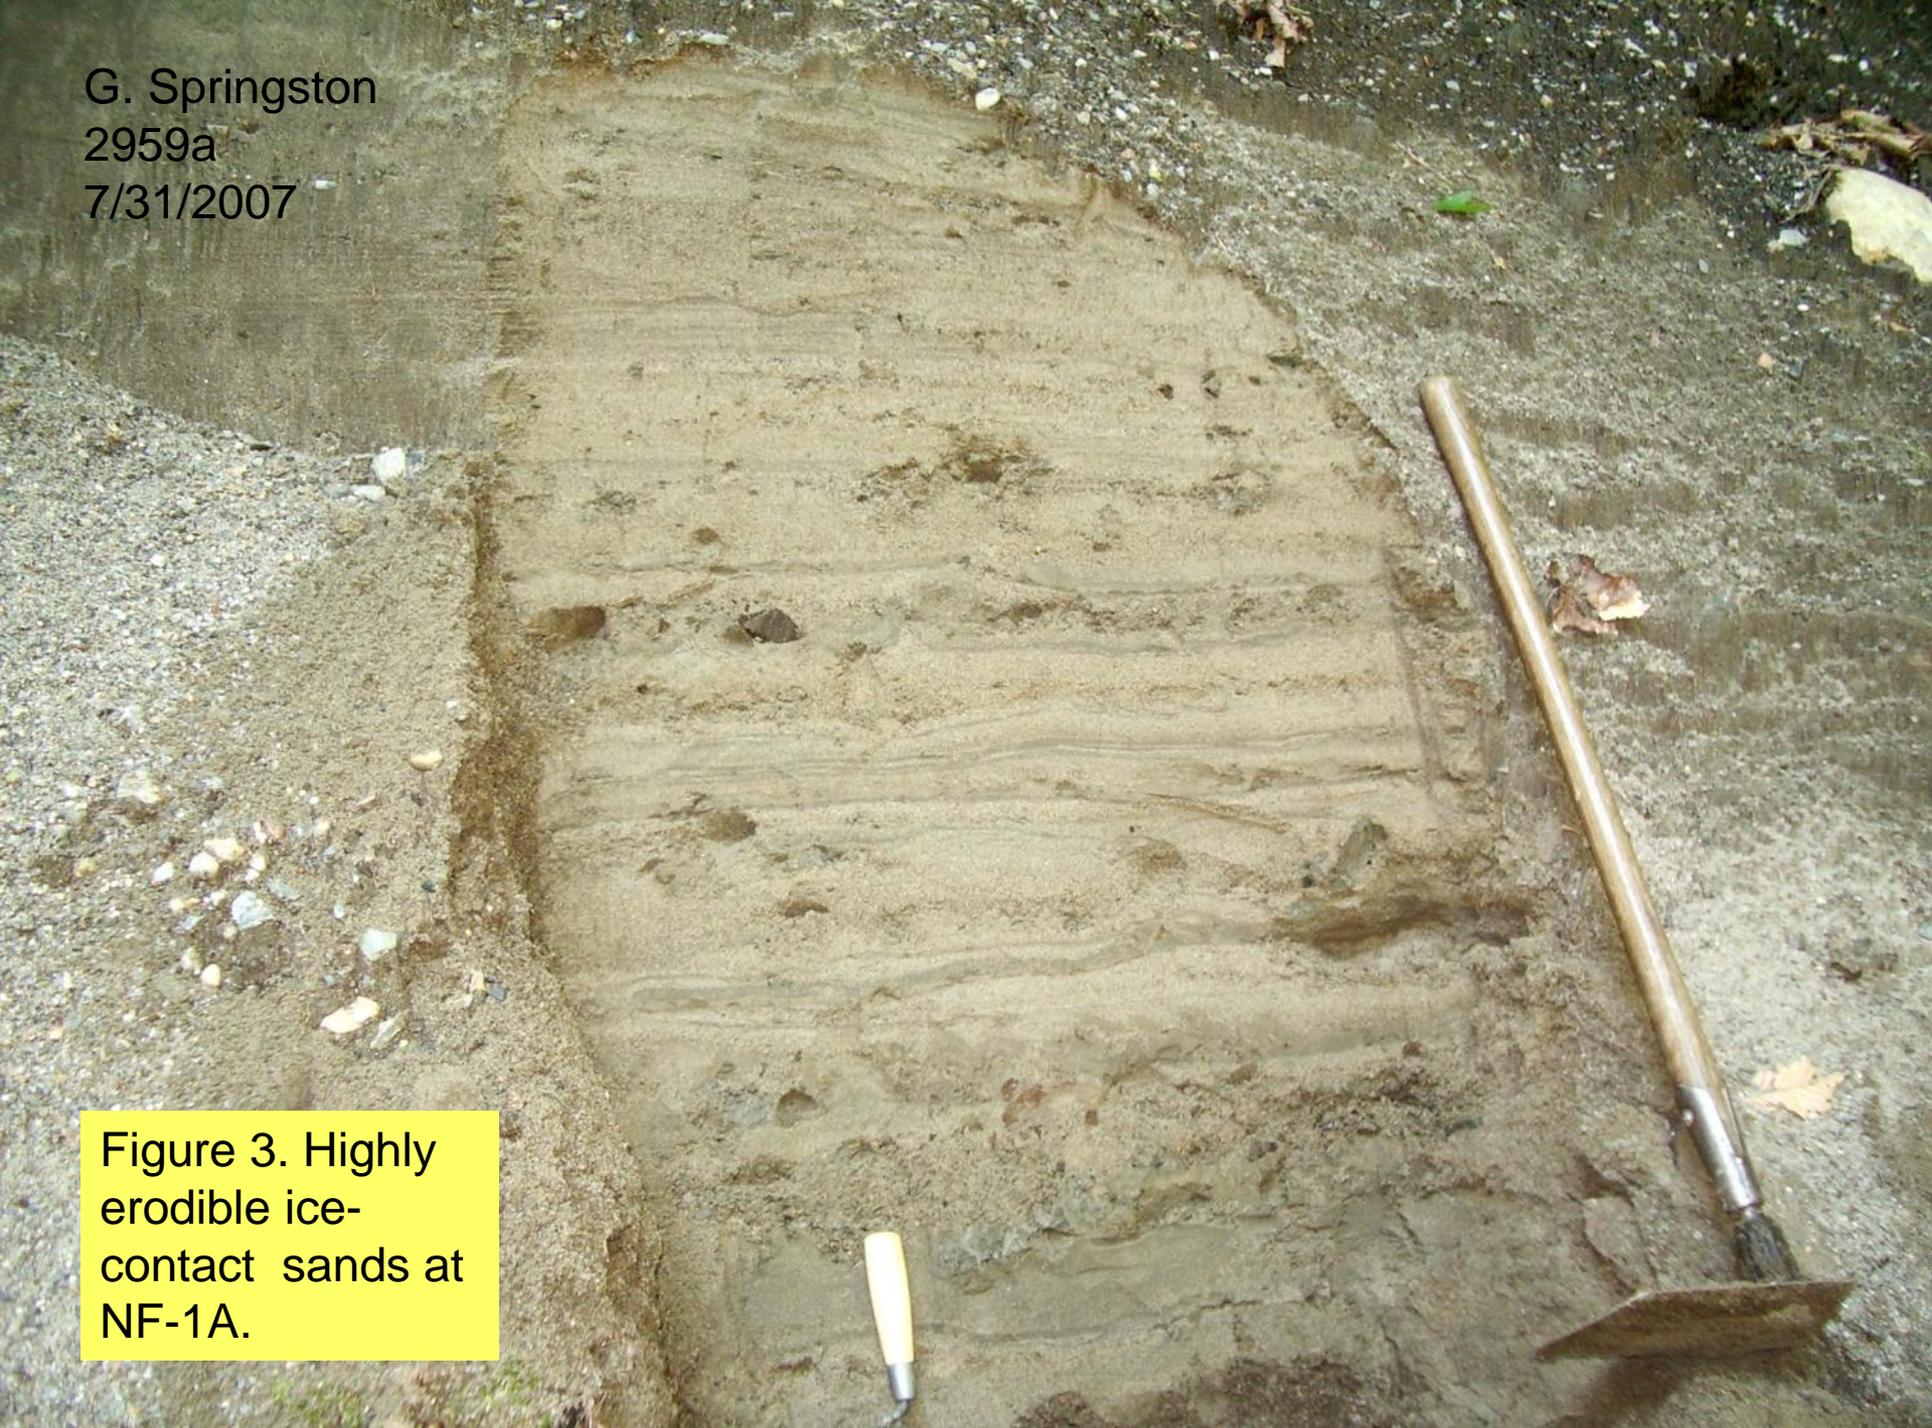
Figure 3. Highly erodible ice-contact sands at NF-1A.

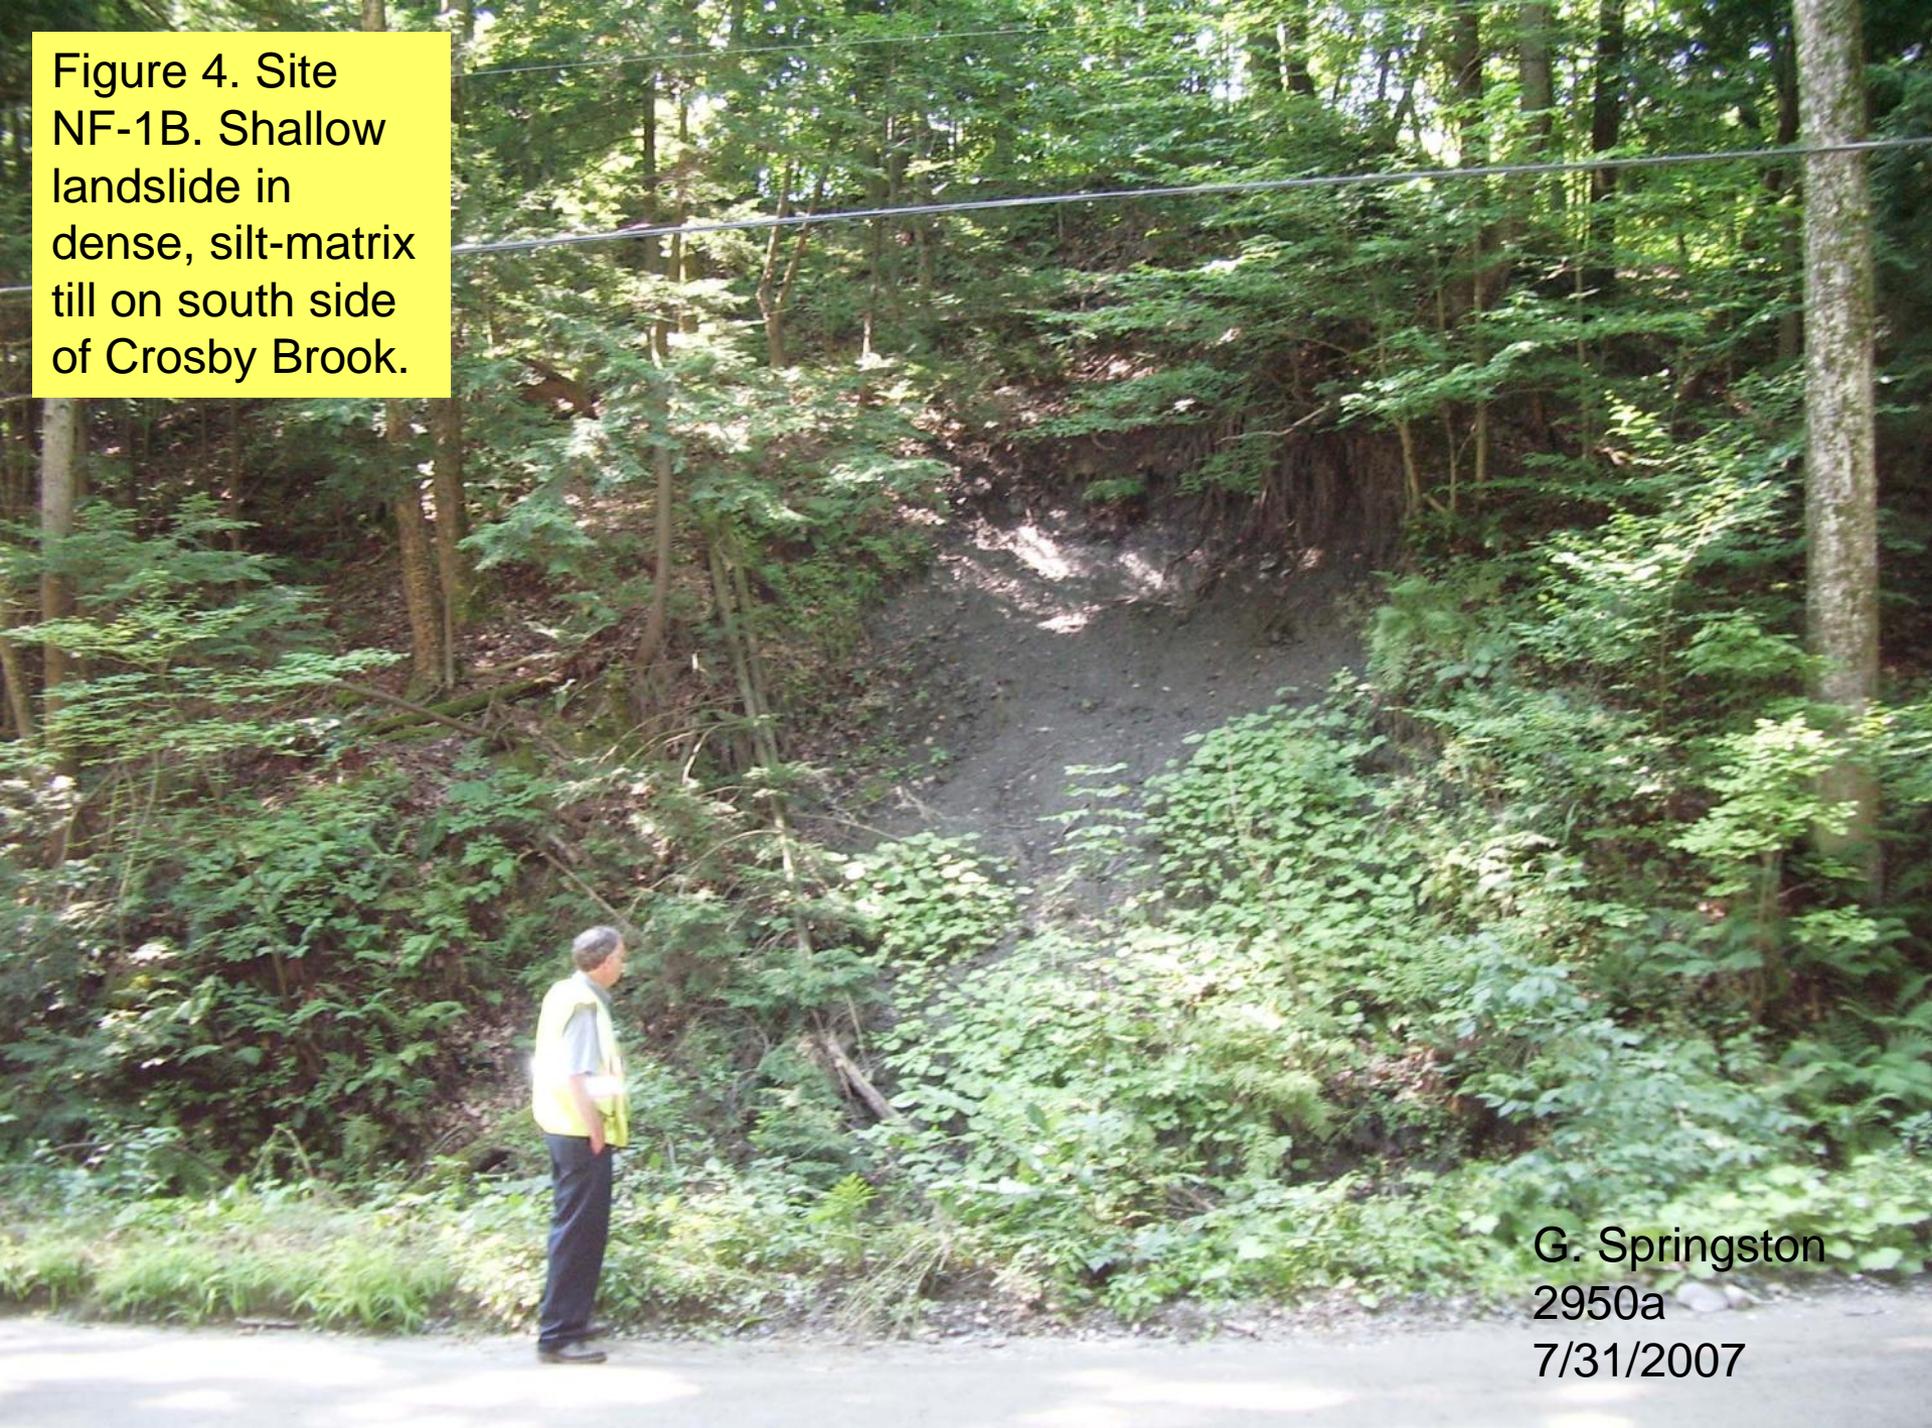
Turning west onto Black Mountain Road, we observed a roughly 35-foot-high landslide in dense, silt-matrix till on the south side of the brook at Site NF-1B (Figure 4). A partly healed landslide scar at this site indicates that it was active in earlier years, stabilized, and has now become active again. Note that the weathered upper parts of this till (upper 2 to 4 feet) are more erodible than the lower, less weathered parts. Thus, landslides in this material tend to be fairly shallow.

Figure 4. Site
NF-1B. Shallow
landslide in
dense, silt-matrix
till on south side
of Crosby Brook.

The slope instability alongside of the brook from NF-1B to D (along Black Mountain Road) is fairly moderate at present. These slides are certainly contributing sediment to the system, but the dense till is about the least erodible surficial material we have and at least it contributes some boulders as well as finer-grained materials. Given the presence of bedrock grade control from about NF-1D upstream, incision is unlikely to be a problem in the higher parts of the stream, although lateral erosion remains a possibility. Although the valley is quite narrow, perhaps some ways can be found to restore some floodplain access. At the very least, further roadway expansion should be avoided and sediment runoff from the road surface and banks should be minimized.

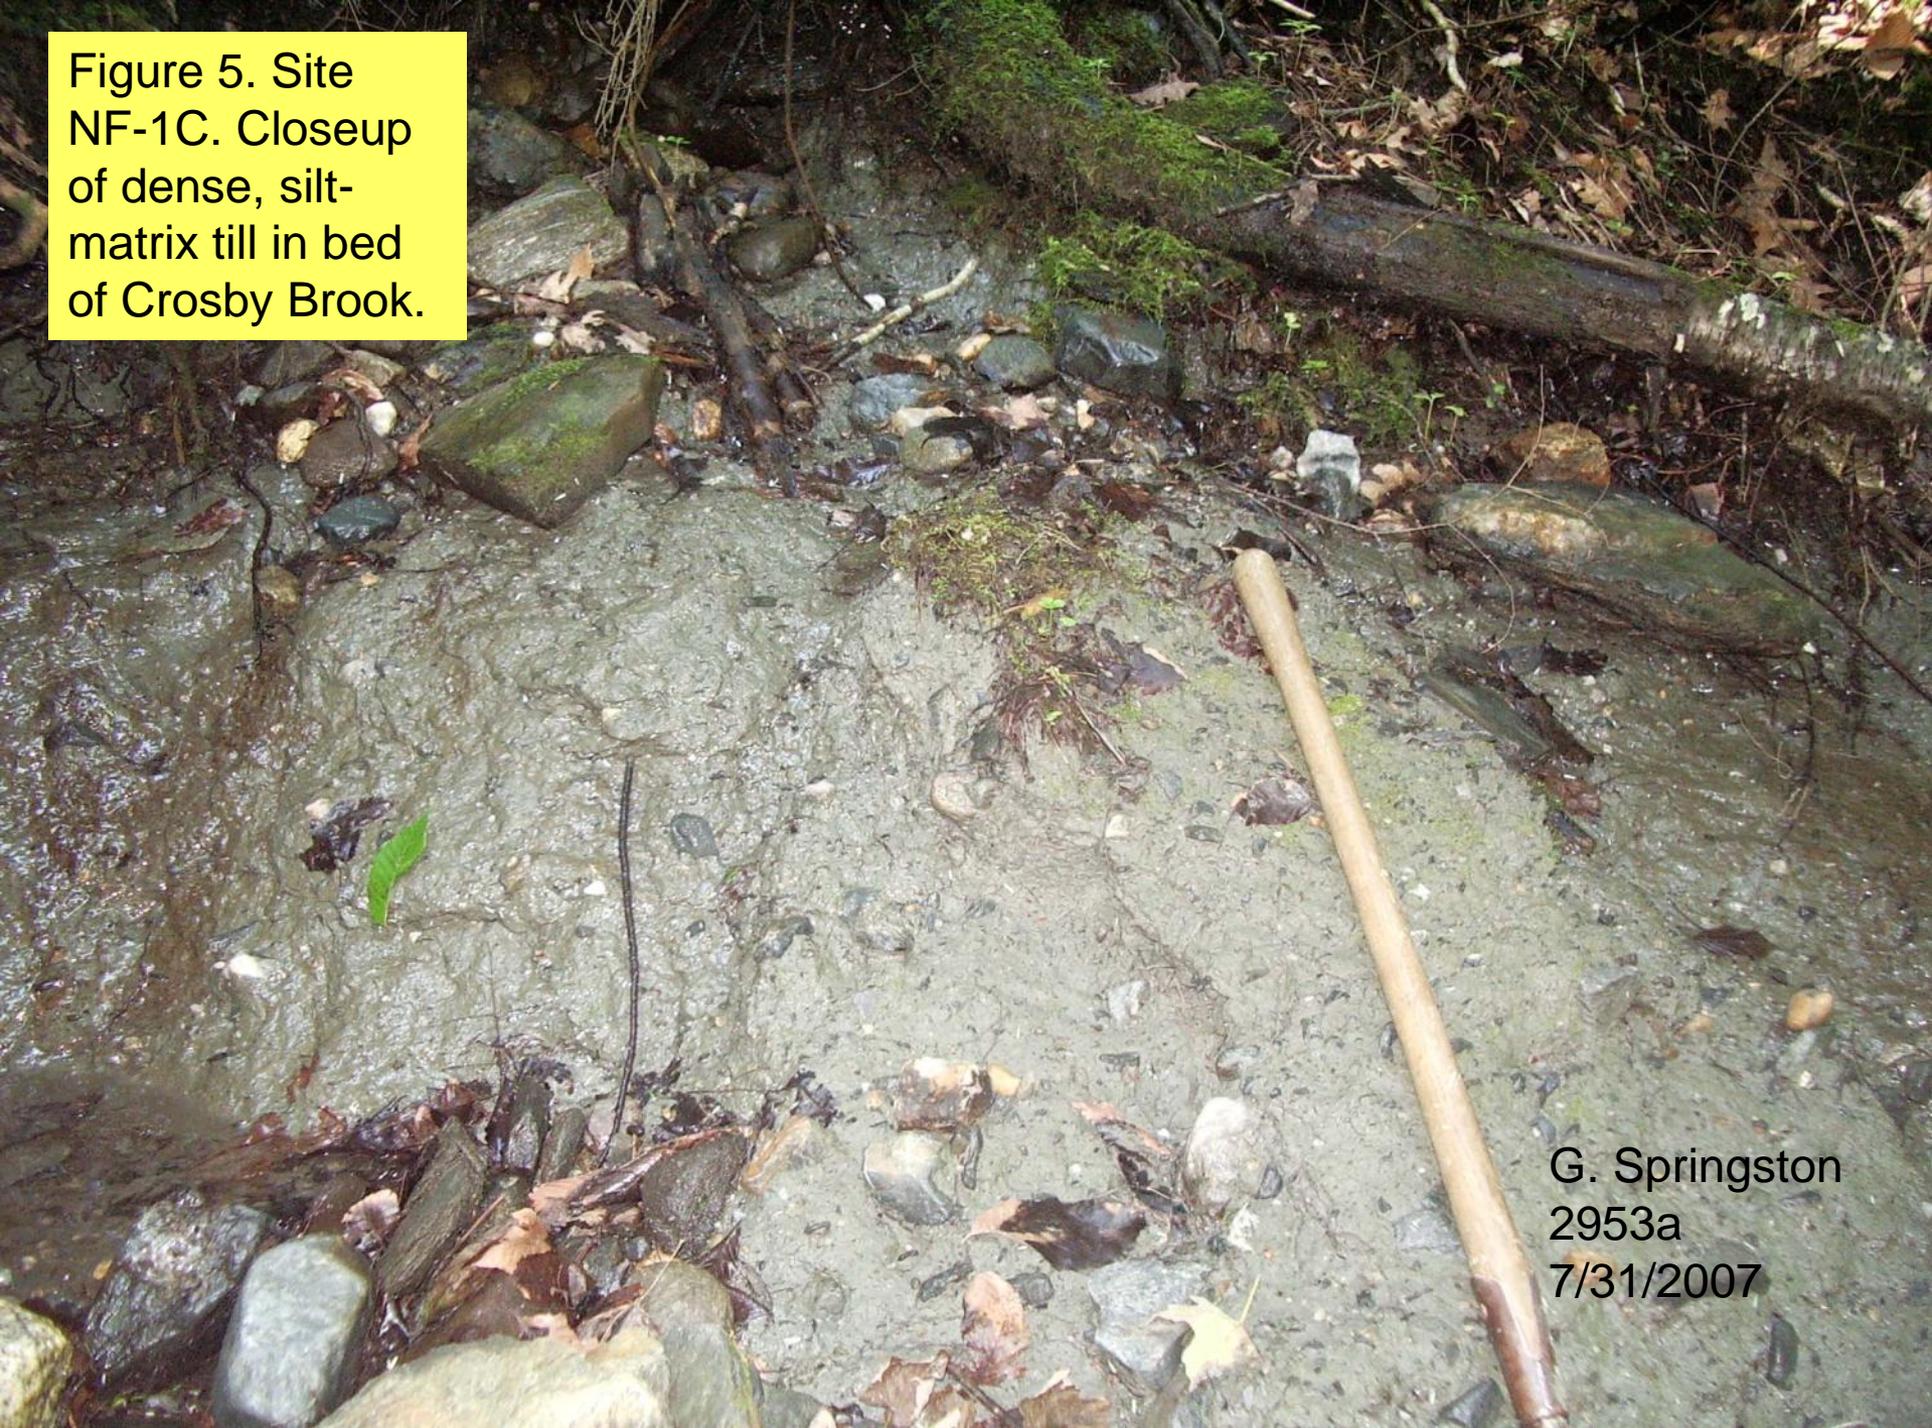
Dense till is again exposed at the base of a gully on the south side of the brook (Figure 5).

Figure 5. Site NF-1C. Closeup of dense, silt-matrix till in bed of Crosby Brook.

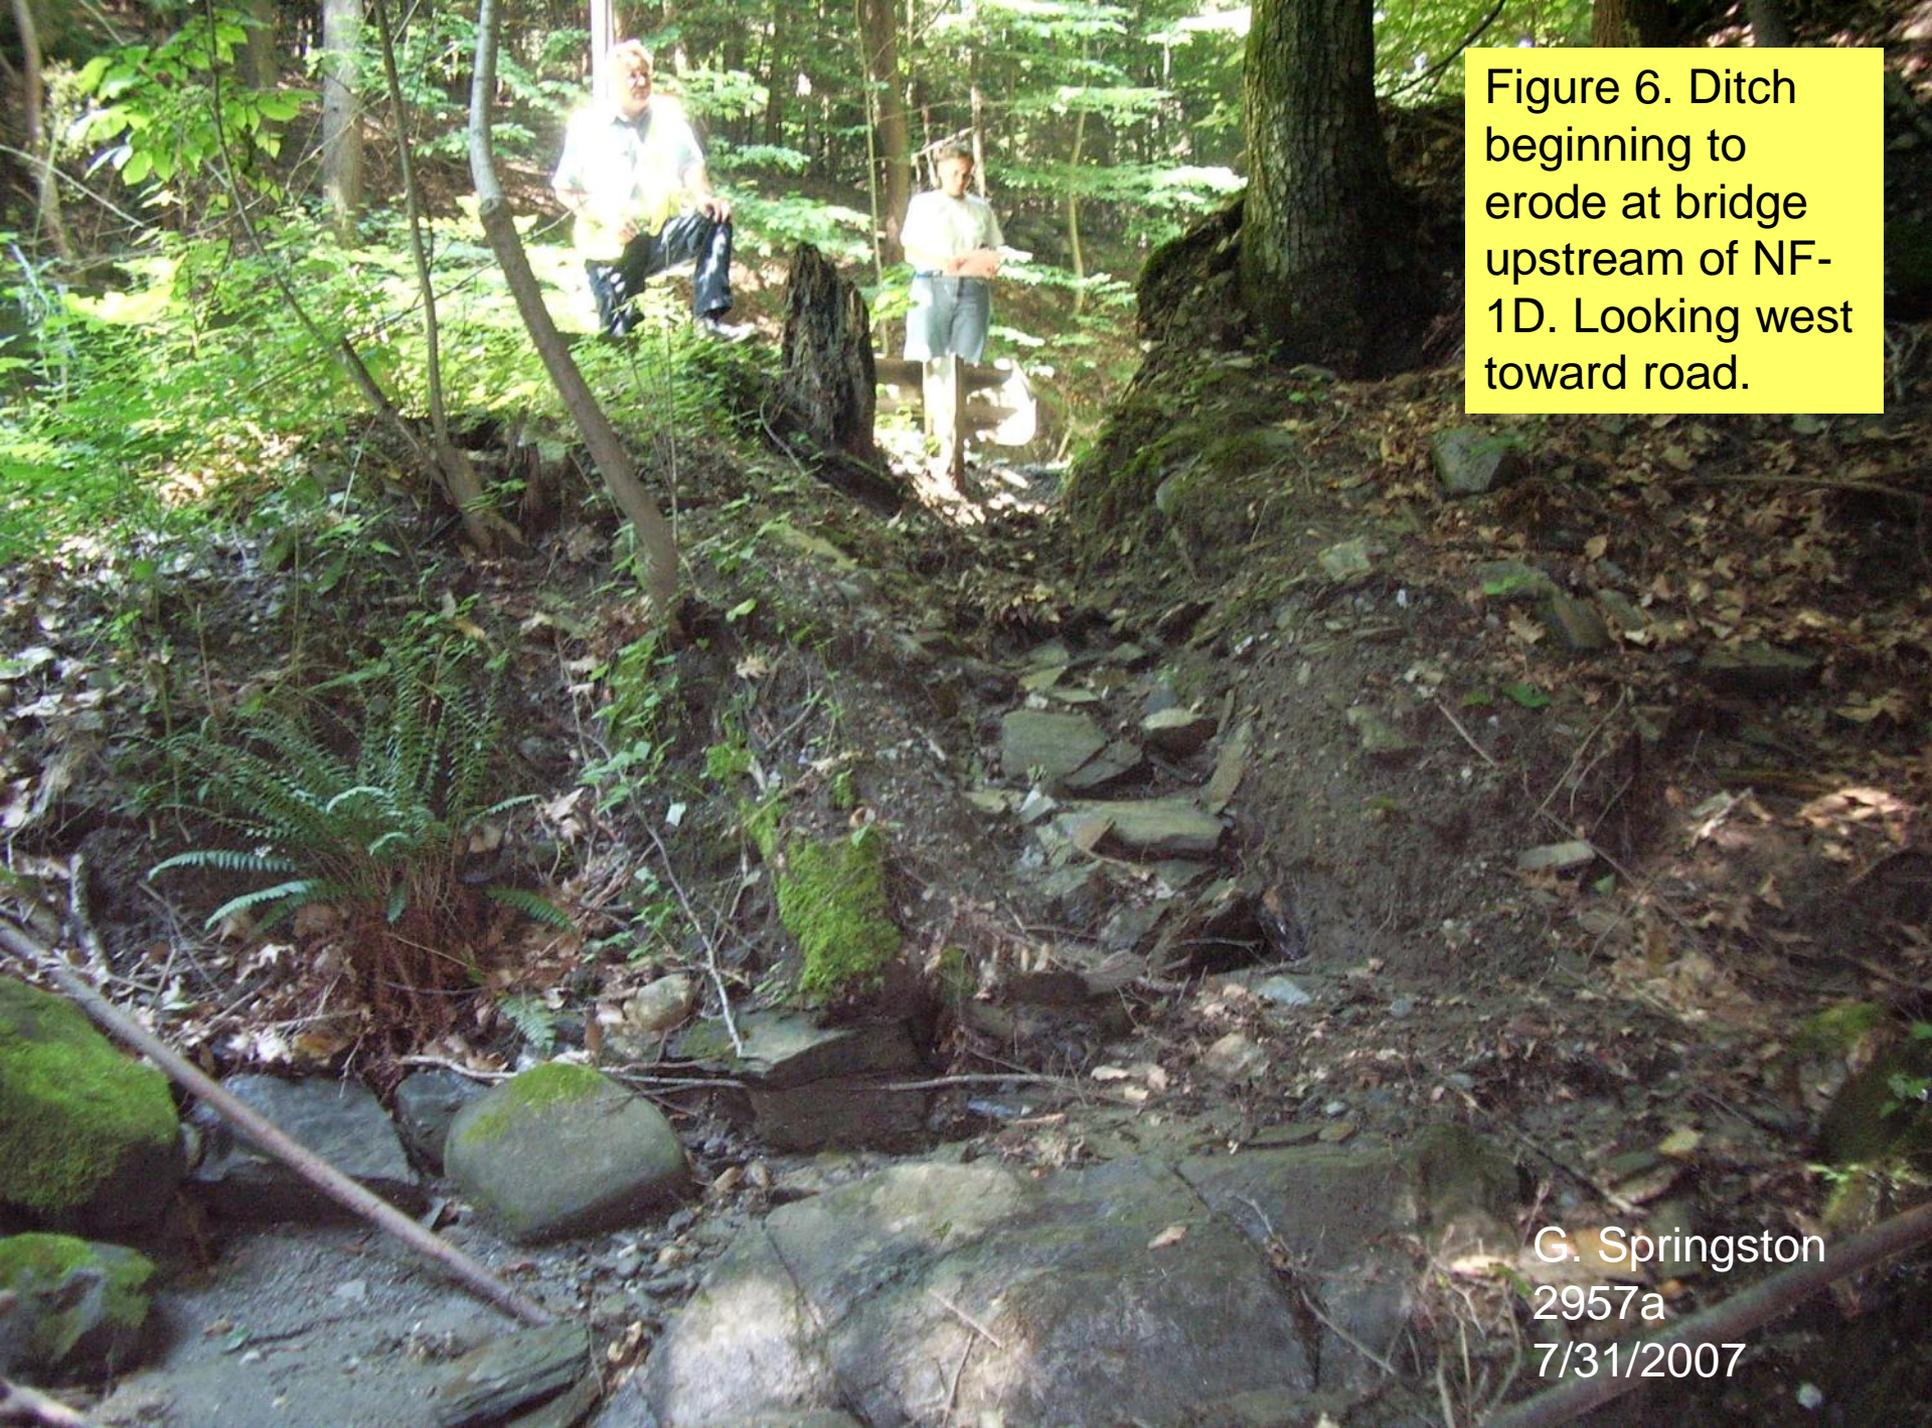
Bedrock grade control is first observed in the stream roughly 75 feet downstream of a bridge. At the bridge, the stream flows over a bedrock cascade (Site NF-1D). Although the main stream here is not subject to downcutting, we did observe that the roadside ditch flowing into the stream from the north was beginning to headcut (Figure 6).

Figure 6. Ditch beginning to erode at bridge upstream of NF-1D. Looking west toward road.

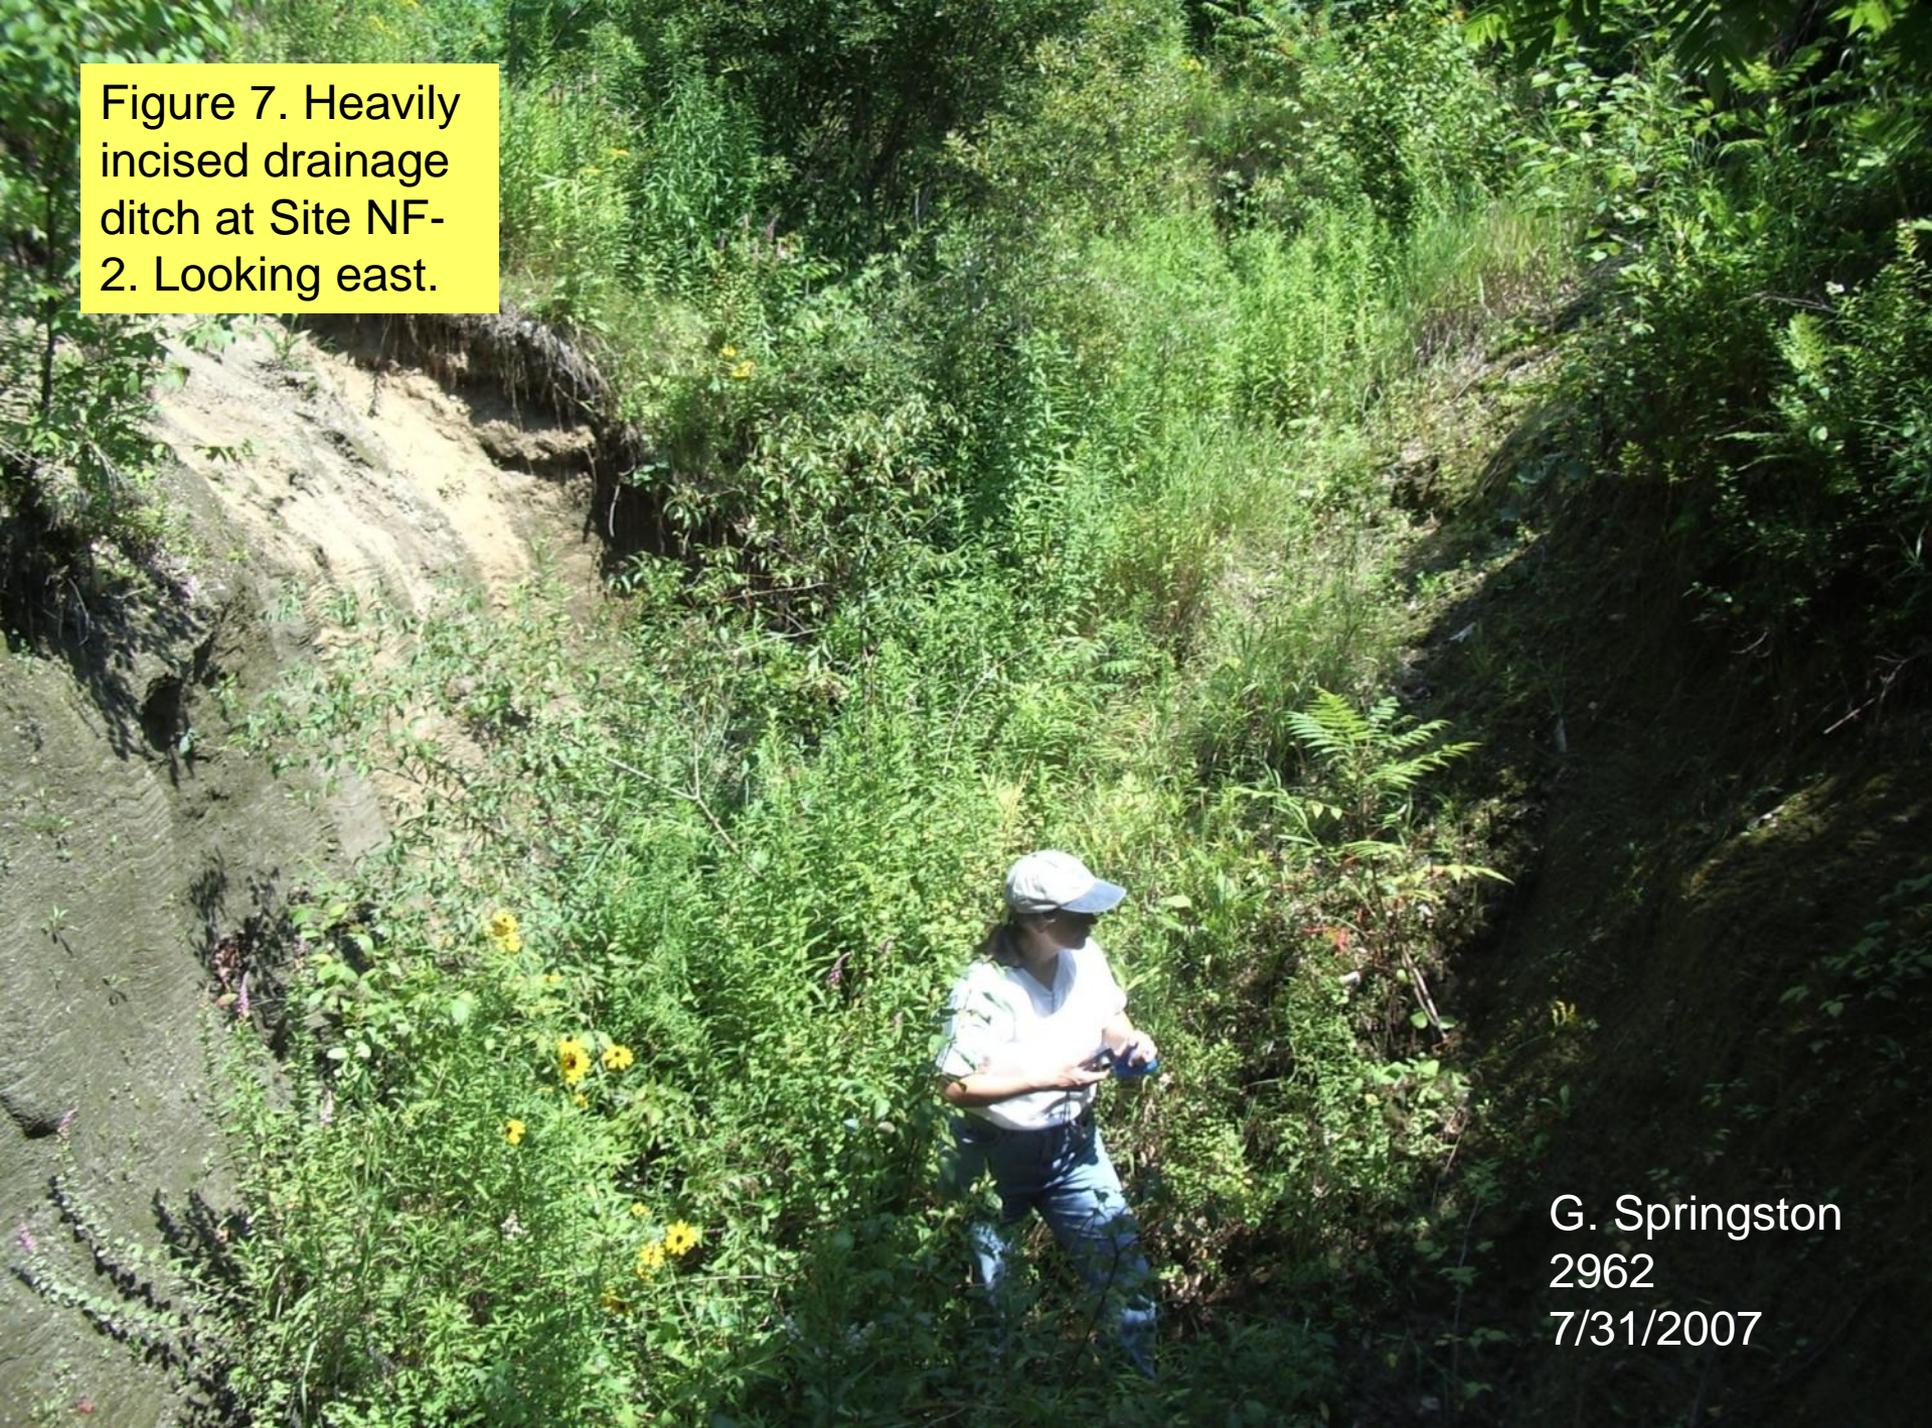
Site NF-2 is located to the southwest of the Pepsi bottling plant. This is a drainage ditch which flows generally westward to the floodplain of the northern branch of Crosby Brook. It appears that as originally dug, the ditch was shallow and carried water up to the edge of the valley of the brook, where the water would then have dropped over the edge onto the floodplain of the brook. However, the materials that make up the gully walls and floor (and the slope above the floodplain of the brook) are varved lacustrine silt and silty clay with no apparent bedrock exposures (Figures 7 and 8). The edge of the valley was thus a knickpoint in erodible materials. Headcutting back from this knickpoint has created a gully about 15 feet deep and has clearly eroded a large quantity of sediment. Some of the sediment has been deposited on a low alluvial fan that has developed on the former floodplain of the brook (Figure 9), but much appears to have been carried on to the brook.

Figure 7. Heavily incised drainage ditch at Site NF-2. Looking east.

The incising ditch at NF-2 is clearly a significant source of sediment and should be stabilized as soon as possible.

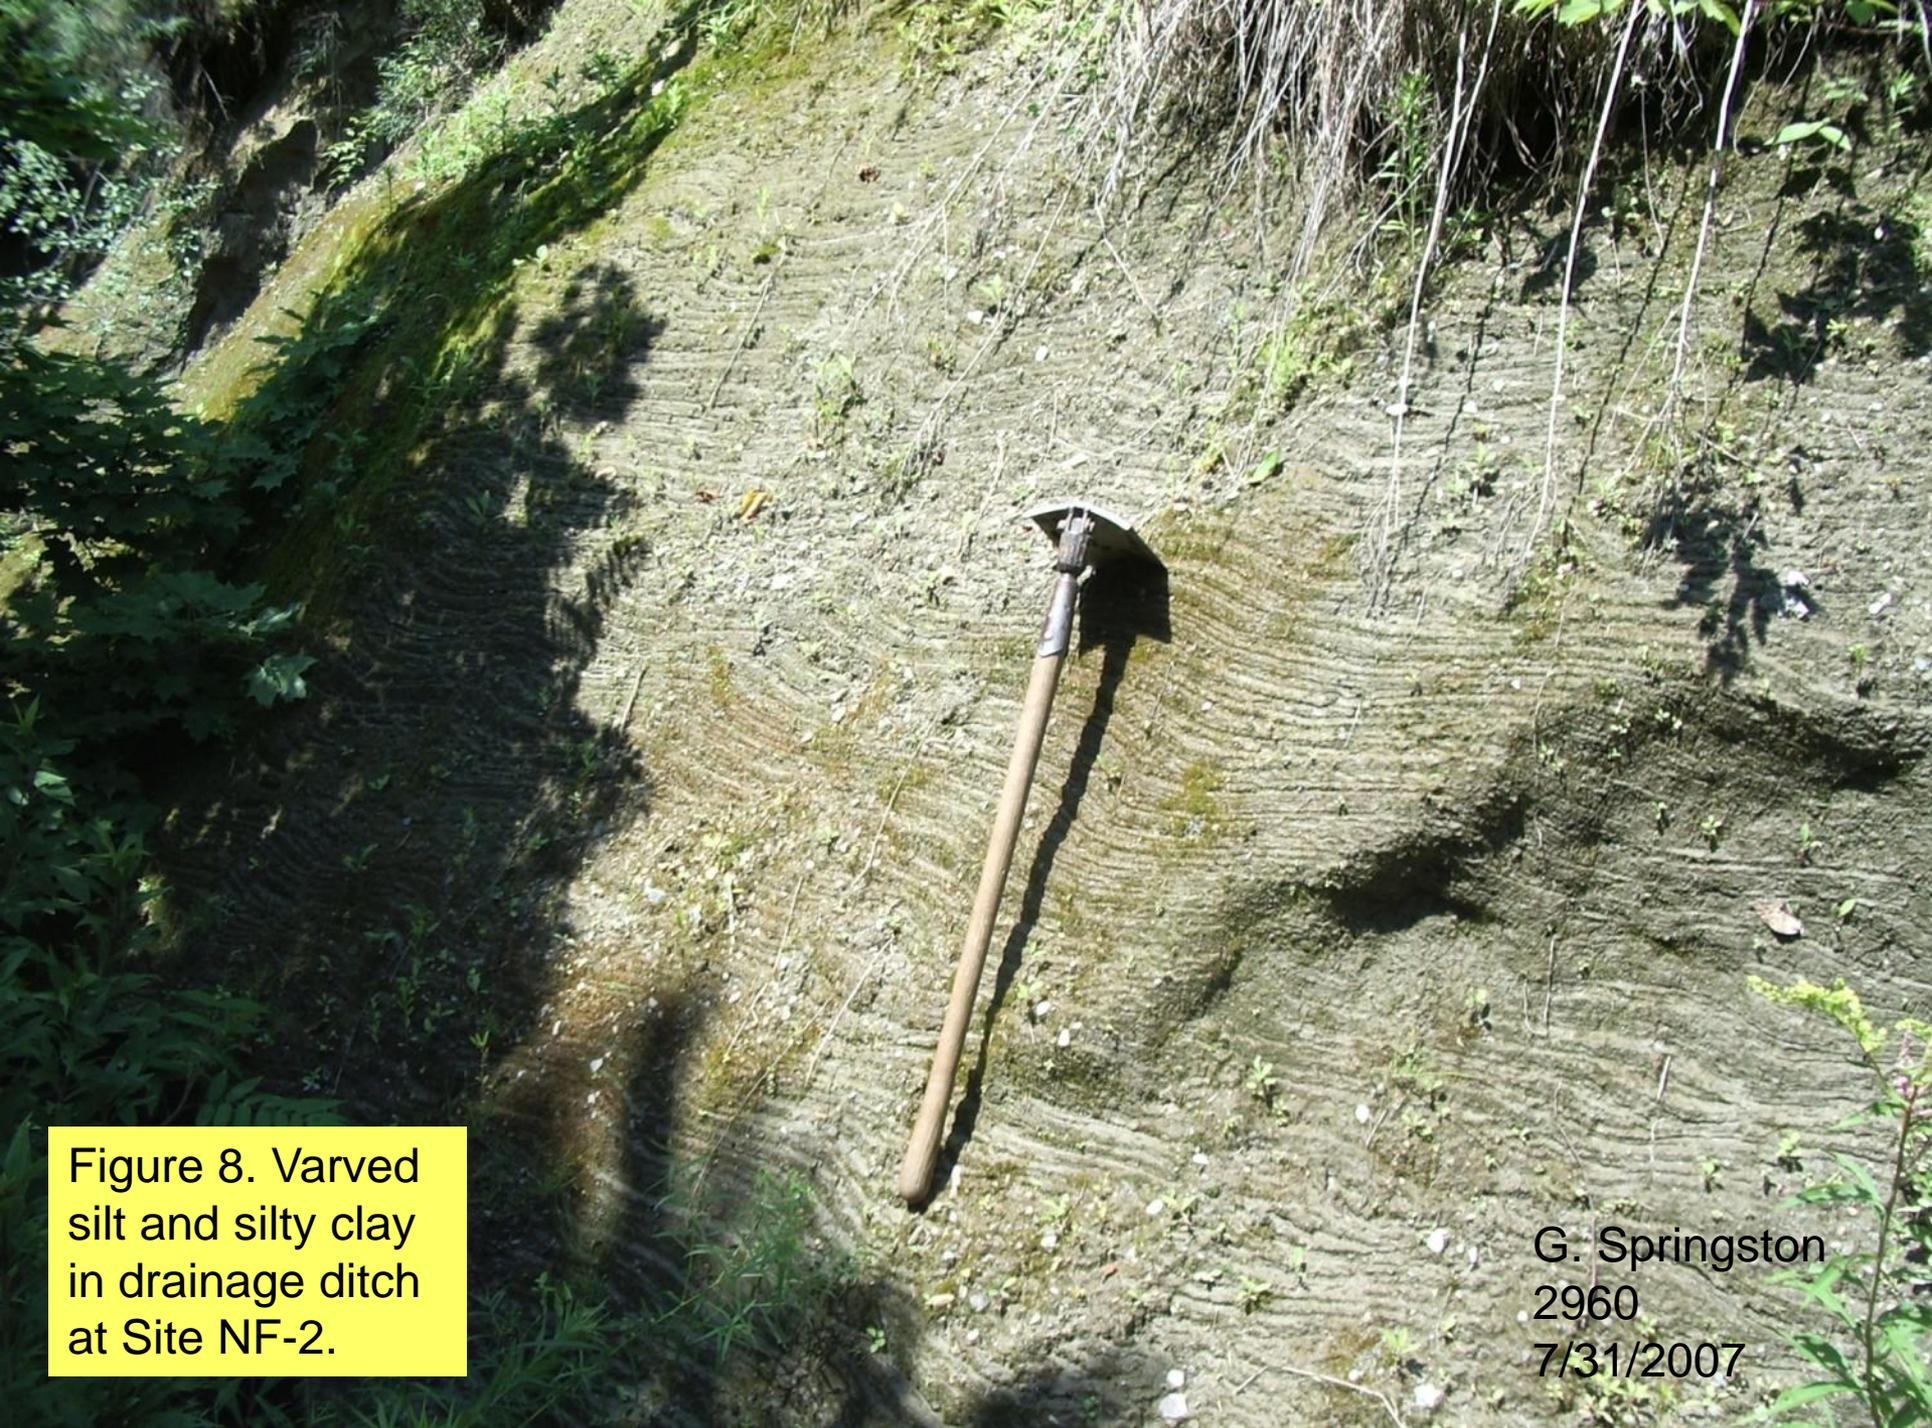
Figure 8. Varved silt and silty clay in drainage ditch at Site NF-2.
