To: Laurence Becker, Vermont State Geologist

From: George Springston, Research Associate, Norwich University

Date: 9/3/2007

Subject: Erosion along Crosby Brook in Brattleboro

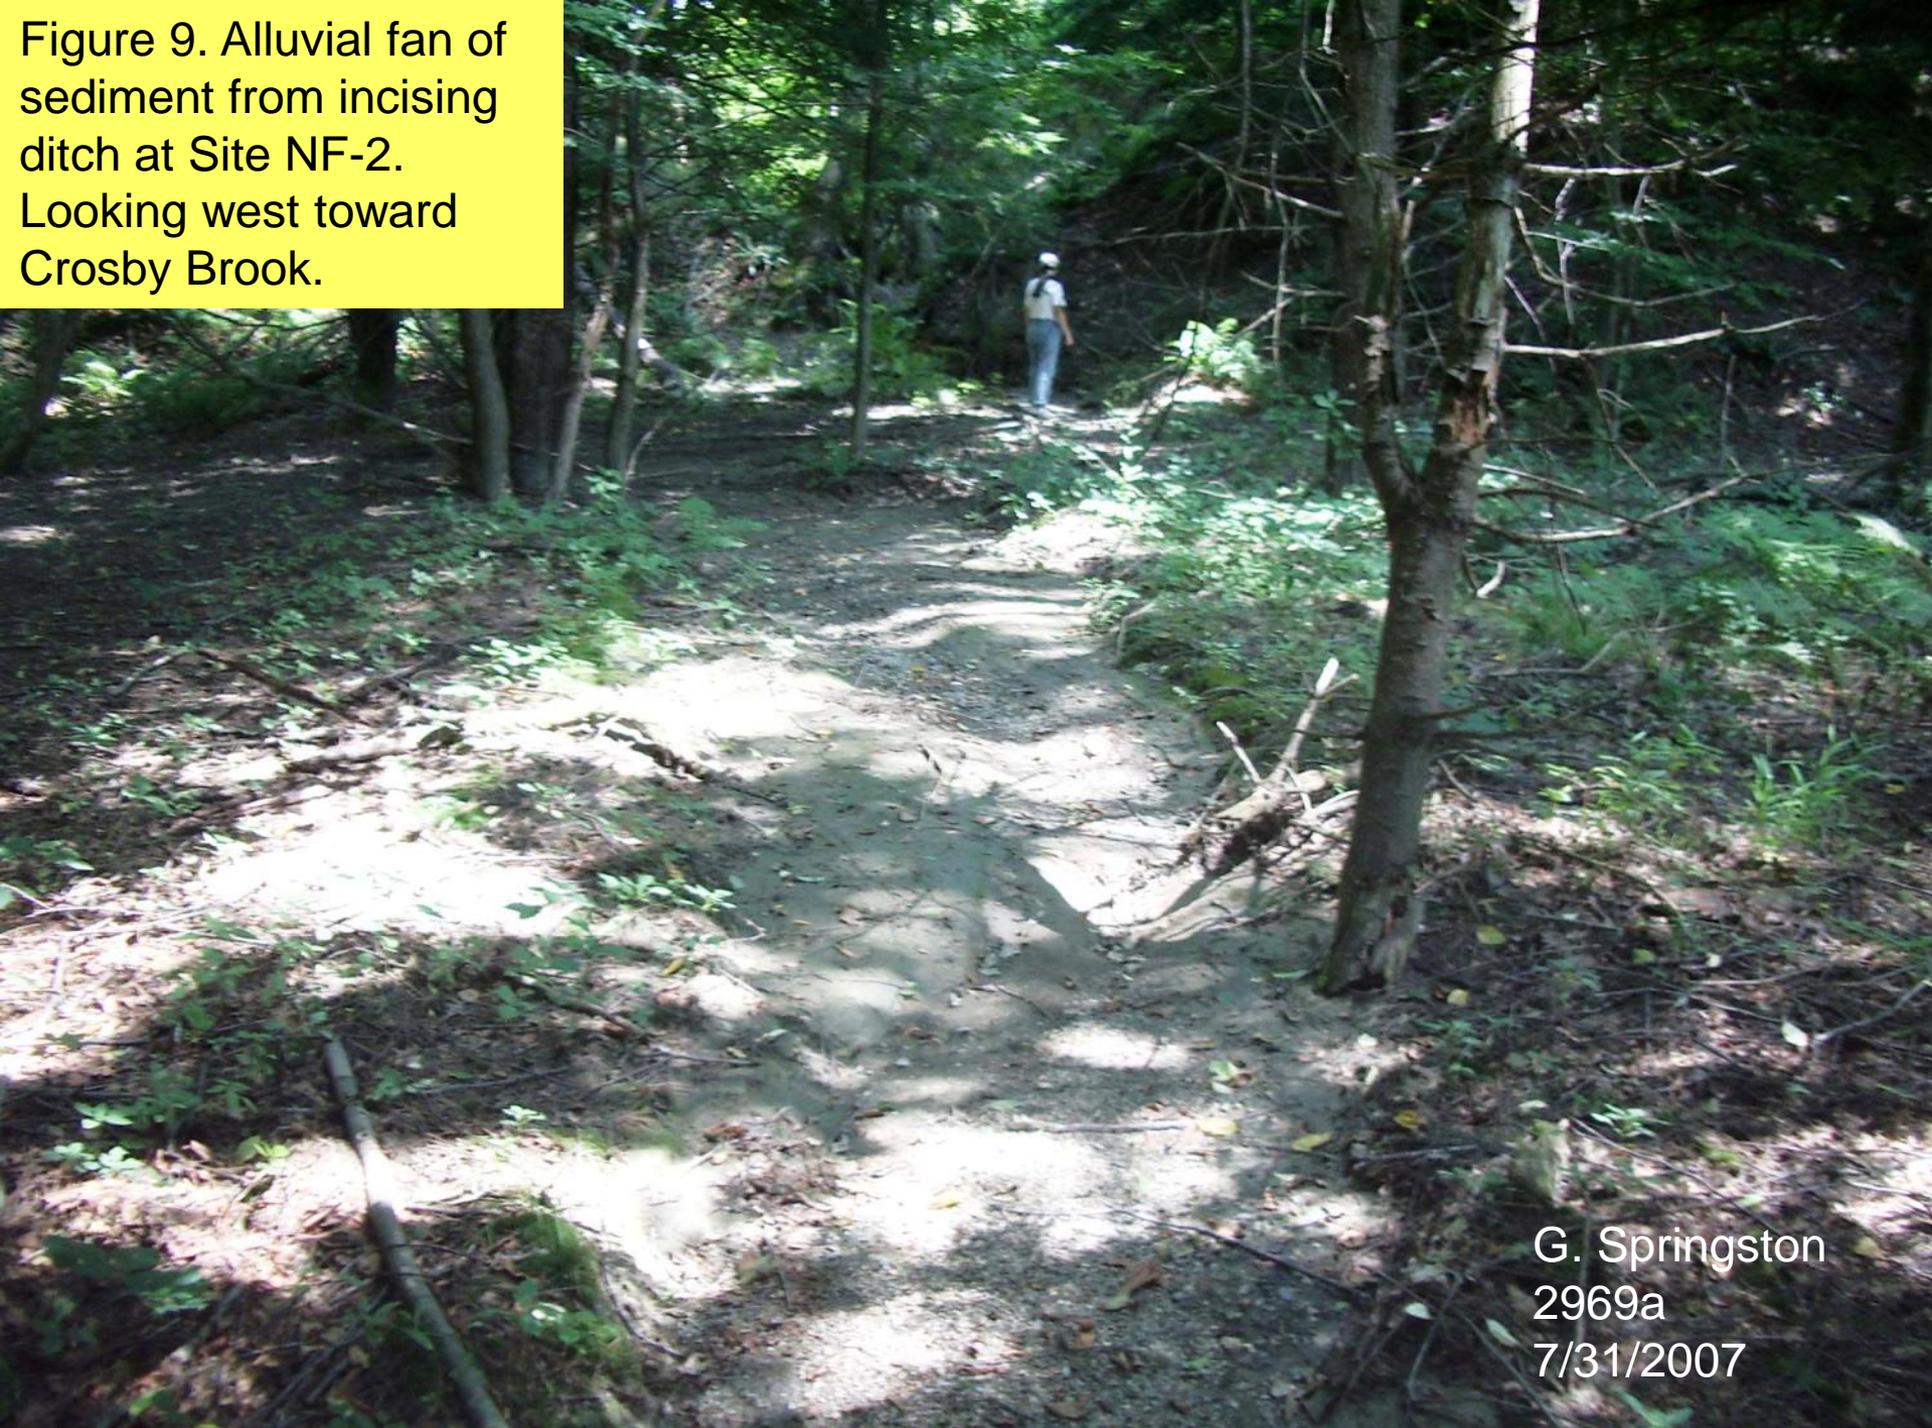
Figure 9. Alluvial fan of sediment from incising ditch at Site NF-2. Looking west toward Crosby Brook.

The incising ditch at NF-2 is clearly a significant source of sediment and should be stabilized as soon as possible.
