To: Rich Tatro, Shauna Clifford, Vermont Agency of Transportation

From: Larry Becker, Vermont State Geologist and George Springston, Research Associate, Norwich University

Subject: Landslide in Hardwick, Vermont

Date: 1/8/2004

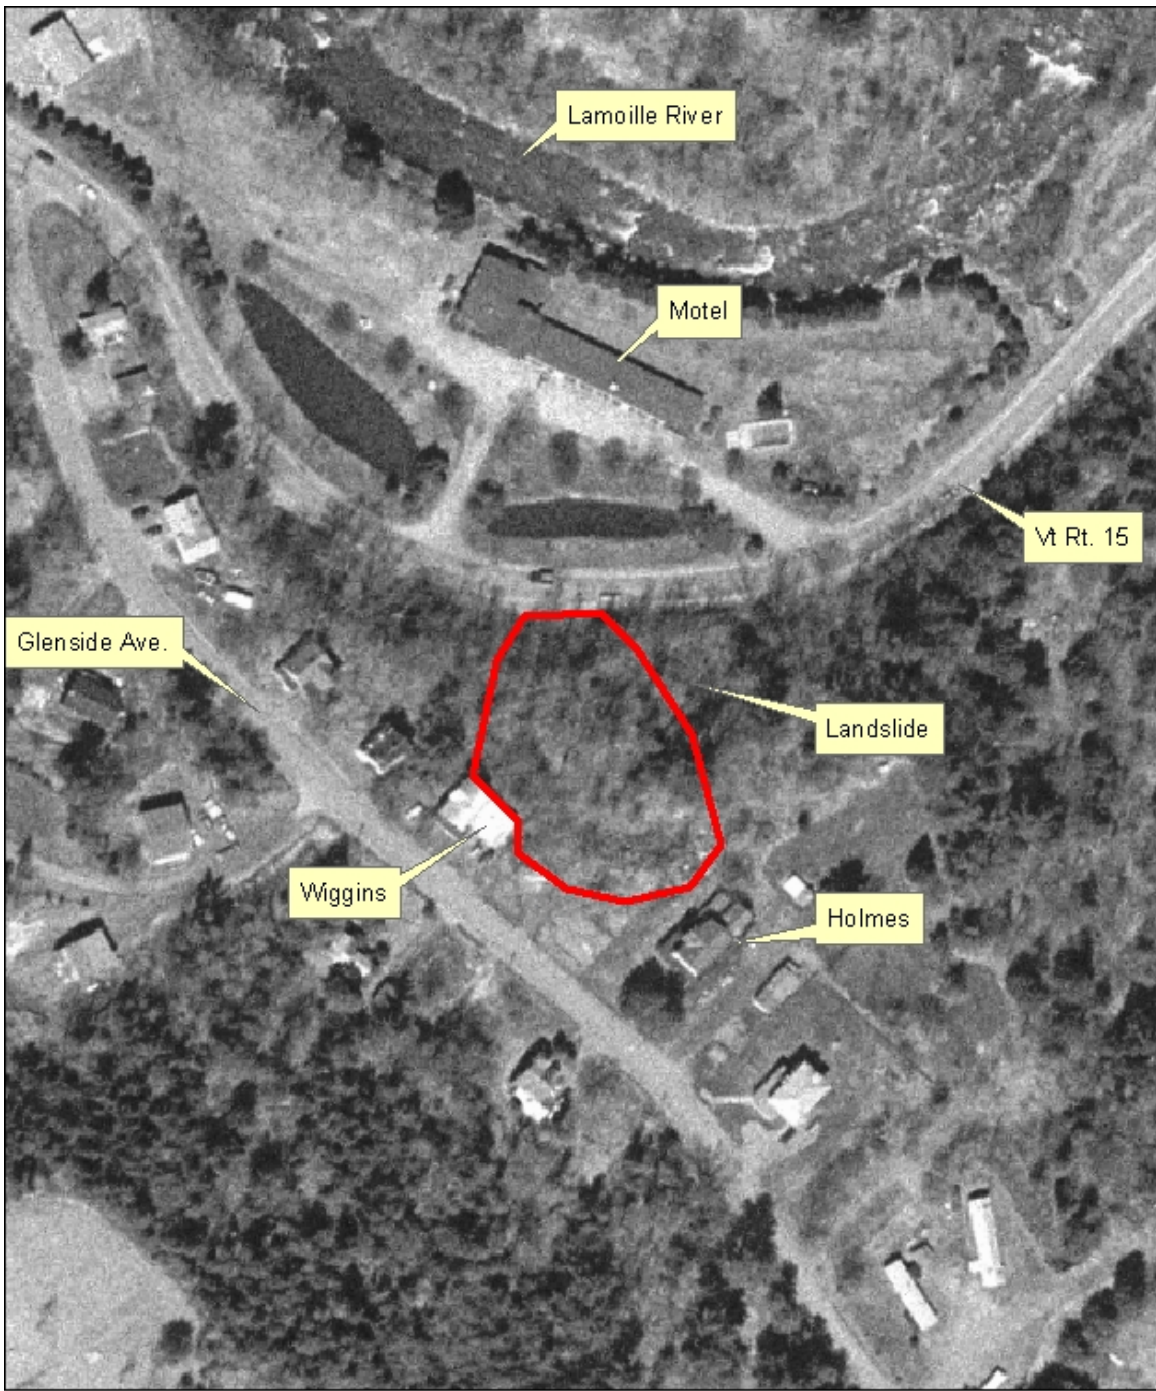
1998--No signs of active sliding are seen on orthophotos produced from 1998 aerial photos (Figure 1b). The orthophotos are not sharp enough to tell whether or not there are signs of failure at the top. However, the lower part of the slide is entirely wooded, so there does not appear to be any landslide large enough to disrupt the tree canopy.

Figure 1b. 1998 orthophoto of the landslide site. The slide outline is roughly shown in red. Base from Vermont Mapping Program orthophotos 160220 and 164220.

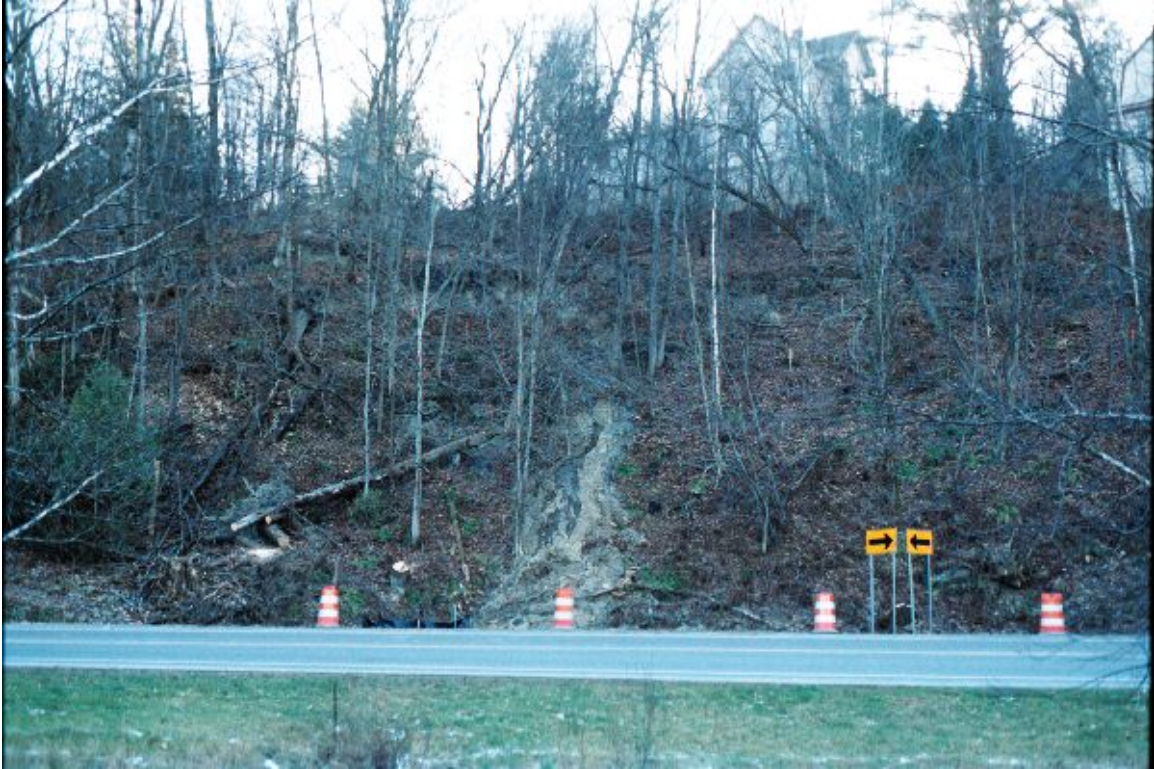
Figure 2. Landslide viewed from below. View looking south-southeast from motel parking lot on far side of Route 15. November 10, 2003.

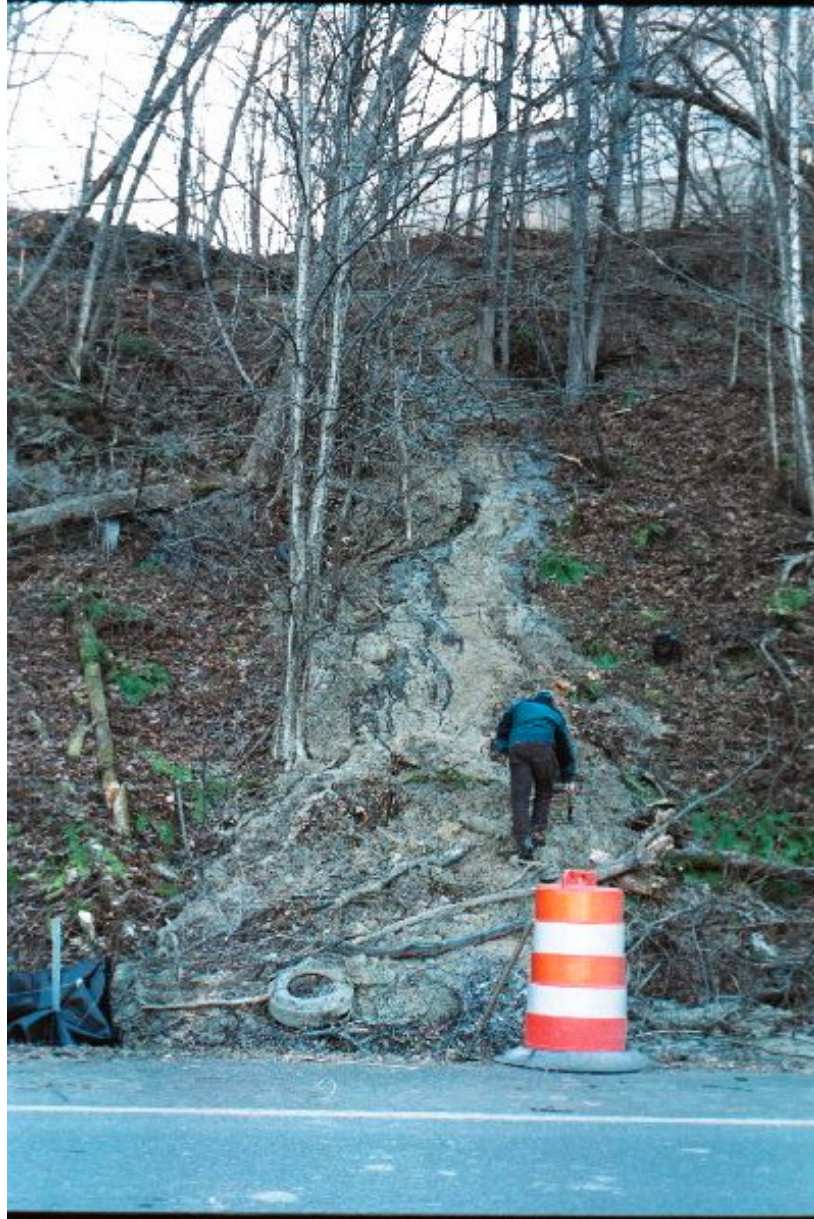
Figure 3. Earth flow originating in central part of slide and flowing down to culvert on east side of State Route 15. November 10, 2003.

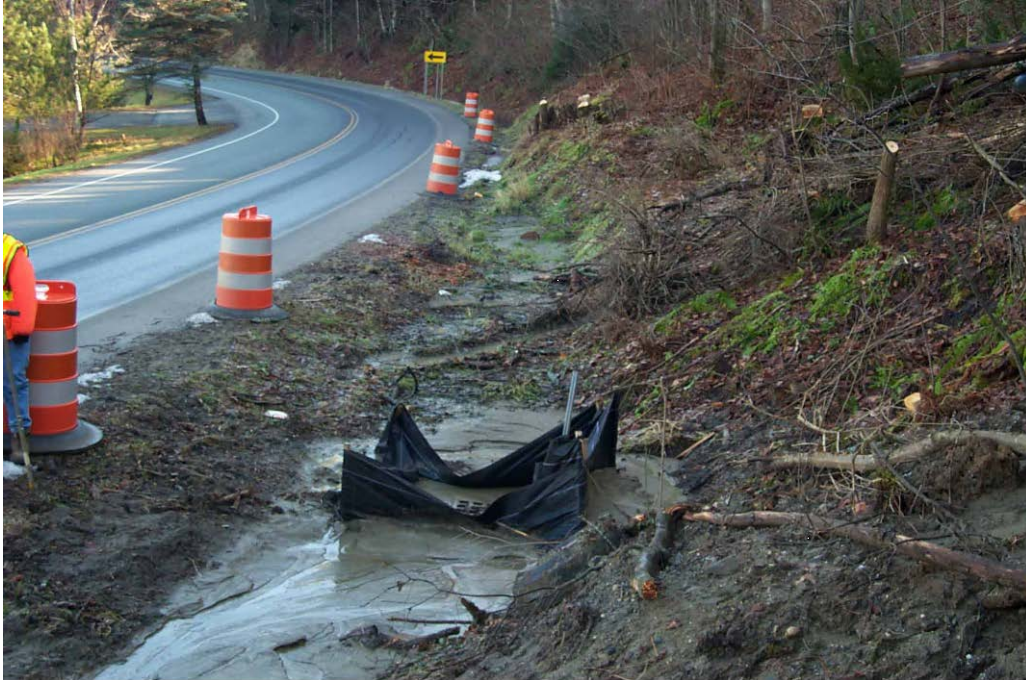
Even if a large slide did not block the road, it is likely that it would result in a large quantity of sediment washing into the catch basin on the south side of Route 15. If this were to clog, the sediment might then wash across the highway.

Figure 4. View of sediment from slide washing into catch basin on south side of Route 15. Looking east. November 21, 2003. Photo by Vtrans.

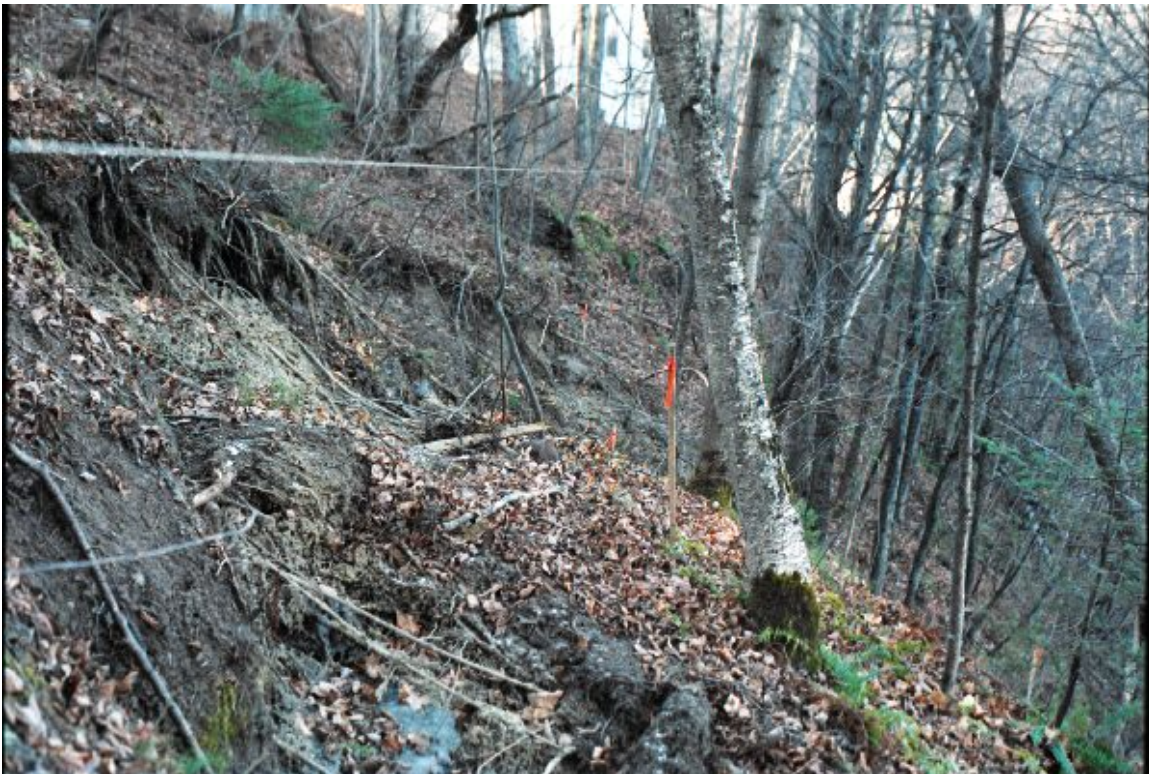
1. The lowest of the three failures is partway up the wooded slope. The top of this fracture is about 57 feet above the highway. This is the section of the slide that is being monitored by VAOT with a system of stakes and strings (Figures 5 and 6). This failure is in glacial till. The till has a silt-rich matrix with angular pebbles, and cobbles. The material we observed had a loose to medium density. Glacial boulders up to several feet in diameter are scattered sparsely throughout the woods. Although a few may have been dumped over the edge from above as part of artificial fill activities, most of the boulders on the slope appear to be from the underlying glacial till.

Figure 5. Recent scarp formed within landslide. Photo looking northwest. VAOT reference strings are shown on left and right sides of photo. Stakes were originally under the strings and have moved downslope since they were installed. November 10, 2003.

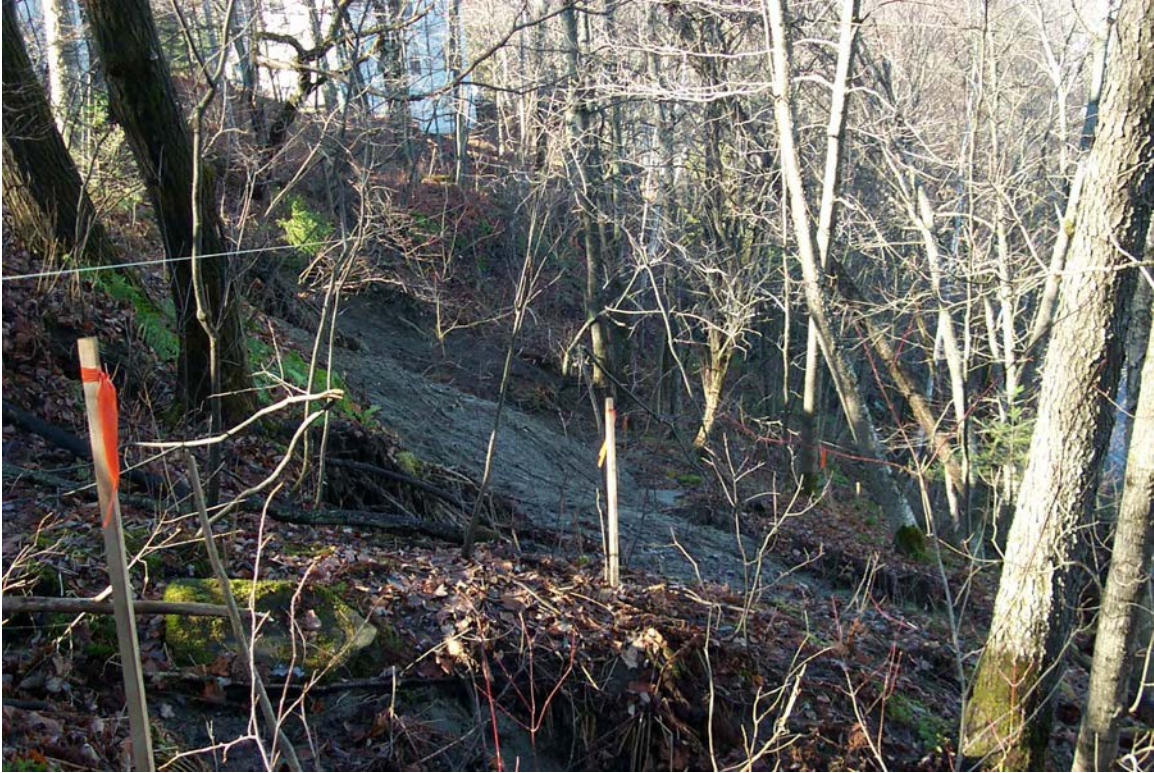
November 21--Site meeting. Further movement of monitoring stakes has occurred since November 10. Stakes that were originally on the upper line have now moved below the lower line. Photos taken by T. Eliassen. After the site meeting, we talked with Mr. Holmes, who stated that they had been adding fill in their back yard for "20 years" in response to continued subsidence.

Figure 6. Reference strings viewed from similar location as in Figure 5. Further movement of stakes has occurred since installation. November 21, 2003. Photo by VAOT.

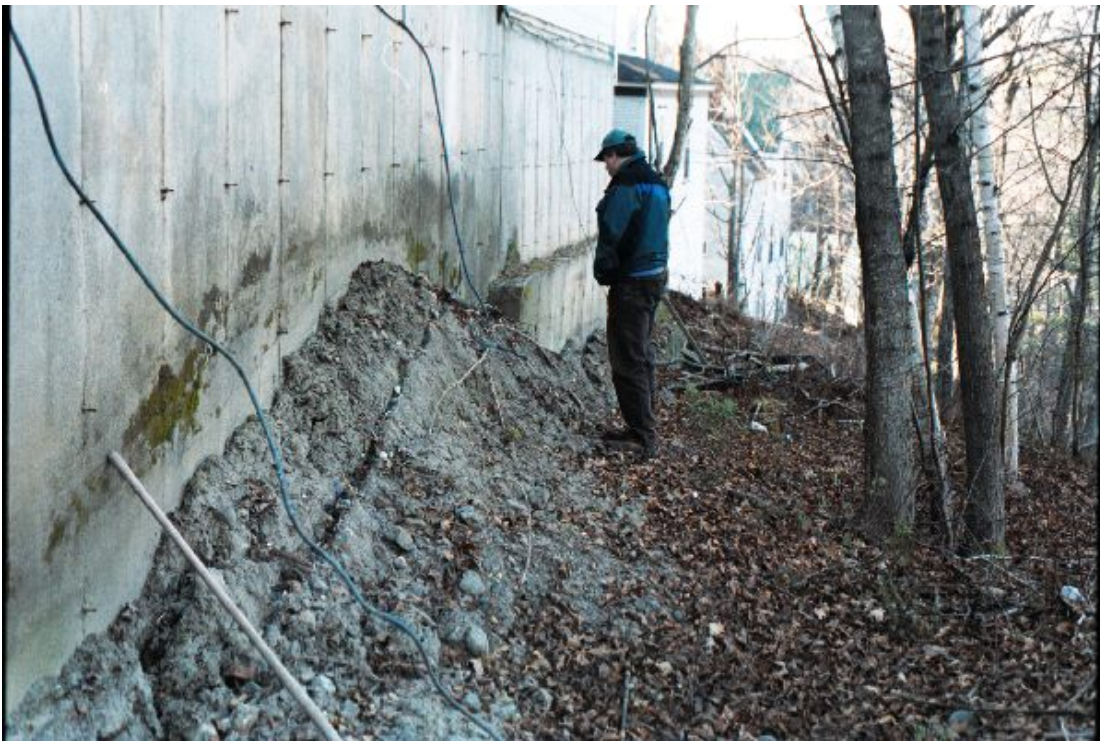
2. A second failure surface is located at the base of the concrete foundation wall at the back of the Wiggins house (Figure 7). The base of the wall is approximately 81 feet above Route 15. Movement on this fracture surface has removed material from the north (downhill) side of the Wiggins foundation. This failure is partly in glacial till and partly in what appears to be artificial fill. At the closest point, the fracture is about 50 feet from the north side of Glenside Avenue. Near the top of the slope at the Holmes residence there is sandy artificial fill that has settled, leaving a prominent steep scarp approximately 3 feet high (Figures 8-11). The top of the scarp is about 105 feet above Route 15. The scarp extends westward onto natural ground and there cuts into approximately 1.5 feet of sand over till. This sand appears to be a natural deposit of lake sand. The scarp drops in elevation as it extends northwest towards the Wiggins house and trends directly toward a propane tank on the southeast side of the house.

Figure 7. Fractures in earth at lower side of foundation of Wiggins house. November 10, 2003.

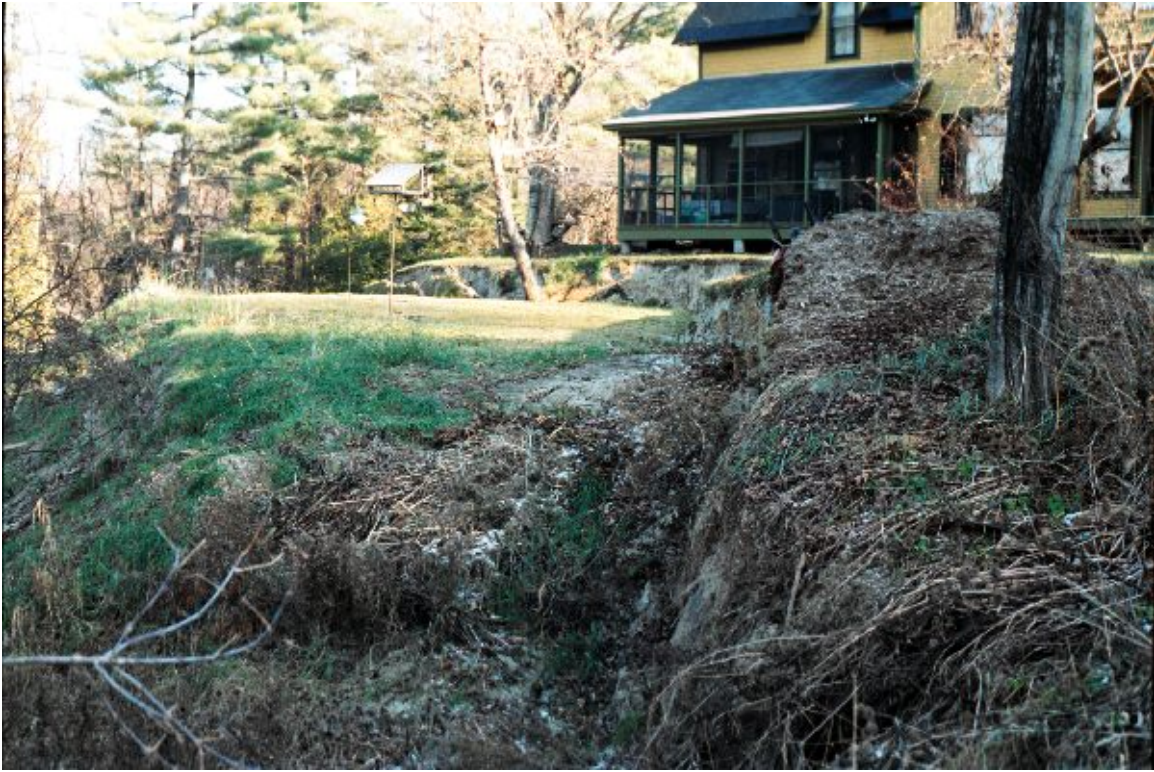
Figure 8. View looking east along fracture surface in artificial fill at Holmes residence. November 10, 2003.

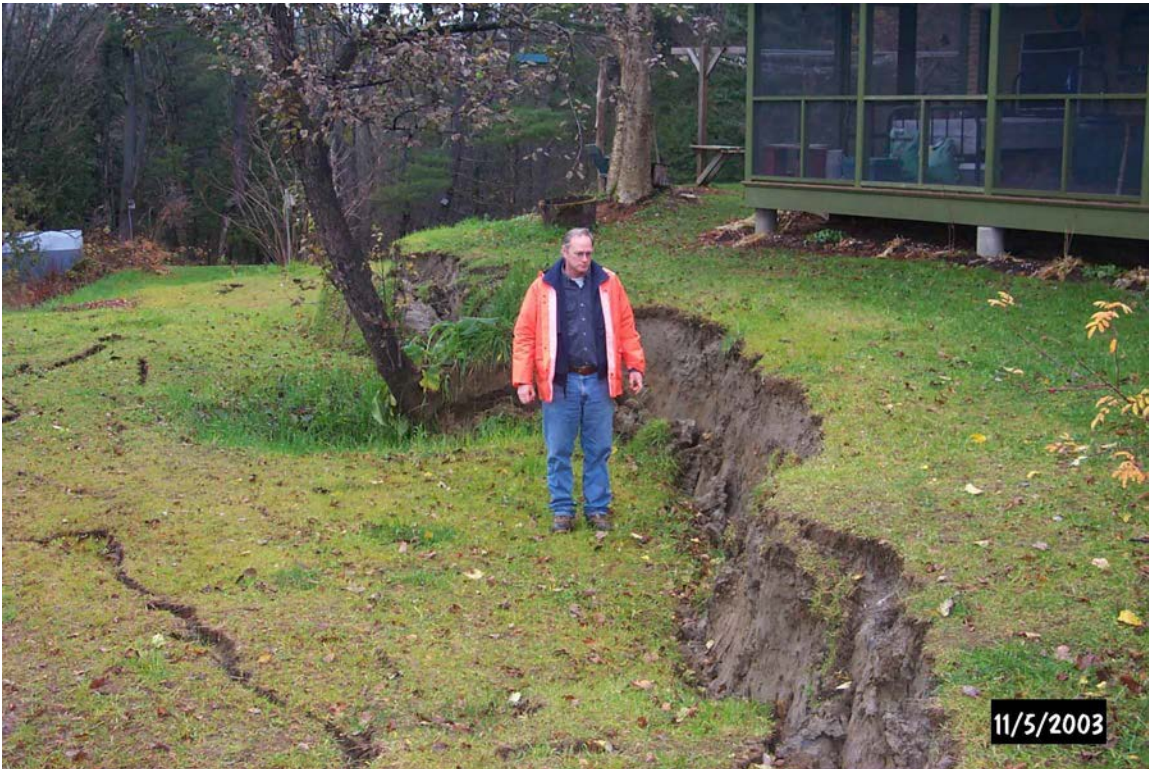
Figure 9. Uppermost scarp at Holmes residence. Looking northeast. November 5, 2003. Photo by VAOT.

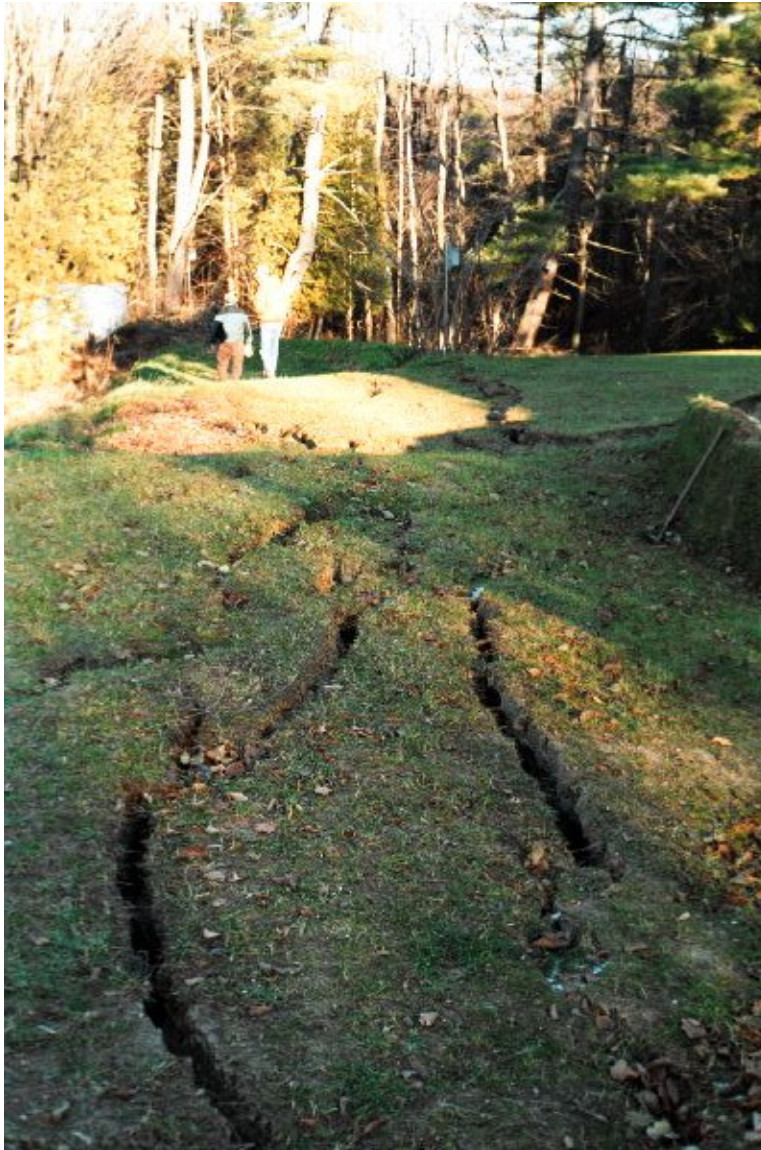
Figure 10. Fractures in artificial fill on northwest side of Holmes residence. Photo looking east-northeast. November 10, 2003.

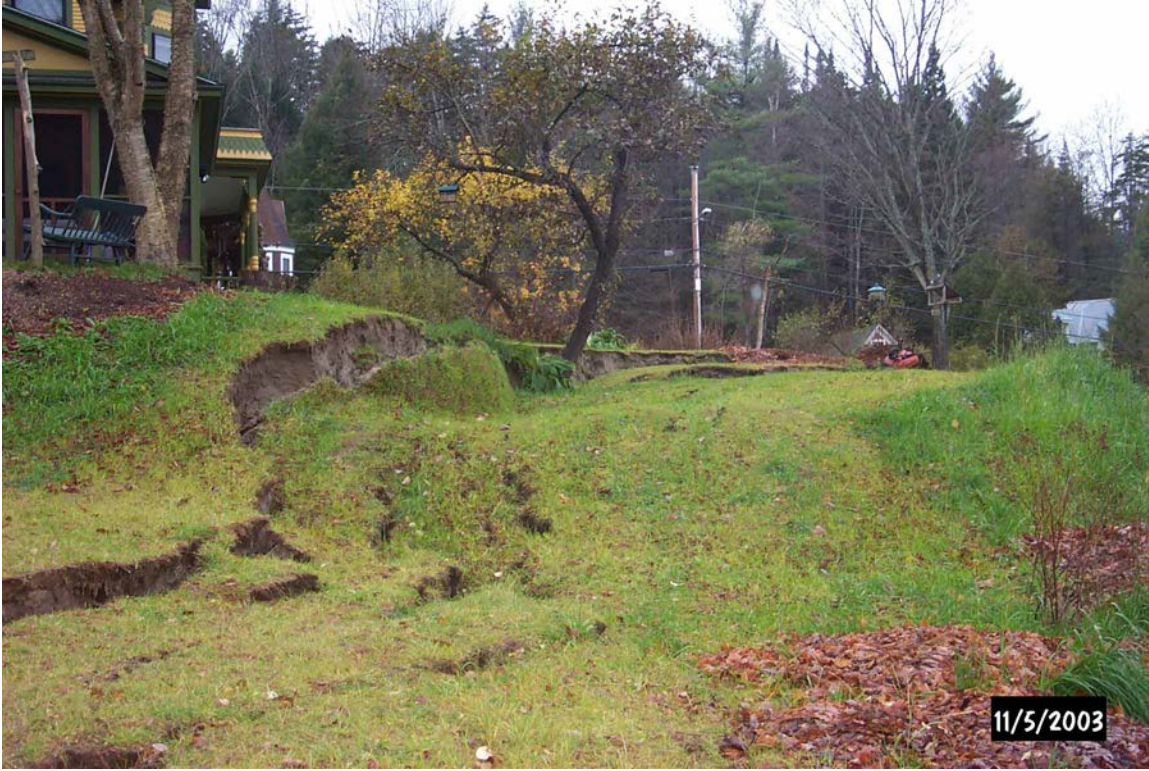
Figure 11. Uppermost scarp at Holmes residence. View looking southwest. November 5, 2003. Photo by VAOT.
