To: Laurence Becker, Vermont State Geologist

From: George Springston, Research Associate, Norwich University

Date: 9/6/2007

Subject: Slope instability and flood damage along Honey Brook in East Barre

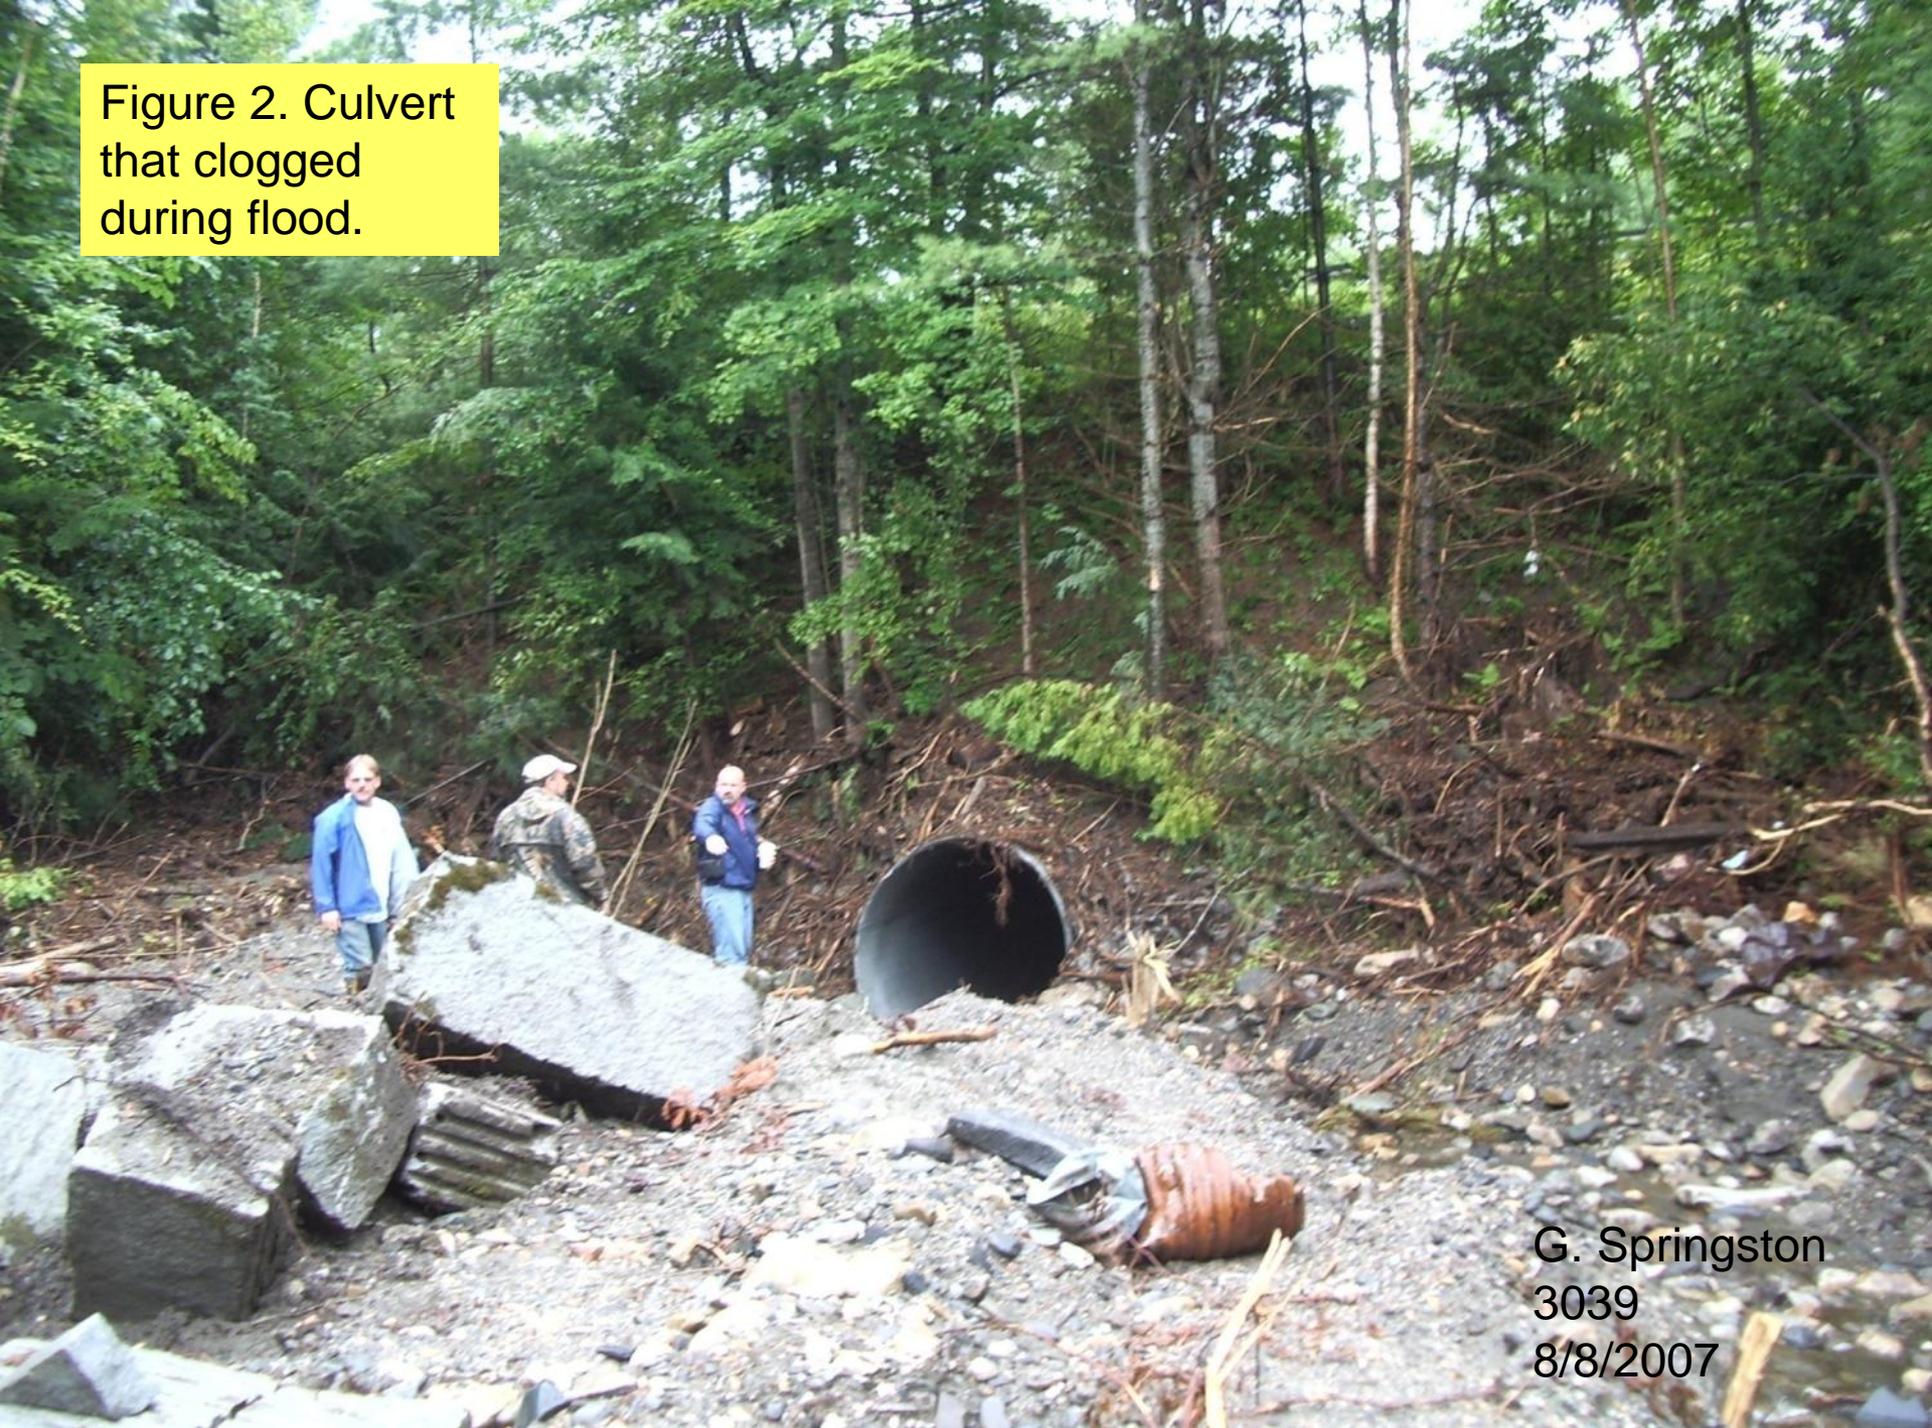
The storm caused extensive road washouts and numerous culvert blockages. We examined the culverts where Nuisl Road crosses the east branch of Honey Brook and where East Cobble Hill Road crosses the main branch. Figure 2 shows the East cobble Hill Road culvert after much debris was removed.

Figure 2. Culvert that clogged during flood.

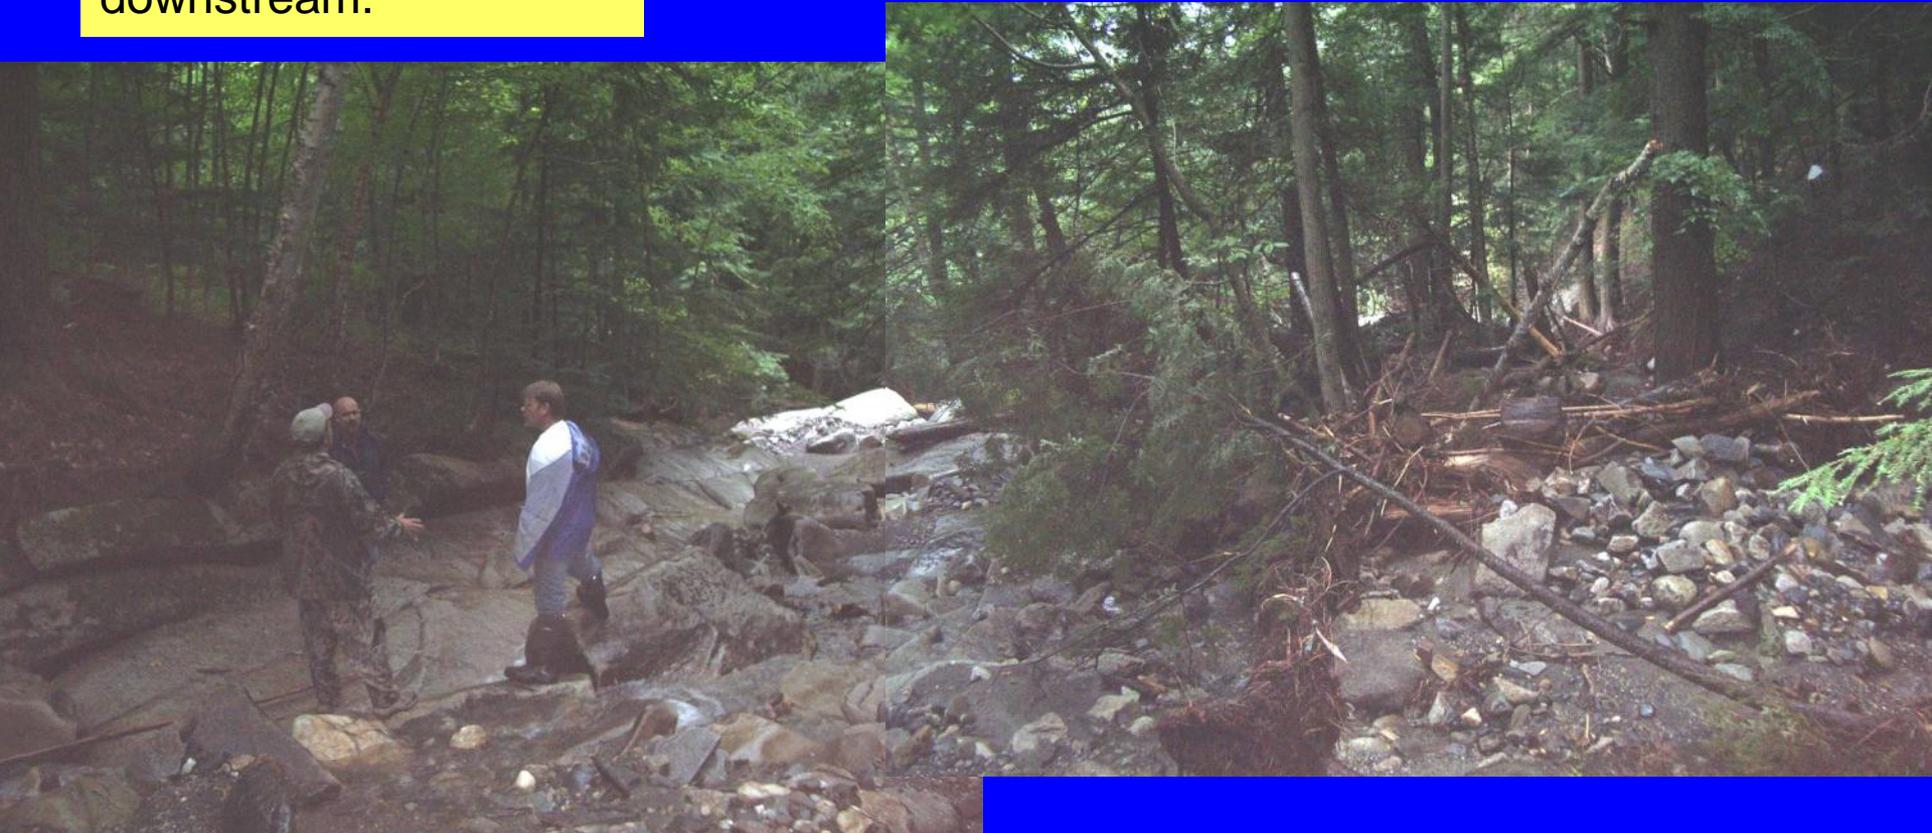
Downstream of East Cobble Hill Road I observed extensive areas of stream bed and bank scour, many flood-transported boulders, and numerous large debris jams. One of the debris jams is shown in Figure 3.

Figure 3. Recent debris jam on right with bedrock grade control on left. Looking downstream.

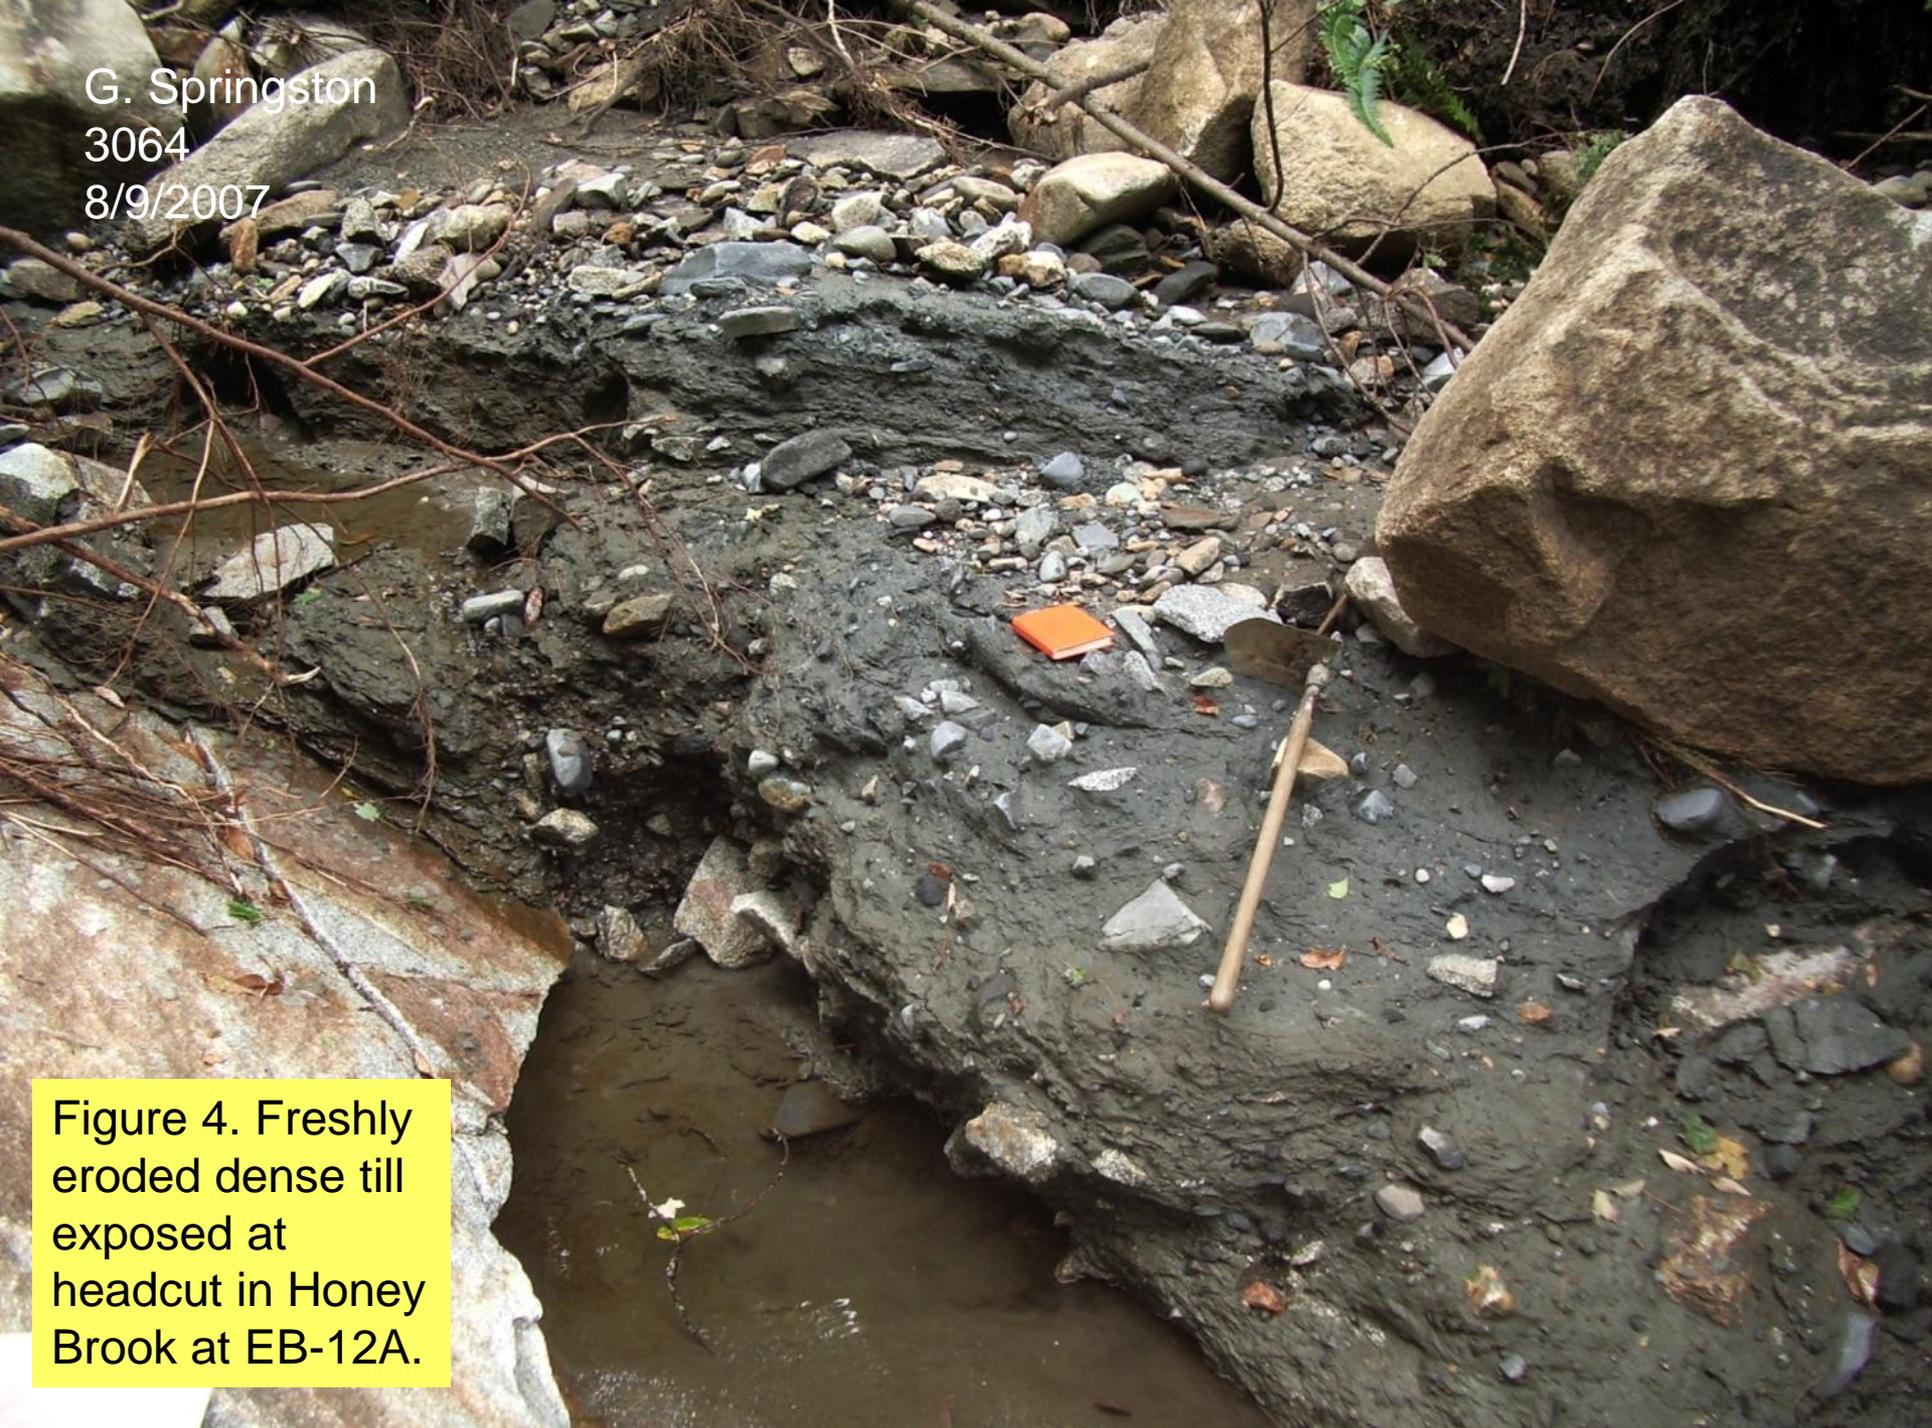
On the channel bottom the flood stripped away sections of stream bed gravels to expose the underlying materials; dense, silt-matrix till with abundant clasts and granite bedrock. Although the till is relatively resistant to stream erosion, the power of the flood resulted in the formation of headcuts up to several feet deep into the till in the stream bottom (Figure 4). The abundant clasts in the till are shown in Figure 5.

Figure 4. Freshly eroded dense till exposed at headcut in Honey Brook at EB-12A.

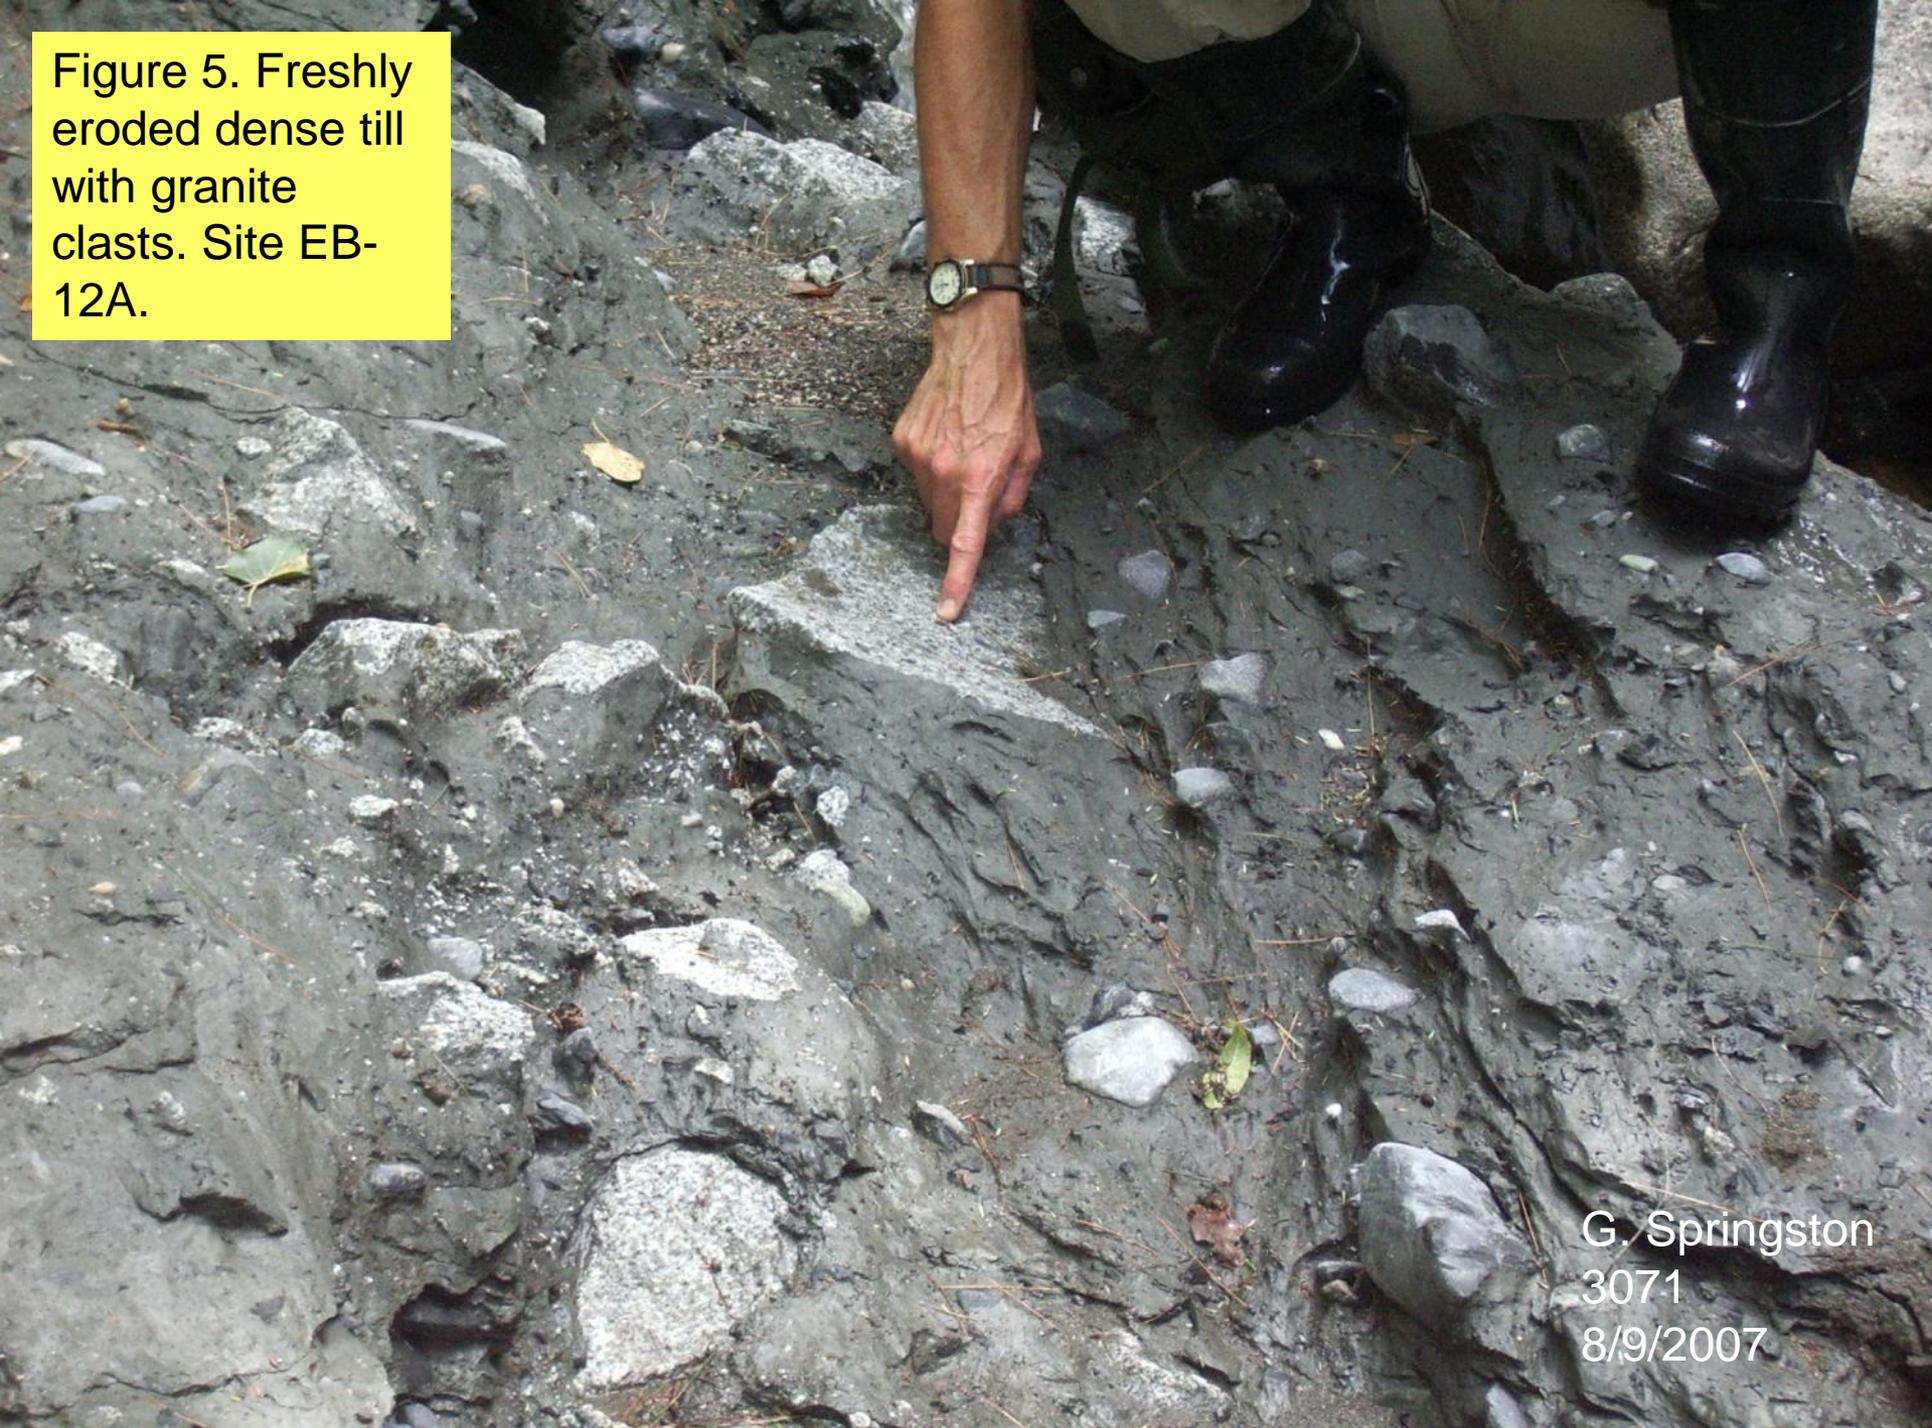
Figure 5. Freshly eroded dense till with granite clasts. Site EB-12A.

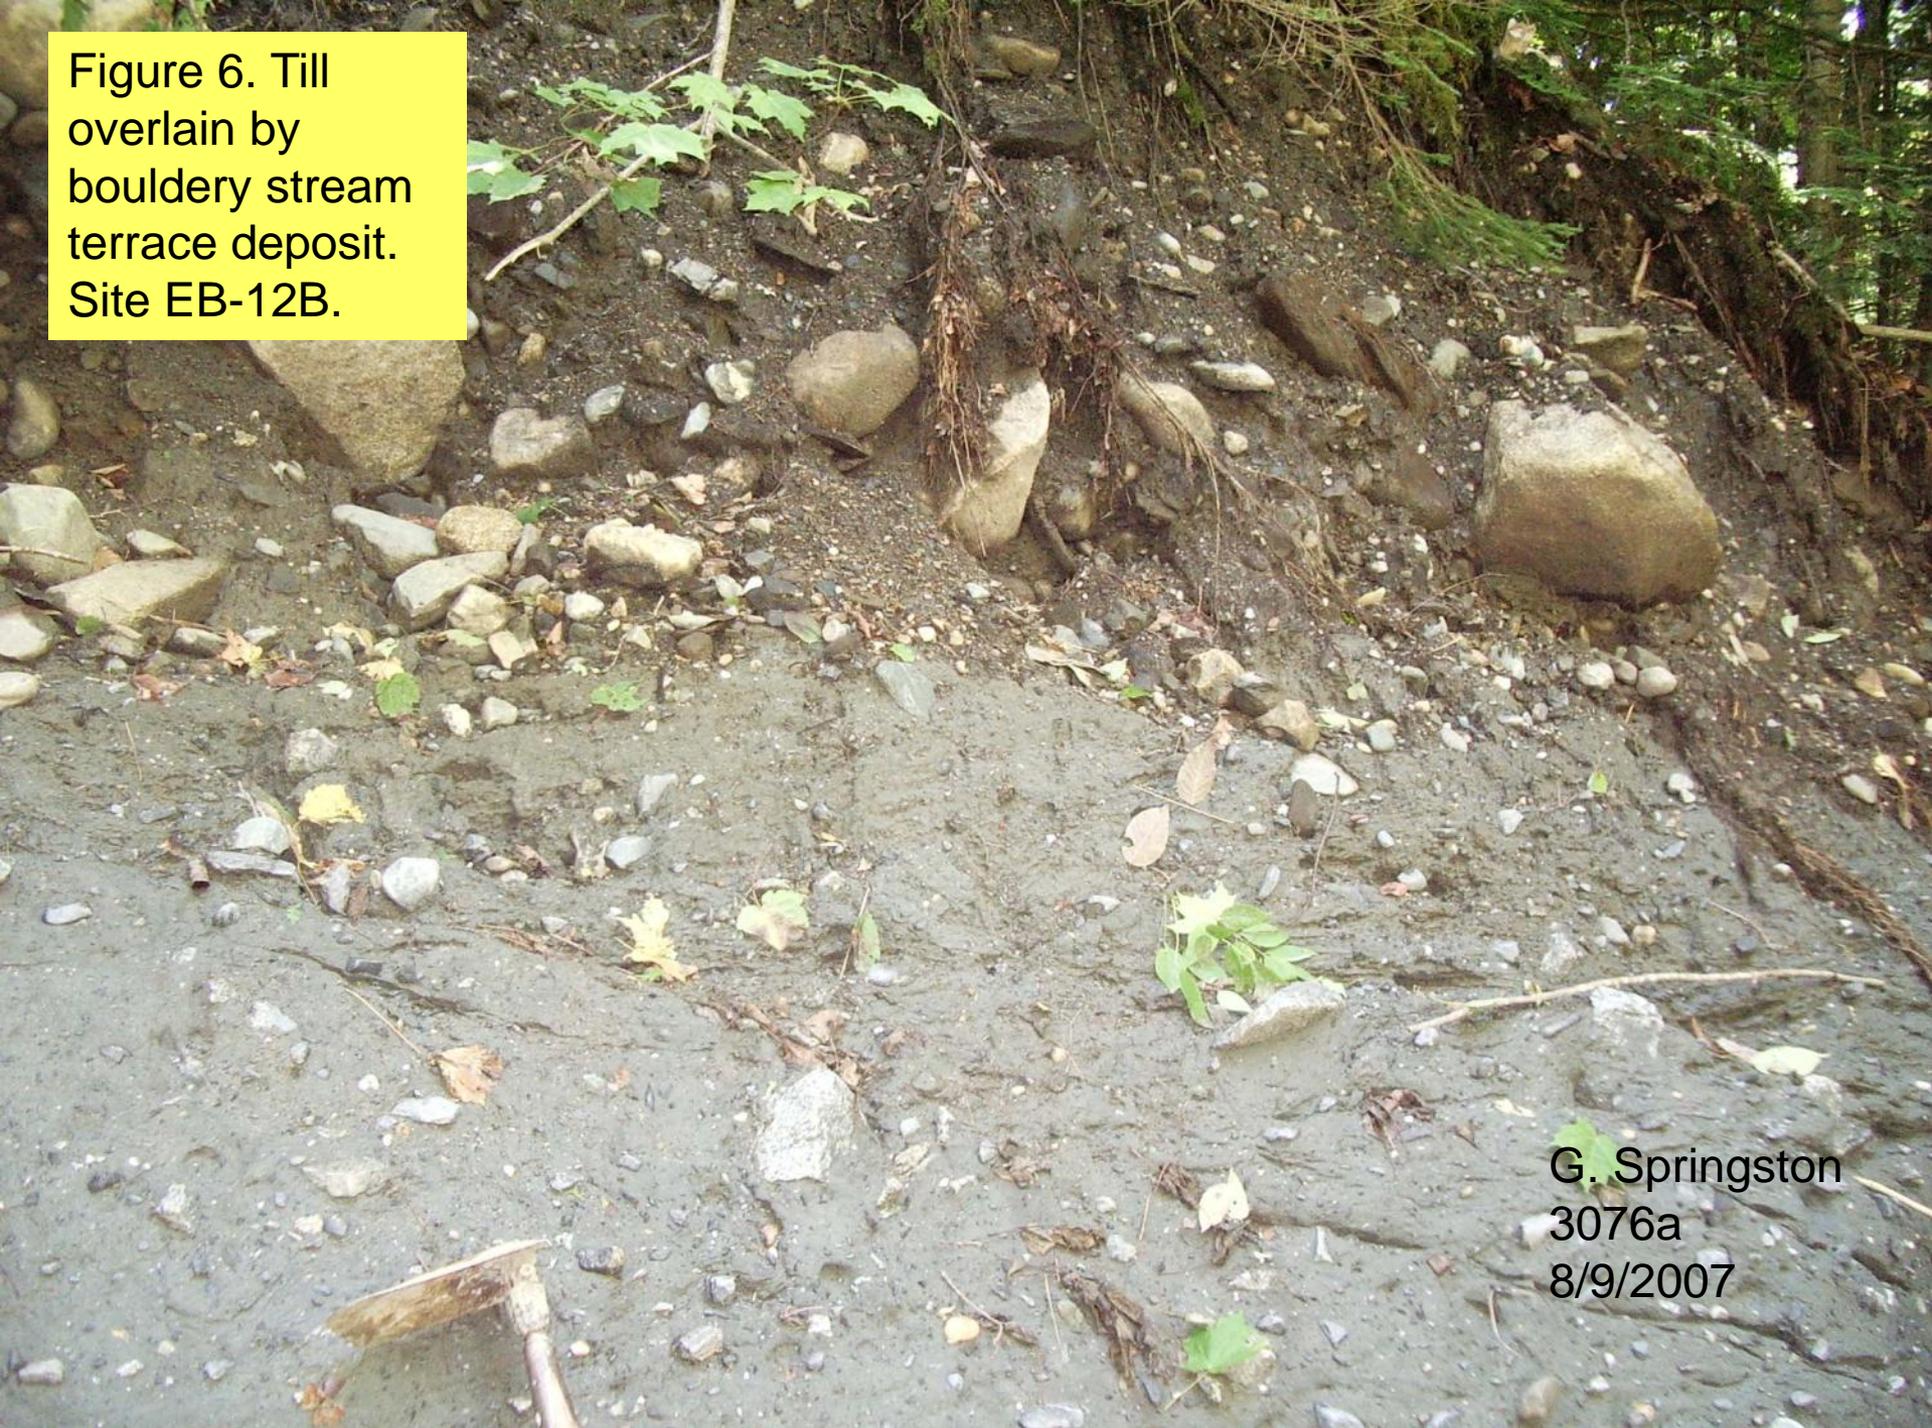
The stream banks, soil was stripped away to expose fresh, unweathered till and overlying stream terrace deposits of loose, sandy, cobble and boulder gravel and loose, cobbly to bouldery sand (Figure 6).

Figure 6. Till
overlain by
bouldery stream
terrace deposit.
Site EB-12B.

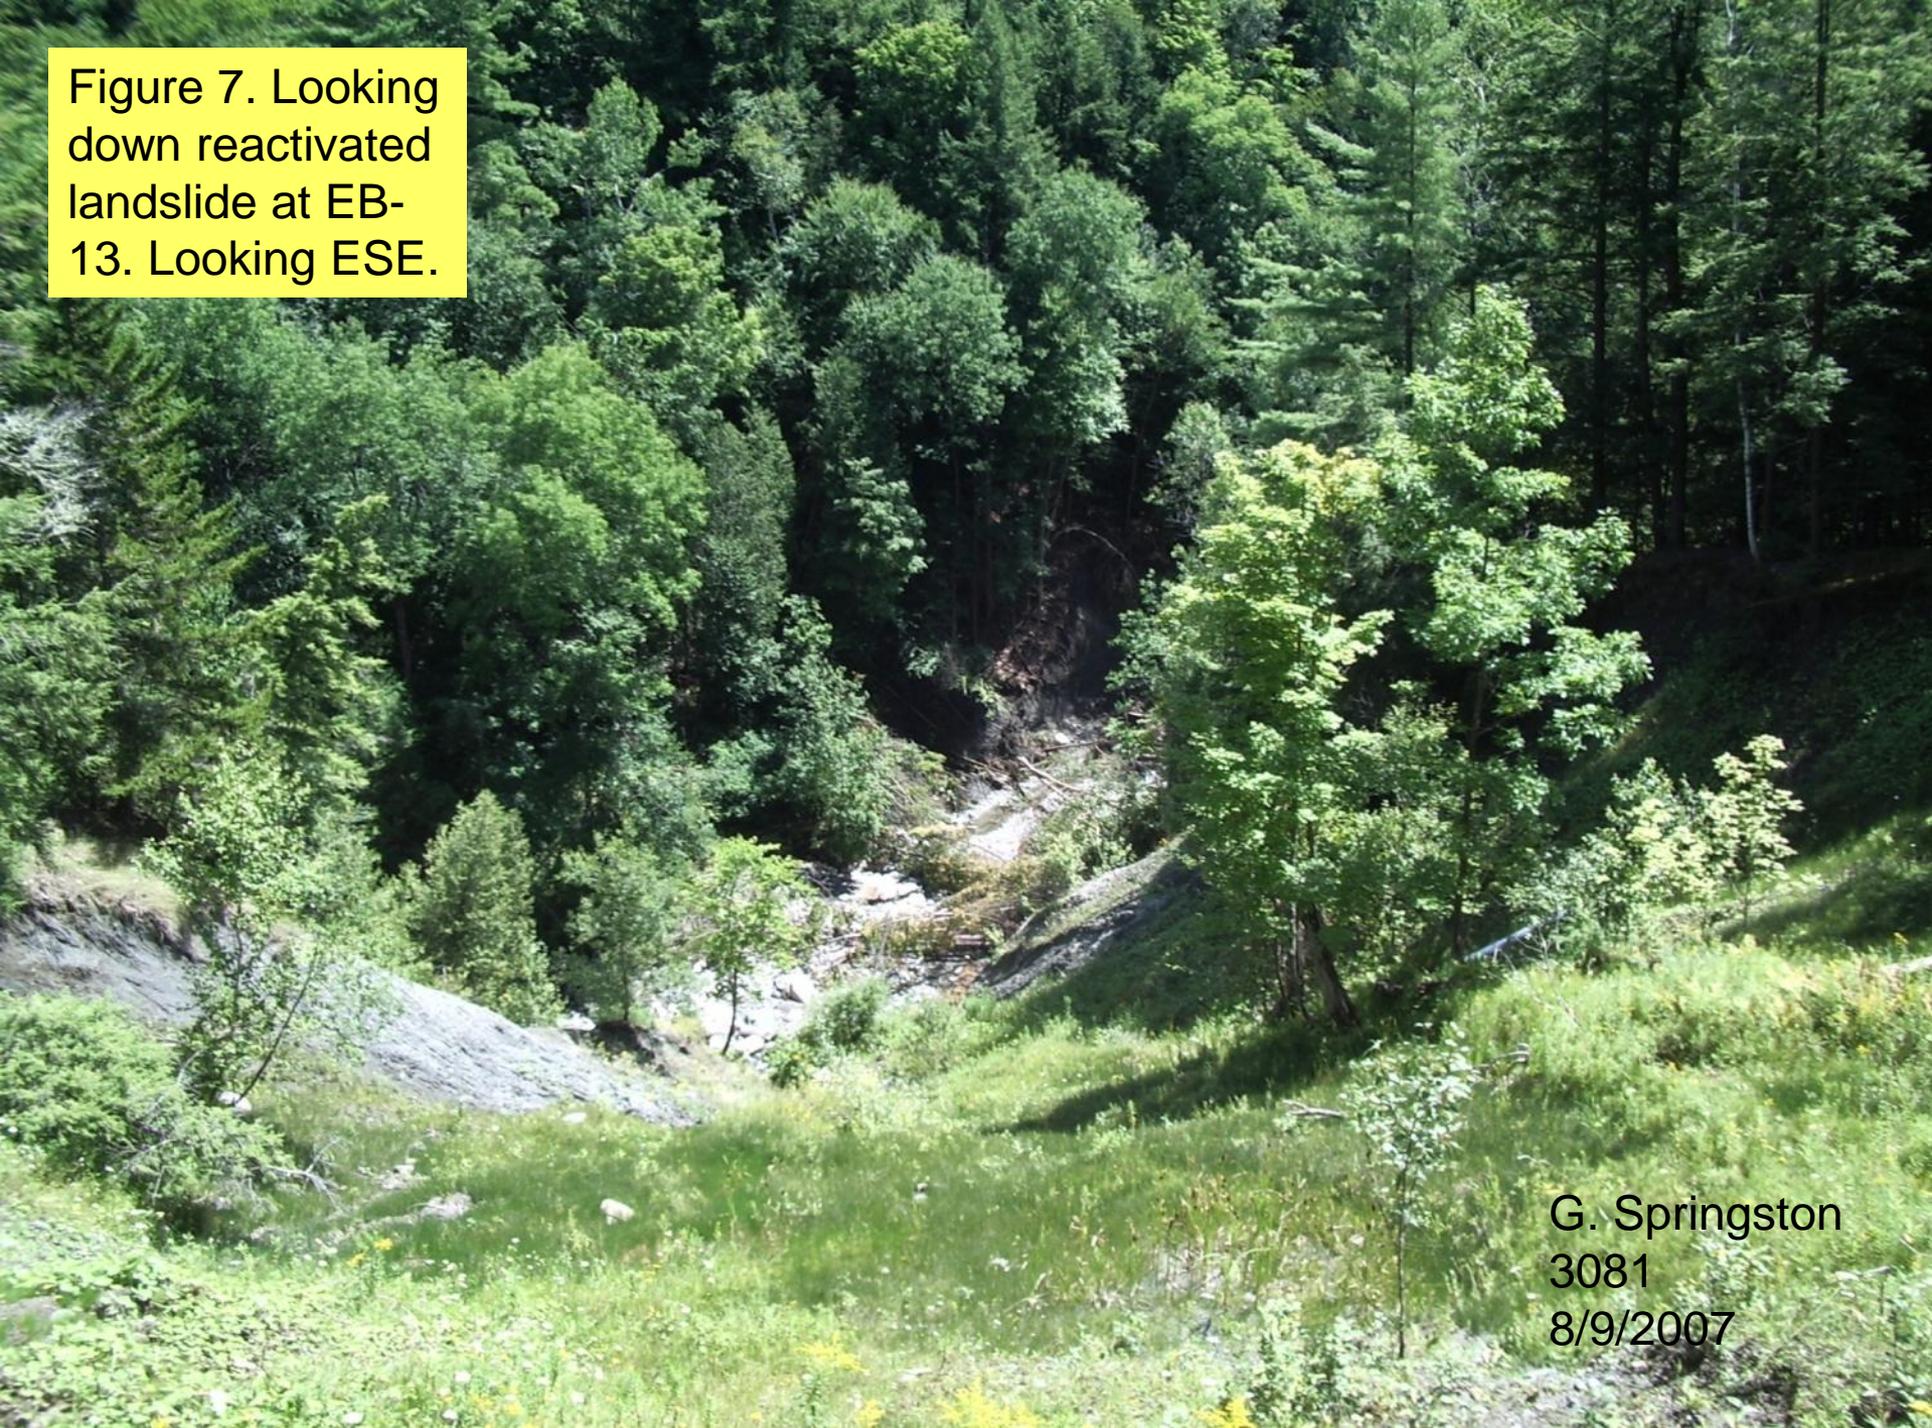
The major landslides begin below the gorge. The first is located on the outside of a meander bend on the west side of the brook at Station EB-13. This slide is about 150 feet high extends about 150 feet along the brook. Figure 7 is taken looking down this slide toward the brook. The materials consist of about 60 feet

Figure 7. Looking down reactivated landslide at EB-13. Looking ESE.

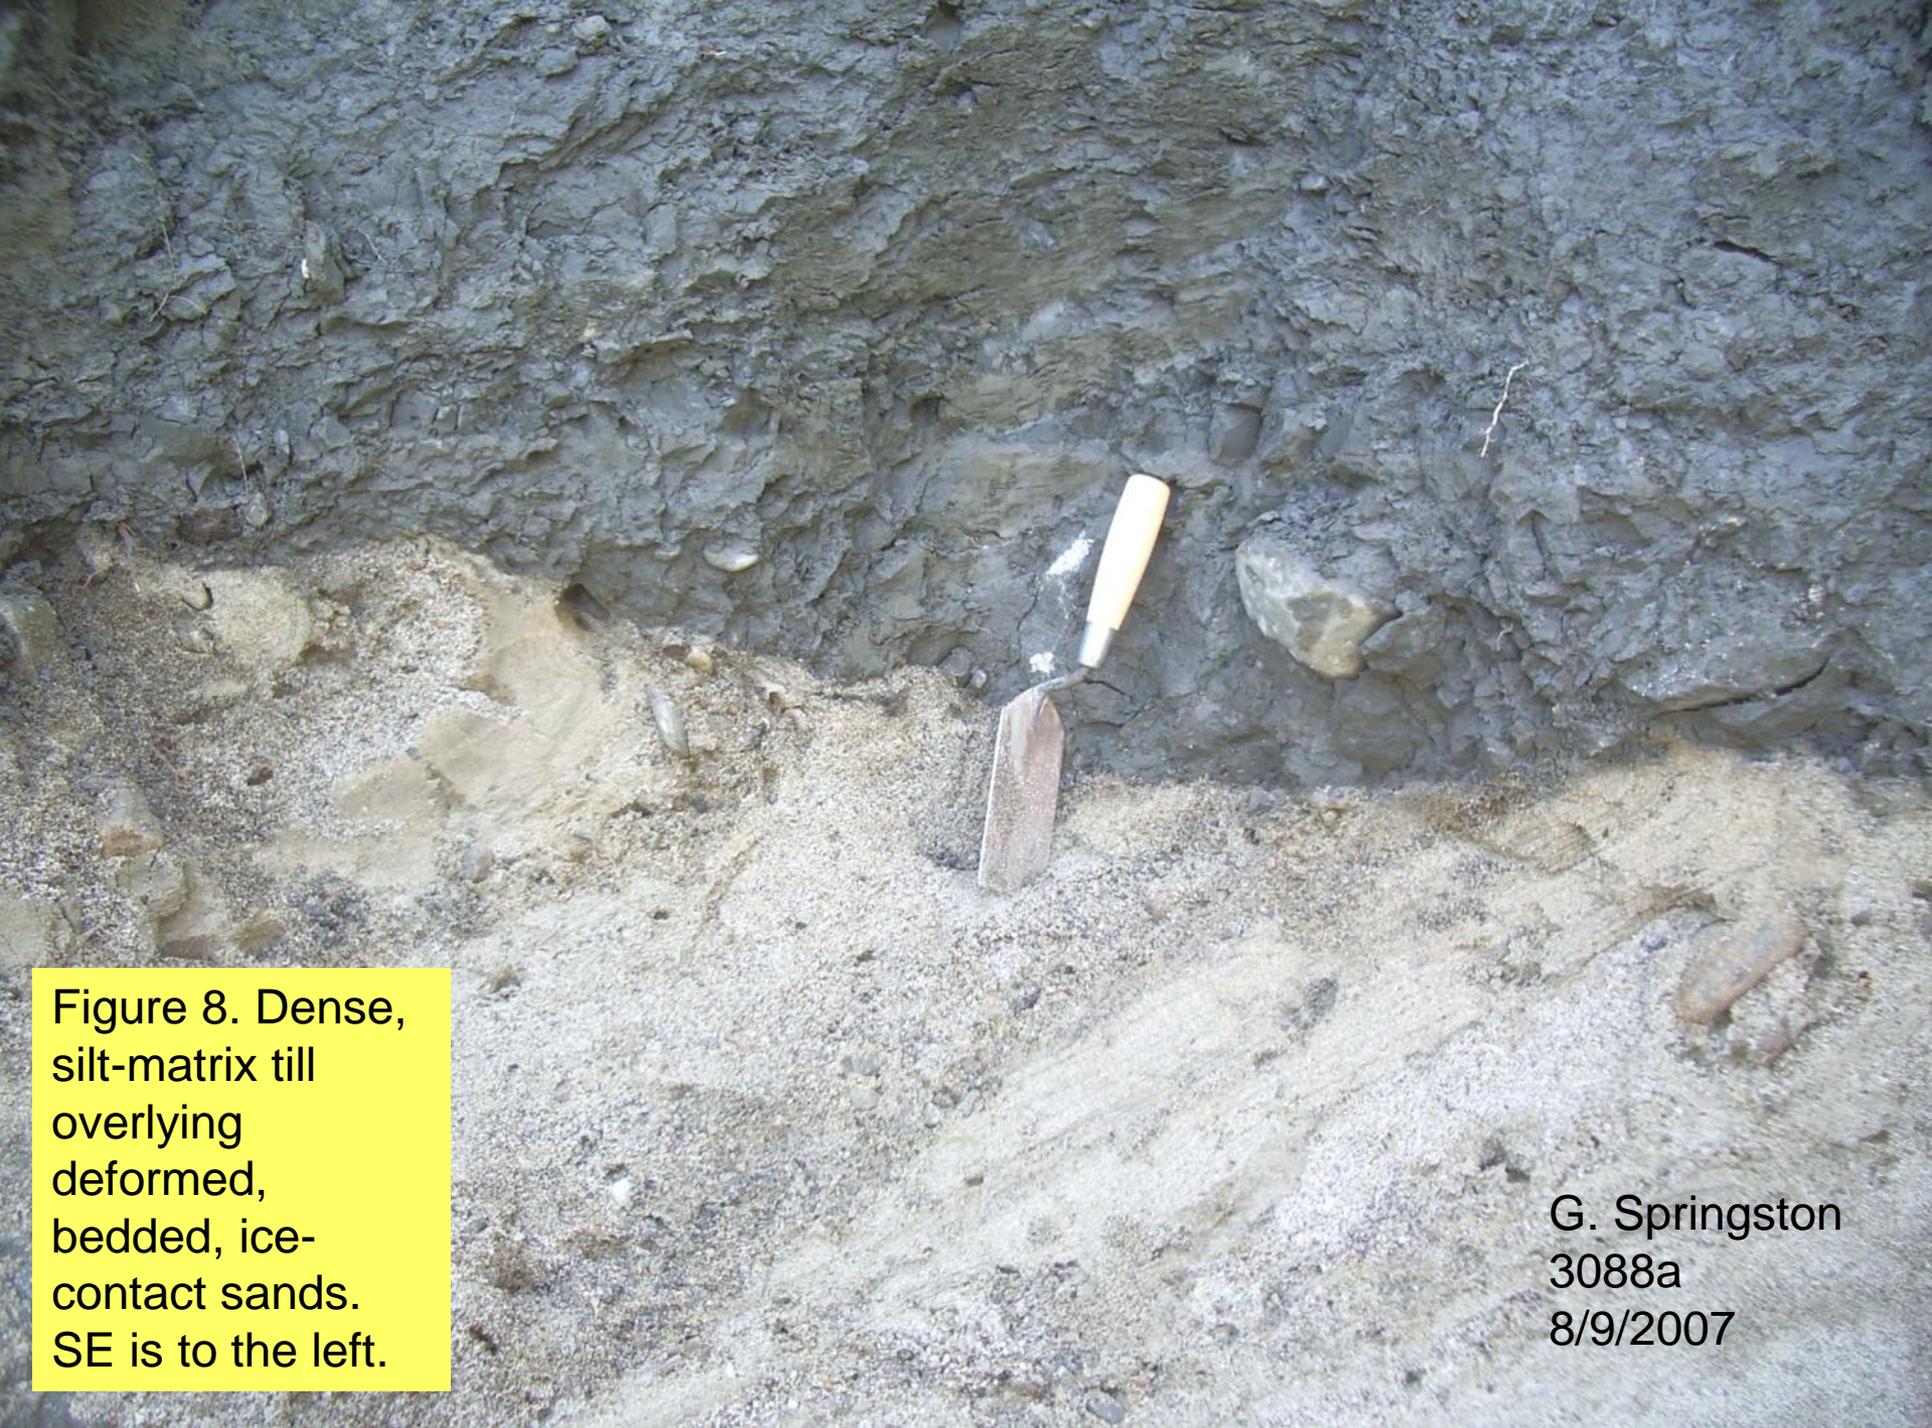
of ice-contact sands and gravels overlain by dense, silt-matrix till. A closeup of the contact between these materials is shown in Figure 8 and a view of the lower portion of the sand and gravel is shown in Figure 9. Flows of till have washed out over much of the underlying sand and gravel, partially obscuring the stratigraphy. Note that this slide has been reactivated by the recent flooding. Mr. Malnati stated that landsliding had occurred here during the 1973 flood. This is confirmed by abundant early successional vegetation on much of the slopes.

Figure 8. Dense, silt-matrix till overlying deformed, bedded, ice-contact sands. SE is to the left.

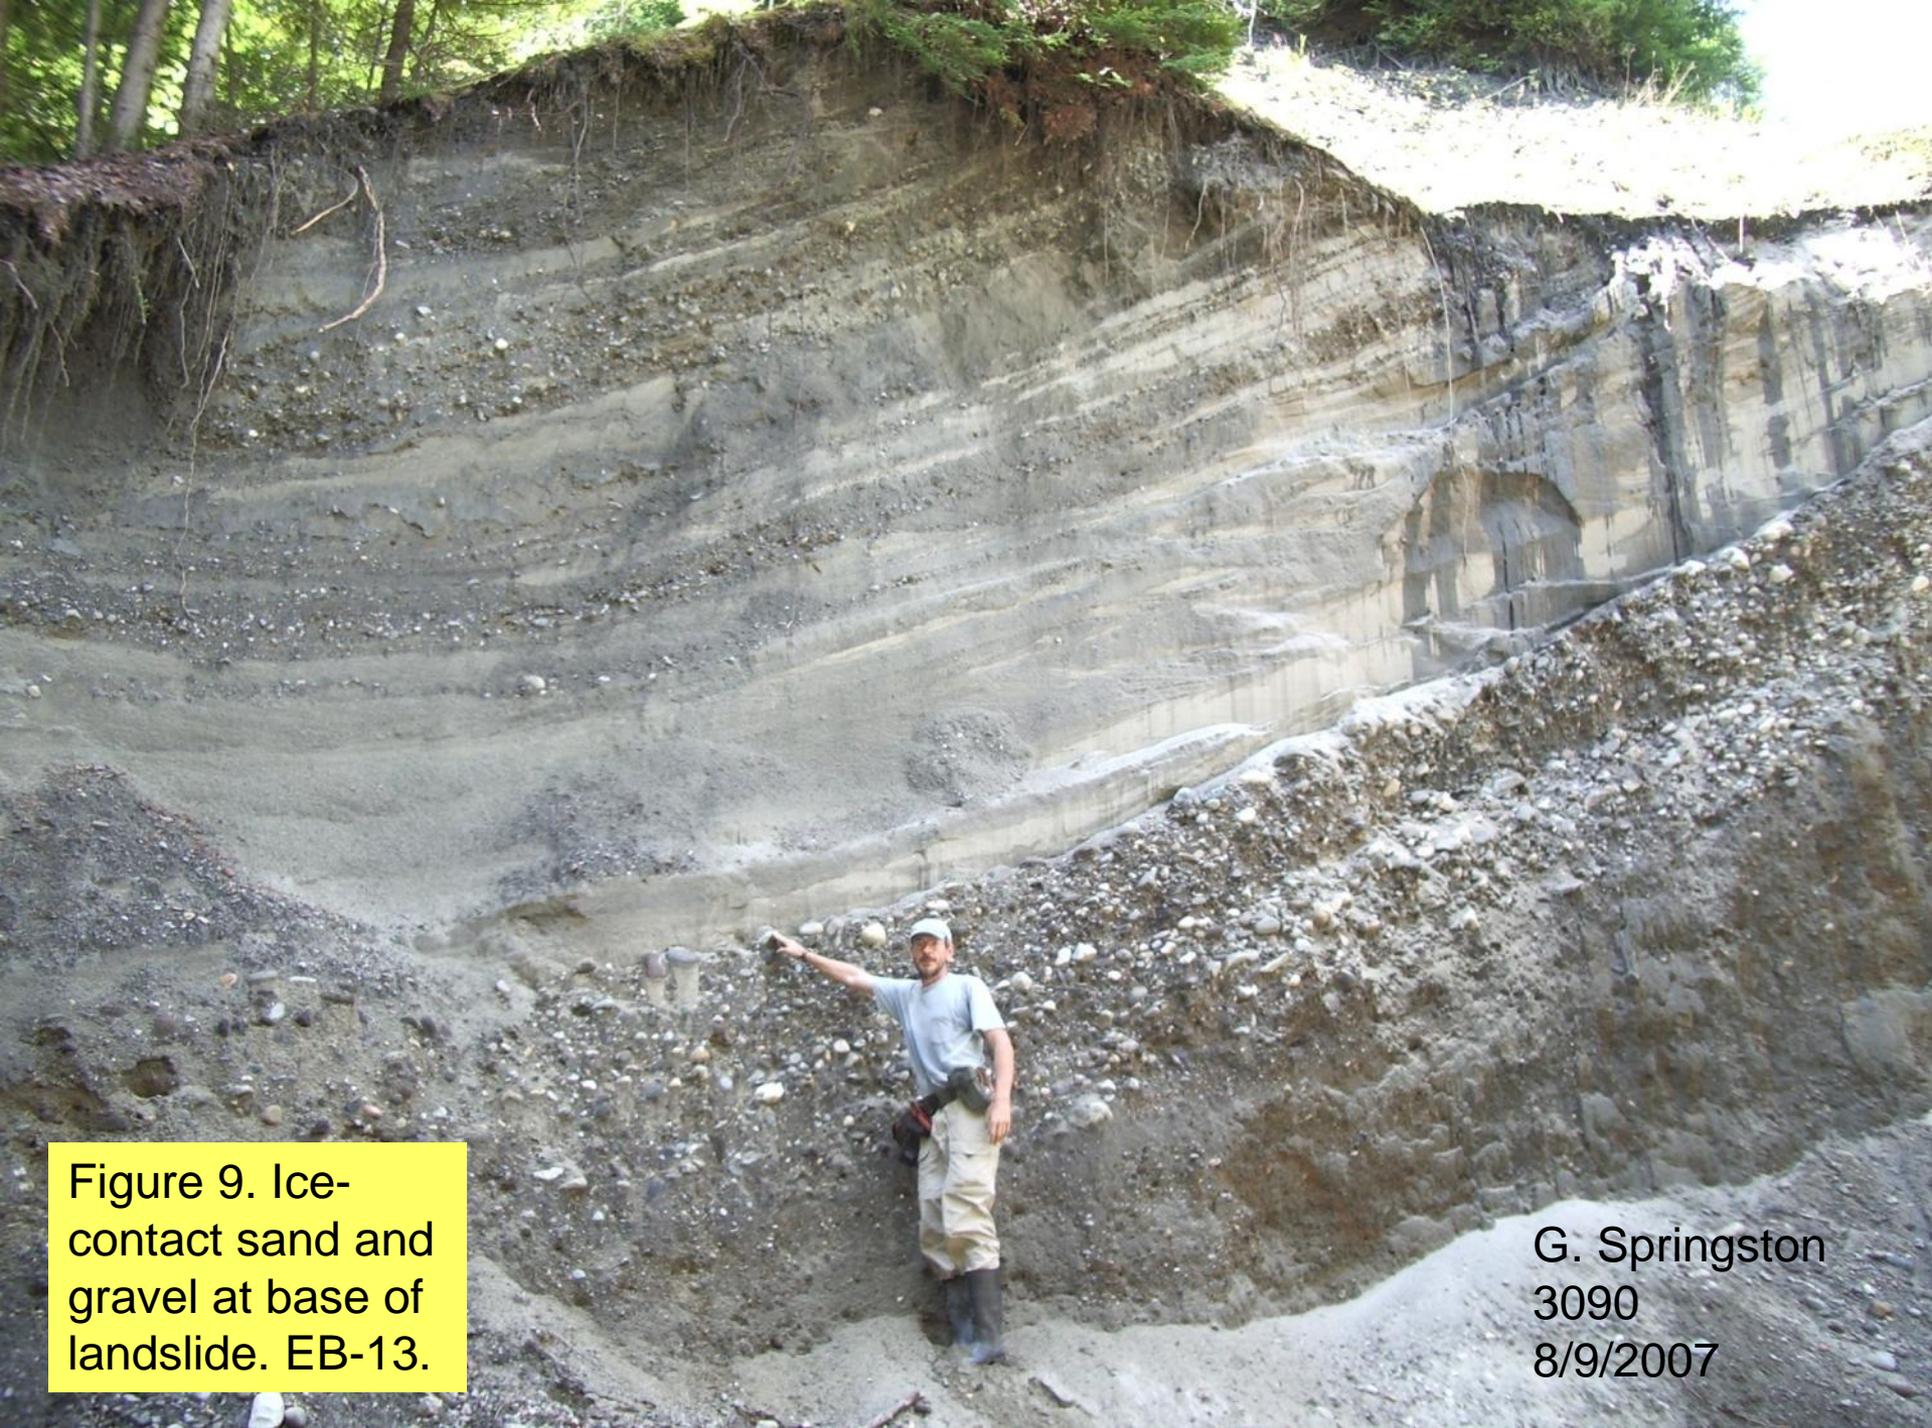
Figure 9. Ice-contact sand and gravel at base of landslide. EB-13.
