To: Laurence Becker, Vermont State Geologist

From: George Springston, Research Associate, Norwich University

Date: 9/6/2007

Subject: Slope instability and flood damage along Honey Brook in East Barre

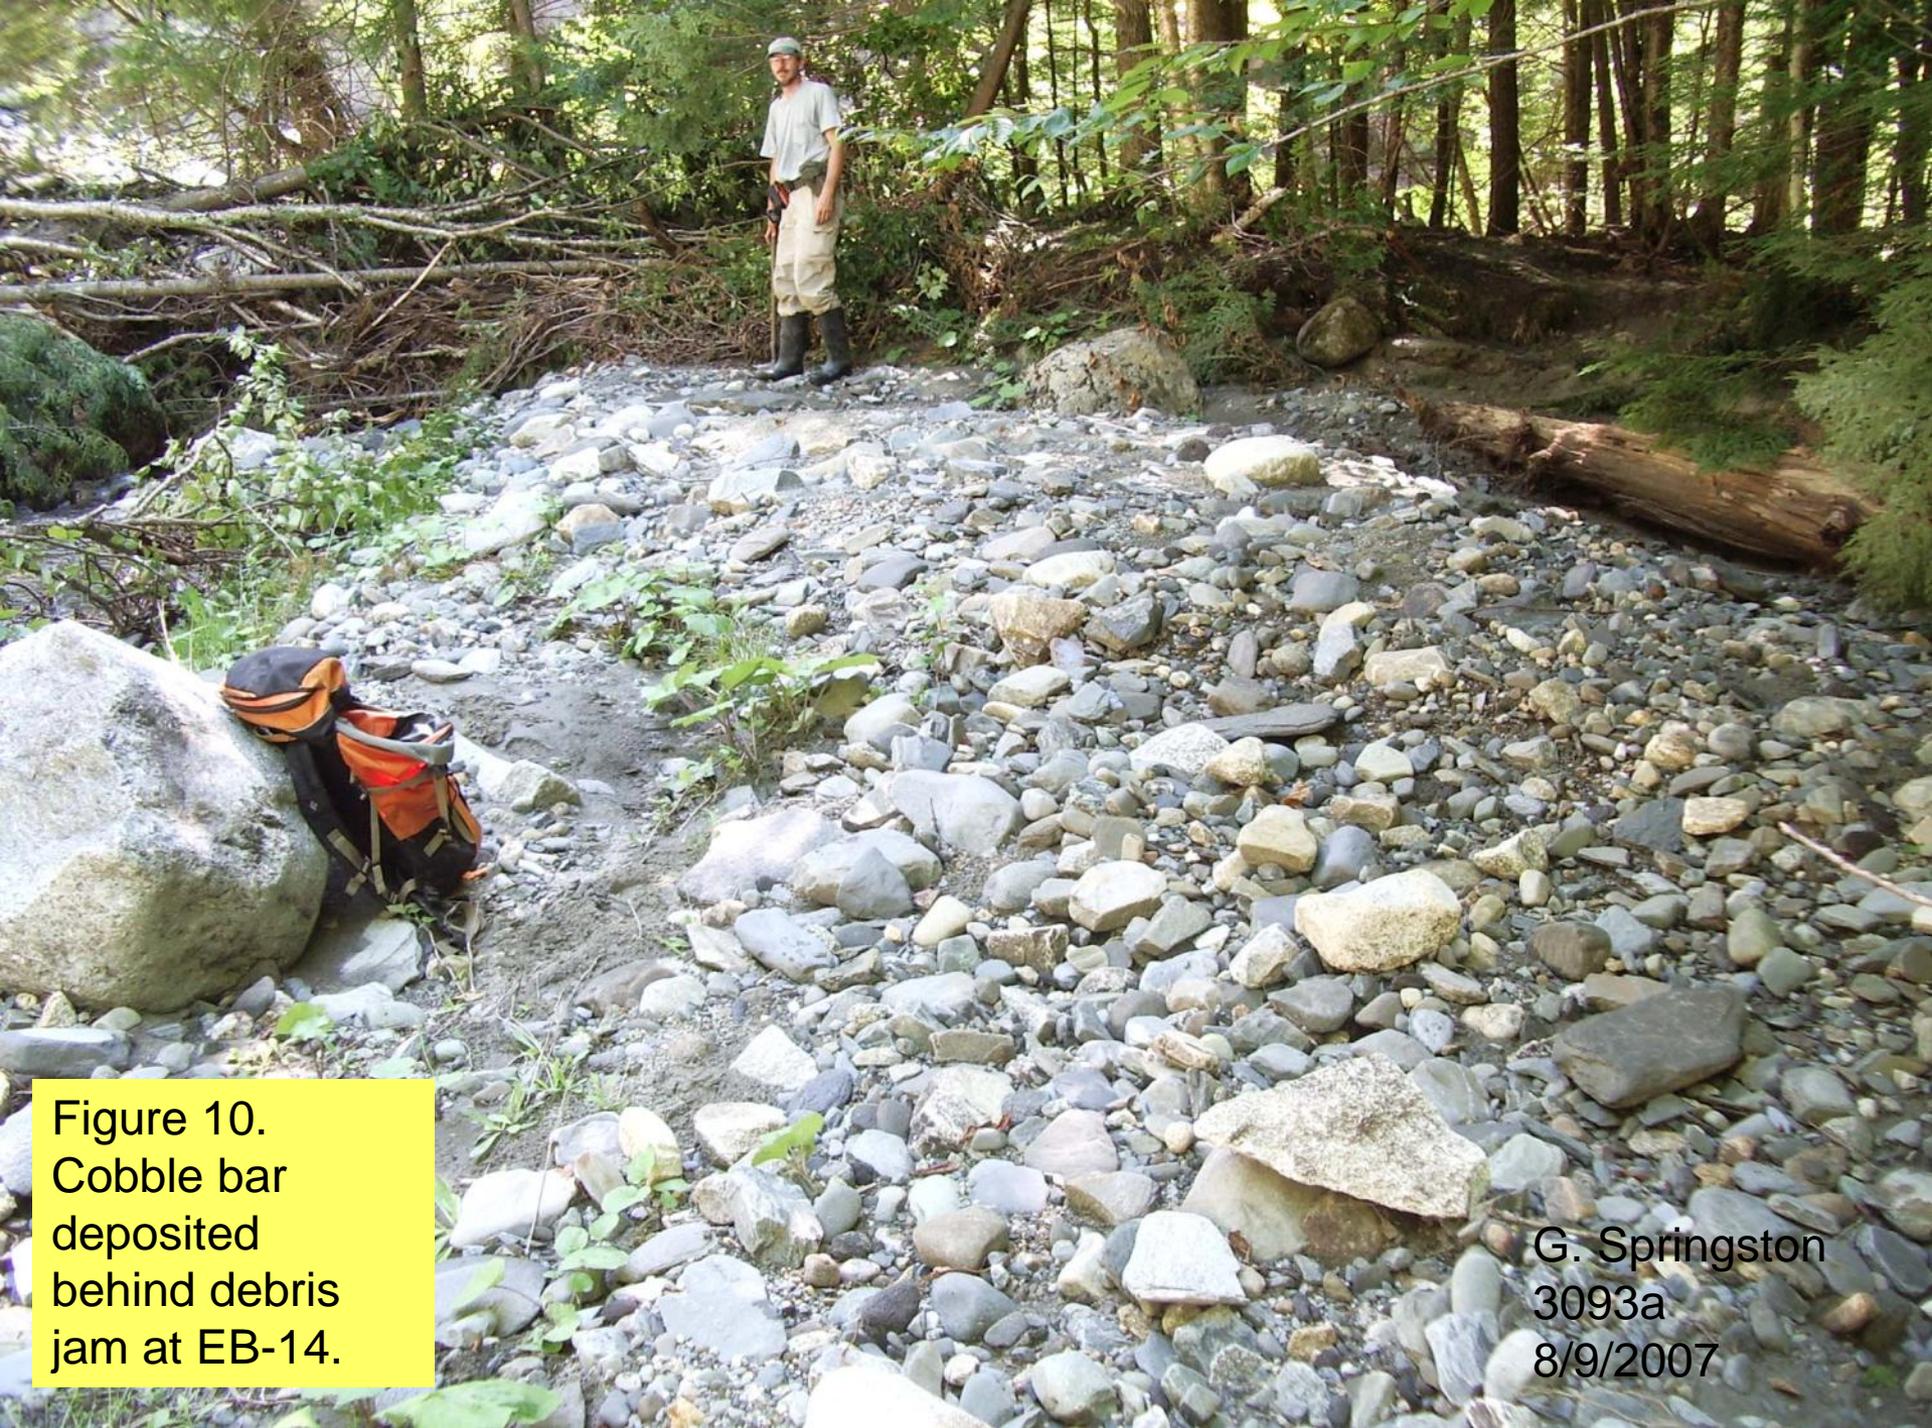
The debris jams continue throughout this section of the stream. An example of a gravel bar that accumulated during the waning of the flood flow is shown in Figure 10. This is a good example of the temporary sediment storage that is occurring behind jams throughout this section of the stream.

Figure 10.
Cobble bar
deposited
behind debris
jam at EB-14.

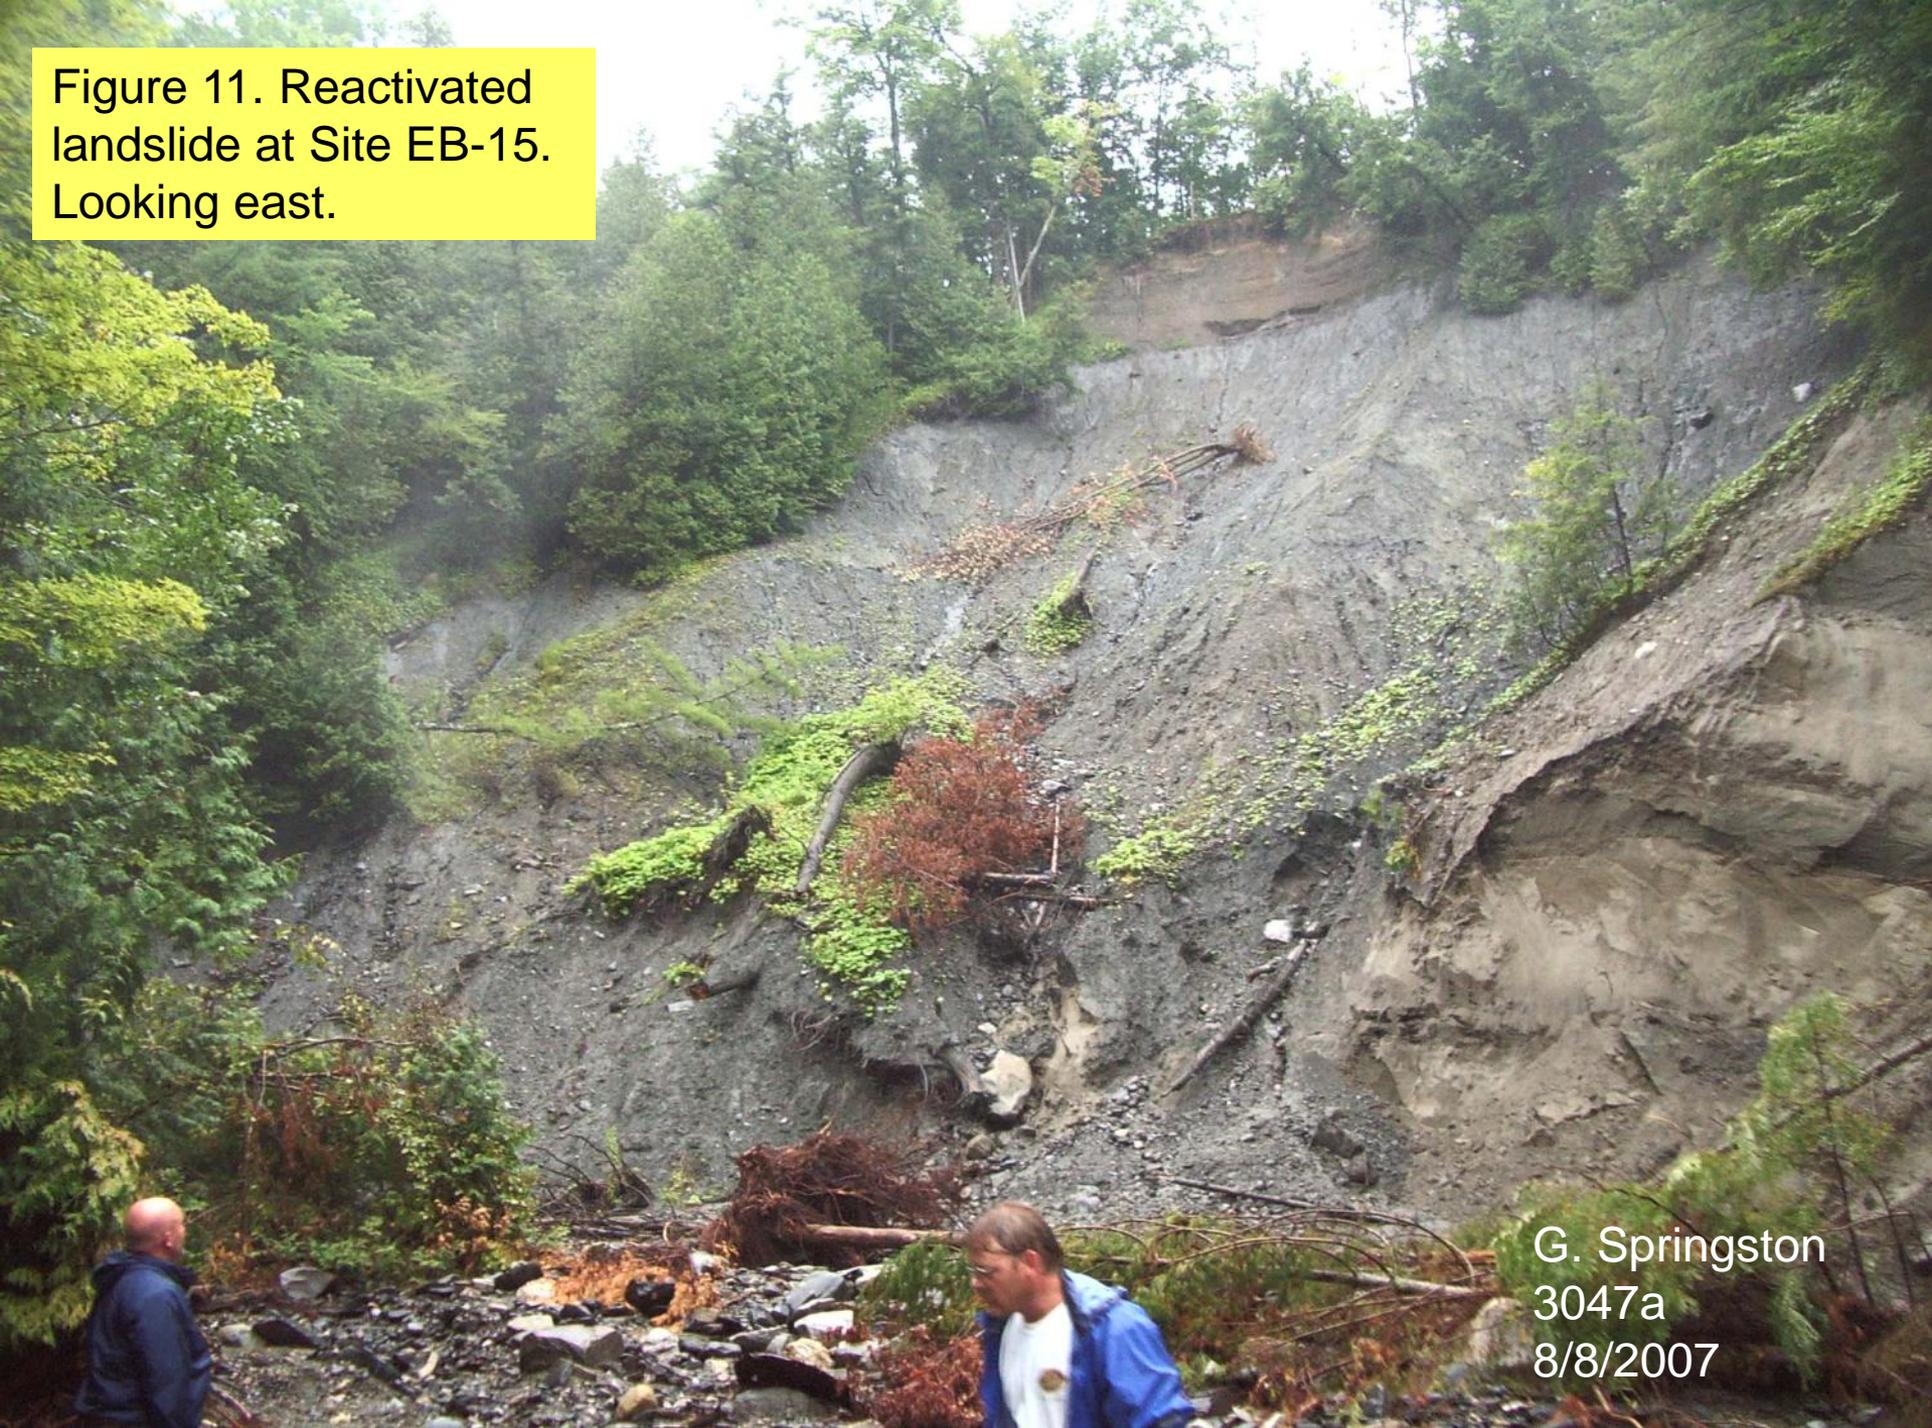
A tremendous landslide is located downstream at Site EB-15 on the outside of a bend on the east side of the brook (Figure 11). This is approximately 180 to 190 feet high and about 230 feet long. The lower portion of the deposit consists of 50 feet of coarse sandy pebble gravel (Figure 12) overlain by dense, silt-matrix till. At about 94 feet above the stream there is a zone of at least 6 feet of laminated diamict. From here up the till appears to be massive, although I did not go out on this part of the face. About 25 feet below the top there appears to be about 5 feet of fine lacustrine deposits and then the upper 20 feet consist of bedded pebble gravel and pebbly sand (stream terrace deposits).

Figure 11. Reactivated landslide at Site EB-15.
Looking east.

Considering the size of the landslides, it appears unlikely that stream restoration techniques could stabilize these banks. Given this, the sizing of the bridge carrying the brook under the highway needs to be adequate to carry floodwaters **and considerable debris**. The hazards to the downstream residences should be carefully evaluated given the likelihood of further slope failures.

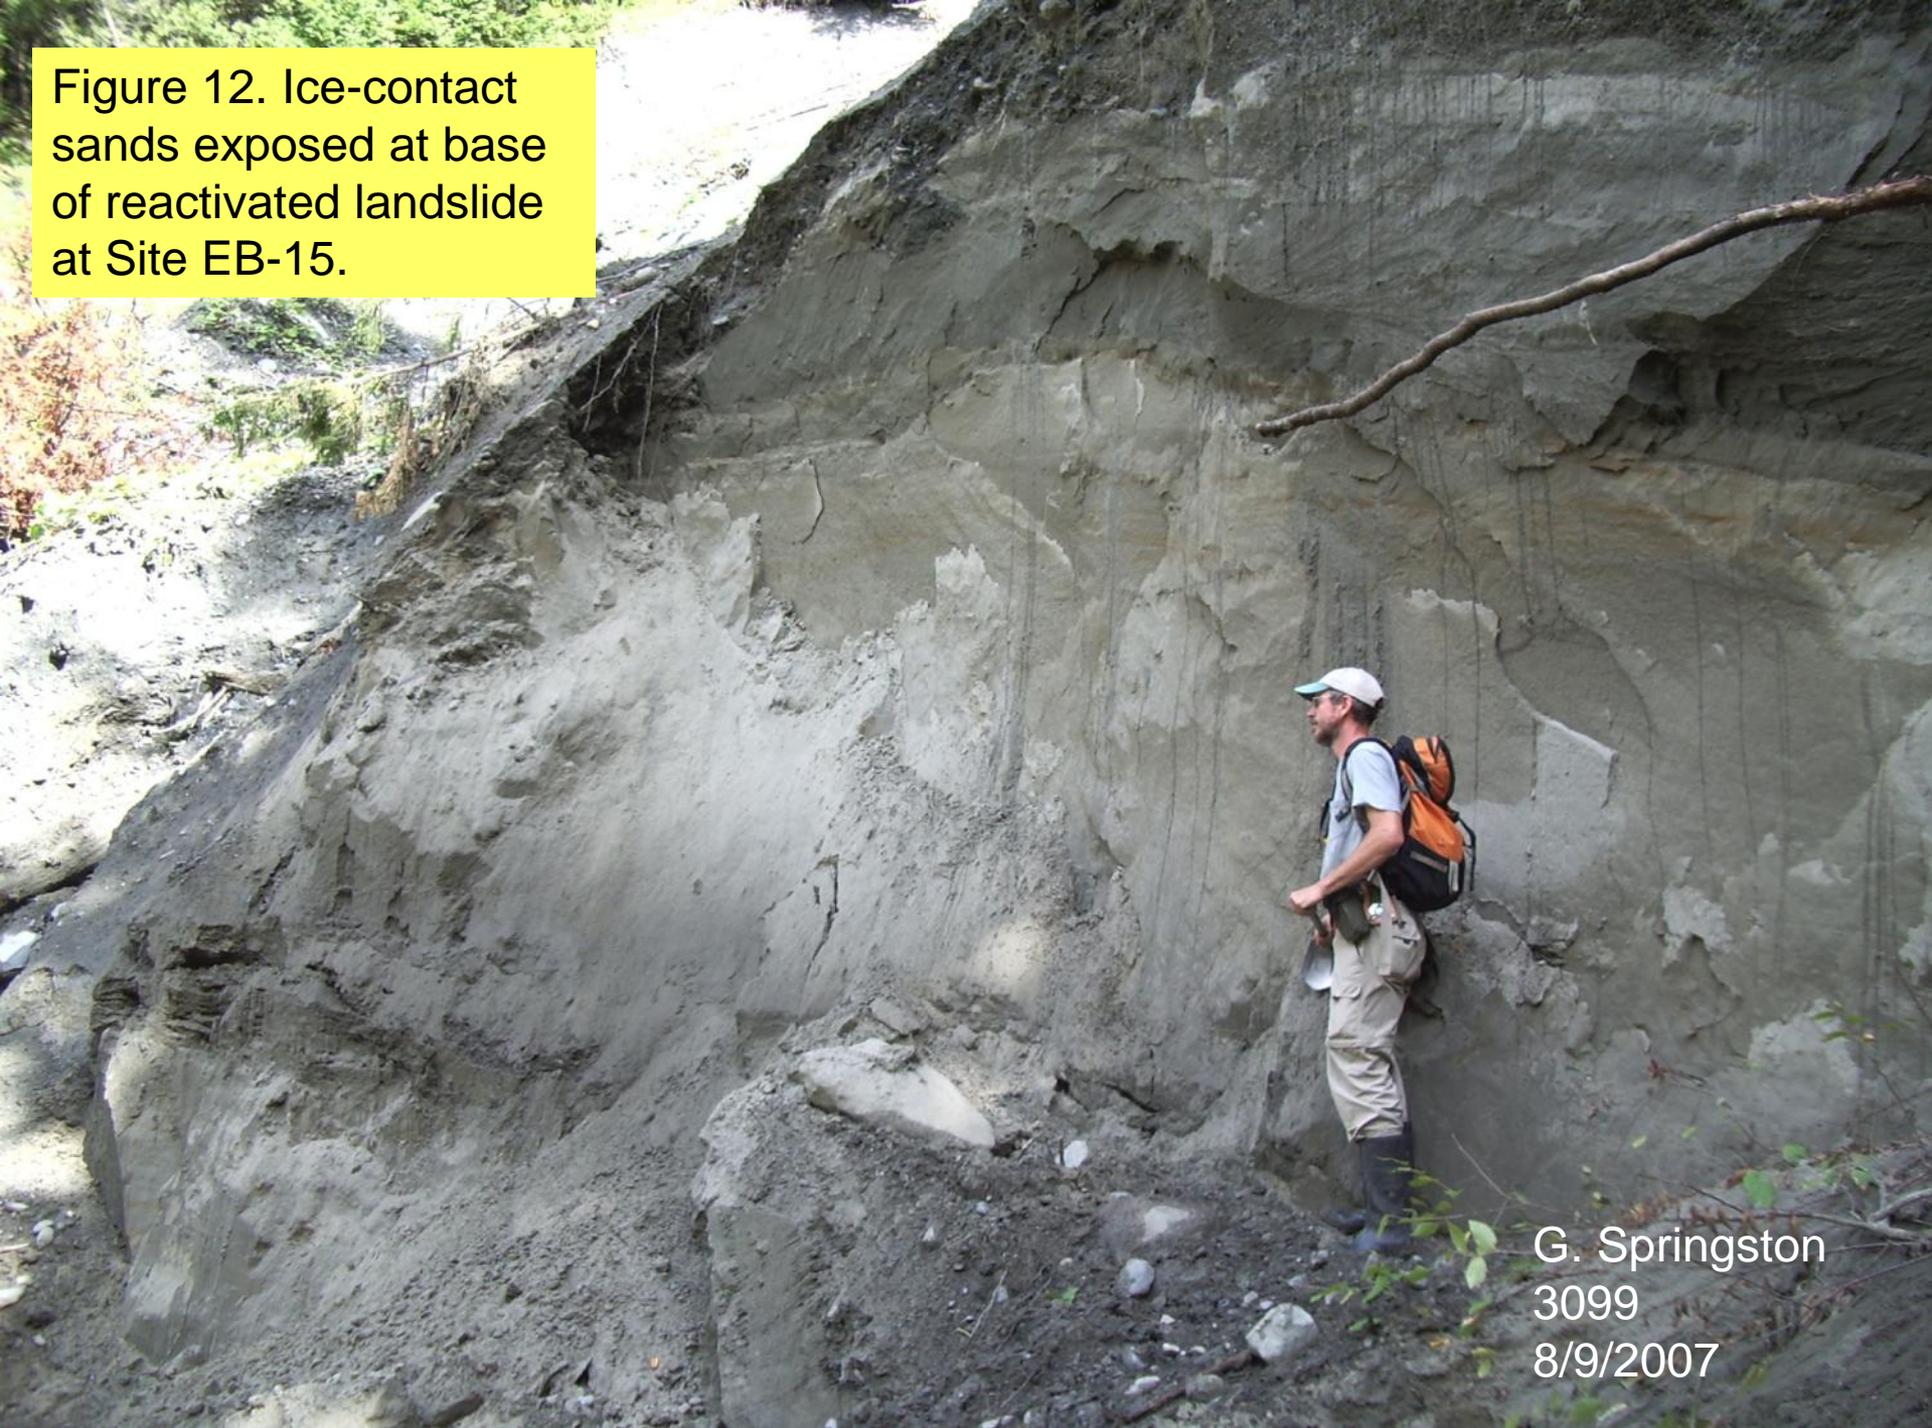
Figure 12. Ice-contact sands exposed at base of reactivated landslide at Site EB-15.

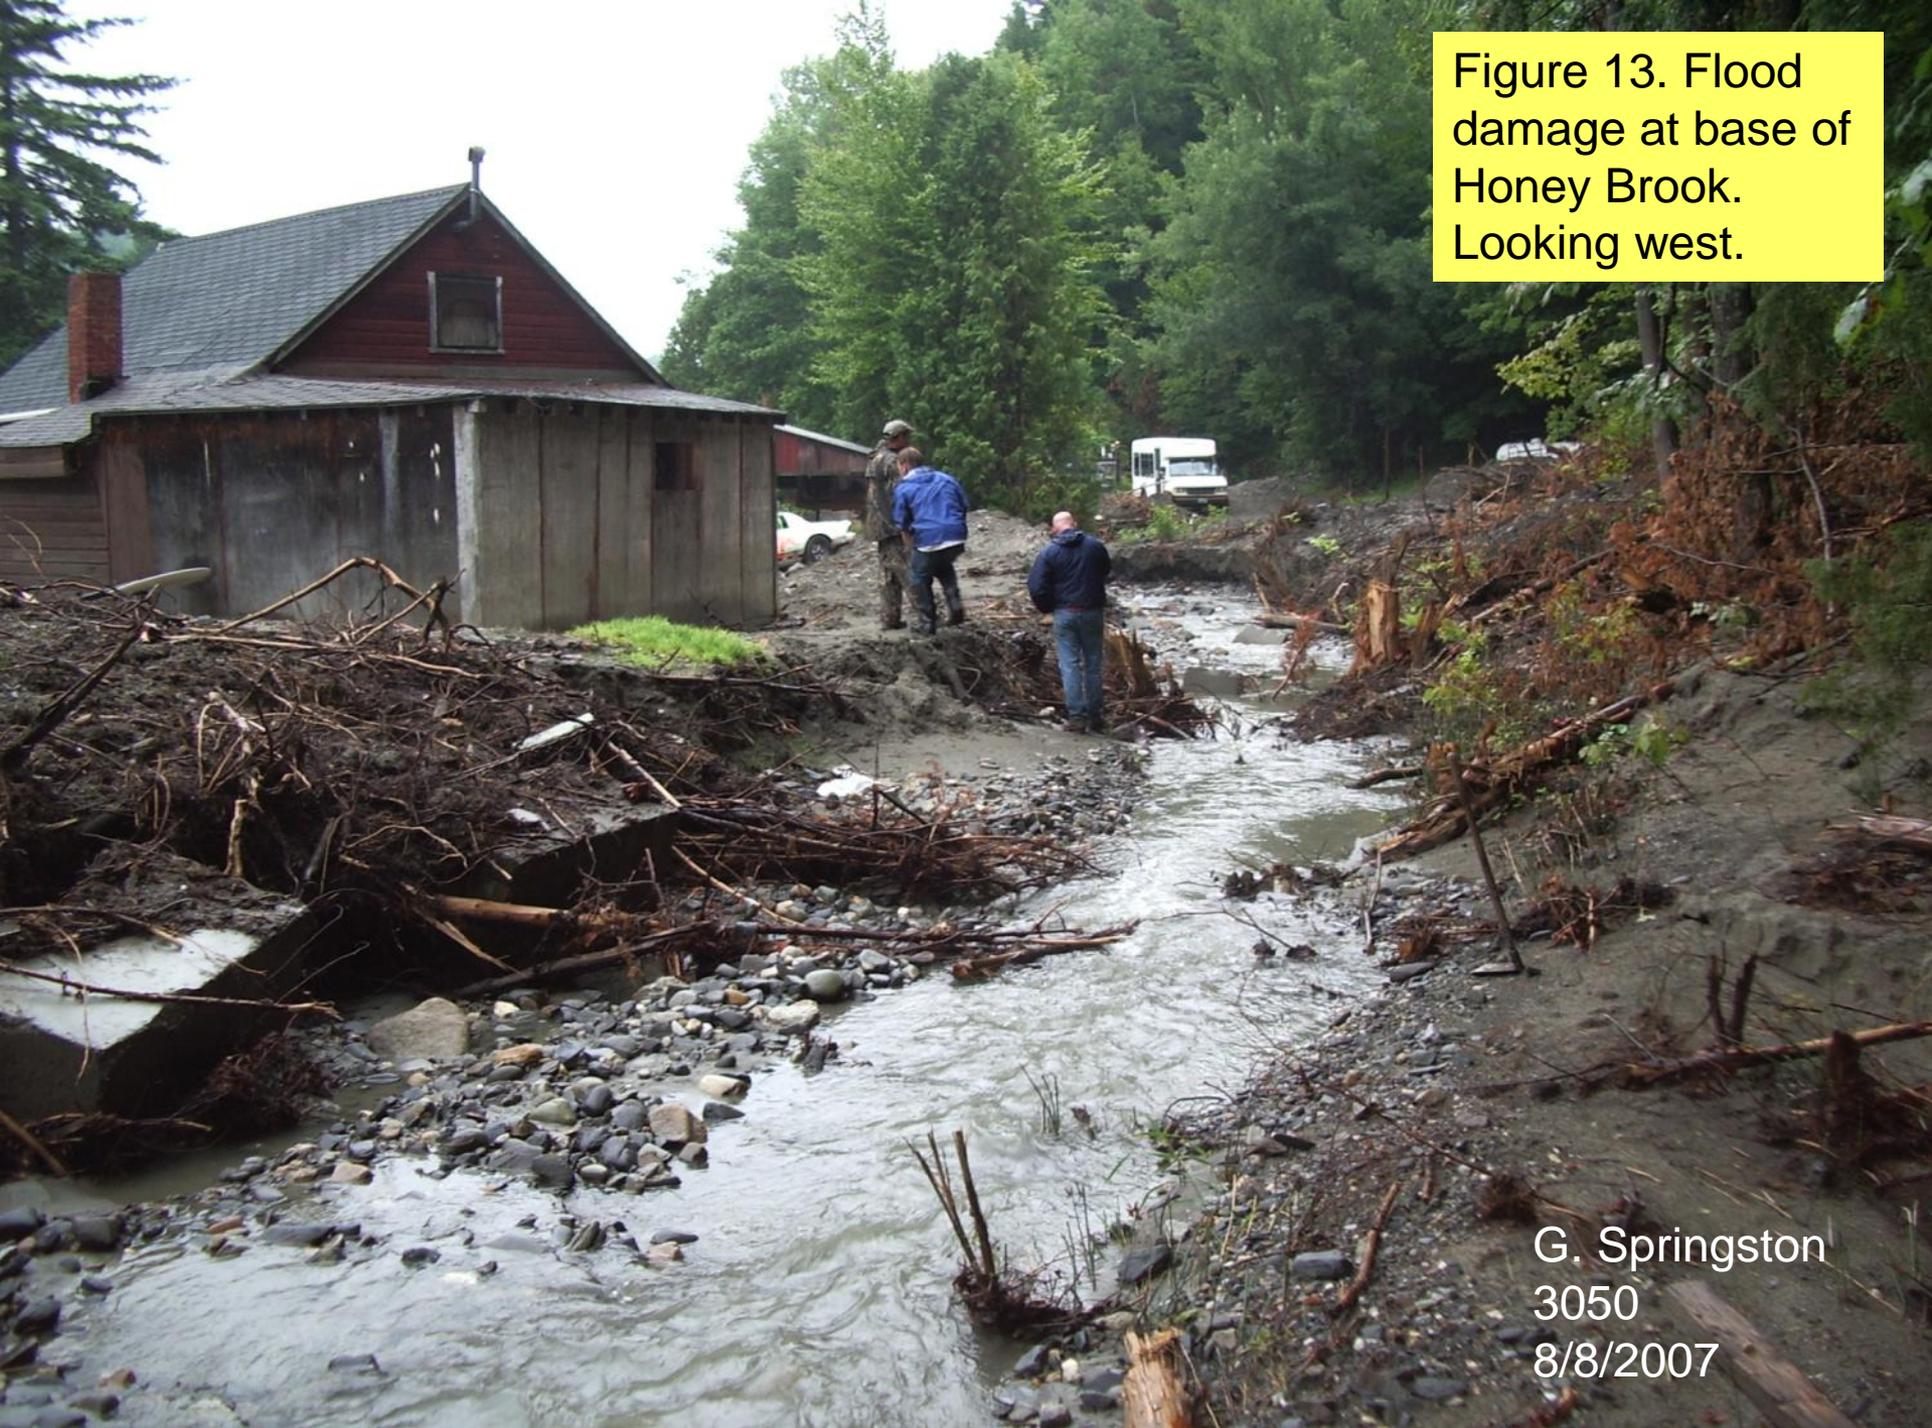
Figures 13 and 14 show the aftermath of the flooding downstream at the Malnati residences. During the storm, the bridge that carries the brook under U.S Route 302 clogged up with debris, the highway was flooded, and extensive scour occurred as the stream found a new course through the Malnati property to the Jail Branch. Following the recession of the floodwaters the channel of the stream was roughly relocated back behind the buildings as shown in the photos.

Figure 13. Flood damage at base of Honey Brook. Looking west.

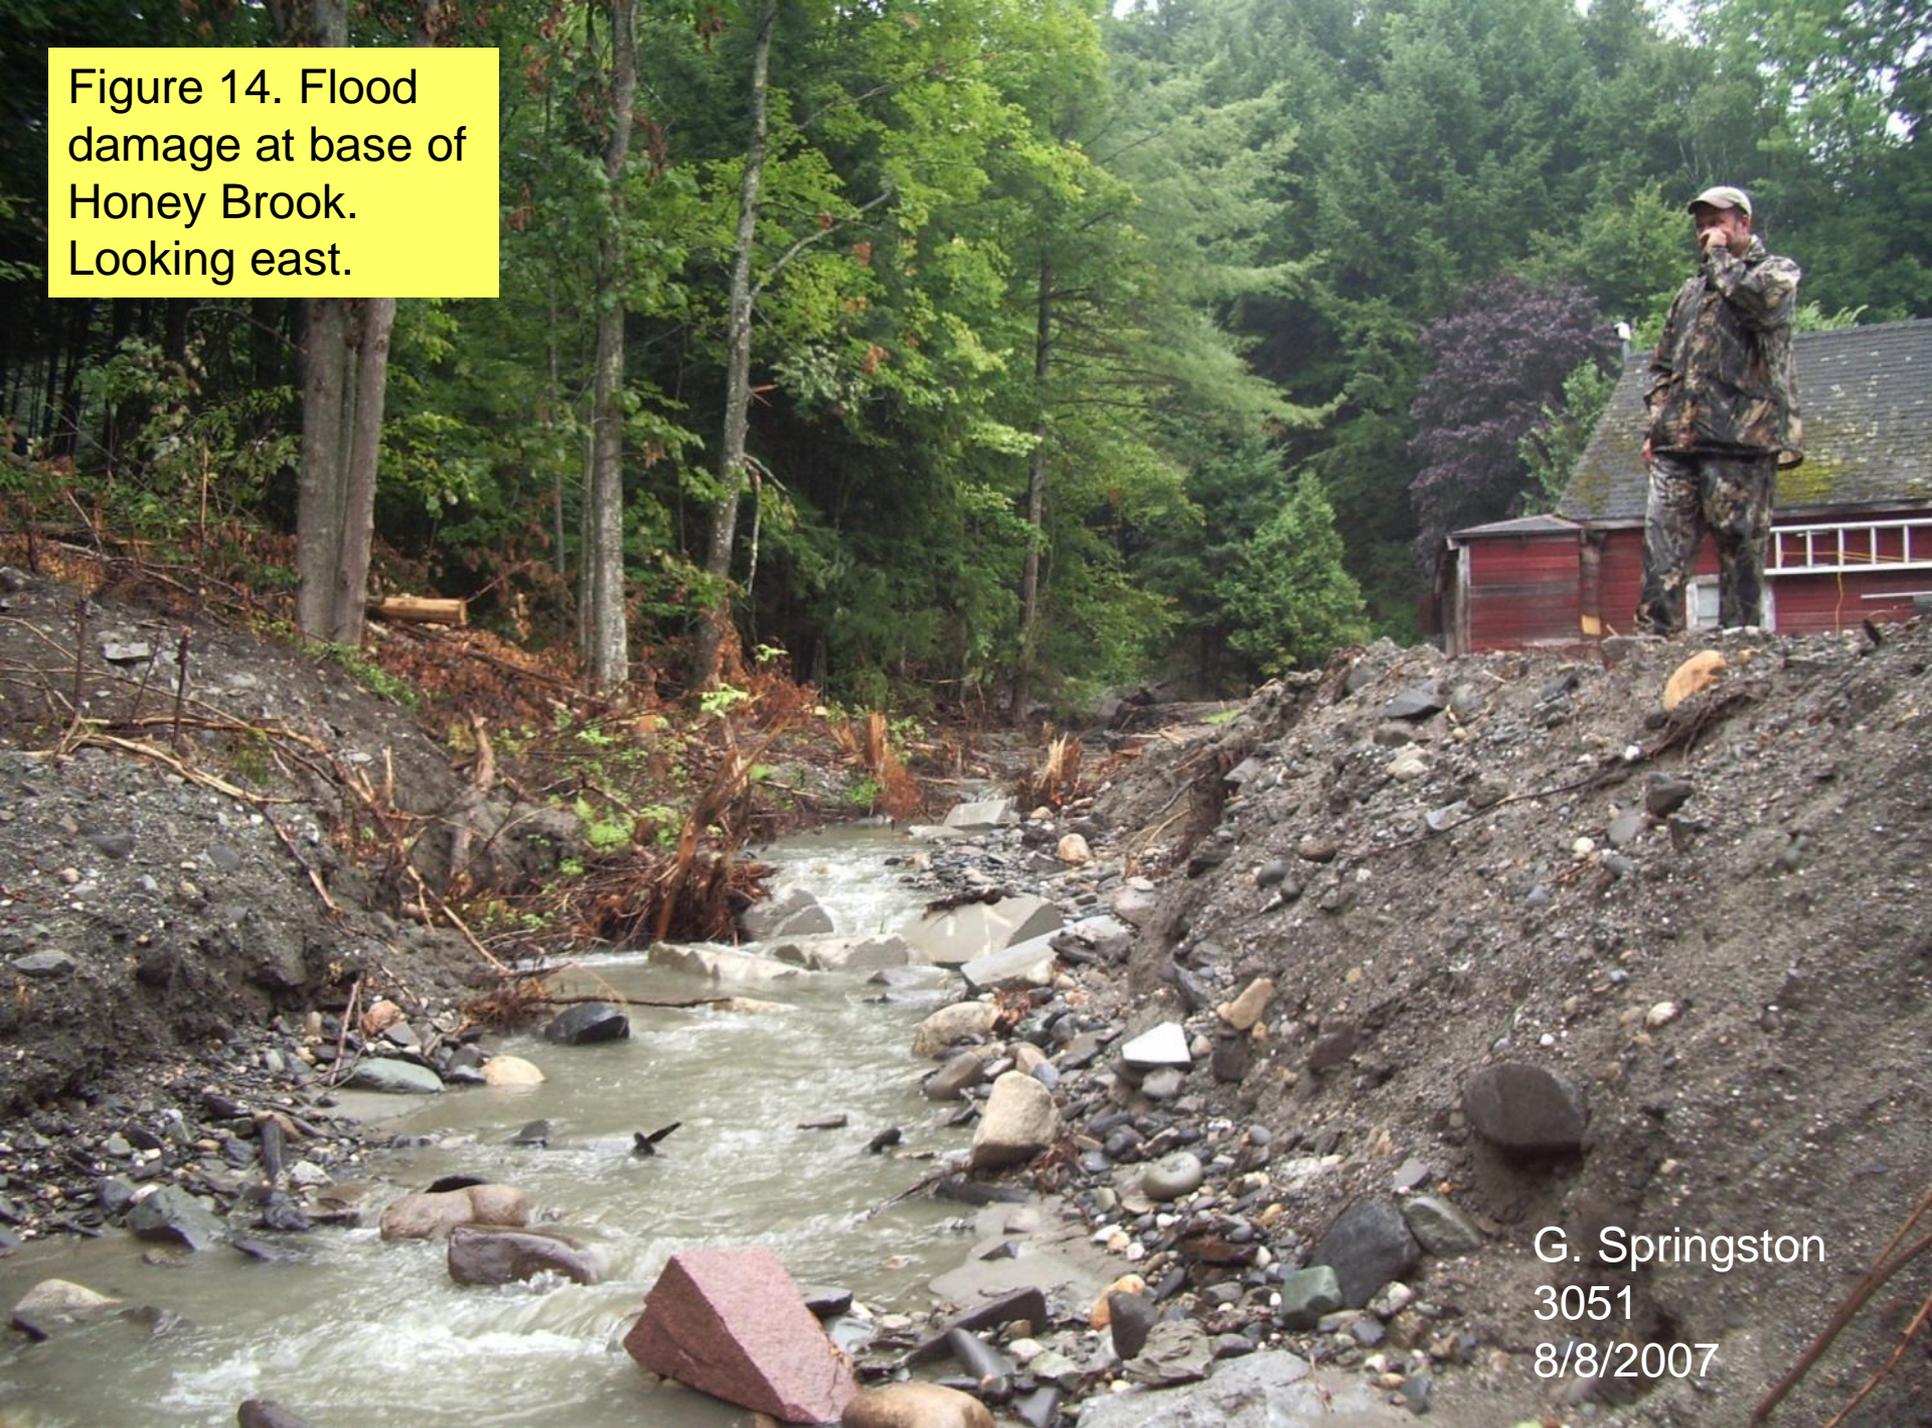
Figure 14. Flood damage at base of Honey Brook. Looking east.
