Vermont Geological Survey Open File Report VG2016-4

Final Report on a Landslide Inventory of the Town of Highgate, Vermont

August 30, 2016

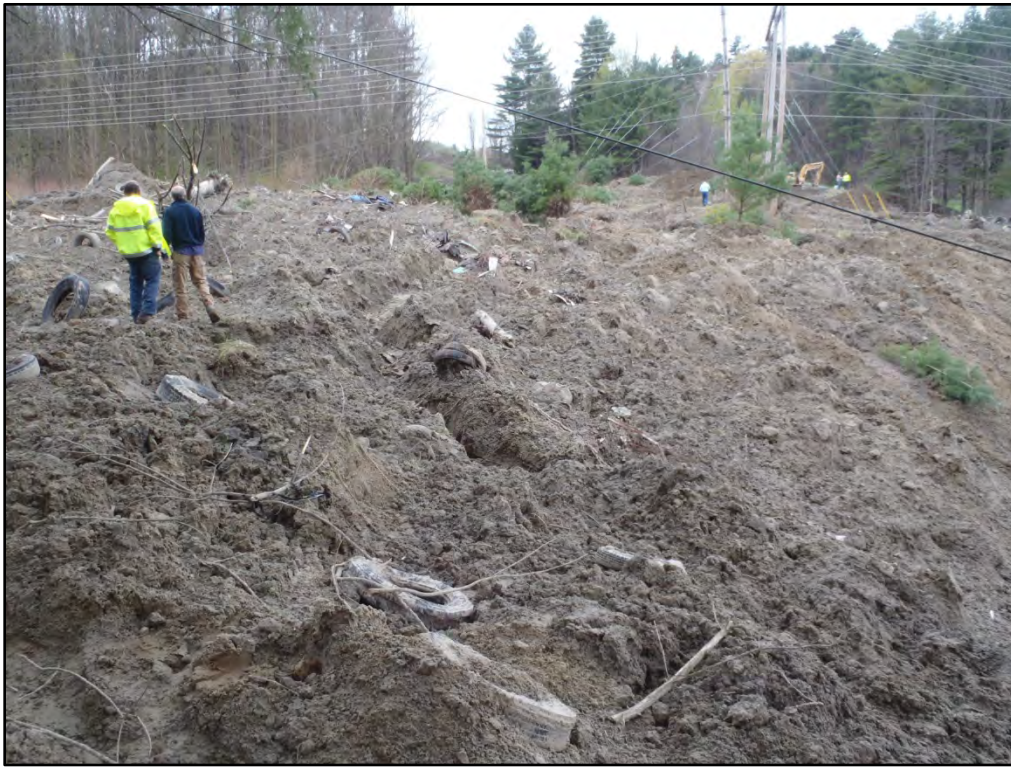
On the cover: Deposit from a large landslide located west of Vt. Rt. 207 and the power dam at Highgate Falls, Highgate, Vermont. Power lines and fiber optic cables were damaged by this landslide that occurred in the spring of 2011. A large quantity of sediment from the landslide entered the Missisquoi River from this landslide. Photo taken on May 6, 2011 by George Springston.

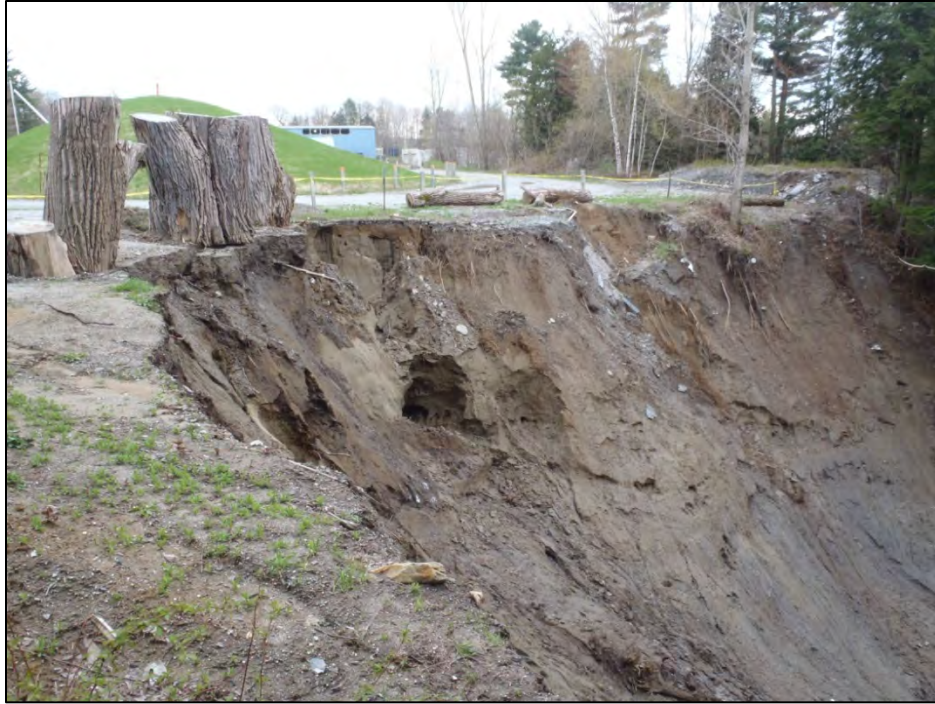
Slope instability appears to be an ongoing problem on the margins of the terrace. One site had been remediated at the time of my October visit and another was being stabilized while I was there. Slope stability modeling by Geodesign suggests that parts of the slopes may be quite unstable, at least during times of high groundwater levels. Factors that may at times contribute to slope instability here also include weighting of the upper parts of slopes due to emplacement of soil or other materials and surface or subsurface runoff of storm water from the site.

One site of particular concern to the Town is an active gully located in the northern part of the site and immediately west of the Sand Shed. The edge of this gully is located within 25 feet of the building and I observed that erosion is occurring in the gully bottom, with trees falling into the gully as the sides collapse. Thus, the slope immediately to the west of the Sand Shed building is unstable and will eventually threaten the stability of the building.

Figure 3. Upper edge of landslide at Highgate Transfer Station with Transfer Station in background. Photo taken on May 6, 2011.

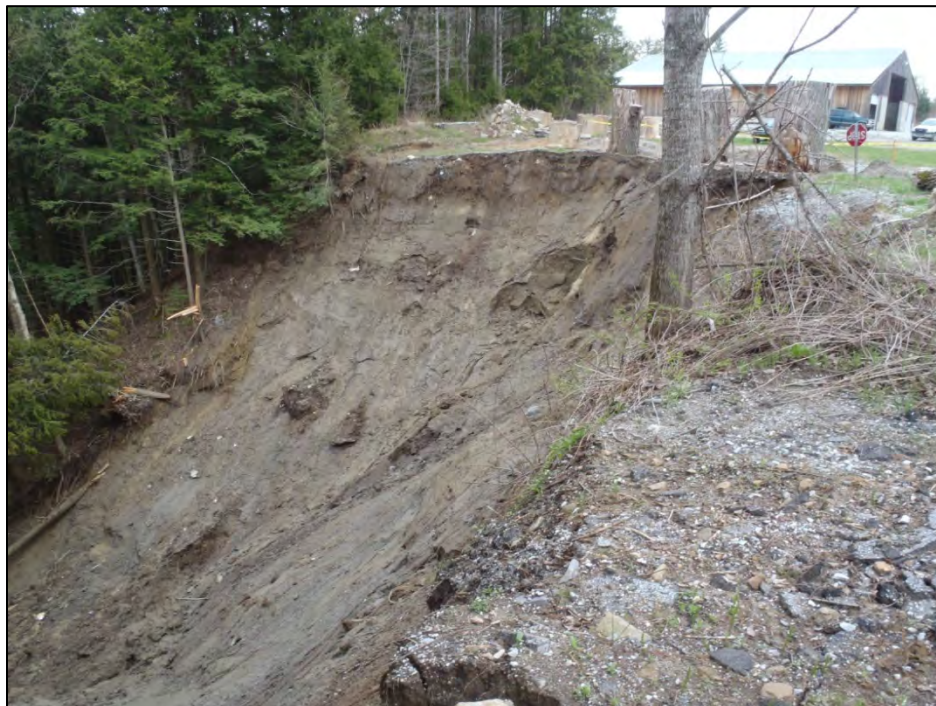
Figure 4. Upper edge of landslide at Highgate Transfer Station, looking toward salt shed. Photo taken on May 6, 2011.

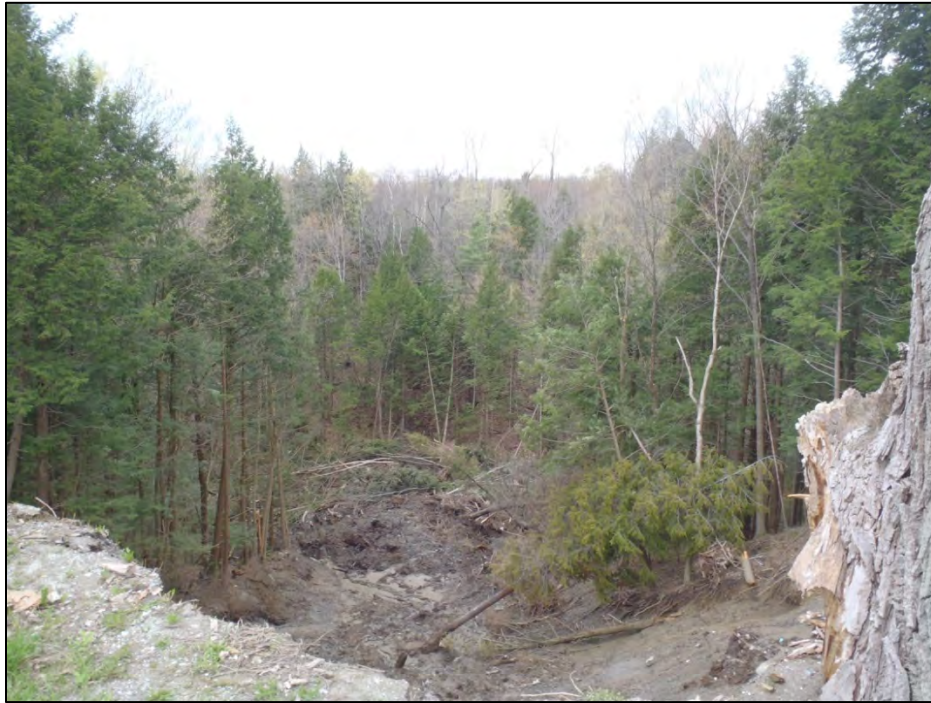
Figure 5. Looking down the landslide towards the toe. Photo taken on May 6, 2011.

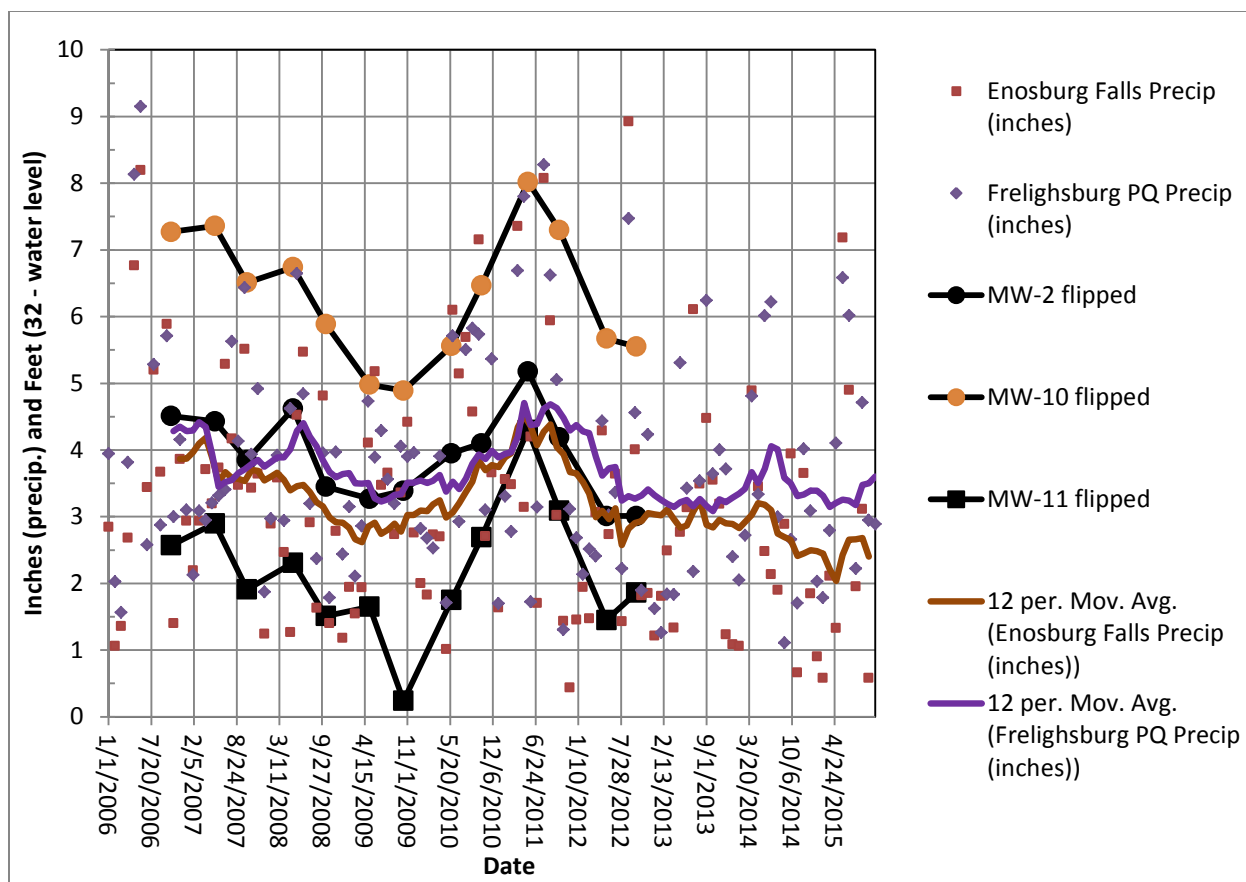
An analysis of groundwater levels in monitoring wells at the site is shown in Figure 6. A peak in average rainfall (12 month moving average) coincides with a peak in water levels in the spring of 2011. The spring of 2011 was one of the wettest on record, which perhaps would be reason enough for the landslides that occurred in several parts of northern Vermont in the late spring of 2011, but the graph also reveals that this was near the end of a two-year period of increasing precipitation. Renewed monitoring of these wells would be helpful in understanding slope stability problems at the site. I recommend monthly monitoring of at least two of the wells.

Figure 6. Comparison of water levels in monitoring wells at Highgate Transfer Station with monthly precipitation at Enosburg Falls and Frelighsburg, Quebec, from 2000 to the present. A peak in average rainfall (12 month moving average) coincides with a peak in water levels in the spring of 2011. Precipitation data downloaded from <http://www.ncdc.noaa.gov/data-access/land-based-station-data> . Water levels are plotted in feet as 32 feet minus depth of water below surface. This effectively flips the line to allow comparisons between water levels and precipitation.

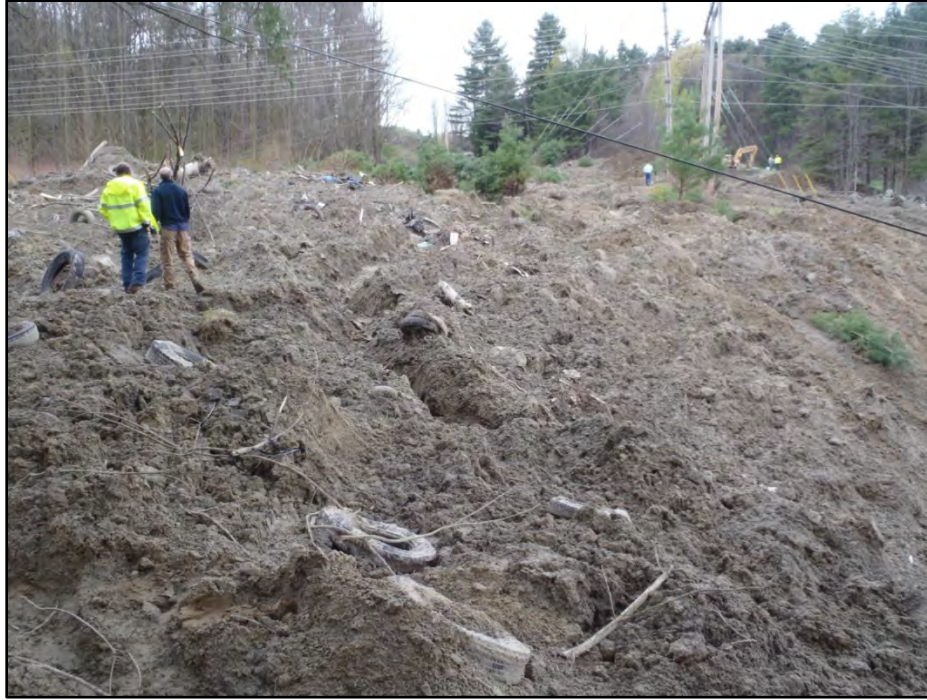
This large, highly mobile rotational slide-flow originated in a ravine on the west side of Vermont Rt. 207 (Highgate Road) and the power dam at Highgate Falls. The material flowed over 900 feet before the material cascaded over the steep drop-off into the Missisquoi River (see Figures 7 and 8). This occurred in early May of 2011. As described above, this had been a very wet spring. The materials around the head of the landslide were difficult to access at the time of the site visit due to saturation with water, but they appeared to be fine sands over silt-clay. The landslide originated in a ravine that had experienced slope failures in the past as the landowner had built retaining walls of old tires in an attempt to stabilize the slopes. The landslide deposits, as shown below, were studded with some of these tires.

Figure 7. Deposit from the large landslide located west of Rt. 207 and the power dam at Highgate Falls, Highgate, Vermont. Power lines and fiber optic cables were damaged by the landslide. A large quantity of sediment from the landslide entered the Missisquoi River from this landslide.

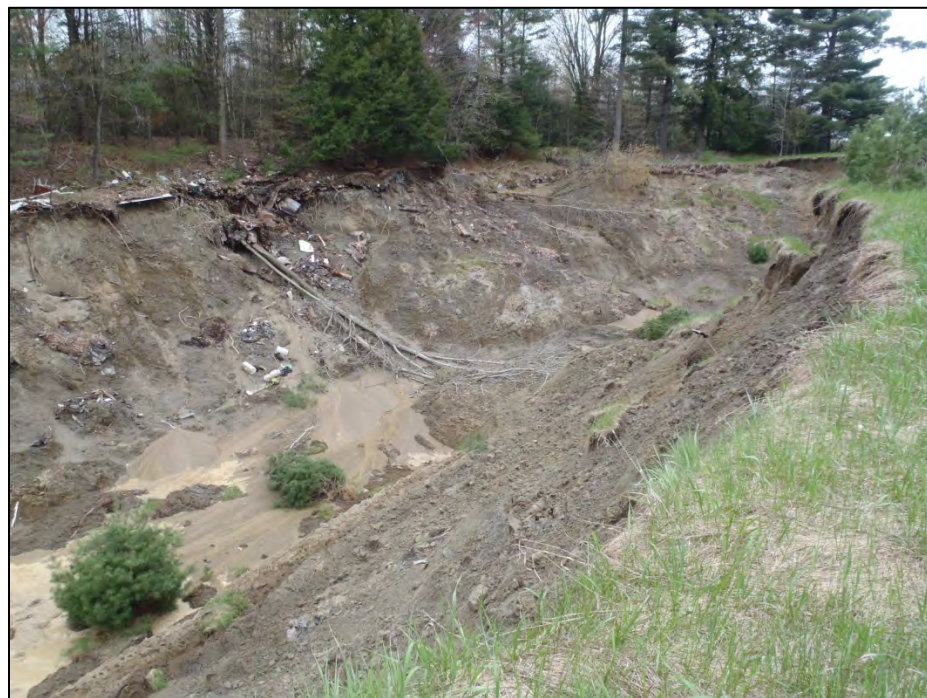
Figure 8. Head of the landslide west of Highgate Falls.

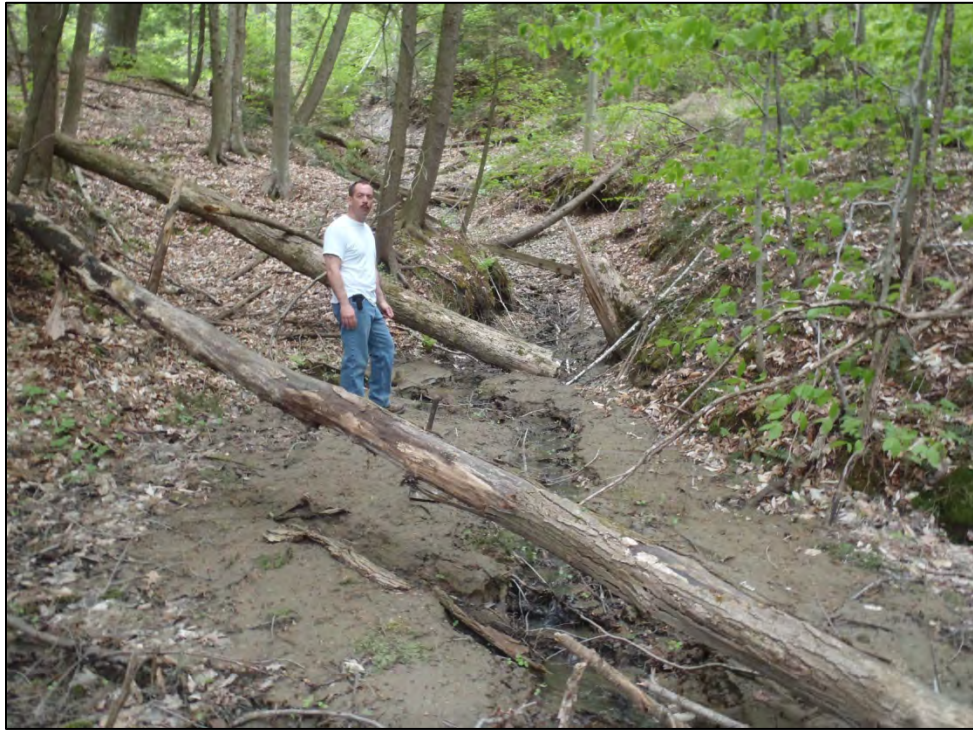
At the time of the site visit the river was not eroding the base of this slope. Whatever the cause may be, it is operating higher up on the slope. At the base of the slope I observed a fan or flow of mud that had washed out of the base of the gully (Figure 10). Exposures on the side of the gully showed wet, plastic silty clay (Figure 11). Seeps partway up the slope appear to mark the transition from fine-grained material below (silty clay or similar material) to coarser-grained material above. The materials exposed in the upper part of the landslide consist of bedded very fine sand, fine sand, and medium sand (Figures 12, 13). These sands appear to be on the order of 55 to 60 feet thick.

Figure 10. Mudflow at base of landslide.

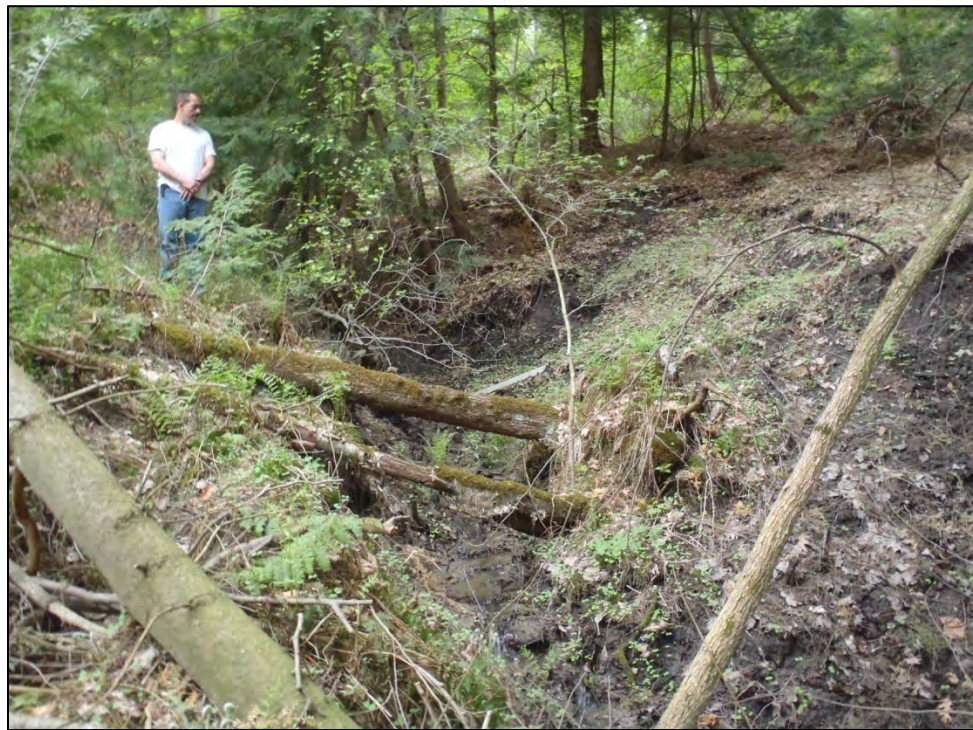
Figure 11. Gully exposing silty clay near base of slope.

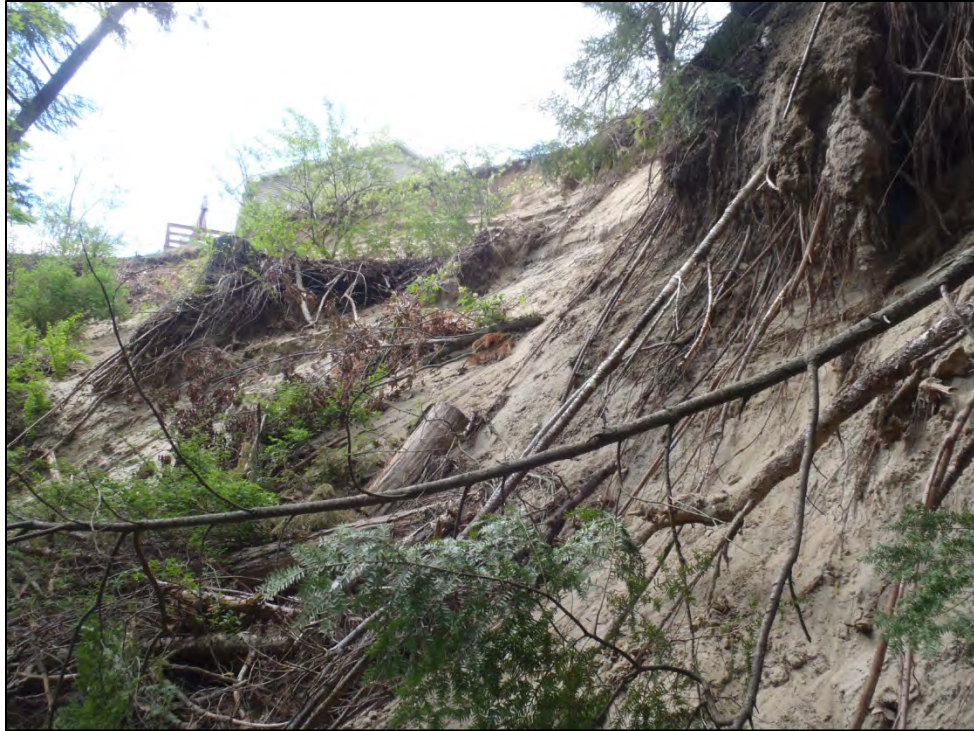
Subsurface erosion appears to be occurring near the base of the sand, leading to the flow of mud at the base and to collapse of the sands above.

Figure 12. Upper part of slide.

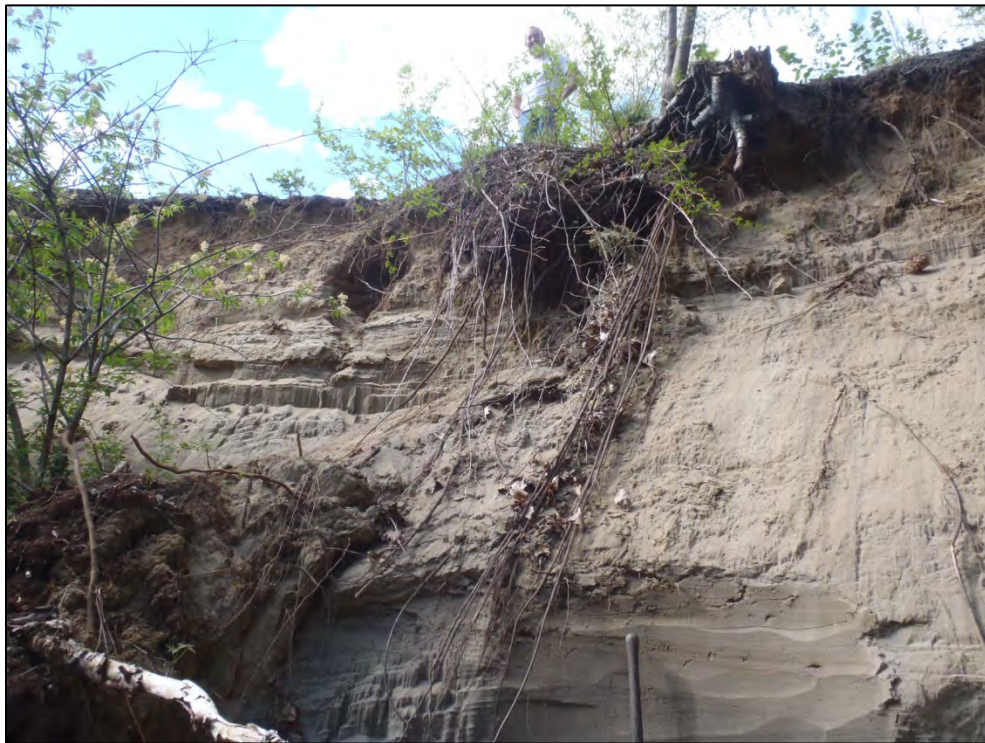
Figure 13. Sands exposed in upper part of slide.

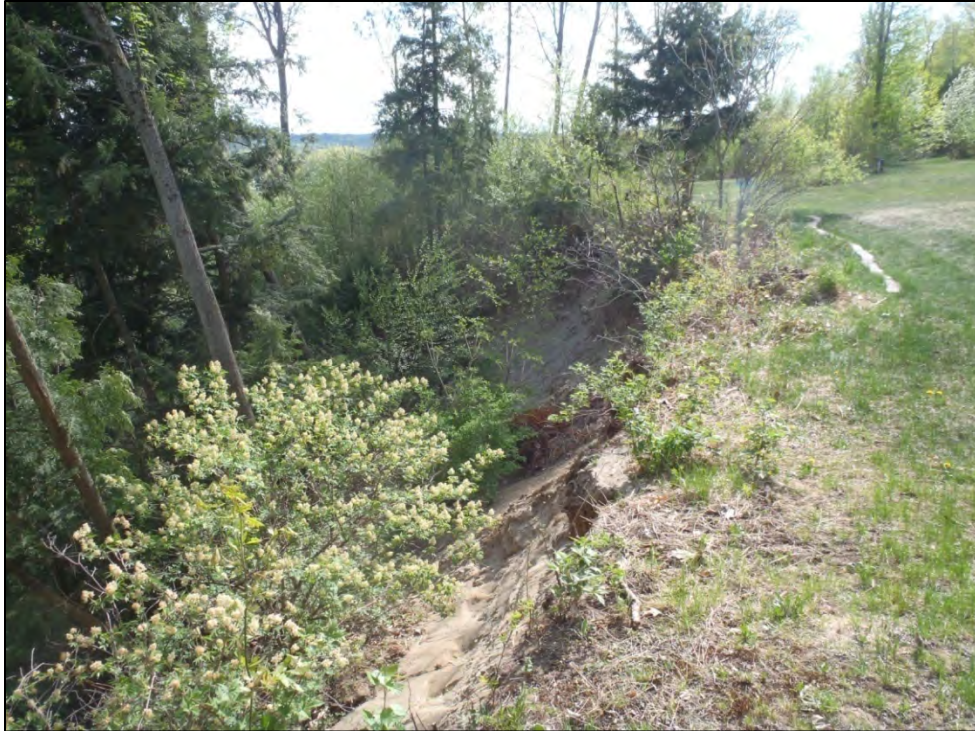
The edge of the landslide was 25.0 feet from the southeast corner of the house at the time of my visit. The top of the slide is shown in Figures 14 and 15. I did not observe any cracks on the outside of the foundation and Mr. Simmons stated that he did not know of any cracks visible on the inside. I recommended that a qualified engineer evaluate this site as soon as possible. Subsequent evaluations led the Town to conduct FEMA buyouts of this and an adjacent property.

Figure 14. Top of landslide.

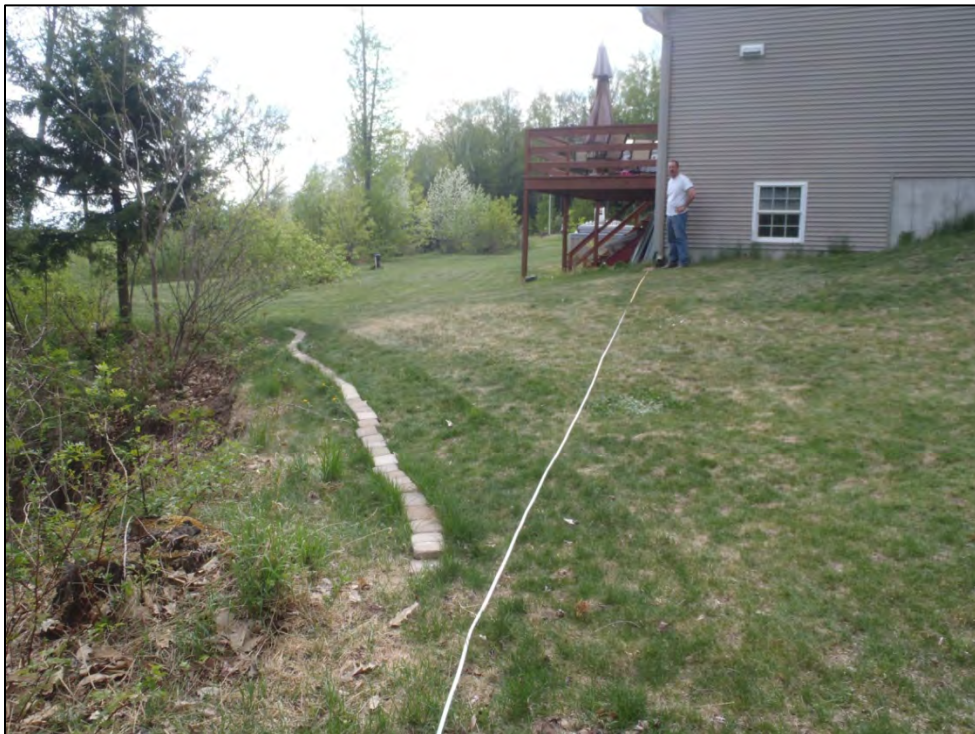
Figure 15. The top of the landslide is to the left of the line of blocks.

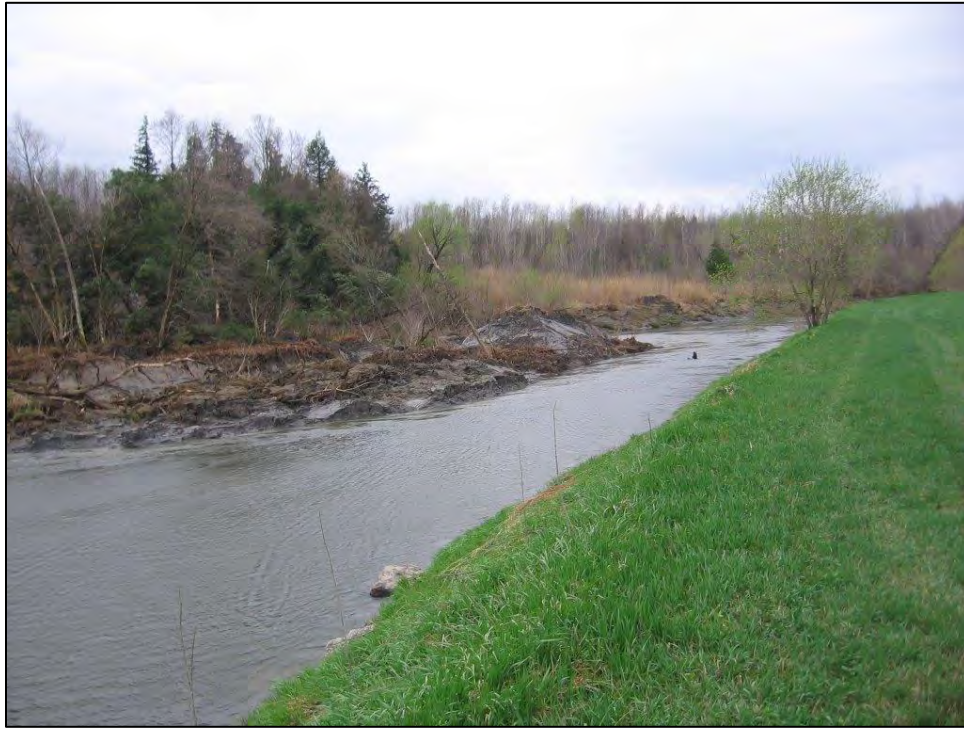
This landslide is located on the outside of a meander bend of the river and appears to have been caused principally by erosion of the toe of the deposit. The landowner on the north bank of the river reported that landslides had occurred here in earlier years. This fits with observations made on the site and interpretation of the lidar slope data.

Figure 17. View of the Sheldon landslide from upstream on May 12, 2009. The landslide toe deposit seen at left has pushed far out into the channel. Photo by Chris Brunelle, VT DEC.

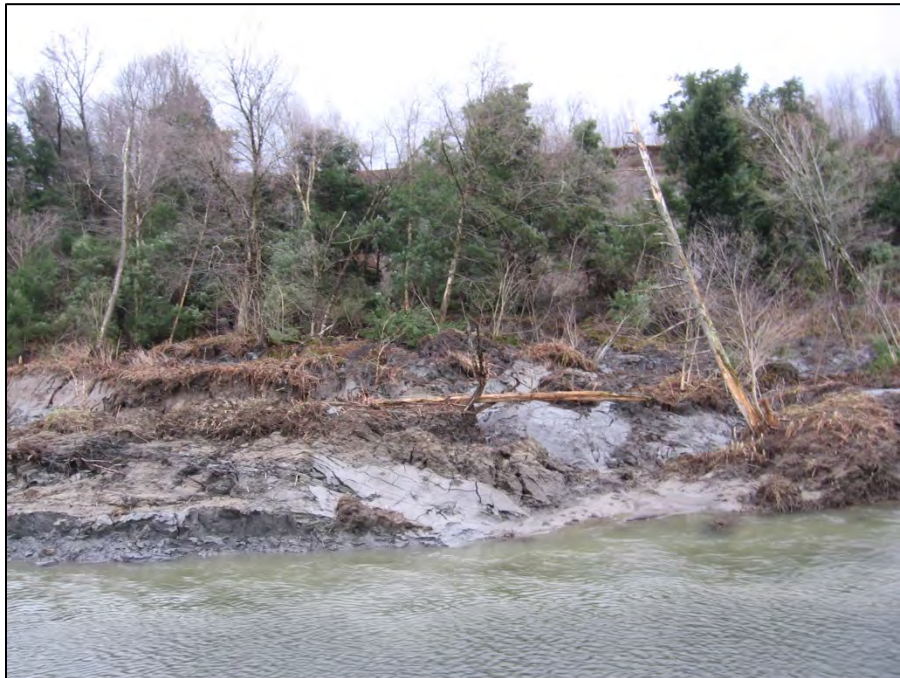
Figure 18. Looking across at back-rotated blocks on south shore of river on May 12, 2009. Photo by Chris Brunelle, VT DEC.

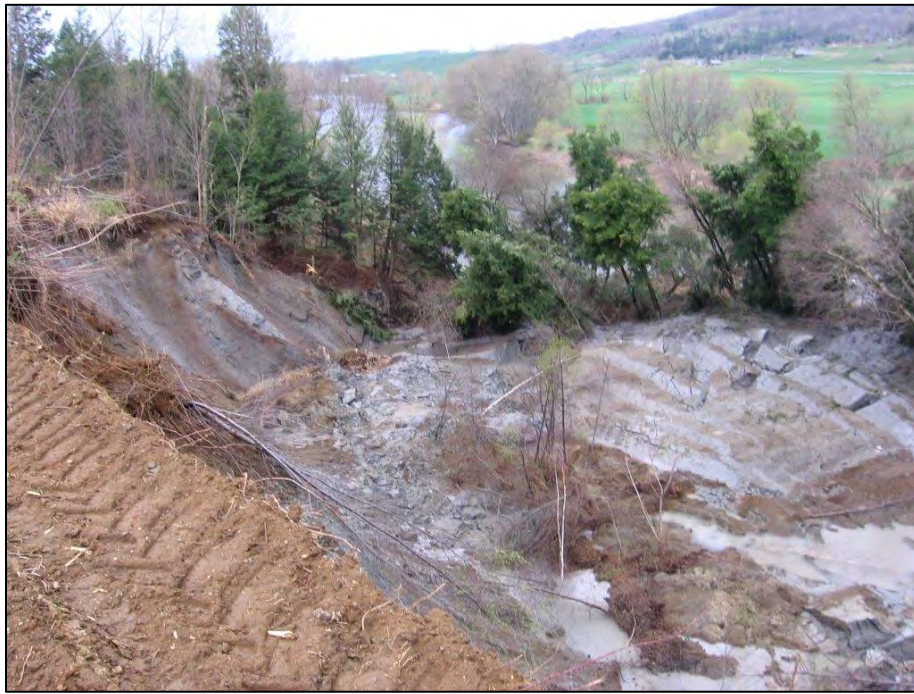
Figure 19. Looking downstream and across landslide from top on May 12, 2009. Photo by Chris Brunelle, VT DEC.

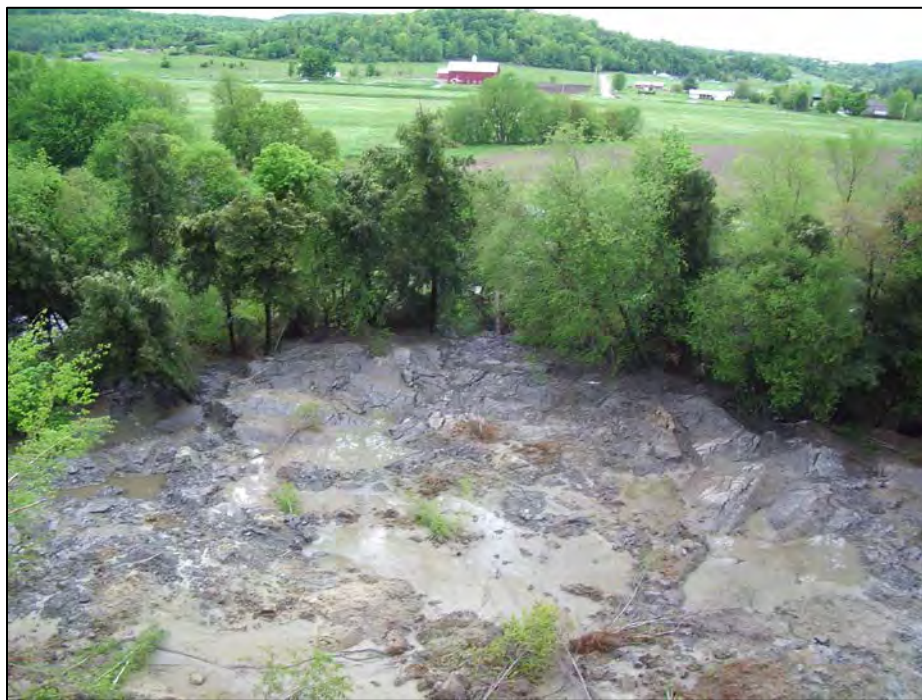
Figure 20. Looking down landslide at blocks of silt-clay in toe deposit on May 28, 2009.

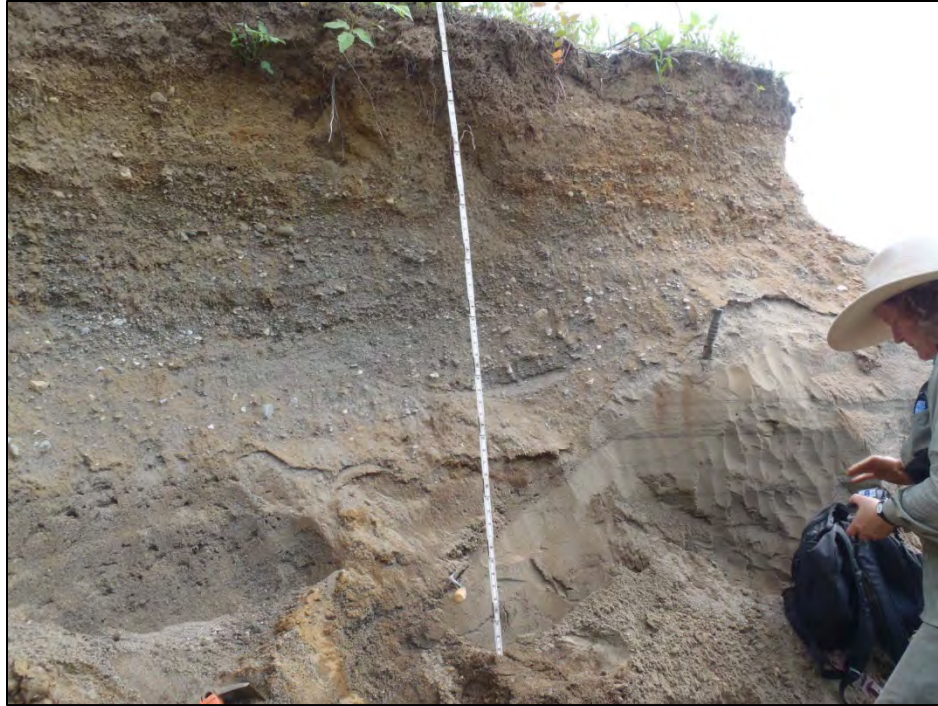
The general stratigraphy is a thin unit of sand and gravel over fine sands over silt-clay (Figures 21 and 22). The uppermost unit consists of 2.3 to 5.7 feet of pebbly medium to coarse sand and coarse sandy pebble gravel. This overlies 3.6 feet of laminated fine sand with ripple-drift cross lamination. Below this is 4 feet or more of dense, varved silt and silty clay. Penetrometer readings in the silt-clay unit varied from 4.0 to greater than 4.5 tons per square foot. The silt-clay unit appears to make up the bulk of the section, although the only materials encountered on the lower parts of flanks are deformed landslide deposits from earlier slope failures.

Figure 21. Fluvial sand and gravel over lacustrine fine sand at the top of the section. June 7, 2011.

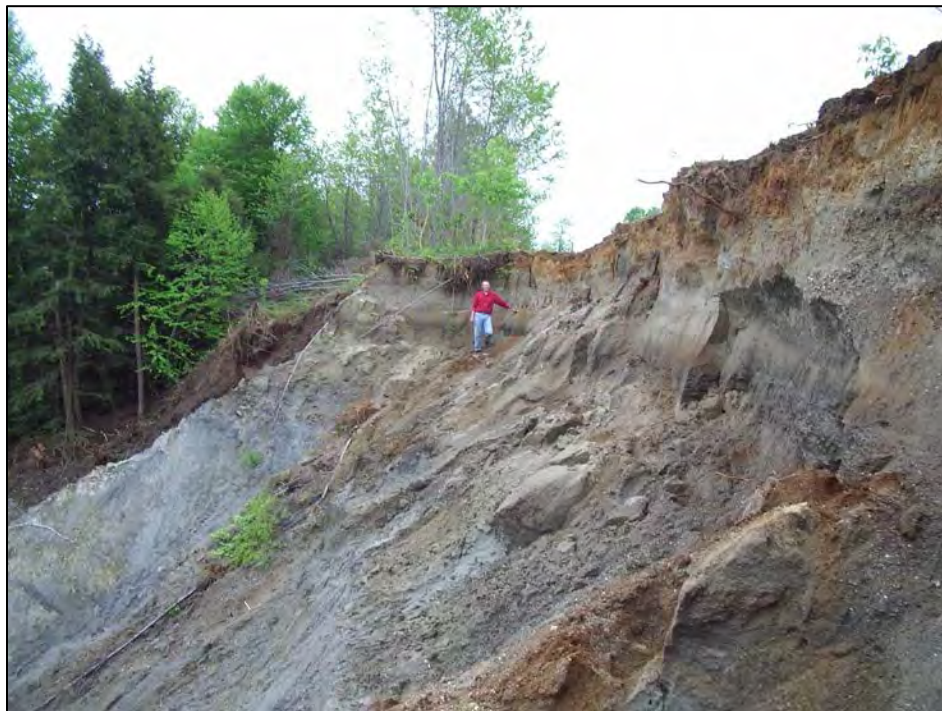
Figure 22. Upper portion of Sheldon landslide on May 28, 2009. Stratigraphic units visible are fluvial sand and gravel, lacustrine fine sand, and the upper portion of the lacustrine varved silt and silty clay.
