Lake Willoughby Rockslides

Jon Kim- Vermont Geological Survey, Waterbury, Vt and Tom Eliassen- Vermont Agency of Transportation

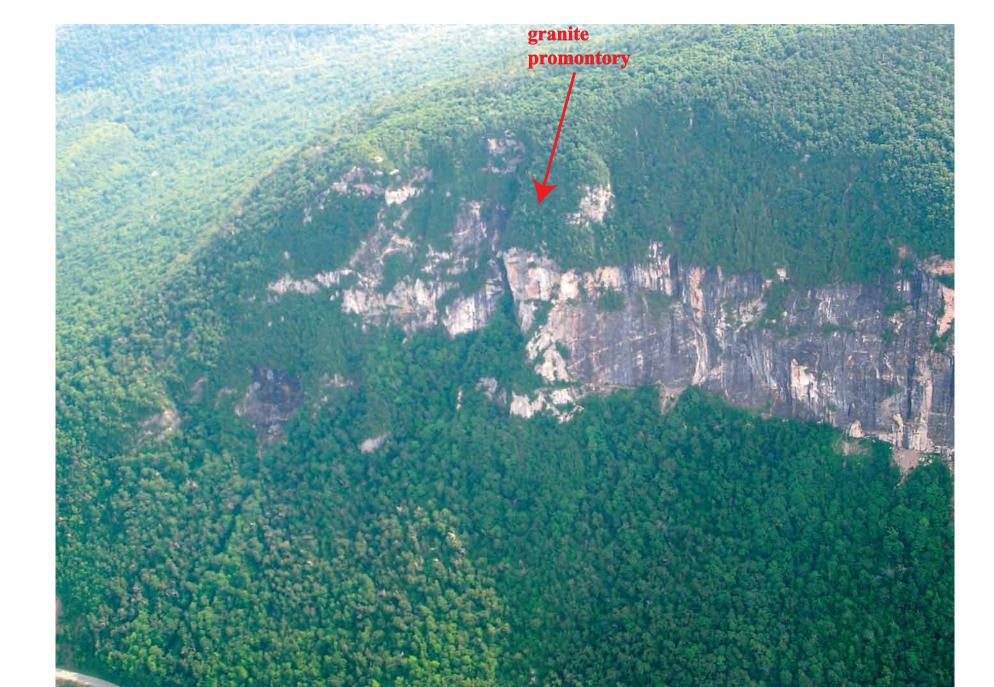
Figure 2- aerial photo of large granite promontory at the north end of the cliff closest to the contact with the granite pluton. Darker areas are predominantly metasedimentary rock whereas lighter areas are granite.

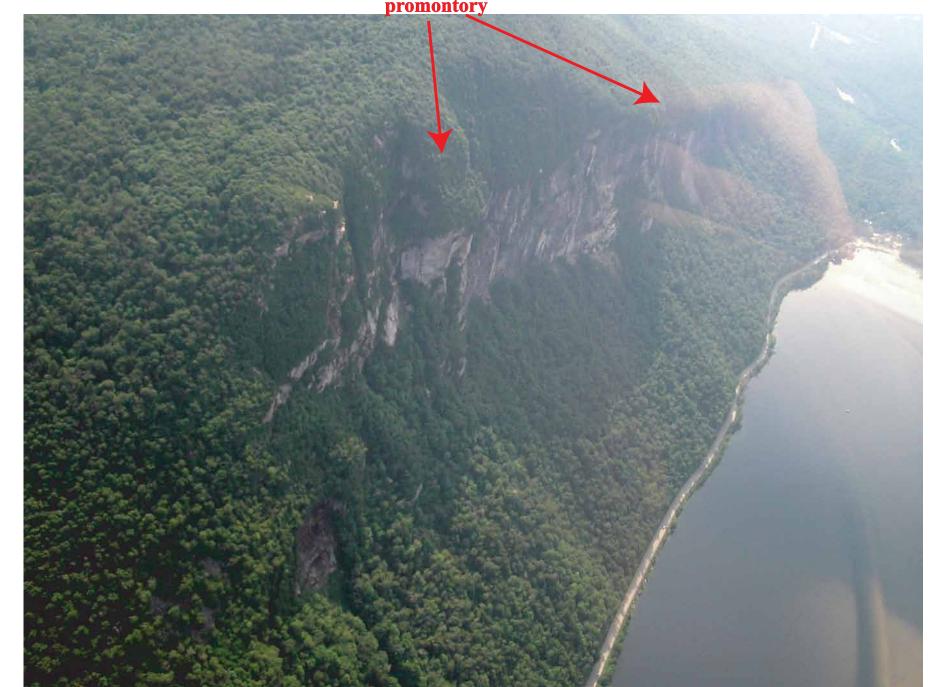
Figure 3- aerial photo of granite promontories looking to south along cliffs.

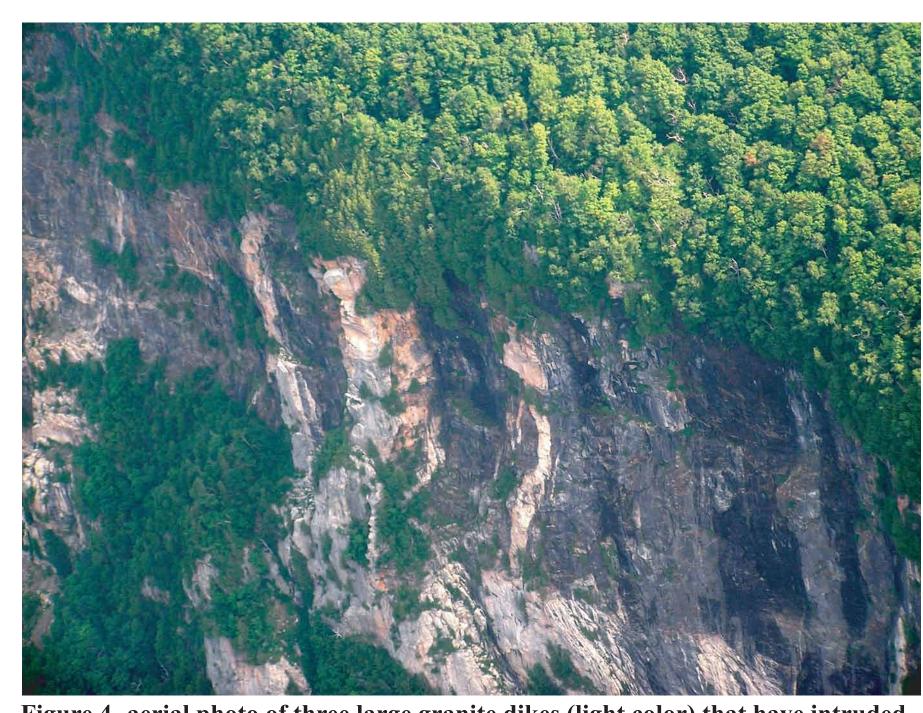
Figure 4- aerial photo of three large granite dikes (light color) that have intruded dark colored metasedimentary rocks of Waits River and Gile Mt. formations.

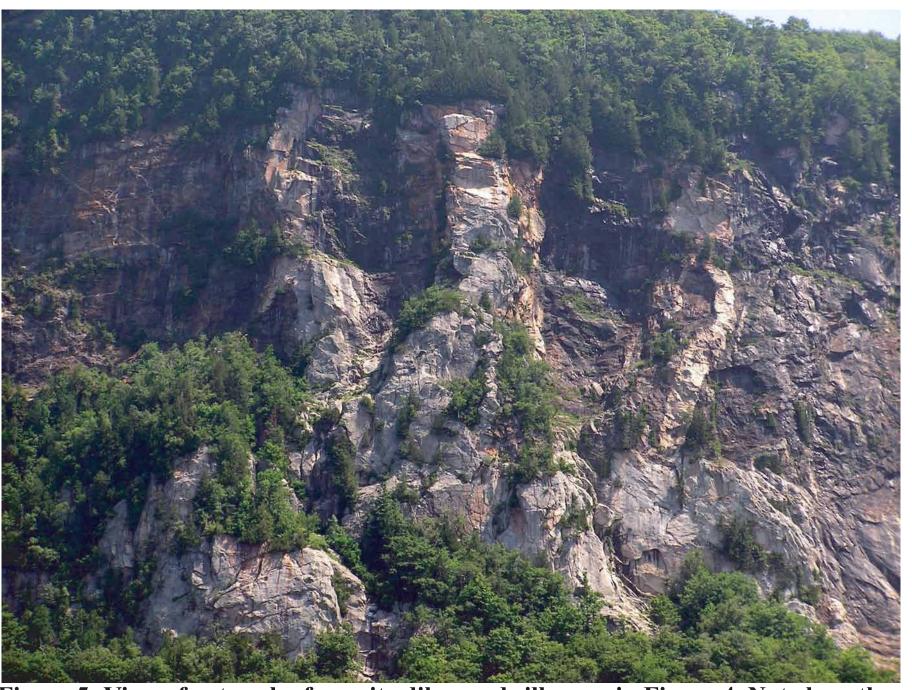
Figure 5- View of network of granite dikes and sills seen in Figure 4. Note how these intrusions form promontories in the Mt. Pisgah cliff face. Main failure areas are between the dikes and sills. Photograph taken at lake level.

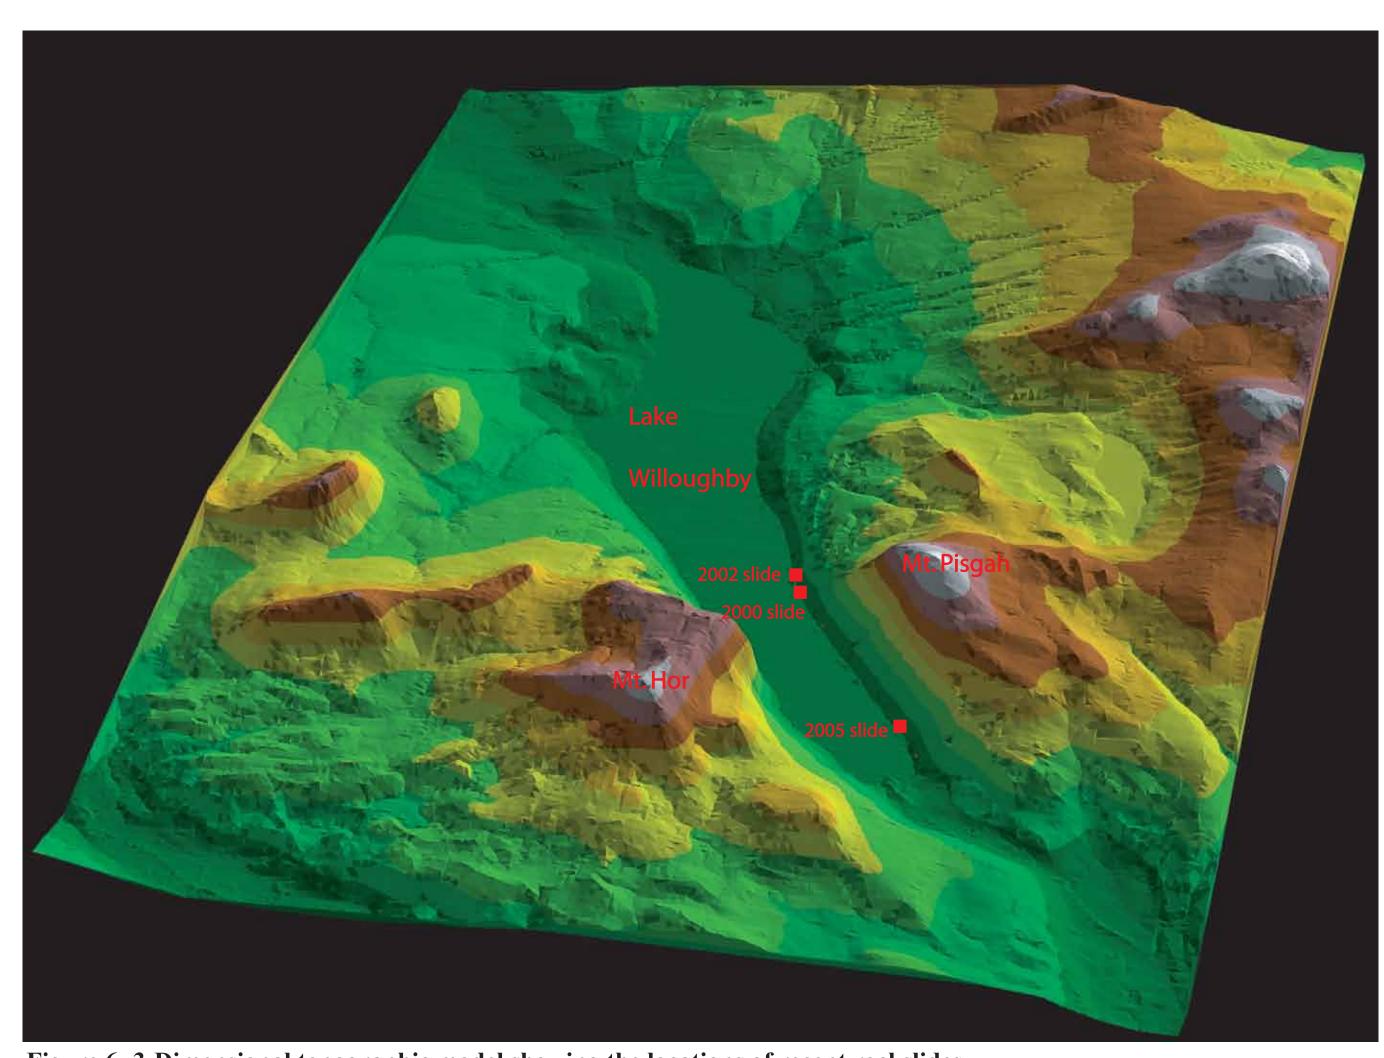
Figure 6-3-Dimensional topographic model showing the locations of recent rockslides.

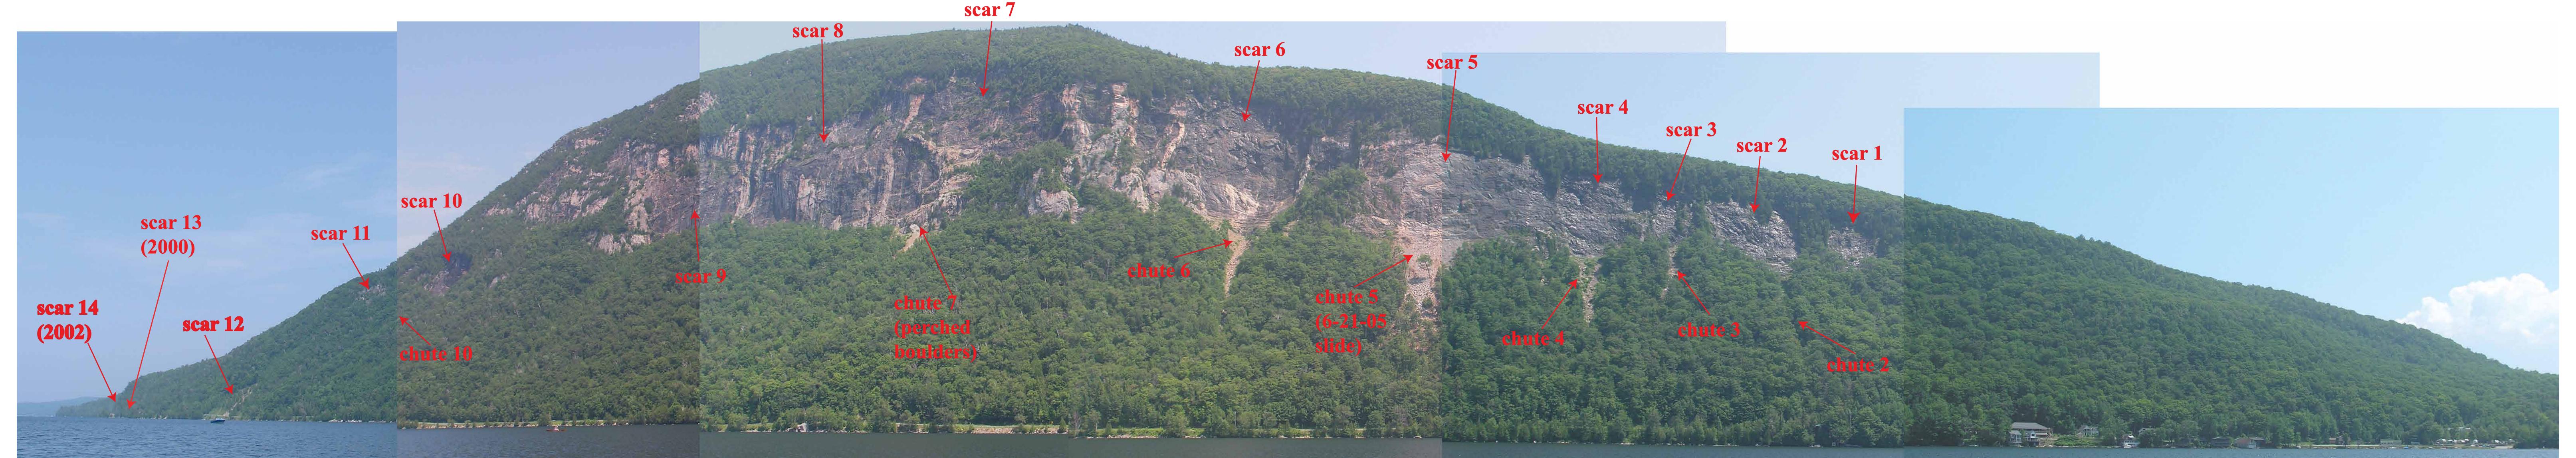
Figure 1- Panorama of the Mt. Pisgah cliffs on the southeast end of Lake Willoughby. Individual scars and chutes are labeled for reference. In general, the scars are metasedimentary rocks of the Waits River and Gile Mountain formations that have been intruded by small granite dikes. The promontories between scars in the northern half of the cliffs are composed of large dikes and sills of granite.

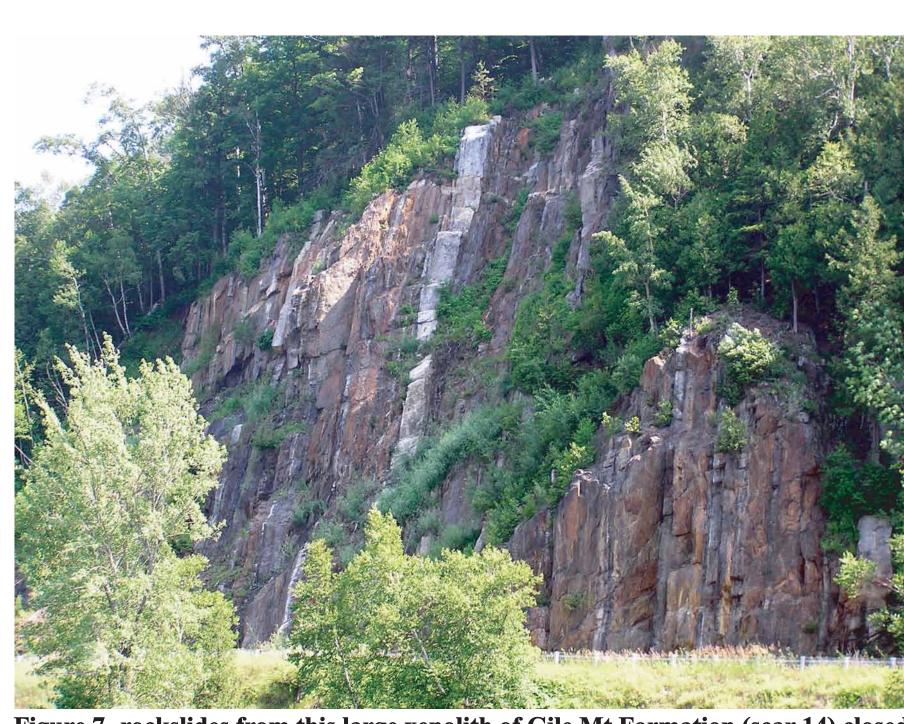
Figure 7- rockslides from this large xenolith of Gile Mt Formation (scar 14) closed Rte. 5A in 2002. Mitigation work to stabilize the slope was done in 2002 by Janod of Montreal. The nearly vertical foliation planes make this phyllitic quartzite unstable.

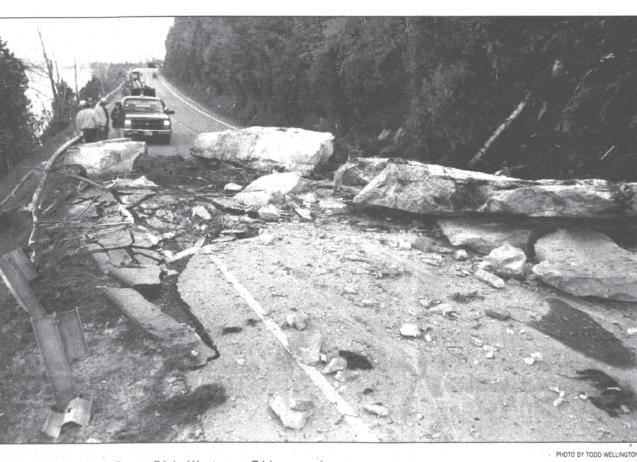
Figure 8- Front page photo from the Caledonian Record of the rockslide that closed Rte. 5A in 2000.

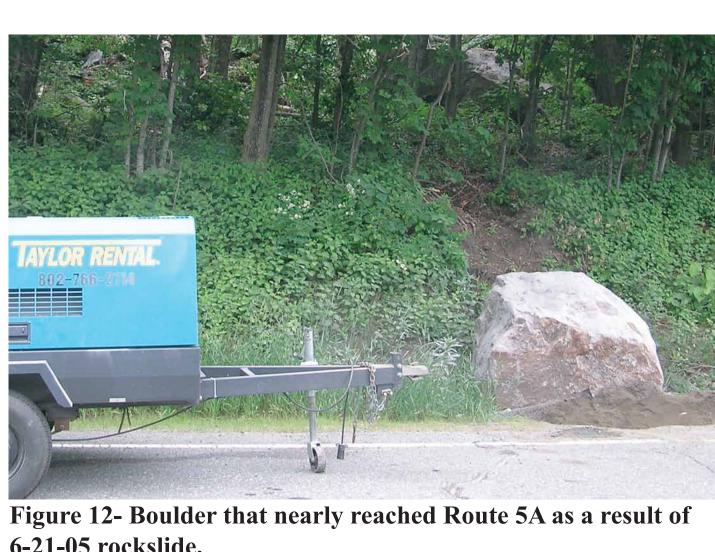
6-21-05 rockslide.

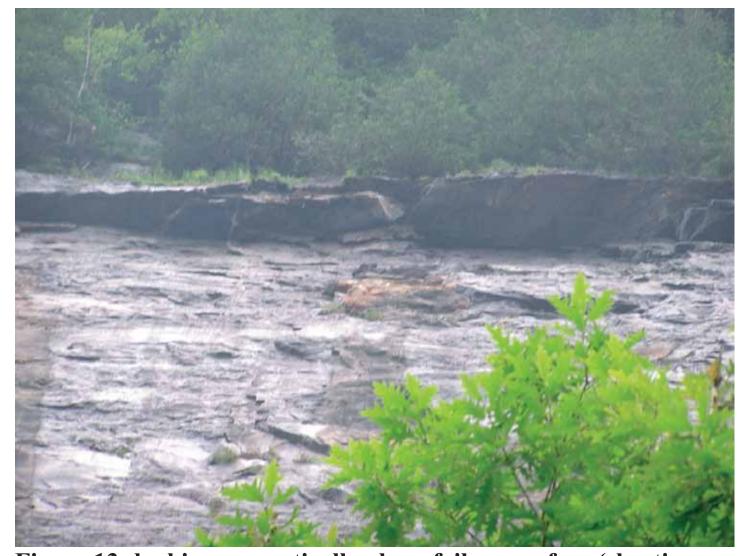
Figure 13- looking up vertically along failure surface (sheeting fracture) for 6-21-05 rockslide. Overhang represents the termination of the failure surface.

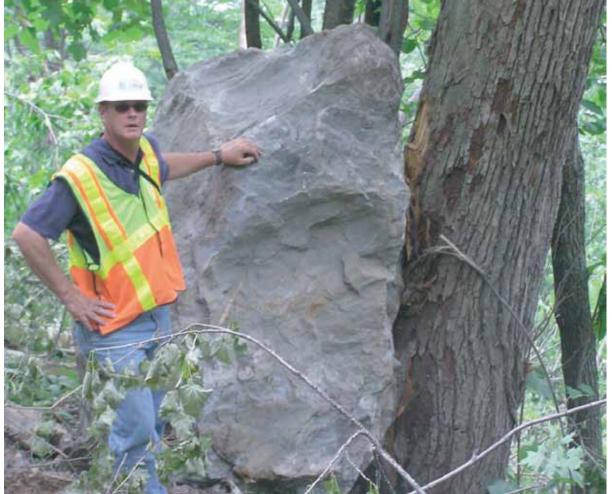
Figure 14- boulder resting against a tree in the chute for the 6-21-05 rockslide.

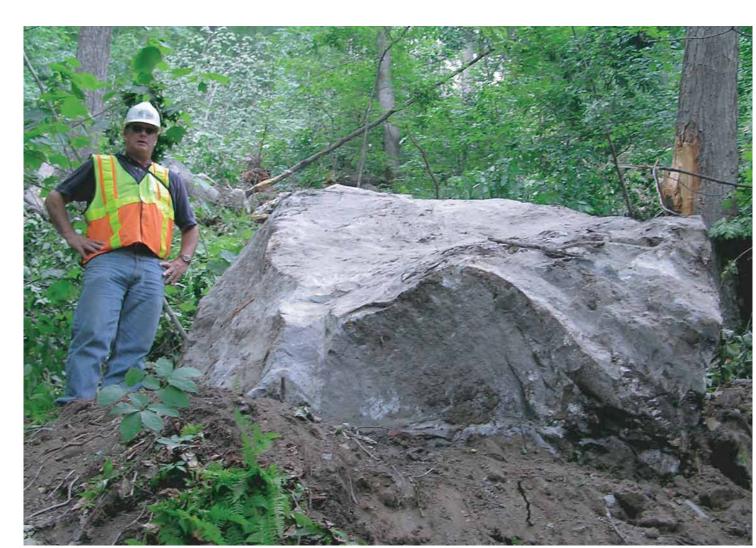
Figure 15- boulder and crater in the chute for the 6-21-05 rockslide.

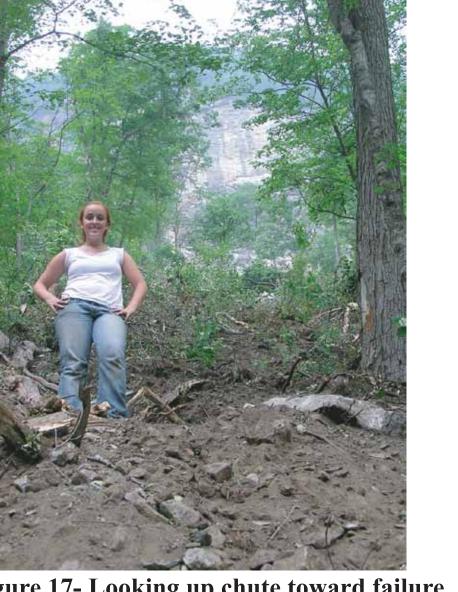
Figure 17- Looking up chute toward failure surface at cliff face.
