# Two Decades of Collaborative Landslide Research in Vermont

Presented at the Joint Southeastern & Northeastern Section Meeting of the Geological Society of America in Reston, VA on March 17, 2023

# What We've Learned About Landslides in Vermont

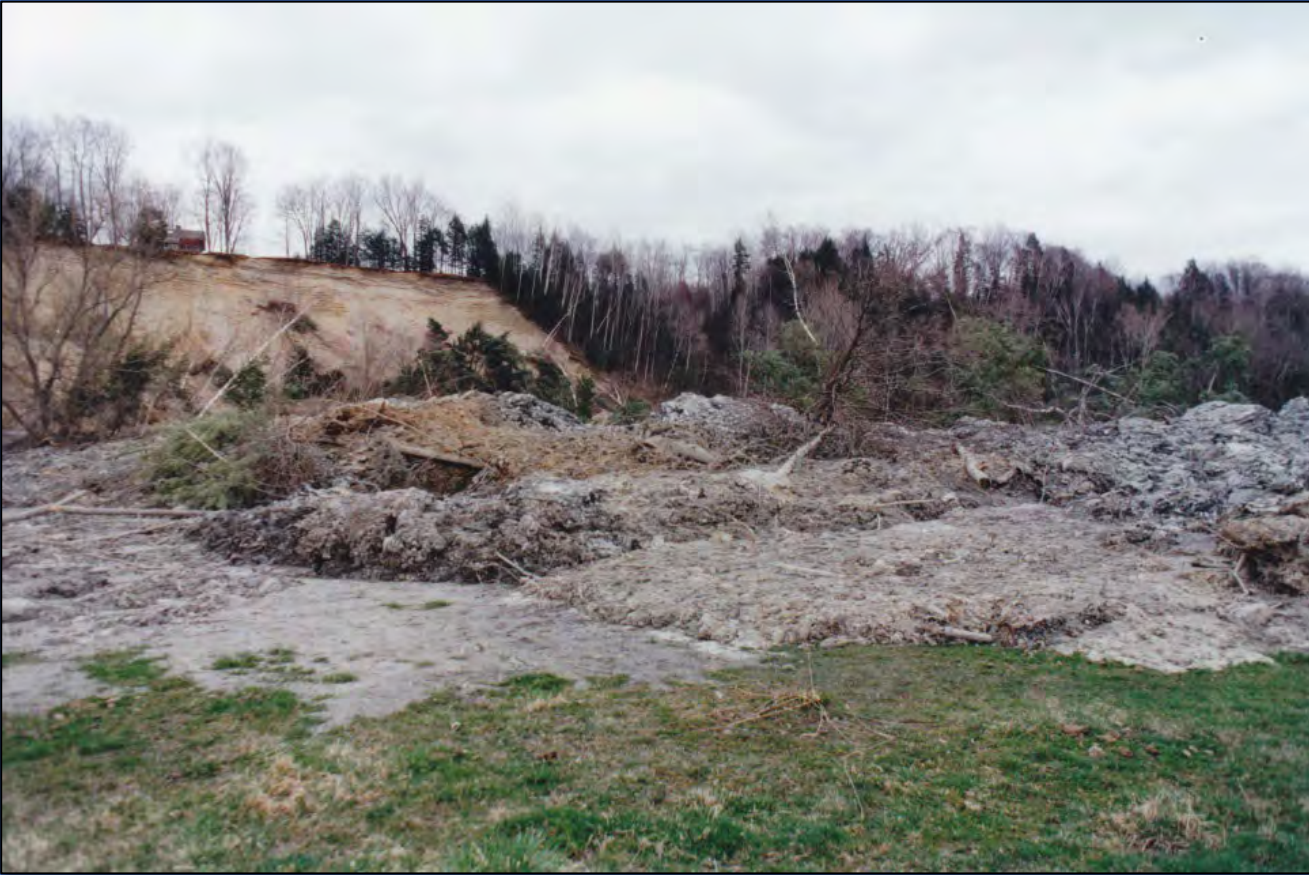
Three complex earth slide-flows in 1999, totaling ~27,000 cubic meters, 43 m high, Runout length ≈233 m, Travel angle of 11.2°.

**Landslides on April 11 and 18, and July 4, 1999. Note house at top of slope at left. This was abandoned after the first landslide.**

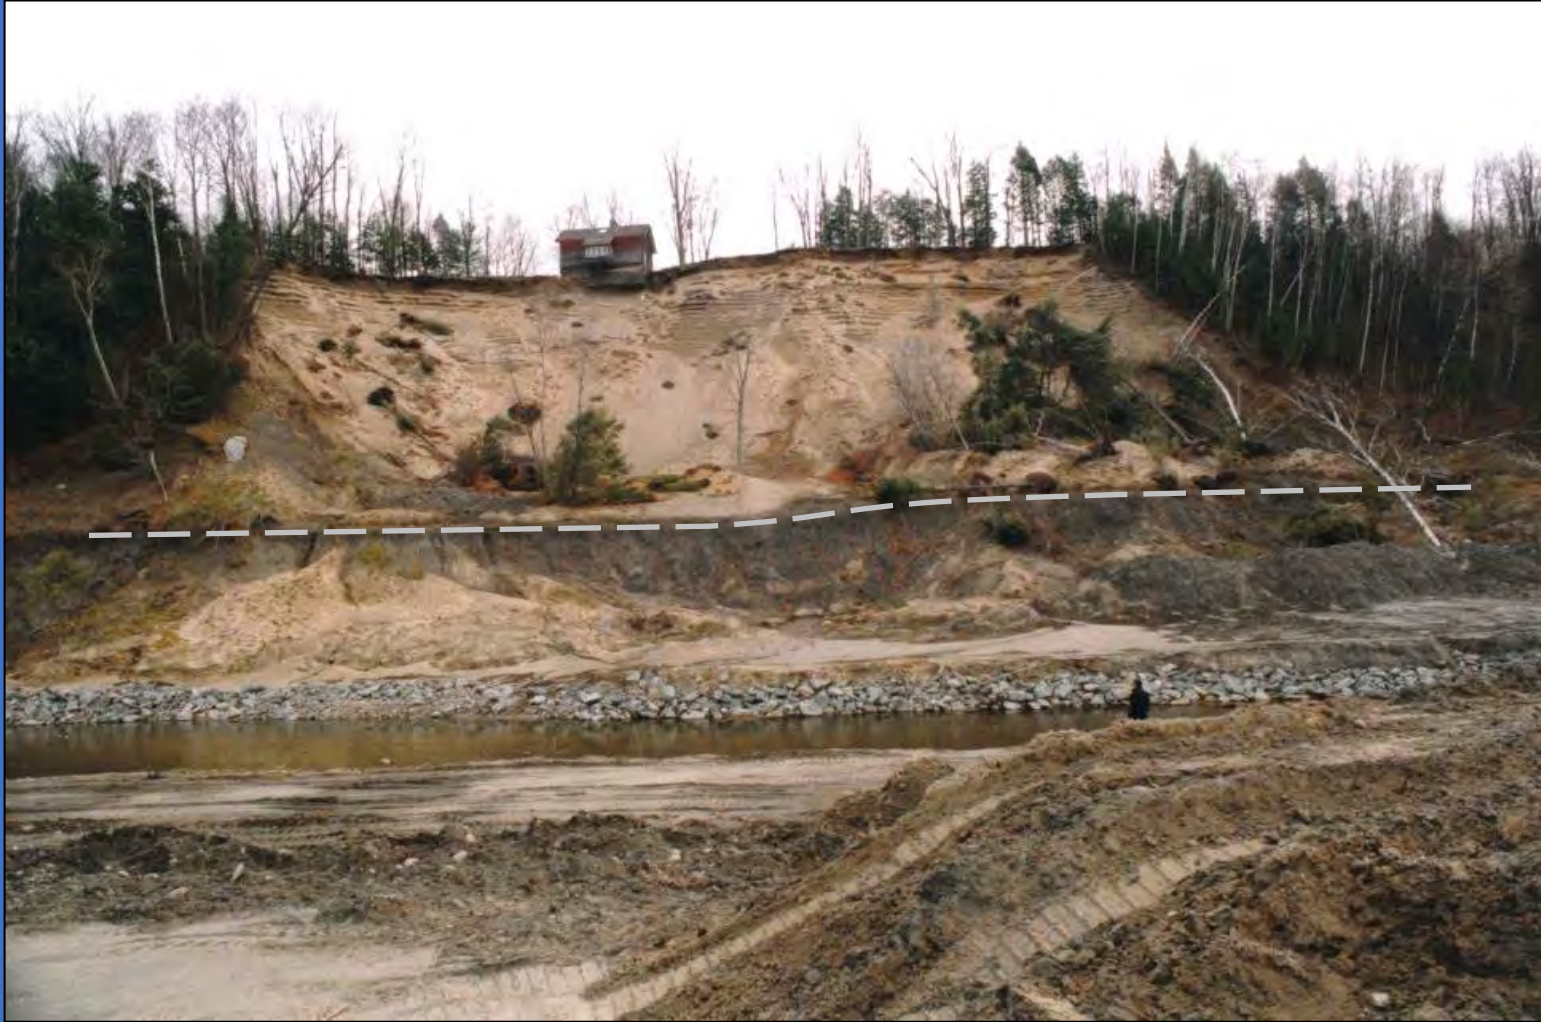
**History of slope failures: pre-1922, 1954, 1999, 2006, 2011.**

1. Toe erosion by river.
  2. Translational slide due to removal of support at base +/- high pore pressure
  3. Subsequent slides: rotational slides/flows on deformed zone in varved lacustrine deposit (top of gray zone, left).
- Failures perhaps due to high pore pressure from losing stream to east.

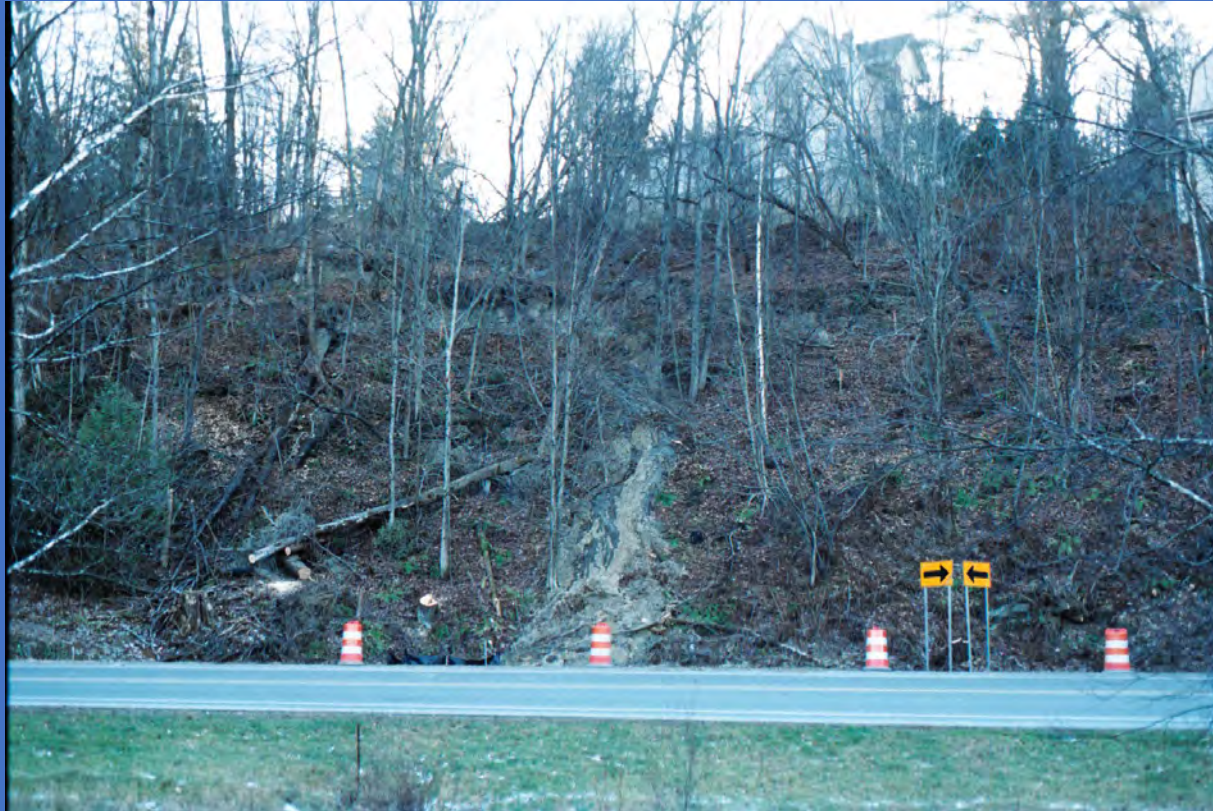
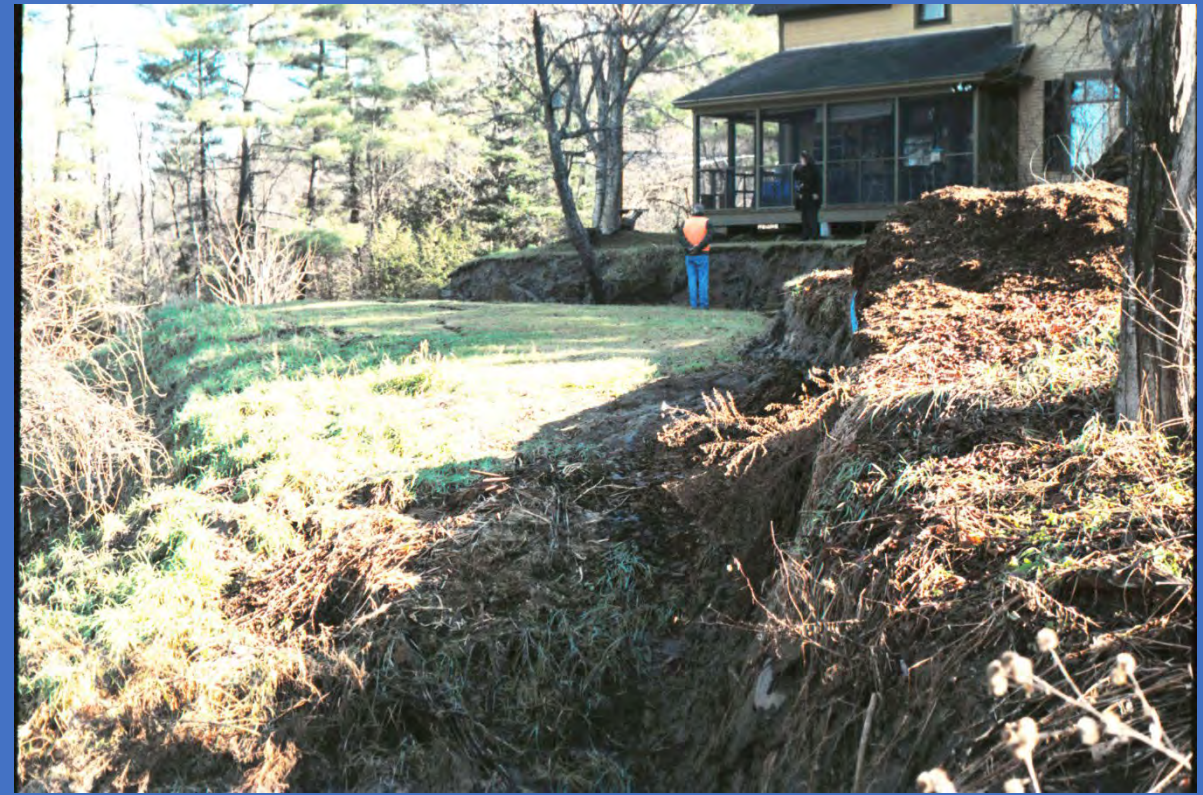
Left: Looking up at slide on November 10, 2003, prior to any major slope failure. Note raw scarp in woods and central mudflow. Right: Top of slope at main scarp. Surface material is recent artificial fill. May 4, 2004 (after major slope movements).

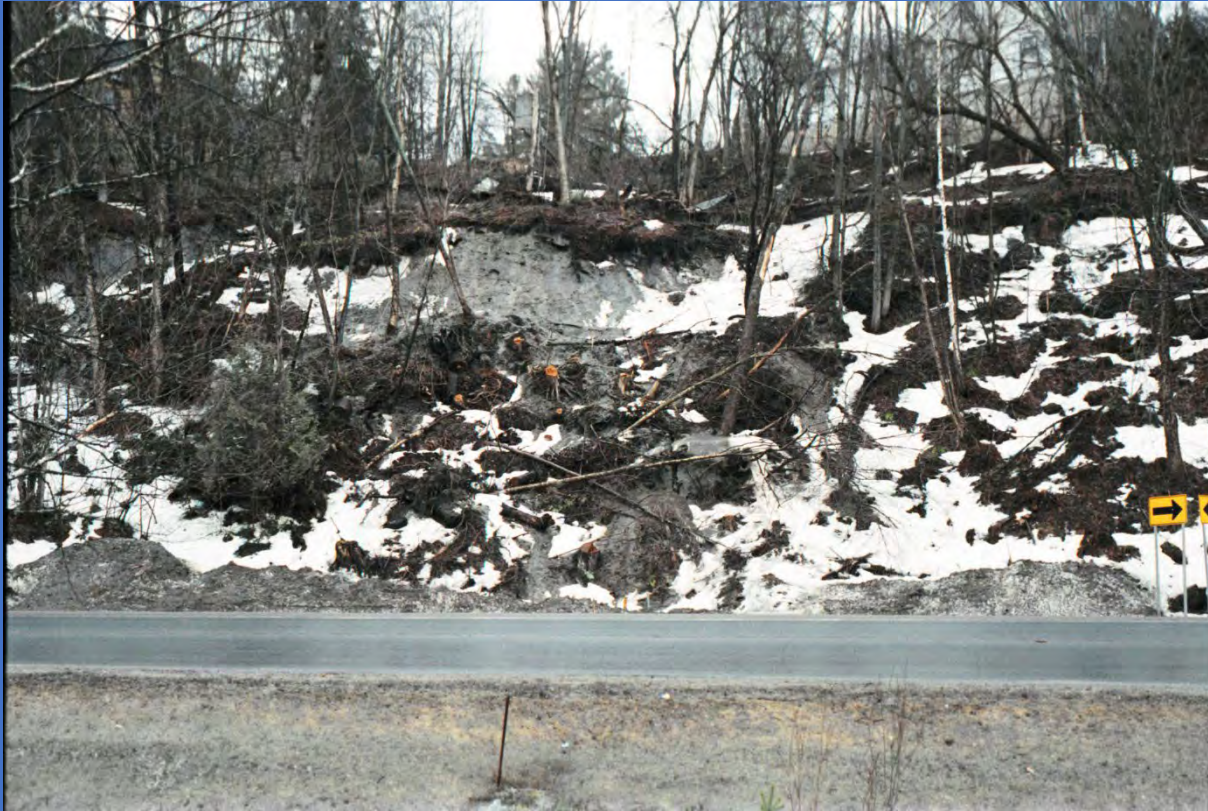
G. Springston  
Photo 1-020Aa 4/2/2004

**April, 2004. Looking up at slide from Vt. Route 15 prior to first slide across road in 2004. Note slide scarps. Some trees have been cut.**

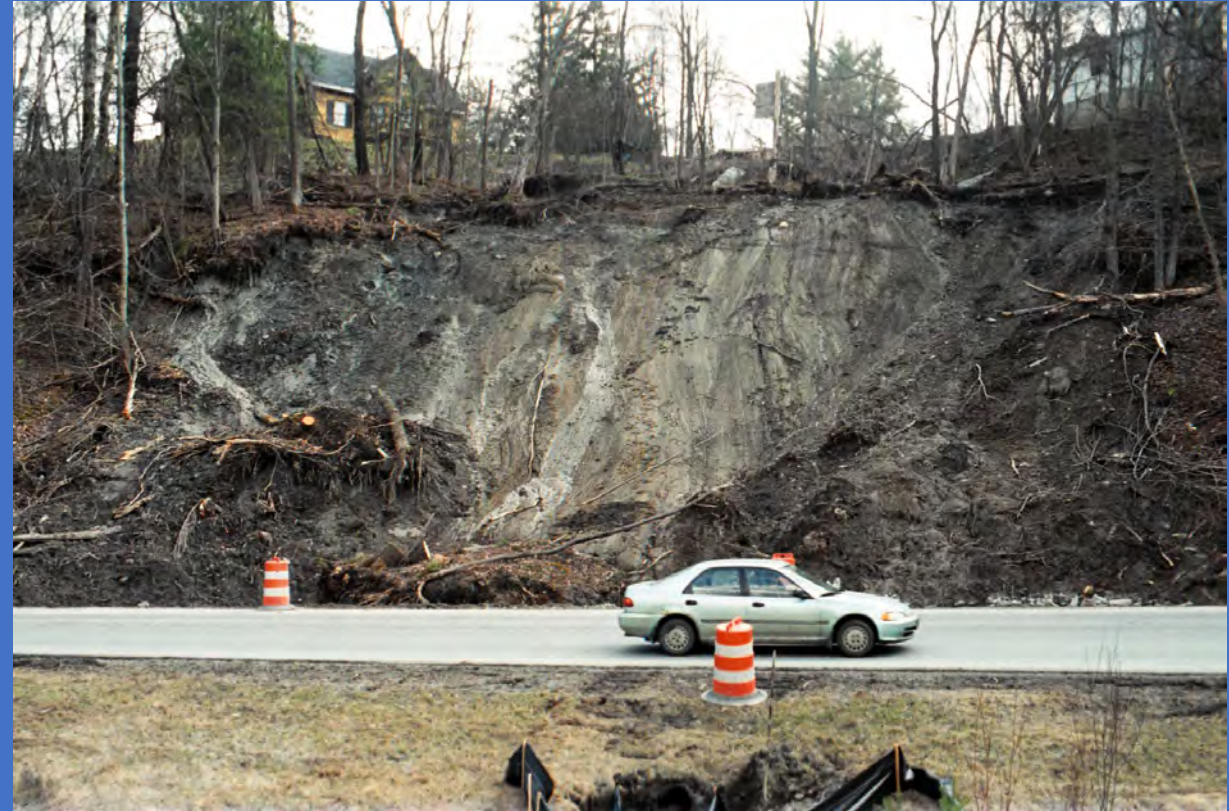
G. Springston  
Photo 7451-020 4/22/2004

**Same view after first of two slides across road in April of 2004.**

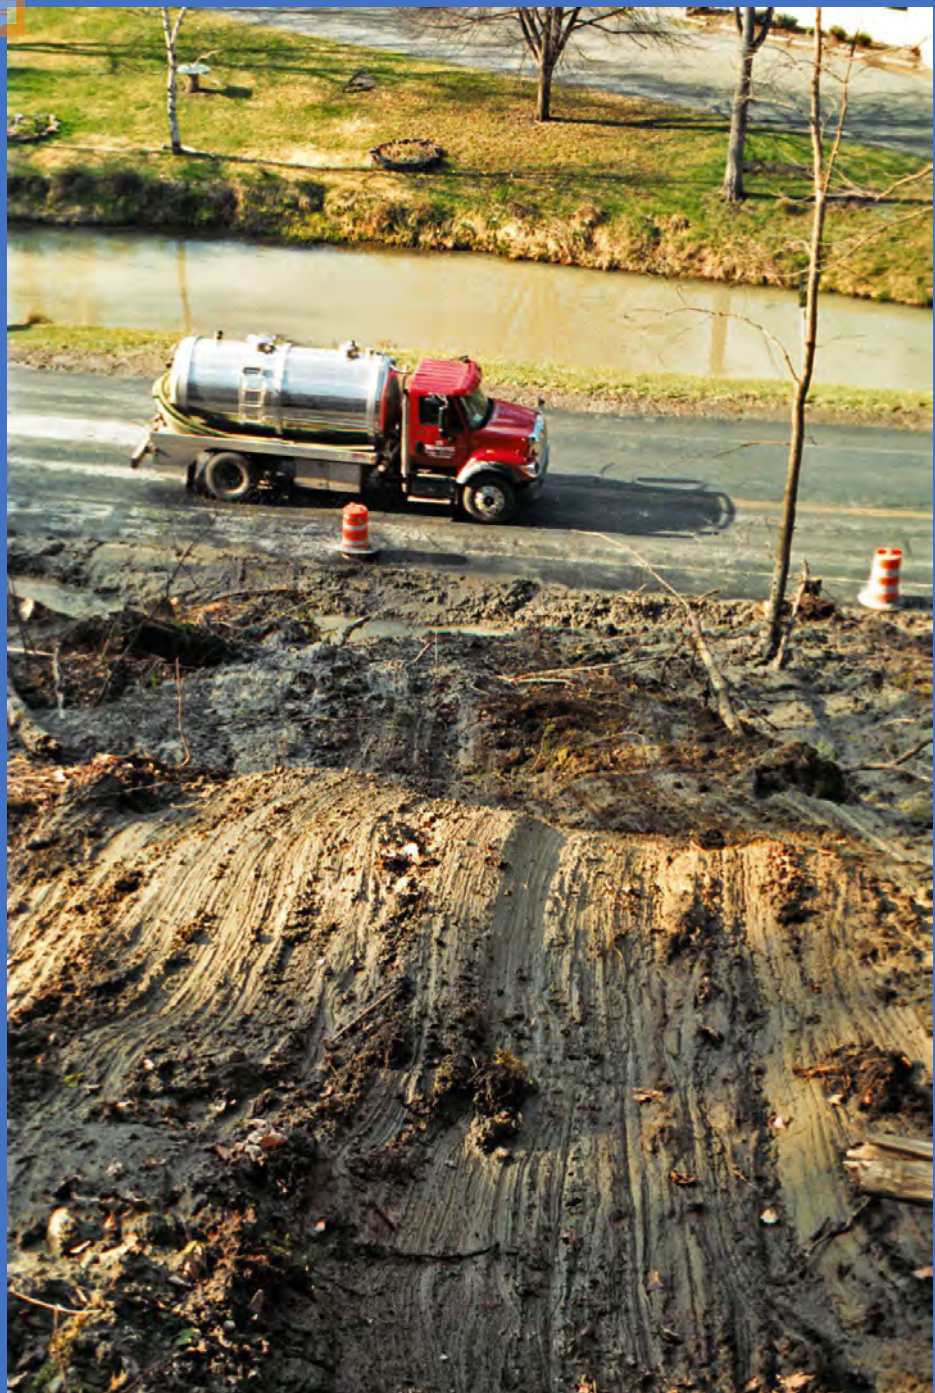
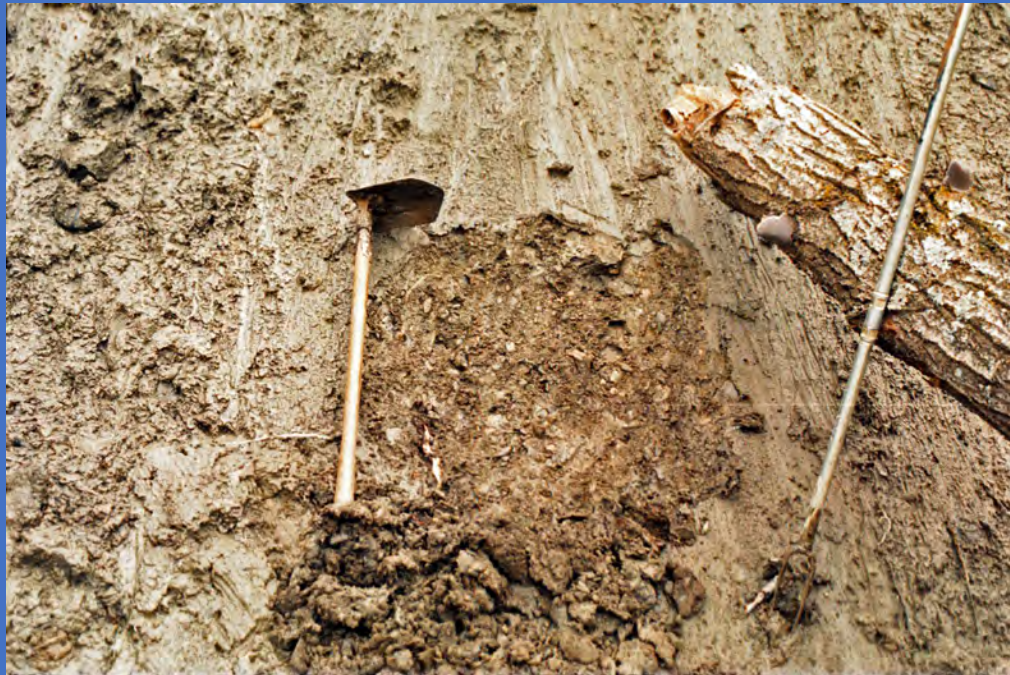
Rt. 15 was clearly at risk (left).

Geologic interpretations played key role in understanding the nature of the failure. Photo below shows dense glacial till exposed beneath a skim of silt-clay on sliding surface.

Fix by VTrans:

- Remove fill
- Install subsurface drains
- Reinforcement of toe of slope with retaining wall

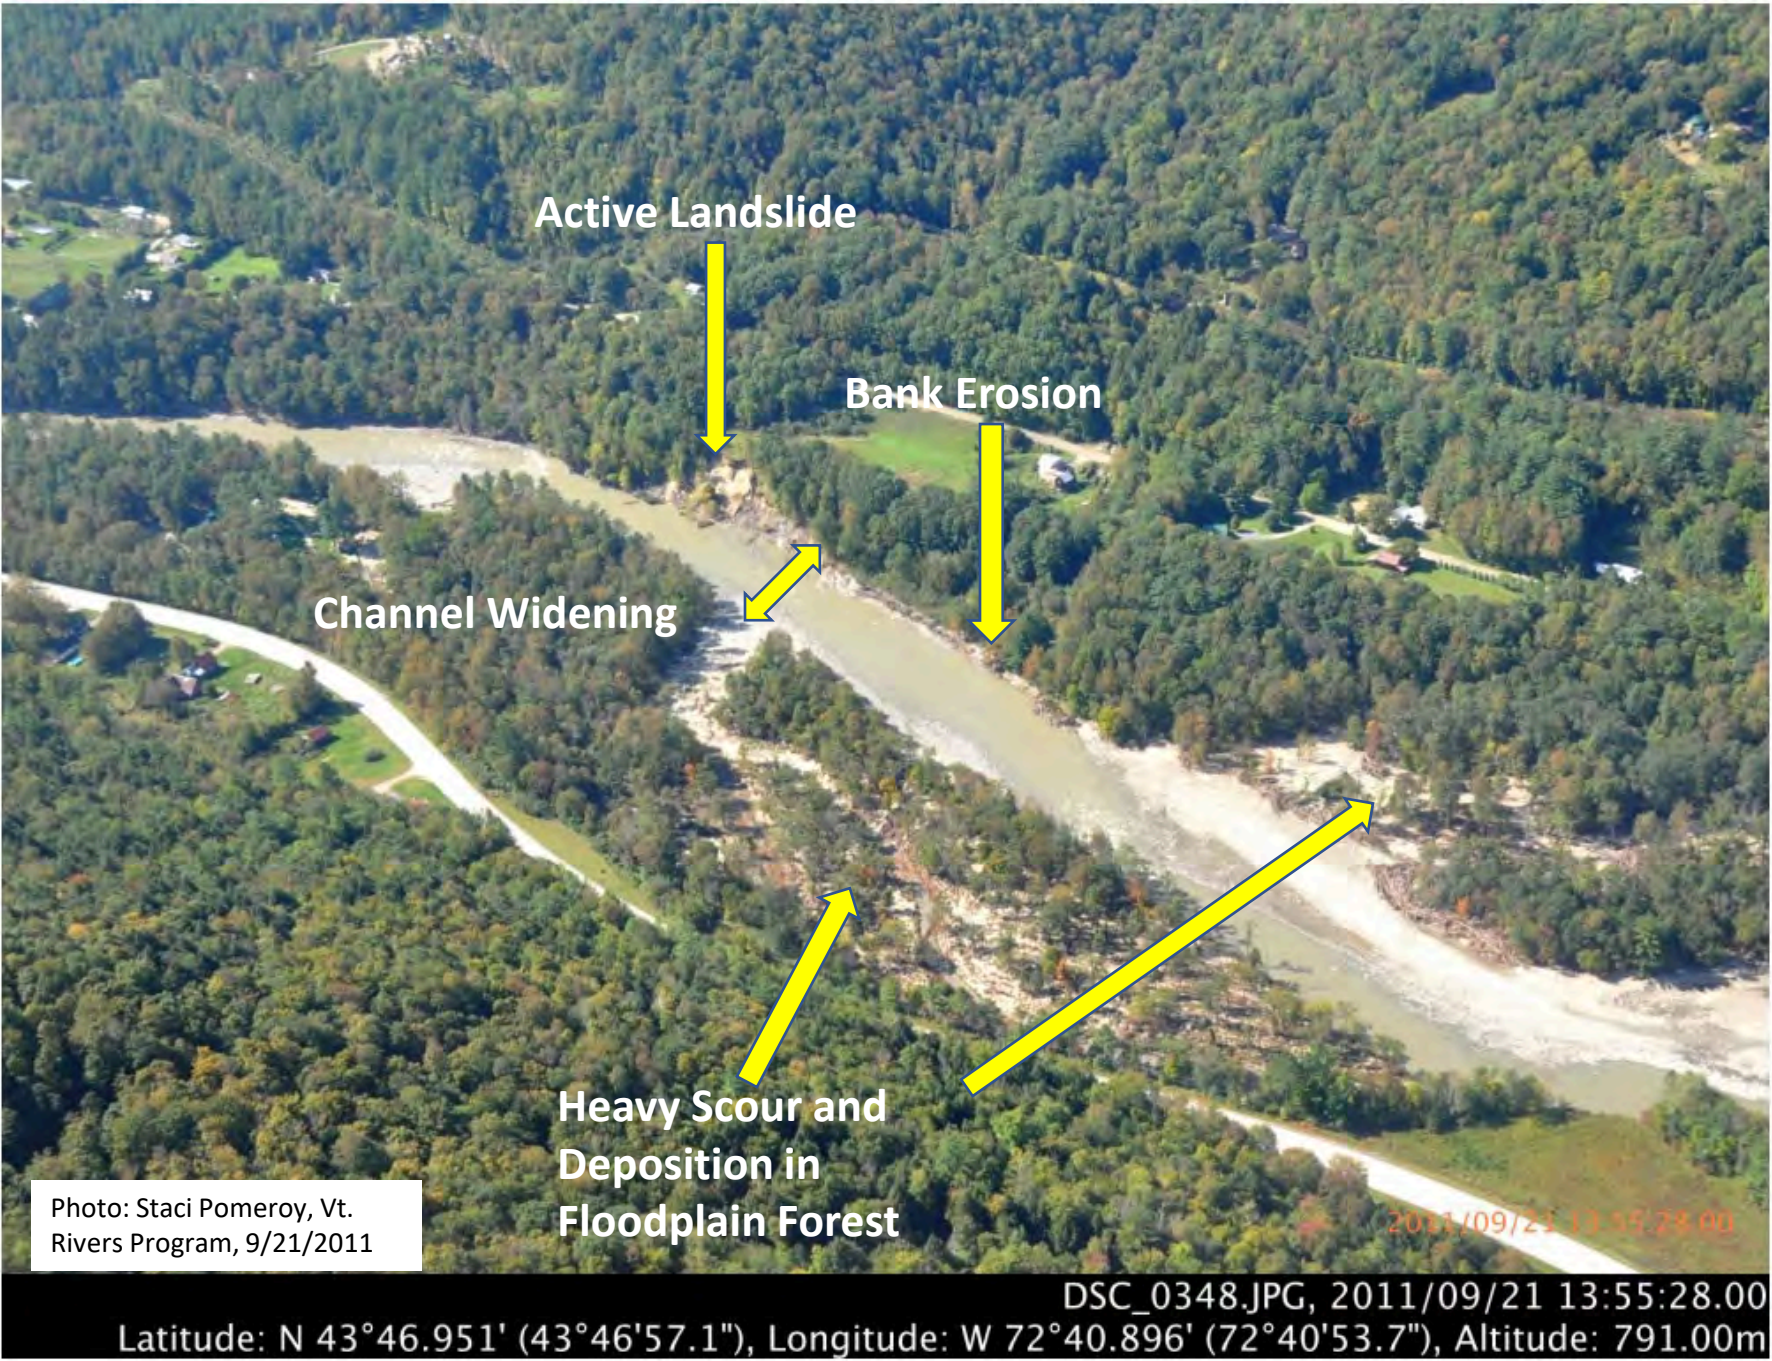
Floodplain Scour and Deposition, Landslide, and Bank Erosion on the White River Downstream of Gaysville, Looking Northwest.

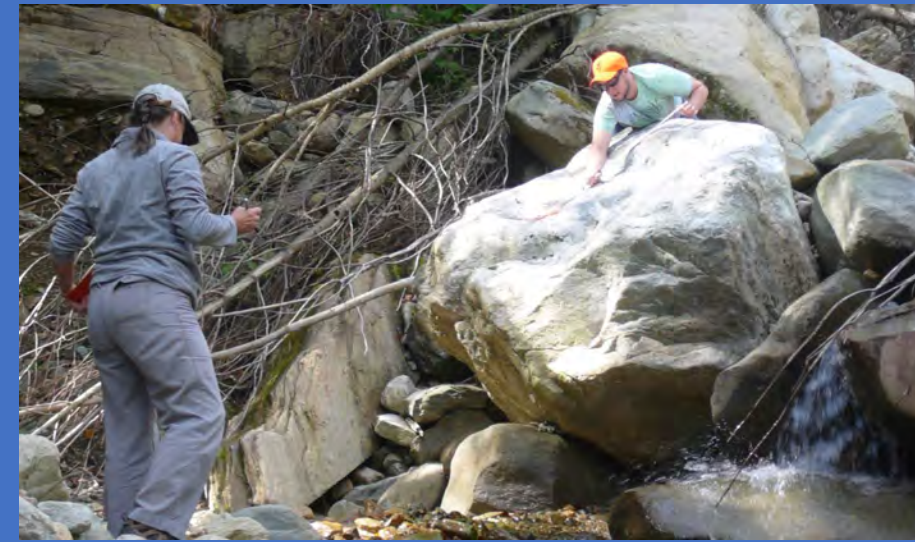
Above: Large landslide in bouldery till, the source material for the boulders on the alluvial fan.

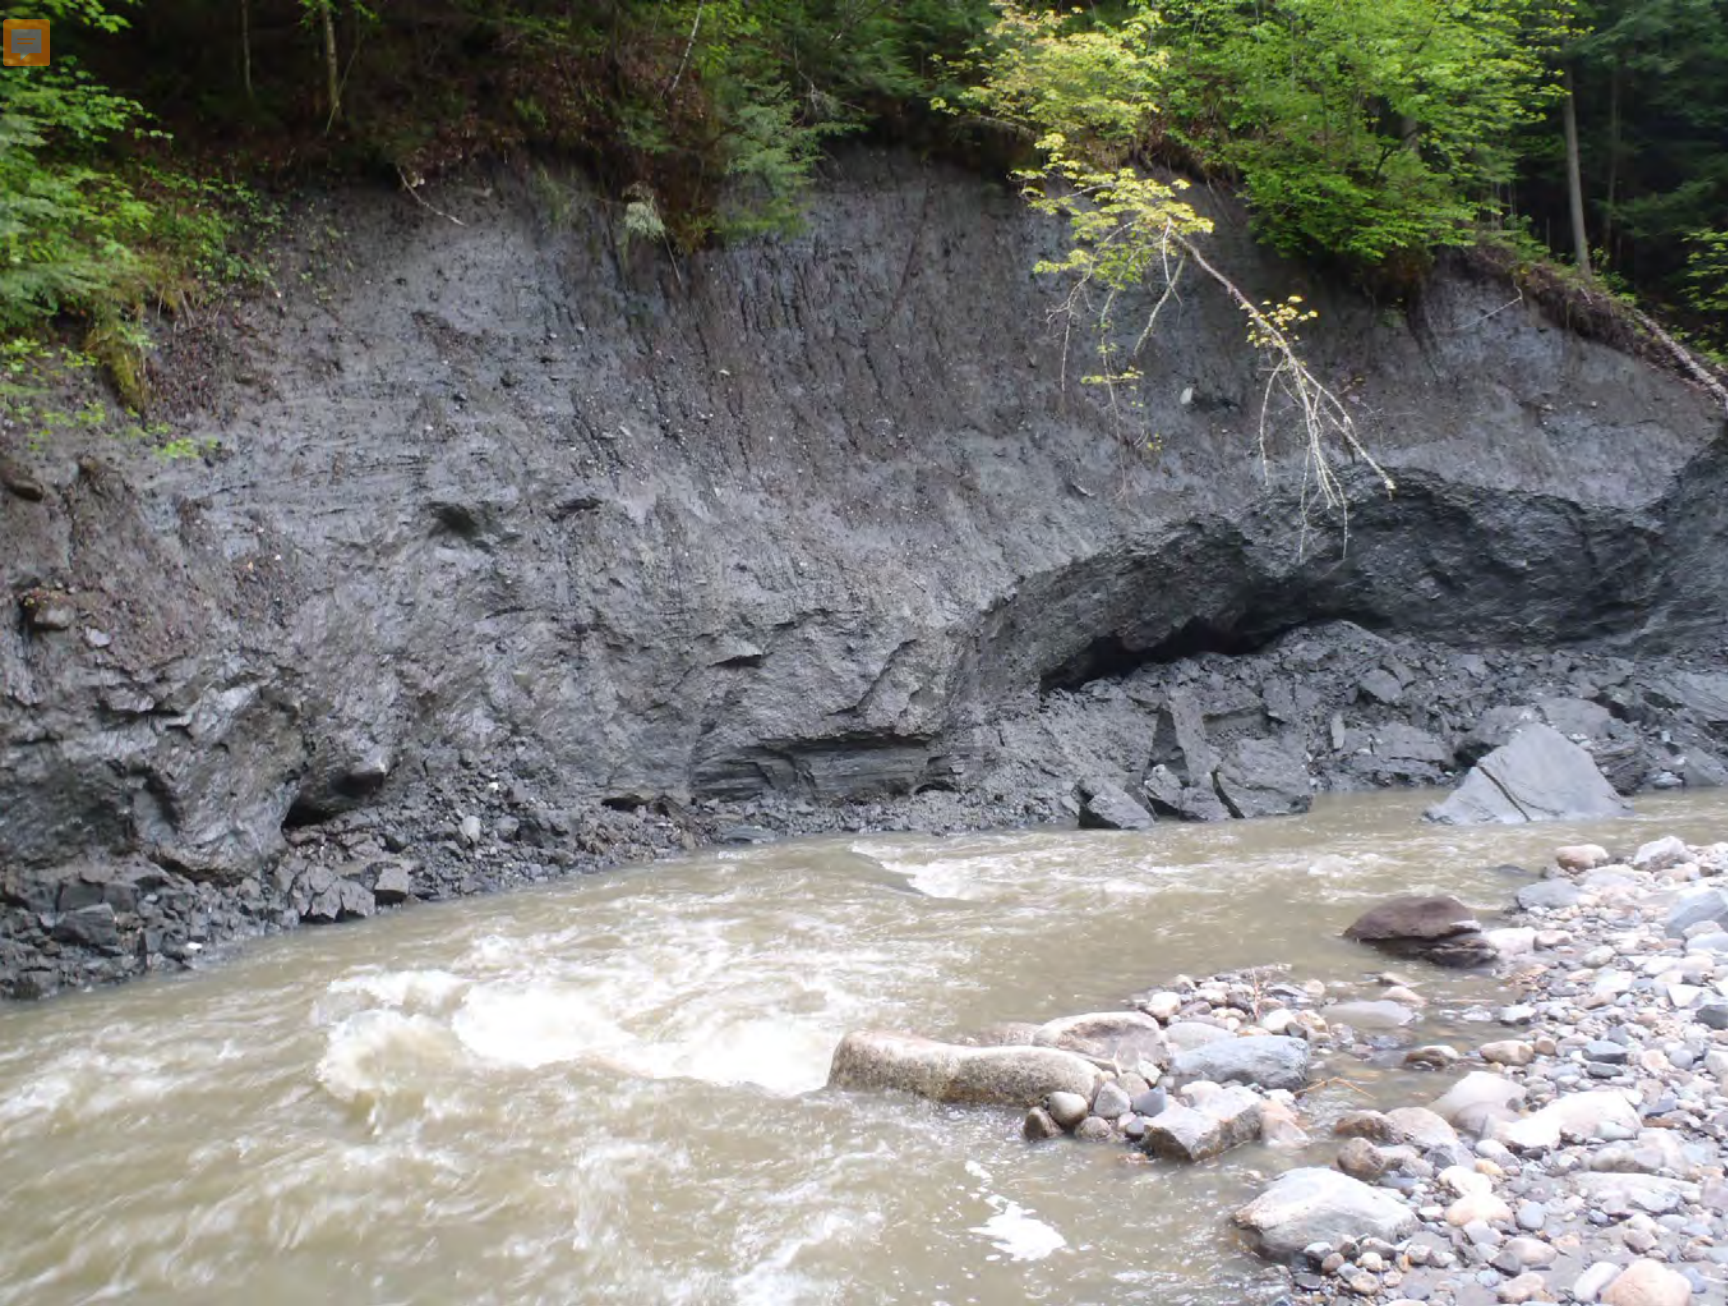
Site GB-1032, 5/29/2011, Post-Irene. George Springston.

Landslide in dense till, two days after flood of May 26, 2011. Note overhangs at base and fallen blocks of till.

Slope is destabilized by continued erosion at toe. Weathering of fresh material begins.

Processes: Undercutting of an existing landslide due to fluvial shear, followed by irregular block detachment.

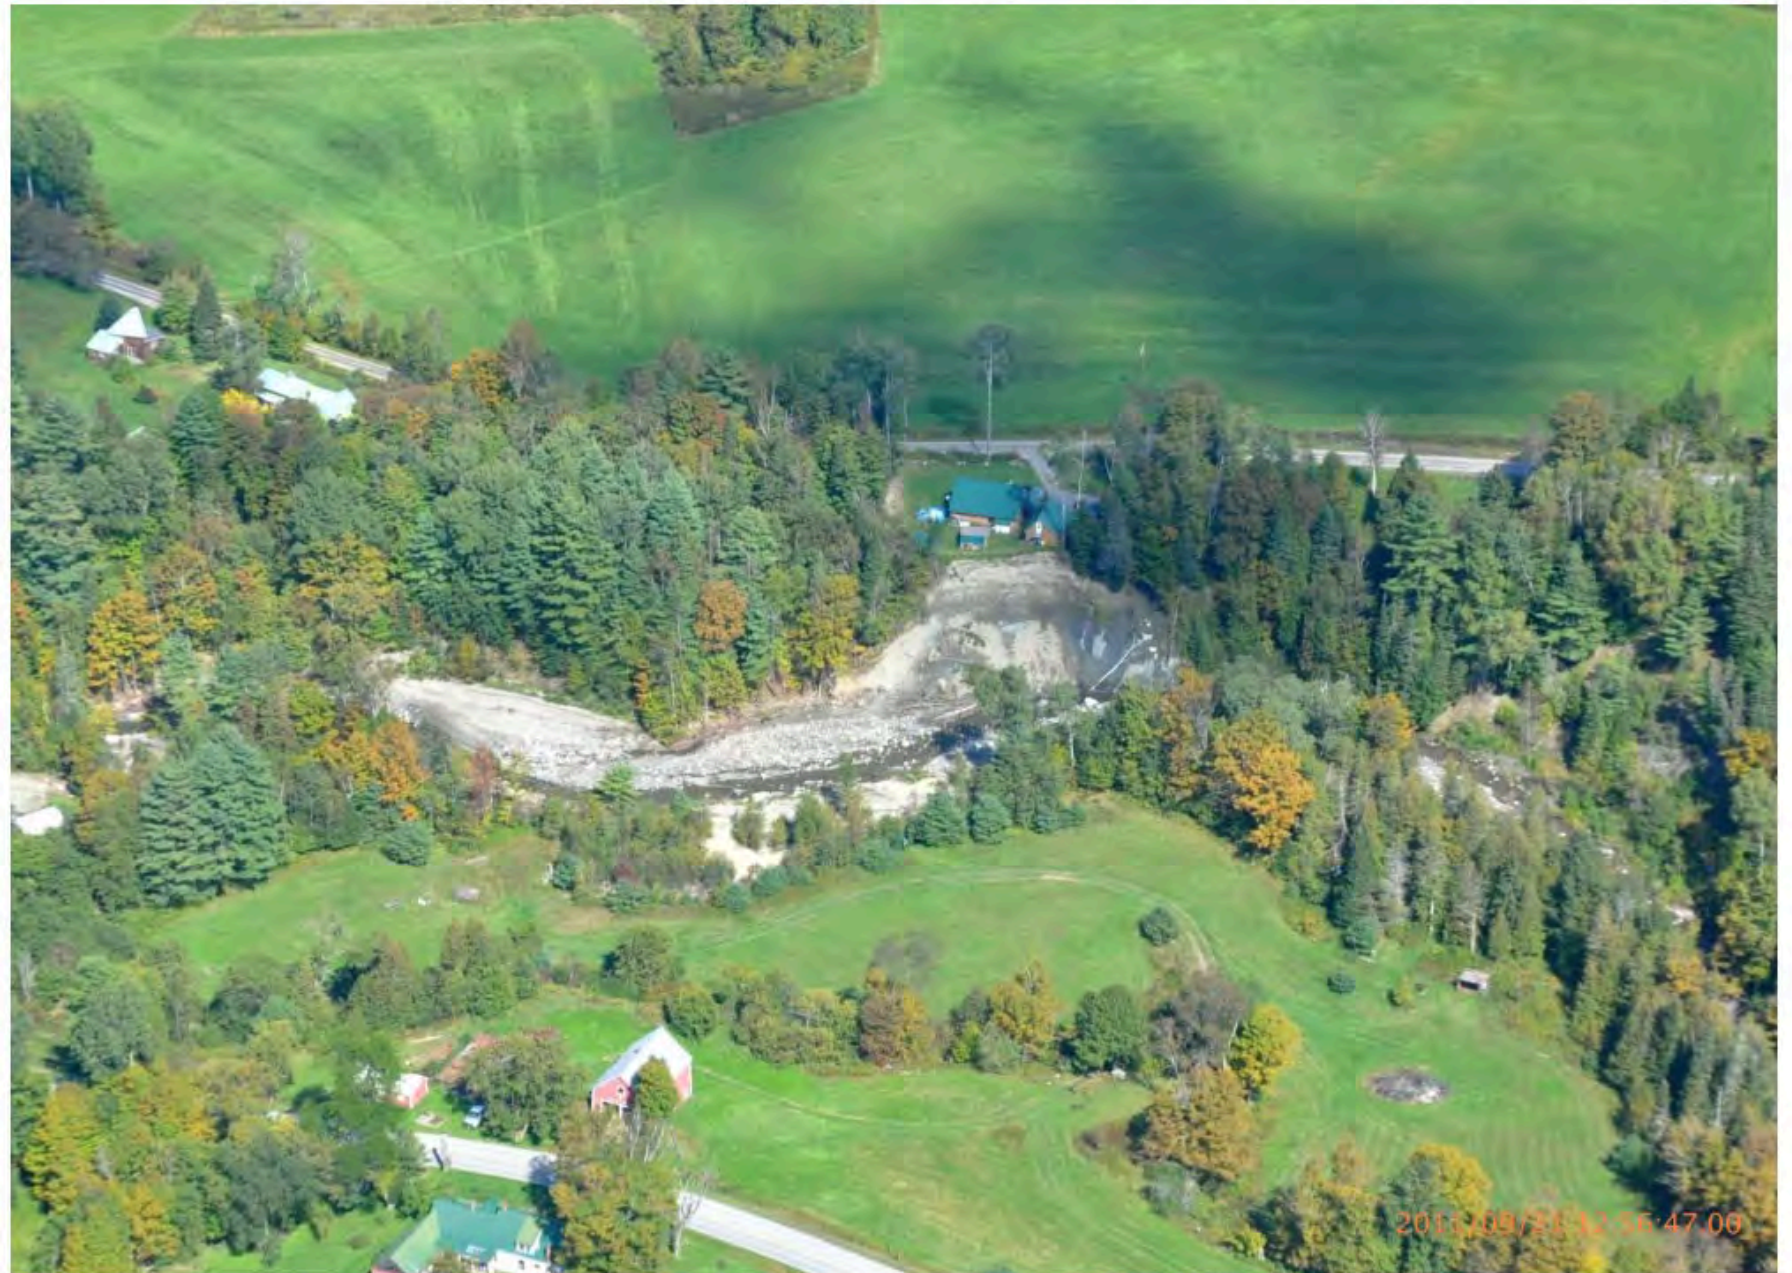
House perched on the edge of an active landslide is shown in center. Brook flows from right to left. Photo taken after Tropical Storm Irene, September, 2011.

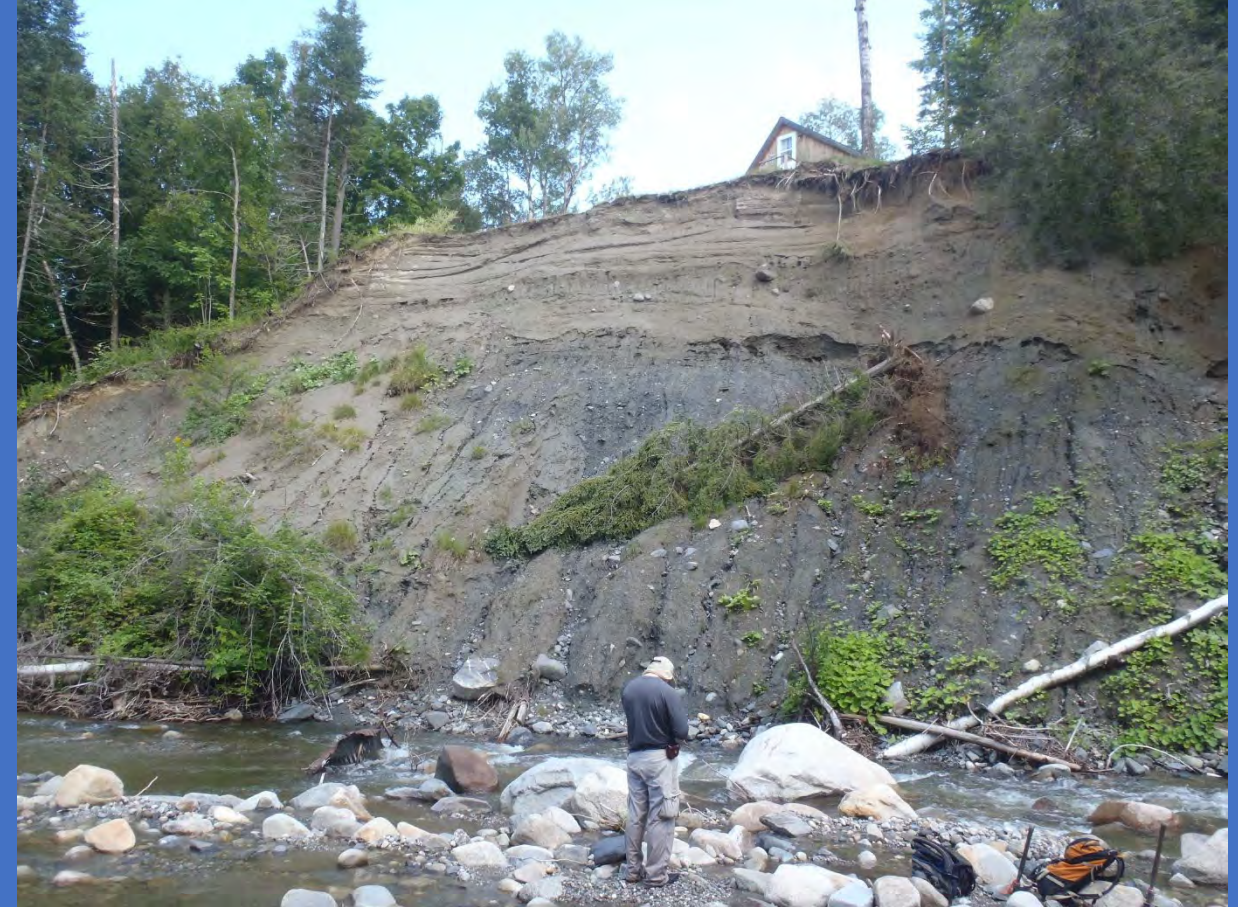
**Above: Landslide at Site GB-1025. Note peak of garage roof at top. Slope is 56 feet high and slope angle is 49°.**

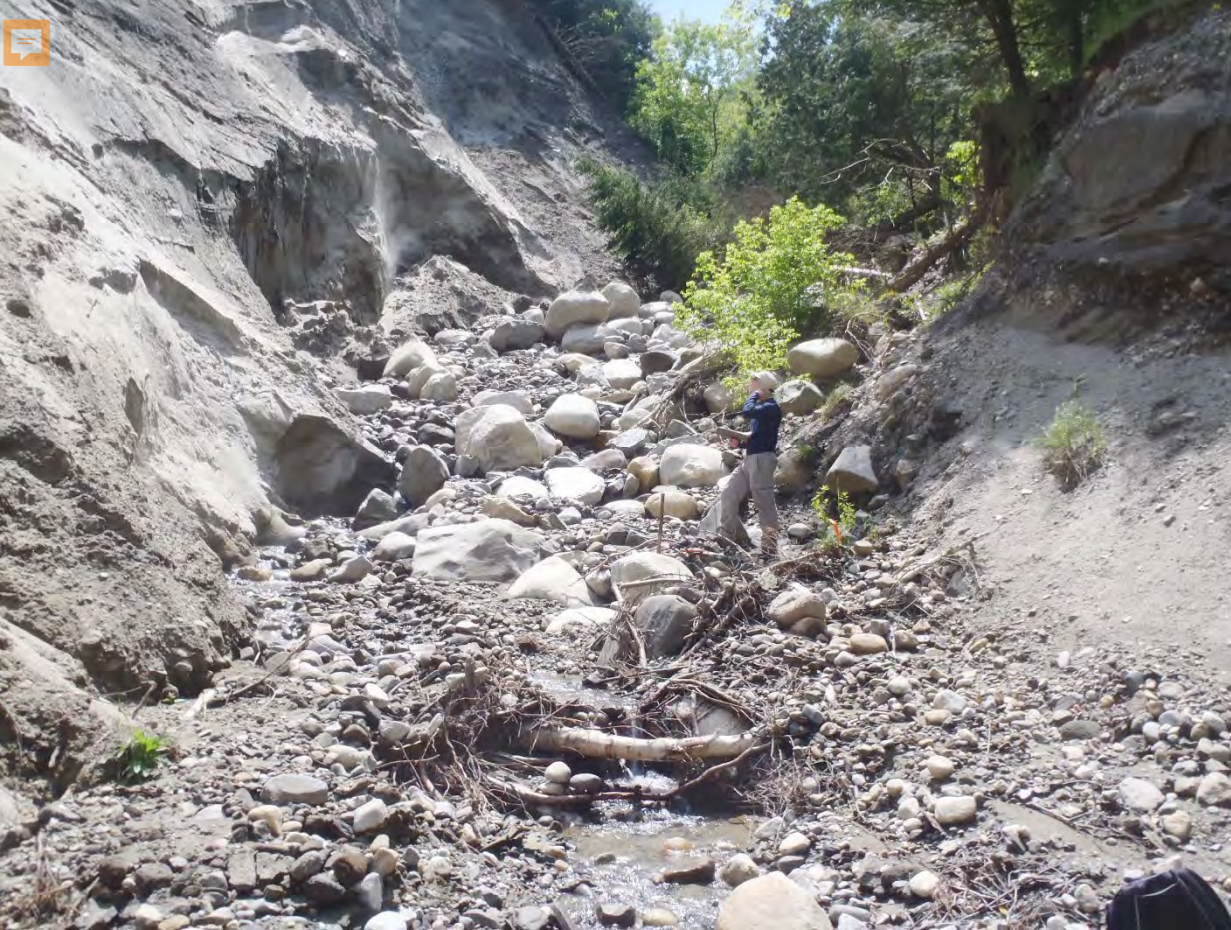
Large gullies in highly erodible sand and silt. These features have been reactivated by additional runoff from an agricultural drainage ditch. Site GB-1010.

**Above: Looking up gully. Note active scour at base of slope on left. Site GB-1010, George Springston, 7/16/2013.**

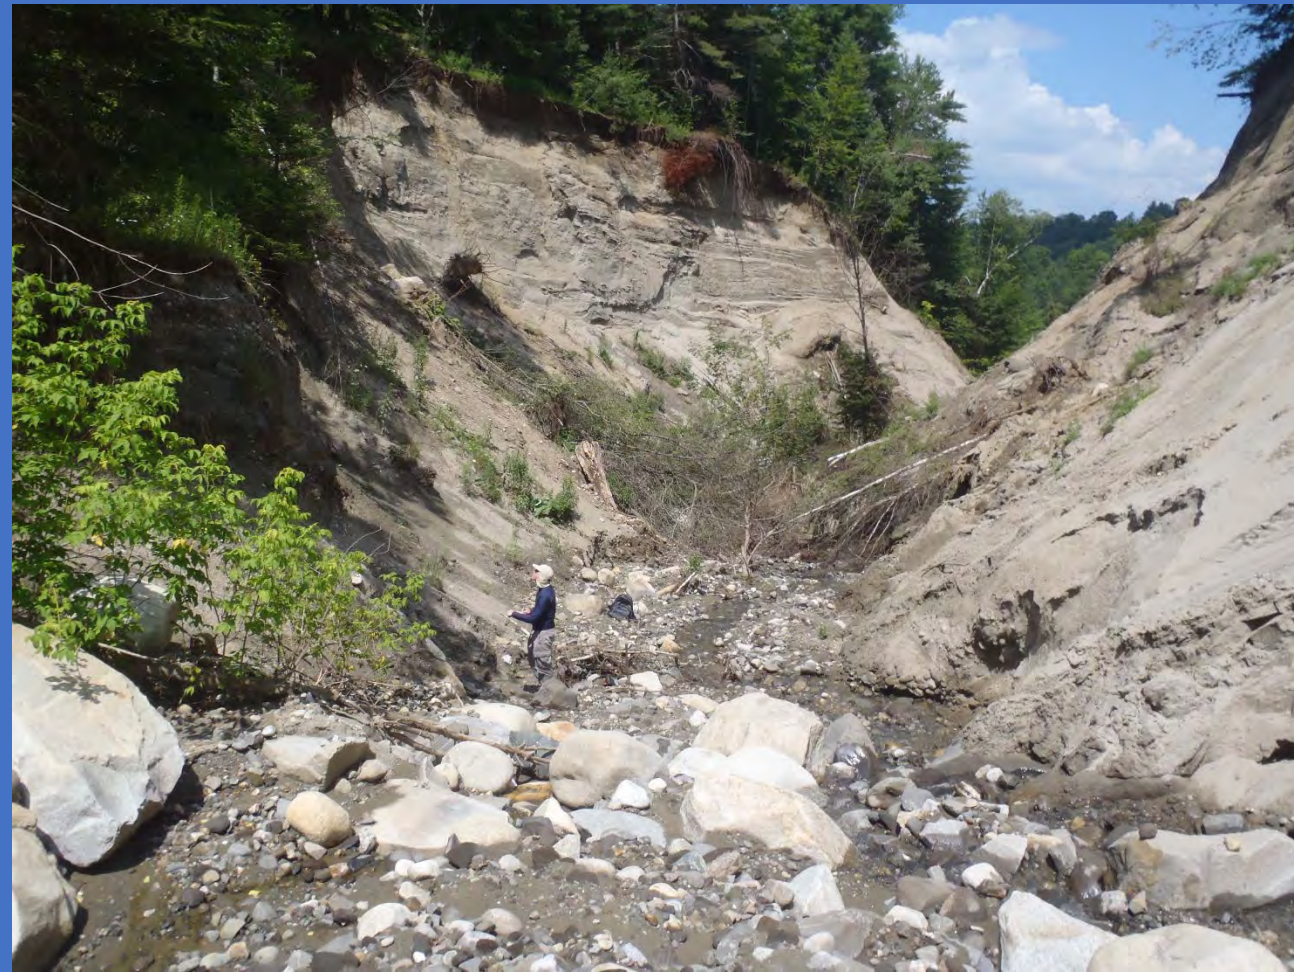
**Below: Looking down gully. Material is 21.4 meters (70 feet) of ice-contact fine to very fine sands and silt with gravel lenses. Site GB-1010, George Springston, 7/16/2013.**

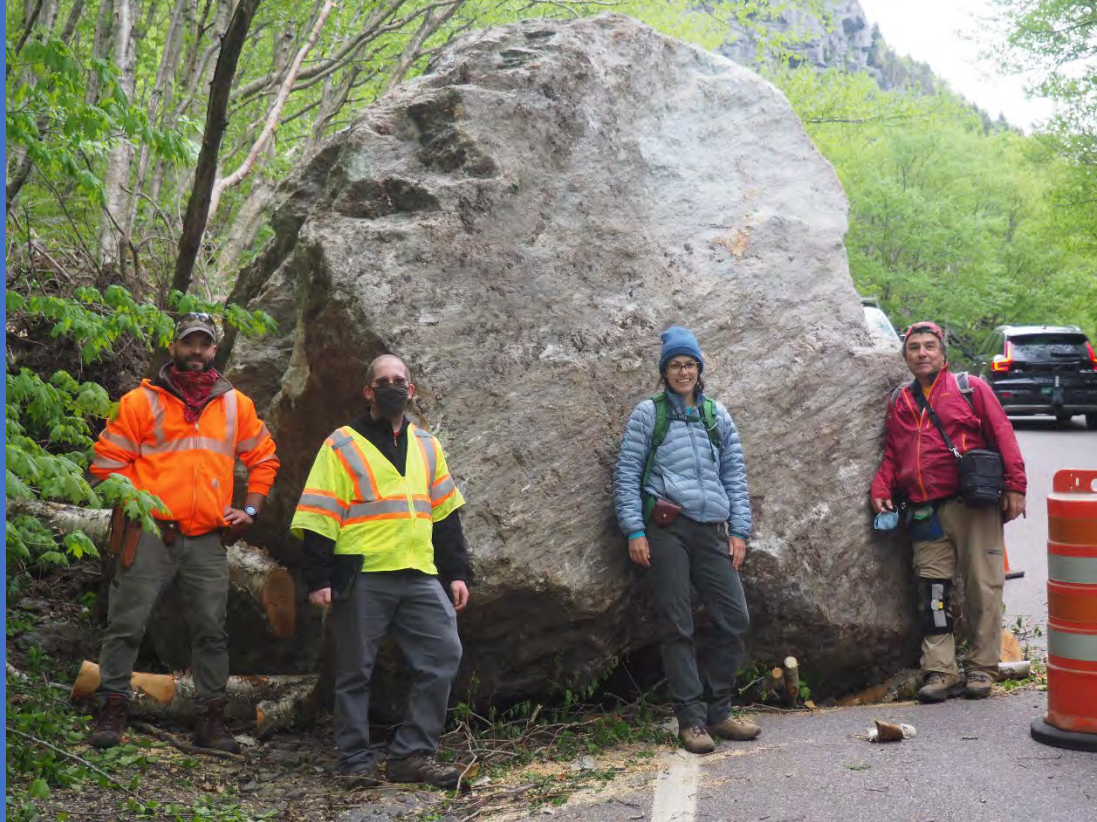
**Above: One of two boulders that reached Rt. 108 in Smugglers Notch, May 30 to June 1, 2020. Right: Source area of rock fall on cliff north of Cass's Gully.**
