# Two Decades of Collaborative Landslide Research in Vermont

Presented at the Joint Southeastern & Northeastern Section Meeting of the Geological Society of America in Reston, VA on March 17, 2023

# What We've Learned About Landslides in Vermont

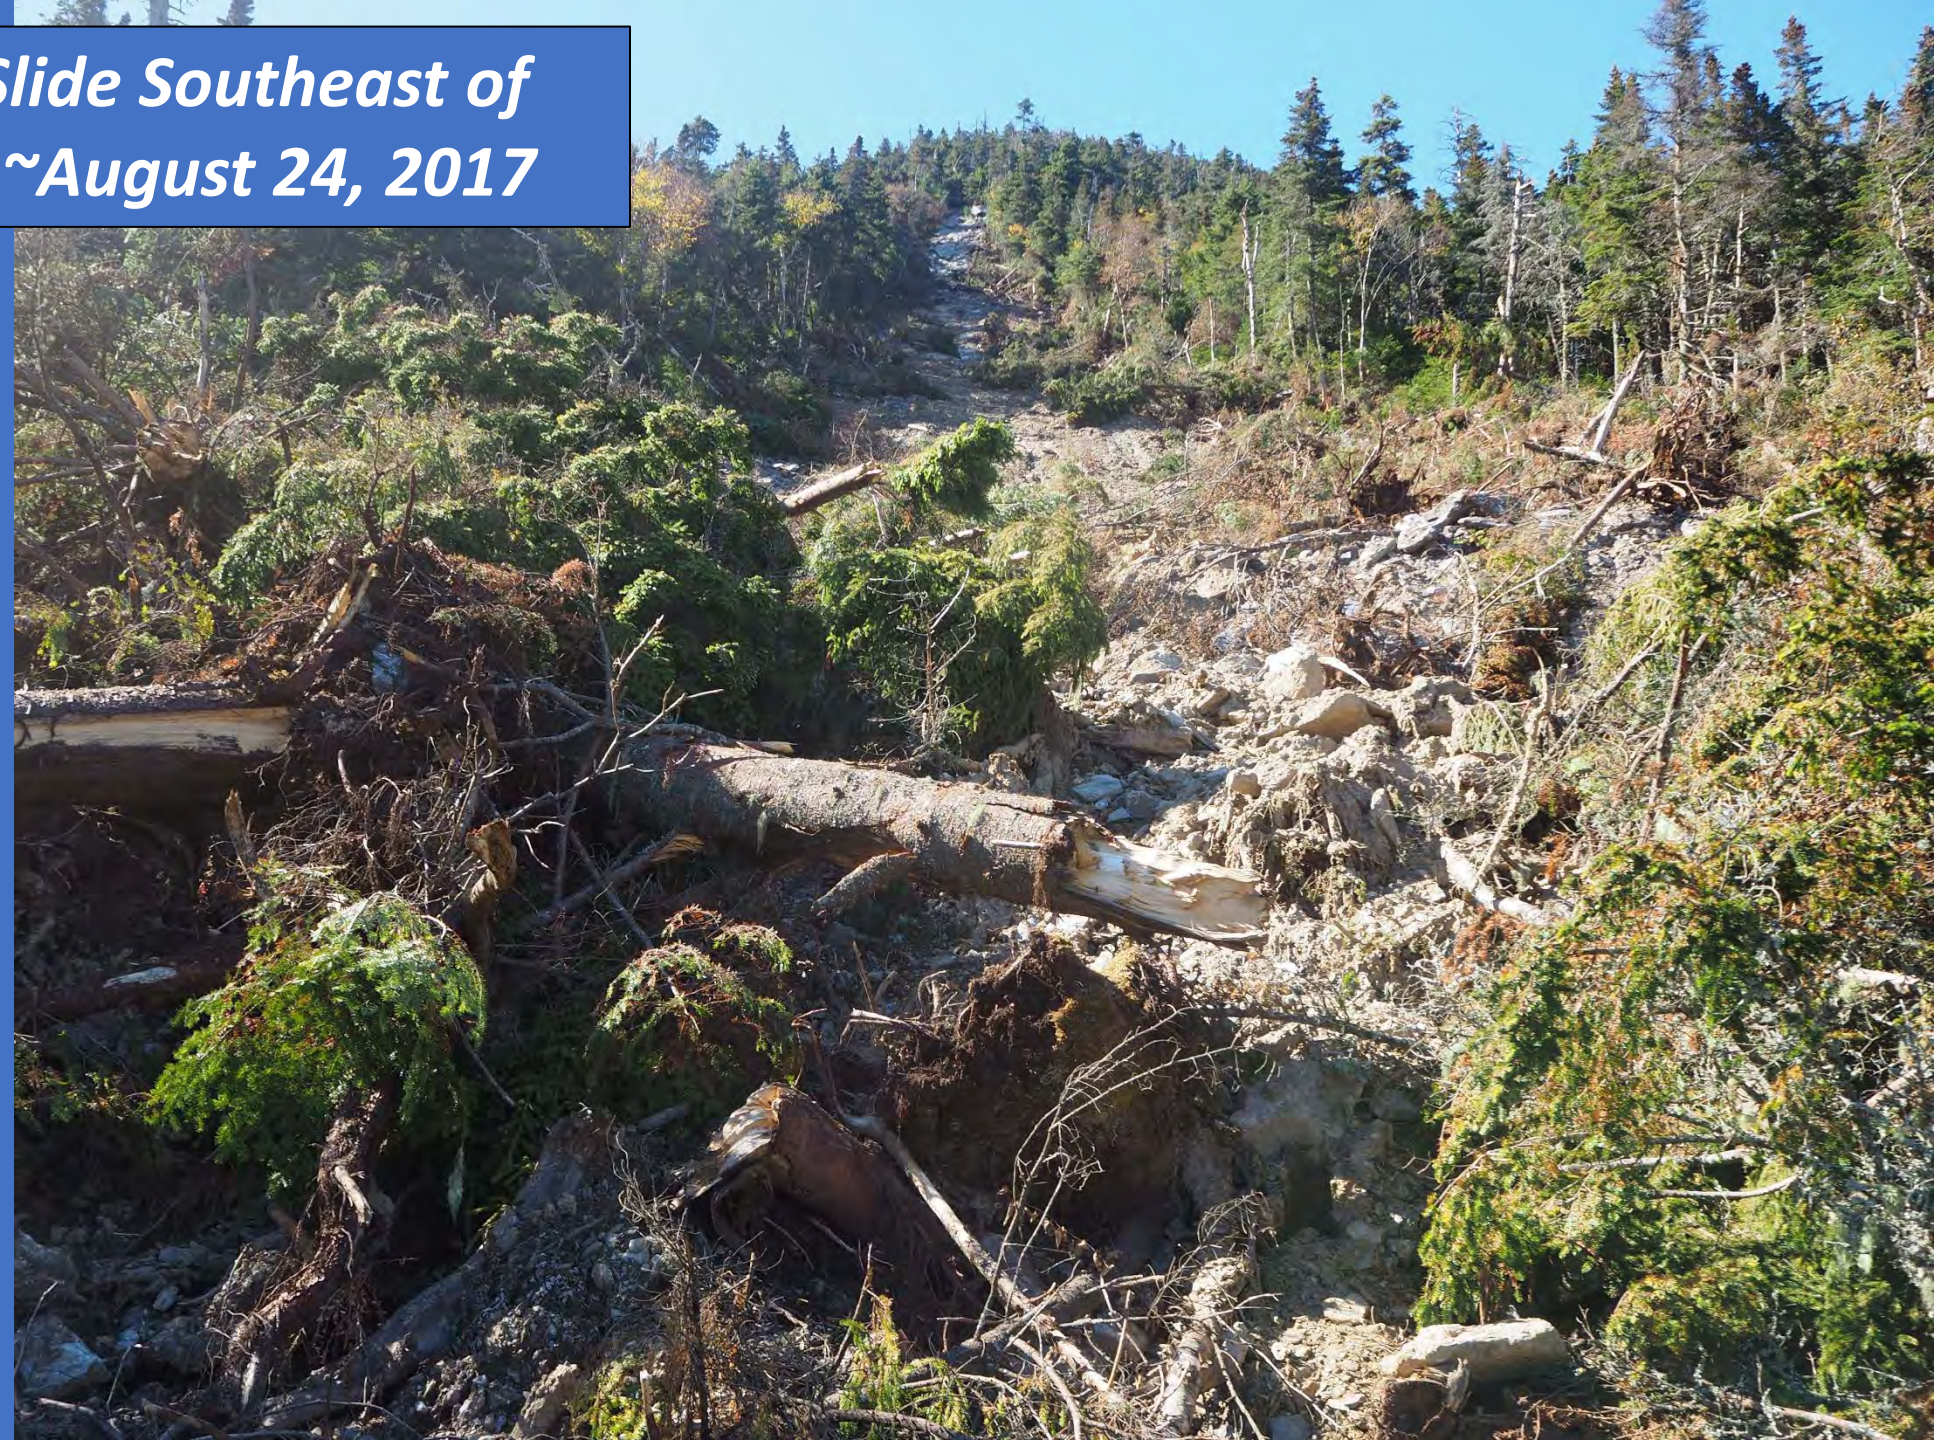
George Springston,  
9/22/2017.

Looking up through broken trees at toe of Mt. Ellen slide. Failure started as a rock slide and transitioned to a debris slide as it moved rapidly down slope.

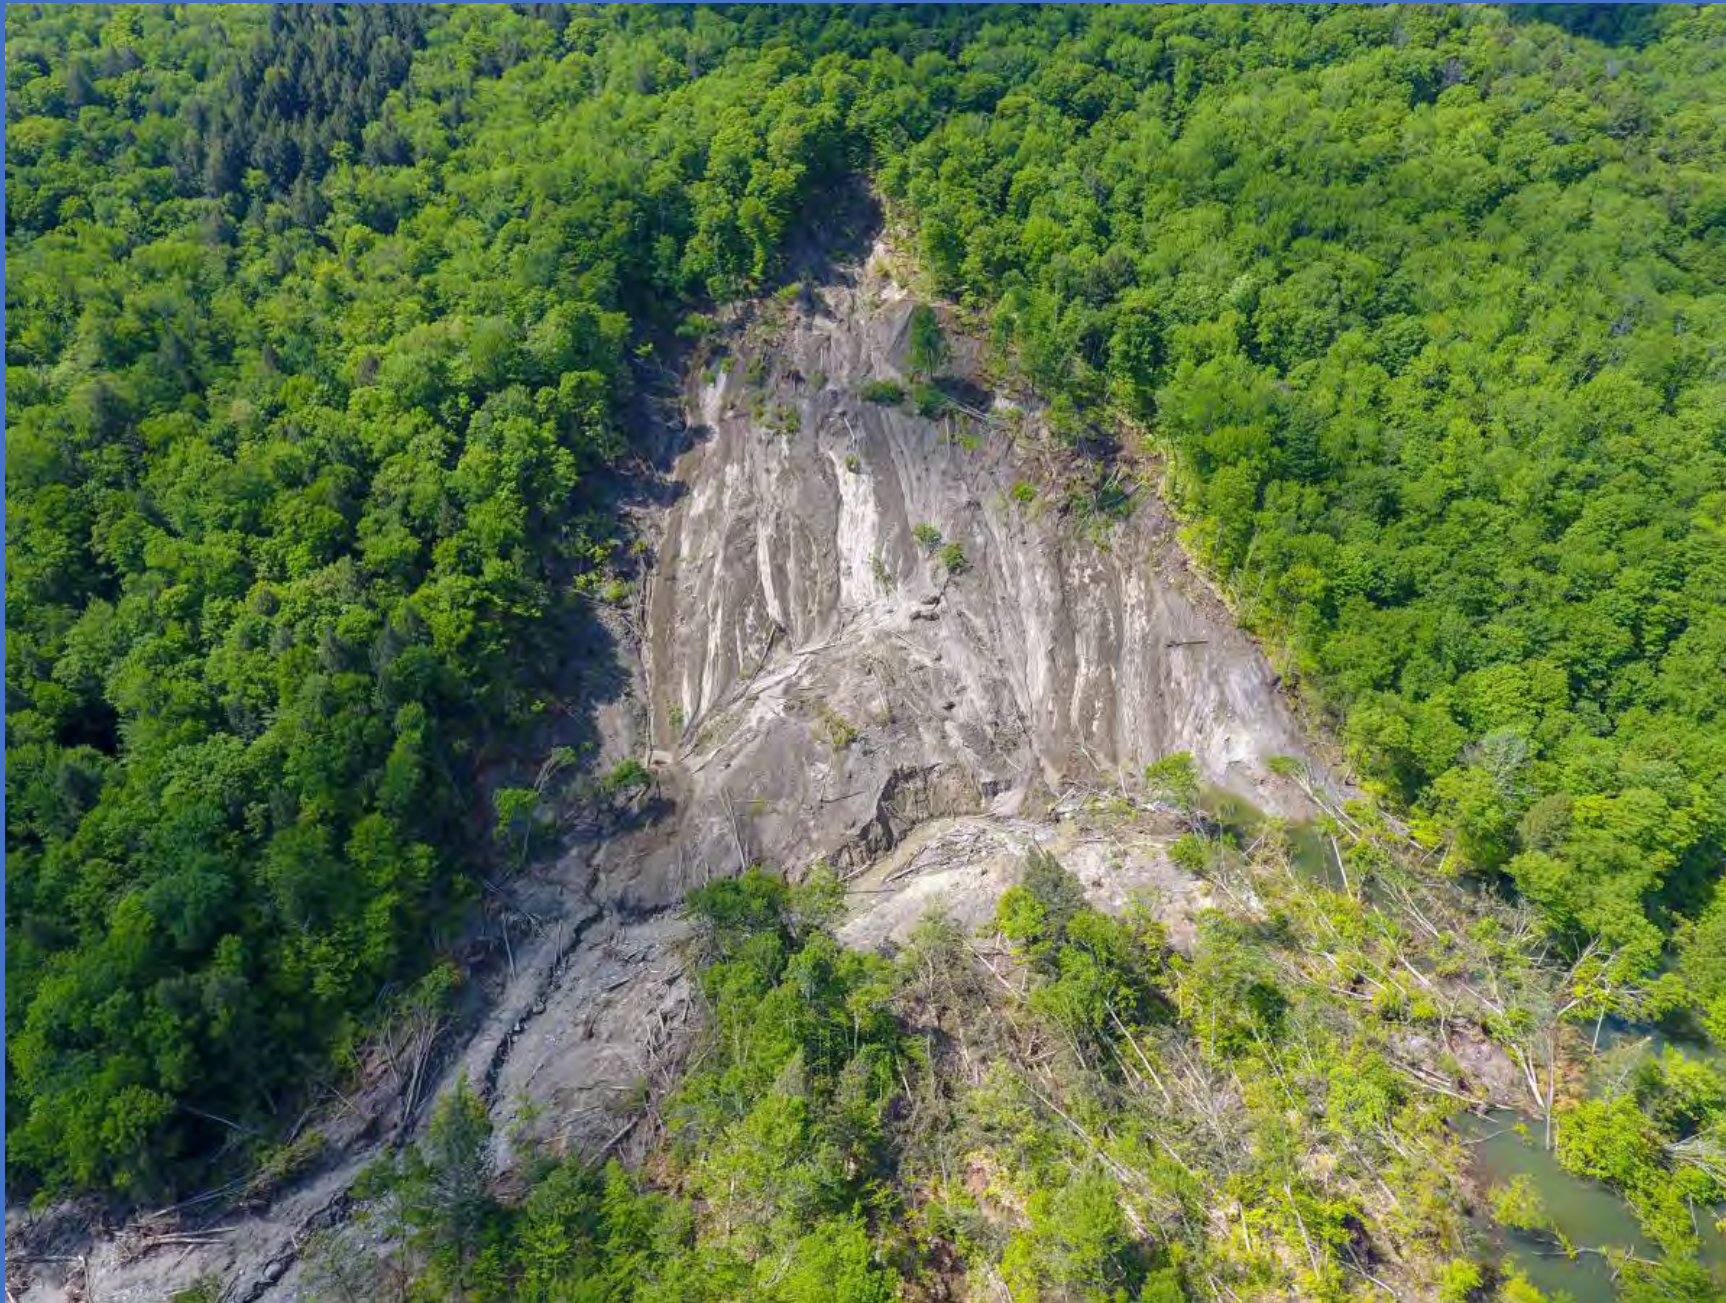
Looking south. The landslide deposit is at the bottom, center and the ponded area is at lower right. Stream flows from right to left. Photo by Evan Robinson, VTrans Rail and Aviation Bureau, 6/12/2019.
