# **Landslide Inventory of Chittenden County, Northwest Vermont**

## **Vermont Geological Survey Open File Report VG2018-6**

George Springston  
Norwich University Department of Earth and Environmental Sciences 108  
Harmon Drive  
Northfield, VT 05663  
802-485-2734  
gsprings@norwich.edu

June 30, 2018

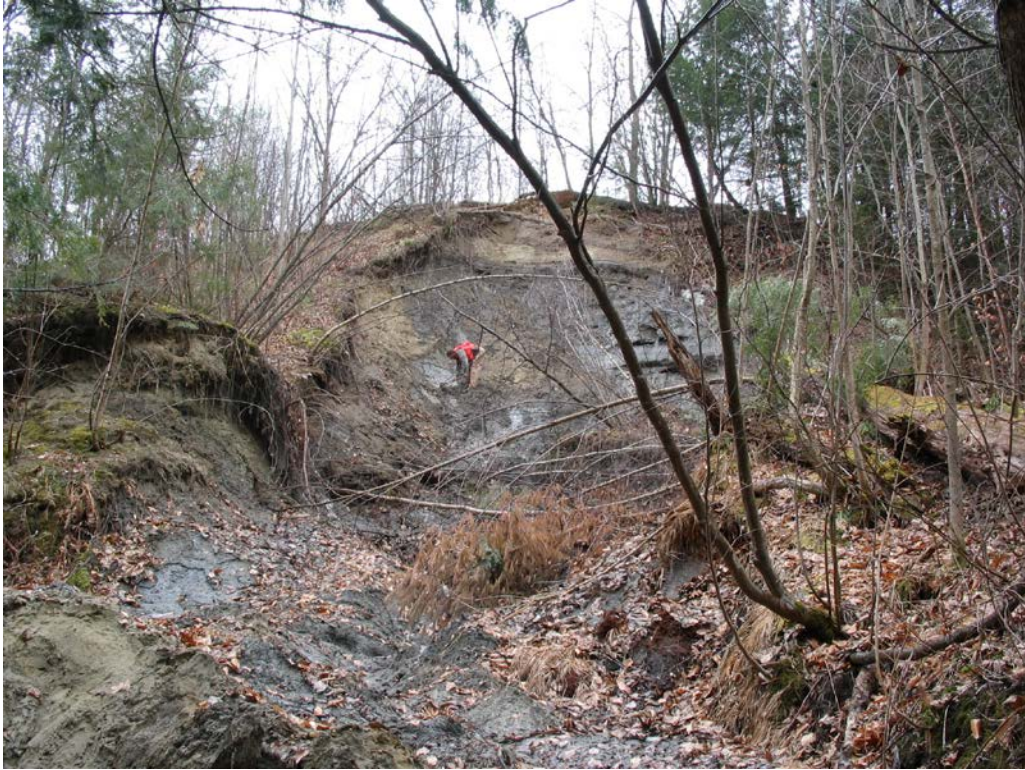
On the cover: Looking up an active landslide on the side of a landslide-gully complex, Colchester. Photo by Barry Cahoon, 2006.

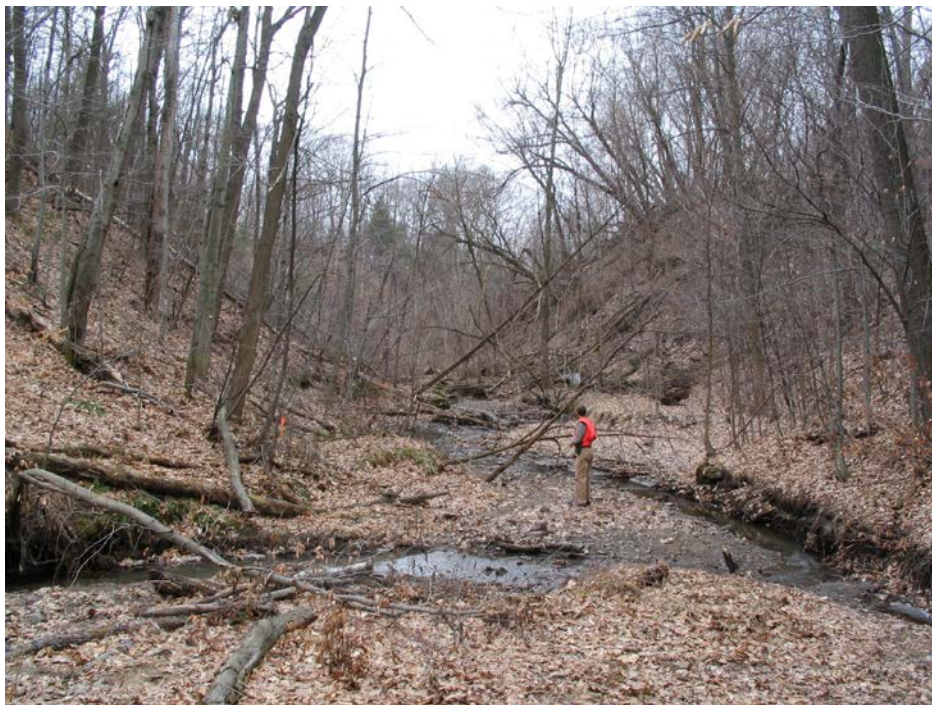
A landslide-gully complex located northwest of the Winooski/Colchester town line is discussed below (Figure 5). Here, a stream known as “Morehouse Brook” or “Town Line Brook” has cut a steep-sided gully into a terrace with a top elevation of about 55 meters (Figure 6). The floor of the gully is freshly incised and the banks are lined with active and currently inactive landslides (Figures 7, 8, and 9). The gully drains westward into the Winooski River.

Figure 6. Looking up Town Line Brook gully. Photo by Barry Cahoon.

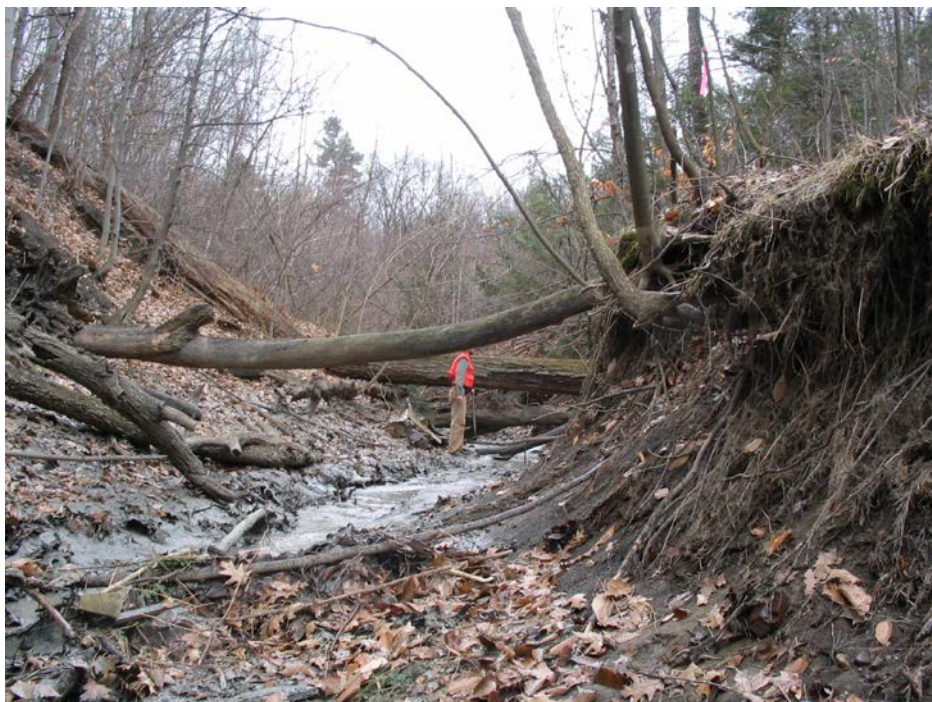
During the 2006 visit we observed active headcuts in the floor of the gully. These indicate that the brook is actively lowering its bed (Figure 7). No bedrock was observed in the gully bottom or on the sides. The downcutting is the immediate cause of the slope failures on the gully sides. From the observed pattern of active and inactive slides, it appears that the active slides are migrating upstream in response to headcut migration. The erosion from the gully results in substantial sedimentation into the Winooski River (Figures 11 and 12).

Figure 7. Fresh incision into floor of gully. Photo by Barry Cahoon.

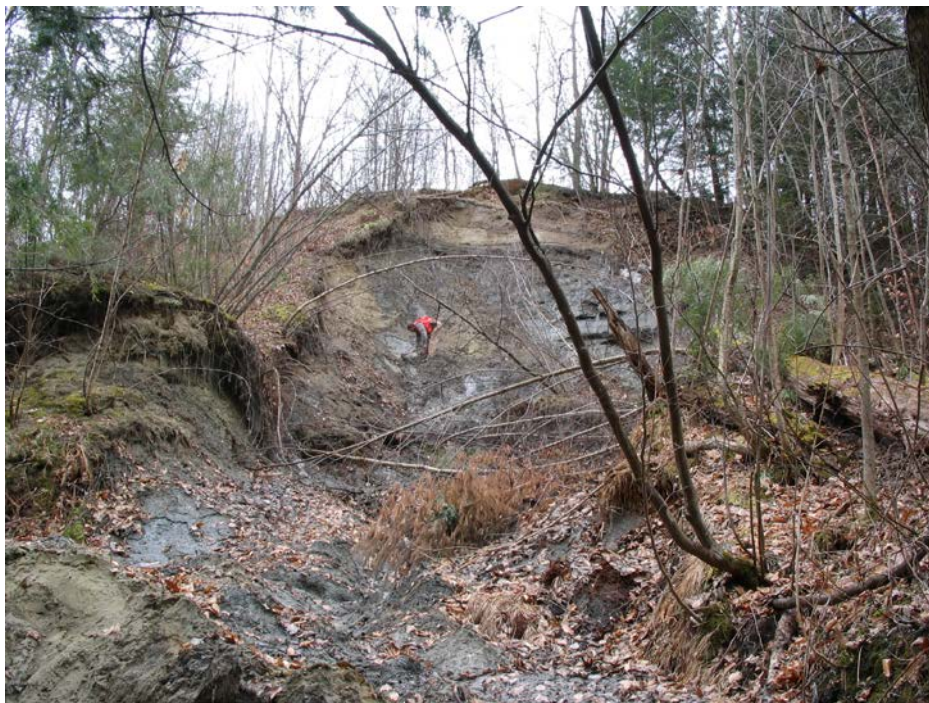
Figure 8. Looking up at active landslide on side of gully. Photo by Barry Cahoon.

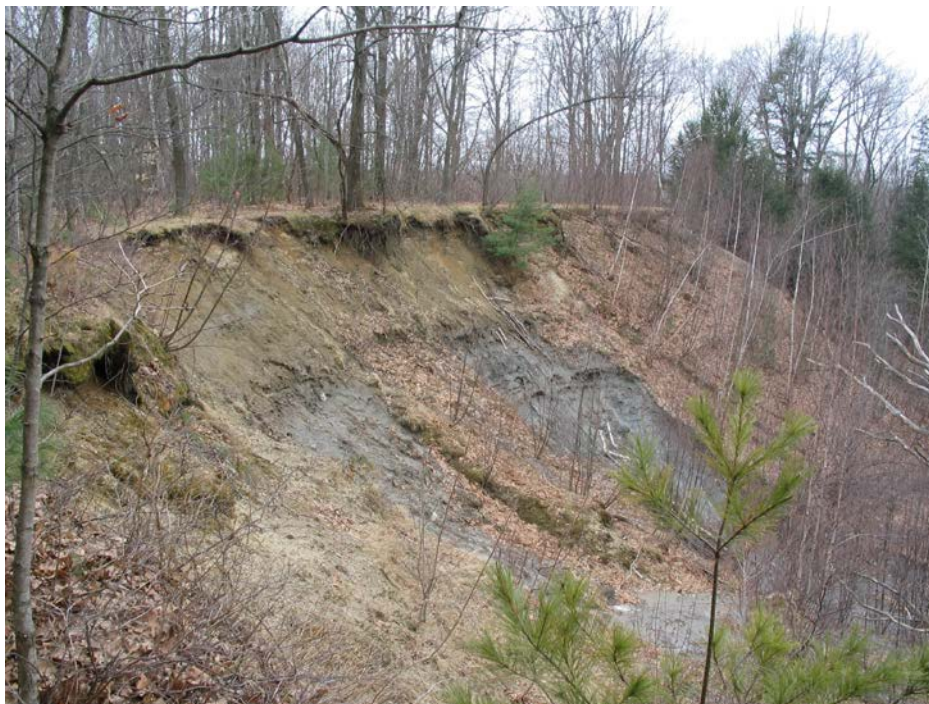
Figure 9. Upper edge of an active landslide on side of gully. Photo by Barry Cahoon.

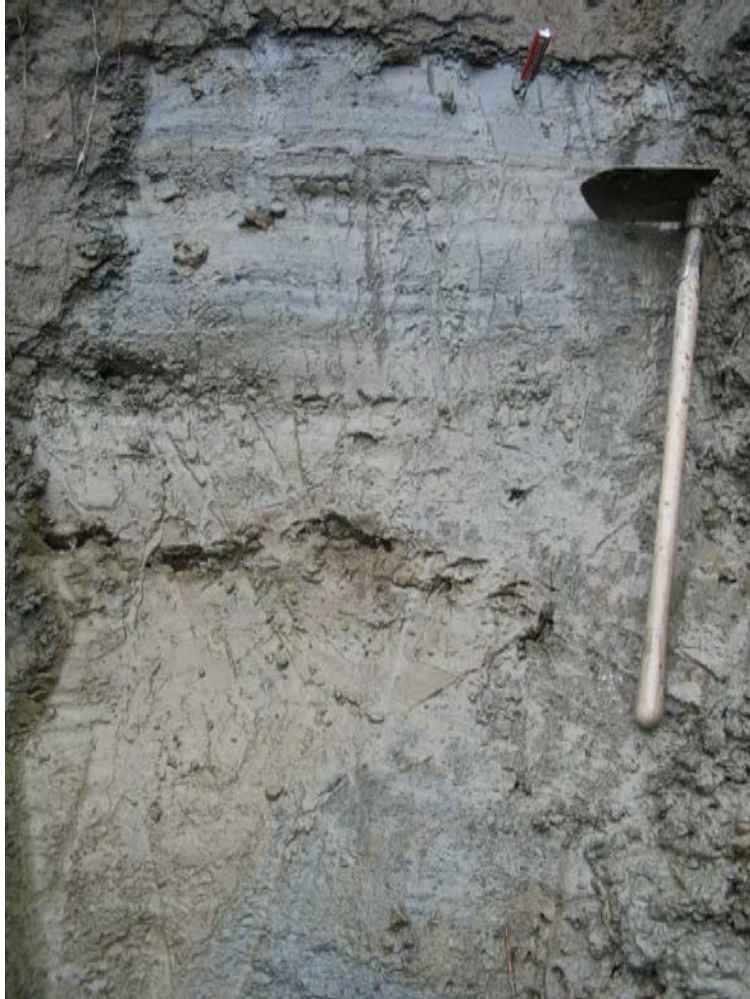
The lowest parts of the gully expose several feet of varved silt and silty clay (Figure 10). The back faces of the active slides expose roughly 40 feet of variably laminated gray silt with some silty clay laminae and showing extensive signs of deformation (faults and injections of silty clay). This material is overlain by roughly 10-12 feet of fine to medium sand. At the top of the section are several feet of pebbly medium to coarse sand. Abundant old garbage and metal were encountered on the north slope and in the bottom of the gully.

Figure 10. Varved silty clay and clay in landslide scar on side of gully. Photo by Barry Cahoon.

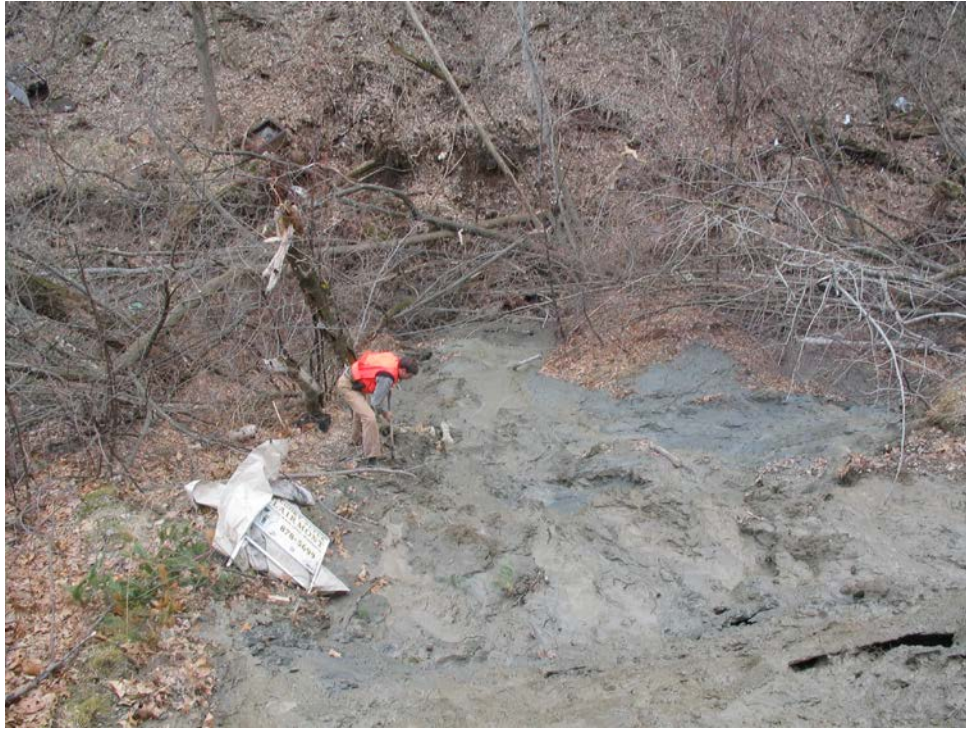
Figure 11. Looking down landslide to mud flow at base. Photo by Barry Cahoon.

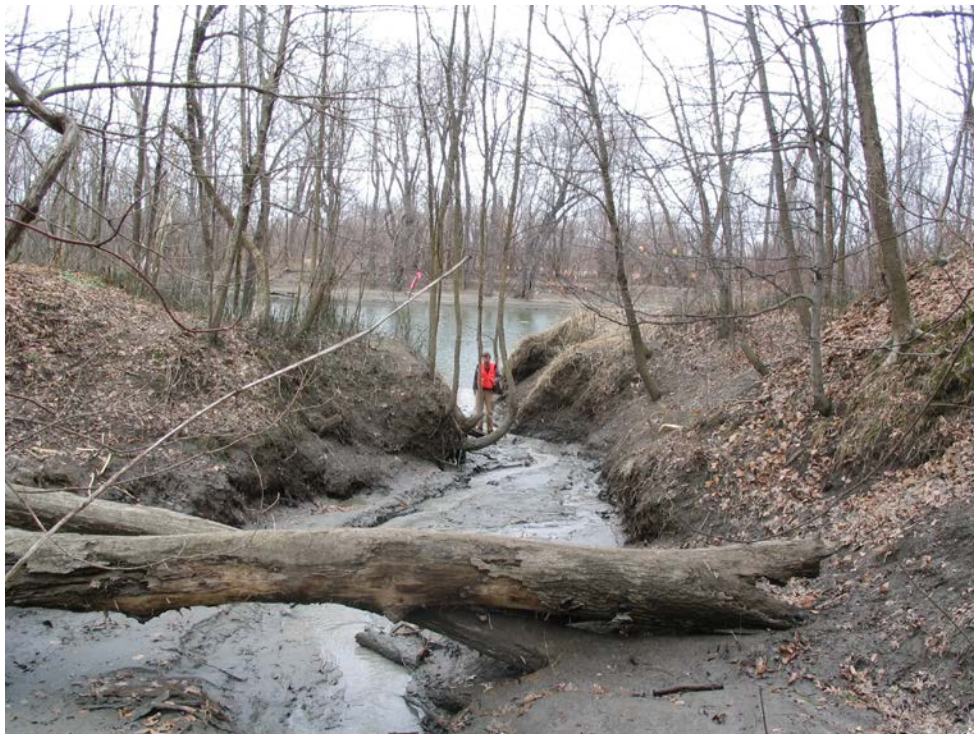
Figure 12. Confluence of gully with Winooski River. Note sedimentation. Photo by Barry Cahoon.

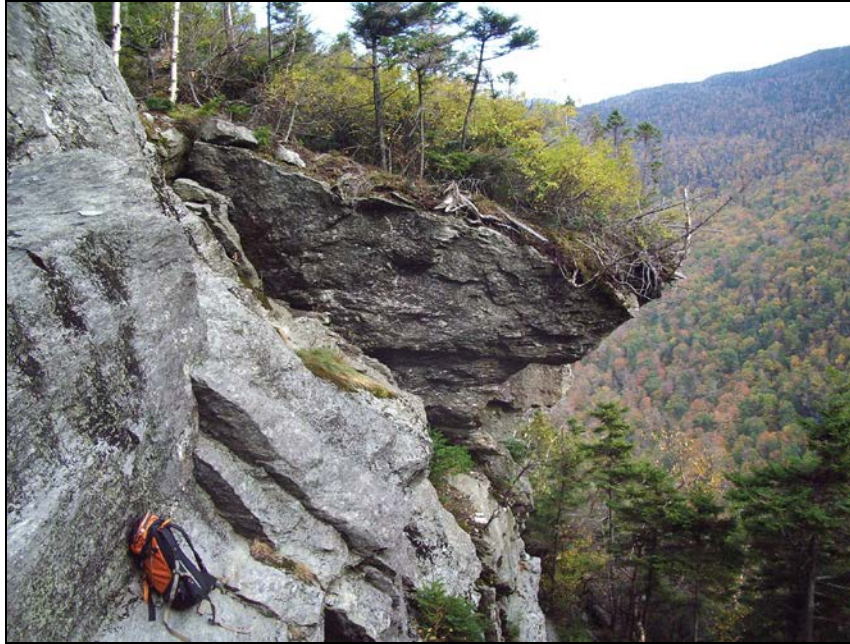
Figure 14. Overhang on cliffs on west side of Smugglers Notch. Knapsack for scale. Overhangs are common on both sides of the Notch. This particular one may eventually fail by sliding or toppling due to an open joint in the left-hand side. Other overhangs serve as source areas for falls. Photo 3534a, 10/2/2007.
