Open File Report VG2021-2

Landslide Inventory of Caledonia County, Vermont

June 30, 2021

Prepared for
Vermont Geological Survey

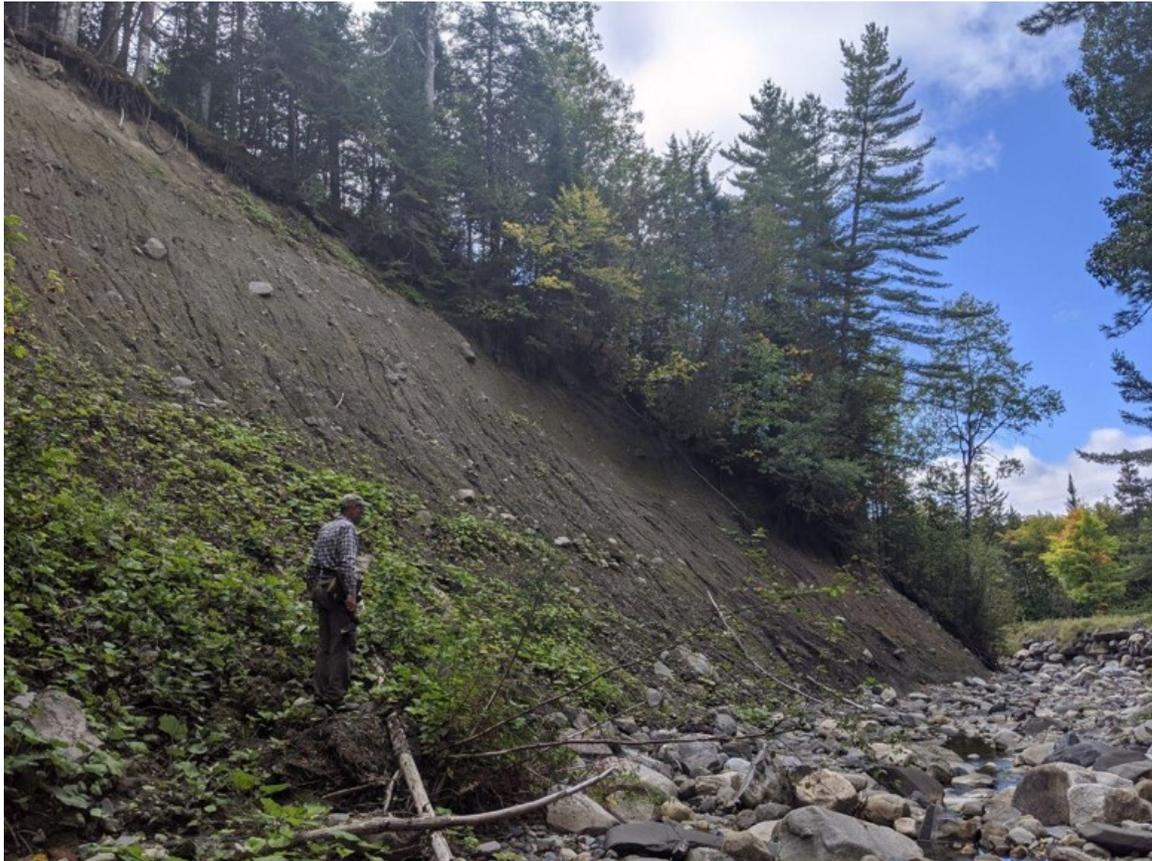
A typical large landslide in dense glacial till is shown in Figure 5. This is one of several identified along the banks of Stannard Brook in Stannard. This landslide has been active for many years. The failure mechanisms may be complex. Certainly an important mode of failure

has been shallow translational sliding, but observations by the author over many years suggest that during large floods there may be deep erosion of the landslide toe due to fluvial shear and subsequent collapse of the over-steepened slope. See Springston and Thomas (2018) and the section in this report entitled *Patterns of Slope Failure on Till Slopes* for a more detailed discussion.

Figure 5. Large translational earth slide in dense glacial till on the south side of Stannard Brook in Stannard. Photo courtesy of Jack Carlson, September, 2020.

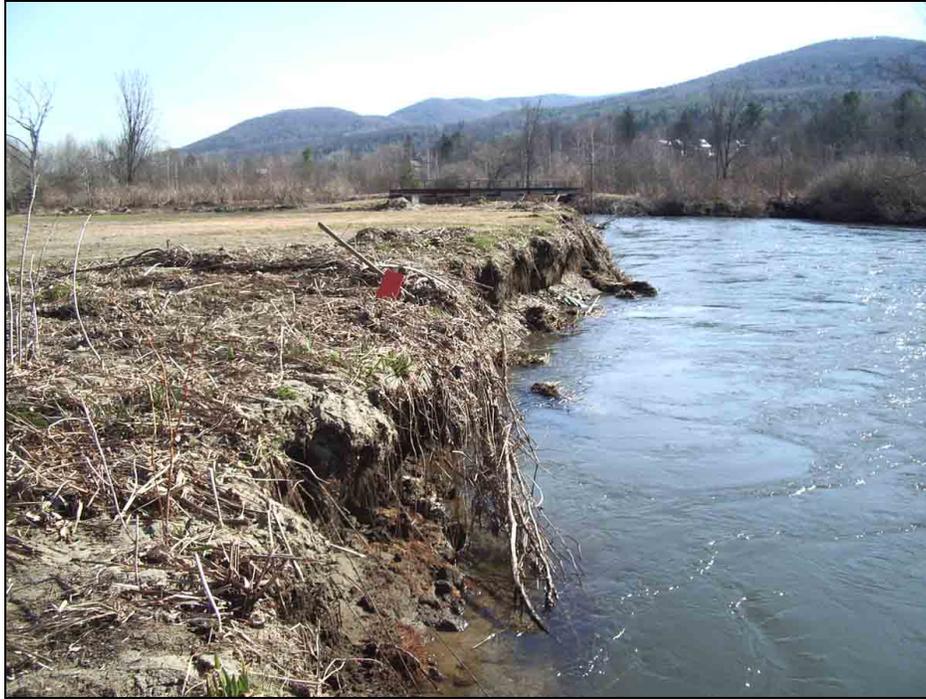
Figure 6. Eroding bank of the Dog River, Northfield, Vermont. Shovel and notebook for scale. Flow is away from observer. Sandy alluvium has been undercut during recent high flows and is in the process of collapsing. Photo by George Springston, April, 2007.

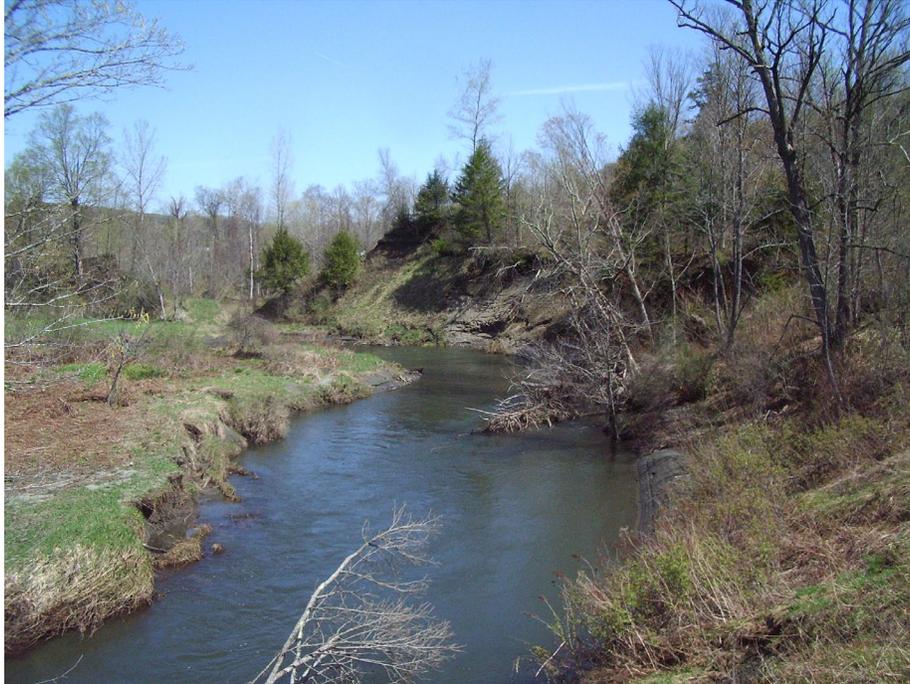
A typical streamside landslide is shown in Figures 6 and 7. This site is on the east side of the Second Branch of the White River in East Randolph and although it is not in the current study area, it will serve as a good example. The landslide exposes an alluvial terrace deposit of sand and gravel overlying glaciolacustrine silt and silty clay interpreted to have been deposited in glacial Lake Hitchcock. The landslide appears to have been driven largely by toe erosion.

Figure 7. Landslide in alluvial terrace deposits overlying lacustrine silt-clay deposits on Second Branch of White River in Orange County. Photo by George Springston, 2006.

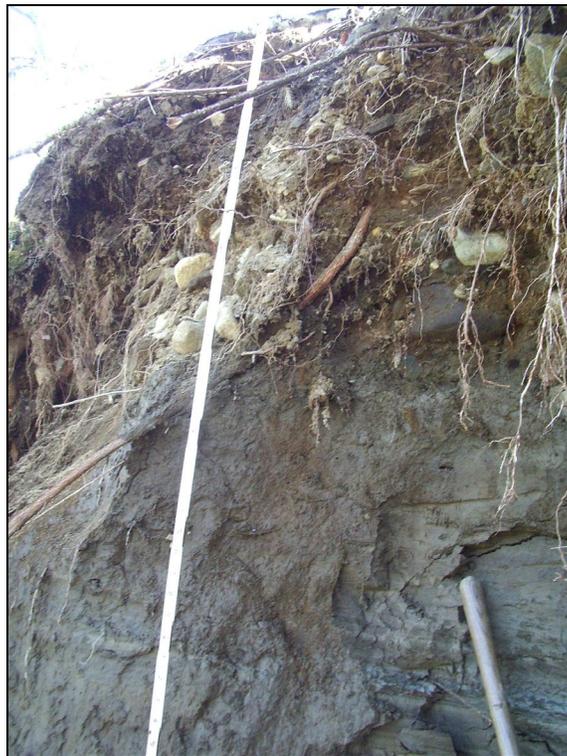
Figure 8. Close-up view of alluvial sand and gravel overlying grey lacustrine silt and silty clay in landslide scar shown in Figure 7. Photo by George Springston, 2006.

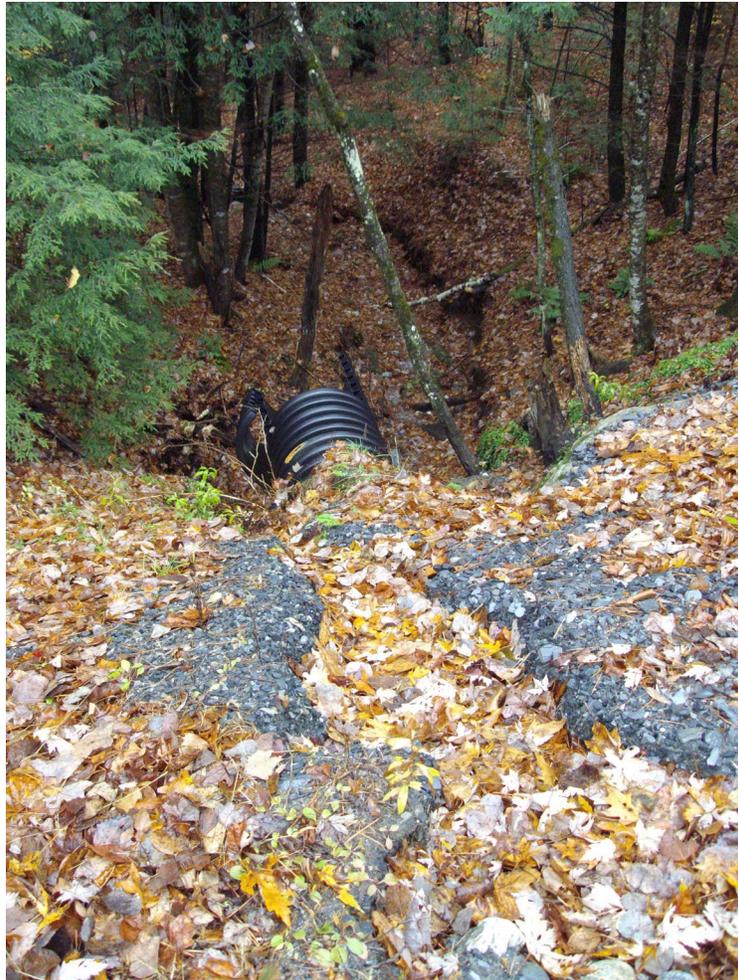
A typical unstable gully from Orange County is shown in Figures 8 and 9. The gully is part of a landslide-gully complex on the southwest bank of the Ompompanoosuc River in Thetford that has eroded into about 20 feet of loose, coarse-sandy boulder cobble gravel overlying 11 feet of dense fine-sand to silt-matrix till over bedrock. The culvert outfall shown in Figure 12 drains onto the slope. In this particular case it appears that road runoff has contributed significantly to the formation of the gully.

Figure 9. Looking down at a typical unstable gully near the Ompompanoosuc River in Thetford.

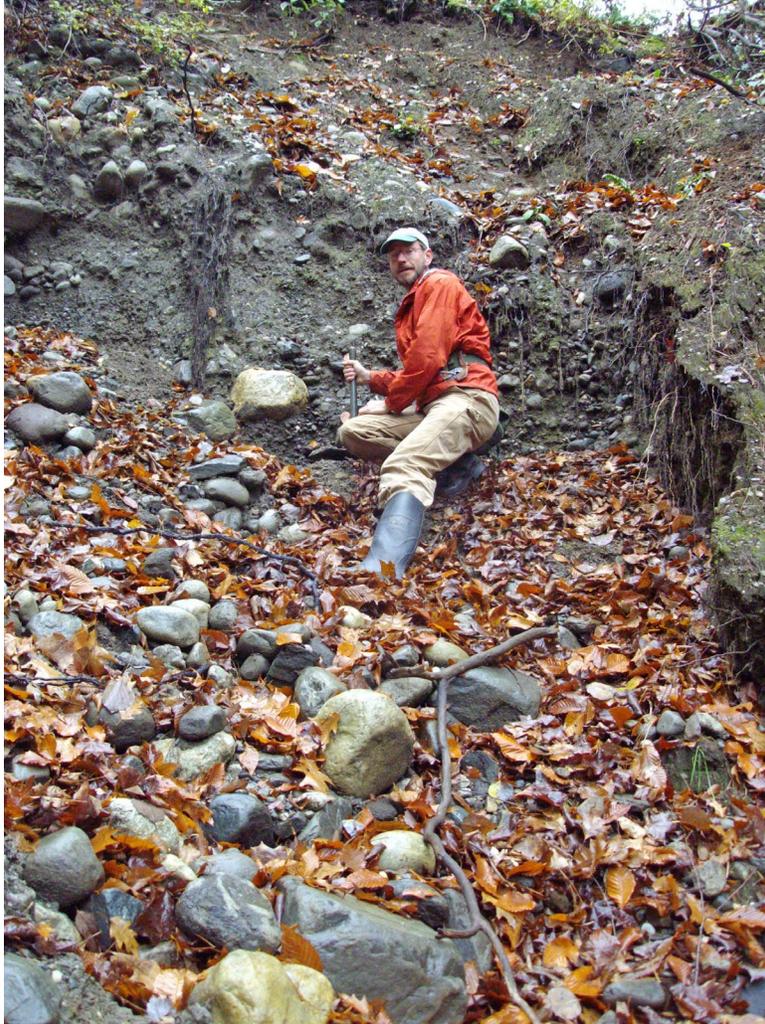
Figure 10. Looking up the center of the gully at highly erodible gravel deposit.

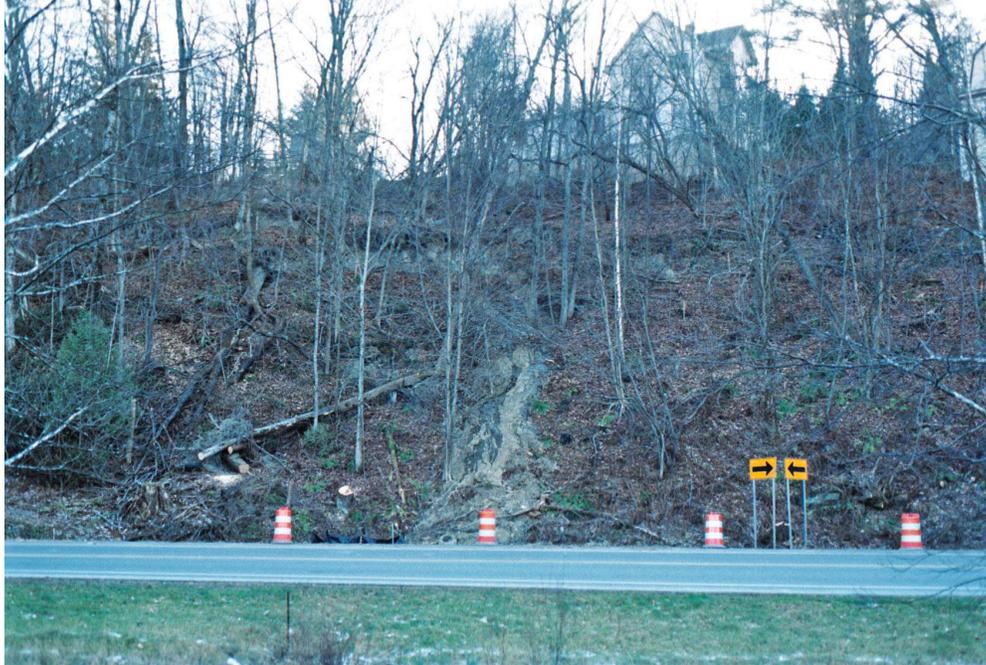
As an example of the type of damage that can result from even a moderate-sized landslide, the following case study is presented: In November of 2003 the Vermont Agency of Transportation (VTrans) alerted the VGS that a landslide was developing on the outer face of a high terrace above VT Route 15 in Hardwick (Figure 11). Site visits on November 10 and 21 revealed an area of active slope movement on a wooded slope south of the highway. Many of the trees on parts of this slope outside the present landslide had curving trunks, indicating at least some previous down-slope movement has occurred. The slope appears to be an ancient cut-bank formed by the Lamoille River, which presently is located to the north of the road. The area of sliding was about 400 feet long, about 105 feet high, and had an overall slope angle of 28 degrees. A general view of the slide as it was in November of 2003 is shown in Figure 12. Using the landslide classification of Cruden and Varnes (1996), this is an active, complex landslide consisting of several rotational earth slumps and a central earth flow. This flow can be seen in Figures 12 and

Figure 12. Landslide viewed from below. View looking south-southeast from far side of Route 15. November 10, 2003. Photo by George Springston.

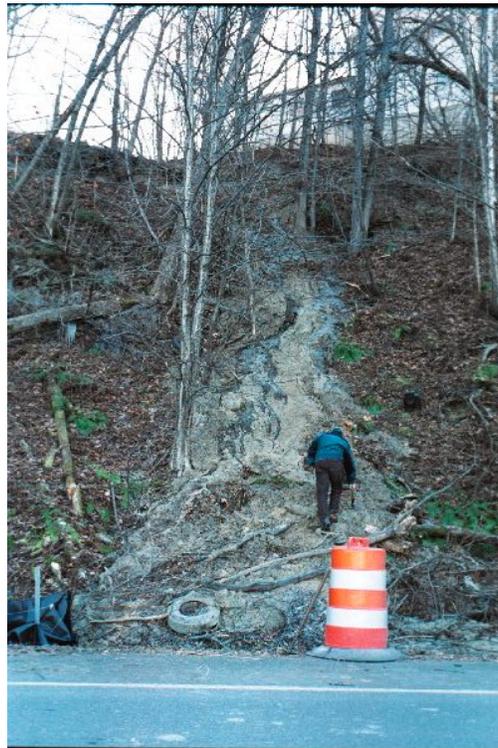
Figure 13. Earth flow originating in central part of slide and flowing down to culvert on east side of State Route 15. November 10, 2003. Photo by George Springston.

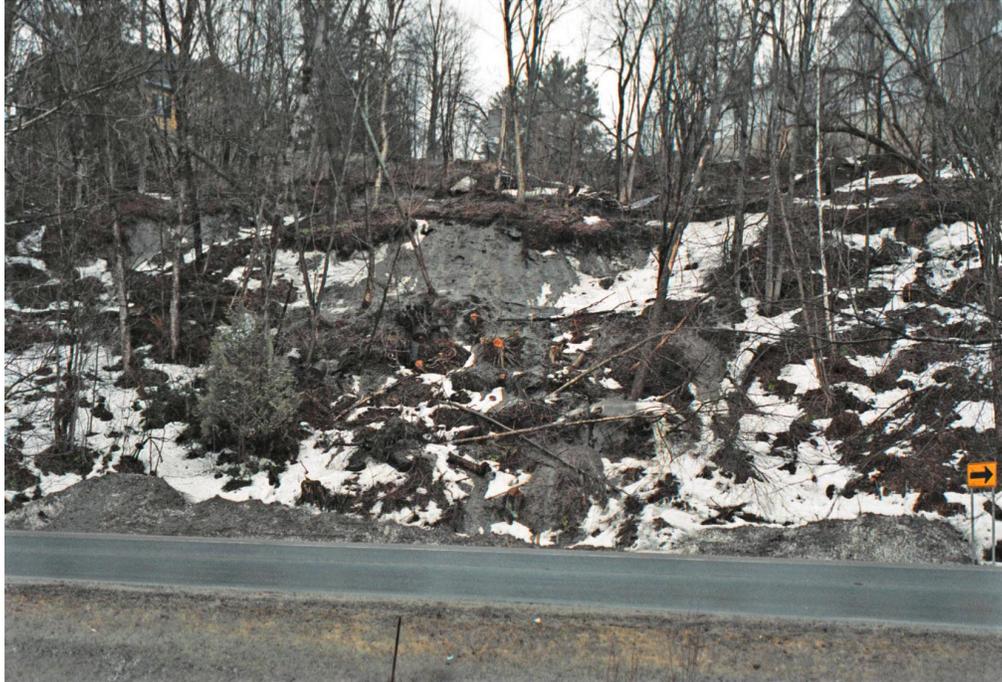
Movement of soil blocks and active flows of mud were observed over the course of November, 2003. The site appeared largely stable over the winter, but a visit on April 2, 2004 showed extensive failure of soil blocks (Figure 14). A major event on the morning of April 19 blocked Route 15. Eyewitnesses report that the slope failure was rapid (less than 30 seconds). Figure 15 shows the site on April 22 after the highway was reopened. Figure 16 shows the site on May 5.

Figure 14. Site on April 2, 2004, prior to major failure. Note changes from Figure 12. Photo by George Springston.

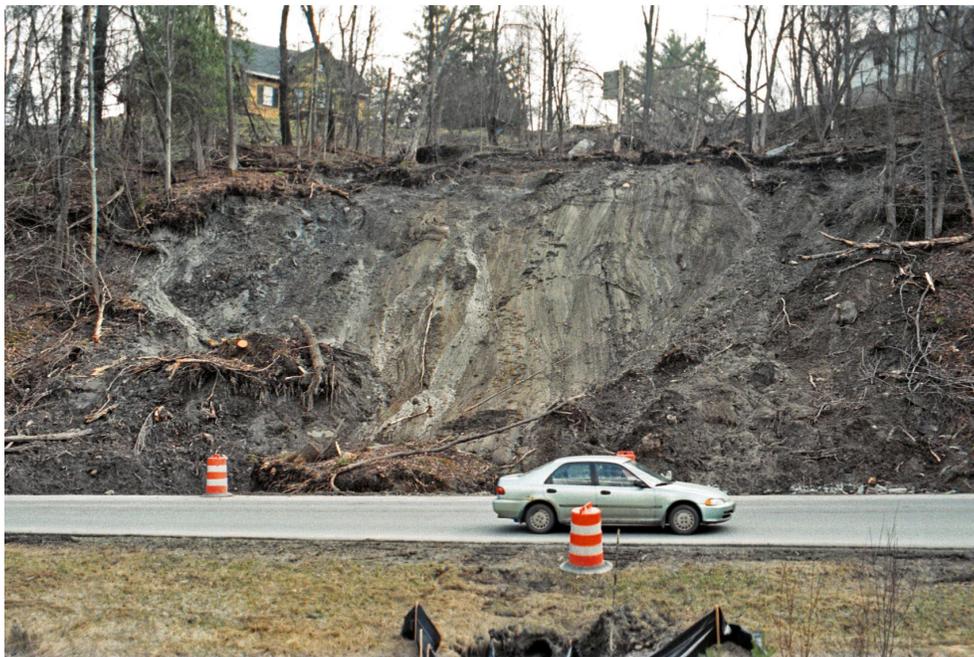
Figure 15. Site on April 22, 2004, 3 days after a major slope failure occurred. Road has been cleared of landslide deposit. Photo by George Springston.

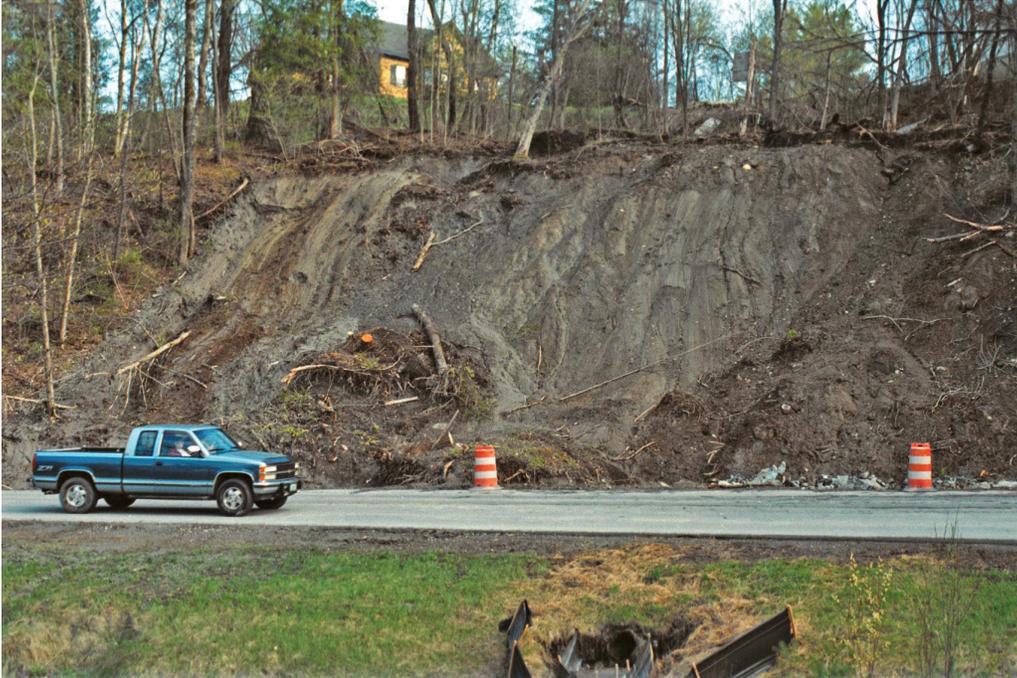
Figure 16. Site on May 4, 2004. Photo by George Springston.

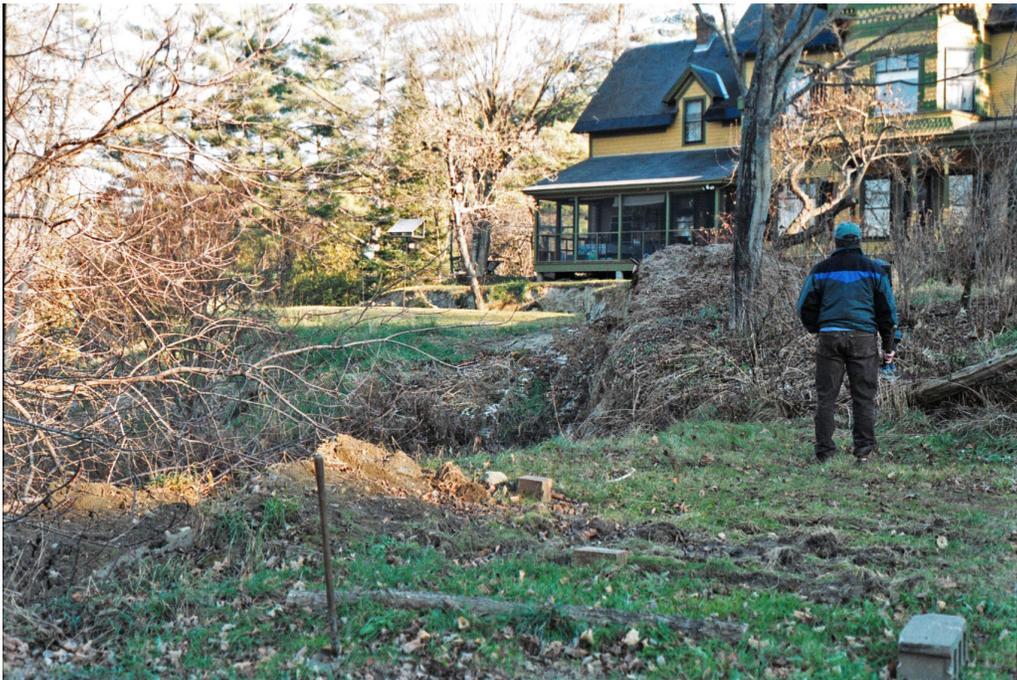
3. Near the top of the slope at the Holmes residence there is sandy artificial fill that has settled, leaving a prominent steep scarp approximately 3 feet high (Figures--). The top of the scarp was about 105 feet above Route 15. The scarp extended westward onto natural ground and there cut into approximately 1.5 feet of sand over till. This sand appeared to be a natural deposit of lake sand.

Investigations showed that a large amount of fill had indeed been placed on the top of the slope. Scarps developed in this material are shown in Figures 17 and 18. Although the main failure surface was coated with a thin layer of silt and clay (Figure 19), scraping revealed that much of the slope was underlain by dense glacial till (Figure 20). Although the landslide was not immediately adjacent to the Lamoille River, a large quantity of fine-grained sediment from the slope failure was delivered to the river via culverts. VTrans subsequently undertook a major remediation project involving removal of fill that had been placed on the upper part of the slope, installation of soil drains, and an engineered buttress at the base of the slope. The slope is currently believed to be stable.

Figure 17. View looking east along fracture surface in artificial fill at Holmes residence. November 10, 2003. Photo by George Springston.

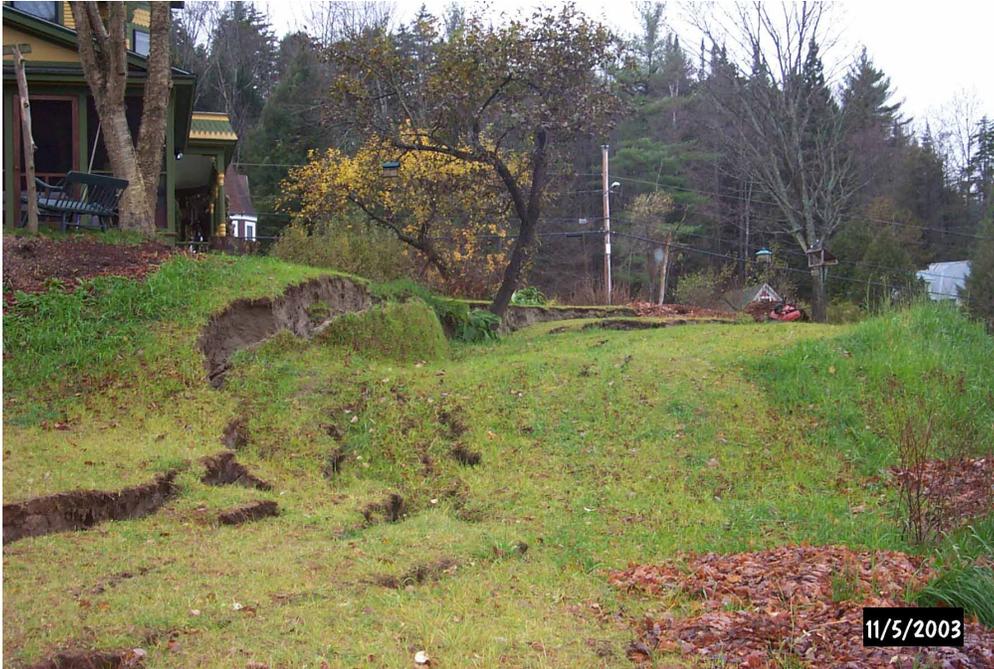
Figure 18. Uppermost scarp in artificial fill at top of landslide. View looking southwest. November 5, 2003. Photo courtesy of VTrans. Much of this material was subsequently removed by VTrans in order to reduce loading on the slope.

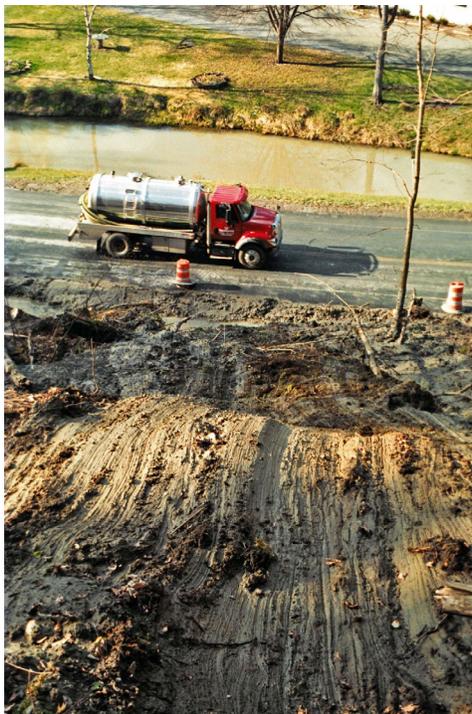
Figure 19. Looking directly down landslide. Note surface of landslide is striated by sliding debris. May 4, 2004. Photo by George Springston.

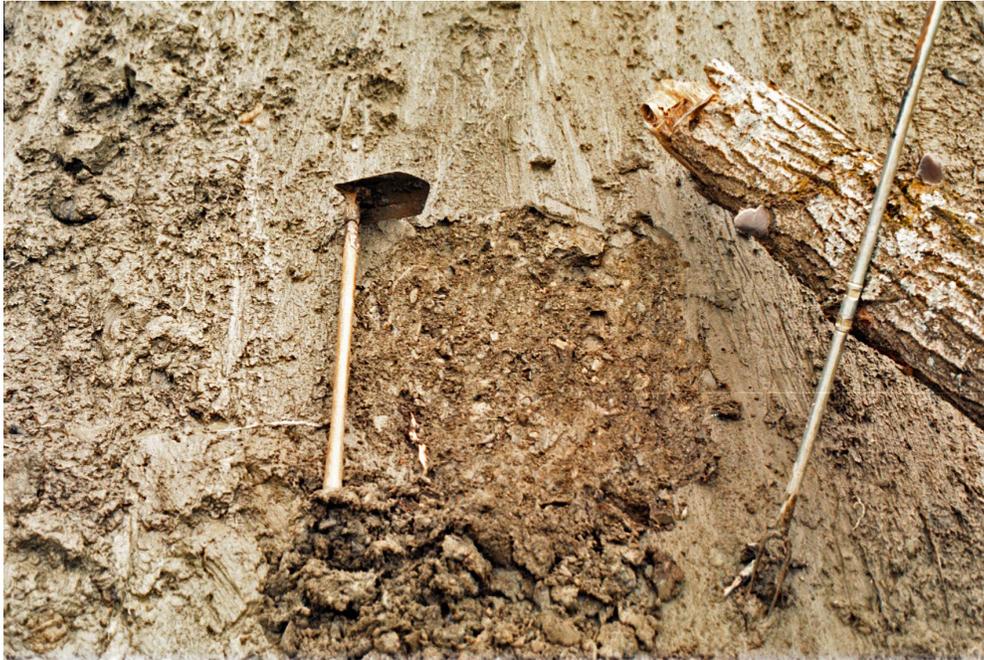
Figure 20. On the landslide failure surface. The area in the center (to the right of the shovel) has been scraped to reveal the underlying dense glacial till. April 19, 2004. Photo by George Springston.

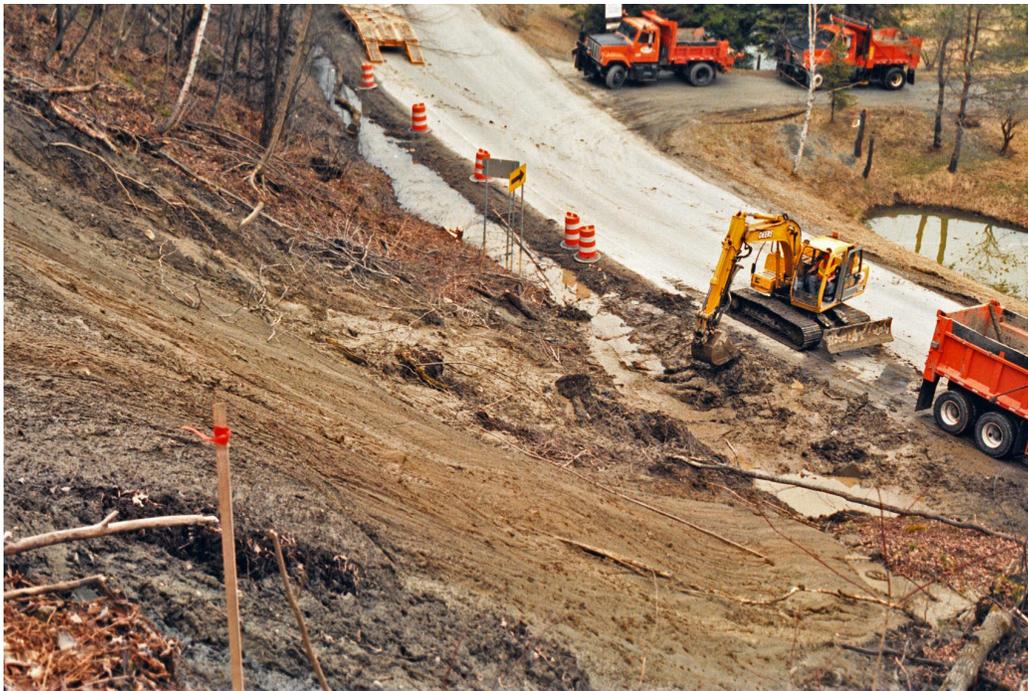
Figure 21. Looking down the landslide at Route 15 as material is being cleared out of roadside ditch. April 22, 2004. Photo by George Springston.

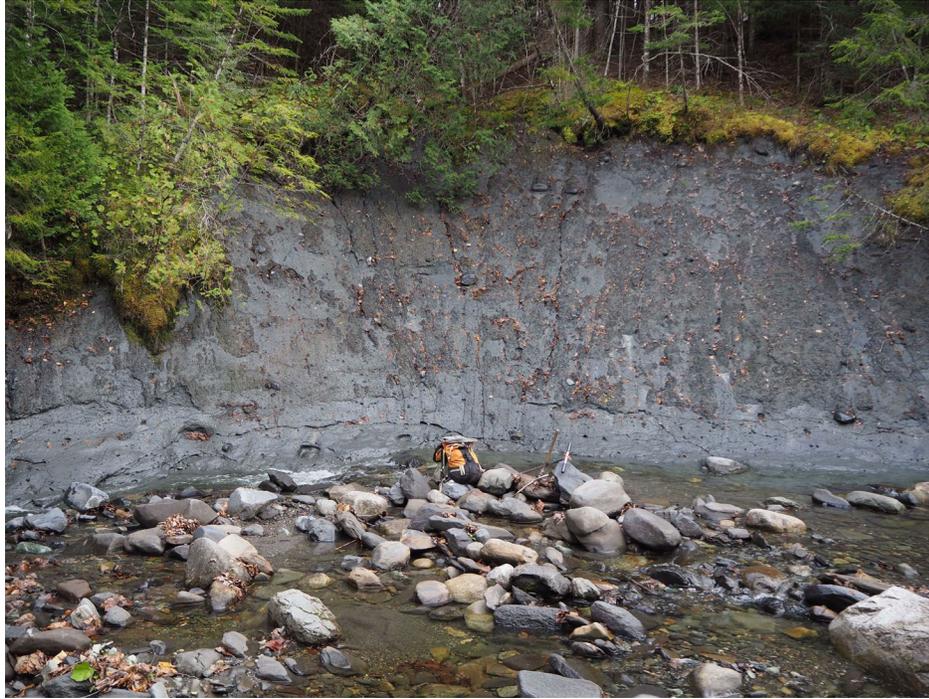
Many of the landslides in Caledonia County originate in glacial till deposits. A typical landslide in till is shown in Figure 22. Observations of the landslides here and elsewhere in Vermont suggest the following as a common sequence of events on till-dominated slopes in response to catastrophic flood events (Springston and Thomas, 2018). Note that the events described below will not always take place in a sequence of discrete steps. For example, a translational slide on the upper part of a landslide may be occurring at the same time that the base is being undercut by flood waters. The model is illustrated in Figure 24.

Figure 22. A typical large landslide in till. Site JP602 on Morrill Brook in Danville, Vermont. Note orange pack at base for scale. Photo taken in 2016 by George Springston.

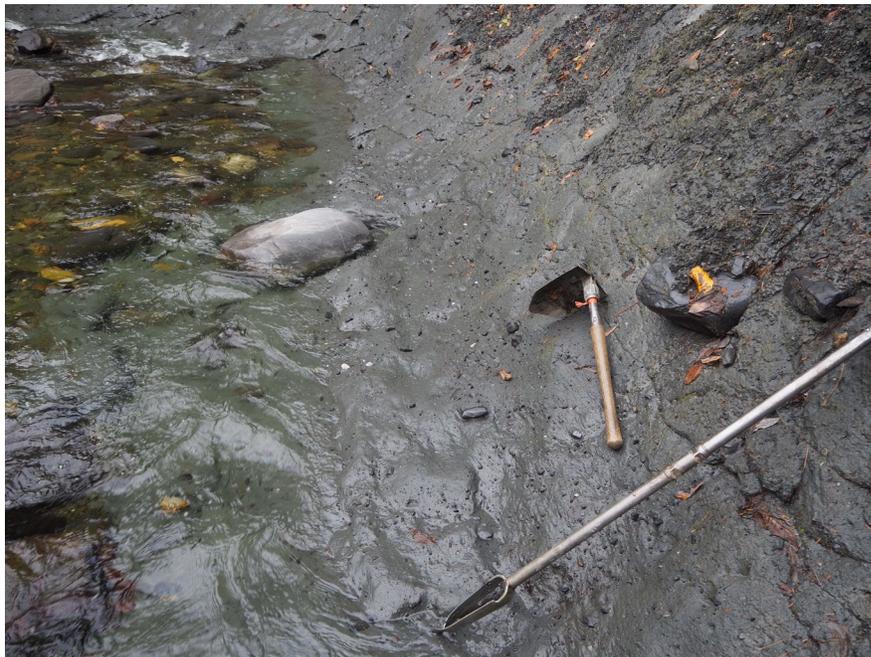
- Fluvial shear results in erosion of the bank and/or bed, over-steepening the slope and, if bed erosion occurs, increasing the effective height of the slope (Figure 23). Dense till and lacustrine diamict typically are detached as irregular blocks. Loose materials typically are detached as single grains. At sites where the material is very strong, the stream may undercut the bank, leaving an overhang. Infiltration of rainfall results in an increase in pore-pressure in the surficial material, reducing the effective shear strength of the material.

Figure 23. Evidence of fluvial shear at base of landslide shown in Figure 22. A weathered till surface is seen in the upper right. The shovel rests on a fresh till surface exposed due to fluvial shear from a recent high-streamflow event. This corresponds to Stage 2 in Figure 24. Photo taken in 2016 by George Springston.
