# Advanced Illicit Discharge Investigations in the Lamoille River, Otter Creek, and Poultney River Basins: Final Report

15-090

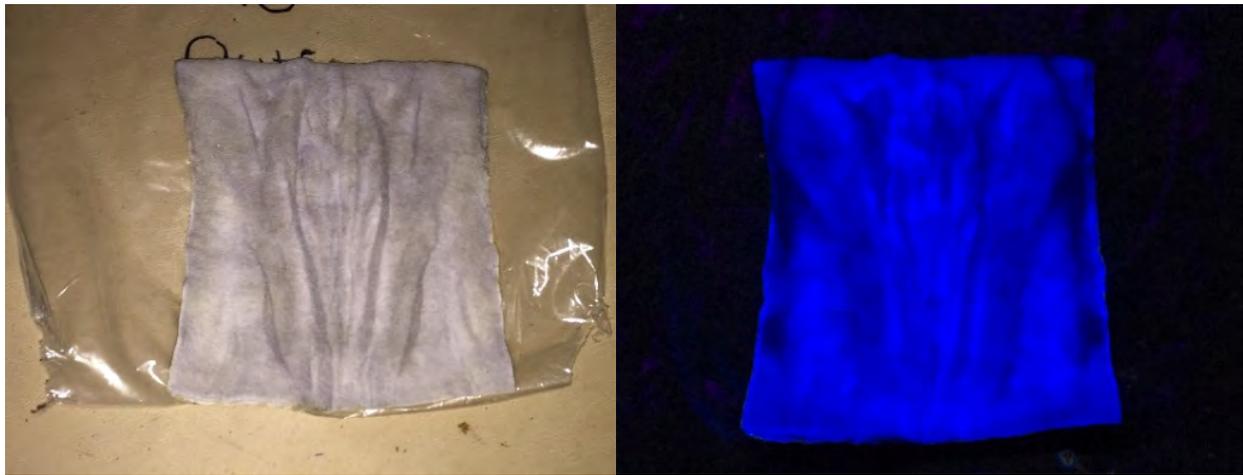
Figure 1. Positive optical brightener monitoring pad under fluorescent (left) and UV (right) lamps

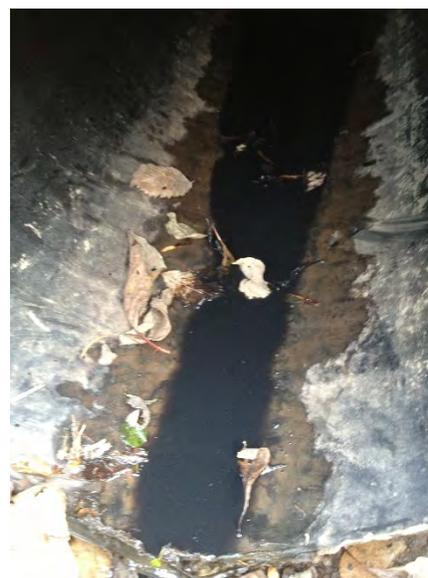
Outfall RU980 is an 18-inch diameter corrugated black plastic pipe located on the north side of the Rutland Plywood facility off Park Street (Appendix D, Map 4). The flow appeared milky in color on July 05, 2012. A low level of chlorine (0.05 mg/L) and exceedingly high specific conductance (53,500  $\mu\text{s}/\text{cm}$ ) were measured at the outfall. On a subsequent visit in 2013, a blackish colored discharge was observed (Figure 2). The source of the flow and contamination was determined to be two floor drains within the facility. A building tenant had been rinsing equipment into these drains, thinking they were connected to the sanitary sewer. This practice has been permanently halted, so the drains will no longer be a source of discharges.

Figure 2. Discolored discharge from RU980 outfall

On September 28, 2016 there was no flow observed at the outfall. An OB pad placed at the outfall was negative (Appendix C, Table 2). We conclude that this illicit discharge has been eliminated.

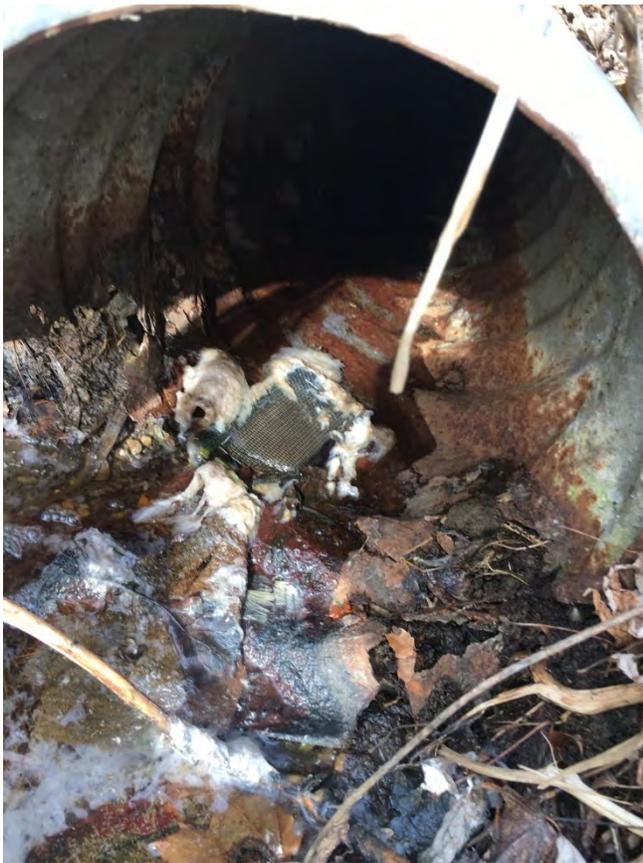
Repeated visits by Stone in 2016 and 2017 revealed ongoing sanitary wastewater contamination at the outfall, as illustrated in Figure 3, which was taken November 30, 2017. A time-lapse camera installed at the outfall also showed flows that did not coincide with rain events.

Stone worked with the VTDEC Project Administrator, Jim Pease, to review engineering plans for the Holiday Inn to identify locations of potential cross connections. Six rooms were identified abutting roof leaders. On January 12, 2018, Jim Pease dye tested these rooms and discovered one room (Room 266) with facilities directly connected to the stormdrain. Holiday Inn management corrected the cross connection by June 27, 2018. On July 12, 2018 Jim Pease dye tested Room 266 and confirmed that the problem had been eliminated.

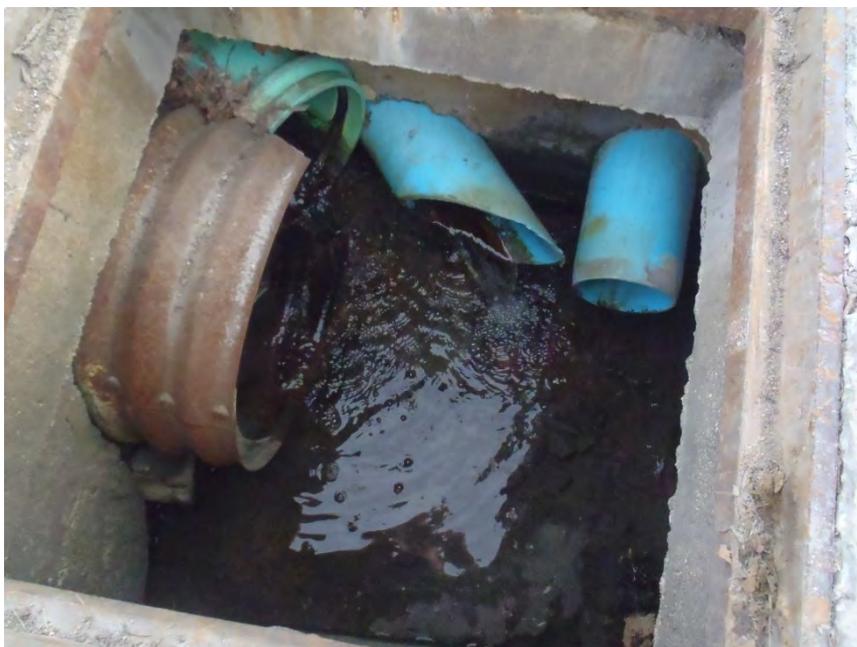
Figure 4. Catchbasin CB-J. The green pipe in the 10:00 position is Pipe B

while pipe A (the main line draining Holden Avenue) and pipe D (from CB-I) were not flowing. Pipes B and C were tested for optical brightener, which was detected at pipe B only (Figure 4). In 2013, moderate concentrations of MBAS detergent (1.0 mg/L) and total chlorine (0.11 mg/L) were measured and optical brightener was detected at the outfall. Due to positive optical brightener results at the outfall and in pipe B in catchbasin CB-J, samples were collected on August 15, 2013 for total phosphorus and *E. coli* analysis. Total phosphorus concentrations were very low at CB-J pipe B (21.1  $\mu\text{g/L}$ ) and pipe C (7.62  $\mu\text{g/L}$ ) and at the outfall (16.6  $\mu\text{g/L}$ ). *E. coli* concentrations were low at both pipe B (51.6 MPN/100 mL) and pipe C (108.9 MPN/100 mL). However, the *E. coli* concentration measured at the outfall was high (1,249.8 MPN/100 mL).

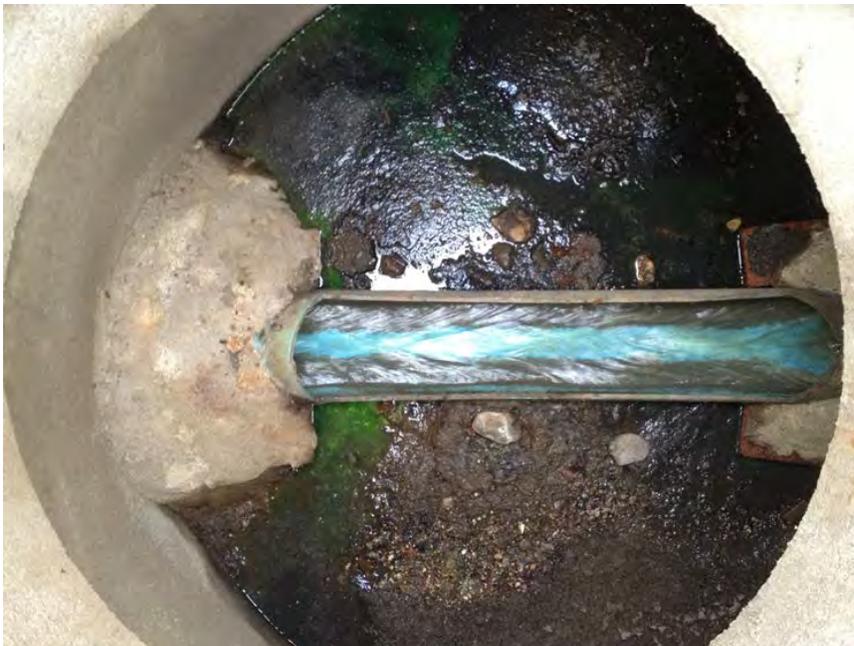
Figure 5. Sanitary manhole on Holden Avenue

Optical brightener monitoring of system PR240 in July 2017 yielded results identical to our 2013 findings. OB was detected in CB-J Pipe B and was not detected in CB-J Pipe C or MH-Q. Additional dye testing, smoke testing, and camera inspection were performed in 2018. No dye was observed in the stormdrain when the Holden Ave. sanitary sewer, 10 Holden Ave., and LaFond's Autos were dye tested. Smoke testing revealed no connection between the sanitary sewer and the stormdrain, in either direction. Given the OB results and the absence of a cross-connection, we reaffirm our earlier conclusion that the most likely source of wastewater contamination in PR240 is migration of wastewater from the sewer main on Holden Avenue into the stormdrain between structures MH-Q and CB-K. The Town of Proctor indicated that the Holden Avenue sanitary sewer will be sliplined when possible.

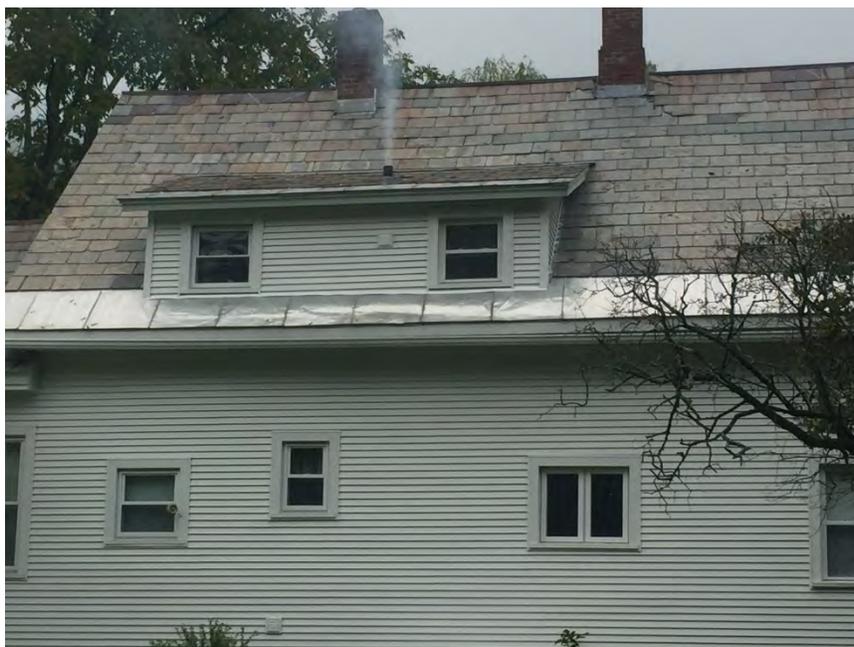
Figure 6. Smoke venting from sewer vent at 24 West Street

Efforts by the Town of Proctor, VTDEC, and Stone to find this source were not successful until the stormdrain was smoke tested on October 3, 2018. Smoke testing revealed a direct sanitary wastewater connection from 24 West Street (Figure 6). It appears that the old lateral was never disconnected, and a new lateral never installed when the new sanitary sewer was installed. No other structures in this neighborhood vented smoke when the stormdrain was tested.

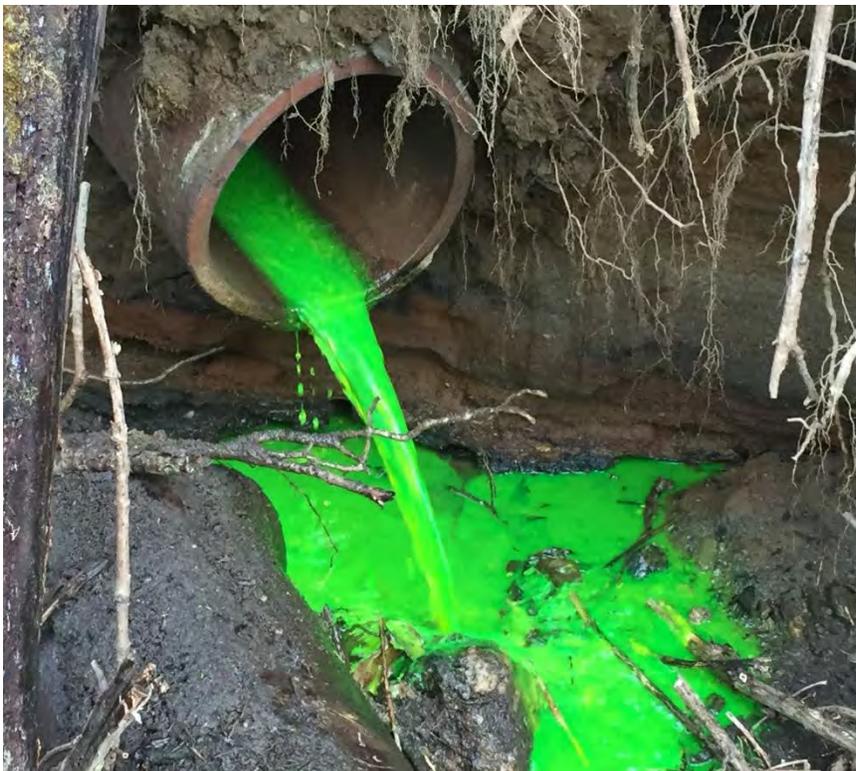
Figure 7. Sewer dye (and wastewater) flowing from the HP160 outfall

Smoke testing on December 8, 2015 revealed a sanitary wastewater connection to the stormdrain from 13 Depot Street Extension. This connection was confirmed with a dye test (Figure 7). The Town of Hyde Park worked with the property owner to eliminate this illicit connection in 2017. However, in June 2017 OB was again detected at the outfall and both the *E. coli* concentration (733 MPN/100 mL) and the total phosphorus concentration (428  $\mu$ S/cm) indicated presence of sanitary wastewater (Table 7).

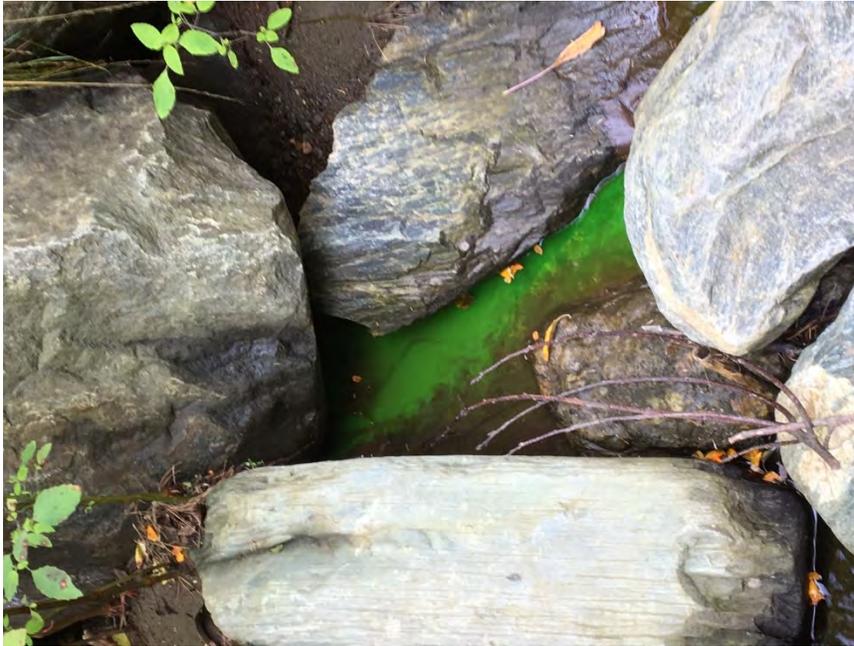
In September 2017 Jim Pease dye tested 264 Main Street, confirming a direct sanitary wastewater connection to the

Figure 8. Sewer dye observed from a dye test at 264 Main Street

stormdrain (Figure 8). The Town of Hyde Park worked with the property owner to eliminate this illicit connection in 2018.
