**CHARACTERIZATION OF OUTFALLS  
TO THE WINOOSKI RIVER AND TRIBUTARIES  
IN BARRE CITY, VERMONT**

**FINAL REPORT – DECEMBER 11, 2003**

***FRIENDS OF THE WINOOSKI RIVER***  
**153 STATE STREET, MONTPELIER, VT 05602**

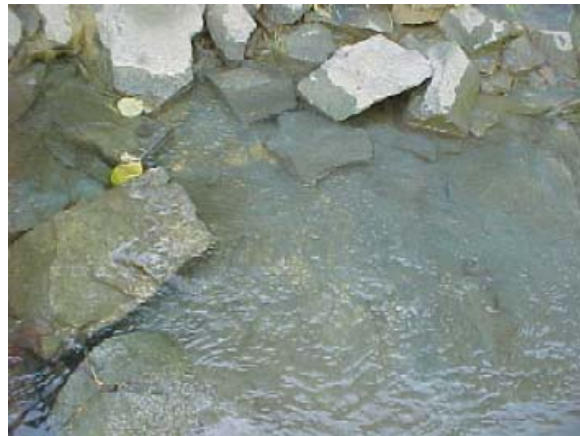
##### Outfall JB-FC-08

Located downstream of the Ayers Street Bridge on the left bank of Jail Branch. A 10 inch steel pipe was observed. On the rocks below and downstream of the pipe grey dust deposits and an oily sheen were observed. Also, downstream of the pipe, oil blackened rocks and a smell were observed although seepage from the bank (apparently from groundwater) appeared clear.

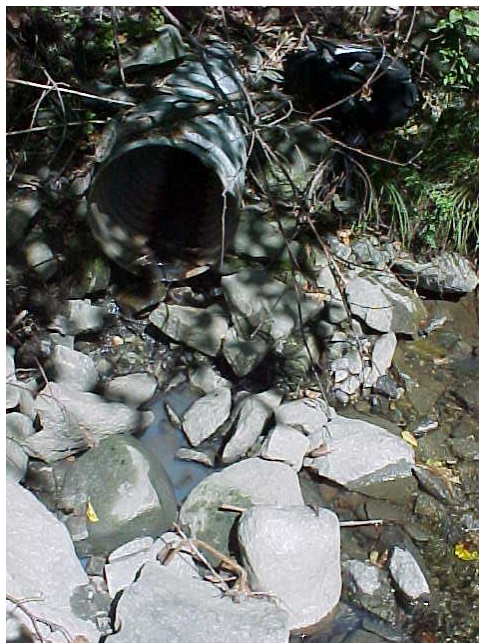
##### Outfall JB-FC-09

Located downstream of the Ayers Street Bridge on the right bank of Jail Branch. The 18-inch steel pipe was observed discharging a milky liquid. Additionally a large mountain of grass clippings lay just upstream on the bank. This clippings dump may significantly increase nutrients downstream leading to excessive plant growth and a lower dissolved oxygen available for aquatic insects and fish.

- FWR recommends that the City will discuss the issue of yard clipping dumping to the owners of the property near JB-FC-09

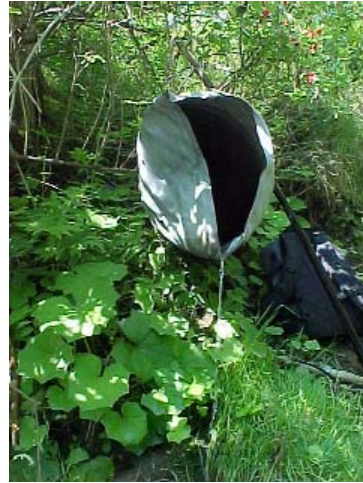
### Outfall SB-BS-06

Upstream from the Willey Street Bridge on the left bank of Stephens Branch a large 16 inch diameter steel pipe was observed discharging a constant flow of water that was colder than the river. The pipe seems to originate from Vermont Granite Works.

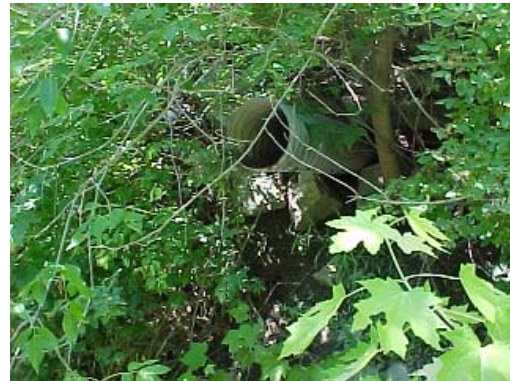
### Outfall SB-BS-11

Downstream from the Berlin Street Bridge on the left bank of the Stephens Branch a 12 inch steel pipe was observed dripping fluid. From the pipe, observers noted that the smell and sounds of industrial machinery were being transmitted. A large industrial complex is above the pipe.

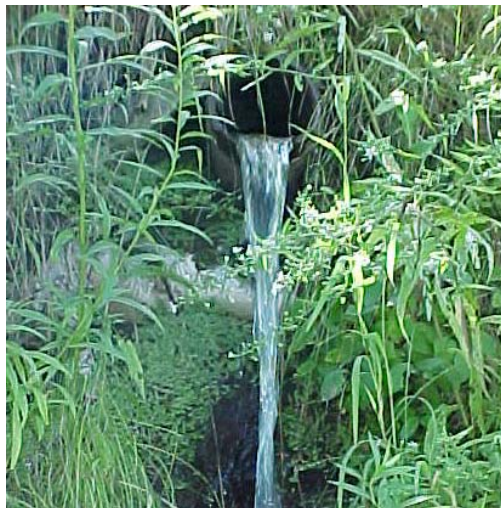
### Outfall SB-FC-01

This outfall is located just upstream of the Berlin Street Bridge on the left bank of the Stephens Branch. A grey discharge was observed coming from the pipe 13 inch steel pipe. The discharge was pooling halfway up bank before entering the stream and causing a plume. Observers noted some oily sheen and smell, as well as some septic smell.

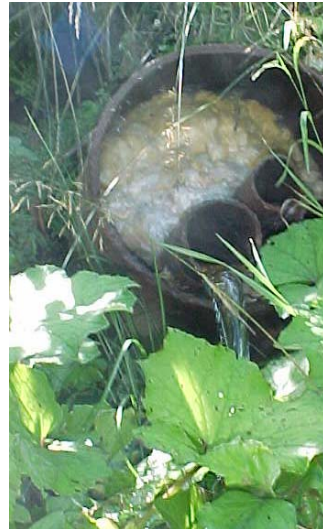
Outfall SB-FC-02

This outfall is located just upstream of the Berlin Street Bridge on the left bank of the Stephens Branch next to SB-FC-01. A black oily residue was noted in this 8 inch plastic pipe which is enclosed in concrete. The pipe was observed exiting the basement of a nearby building. The discharge from the pipe had a strong petroleum smell.

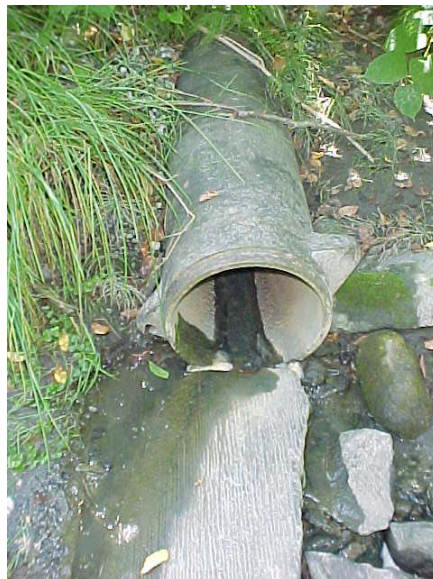
Outfall SB-FC-06

Located downstream of the Blackwell Street Bridge on the left bank of the Stephens Branch this outfall appears to drain the Bellavance Granite Company parking lot. At the time of observation a Bellavance employee was washing a truck over the parking lot drain. The observers noted a foamy discharge from this 9 inch concrete pipe.

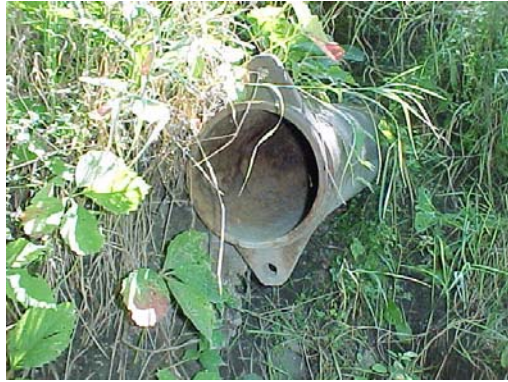
### Outfall SB-FC-12

Upstream of the Route 62 bridge on the left bank lies this outfall, a 12 inch plastic pipe. Observers noted cold air and a strong septic smell originating from the pipe during dry weather.

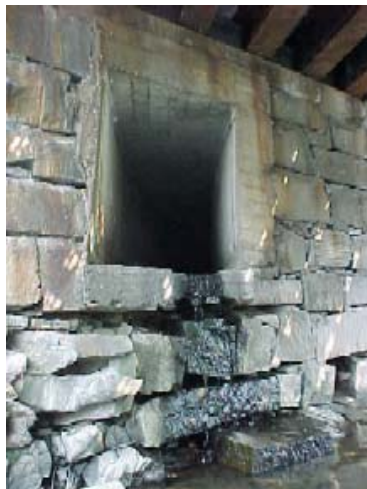
### Outfall SB-FC-20

This outfall pipe drains an auxiliary to Potash Brook and enters the right bank of the Stephens Branch at the Prospect Street Bridge. It is a 60 inch granite culvert. At the time of observation, dry weather had been reported for the past 24 hours. The clear flow out of the pipe had a septic smell and was subsequently flagged by the observer.

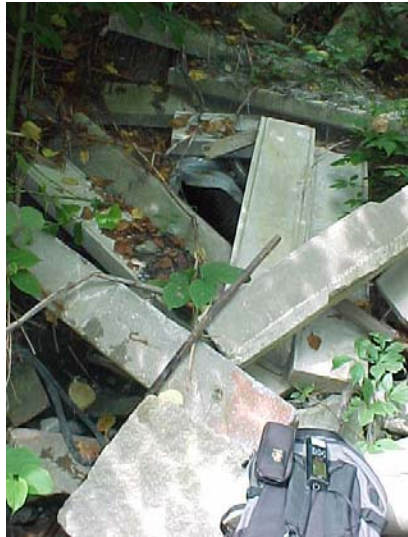
Outfall SB-FC-30

Located on the right bank of the Stephens Branch upstream of the confluence of the Jail Branch. Observers noted a 19 inch steel outfall pipe that was partially buried and crushed by concrete debris. During the period of observation the flow in the pipe suddenly increased for no apparent reason. The discharge remained clear, however further investigation should be taken.

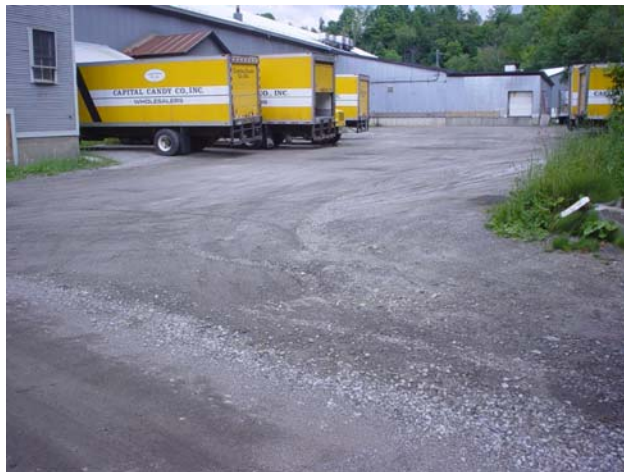
Outfall AB-MB-01

This storm drain empties into Aldrich Brook at the crossing with Burnham Street. The watershed for this drain is the gravel parking lot at Capitol Candy. This site was flagged as a sediment source to the Winooski River during storm events.

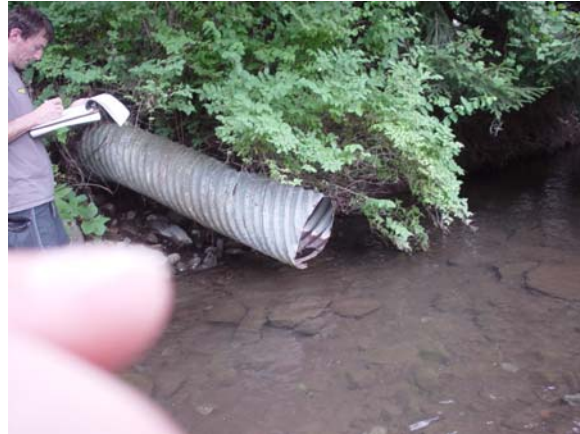
### Outfall GB-MB-14

A 16 inch steel pipe has been undermined and extends five feet out into Gunners Brook upstream of the Brook Street Bridge. The pipe is cracked and rusted, however a constant stream of water could be heard entering the brook from within the bank. The air near the pipe had a slight septic smell and there were several residential houses nearby. Need further study and perhaps replacement.

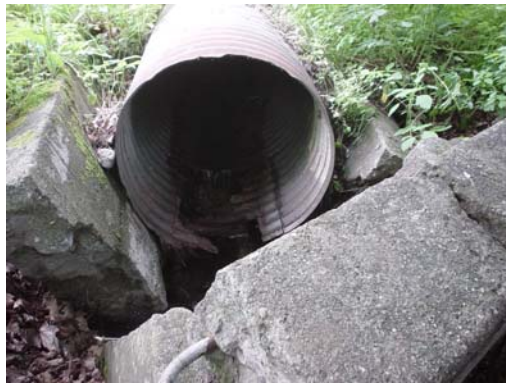
### Outfall PB-MB-01

A thirty inch steel pipe that enters Potash Brook near its daylight at Jefferson Street. A slight septic smell was observed. Residential houses nearby. Flagged for further study.

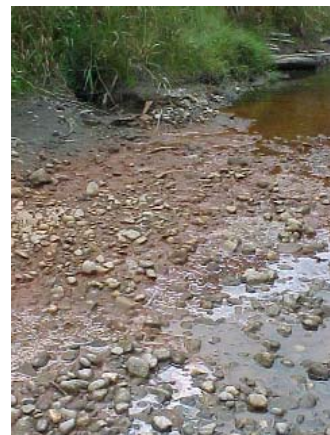
Outfalls were found to be the cause of moderate to severe streambank erosion in 13% of surveyed pipes. River bed erosion caused by discharge from an outfall was recorded in 4% of cases, and 2% of outfalls contained enough sediment to cause the formation of a gravel bar where they entered the stream.

- Those outfalls in danger of failure from severe bank erosion should be stabilized by Barre City. A combination of rock riprap and vegetative planting would be effective in most situations.
- Bed erosion should be prevented by redesigning the outfall or the installation of a rock-lined basin, which may also help to intercept sediment in runoff.

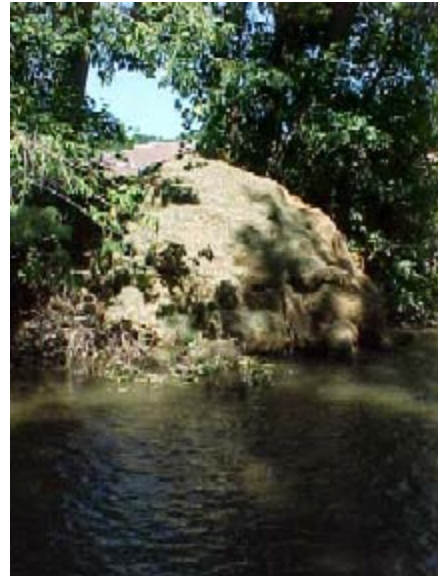
The Barre City outfalls survey turned up several suspect contaminations that were not outfall related. At site JB-FC-09 a large dump of grass clippings was observed on the bank upstream.

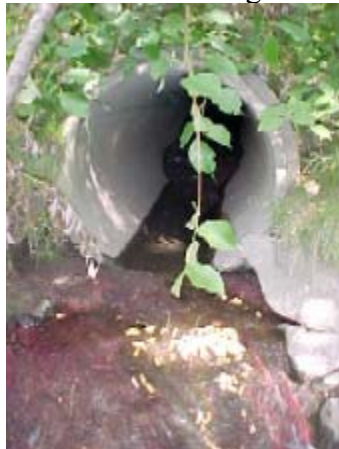
Also noted at outfall SB-FC-10 was a high concentration of cigarette butts.

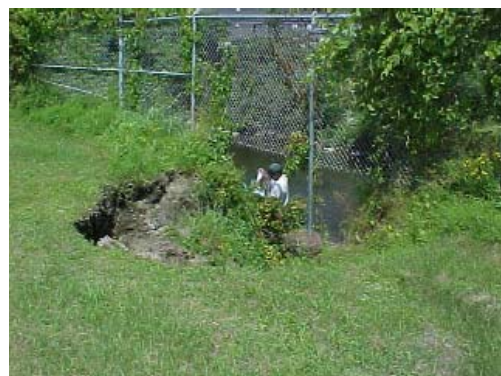
In the area of the wastewater treatment plant a large sinkhole was observed at the top of the bank. The hole is contributing sediment to the bank and is threatening the fence of the plant.
