Detecting and Eliminating Illicit Discharges in Basin 10: Final Report

16-179

David Braun / Senior Water Resources Scientist
Stone Environmental, Inc.
535 Stone Cutters Way
Montpelier, VT 05602
dbraun@stone-env.com
802.229.5379

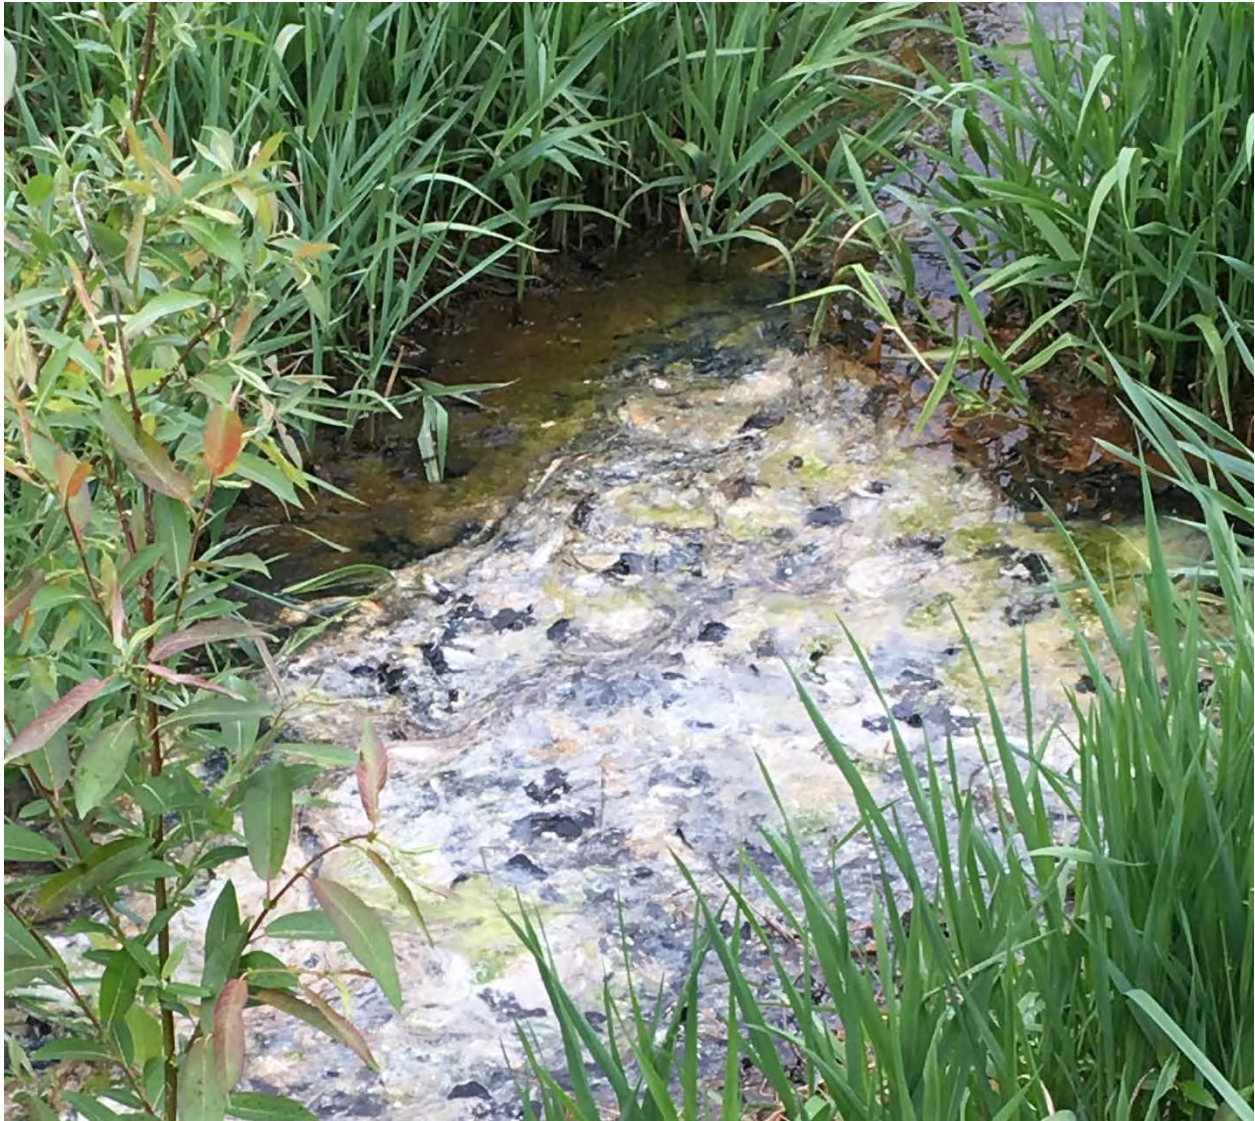
*Cover photo:
cheese production
waste in a
drainage swale in
Plymouth*

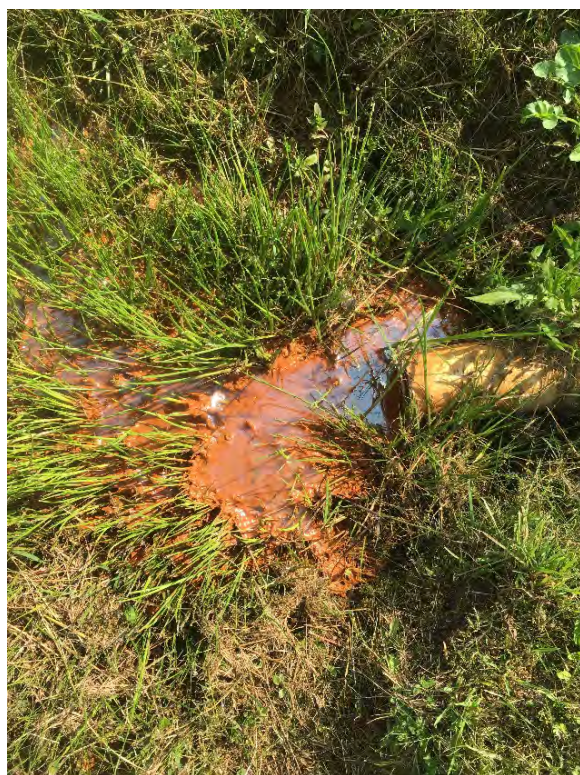
Figure 2. Iron floc from footing drain in swale in front of the Killington Motel

- Stone revisited the system on July 13, 2018. A drainage swale was found dripping into catchbasin CB2, and all the flow from the swale was from a footing drain near the Killington Motel. There was significant iron staining and iron floc around this drain outlet (Figure 2). A low concentration of free chlorine (0.11 mg/L) was detected in a sample from the footing drain; however, there was a significant amount of iron floc in the sample. After carefully decanting the sample into a cuvette to ensure no iron floc was present, zero free chlorine was detected.

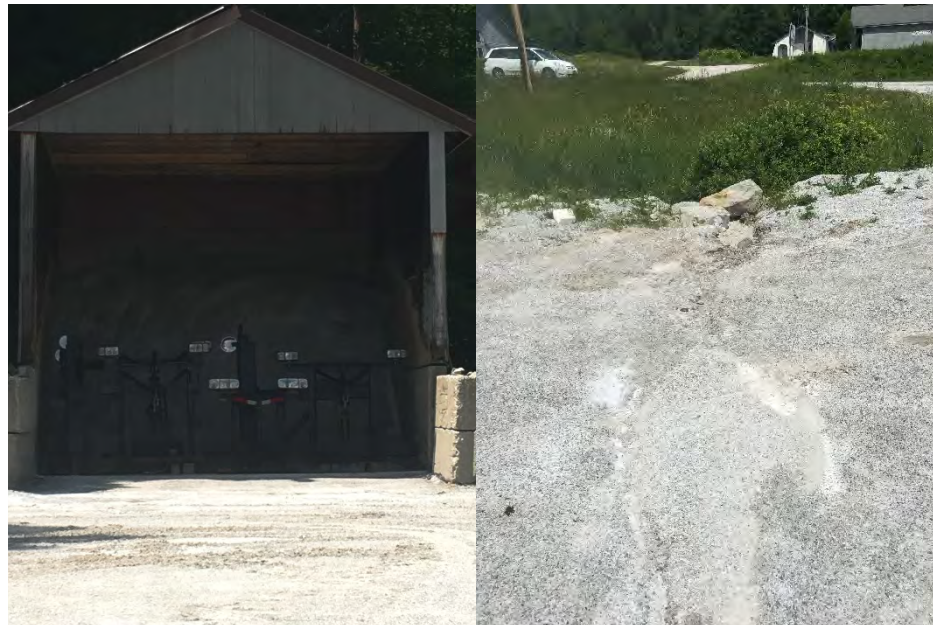
Figure 3. Salt shed (left) and salt deposits (right) leading to outfall

- There is a salt shed at the northeast corner of the property and a small gully between the shed and the top of the outfall (Figure 3). The parking lot appeared to have dried salt across the area.
- Based on review of the VT ANR Environmental Research Tool, this property and the abutting property to the east are both listed hazardous waste sites. At the Killington Lower Maintenance Garage (SMS #95-1905), there was an historic gasoline UST release that resulted in contamination to groundwater. At GTE Sherburne (SMS#93-1516) a diesel UST was removed in 1993 and petroleum contaminated soil was discovered in the UST grave.

Conclusion: We believe the water quality data recorded at the outfall are explained by a history of heavy road salt application in the vicinity as well as runoff from the salt shed on the property. The extensive iron staining throughout the swale is consistent with contamination by degraded petroleum products, likely the result of known releases from fuel oil USTs on the property and from an abutting property.

Resolution: By this report, the problem is referred to the DEC Hazardous Waste Management Section. While we are unable to provide specific guidance on the application of deicing agents by the town, or any private entities, reducing application rates should over time result in decreased chloride concentrations and lower specific conductance.

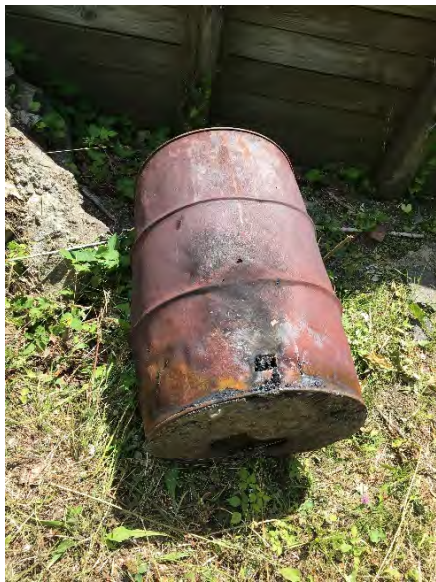
Figure 4. Metal burn barrel found near the outfall

- A low concentration of free chlorine (0.06 mg/L) was measured at the outfall on May 17, 2017. Optical brightener was not detected. However, the pad retrieved on May 23, 2017 was covered in an unidentified petroleum substance. This substance was not detected in any upstream structures. A metal drum (Figure 4) containing burned debris and ash was found on the river bank near the outfall. This ash and debris were scattered across the ground surface in the area of the drum.

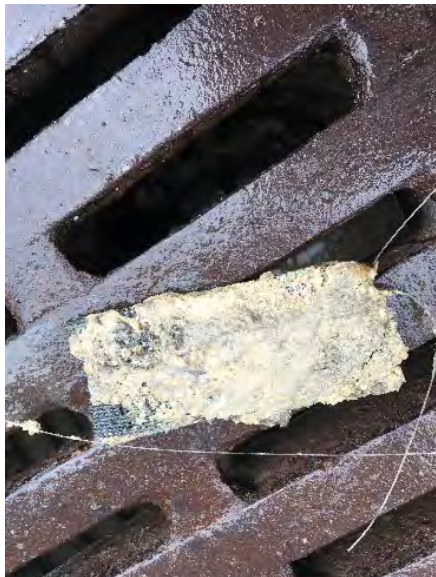
Figure 5. Optical brightener pad coated in sawdust from CB10 sump

- Optical brightener pads were deployed in catchbasins CB2, CB6, and CB10 and the outfall between June 21-29, 2017. Neither optical brightener nor any petroleum were detected on these pads; however, a thick layer of sawdust coated the pads (Figure 5). Sawdust was discovered in catchbasins throughout the system. The source was determined to be a large bag of sawdust in the alley between the Ludlow Town Hall and 190 Main Street. A trail of dried sawdust was observed in the alley, where it had been washed into catchbasin CB10, and was subsequently transported throughout the system. The building at 190 Main Street was undergoing renovation at the time.

Conclusion: Repeated sampling and observations demonstrated no chronic illicit discharge in the system. We believe that the unidentified petroleum product found on the optical brightener pad retrieved on May 23, 2017 was the result of trash burning in a metal barrel found adjacent to the outfall. The sawdust observed throughout the system on June 21, 2017 was traced to construction activities at 190 Main Street. Follow-up investigation confirmed that both the sawdust and petroleum contamination observed in the system resulted from transient sources.

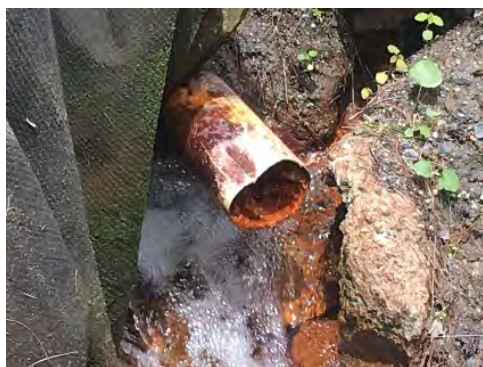
Figure 6. Original LL590 outfall

Date	Flow Condition	Ammonia (mg/L)	Free Chlorine (mg/L)	MBAS (mg/L)	Specific Conductance (μS/cm)	OB Result	Observations
LL590	6/08/17	Dripping	0.6	0.31	0.15	2,780	Negative	Iron stained, sediment build-up

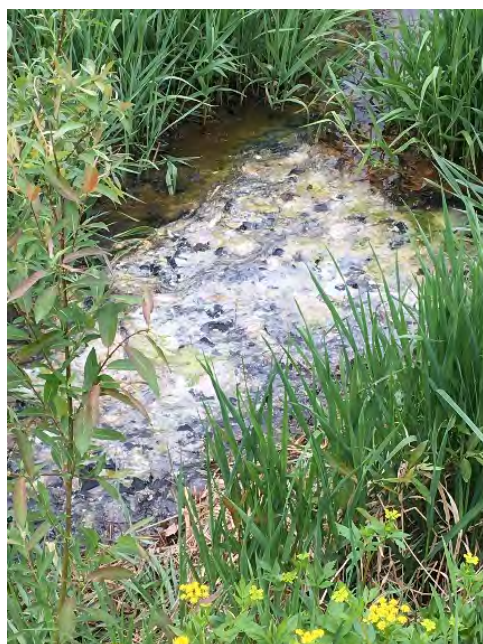
Figure 8. Cheese waste observed at the outlet in May 2018

Structure ID	Date	Flow Condition	Ammonia (mg/L)	Free Chlorine (mg/L)	MBAS (mg/L)	Specific Conductance ($\mu\text{S}/\text{cm}$)	OB Result	Observations
PM040	6/21/17	Flowing	0.0	0.0	0.0	808	NA	cheese byproduct throughout

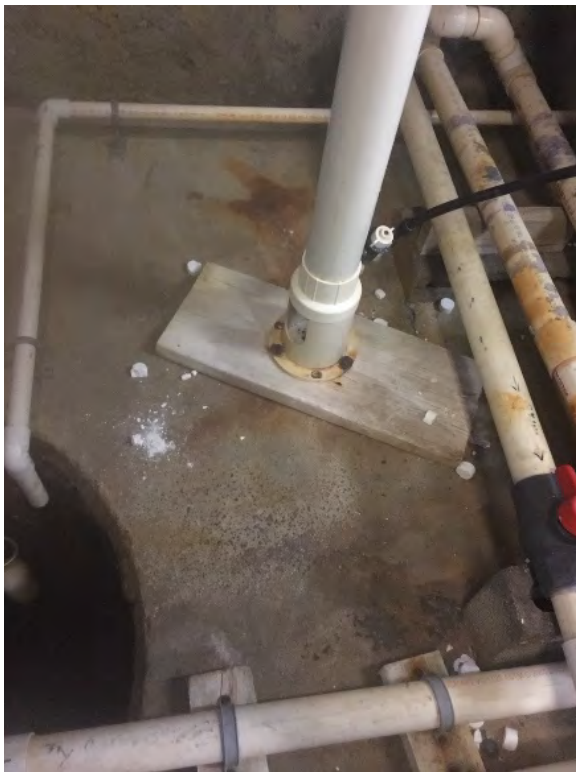
Figure 9. Bromine tablets on the basement floor by the sump in the Climb Fitness Center

- On November 7, 2018, Stone met with the Facility Manager, Ken Moore, who toured us through the facility. There is a water recycling system in the basement that treats water for the outdoor and indoor pools. Bromine is used for disinfection and 5-gallon buckets containing bromine tablets are stored in the basement. There is a large sump pump in the basement connected to CB1 and bromine tablets were found scattered across the floor surrounding the sump pump (Figure 9). We tested a bromine tablet and it reacted very strongly with the reagents used in the free chlorine test, producing a similar color.

- In our November 7, 2018 meeting, Mr. Moore indicated that when the outdoor pool is closed for the season, the water is pumped directly into catchbasin CB3 next to the pool. This timing is consistent with our results in fall 2017, likely explaining the highest observed chlorine (bromine) concentrations.

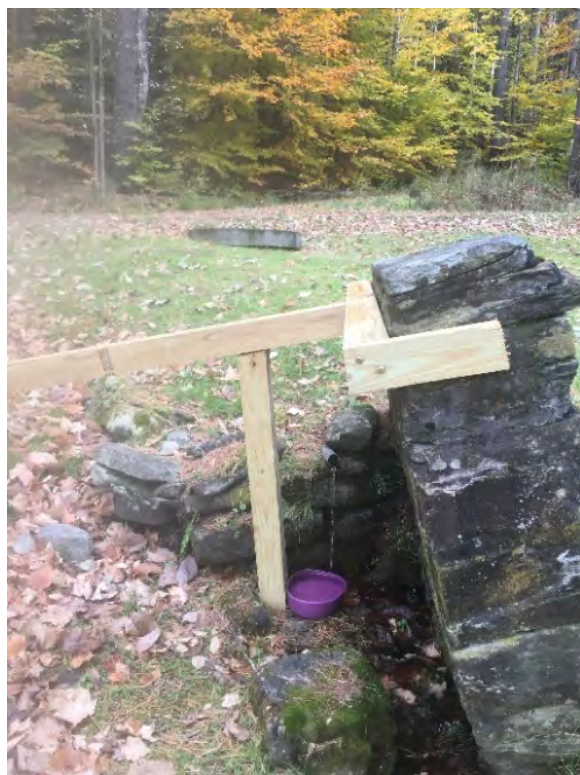
Figure 10. Public spring on Golf Avenue

- On October 31, 2018, the pond on Golf Avenue was inspected for any inlet pipes or other sources of municipal tap water. A moderate concentration of free chlorine (0.18 mg/L) was measured in the pond. The pond had a brownish appearance, indicating a high concentration of dissolved organic matter. A public spring (Figure 10) appeared to be the only inflow to the pond. No free chlorine was detected in the spring.

Conclusion: Discharge from the pond constitutes the majority of the flow through the stormwater system during dry weather. The area surrounding the pond was investigated and the only inlet found to the pond was the public spring, which has no chlorine. We suspect that elevated free chlorine concentrations measured in the pond and in downstream structures result from chemical interference with dissolved organic matter.
