Detecting and Eliminating Illicit Discharges in Basin 11

18-027

Detecting and Eliminating Illicit Discharges in the West-Williams-Saxtons-Lower Connecticut River Basin: Final Report

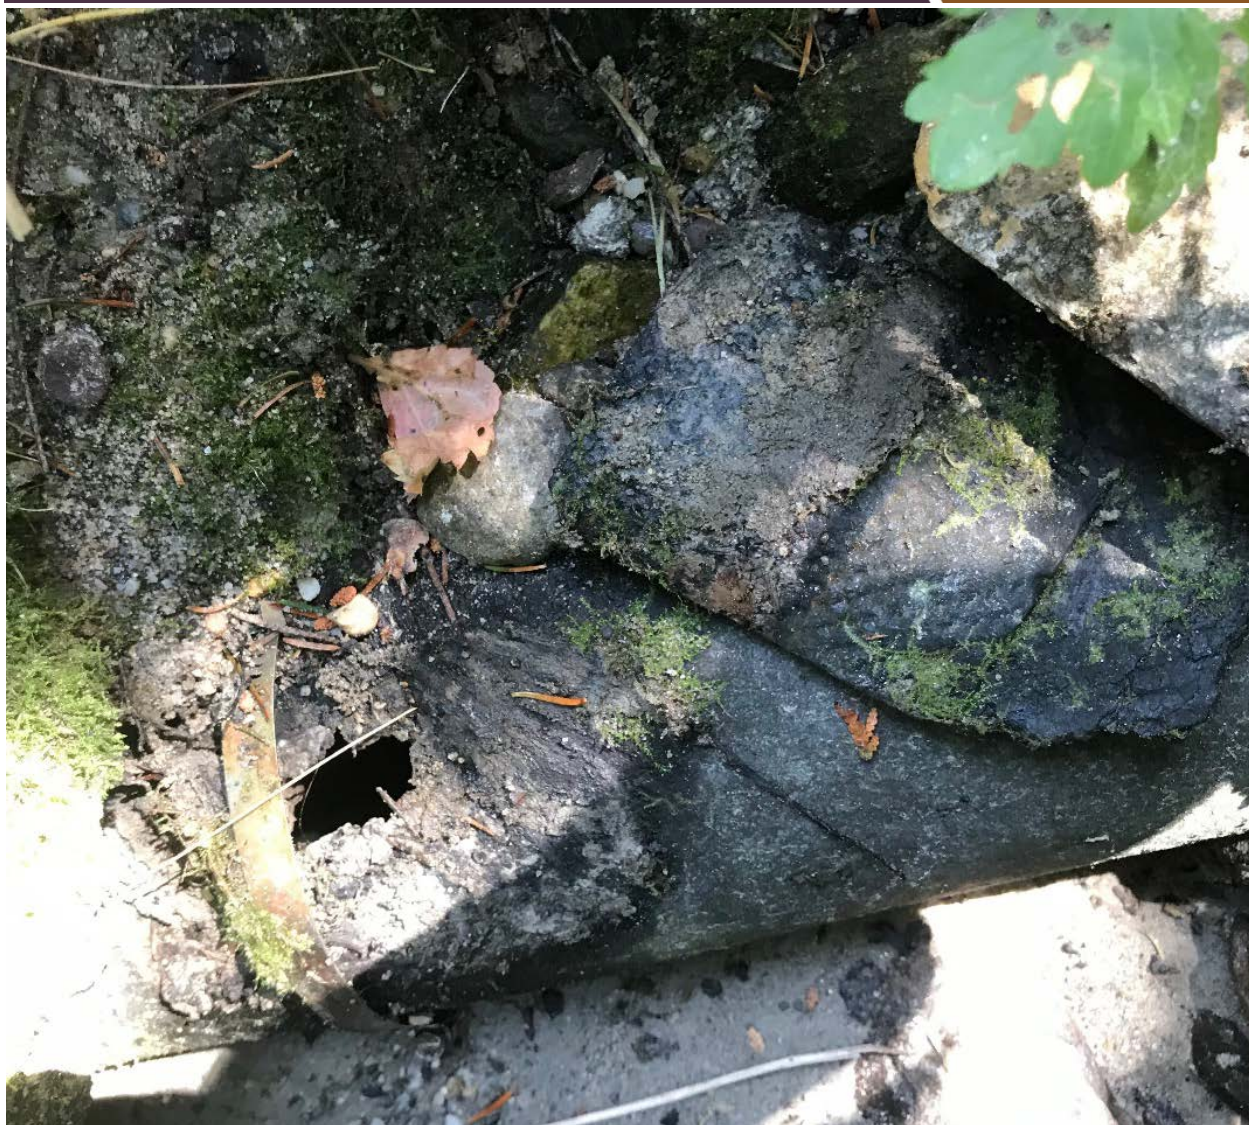
Cover photo: a broken sewer lateral discovered in a catchbasin in Weston

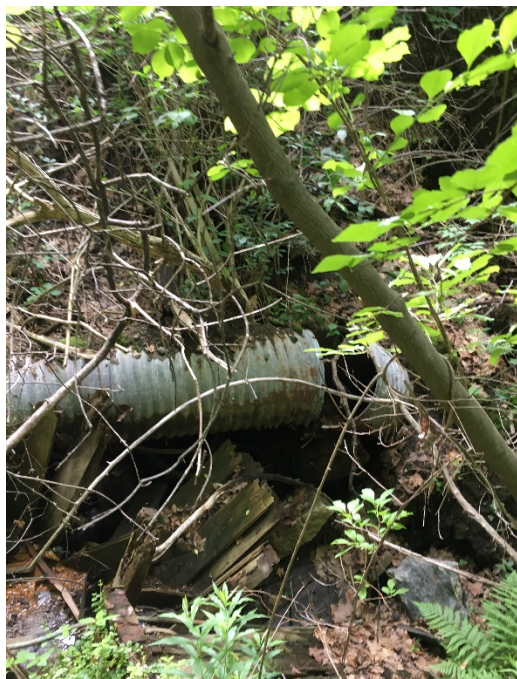
Figure 2. Erosion and broken stormwater pipes in the gulley containing PU230 and PU240

- On August 24, 2018 a low concentration of MBAS (0.30 mg/L) was measured at the outfall, along with moderate specific conductance (1,545 μ S/cm).
- When the system was revisited on June 19, 2019, no flow was detected north of the drop inlets, CB1 and CB2, which are located in a gulley. There was a substantial groundwater seeping from the bank of the gulley, which entered CB1 and CB2 as overland flow. Erosion was noted between CB1 and the outfall, and the stormwater pipe was broken in several places (Figure 2). No contaminants were measured above levels of concern at the outfall.

Conclusion: All flow through the system was found to result from groundwater discharge in the gulley. No flow was detected above the gulley along Main Street. Repeated sampling and observation demonstrated no chronic illicit discharge to the system.

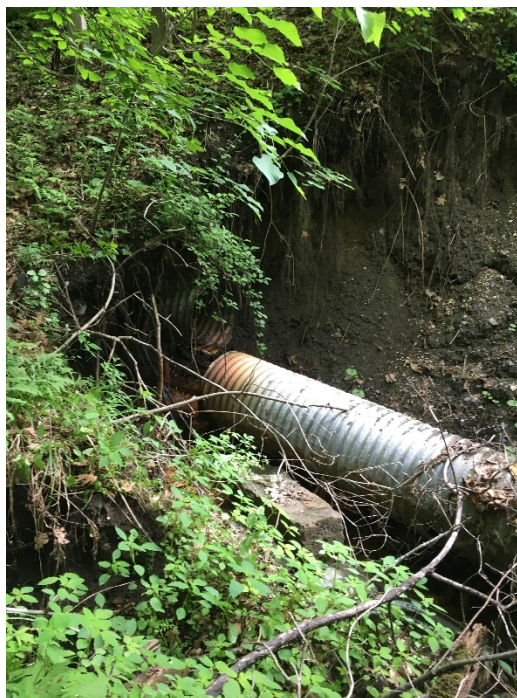
Figure 3. Broken stormwater outfall and significant erosion around PU240

Conclusion: Repeated sampling and observation demonstrated no chronic illicit discharge in the system.

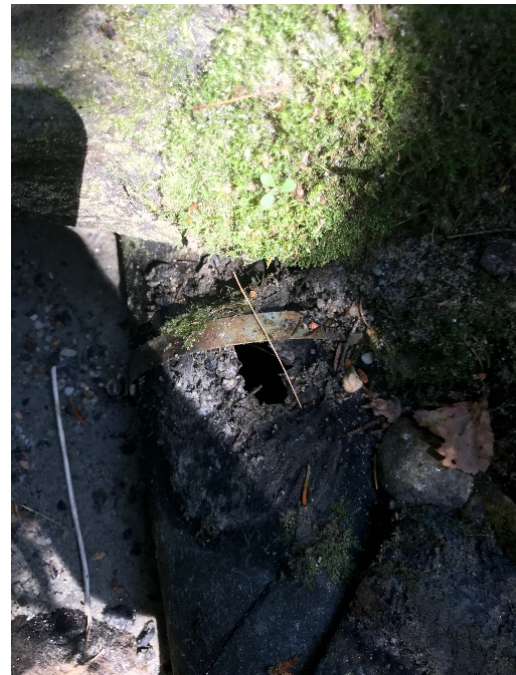
Figure 5: Broken sewer lateral in catchbasin CB1

- High specific conductance (1,700 μ S/cm) was measured at the outfall during the initial assessment on June 6, 2018. Optical brightener was also detected.
- The system was not flowing when visited on June 28, 2019. Each structure was inspected, and optical brightener pads were deployed in every accessible structure, including the outfall and catchbasins CB1, CB3, CB4, CB5, CB6, and CB7. Optical brightener was detected at the outfall, although fluorescence was weak. All other pads were negative.
- We attempted to collect *E. coli* and TN samples on July 7, 2019, but the system was dry.
- While inspecting catchbasin CB1, a hole was observed in the top of a pipe labeled sewer line in the VTDEC maps. There was a shim over the hole loosely held in place with a hose clamp (Figure 5).

Conclusion: A hole was located in the sewer lateral crossing through catchbasin CB1 from the house at 652 Main Street. We suspect that wastewater flowed out of the damaged lateral into the stormdrain under high flow conditions.

- On December 2, 2019 in an email to Jim Pease of the VTDEC, Mr. Harper indicated that he had repaired the pipe at the recommendation of the Weston Select Board and Weston Health Officer.

Resolution: Stone recommends VTDEC inspect the repair in the sewer lateral crossing catchbasin CB1.
