Detecting and Eliminating Illicit Discharges in Basins 1 and 12

18-151

Detecting and Eliminating Illicit Discharges in Basin 1 and Basin 12: Final Report

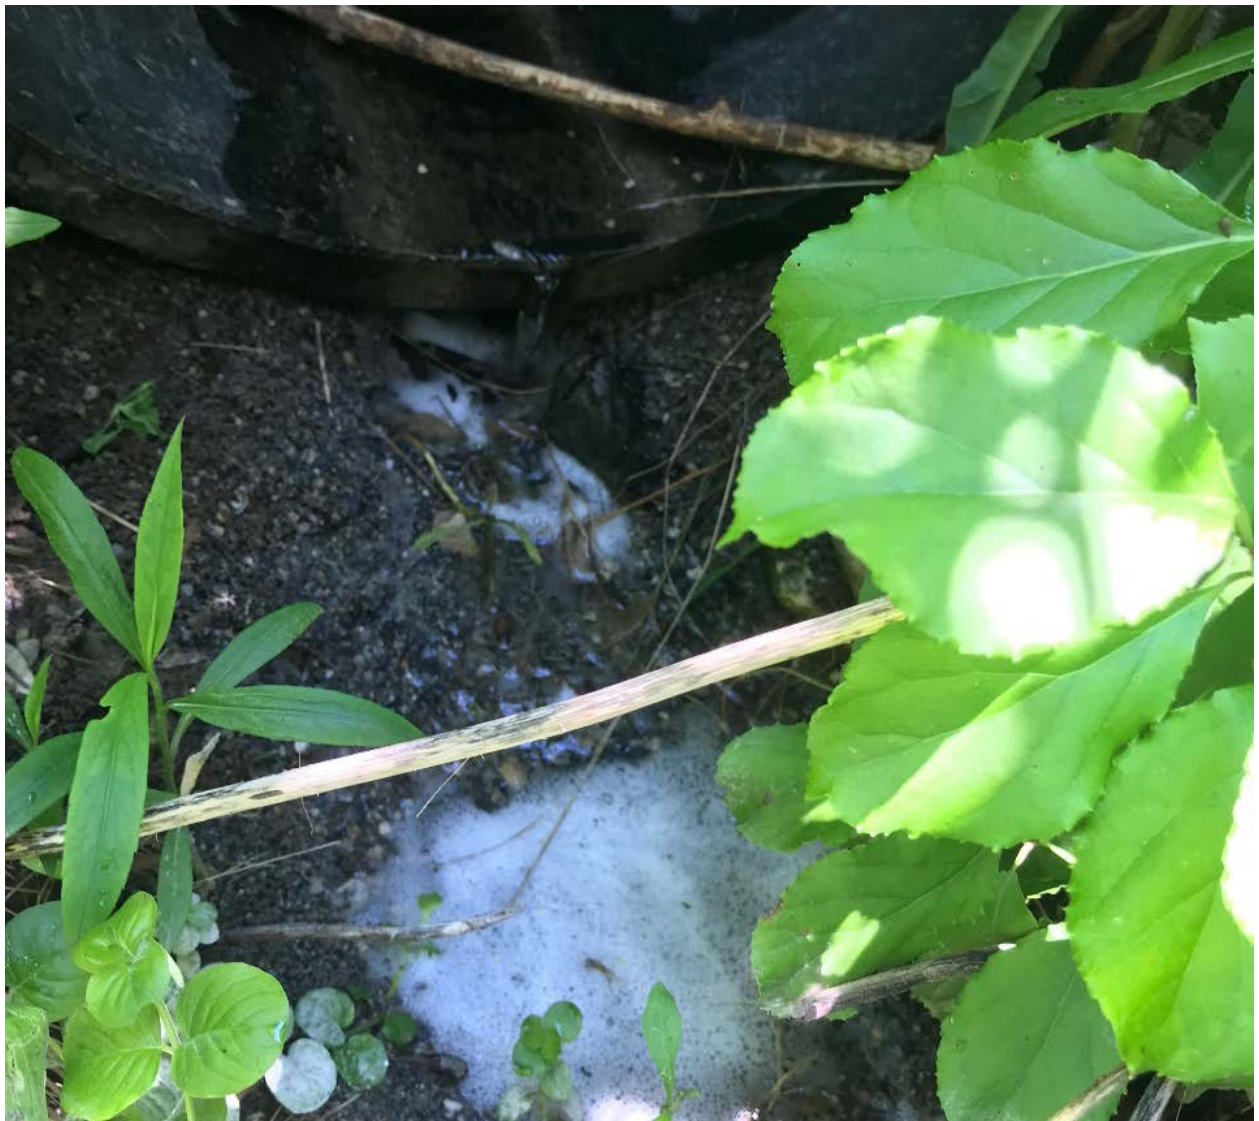
*Cover photo:
Laundry suds at a
stormwater outfall
in Arlington.*

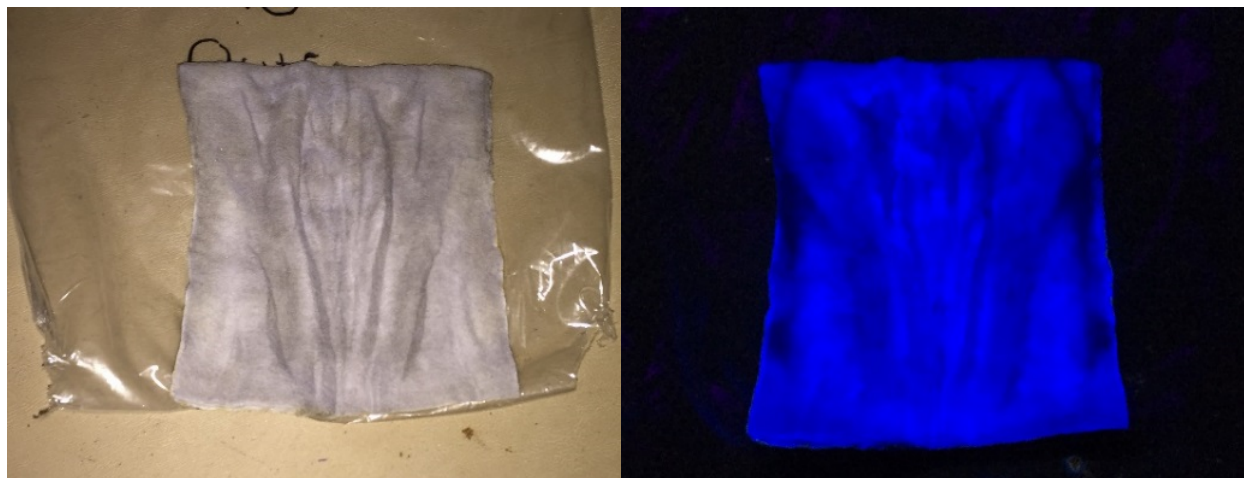
Figure 1. Positive optical brightener monitoring pad under fluorescent (left) and UV (right) lamps

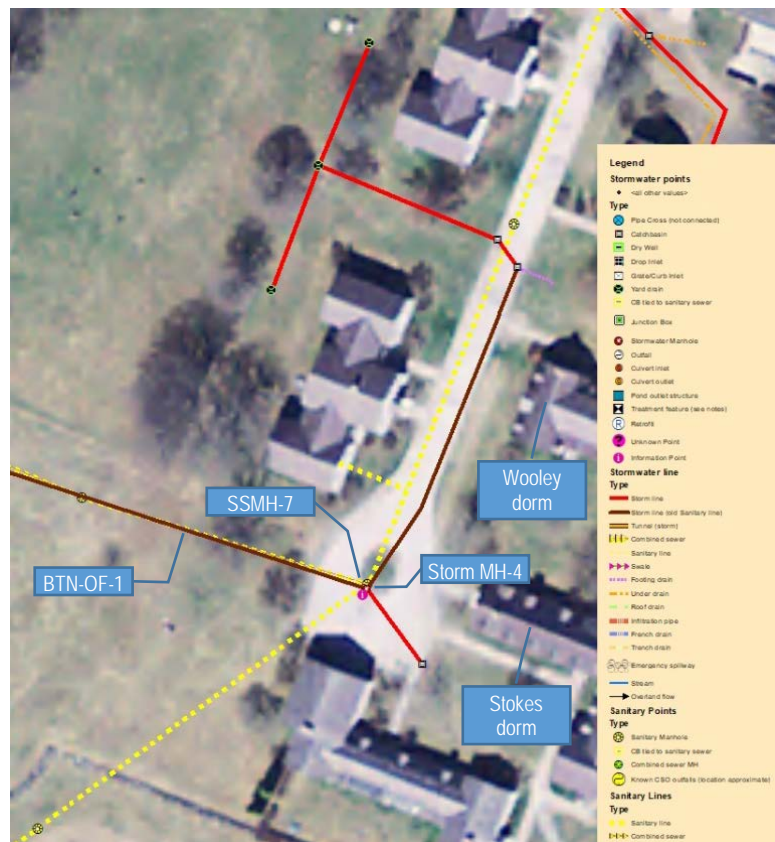
Figure 1. System BTN-OF-1 on 1st Street

Stormwater manhole MH-4 (Figure 1) is located at the cul-de-sac at the end of 1st Street. When visited on August 2, 2019, MH-4 had a small pool of water and a slow trickle of flow through the structure. A sample collected from the pool had an offensive (wastewater/fish) odor and a high ammonia concentration, 4-5 mg/L.

Through repeated smoke testing, we determined there is a connection between the sanitary sewer on 1st Street and storm manhole MH-4. Smoke blown in SSMH-7 appeared quickly in MH-4, diffusing through the bricks above and also entering through the incoming 15" VC stormdrain. Since the

sewer main has been sliplined, we suspected that one or both of the sewer laterals connecting the Swan or Wooley dorms to the sewer main were leaking into the underlying stormdrain. Alternately, it is possible there is an imperfection in the lining allowing wastewater to leak out into the stormdrain.

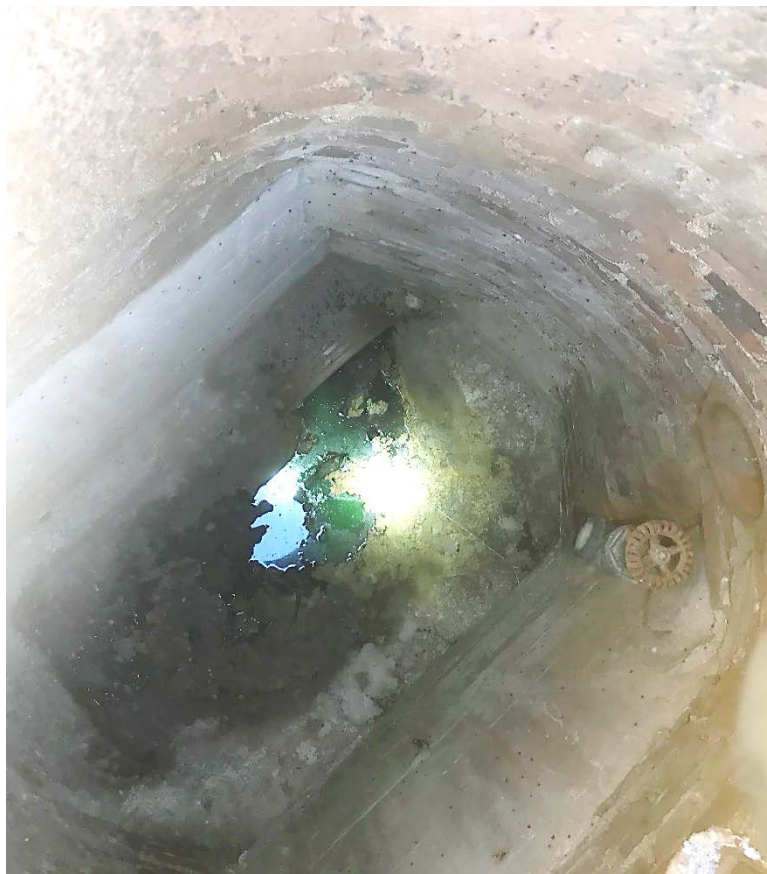
Figure 2. Dye in stormwater MH-4 after flushing in Wooley dorm

Red dye was flushed in the Swan dorm and green dye was flushed in the Wooley dorm. Dye did not appear in storm MH-4 in the first ~20 minutes. Green dye was observed in MH-4 when rechecked about 2 hours later (Figure 2). No red dye was observed; however, given the weakness of the red dye relative to the green dye, the red dye could have been present and overwhelmed by the green dye.

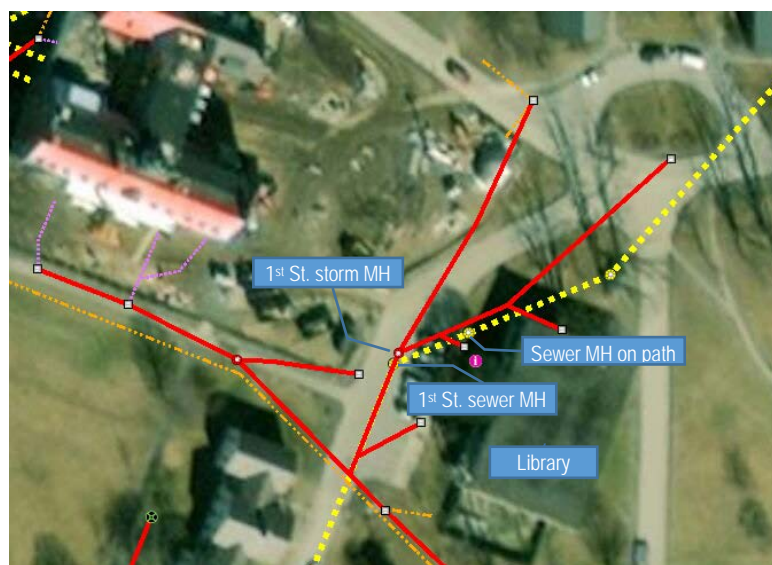
Figure 3. System BTN-OF-151 (outfall not shown)

The BTN-OF-151 system drains the upper portion of 1st Street and discharges to a stormwater pond in the southeast corner of the campus (Figure 3).

There was a trickle of flow and a faint wastewater odor in the stormwater manhole on 1st Street in front of the library (“1st St. storm MH”) when this system was first investigated on August 2, 2019. An optical brightener pad deployed in this manhole by Todd Siclari was positive.

On September 19, 2019 sinks and toilets throughout the library were dye tested. Some of the results were a little confusing. It turns out that the bathrooms on the 1st level are connected to the lower pipe in the sanitary manhole next to the library path (“Sewer MH on path”), whereas the 3rd floor lounge bathroom and the second floor librarian bathroom and sink are connected with the upper pipe in this same manhole. The sink in the basement utility room is not connected to this manhole at all, as had been assumed. Dye poured in this sink was observed in the sanitary manhole on 1st Street (“1st St. sewer MH”).
