FINAL REPORT – BENNINGTON AND PAWLET IDDE STUDY

BENNINGTON AND PAWLET, VERMONT

DRAFT FINAL REPORT

January 2016

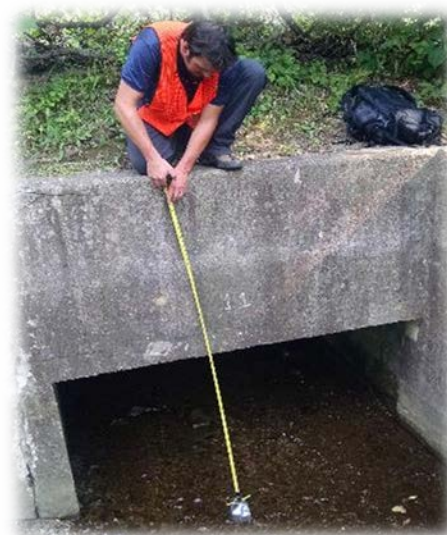
The outfall was subsequently re-visited on 9-2-15 with staff and canines from ECS. One of the canines alerted at the outfall while the other did not. Catchbasins that did not have stream flow present were evaluated in an attempt to eliminate or bracket certain sources. Alternating catchbasins with stream flow were investigated using the canines to confirm that a possible illicit discharge was still present. Additionally, the stream itself was evaluated by the canines prior to its entrance into the underground box culvert – neither canine alerted. Therefore, it was concluded that no further investigation was necessary on upstream systems (i.e. systems that enter the stream upstream of its entrance to the underground box culvert).

Dana Allen, WCA, obtains a sample from BTN-11.

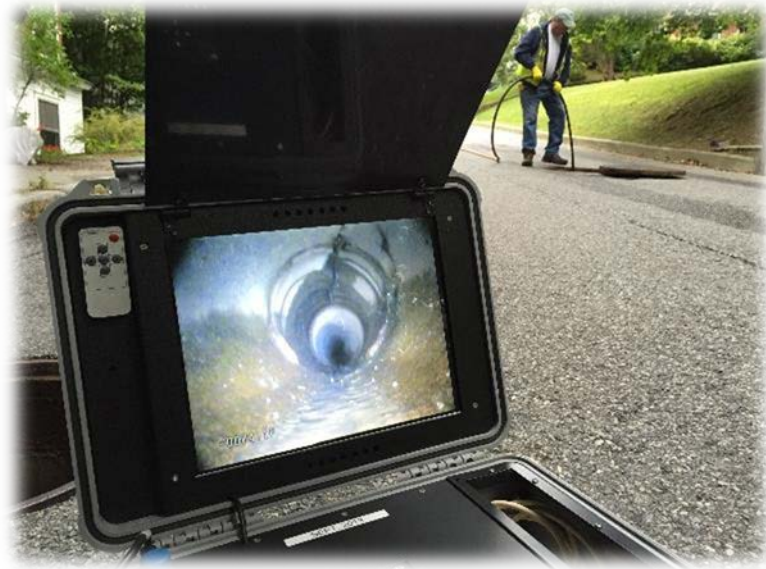
WCA and ECS investigated up the stormline to this sanitary manhole and the adjacent storm catchbasins on 9-2-15. Both canines alerted on the catchbasin downstream of the sanitary manhole and on the nearby stormwater manhole sump. A small amount of water was observed in the sump of the stormwater manhole. WCA opened the sanitary manholes to observe conditions. The piping in each sump was different, indicating an incomplete slip-lining at some point in the past. Water sampled from the stormwater manhole seemed to confirm that some leaking from the sanitary line was taking place (results above). As there was no flow, no total phosphorus sample was taken.

Town of Bennington Water Dept. crew uses a camera to identify a leak in the line near SMH-1450. Cracks in the pipe are visible in the photo.

WCA returned on 9-22-15 with the Town of Bennington staff to televise the pipe. Cracks were found in the sanitary manhole sump, confirmed by televising the stormline while jetting the sanitary line with dyed water. A clear increase in flow was noted as soon as the jet was introduced. Dye was observed in the stormline. The Town of Bennington staff returned and added concrete to the sanitary manhole sump and re-tested using the camera and water jet. No discharges were found after the fix. The issue is considered resolved.

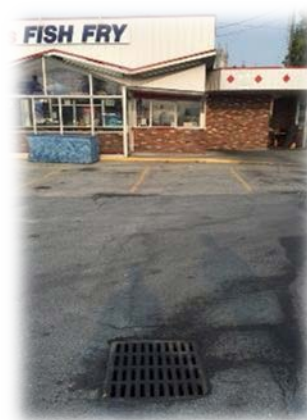
On 9-3-15 WCA and ECA observed staining on the parking lot from the door of TJ's Fish Fry restaurant to the catchbasin. WCA suspected dumping of mop bucket wash water. The Town of Bennington indicated that the site has on-going sanitary sewer failure issue. The issue was initially referred to the Town of Bennington's Water Department and Health Office. The town declined jurisdiction over the issue and referred follow-up to the State of VT Wastewater Management Division. The State followed up with the restaurant and was assured that this was a one-time issue and would not occur again in the future. The issue is considered resolved.

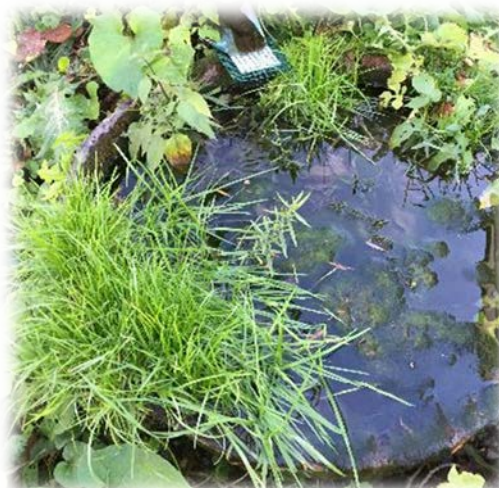
On our initial visit on 7-9-15, staff sampled from what is now know to be small PVC lawn underdrain pipe. There is a spring that runs through the basement of the house uphill and outlets into a small round metal basin. This then overflows, resulting in the need for the underdrain. Staff sampled from the underdrain thinking this was the catchbasin outfall, but this is not the case.

‘Bird Bath’ structure with OB pad placed at outlet of the feeder pipe.

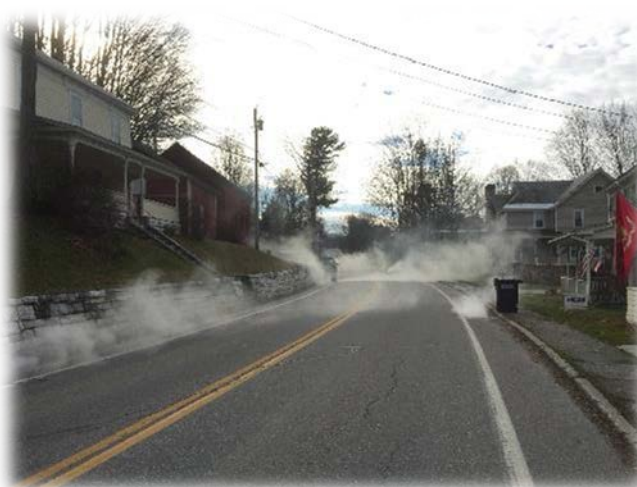
The results of all these tests do not indicate the presence of any chronic illicit discharge at PWL-19.

Smoke testing PWL-19 in Pawlet.
