Illicit Discharge Detection and Elimination in Brattleboro

FINAL REPORT

January 9, 2012

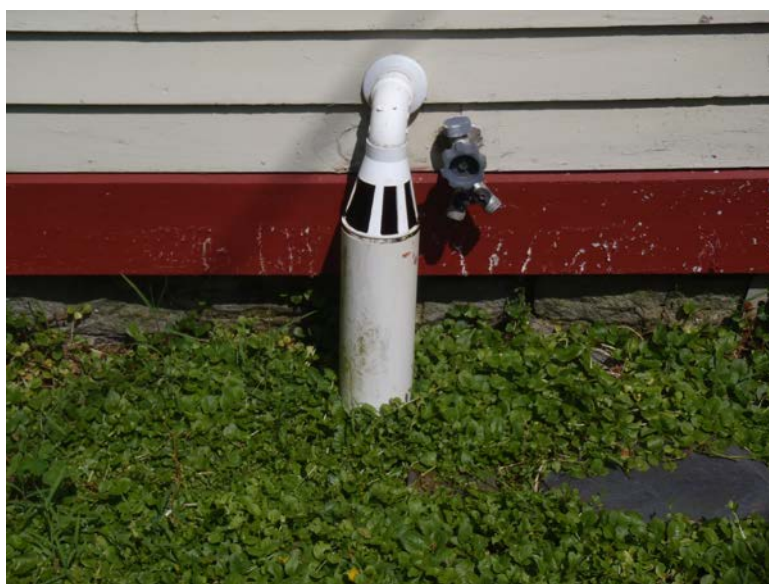
On June 16, 2011, a thorough assessment of the contributing drainage system was made to identify the source of the dry weather flow and the low levels of detergent. A sump pump was found discharging to the system at the end of Stewarts Place; this appeared to contribute most of the dry weather flow in the system. The outlet of this pump is shown in Photo 1. No MBAS detergent was found in this flow and no other sources of inflow were observed in the system except for groundwater seepage entering catch basins on Elliot Street at the toe of a steep slope. Because the primary source of the dry weather flow was found to be a sump pump and because only low levels of MBAS detergent and no optical brightener were found at the outfall, detection of MBAS detergent was attributed to outdoor washing.

Photo 1. Outlet of sump pump in system discharging at BR-800

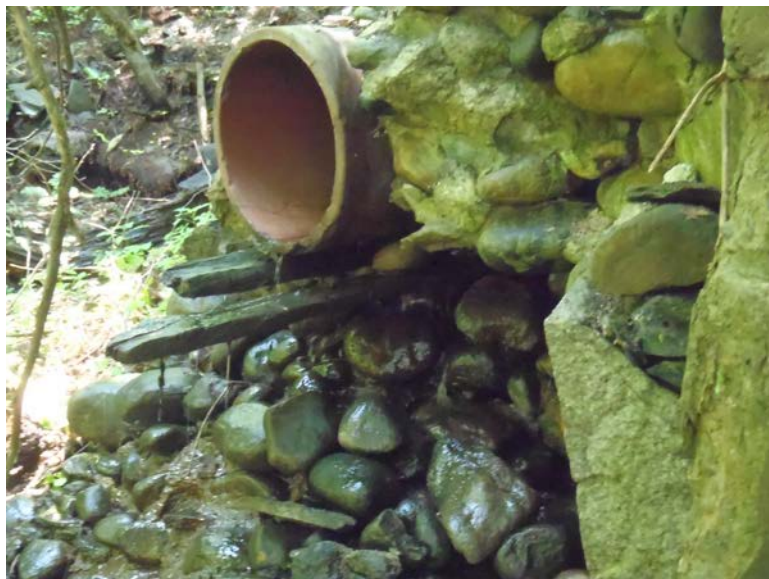
BR-920 is a 20-inch diameter ceramic outfall from the Canal Street storm sewer (Photo 2). It discharges to Whetstone Brook just east of the Elm Street bridge and drains much of the southern end of the town (Figure 2). Most of the dry weather flow passes through a gap between the final two pipe sections into the rocks below,

Photo 2. Outfall BR-920

A low concentration of MBAS detergent (0.2 mg/L) was detected during the assessment on October 19, 2010 (Table 5). However, the flow was clear and not malodorous and neither optical brightener nor ammonia was detected. Sampling on December 10, 2010 produced similar results. When the outfall was revisited on June 16-17, 2011, the flow had a septic odor and grayish cast and ammonia and optical brightener were detected. Duplicate samples collected on July 6, 2011 had *E. coli* levels exceeding the analytical range (>2,419.6 MPN/100 mL). Therefore, an extensive investigation of the Canal Street storm sewer for optical brighteners was performed to bracket the source(s) of contamination. Strong detections of optical brightener were found in the lower block, between the intersection of Brook Street and the outfall.

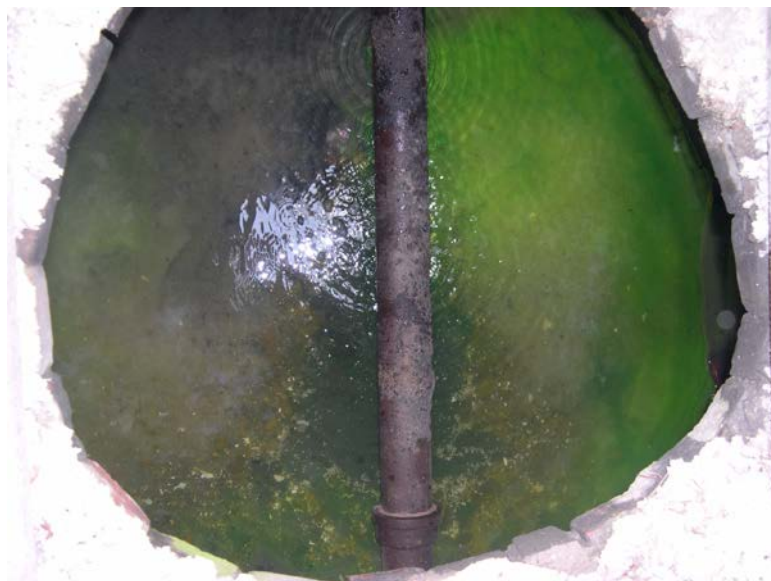
On July 21, 2011, the system was inspected with Rick Ethier. A catch basin (catch basin BR-920C in Figure 3) that had been partially paved over was opened, revealing an obviously leaking iron sewer service line from an apartment house crossing through the catch basin (Photo 3). Feces and toilet paper were observed in the catch basin. Dye was added to a toilet in the apartment house to confirm the failure of

the sewer line. According to Gary Corey, a neighbor of the apartment house who happens to work for Brattleboro DPW, the apartment house has seven permanent residents plus many regular guests. Mr. Corey noted that a drain cleaning company (Roto-Rooter or similar) cleared a clog in the service line during the winter or early spring of 2011; it is possible this work caused or increased leakage from the pipe subsequent to the December 2010 outfall sampling. Brattleboro DPW sleeved the broken sewer line the same day and has required the owner of the apartment house to reroute the sewer service line. The property owner plans to connect the building sewer to a different pipe serving a neighboring property.

Photo 3. Catch basin BR-920C. Note green dye from sewer system

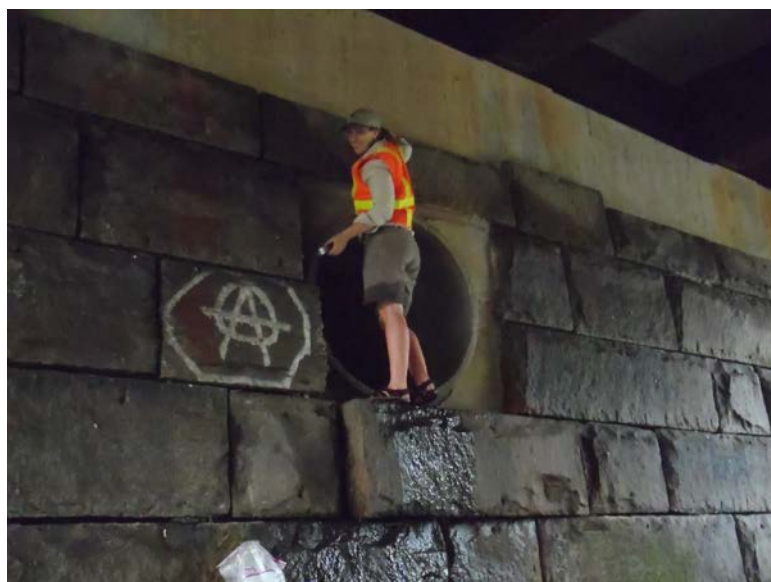
Outfall BR-1160 is a 42-inch diameter concrete pipe that discharges to Whetstone Brook under the north side of the Main Street bridge (Photo 4). The contributing drainage system includes north Main Street and portions of Elliot, High, Grove, Linden, and other side streets (Figure 5). Optical brightener was found at the outfall during the initial assessment on October 20, 2010. Results of the initial assessment and follow-up sampling at outfall BR-1160 are presented in Table 7.

Photo 4. Outfall BR-1160

Due to the detection of optical brightener on October 20, 2010, an investigation was performed to bracket the source of the contamination. Intensive optical brightener monitoring of the BR-1160 storm sewer was performed on June 16 and again on July 14, 2011, with over 40 pads deployed in total. Fluorescence of the pads was observed in three areas: High Street between North Main Street and Oak Street; in the Brown & Roberts building parking lot off High Street; and in the lot behind the Brooks House (Figure 6).

Optical brightener was found in the main storm line on High Street from North Main Street up to the catch basin located approximately 350 feet east of Oak Street. On July 21, 2011, I visited the site with Rick Ethier. Wastewater infiltration was suspected between catch basin #36, which was dry, and catch basin #34 (Figure 6), which had a small amount of flow and a laundry odor. There are four houses between these catch basins. An apartment house close to the intersection of High Street and Brook Street was entered to perform dye testing. The apartment building appeared to have three sewer lines, only one of which could be easily tested. Within approximately 10 minutes, no dye was seen in catch basin #34. The other houses were not entered. Mr. Ethier committed to follow on investigation, possibly using a sewer line camera.

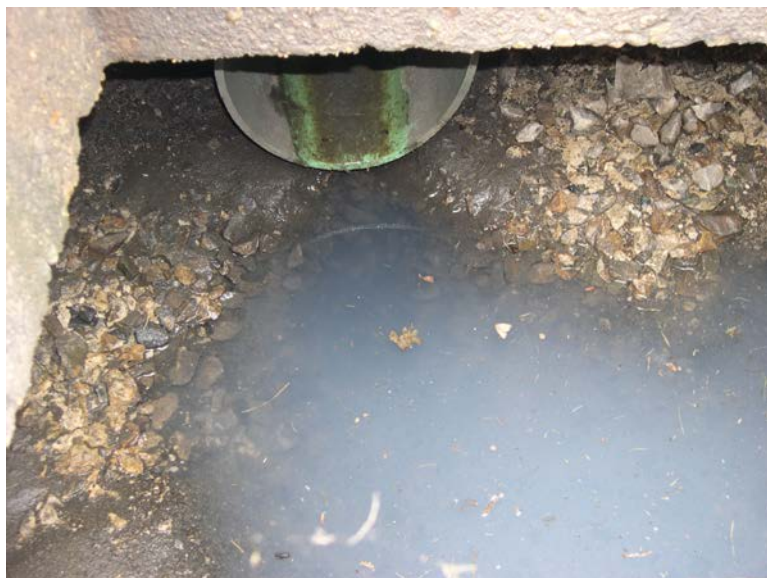
Optical brightener was found in the catch basin in the driveway of the Brown & Roberts apartment building (#24) and in down-pipe catch basins. An 8-inch diameter PVC pipe enters this catch basin from the direction of the apartment building. On July 21, 2011, I visited the site with Rick Ethier. The PVC pipe was not flowing but there was a discolored pool of water in the basin (Photo 5). Mr. Ethier indicated that he would work with the owner, Hugh Barber, to determine the origin of the pipe.

Photo 5. Catch basin in the Brown & Roberts lot

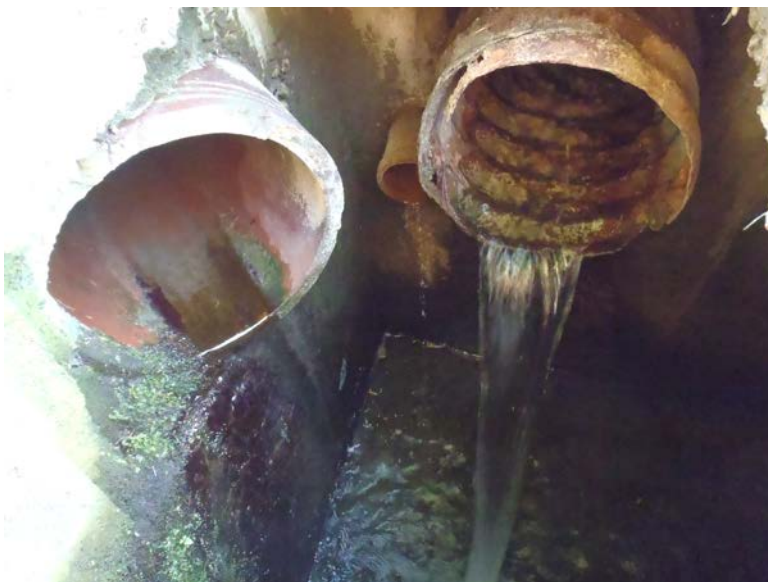
Photo 6. Catch basin Q in BR-2020 storm sewer

During deployment of optical brightener monitoring pads on November 30, 2010, many plastic bags apparently filled with dog waste were found in catch basins near #113, #132, and #139 Green Meadow Road. When alerted to this condition, the Brattleboro Public Works Department promptly placed a sign in the area discouraging pet waste dumping into the drainage system.

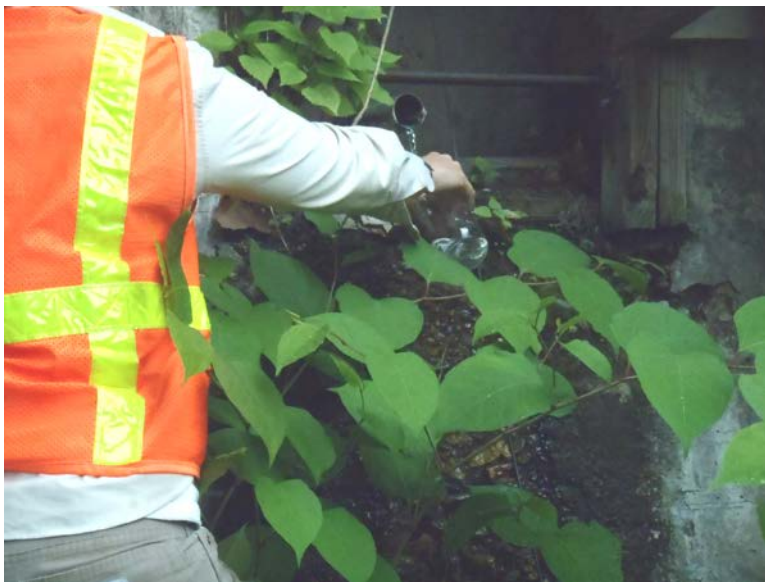
Outfall BR-1140 is a small diameter (1.5-inch) pipe next to the air conditioning unit behind the Latchis Theater (Figure 11; Photo 7). This small flow appears to be tapwater. When assessed on October 20, 2010, the chlorine concentration was high (0.53 mg/L) and no ammonia or MBAS detergent were detected (Table 12). The site was pointed out to Rick Ethier on July 21, 2011, who indicated that DPW would discuss the source of the flow with the property owner to seek its elimination.

Photo 7. Sampling outfall BR-1140

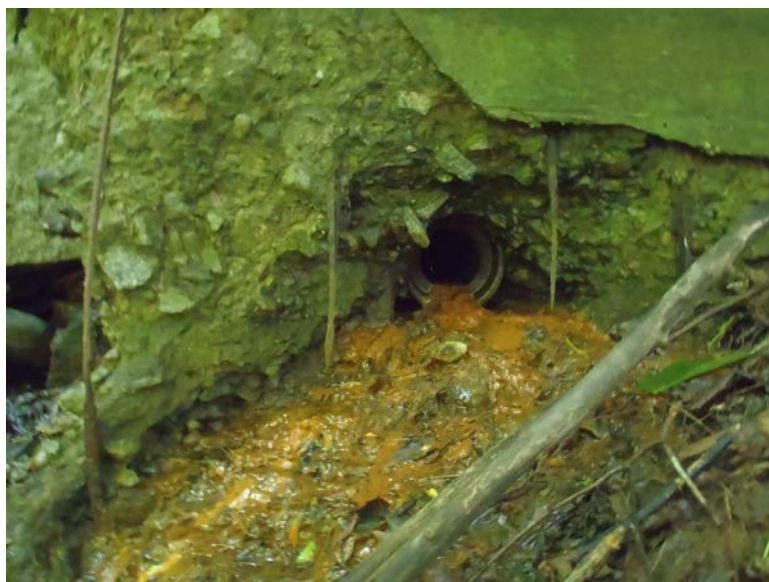
Outfall BR-910 (Photo 8) is a 4-inch diameter pipe discharging to the south bank of Whetstone Brook, 150 feet east of the Elm Street bridge (Figure 3). The pipe discharges at the base of a concrete abutment. Flow from the pipe had a distinct petroleum odor when observed on October 19, 2010 and again on June 16, 2011 (Table 14). Iron staining is present at the pipe outlet.

Photo 8. Outfall BR-910

Outfall BR-910 is suspected of passing contaminated groundwater, likely related to the gasoline release at Canal Street Mobile on Canal Street (DEC site #91-1005), which was identified in 1991. Monitoring wells located in the adjacent wetland area are part of DEC's response to this release. Water flowing around the edge of this wetland at the base of the slope also has a distinct petroleum odor. This flow, identified as BR-940, is shown in Photo 9. It is assumed to be contaminated groundwater from the same source as present in BR-910.

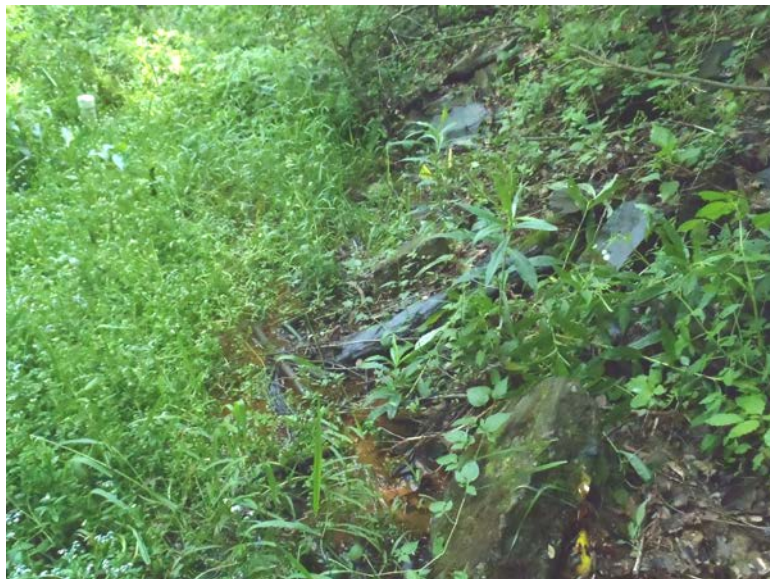
Photo 9. Seep BR-940 bordering wetland

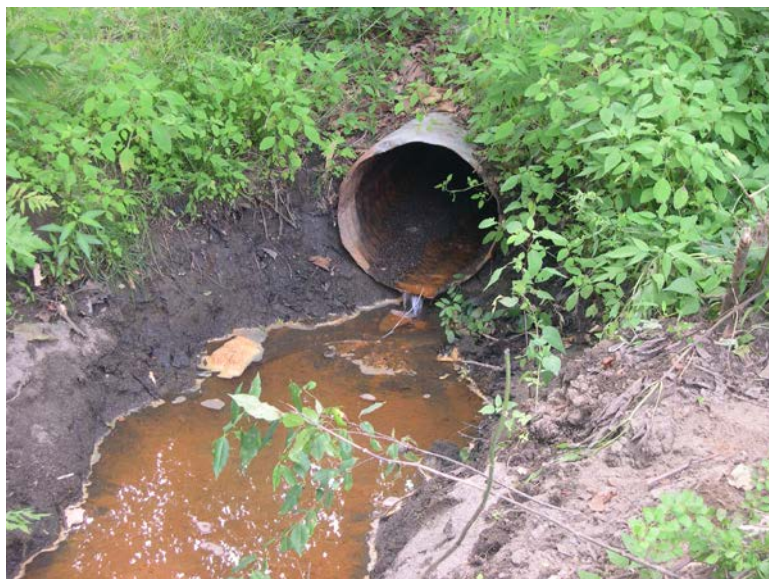
Outfalls BR-2280 and BR-2370 are located behind homes on Valley Road in West Brattleboro (Figure 12). Outfall BR-2280 behind #7 Valley Road is an 18-inch diameter corrugated metal pipe (Photo 10). Outfall BR-2370 behind #17 Valley Road is buried in rubble. When outfalls BR-2280 and BR-2370 were observed on November 2 and 8, 2010, respectively, petroleum odor and an orange floc attached to the substrate were evident (Tables 15 and 16). In the summer of 2011, the Brattleboro Department for Public Works made an excavation on Valley Road to complete a water line repair and noted a strong petroleum smell in the excavation, which corroborated our field observations and suggests a larger source rather than separate sources infiltrating into the BR-2280 and BR-2370 storm sewers.

Photo 10. Outfall BR-2280

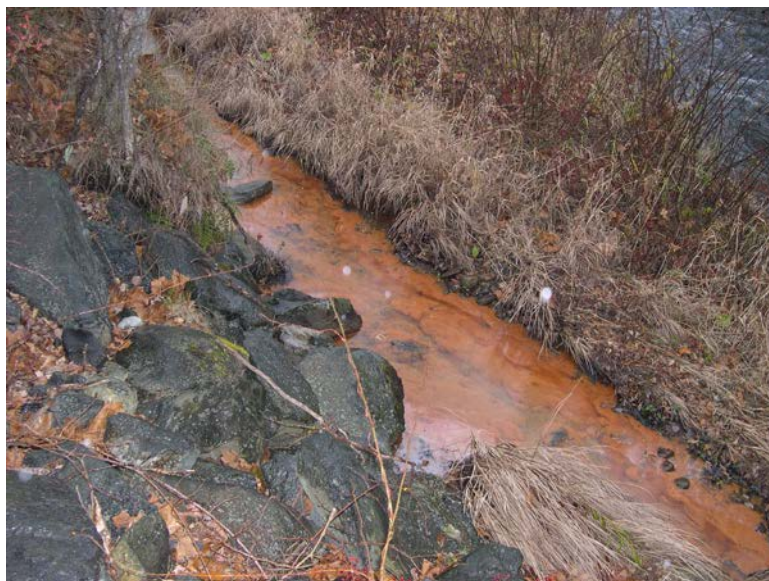
Date	Ammonia (mg/L)	Sp. conductance (µs/cm)	Chlorine (mg/L)	MBAS (mg/L)	Observations
11/25/10	0.0	274	0.00	0.0	Iron staining, slight petroleum odor

Photo 11. Seep BR-2960

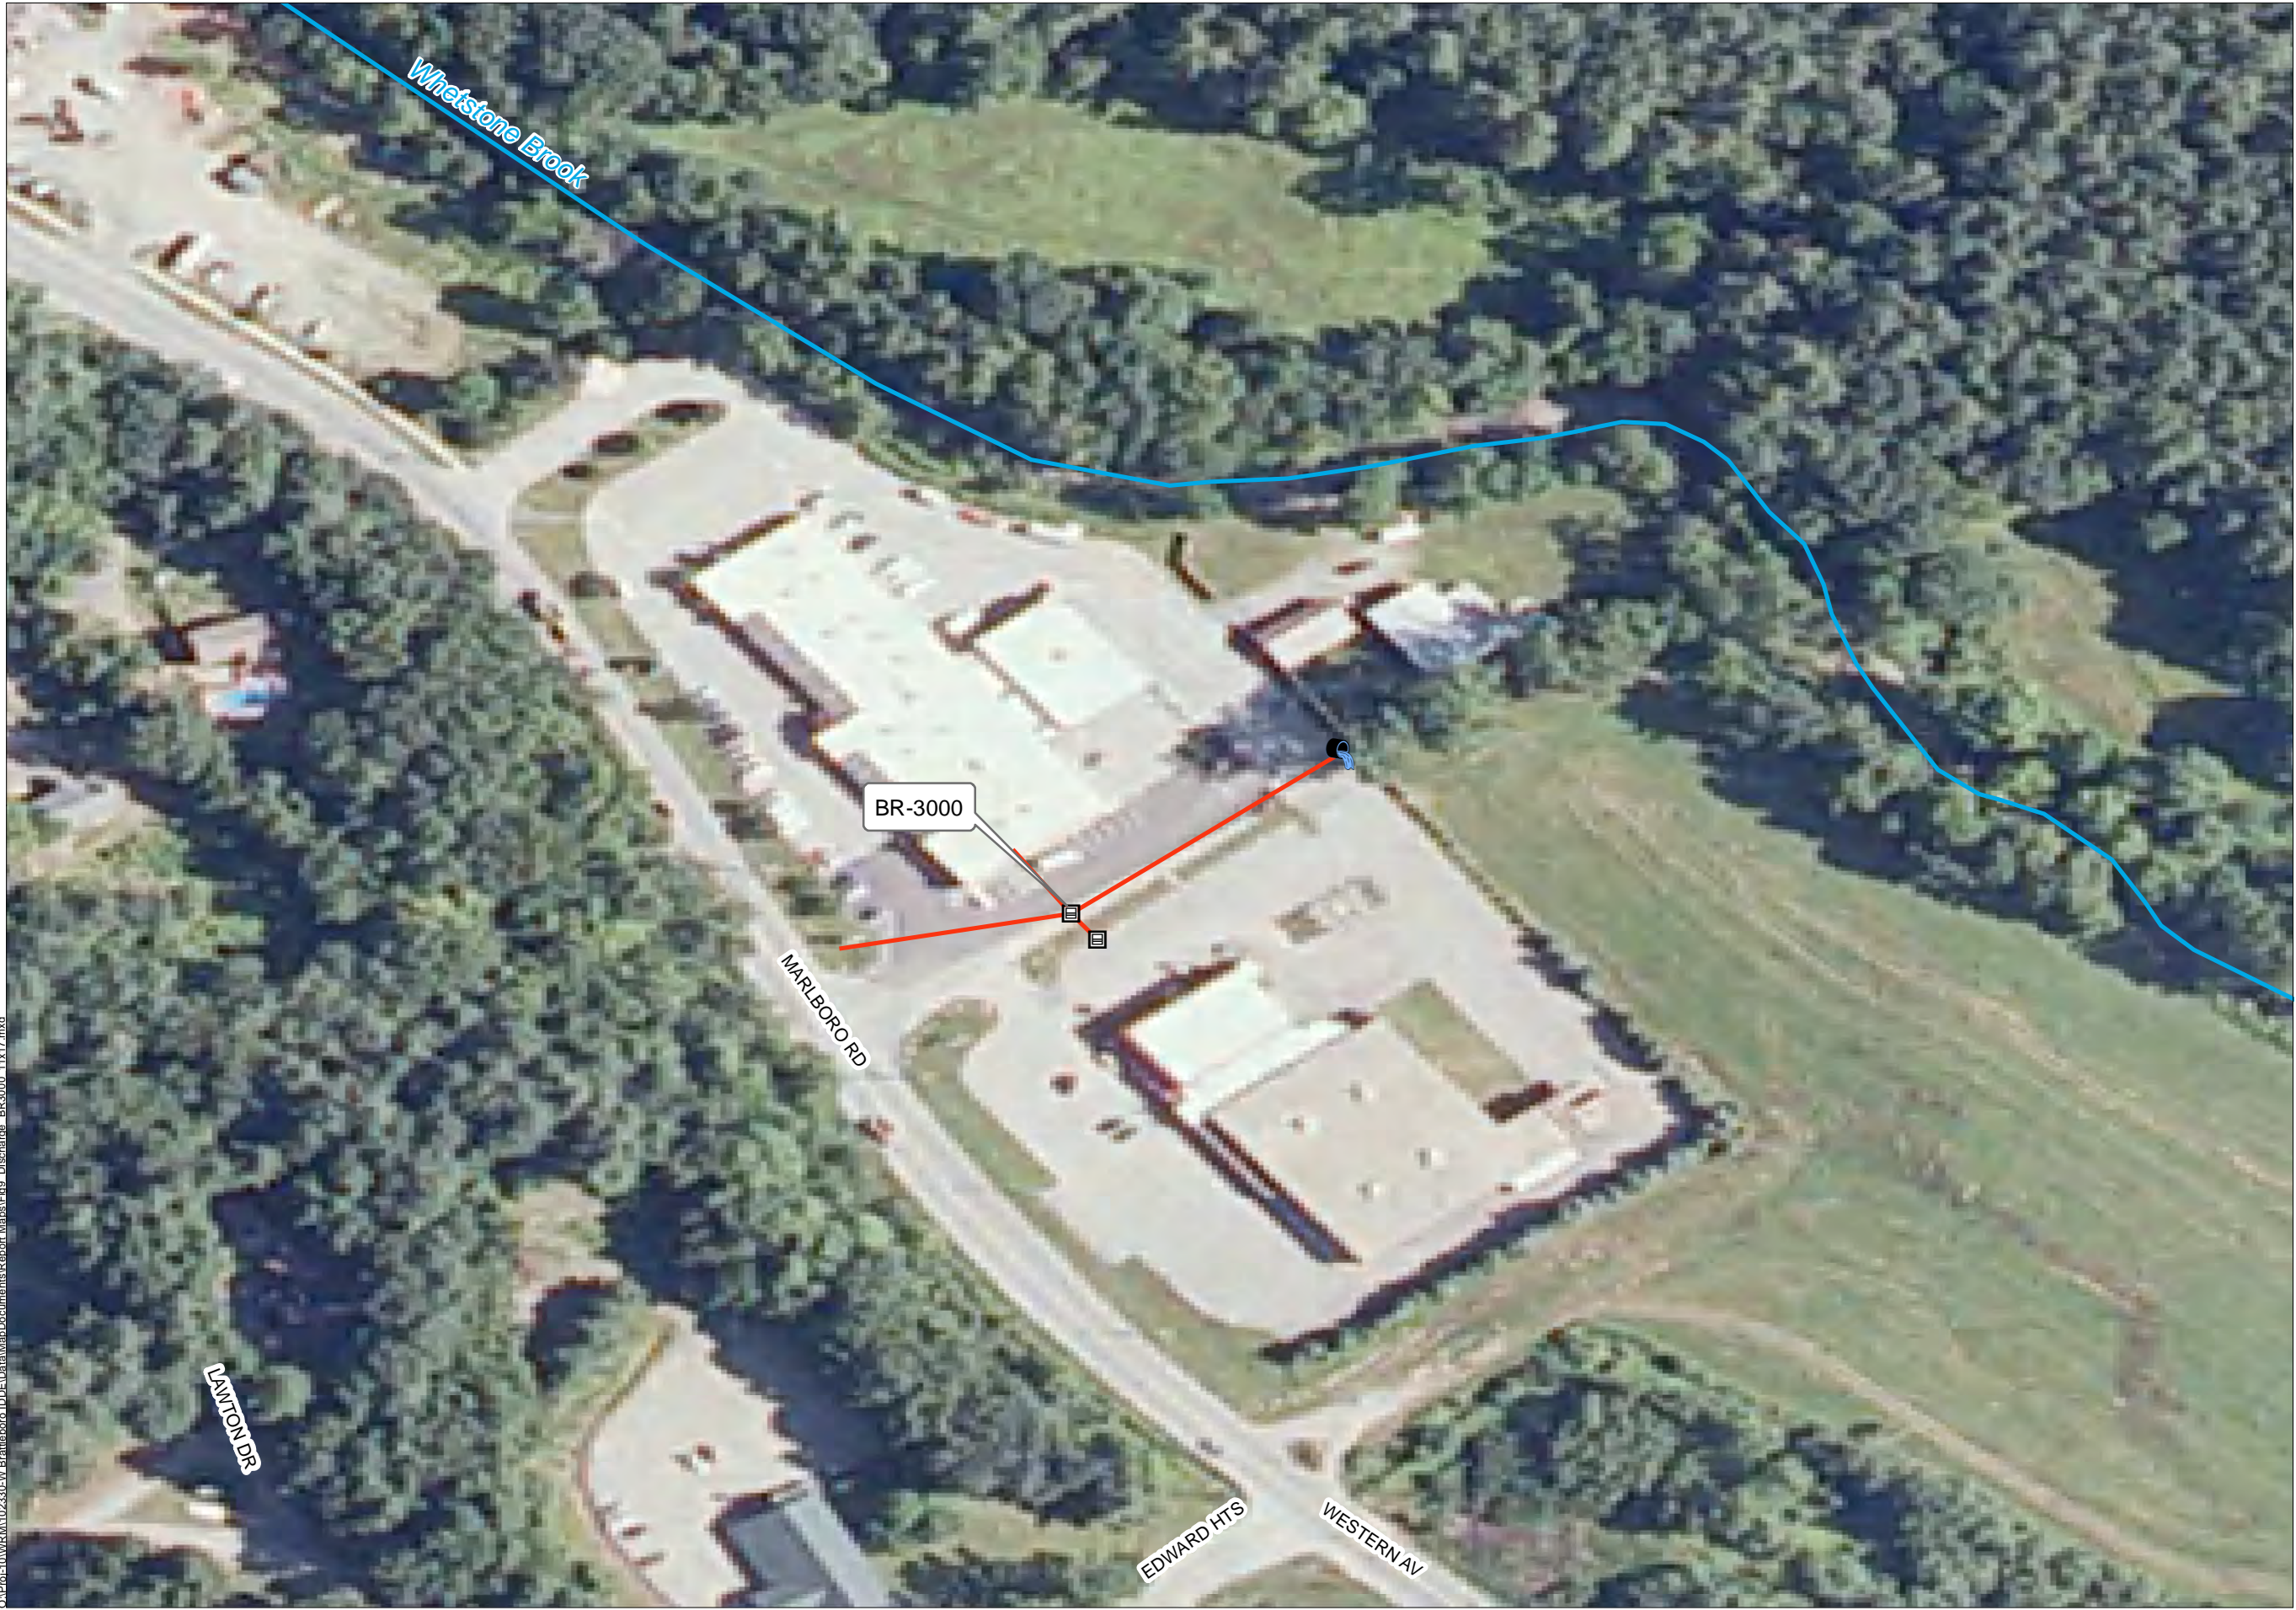
Figure 9
Brattleboro IDDE
Brattleboro, VT

Catch basin BR-3000 is the furthest downstream structure that can be accessed in a collection system draining Western Avenue and adjacent commercial lots (Figure 9). The outfall is located on posted, private property. Three pipes discharge to the catch basin. When observed on November 15, 2010, only one pipe was flowing, a small diameter PVC pipe entering from the direction of the appliance store ("Pipe C"). This discharge had an elevated ammonia concentration (Table 10). Pipe C was dry on several return visits, including November 30 and December 10, 2010. The discharge was resampled on June 16, 2011 when a trickle of flow was observed from Pipe C. A low concentration of ammonia was detected on this date.

We suspect there may be a floor drain or other drain in the building housing the appliance store that is connected to catch basin BR-3000. However, we rarely observed flow in the suspect pipe and never observed high concentrations of any measured parameter. The moderate level of ammonia (0.6 mg/L) measured on November 15, 2010 suggests that some type of discharge occurred at this time, possibly mop water added to an interior drain. However, with no additional support in the data we took no further steps to identify the problem.

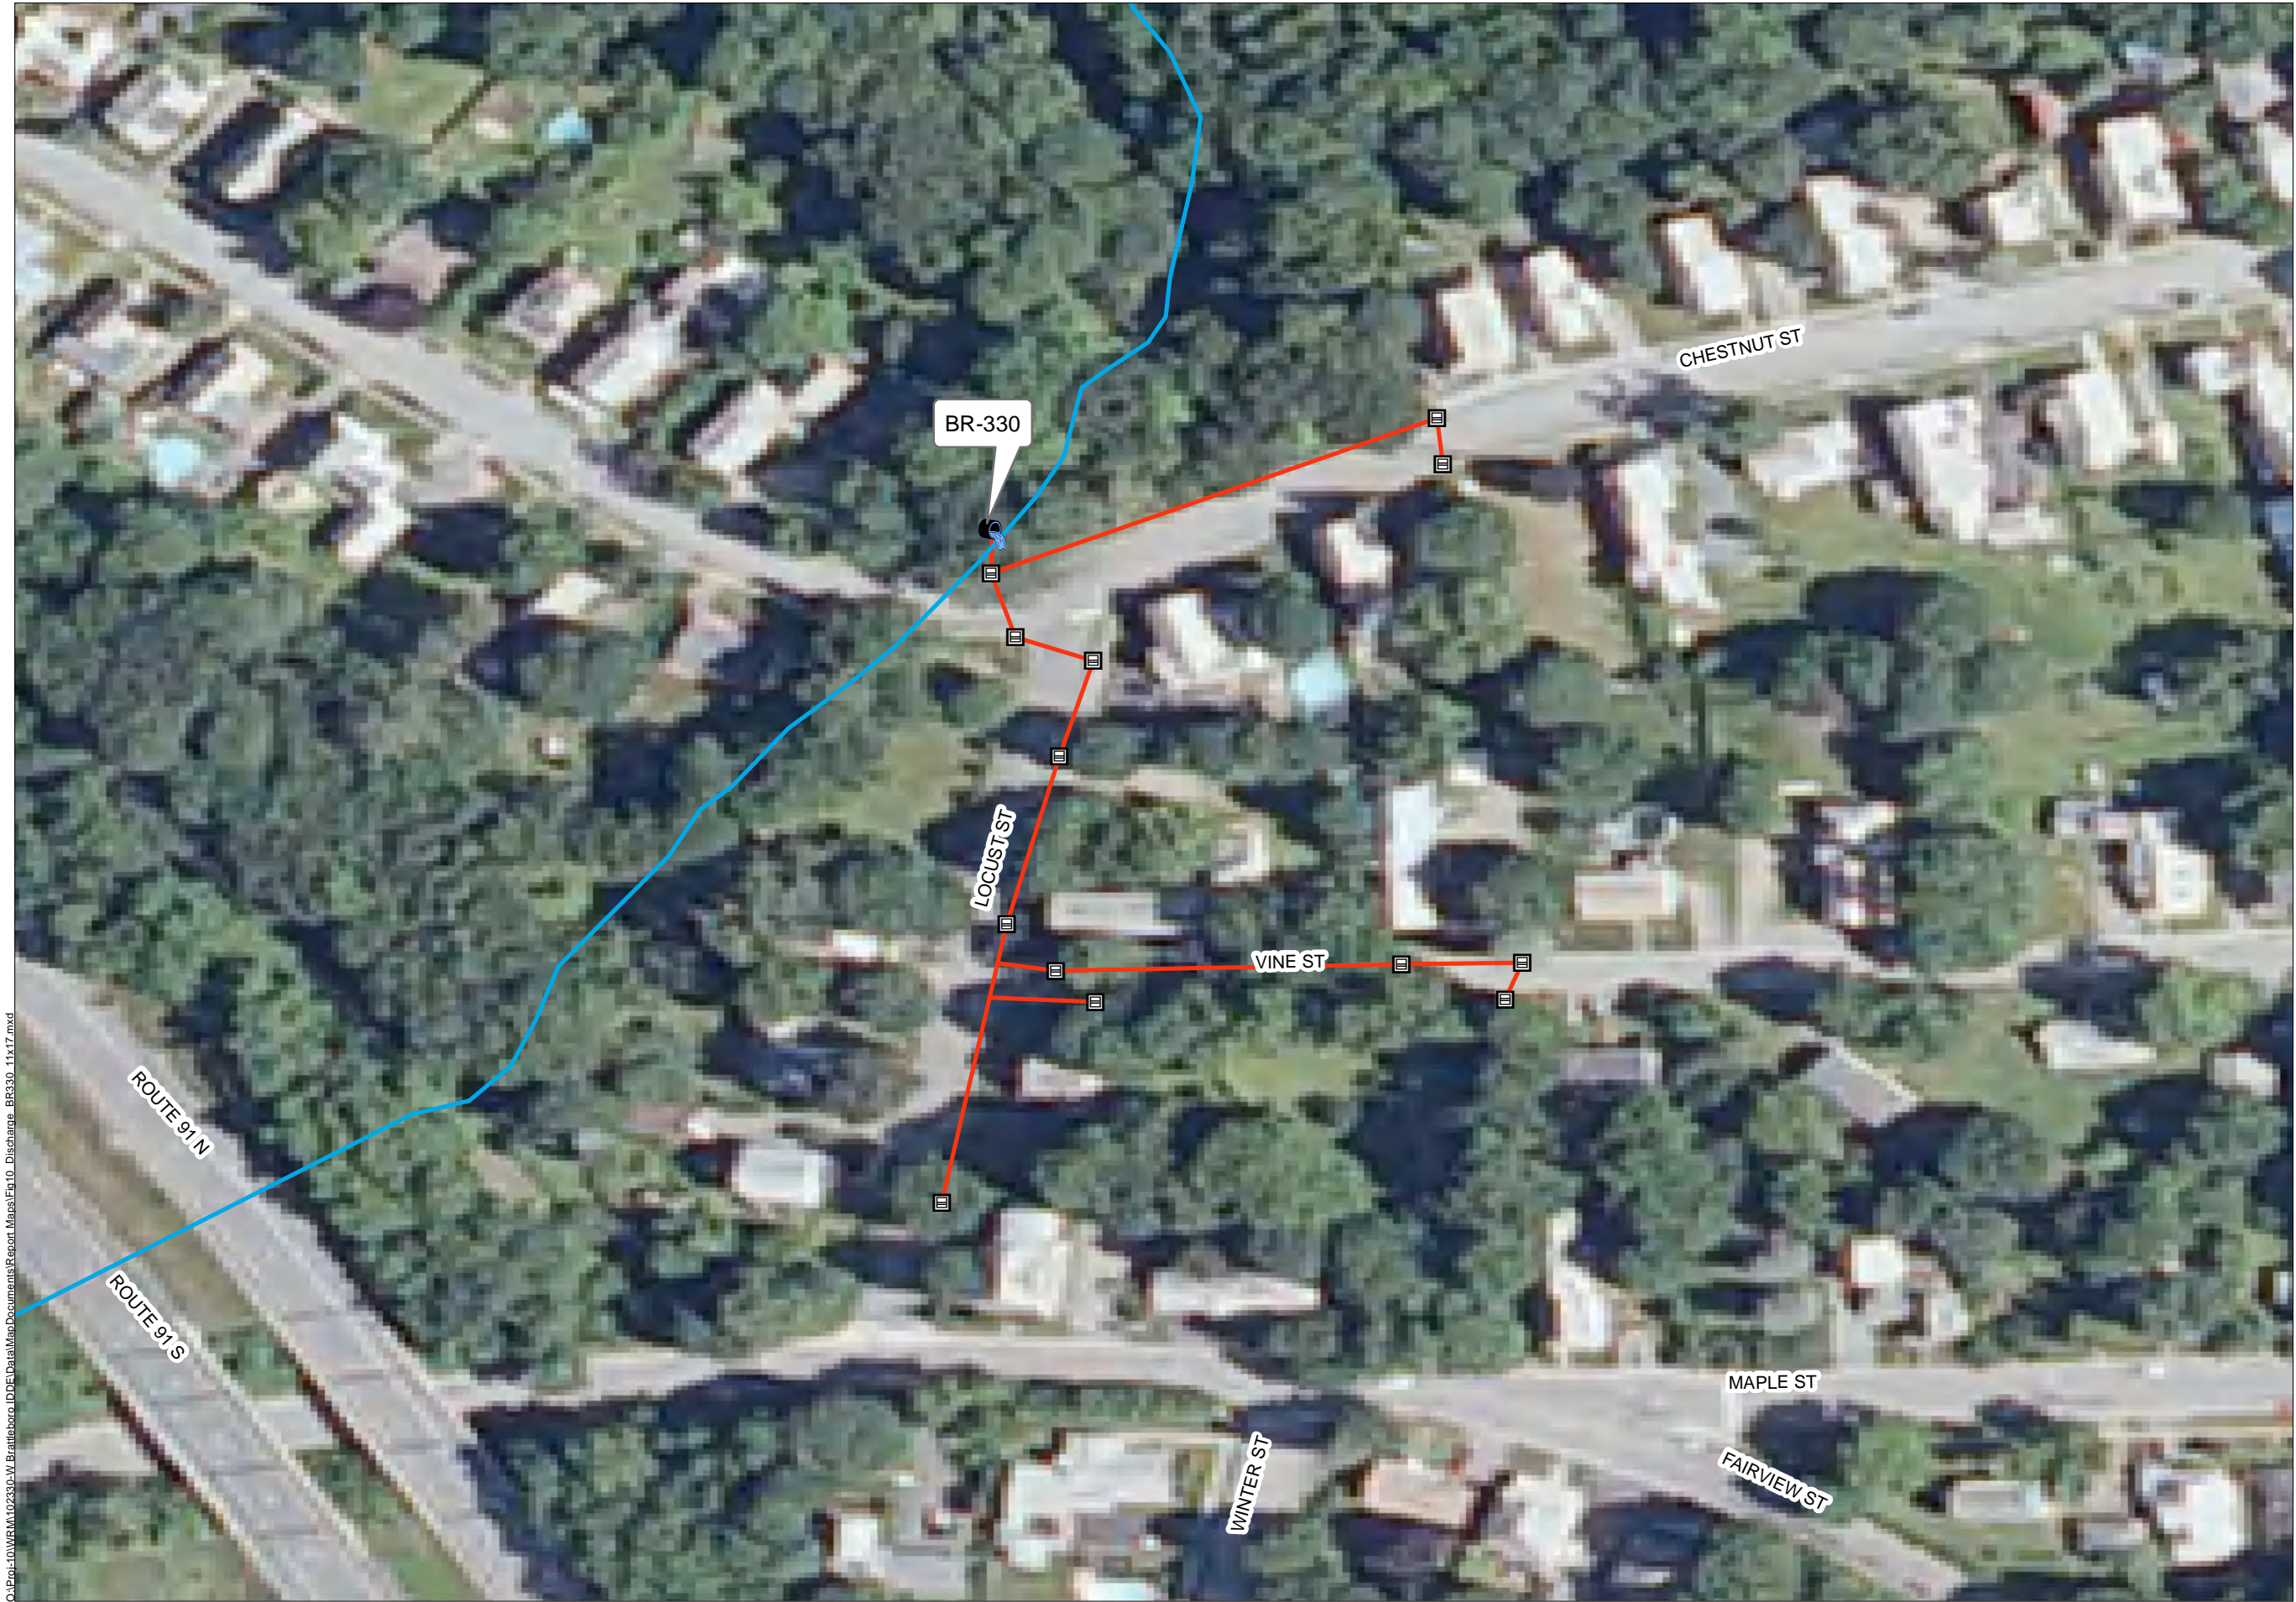
Figure 10
Brattleboro IDDE
Brattleboro, VT

Outfall BR-330 is a 4-inch diameter PVC pipe near the intersection of Chestnut and Locust Streets (Figure 10). The outfall was flowing when assessed on October 11, 2010. The depth of flow was approximately ¼ inch. The measured chlorine concentration was 0.88 mg/L, indicating an undiluted tapwater source (Table 11). No ammonia, MBAS detergent, or optical brightener was detected and the water appeared clear. A water leak was identified in a nearby valve chamber.

The Brattleboro DPW reportedly fixed the water leak in November, 2010. The pipe was dry when checked again on June 6, 2011, indicating the repair was successful.
