# Final Report: Contract #35956 Statewide IDDE

March 2021

**Andres Torizzo**

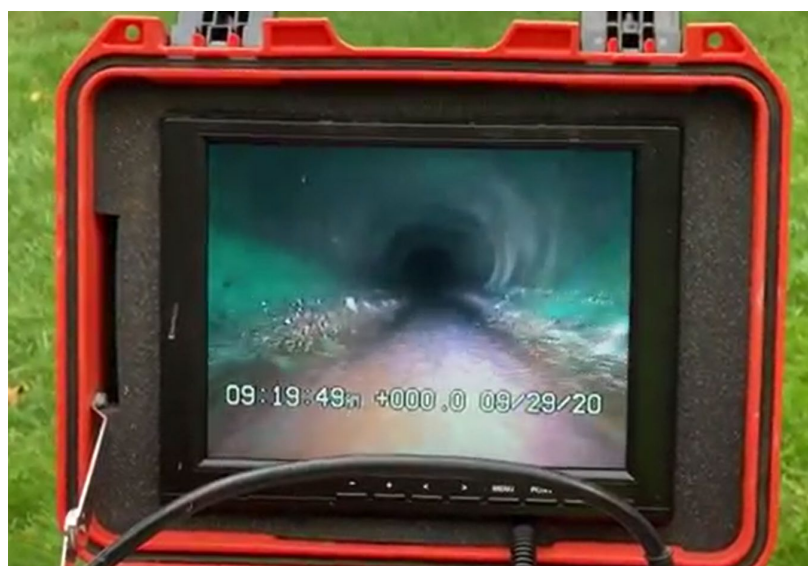
**Figure 1. Photo from Camera Scoping.**

Watershed followed up on this work and on August 20, 2020, a televised survey of the sewer system was completed to further evaluate CAMB\_7. A push camera was installed into the sewer manhole as indicated on the plan in Figure 2. The camera was extended through the sewer line beyond the crossing with the subject stormwater line to the next sewer manhole structure as seen in Figure 1. The pipe was observed to be in good condition with no evidence of bends or cracks. The outfall was observed to be dry at the time of the inspection with no visual evidence of contamination.

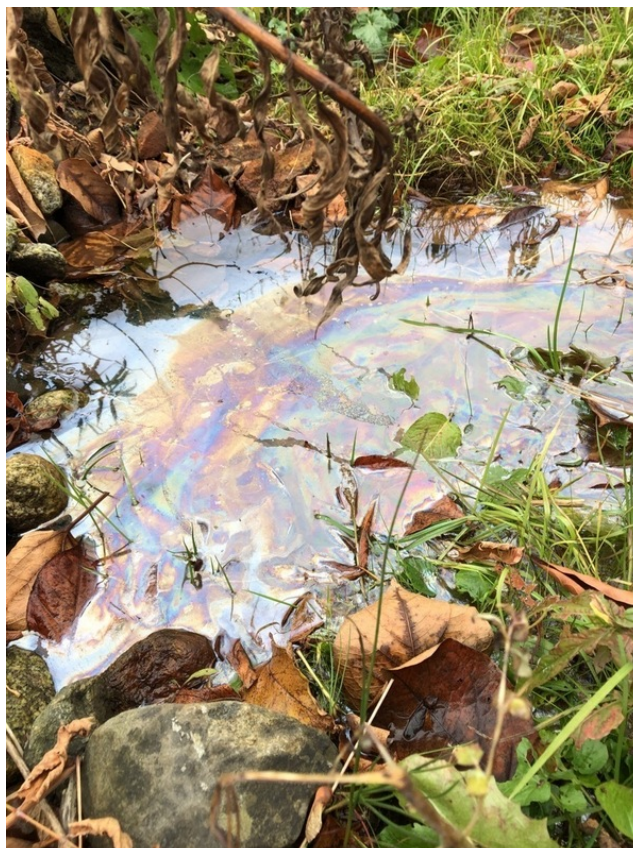
Figure 3. Oil Sheen at Underdrain Outfall.

Upon review of water quality data, CHRL\_5 was flagged for advanced investigation due to high phosphorus, ammonia, and specific conductivity values. The system was smoke tested on 10/29/2019 and no crossover was observed. During the October site visit, it was observed that the outfall had been buried during the previous site visit, and the “outfall” that had been sampled prior was an underdrain for the nearby garage. The actual outfall was not flowing during the site visit. Due to this misidentification, the lack of flow, and the lack of crossover during smoke testing, it is our conclusion that no chronic illicit discharge is occurring in this system. However, it does appear that the underdrain from the nearby maintenance garage may be polluting the stream it discharges to. The pool at the underdrain outfall had very poor quality, high ammonia and total phosphorus, and a visible oil sheen (Figure 3).

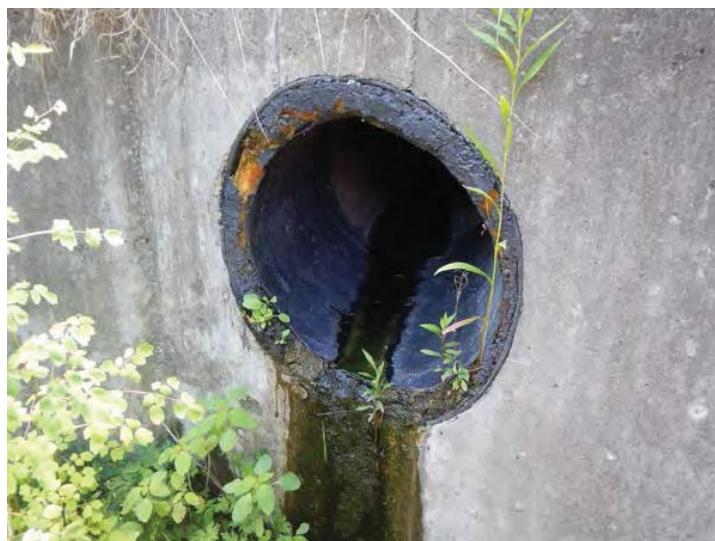
**Figure 4. DT030 outfall**

The DT030 system consists of one catchbasin, located in the lawn of 31 Hinman Settler Rd, piped directly to an outfall. The system was totally dry so no water quality analysis could be performed, but an OB pad was left at CB1. The previous issue was identified as surfacing effluent from the septic system at 31 Hinman Settler Rd. No surfacing septic was observed upon the initial visit and when the OB pad was collected. No optical brightener presence was found in the DT030 system. Based on our findings, no illicit discharge is occurring in this system.

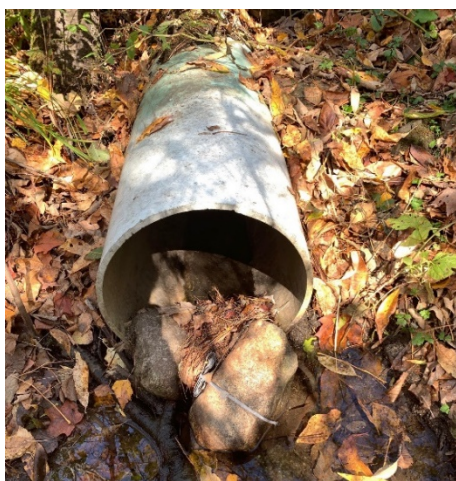
**Figure 5. Outfall GI020 with OB pad between 2 rocks and covered with debris.**

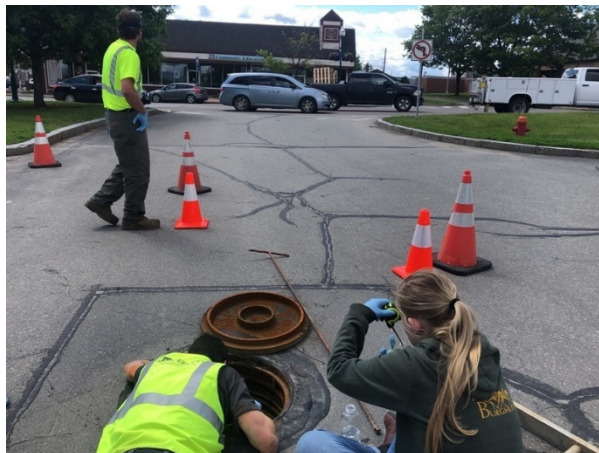
**Figure 6. Visual Inspection of NC360\_MH1.**

Infrastructure ID	Date	Notes	Flow	Specific Conductivity (uS/cm)	Ammonia (mg/L)	Detergents (ppm)	Canine Alert?	E. Coli (MPN/100 mL)	Total Phosphorus (mg/L)
NC360_MH1	6/14/2019	There was a leak in a cement pipe connected to sewer, but it was plugged on site.	yes	3999	0.28	0.5	yes	5.3	0.096

The advanced investigation of NC360 revealed very elevated specific conductivity levels, elevated detergents concentration, slightly elevated ammonia concentration. After testing water quality parameters, both the storm and sanitary systems were smoke tested, but the results were inconclusive. However, upon further visual inspection it was determined that the same cross connection pipe that was sealed because of the previous Lake Memphremagog study (VT DEC & Stone Environmental, Inc., 2016) was once again discharging to the storm system. The pipe was sealed again onsite. It is recommended that Newport City keep a watch on this as it has leaked twice in three years.

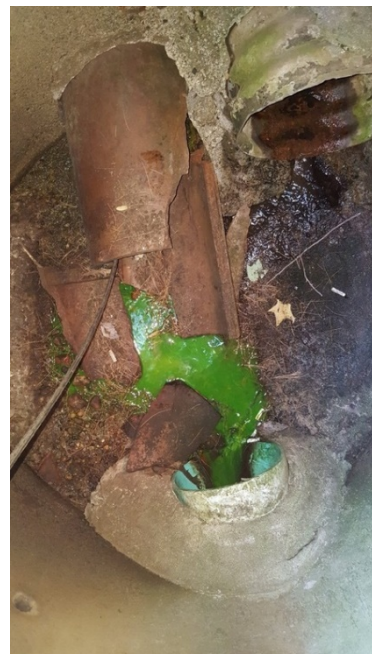
**Figure 7. NC1050 Dye Testing.**

The advanced investigation of NC1050 identified a clear illicit discharge occurring in NC1050\_CB3\_pipe C. Specific conductivity, ammonia, detergents, *E. coli*, and TP were all significantly elevated. Additionally, while sampling from pipe C, floatables including feminine hygiene products and toilet paper was observed flowing down the pipe.

The site was visited again on 8/23/2019, and dye testing was conducted from all school bathrooms in the old wing of the school. A camera was used to inspect CB3 during dye testing with help from Tom Bernier and Newport Public Works. A direct connection between the toilet in room 131 and CB3\_pipe\_C was found. Newport City Public Works and the Newport City Elementary School were notified of the connection, and the toilet was immediately stopped from being used.

The site was revisited on 10/29/2019 and pipe C was dry, indicating that stopping use of the room 131 toilet was effective and there are no further illicit discharges. As of March 2021, the School and the Public Works Department are in negotiations with a neighboring property owner over a right-of-way to connect the School's sewer line into the adjacent line. W

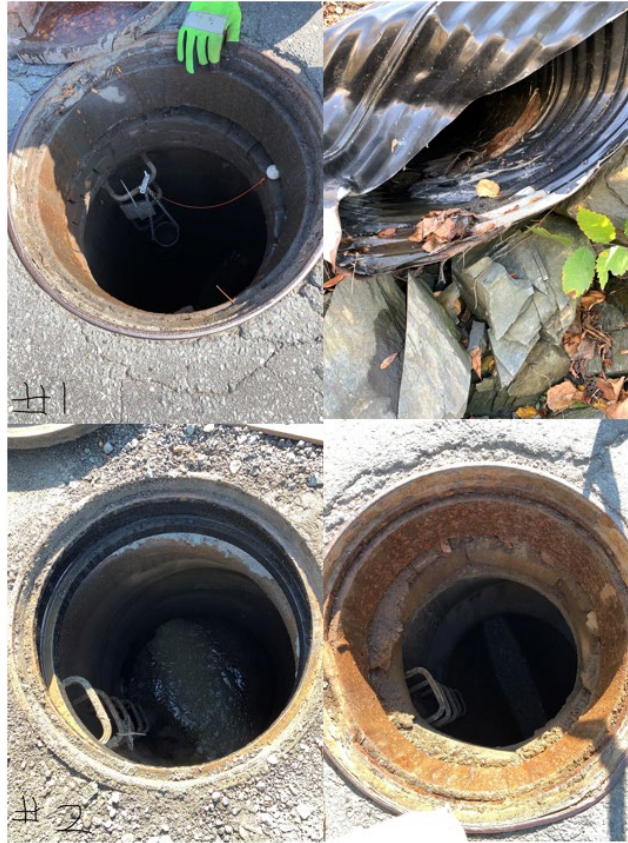
Optical brighteners pads were deployed at SJ 440 outfall and 3 manholes (MH 2-4) on Concord Ave on September 28, 2020. These were collected a week later on October 5, 2020. The pads were left on the top stair step. All pads were knocked off the step because of high flow during that week. Within that week, there was a 1.82" rainstorm. MH 2 has a golf ball flow gauge under the rim but was not triggered because of high flow. Pads were analyzed for presence of optical brighteners under black light. Results were inconclusive.

**Figure 8. Manholes with OB pads attached to the metal ladders and the outfall with pad attached, under leaves.**

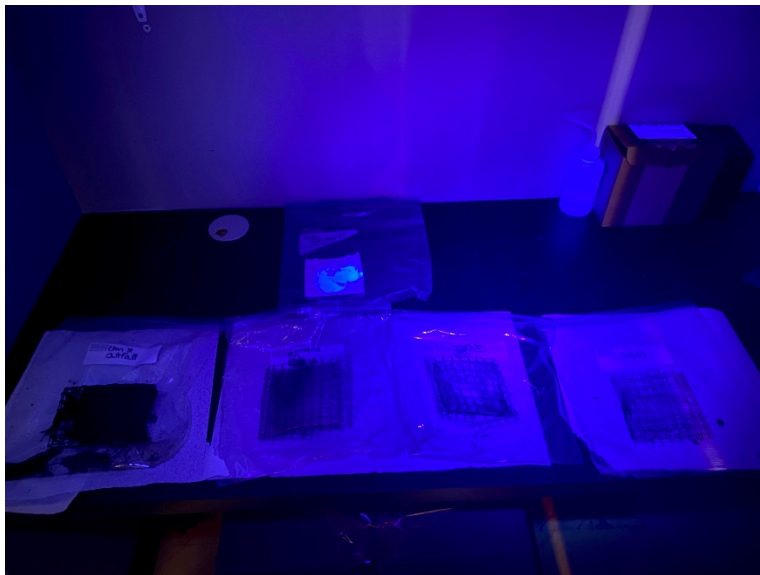
**Figure 9. Optical Brightener presence analysis under black light.**

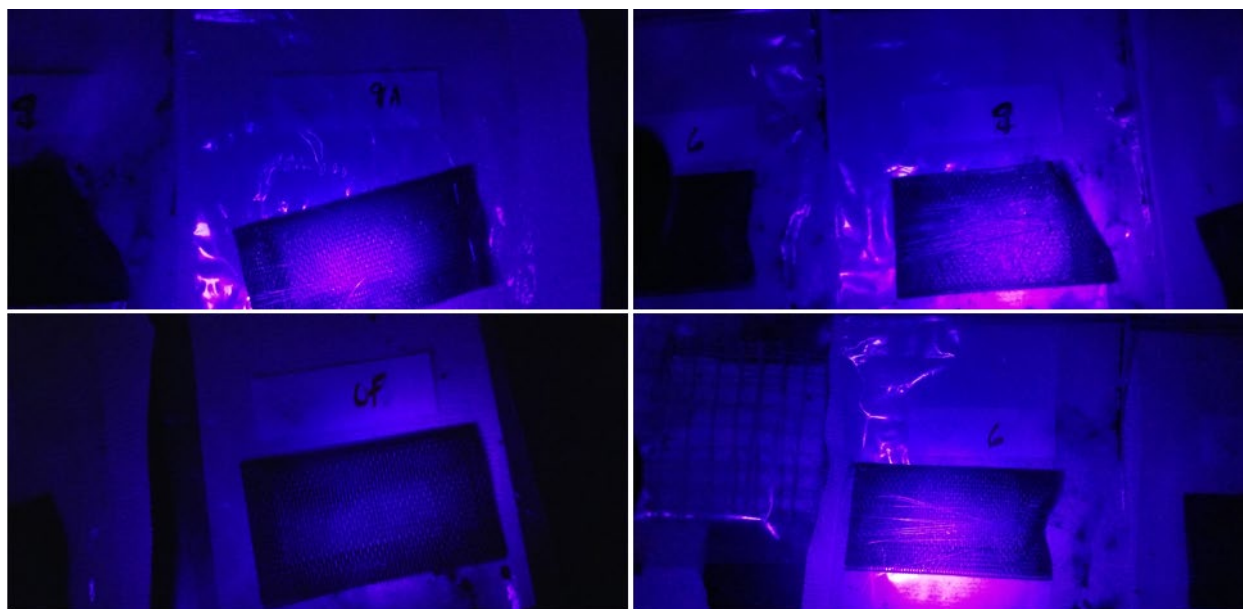
Again, OB pads were placed in CB 6, CB 9, CB 9A and the outfall in December 2020. Pads were analyzed and presence of optical brighteners was not detected as no pad exhibited any noticeable fluorescence.

**Figure 10. OB Pad analysis for CB 9A and 9 (top) and the outfall and CB 6 (bottom).**

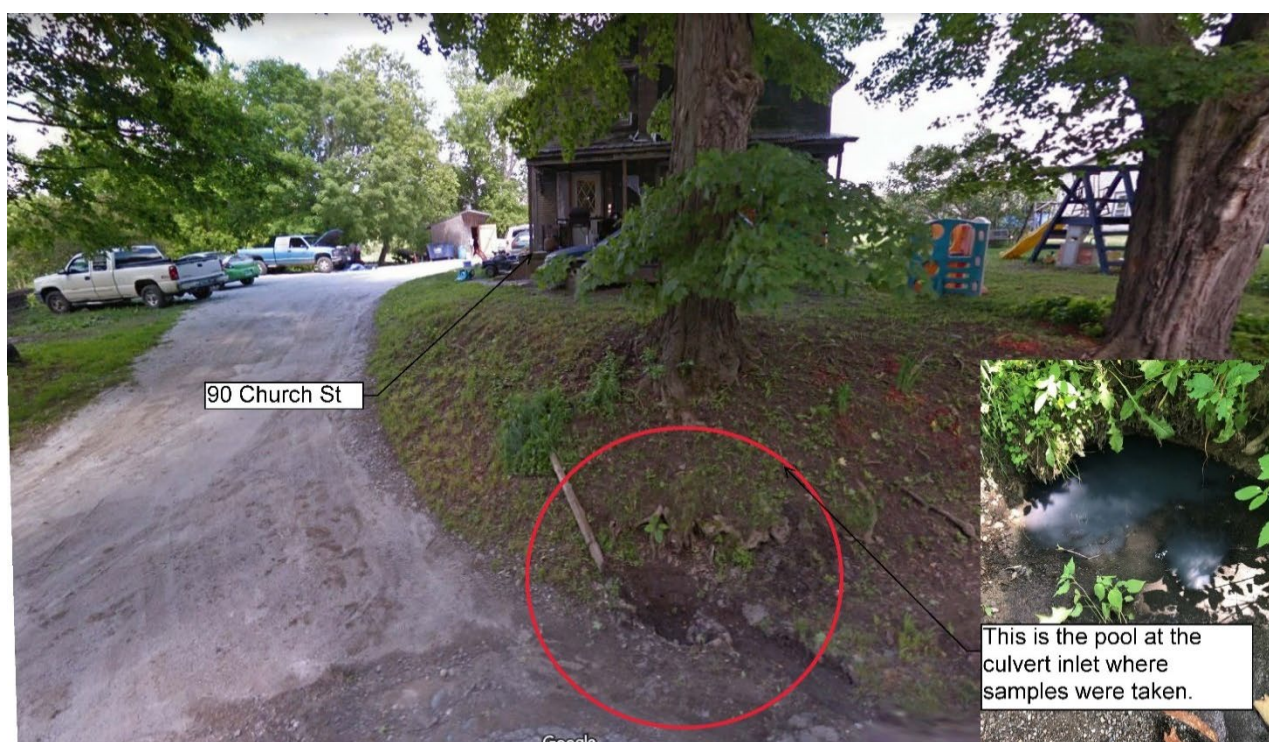
**Figure 11. 90 Church Street View.**

At 90 Church Street, there was a pool of purple/blue tinted water at the inlet to a culvert immediately adjacent to the front lawn. The pool of water not only looked like it was heavily polluted with detergents, but it also had a strong wastewater odor, and an accumulation of what appeared to be partially treated feces at the bottom of the pool (Figure 11). All water quality analysis parameters support the visual observations made. Therefore, it is confirmed that there is chronic illicit discharge occurring from the septic system at 90 Church Street. The culvert that receives the partially treated sewage is hydrologically connected to Black Creek, so it is of utmost importance that the illicit discharge is corrected as soon as possible. The issue was reported to Jim Pease at the Vermont DEC and was referred to enforcement.

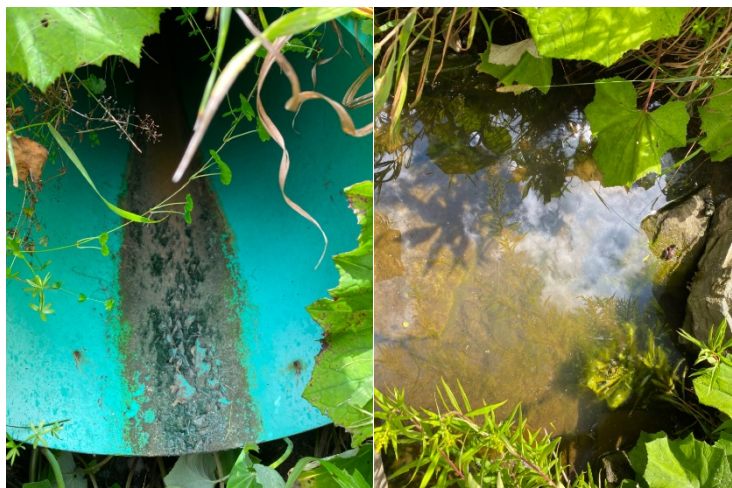
The system was revisited due to lack of data from the first visit. Resampling of the system indicates that there is a source of detergents to the system. On August 20, 2020, a liquid smoke survey was completed at Thetford Academy to further evaluate THTF\_4. Liquid smoke was injected at the lowest catchbasin along the collection line above the outfall. With Academy maintenance staff, the entire collection system drainage area was monitored during the smoking process including sewer manholes, building vents, and interior floor drains, bathrooms, and sinks. Smoke was observed in stormwater catchbasins throughout the drainage area. No visual evidence of cross contamination was observed during the smoking process. The outfall was observed, and field tested following the smoke survey. Only a trickle of flow was observed with no visual indicators present.

Figure 12. Outfall pipe THTF\_4 with no flow and a standing pool right below the outfall.

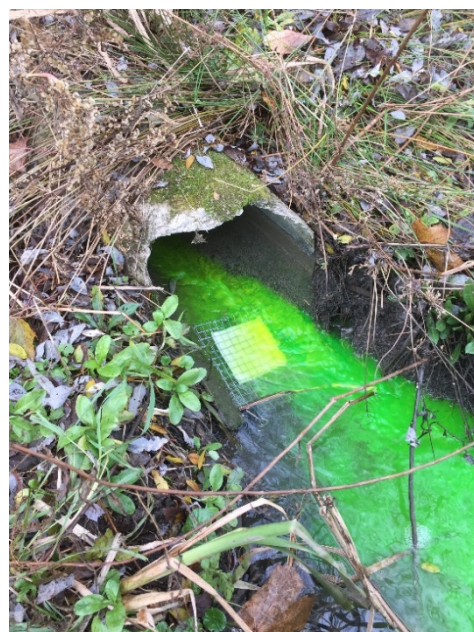
Figure 13. THTF\_7 Dye Testing.

The water quality data from the 8/6/2018 field visit, specifically the ammonia, detergents, and TP concentrations, triggered an advanced investigation of this system. The system was revisited on 8/20/2018, and dye tested from the Thetford Elementary School utility sink; dye was observed coming from the THTF\_7 outfall (Figure 13). The school was notified of the issue, and their facilities staff has placed the utility sink out of order. The School plans to tie the offending drain into their septic system as part of a larger renovation, but budget constraints due to their COVID-19 response has delayed the project until Summer 2021. As of March 2021, a restroom renovation project is currently out for bid. This will include a new utility sink tied to the wastewater system.
