Detecting and Eliminating Illicit Discharges in St. Johnsbury to Improve Water Quality

Final Report

August 14, 2015

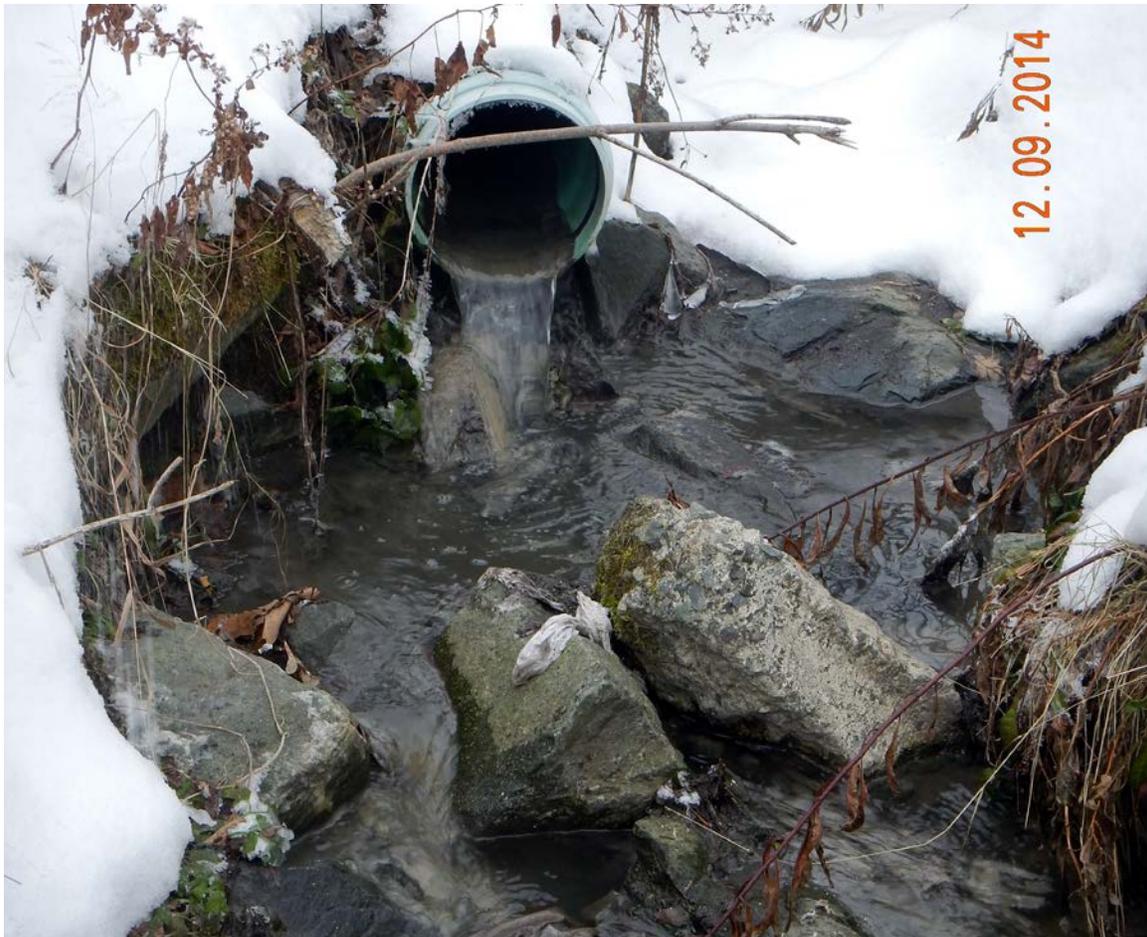
Sanitary wastewater discharging to the Passumpsic River from an overflow structure in St. Johnsbury on December 9, 2014. This overflow occurred during dry weather due to an obstructed sewer pipe. The problem was quickly corrected when brought to the attention of the Town.

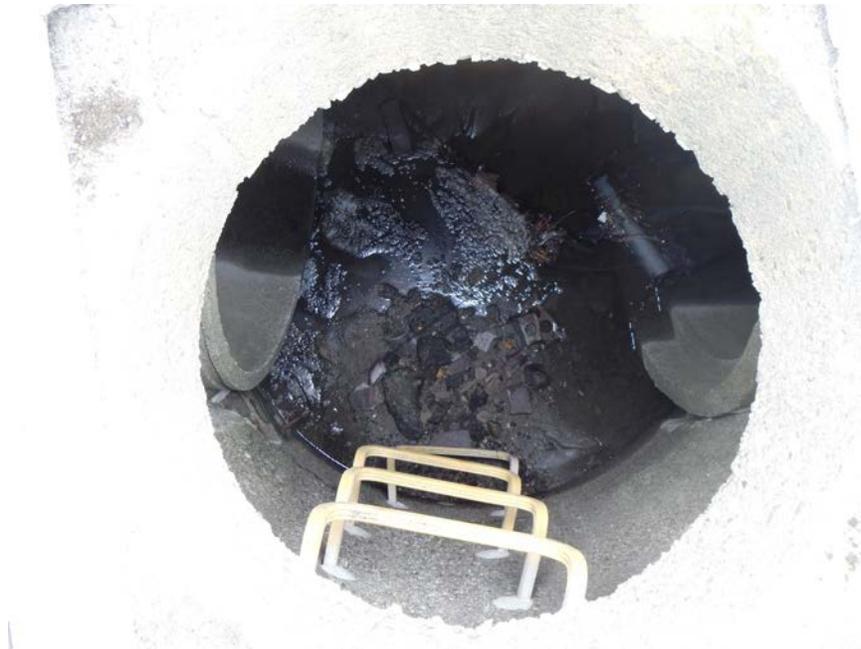
Figure 2. Suds in catchbasin CB-D on May 13, 2015

- Drain pipes enter catchbasins CB-F, CB-G, and CB-H from the direction of the mall building. No drains enter catchbasins CB-C, CB-D, or CB-E. Catchbasin CB-B was not found.

Conclusion: We suspect that the slop sink or another interior drain in the Green Mountain Mall is connected to the stormdrain on the backside of the property and that washwater is routinely discharged to this sink or drain. Another possibility is that cleaning of roof vents or air conditioning units introduces detergent and ammonia to the stormdrain. Regardless of the source, it is clear that contaminated water has been discharged to the stormdrain on the mall property in violation of the mall's stormwater permit.

Resolution: At this time, Stone recommends that this issue be referred to enforcement by the DEC project manager.

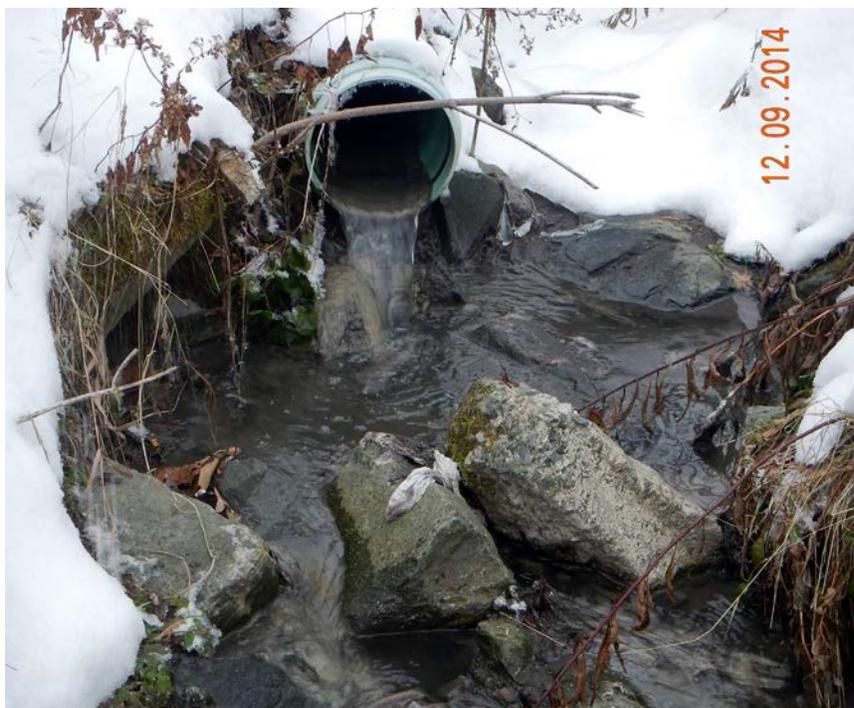
Figure 3. Sanitary wastewater overflow at CSO #21, December 9, 2014.

- In the fall of 2014, significant overflows were observed on two visits following light rains. These observations were communicated to the Town in a November 19, 2014 meeting.
- On December 9, 2014, with temperatures below freezing, snow on the ground, and no recent rain, a significant sewer overflow (estimated at 26 gpm) was observed at the outfall (Figure 3). An email describing these observations was sent to the town manager and the public works director on December 10, 2014. The Town quickly corrected the problem after determining that the overflow was caused by a blockage in the line.

Conclusion: The Town of St. Johnsbury corrected a blockage in a sewer line contributing to the dry weather overflow observed on December 9, 2014 (and presumably also the frequent overflow events during the fall of 2014).

Resolution: The dry weather overflow problem we observed was corrected by the Town of St. Johnsbury. CSO #21 is an active CSO. Additional sewer separation is planned within the contributing area (Dufresne Group Consulting Engineers, 2014).

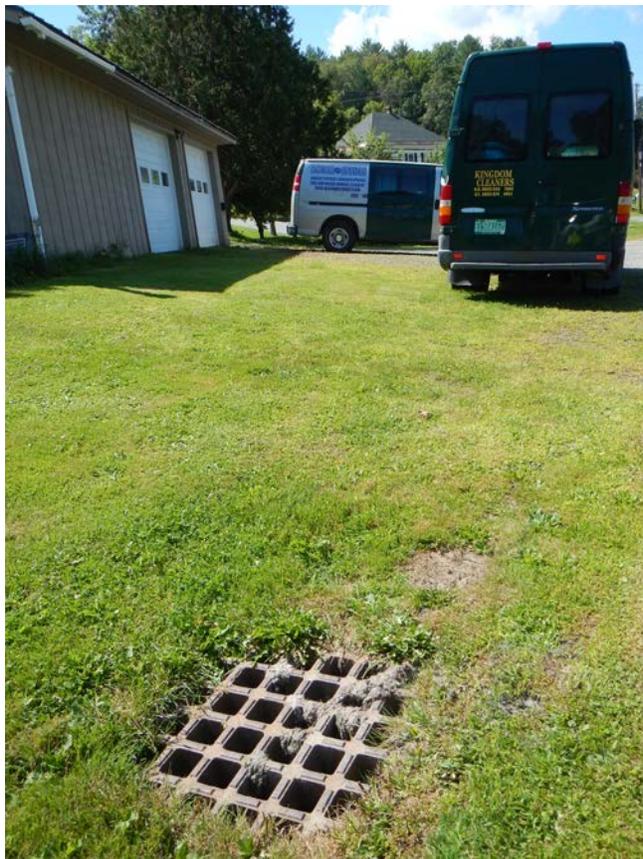
Figure 4. Catchbasin CB4A on Lafayette Street showing debris caught on catchbasin grate

Findings: On August 26, 2014 an exceedingly high MBAS concentration was measured in catchbasin CB4A on Lafayette Street (Map SJ-9). The ammonia concentration was moderately high. The sample appeared cloudy, had a strong sewage odor, and foamed when shaken. Waste deposits were present on the catchbasin grate. The apparent source of the washwater was dumping from Kingdom Cleaners to catchbasin CB4A. A Kingdom Cleaners vehicle is often parked near the catchbasin (Figure 4). This conclusion was reinforced on October 30, 2014 when suds were observed in the catchbasin and lint and fibers were again found on the grate. However, on a recent visit (May 25, 2015), there were no signs of washwater dumping.

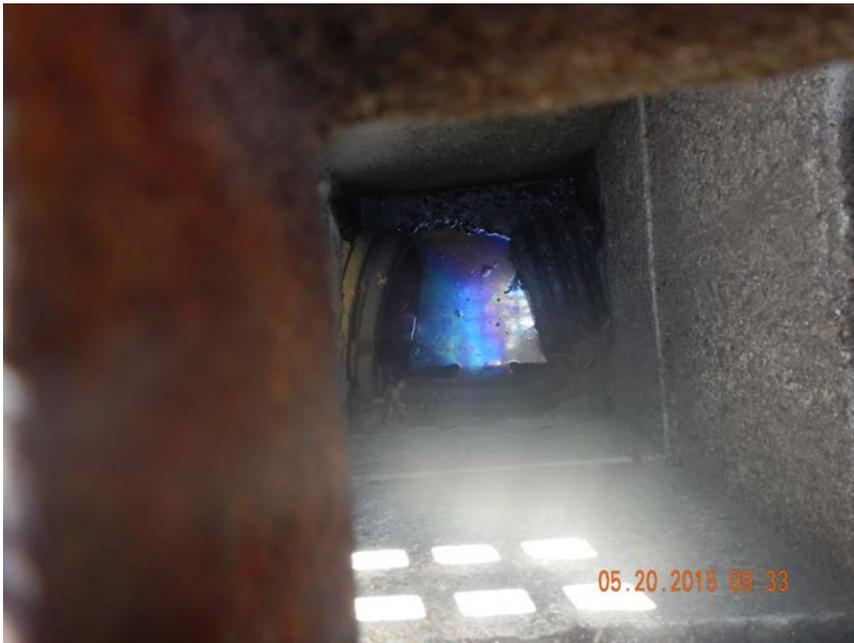
Figure 5. Petroleum sheen in catchbasin CB3 in system SJ840. Contaminated groundwater appears to infiltrate Pipe A, which connects to CB3 to CB4

- Dry weather flow appears to originate in the section of pipe between CB4 and CB3, indicating groundwater infiltration. No outflow has been observed in catchbasins CB4 through CB9. Figure 5 shows catchbasin CB3 with contaminated flow entering from the pipe on the left. The surface of the catchbasin appears to have petroleum sheen.

Conclusion: Petroleum contaminated groundwater and the reported use of large quantities of deicing salt by St. Johnsbury Academy would appear to explain most of the water quality data collected in this system. The possibility that pool water is discharged via the stormdrain appears unlikely based on the dye testing already performed; however, the Facilities Director agreed to investigate this possibility.

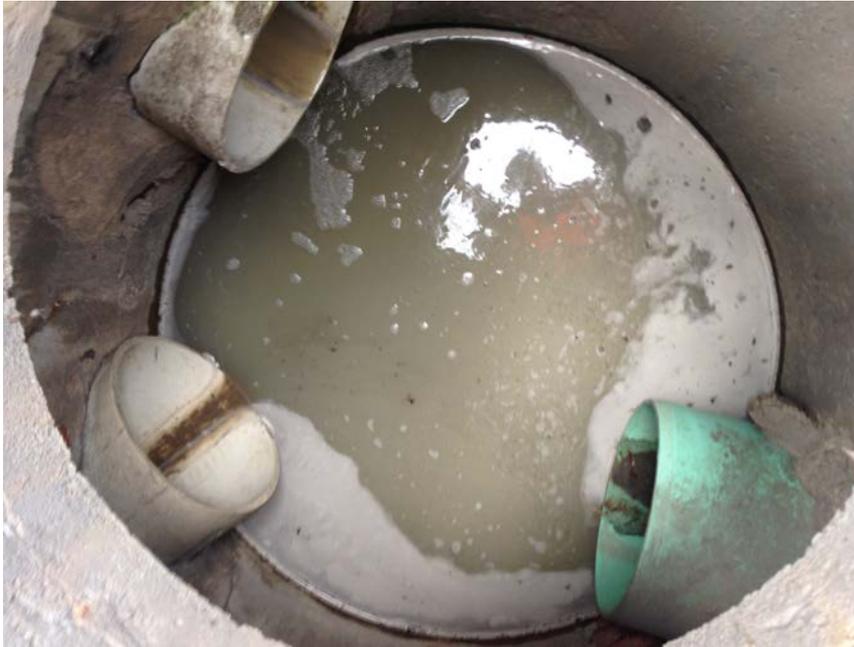
Figure 6. Suds in catchbasin CB11 in system SJ880 on May 21, 2014.

- Ammonia, chlorine, and detergents were detected in this system at various points while construction was ongoing in the drainage area in 2014. Figure 6 demonstrates the poor water quality observed during certain construction activities.
- Since most construction activities in this system were completed, no contaminants were present above limits of detection.

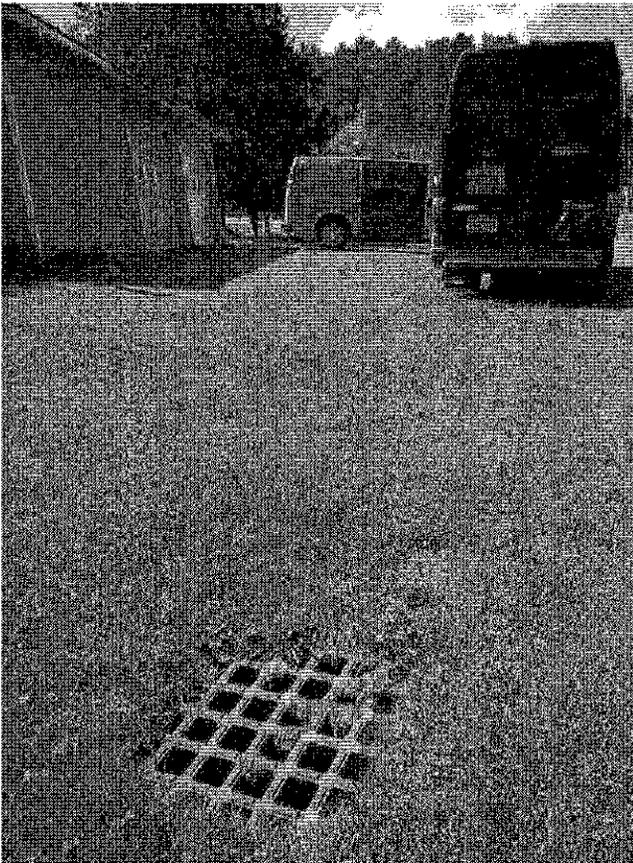
Catch basin CB4A on Lafayette Street showing debris caught on the grate
