Illicit Discharge Detection and Elimination Statewide Project #4

19-128

Illicit Discharge Detection and Elimination Statewide Project

#4: Final Report

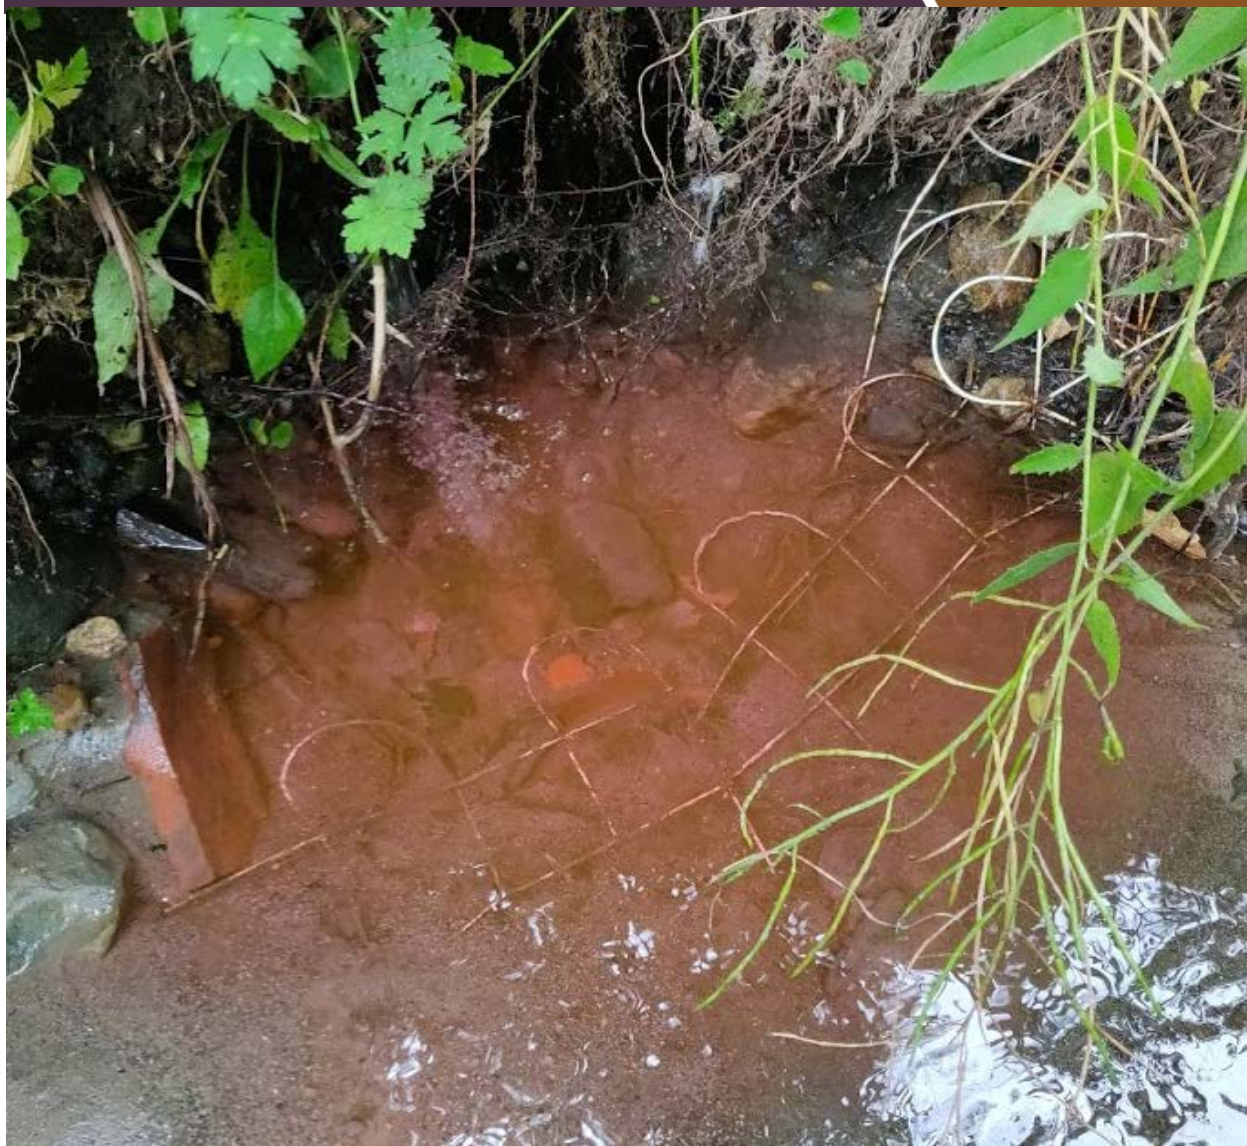
*Cover photo:
Red dye at the
SJ1730 outfall
confirmed an illicit
greywater
connection*

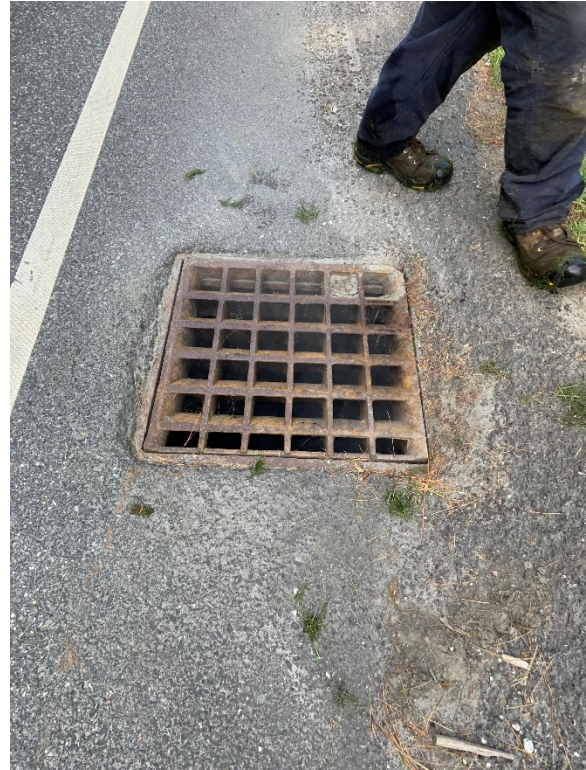
- Smoke testing was performed from a sanitary manhole located in the grass on the north side of the cemetery. No smoke was observed in the stormdrain.
- The smoke blower was then moved to a sanitary manhole on Maple Avenue downhill from the cemetery and the test was repeated. Diffuse smoke was observed at catchbasin CB6 (Figure 2), indicating crossover from the sanitary sewer. Smoke entered CB6 from the upstream direction. Catchbasin CB6 is the same structure at which Watershed Consulting observed dye in 2018 and Stone observed a wastewater odor on June 7, 2021.

Figure 2. Smoke observed in catchbasin CB6

Conclusion: We suspect there is a break in the sanitary sewer main in the vicinity of catchbasin CB6 and storm manhole MH2. It is possible that damming by wastewater solids backs up sewer flow intermittently, causing it to leak from the sewer and enter the stormdrain through an unknown pathway. Such a scenario could explain the contamination in the system and the crossover of dye to CB6 during a test by Watershed Consulting in 2018. The likeliest point of wastewater entry to the stormdrain is to the pipe crossing Maple Avenue into MH2.

Resolution: Stone demonstrated there is a wastewater connection to the stormdrain in the vicinity of CB6 and MH2. We recommend the City of Barre camera the Maple Avenue sanitary sewer main in this area to pinpoint the wastewater leak or cross connection.

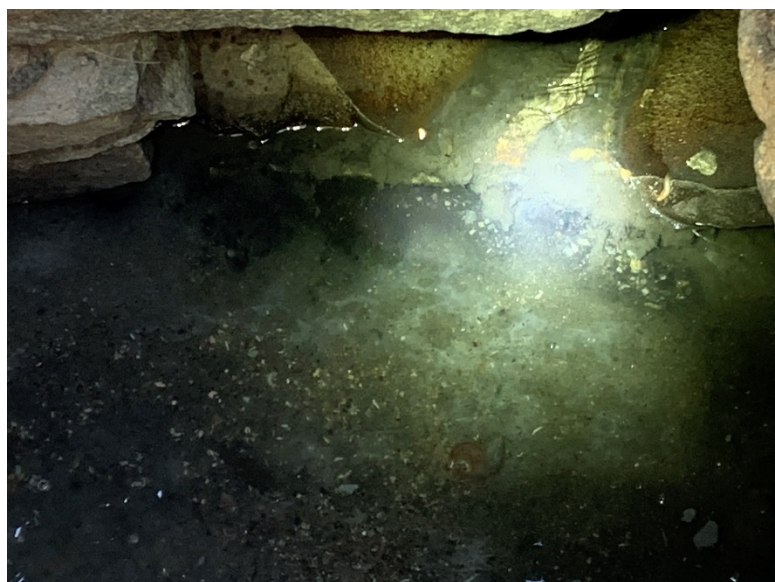
- A grey biofilm was observed in storm manhole

Figure 3. Biofilm indicating wastewater contamination in MH11

Resolution: Working with the City DPW, Stone has demonstrated there is a fourth, substantial leak in the Hill Street sanitary sewer. We recommend the City of Barre reconstruct the sanitary sewer between Nelson Street and the sanitary sewer manhole at 204 Hill Street.

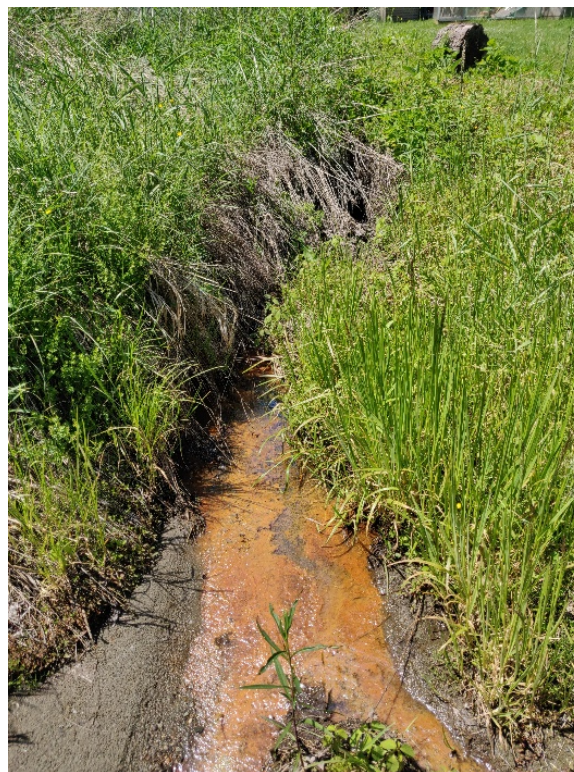
- A sample collected on June 17, 2020 from the swale below the CT01 outfall had a slightly elevated ammonia concentration (0.5 mg/L).
 - Iron staining was observed in the swale below the outfall (Figure 5).
 - OB pads set at the outfall and catchbasin CB2 were negative.
- On June 25, 2020, iron staining was observed in groundwater seeps in two other locations.

Conclusion: Iron staining and the elevated ammonia concentration measured in the swale likely result from a historic petroleum release. Ammonia is often associated with degraded petroleum and accumulations of ferric iron, due to reducing conditions in shallow groundwater. However, the origin of contamination is not clear in this case. The nearest known petroleum release (Berkewitz Transport; site 93-1449) is approximately 300 feet north of the closest catchbasin in the CB01 stormdrain. We suspect the low ammonia concentration and iron staining observed in the swale below the CT01 outfall result from a historic petroleum release, rather than a currently active discharge.

Figure 5. Iron staining in swale below outfall CT01

Resolution: Not applicable.

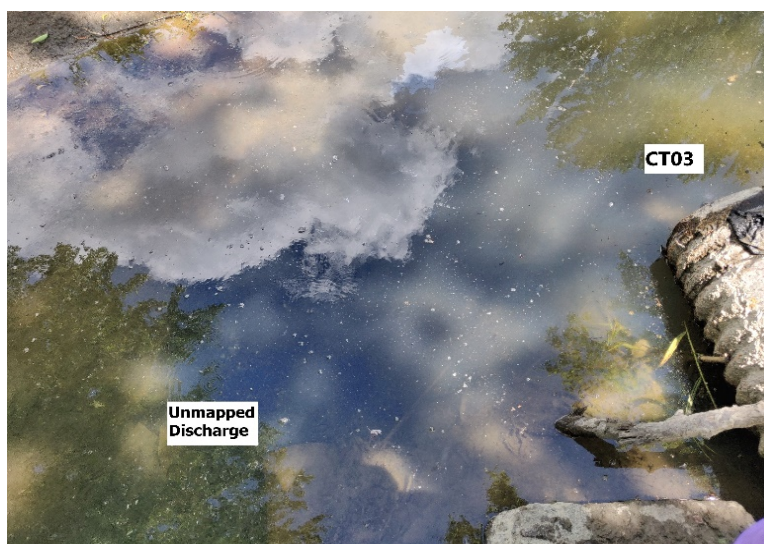
- When first observed on June 25, 2020, this pipe was noticeable due to the plume of black, oily sediment at the outlet (Figure 6). The plume of oily sediment measured roughly 4 feet x 6 feet. When probed, this sediment plume released bubbles of black oil which floated to the surface. Multiple stained white shop

Figure 6. Oily sediment plume from unmapped iron pipe

- The closest facility to this outfall is a garage operated by McDermott's Inc., a trucking company.
- The garage site currently operated by McDermott Inc. is the site of a previous hazardous materials release (file 93-1449) when operated by a former business, Burkewitz Transport. Three leaking underground fuel storage tanks and 200 cubic yards of petroleum contaminated soil were removed from the site. Subsequent testing demonstrated acceptably low levels of petroleum vapor in the buildings on site. A plan for the site, provided in a letter dated February 15, 1994, from Dufresne-Henry, Inc. (Bruce Cox, P.E.) to the VTDEC Hazardous Materials Management Division (Chuck Schwer), shows a 4-inch diameter clay pipe passing diagonally across the site. It is likely this pipe is connected with the submerged iron pipe observed in the Black River, although this has not been confirmed. There is no mention of the iron pipe in the 93-1449 site file. If the clay tile line is connected with the iron pipe, the presence of the oily deposit at the pipe outlet may result from residual petroleum migrating from the site via the clay tile line to the Black River. However, the presence of rags at the site suggests a more direct connection, such as from a connected floor drain or sink in the garage building.

Resolution: These findings were sent to the Town of Coventry's Road Commissioner on May 15, 2023, with a request that the Town of Coventry contact McDermott's garage. The VTDEC Hazardous Materials Management Division was recently notified of this issue in November 2023.

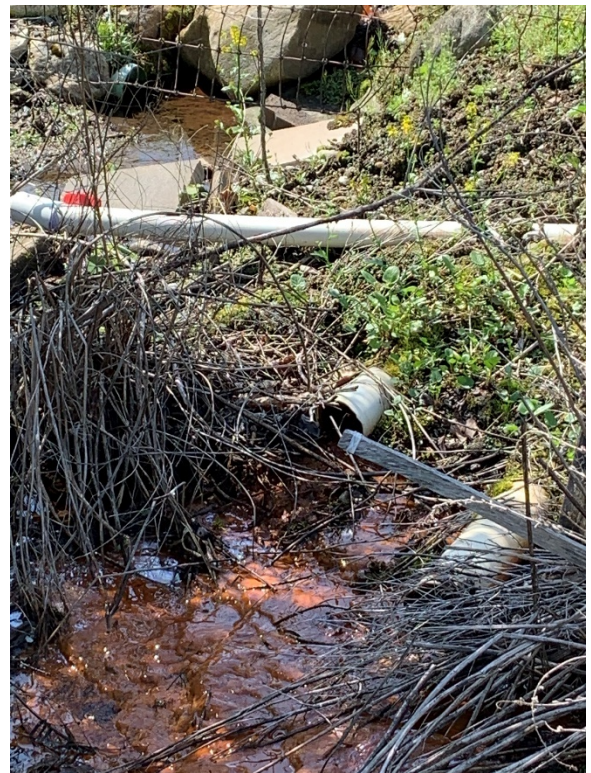
Figure 9. Gully and drainage pipe at north side of nursery property

Resolution: It is unclear what, if any, recourse DEC or the Town of Hartford may have to reduce flow and transport of iron floc from the nursery property onto the sports complex property.

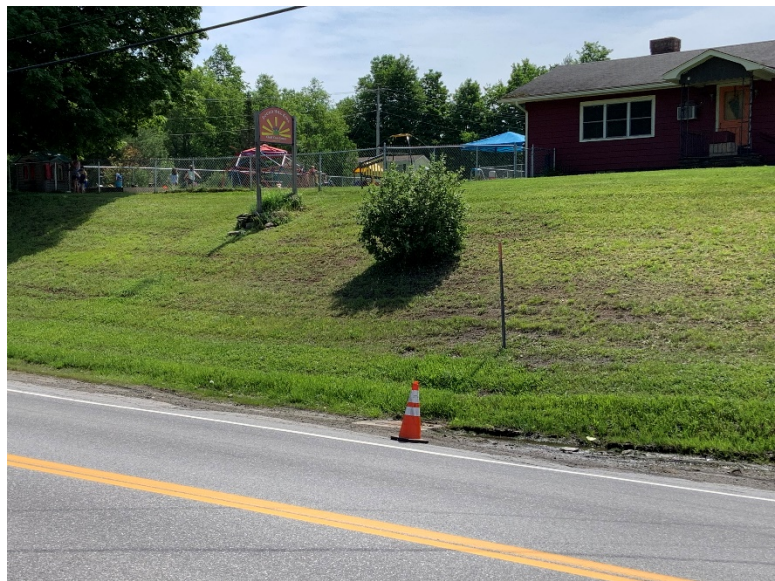
Figure 12. Proximity of catchbasin CB01 (at cone) to leachfield

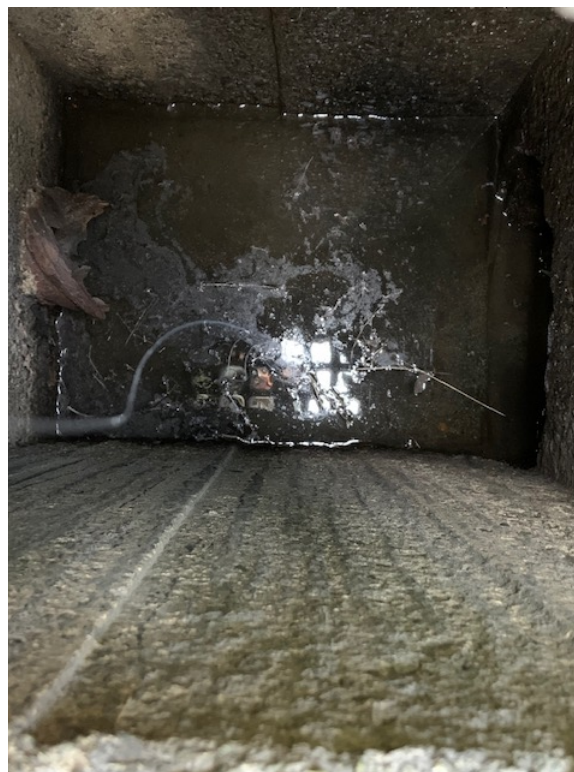
Figure 13. Catchbasin CB02 on stormdrain MV01

Resolution: The Town of Montgomery is making progress planning community wastewater treatment systems for Montgomery Village and Montgomery Center. Stone is part of a team assisting the town in designing these systems. The MV01 drainage system is within the area to be served by the new village system. Construction of the wastewater collection and treatment systems is projected for 2025. Stone is confident that construction of the village wastewater system will eliminate any existing illicit wastewater discharges in Montgomery Village.

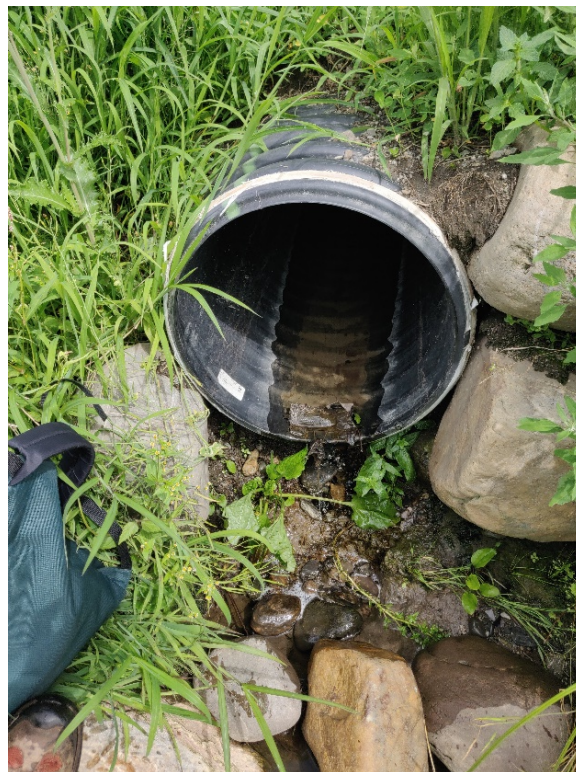
- Water samples were collected at the outfall on July 21, 2020. OB was detected at the outfall, although the fluorescence was weak. A small amount of foam was also noted (Figure 14). The specific conductance was very low ($95.9 \mu\text{S}/\text{cm}$).
- In subsequent visits on August 19 and 25, 2020, we attempted to bracket the source of the OB. OB pads were placed at the outfall and in catchbasins CB01 and CB02. All these pads were negative.
- A fourth visit was made on August 31, 2020. Ammonia was detected at catchbasin CB01 and the culvert inlet (SW01). No ammonia was detected a short distance upstream from the culvert inlet (SW02). A faint wastewater odor was noted in the churchyard adjacent to the stream.

Figure 14. Suds at the MV04 outfall, July 21, 2020

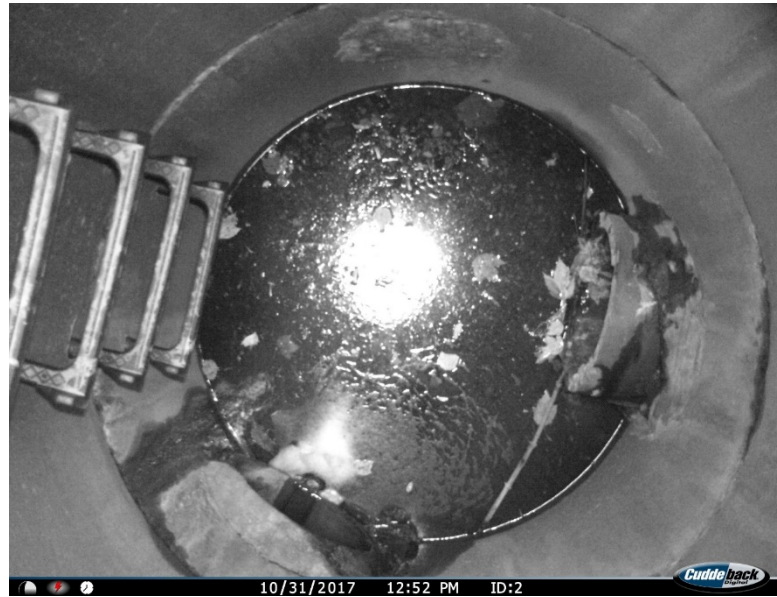
- Samples collected at the outfall on July 16, 2020, had slightly elevated MBAS (0.3 mg/L) and *E. coli* (461.1 MPN/100 mL) concentrations (Table 31).
- Dye testing of the apartment at the back of 176 Main Street was attempted on September 8, 2021; however, we could not access the apartment. Flow in manhole CB7 was clear and there was no odor.
- A sample collected at the outfall on September 8, 2022, had 124.6 MPN/100 mL *E. coli*.

Figure 15. Detergent suds entering manhole CB7

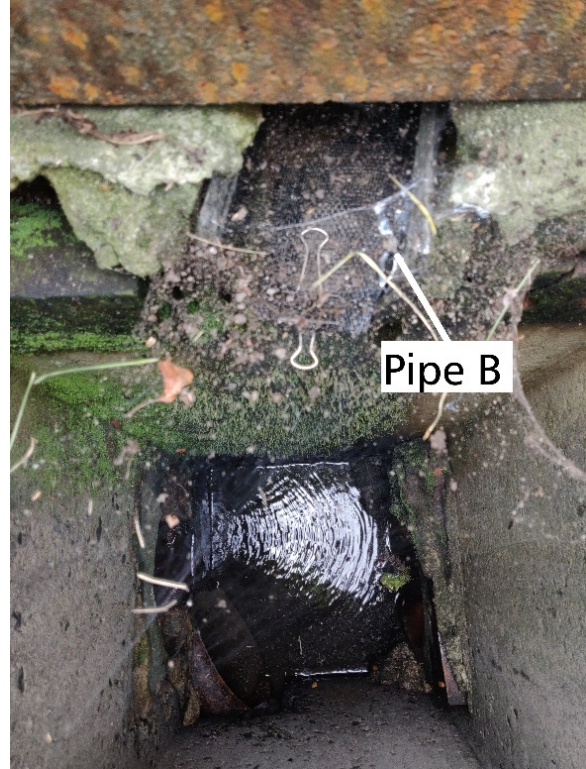
- OB pads placed at the outfall and catchbasins on Berlin Street above and below the Wilson Street connection in August 2022 were all negative.
- The Montpelier DPW did their own investigation of this area and found no sanitary wastewater connections to the separate stormwater system. They did, however, confirm a water leak at the Wilson Street–Highland Avenue intersection.

Figure 16. Unmapped pipe enters catchbasin CB28

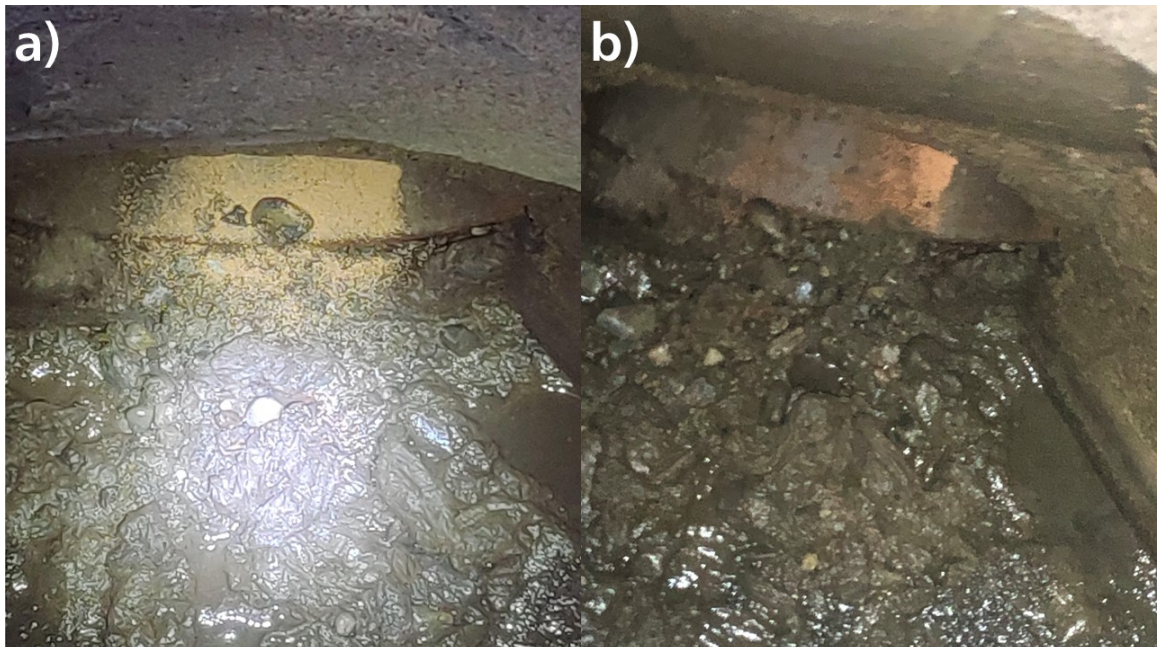
Figure 18. Manhole MO01-MH1: a) Cork placed in inlet pipe; b) after flow on August 17, 2020

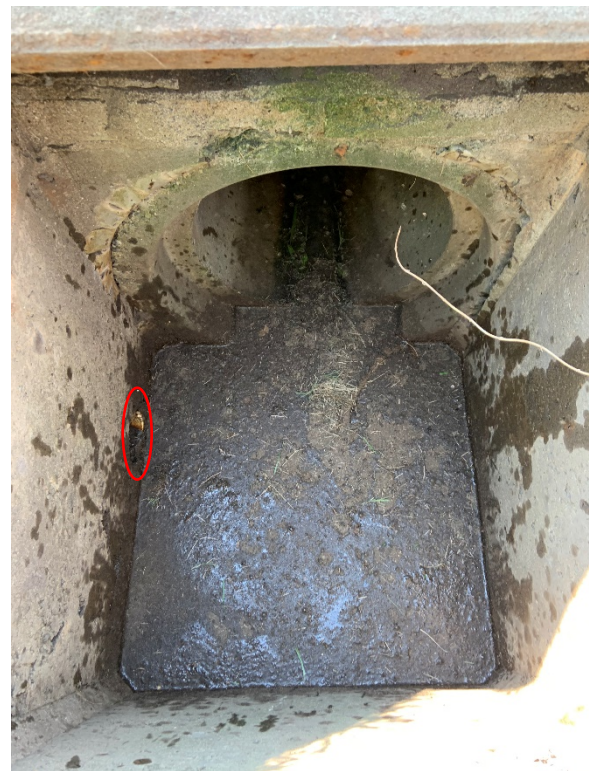
Figure 21. Pipe (circled) entering catchbasin CB1

Resolution: With this report, we are notifying the Town of South Hero and DEC's Regional Wastewater Engineer of this finding.

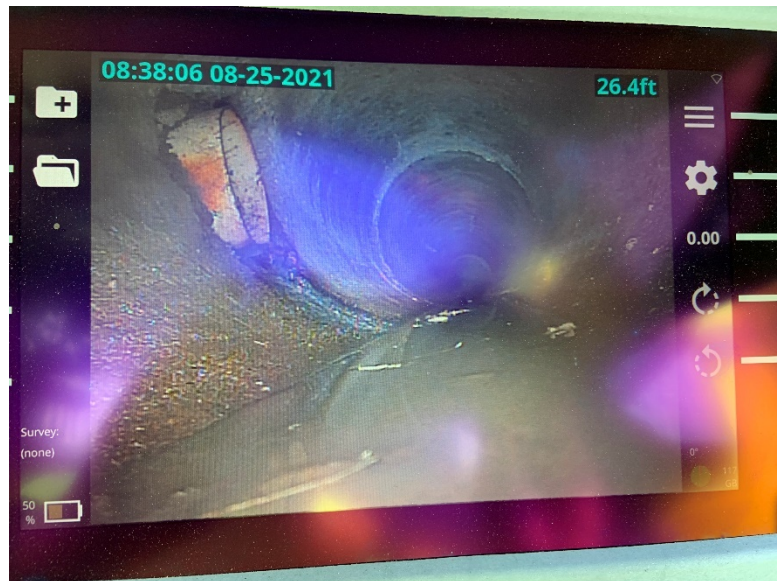
west. The first pipe (Figure 24) enters the stormdrain ~25 feet downstream (north) of catchbasin CB05 and appears aligned with 471 US-2. The second pipe enters the stormdrain ~56 feet downstream of CB05 and appears aligned with the side yard at 473 US-2. When we smoke tested this section of the stormdrain, the basement of 471 US-2 filled with smoke, which indicates the first pipe is either a connected interior drain or possibly a wastewater connection venting through a dry plumbing trap. The house at 471 US-2 was vacant, which makes the dry trap scenario plausible. Also, faint smoke appeared in the side yard at 473 US-2 in the vicinity of the septic tank, suggesting the second pipe is a septic tank overflow from 473 US-2.

Figure 24. View downstream (north) in SO05 stormdrain

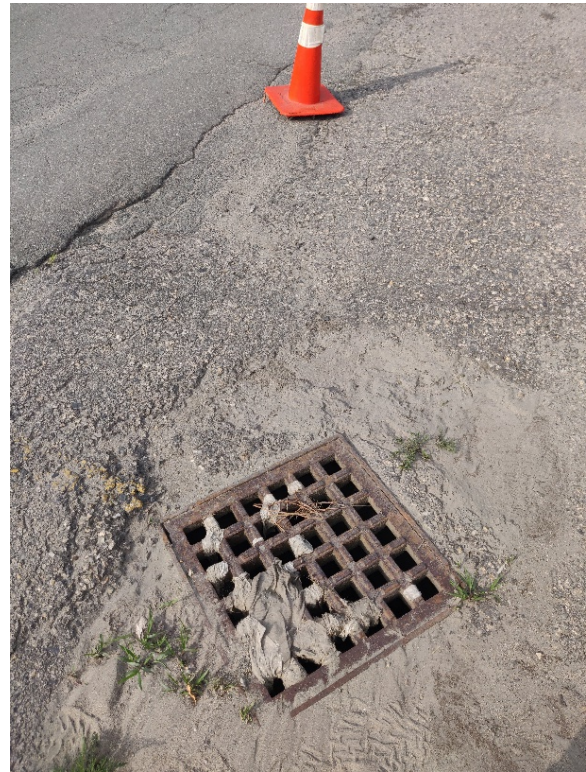
- When it was clear there were no direct illicit connections to CB02 and CB03, two St. Johnsbury DPW employees explained that combined sewer manhole SMH03 had overflowed to the street several times during rainstorms over the summer, including once in the week prior to the August 19, 2020, visit. In this most recent event, sanitary wastewater had flowed out into the parking lot at 492 Bay Street.

Figure 25. Shop rags on catchbasin CB02 grate

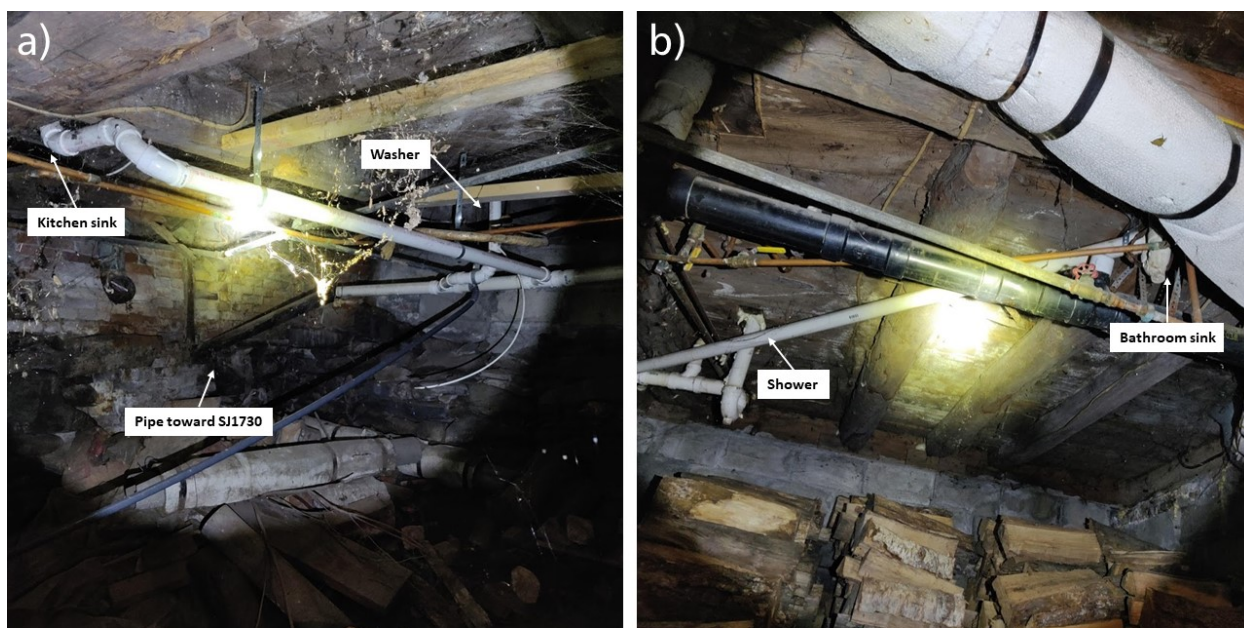
- Stone technician George Valentine returned to 1714 Breezy Hill Road to inspect its wastewater piping. The homeowner confirmed that for as long as they have occupied the house a pipe has drained greywater from the rear of the house, separate from the septic system. The existence of this 3-in. pipe was confirmed in the basement. It drained the kitchen sink, dishwasher, shower, and bathroom sink (Figure 26). Red dye poured in the shower drain appeared at catchbasin CB1 (Figure 27a) and at the outfall (Figure 27b) shortly afterward.

Figure 26. Greywater connection at 1714 Breezy Hill Road

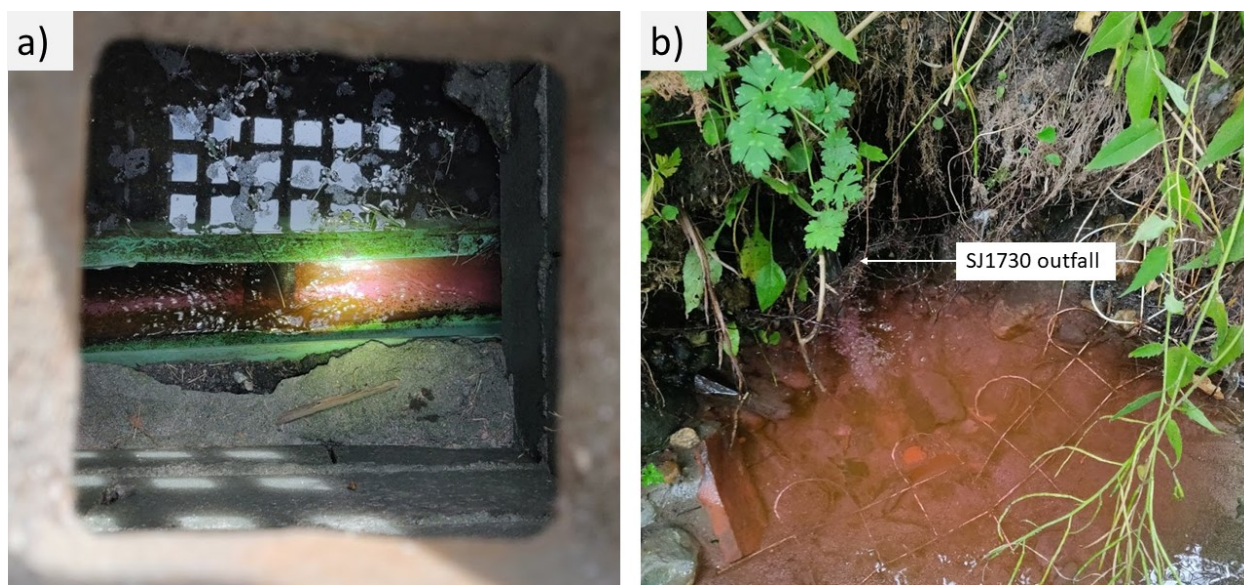
Figure 27. Red fluorescent dye a) in catchbasin CB01 and b) at the SJ1730 outfall
