Upper Winooski River Basin Illicit Discharge Detection and Elimination Project: Final Report

15-090

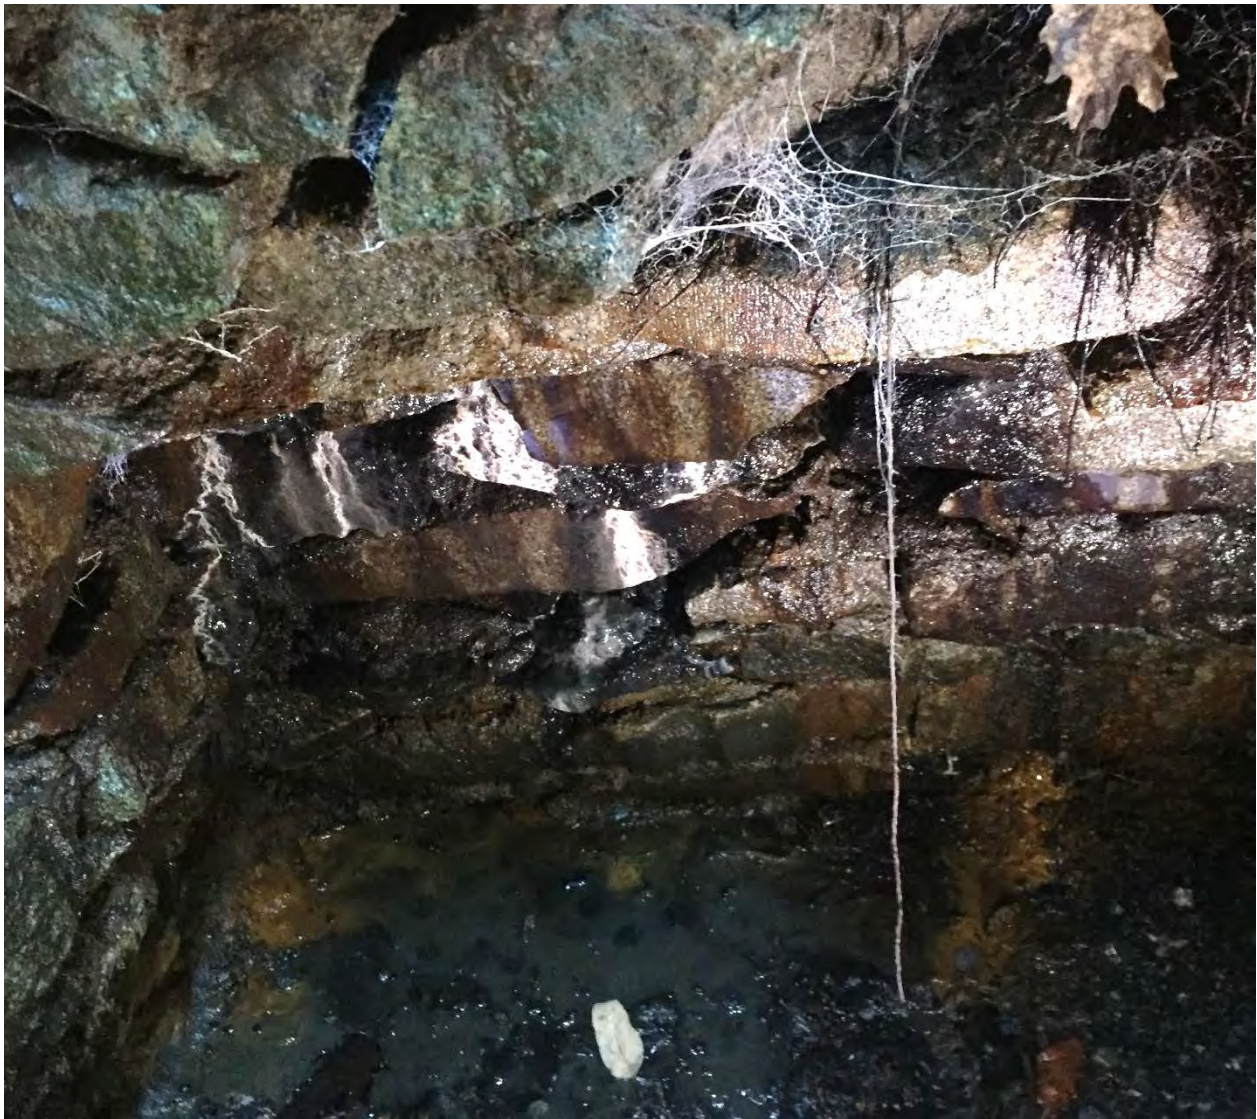
*Cover photo:
wastewater from
a broken sewer
lateral leaking
through the walls
of a catchbasin in
Barre*

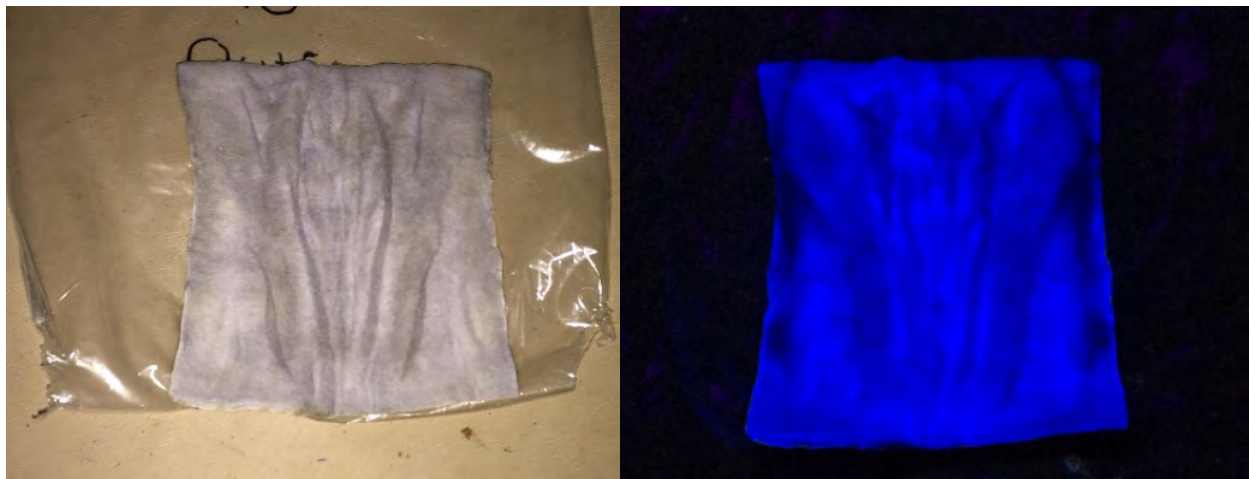
Figure 1. Positive optical brightener pad under fluorescent (left) and UV (right) lamps.

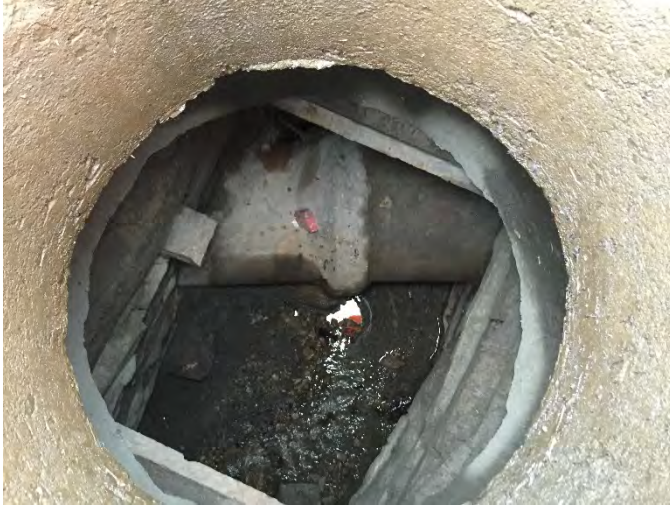
Figure 2. Stormwater manhole MH1 with concrete sewer main running through it

- The concrete sewer main flowing through stormwater manhole MH1 (Figure 2) has reportedly been repaired multiple times in the last decade. This pipe was found to be leaking badly when FWR and Stone performed the first Barre City IDDE project in 2006. According to the Department of Public Works, it was repaired in 2006 and again more recently. In a November 24, 2015 meeting, Everett Hoyt indicated he had recently inspected the pipe section and it was not leaking. Mr. Hoyt also explained that he had found

and cleared a major obstruction in the sewer main in the sanitary manhole immediately below this section of pipe. The obstruction has caused wastewater to surcharge but not overflow the sanitary manhole.

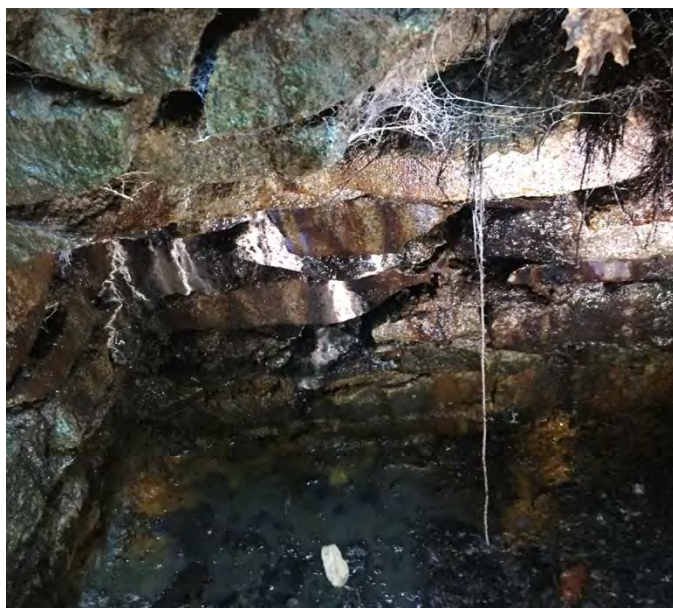
Figure 3. Interior face of CB4 showing wastewater infiltration

- A previously unidentified pipe was found in CB4 on October 19, 2017. This 12-inch diameter pipe appears to be an old sanitary sewer line. This pipe (Pipe A) was dripping when observed. OB pads were placed in Pipe A and Pipe B (the 4-inch diameter drain) on October 13, 2017 and retrieved on November 1, 2017. Optical brightener was detected in Pipe A but not in in Pipe B.

- On November 21, 2017, Dave Braun, Mr. Graham, and Mr. Hoyt inspected catchbasin CB4 Pipe A with a CCTV camera. While pipe A was wet at the outlet, the inside of the pipe was dry within three feet of the opening. The interior of the pipe was filled with dry debris, indicating the pipe flows rarely, if at all. However, water was seeping through the stone walls of the catchbasin and pooling at the base of the wall (Figure 3). A white film was observed on the walls and a foul odor and flies were present. The water seeping through the walls was also wetting the end of Pipe A, which explains the OB detection in Pipe A.
