Detecting and Eliminating Illicit Discharges in the Upper and Middle Connecticut River Basin: Final Report

15-090

Jim Pease / *Environmental Scientist*
VT Department of Environmental Conservation
1 National Life Drive, Main Building, 2nd Floor
Montpelier, VT 05620-3522
Jim.Pease@vermont.gov
802.490.6116

David Braun / *Senior Water Resources Scientist*
Stone Environmental, Inc.
535 Stone Cutters Way
Montpelier, VT 05602
dbraun@stone-env.com
802.229.5379

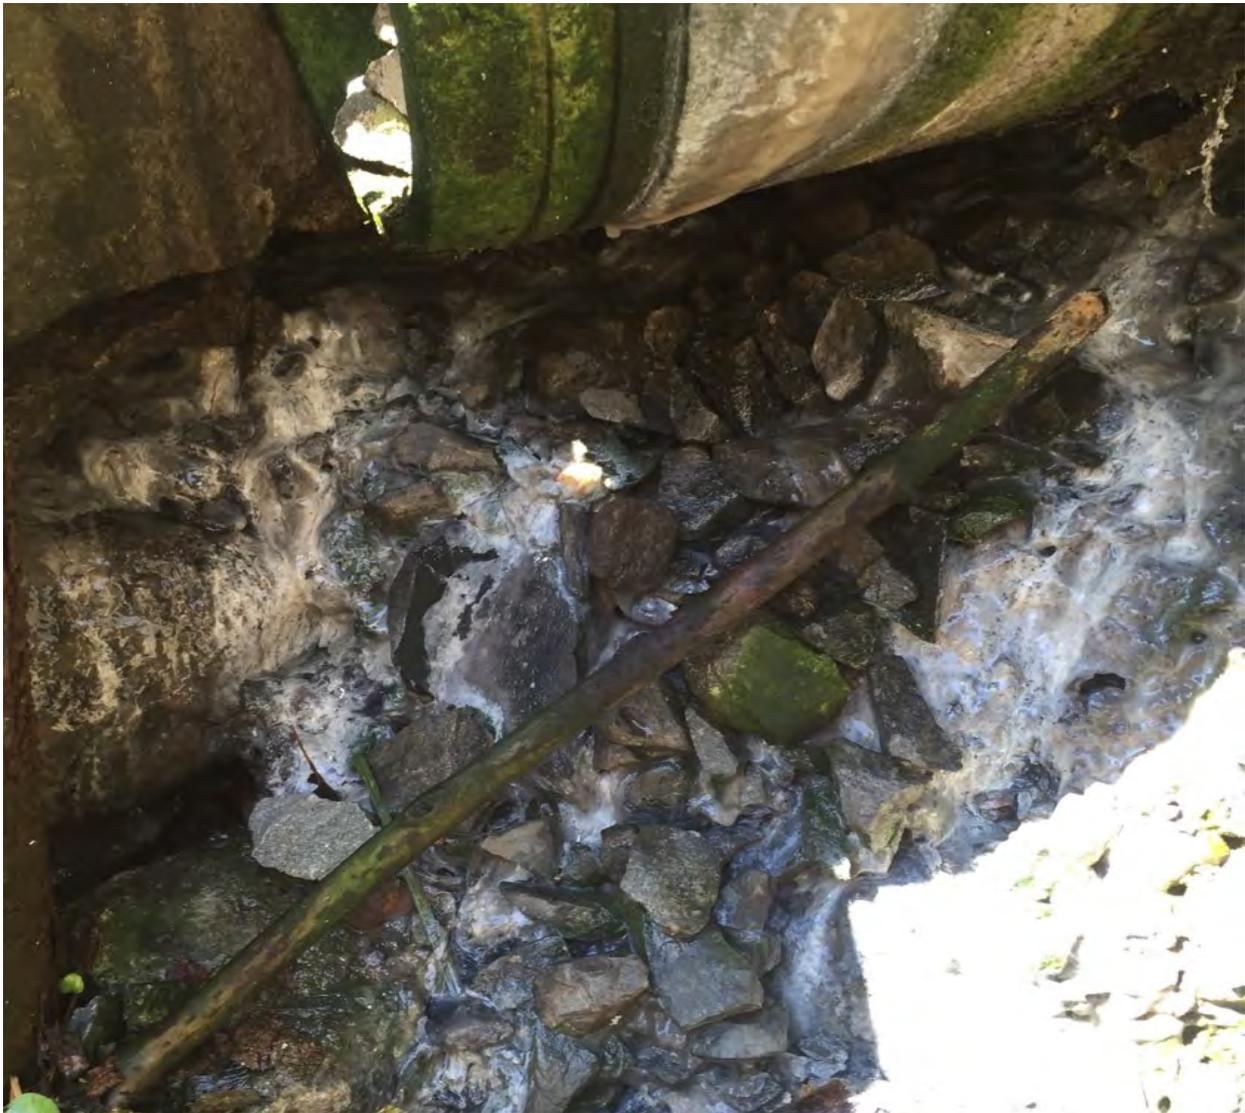
*Cover photo:
wastewater from
a failed septic
system surfacing
into a ditch in
Concord*

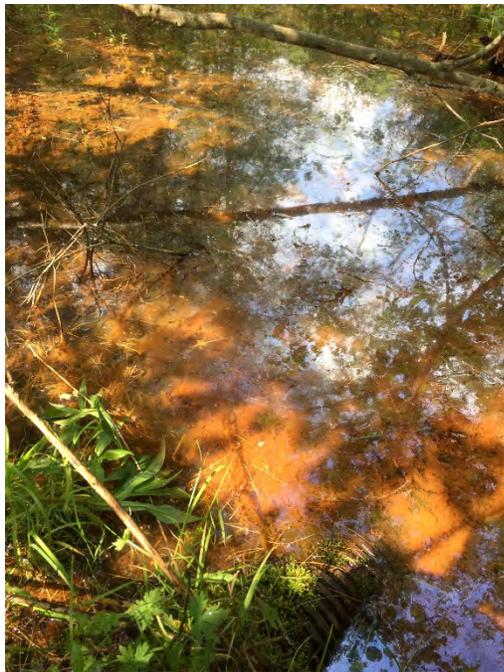
Figure 2. Iron floc in pool behind the East Burke Garage.

- The outfall was found submerged in a large pool, west of the East Burke Garage, which drains to the Passumpsic River (Figure 2). Heavy deposits of iron floc were present throughout the pool.
- On June 2, 2016, several out of range free chlorine results were recorded due to the high turbidity of the samples. Poor sample quality may have resulted in an inaccurate chlorine measurement on the first assessment date.
- VT ANR's Environmental Research Tool provides one record that is potentially related to the contamination observed. At the East Burke Garage (facility ID #51), two 1,000 gallon gasoline tanks installed in 1961 were removed thirty years later, in 1991. One tank was deemed to be in good condition, while the other was in fair condition.

contamination by degraded petroleum products. We suspect the problem may stem from a leaking underground storage tank. One of the tanks removed in 1991 was reported to be in fair condition. The petroleum release may well predate the tanks removed in 1991.

Resolution: By this report, the problem is referred to the DEC Hazardous Waste Management Section.

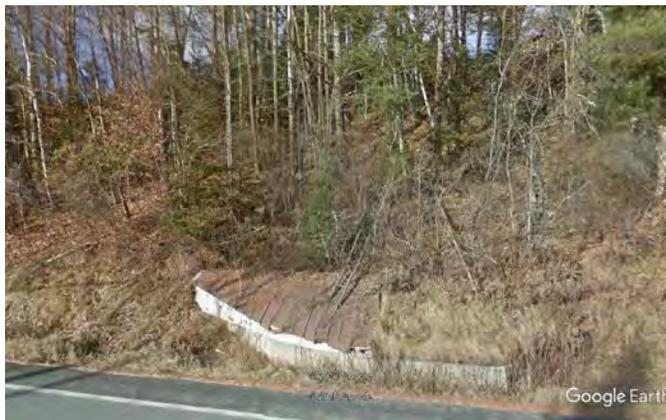
Figure 3. Community spring next to Route 2 in Concord

Conclusion: The consistent detection of optical brightener at the outfall confirms the presence of wastewater. Given the clear appearance of the discharge and the absence of ammonia and MBAS detergents, the wastewater component of the flow is likely minor and partially renovated. While the low concentration of *E. coli* (10 MPN/100 mL) found at the outfall does not exceed water quality standards, any presence of *E. coli* would be cause for concern if this flow was indeed connected with the community spring water supply. If this flow is from the spring, it will be important to determine whether wastewater is infiltrating the spring or the piping system from the spring.

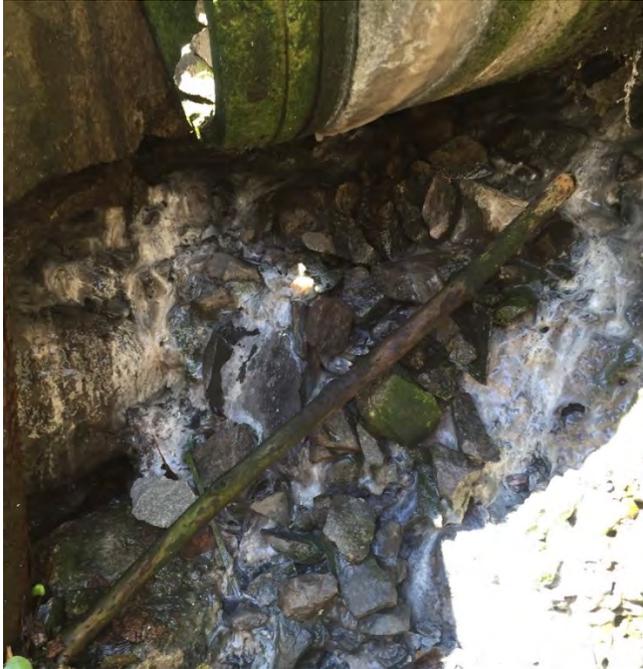
- Optical brightener was detected at the outfall and in all structures up to a ditch east of 6 High Street. The following structures tested positive for optical brightener: catchbasins CB1 through CB5, the small stream behind 46 High Street, the ditch east of 6 High Street, and the footing drain south of 91 High Street.
- Optical brightener detections led to surfacing wastewater at 6 High Street (Figure 4). Wastewater odors were present in water surfacing into the ditch at the base of the retaining wall.

Figure 4. Surfacing wastewater at 6 High St., Concord, May 18, 2016

- Catchbasin CB5 tested positive for optical brightener, although it is not downstream of the surfacing effluent at 6 High Street.
- Samples were collected at the outfall on July 26, 2016 for *E. coli* and TN analysis (Table 30). The *E. coli* level (31 MPN/100 mL) was surprisingly low. The rate of effluent surfacing at 6 High Street appeared to decline over the dry summer months.
- The DEC Regional Engineer, Richard Wilson, visited the site on August 11, 2016 and confirmed that wastewater from 6 High Street was surfacing into the ditch.

We recommend that optical brightener testing be conducted in 2017 at the outfall and at catchbasin CB5, to verify whether additional sources of contamination may exist in this system.

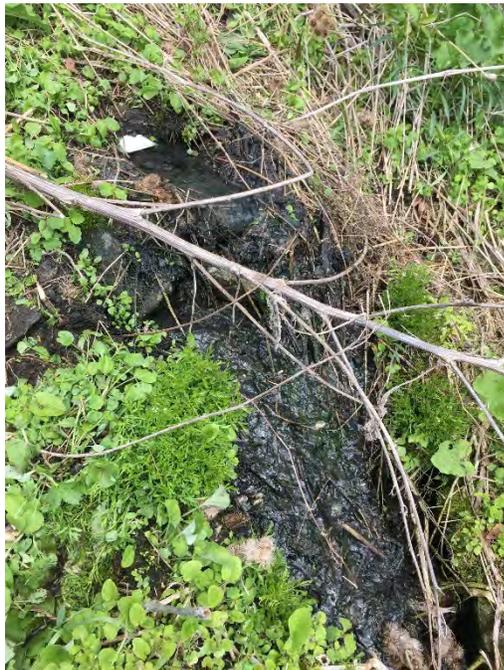
Figure 5. Septic tank overflow at top of streambank

- Optical brightener was detected at the outfall (strong fluorescence) in May 2016. Concentrations of ammonia and MBAS detergent were also elevated.
- A gray growth and black film were seen at the outfall and on the ground surface (Figure 5), and a strong wastewater odor was observed.
- On July 26, 2016, samples were collected for *E. coli* and TN analysis (Table 30). No *E. coli* was detected. The TN concentration (110 mg/L) was extremely high. Unfortunately, no flow measurement was possible.
- The DEC Regional Engineer, Richard Wilson, visited the site on August 11, 2016 and determined that the outfall was a septic tank overflow pipe from the 356 Main Street apartment house.

Conclusion: This discharge was confirmed to be an overflow pipe from a septic tank serving the apartment house at 356 Main Street. The absence of *E. coli* likely resulted from an inimical condition in the septic tank or in the sample container that caused the *E. coli* to die off. Clearly, this discharge consisted of septic tank effluent, and was therefore, highly polluted.

Resolution: According to Mr. Wilson, the owner of 356 Main Street contracted with an engineering firm to design a new onsite wastewater treatment system for the property. In November 2016, the septic tank overflow pipe was eliminated, the tank was pumped, and a running toilet inside the building was repaired.

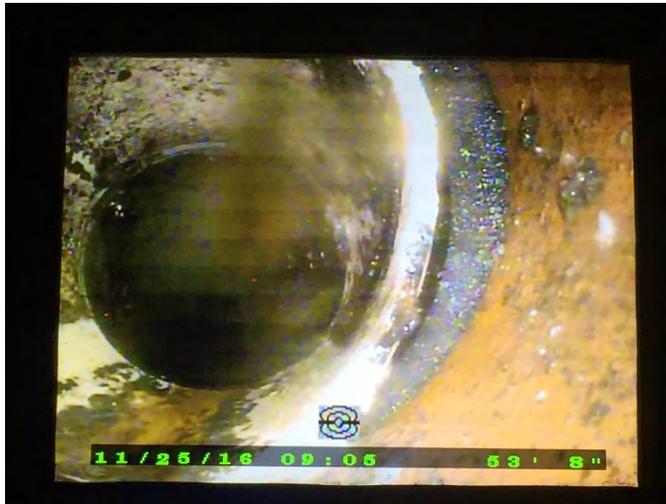
Figure 6. Displaced coupling on house sewer lateral on Jefferson Avenue in Gilman

- At least two houses on Jefferson Avenue, #40 and #50, have leaking sewer laterals. Dye flushed down the toilet or poured into the floor drain in these houses passed quickly into the sanitary sewer. After a significant delay (~15 minutes), the dye appeared in the stormdrain. Because the dye did not pass from the sanitary main to the stormdrain, the leaks must be in the laterals. Figure 6 shows a misaligned joint in the sewer lateral serving #40 Jefferson Avenue.

Conclusion: Two houses, #40 and #50 Jefferson Avenue, were confirmed to have sewer laterals that leak wastewater into the stormdrain. We expect the same problem exists at #56 Jefferson Avenue, but we were unable to confirm this. Two other houses with potentially faulty (leaking) sewer connections are #53 and #45 Jefferson Avenue; however, neither house could be tested. We believe that the remaining houses on Jefferson Avenue do not have a problem. The sewer main on Jefferson Avenue appears to be in good condition.

Resolution: Between two and five houses on Jefferson Avenue have faulty sewer laterals. Laterals at two of these houses (#40 and #50) were confirmed to leak wastewater into the old, repurposed sewer. One approach for eliminating the discharge is to compel or enable the homeowners to replace their leaking laterals. The three houses with uncertain sewer connections (#56, #53, and #45) should also be dye tested when possible to identify whether any of them are contributing wastewater to the stormdrain. This approach would likely be time consuming for the Town of Lunenburg (or alternatively, DEC) and expensive for the homeowners.

An alternate approach for eliminating the discharge is to plug the old, repurposed sewer line on Jefferson Avenue. There are currently no functional surface inlets to this old sewer line; it does not appear to convey stormwater at all. The old system represents a maintenance liability for the Town of Lunenburg. We expect that if the drain was plugged, wastewater leaks in the laterals would slow, and without a conduit, the town could eliminate wastewater discharges to surface waters.

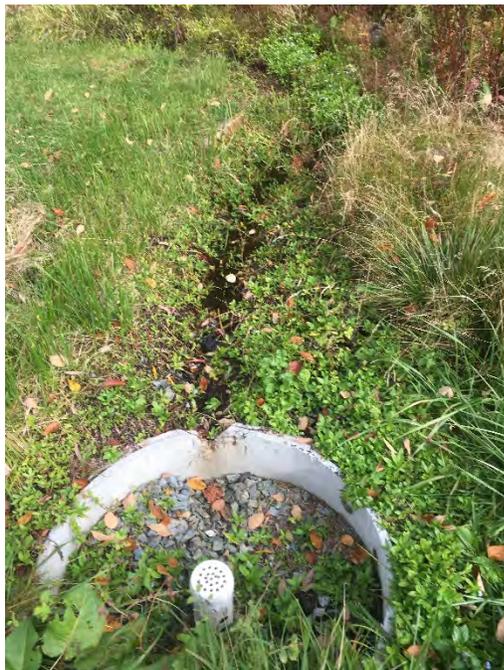
Figure 7. Drainage structure behind 1426 Route 302 in Groton

- The initial assessment of the GR040 system occurred on October 22, 2015. The outfall was not found during this visit. Ammonia (0.3 mg/L), optical brightener, and a slight septic odor were detected in a catchbasin on Route 302. We assume this catchbasin was the nearest accessible catchbasin to the outfall. However, the specific structure sampled is unclear.
- Optical brightener monitoring pads were deployed throughout the GR040 system on June 15, 2016. Optical brightener was detected in five of the 16 structures. The structures in which OB was detected (CB12, CB11, CB10, CB5, and the outfall) form a consistent path from catchbasin CB12 to the outfall. A definite wastewater odor was observed in CB12.
- In October 2016, additional pads were deployed in catchbasin CB12 and in the next upstream structure, depicted in Figure 7. This drainage structure is located at the end of the

driveway at 1426 Route 302 and collects water draining from a wetland area that is conveyed to a pipe under the driveway. Optical brightener was found in both CB12 and in the drainage structure. A pronounced wastewater odor was present in catchbasin CB12 when the pads were retrieved on October 23, 2016.

- In November 2016, the Groton Town Health Officer, Dan Webster, reported that he found a structure in the wetland area north of the house at 1448 Route 302 that he suspected was the source of the wastewater contamination in GR040. This wetland area is immediately east of the fire department building. Mr. Webster suspected that the structure he found is some type of wastewater seepage pit. A small stream was flowing over the top of the structure and the structure was releasing a discolored effluent. Mr. Webster also noted that the structure was not owned by the Groton Fire Department.
- The Regional Engineer, Richard Wilson, was immediately contacted about this finding and he agreed to visit the site. However, he was unable to find the structure. Mr. Wilson is now planning to inspect the structure together with Mr. Webster in the early spring of 2017.

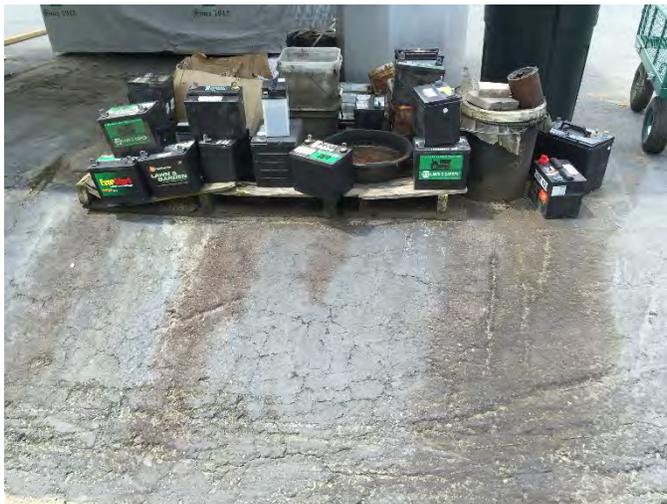
Figure 8. Batteries and waste oil in lot behind True Value Hardware

- On August 28, 2015, a petroleum sheen was observed below the outfall in a drainage swale behind the True Value Lyndonville Hardware store.
- There was no sheen when the outfall was revisited on June 2, 2016; however, a collection of waste oil pans and batteries was observed behind the store (Figure 8). Stains on the pavement indicated that waste oil had at times washed down from these materials into a drain at the bottom of a loading ramp. This drain appears connected to the outfall.
- The store manager was notified immediately of this problem.
