FINAL REPORT – WHITE RIVER BASIN ILLICIT DISCHARGE DETECTION AND ELIMINATION STUDY

BARNARD, BETHEL, CHELSEA,
GRANVILLE, HANCOCK, HARTFORD,
PITTSFIELD, QUEECHEE, RANDOLPH,
ROCHESTER, ROYALTON, SHARON, AND
TUNBRIDGE,

FINAL REPORT

9-26-2018

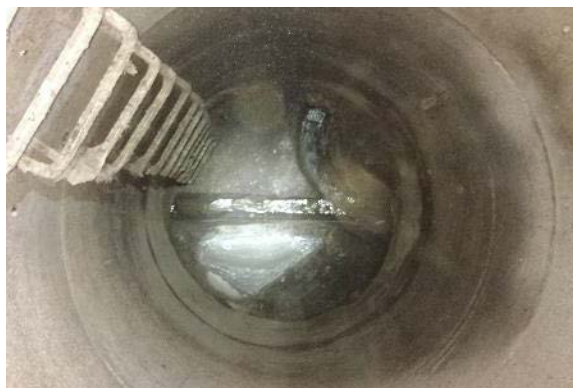
Figure 1: Sanitary manhole sump after repair. Note grout blocking pipe inlet.

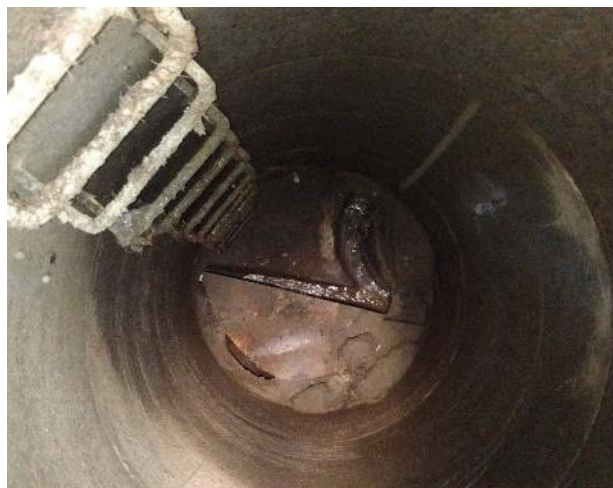
Figure 2: Sanitary manhole sump prior to repair.

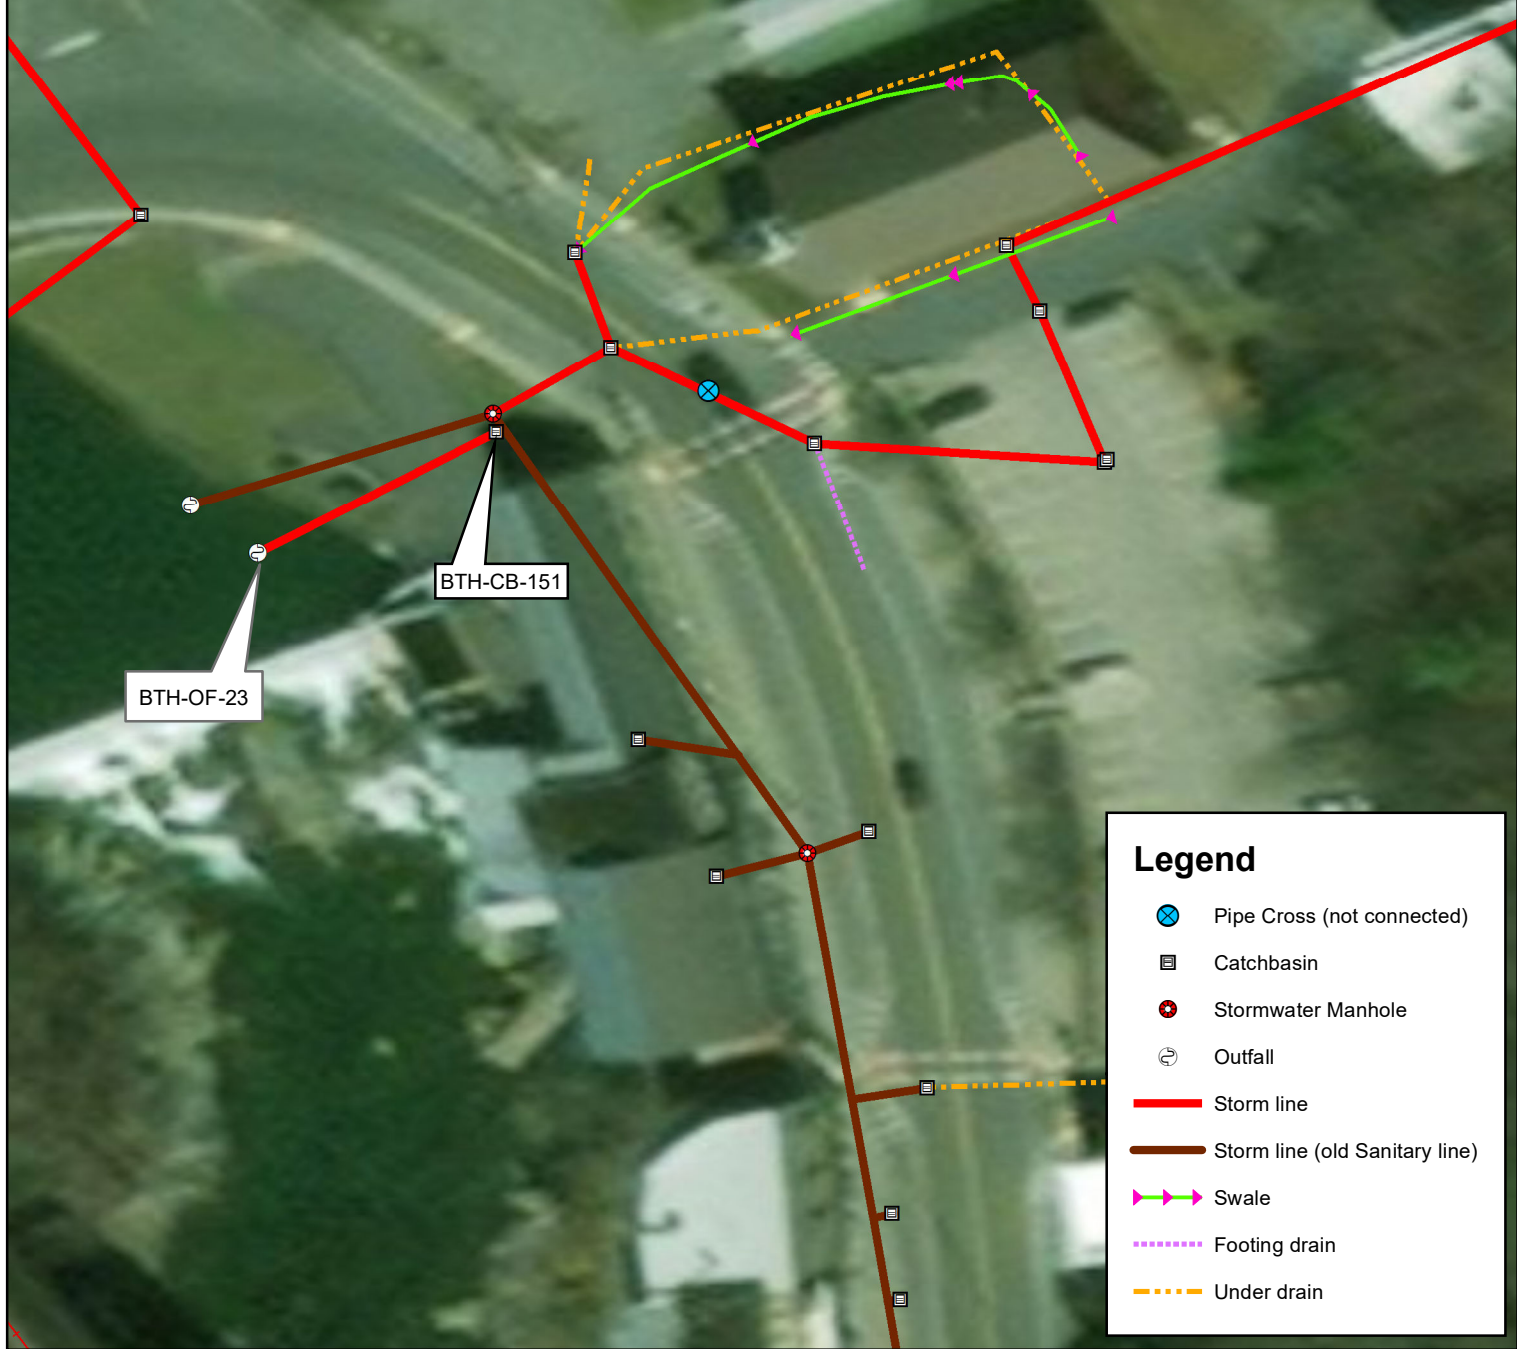
Upon two different dry weather surveys outfall BTH-OF-23 demonstrated small amounts of flow. At these times, the only catchbasin in the system, BTH-CB-151, showed no signs of flow. The system was smoke tested from BTH-CB-151, no smoke appeared to discharge from any location except the outfall. The adjacent sanitary system was also injected with smoke, no smoke appeared from any stormwater infrastructure. It is concluded that the observed flow from BTH-OF-23 is due to groundwater intrusion to the pipe.

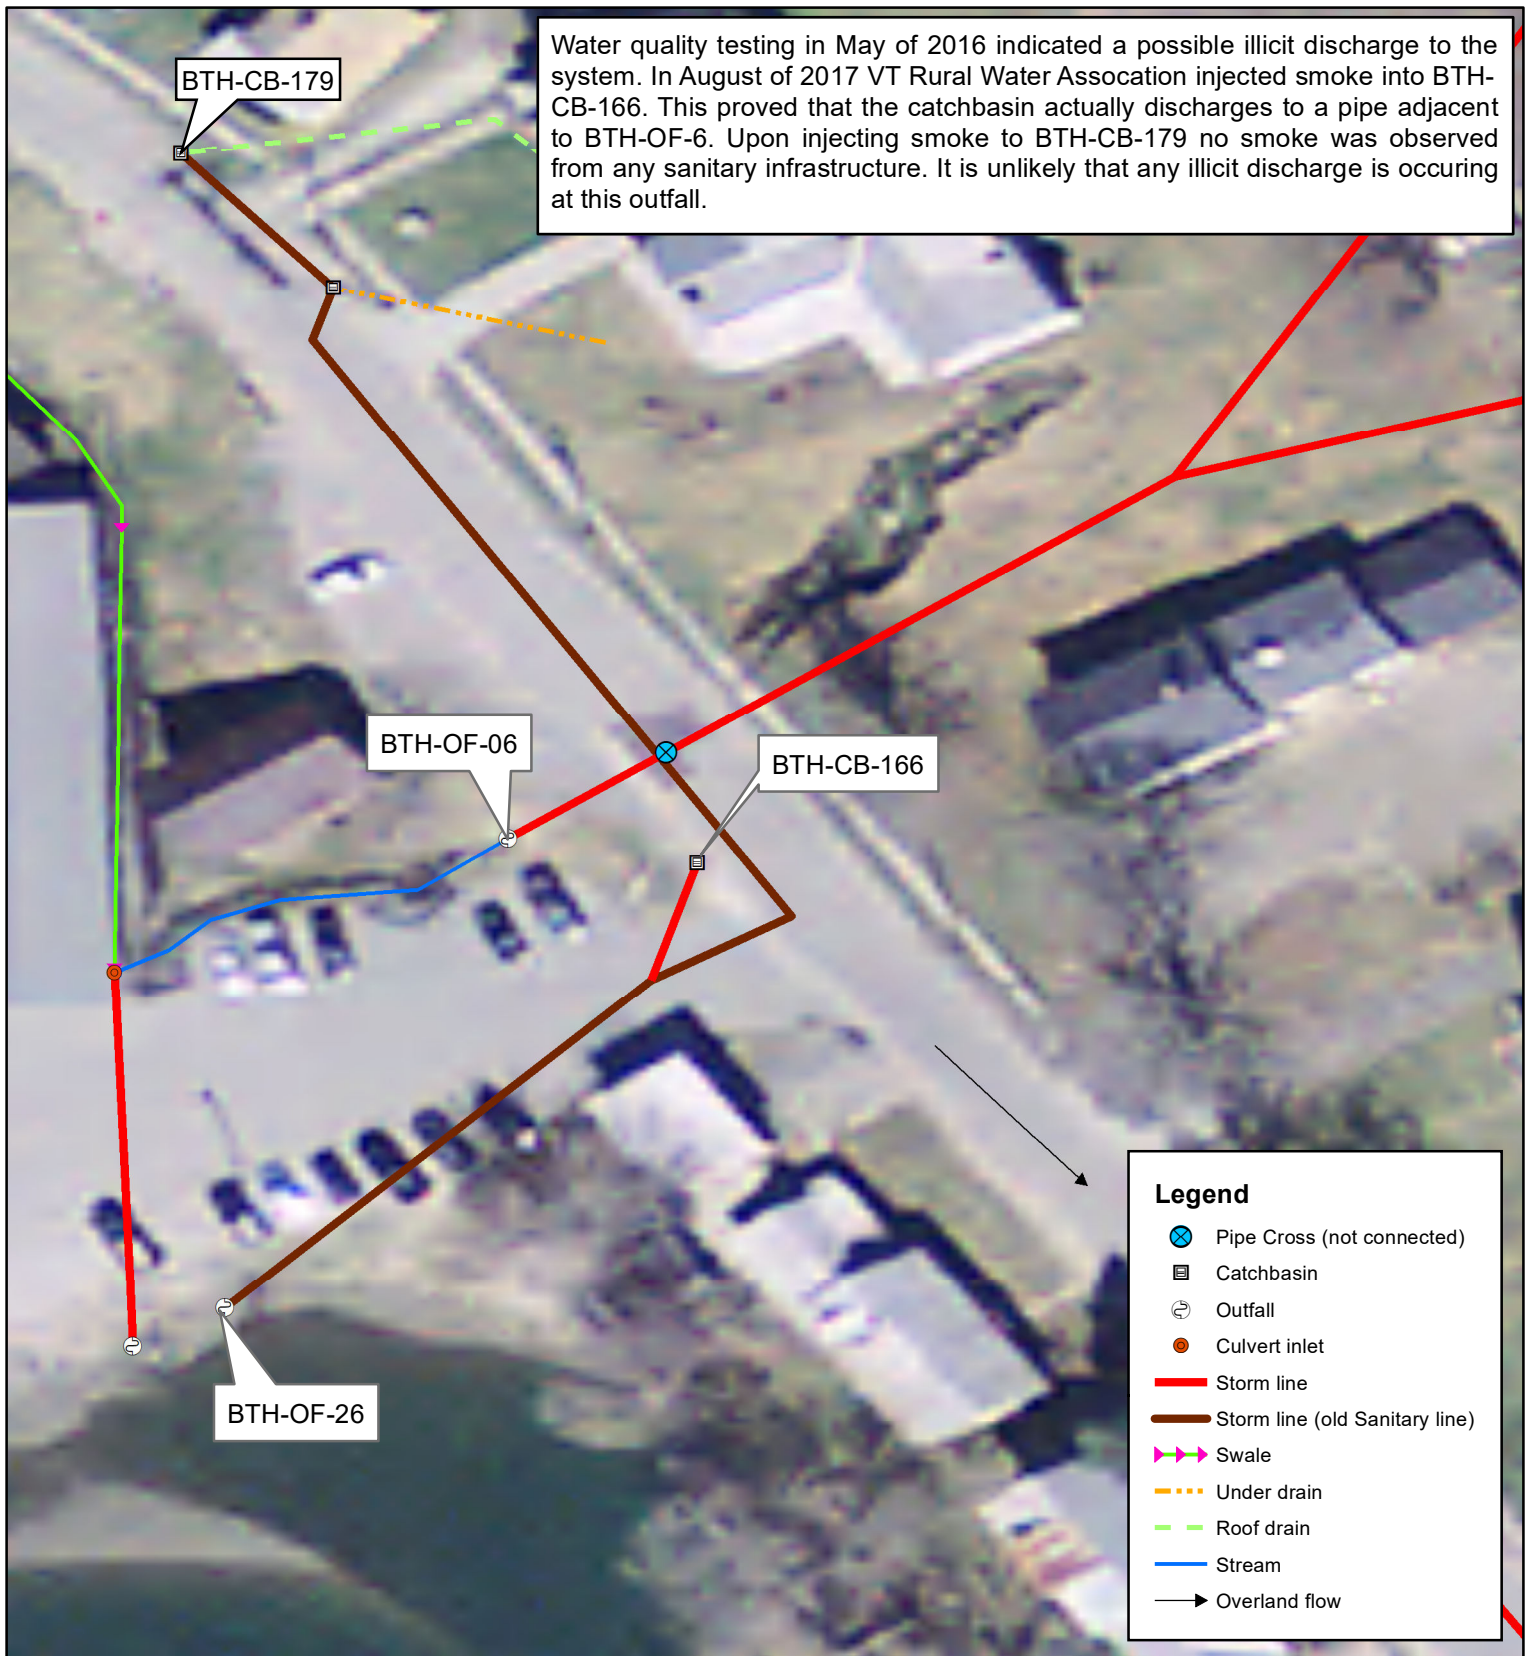
Water quality testing in May of 2016 indicated a possible illicit discharge to the system. In August of 2017 VT Rural Water Association injected smoke into BTH-CB-166. This proved that the catchbasin actually discharges to a pipe adjacent to BTH-OF-6. Upon injecting smoke to BTH-CB-179 no smoke was observed from any sanitary infrastructure. It is unlikely that any illicit discharge is occurring at this outfall.

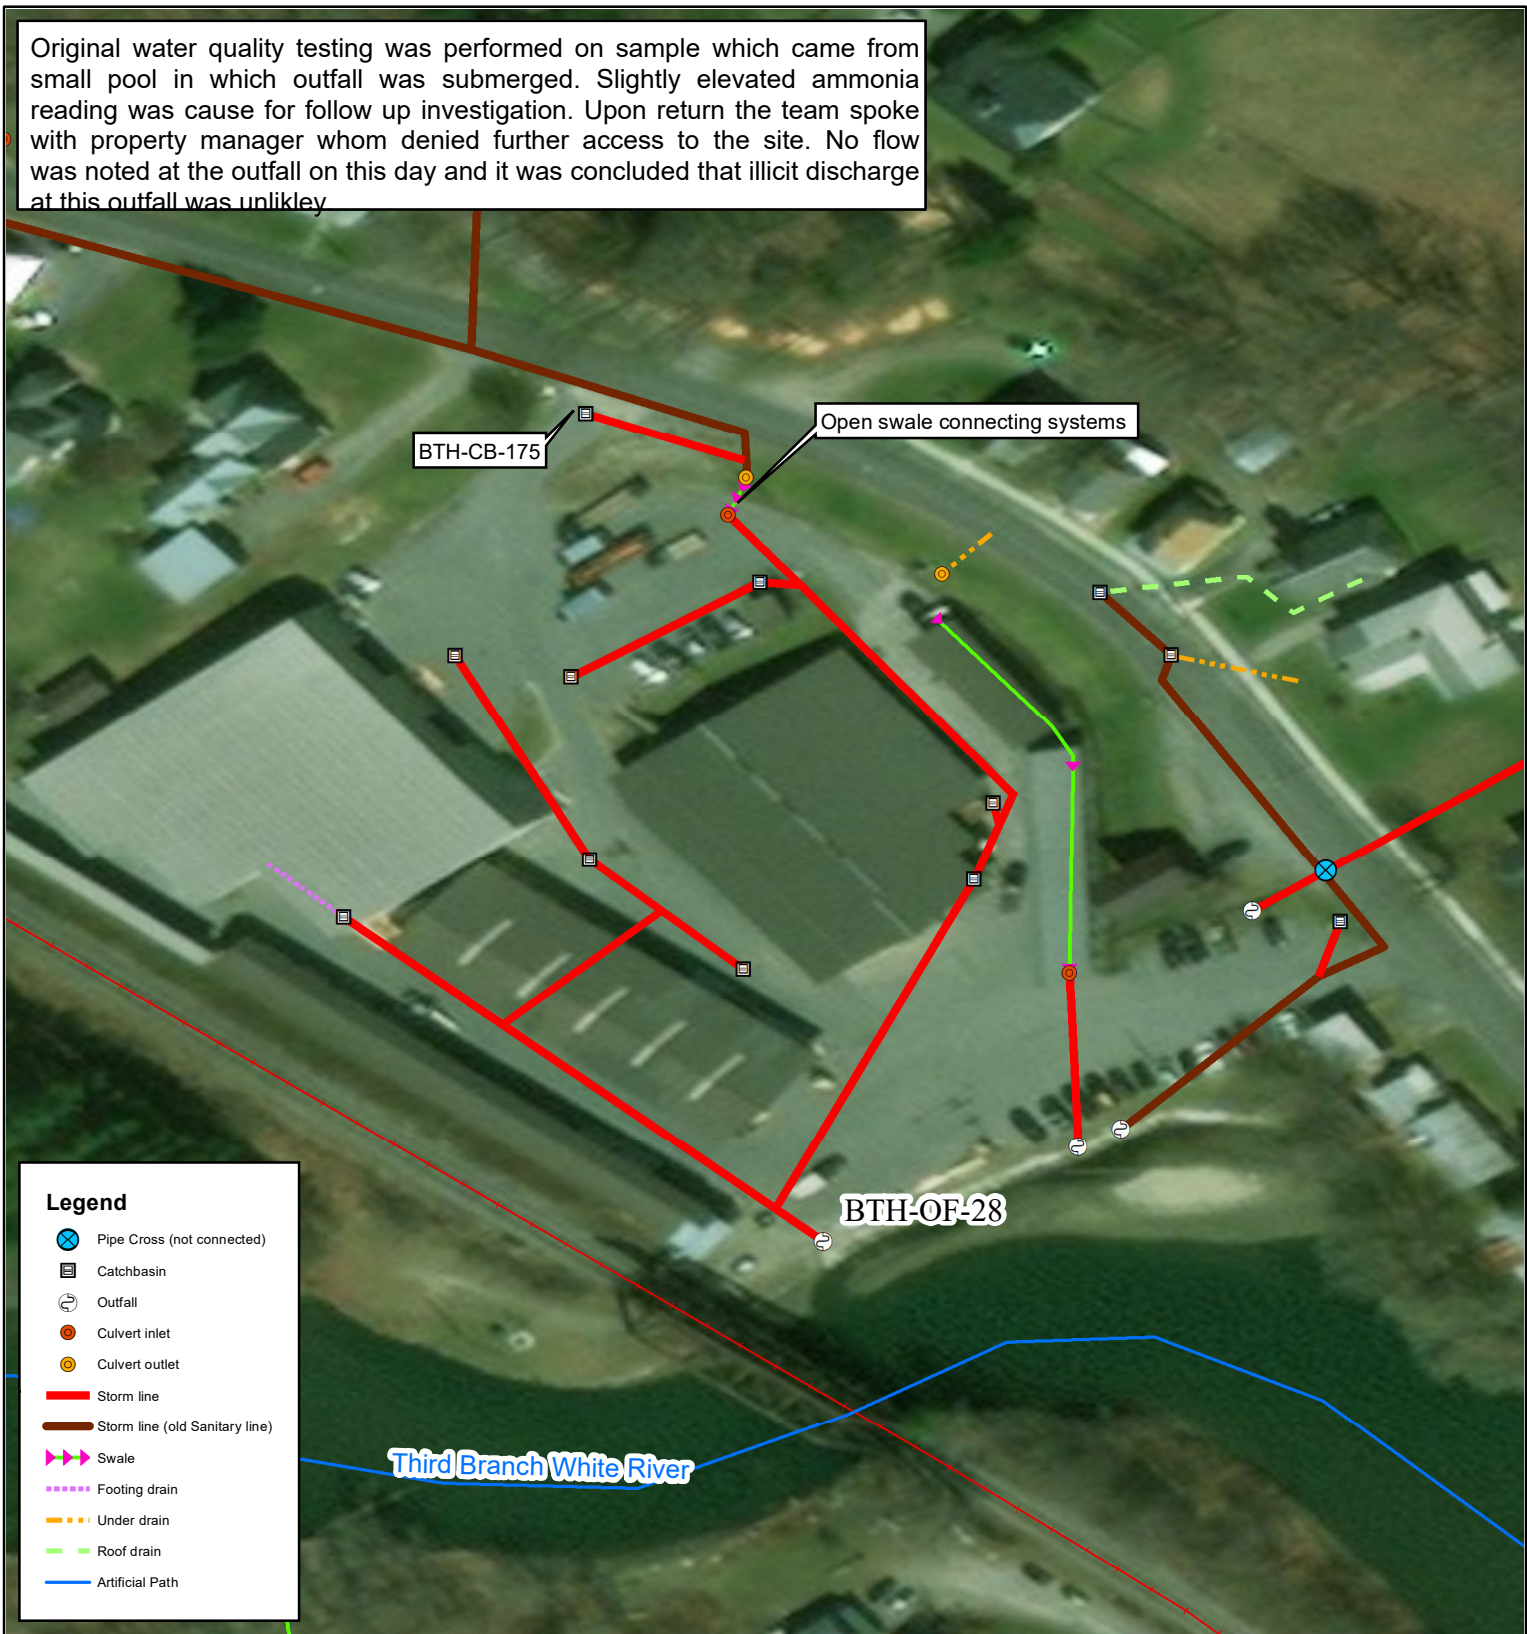
Original water quality testing was performed on sample which came from small pool in which outfall was submerged. Slightly elevated ammonia reading was cause for follow up investigation. Upon return the team spoke with property manager whom denied further access to the site. No flow was noted at the outfall on this day and it was concluded that illicit discharge at this outfall was unlikely

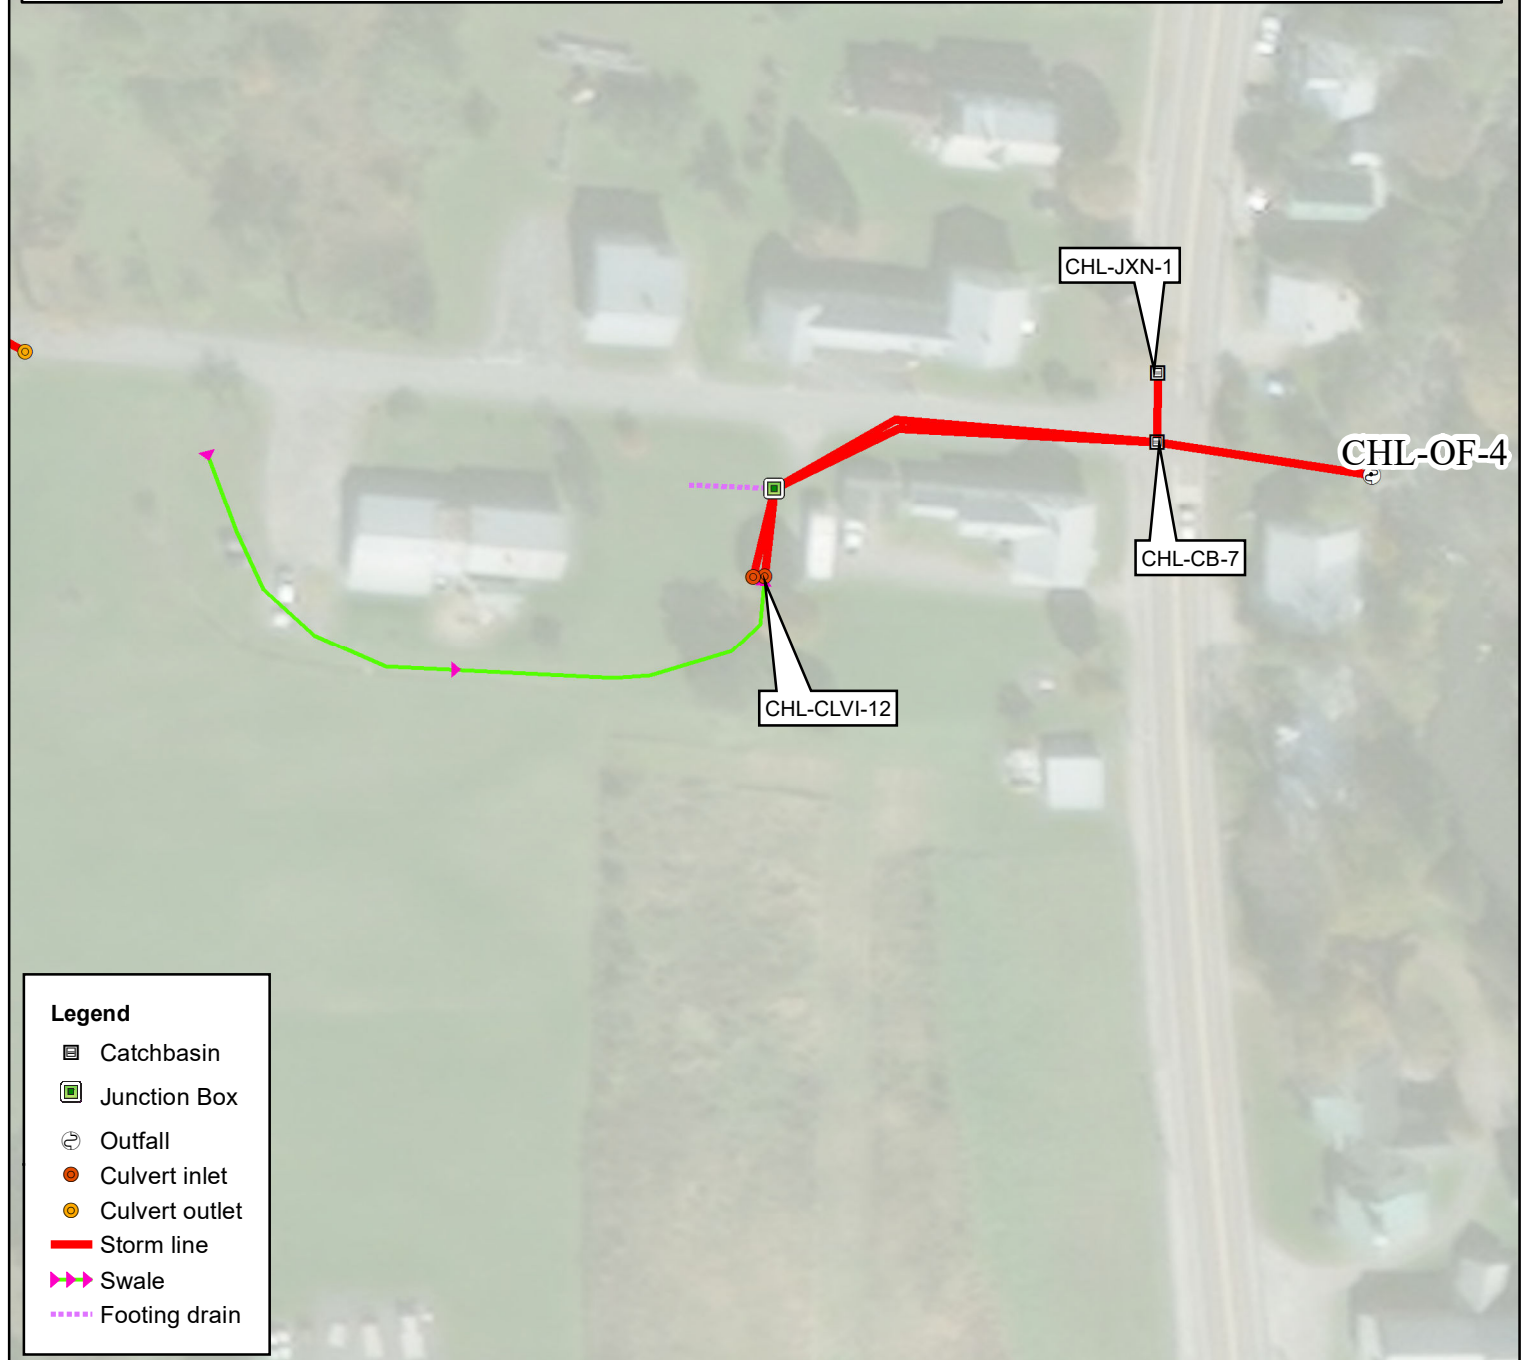
Initial water quality testing at CHL-OF-4 revealed slightly elevated levels of ammonia and MBAS. Pipes connected to the system showed flow on many occasions and smoke testing was conducted to determine if they were connected to any non-stormwater sources. The test proved successful as no smoke was observed from non-stormwater related infrastructure. Elevated levels of ammonia and MBAS were likely due to saturated groundwater and roadwash off, respectively.

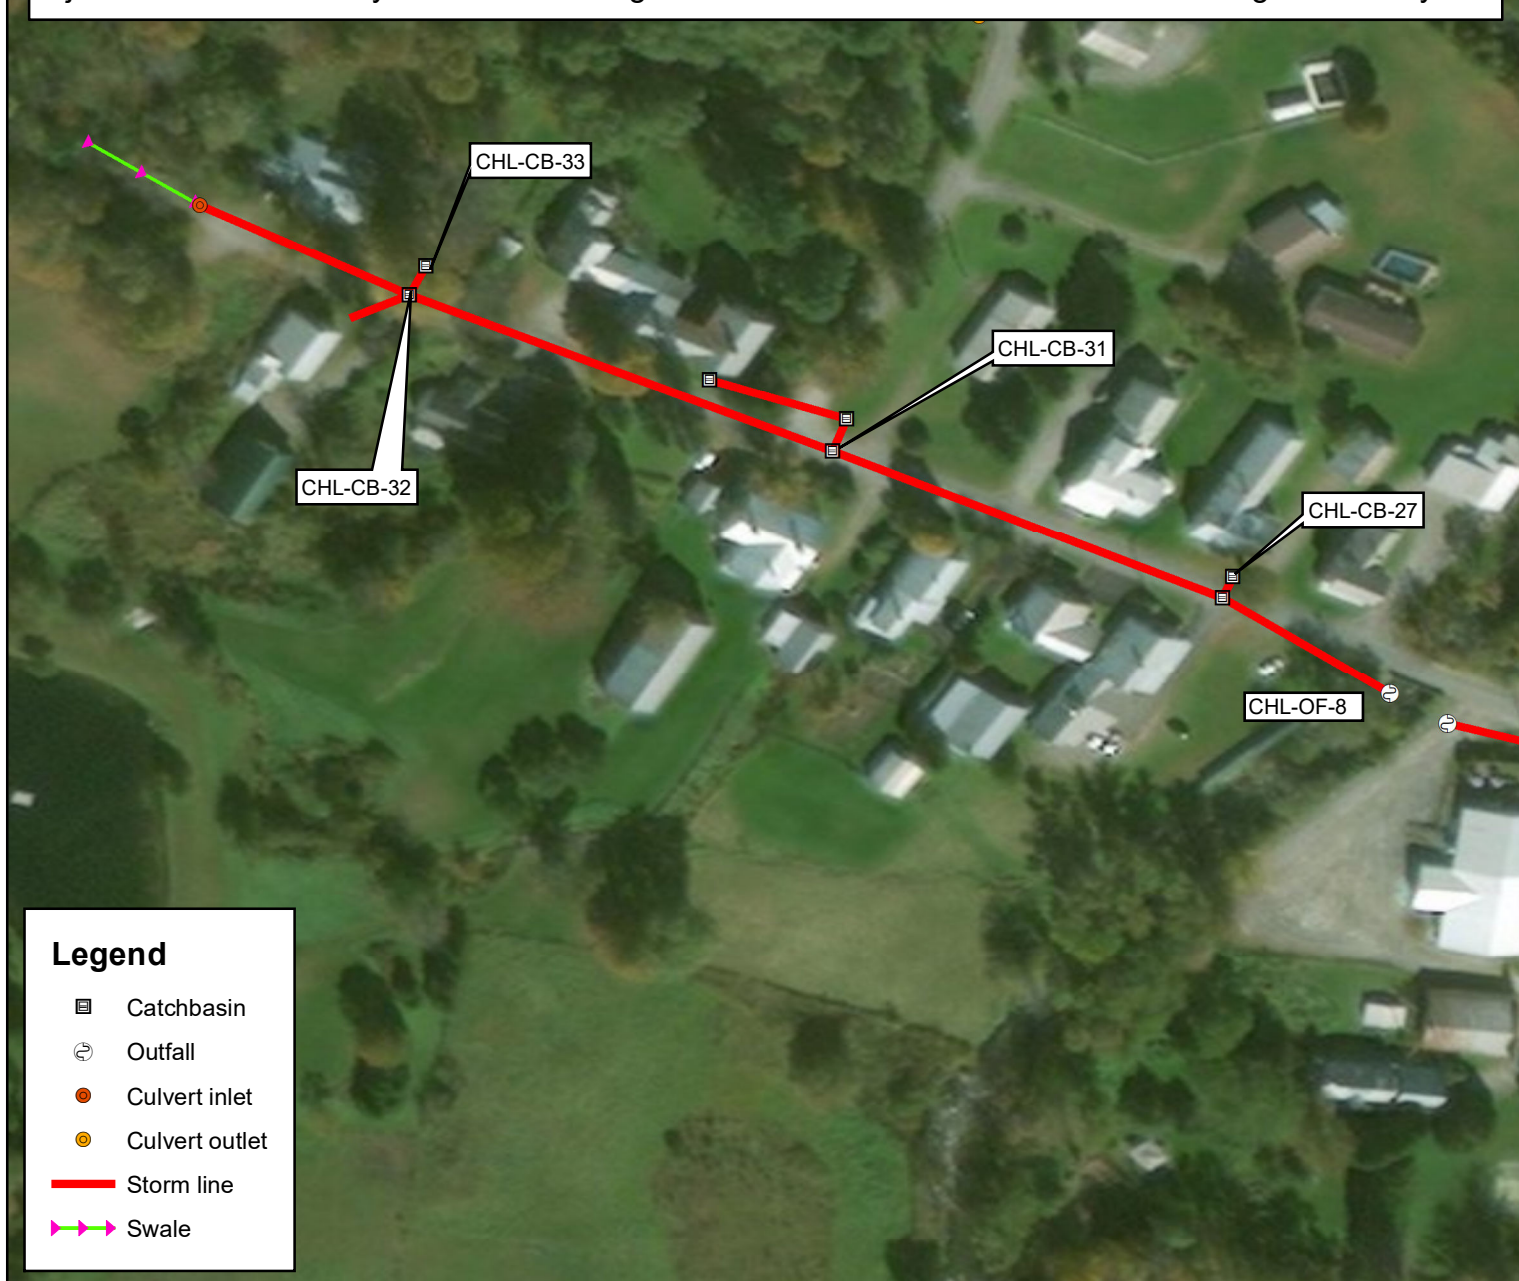
Initial water quality testing revealed very low pH of 3.7 with no other elevated parameters. Upon return with a recalibrated pH meter revealed a more typical reading of 8.29. Smoke was injected into CHL-CB-27 and no smoke was observed at any non-stormwater related infrastructure. Smoke was also injected into the sanitary sewer line and again no crossover was evident. Illicit discharge is unlikely.
