**DETECTION AND ELIMINATION OF
NON-STORMWATER DISCHARGES
TO THE STREAMS OF THE CITY OF BARRE**

March 2007

FRIENDS OF THE WINOOSKI RIVER
PO Box 777 Montpelier VT 05601

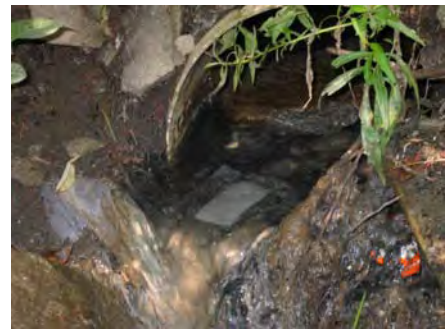
Flow observation: Strong wastewater odor, grayish color, toilet paper

E. coli = Too Numerous To Count

Optical brighteners = Positive (strong)

Potassium = 9 ppm (highest observed)

Follow up: In the first storm drain manhole on River St. up from the outfall, a sewer main crossing through the manhole appeared to be leaking. The City patched a hole in the sewer main crossing the first storm drain manhole up from the discharge point.

Follow up visual inspections indicates the joint is watertight. To confirm the correction of the problem, a sample was collected for *E. coli* analysis on 8/30/06. Flow from the pipe appeared clear. The 1,660 cfu/100 mL result indicates that *E. coli* were either still flushing through or that there is a second break in the sanitary line. A subsequent optical brightener pad in early October returned a very low positive result. A subsequent *E. coli* test revealed no additional contamination. The City will continue to monitor this outfall as it has been added to the prevention plan.
