Otter Creek Basin Illicit Discharge Detection and Elimination Project

FINAL REPORT

May 31, 2014

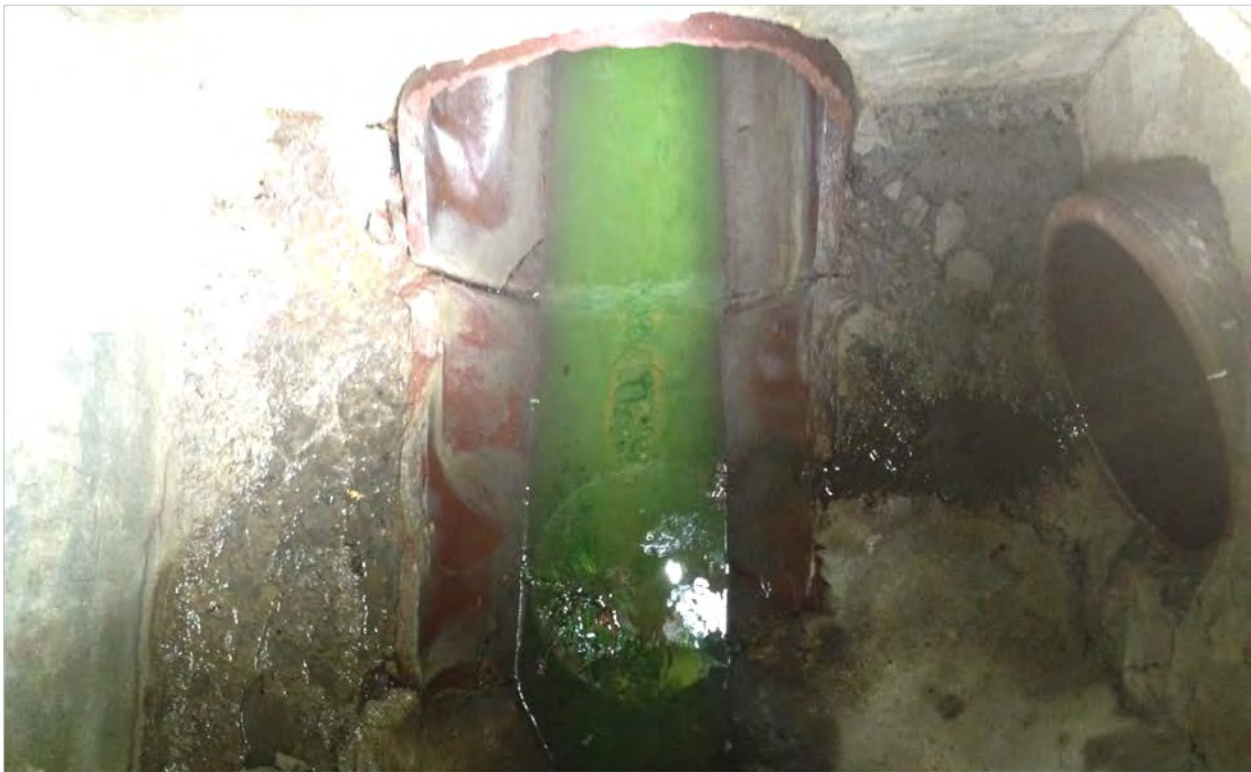
Dye testing of toilets in two houses on North Pleasant Street in Middlebury revealed cross connections to a stormwater line, visible in this manhole above

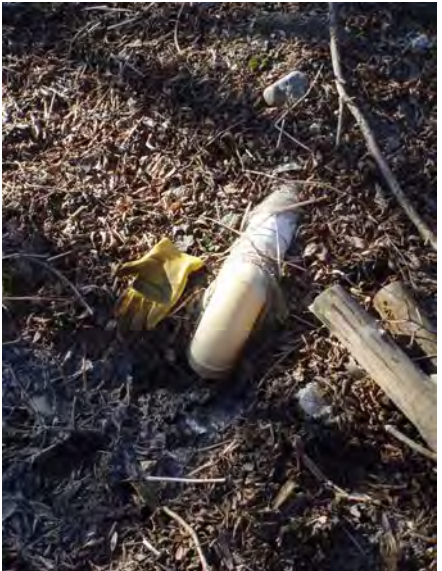
MB520	<p>Description: Outfall MB520 is a fully submerged pipe which discharges to Otter Creek just upstream of the Pulp Mill covered bridge. A small stream enters the system at the intersection of Seymour Street and Seymour Street Extension. Optical brightener and chlorine (0.11 mg/L) were detected when the outfall was first assessed on November 2, 2011. The optical brightener test was repeated at the outfall on November 17, 2011 and the result was again positive.</p> <p>Due to the optical brightener detections in the drainage system, on December 1, 2011 samples were collected for <i>E. coli</i> and total phosphorus analyses. Samples were collected from the up-pipe catchbasin MB520-B. Low <i>E. coli</i> (<10 MPN/100 mL) and total phosphorus (130 µg/L) concentrations were found, suggesting a washwater source rather than a sanitary wastewater source.</p> <p>On December 13, 2011, optical brightener monitoring pads were deployed throughout the drainage system. Positive results were found from outfall MB520 up the drainage system to a point below a white, 4-inch PVC pipe (see inset photo). This pipe is located behind a residence on Seymour Street Extension, south of Pinewood Road. There was an obvious laundry odor at the pipe outlet and discoloration of the surrounding area. The Middlebury Public Works Director was notified of the direct discharge on January 5, 2012.</p> <p>Status: The Department of Public Works contacted the landowner who quickly fixed the problem by connecting the laundry machine to the municipal sanitary sewer.</p>

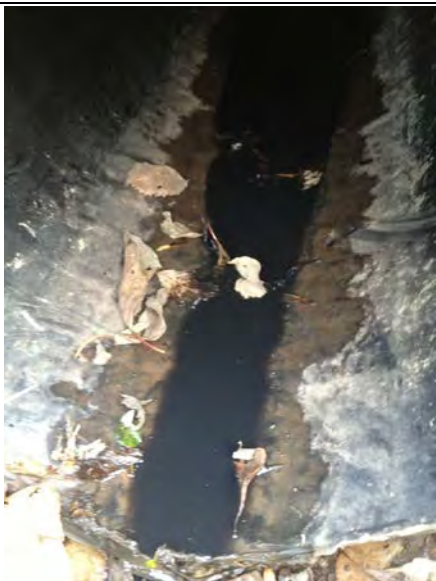
System ID	Assessment Findings	Map
RU980	<p>Description: Outfall RU980 is an 18-inch diameter corrugated black plastic pipe located on the north side of the Rutland Plywood facility off Park Street. The flow appeared milky in color on July 05, 2012. A low level of chlorine (0.05 mg/L) and exceedingly high specific conductance (53,500 $\mu\text{S}/\text{cm}$) were measured at the outfall. There are no catchbasins or other visible inlets in this system. The source of the flow and contamination appears to be within the facility. The outfall was dry on a follow-up visit.</p> <p>On October 30, 2013 the outfall was trickling. The discharge was black in color and had no odor. Zero total chlorine and a low ammonia concentration (0.25 mg/L) were measured. The specific conductance was low (862 $\mu\text{S}/\text{cm}$).</p> <p>Status: Following our November 14, 2013 meeting, the City Engineer contacted a manager at Rutland Plywood regarding this discharge. The discharge reportedly resulted from two floor drains in the facility. A building tenant had been rinsing equipment near these drains, thinking that they connected to the sanitary sewer. The material being rinsed off was comprised of water and dust that is created when tiles are tumbled in a wet finishing process. The color of the tiles varies, explaining the different color discharges. This practice has been permanently halted, so the drains will no longer be a source of discharges. In addition, Rutland Plywood has contacted John Daly of DEC's Environmental Assistance Office, seeking guidance on best practices for managing floor drains in order to prevent a recurrence.</p>

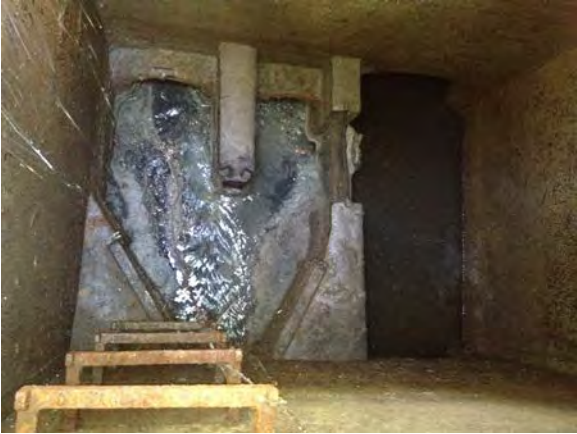
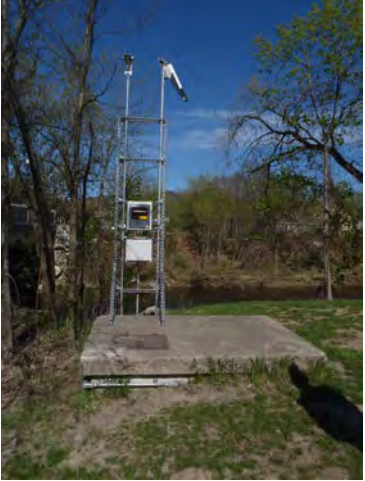
System ID	Assessment Findings	Map
RU1400	<p>Description: RU1400 is a combined sewer overflow structure located at the West Street Bridge over East Creek. When this structure was assessed on July 10, 2012, sanitary sewage was overflowing the weir and discharging to East Creek due to clogs in both sewer lines. The City of Rutland responded immediately to clear the clogged pipes. The City reported that it inspects the structure frequently, but bridge construction work may have limited access to the structure in the few weeks prior to the July 10 assessment.</p>

<p>Status: The City of Rutland responded immediately to clear the clogged pipes causing the sanitary sewer overflow. The City reported the release to DEC as it was required to do. Since this incident, the City of Rutland installed instruments (see inset photo) to monitor the water level in the structure and communicate the data to the Public Works Department.</p>

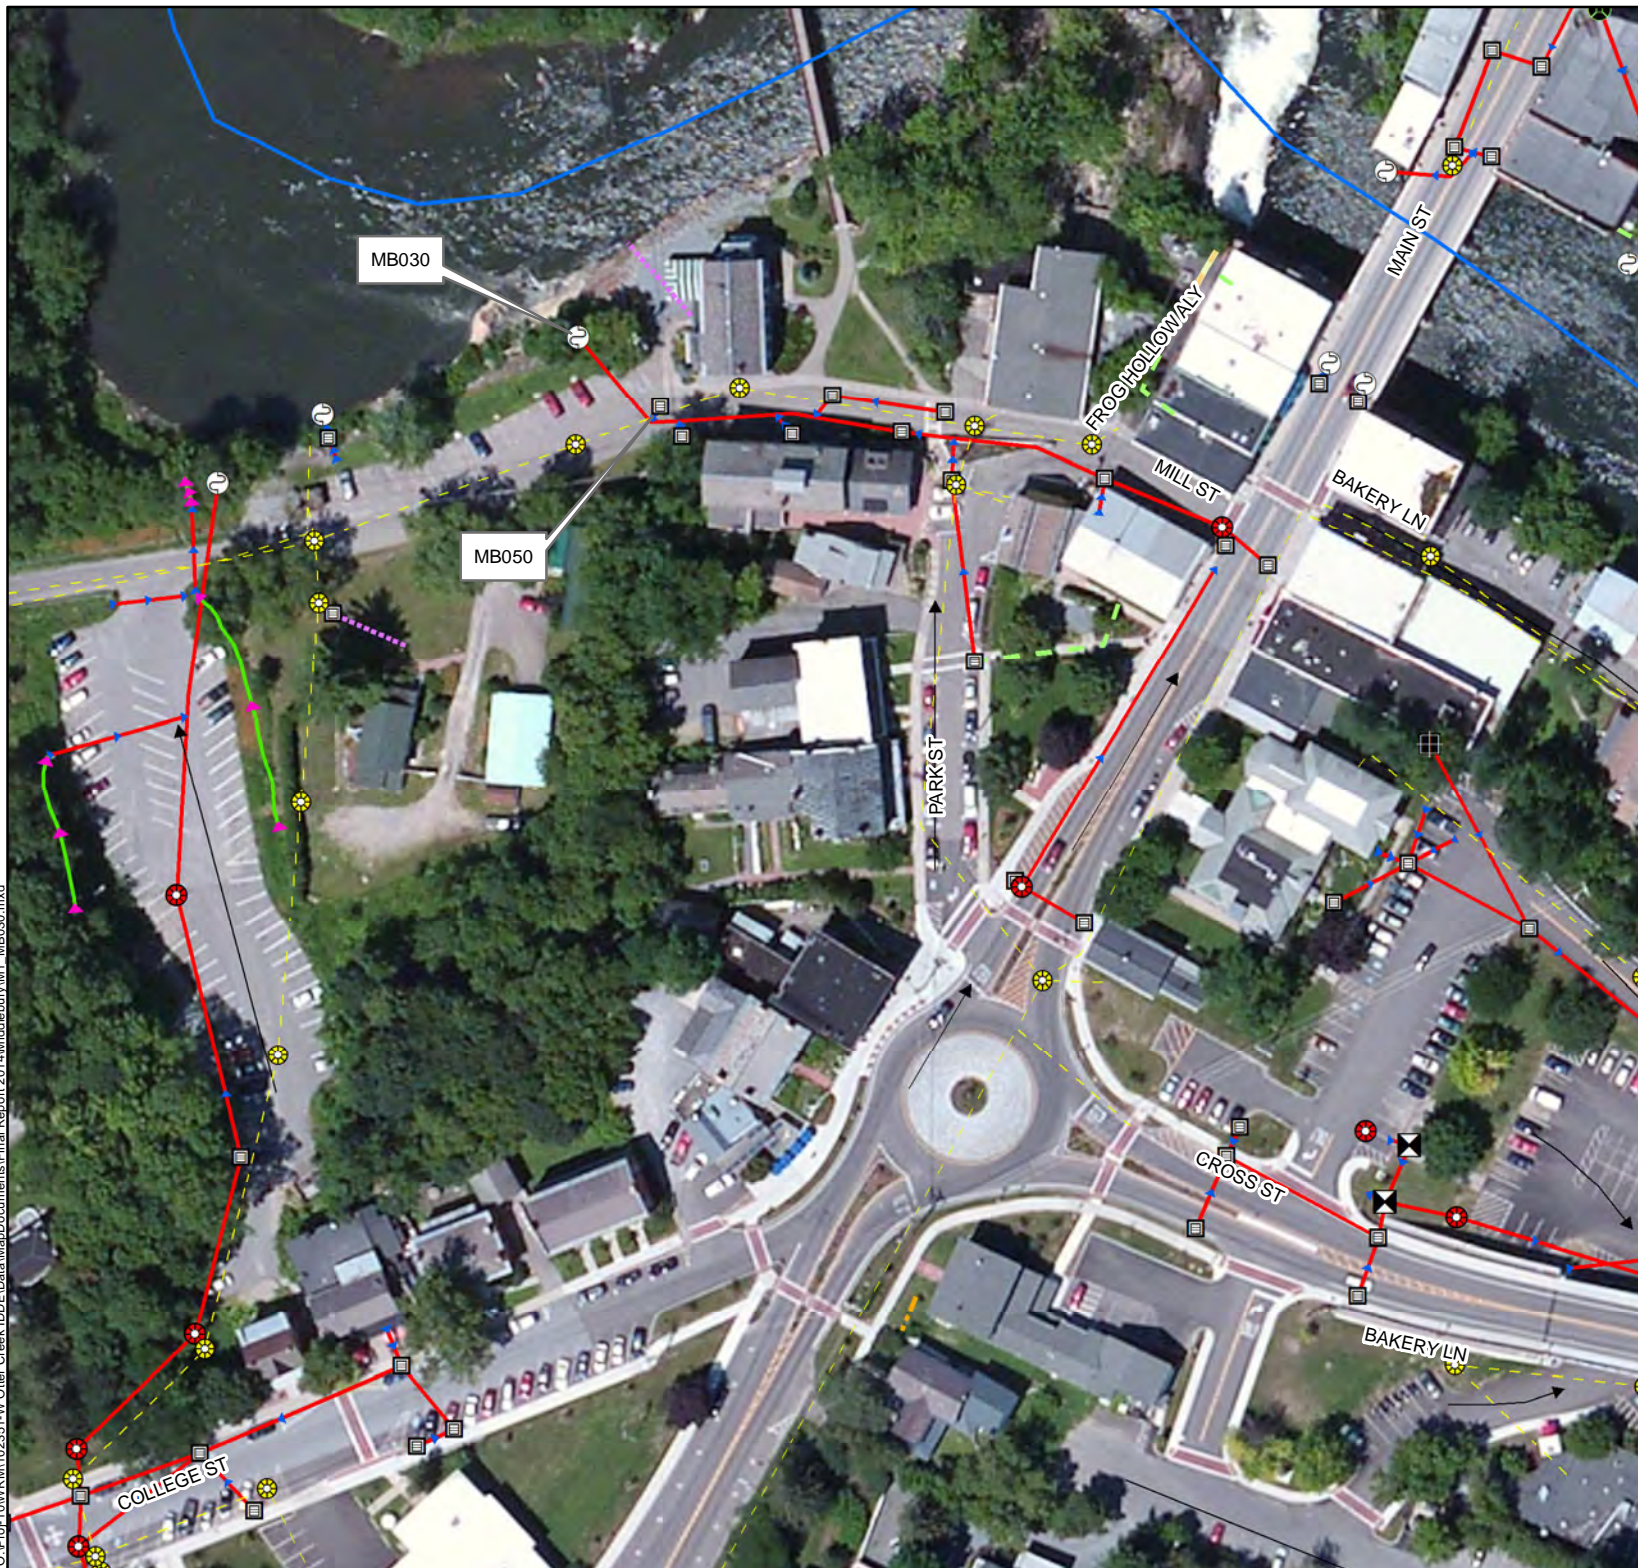
Map M1

System ID	Assessment Findings	Map
MB030	<p>Description: Outfall MB030 discharges to Otter Creek on the east side of the Storm Café on Mill Street. The system drains the eastern length of Mill Street and a short section of Main Street. During sampling on October 28, 2011, the field crew noted turbid water and a distinct swimming pool odor in the structure (catchbasin MB050) immediately up-pipe from the outfall. A sample collected from the catchbasin had an exceedingly high total chlorine concentration (2.20 mg/L) and elevated ammonia (0.5 mg/L). The MBAS detergent test was invalid, possibly because the concentration exceeded the analytical range. While samples were being processed, a Storm Café employee was witnessed dumping mop water into catchbasin MB050.</p> <p>Status: The employee and restaurant manager agreed to stop dumping to the storm sewer. During a follow up visit on December 8, 2011, ammonia and chlorine concentrations were below the limit of detection at the outfall and the restaurant manager confirmed that wastes were no longer discharged to the catchbasin. Therefore, we consider this discharge to have been eliminated.</p>	M1

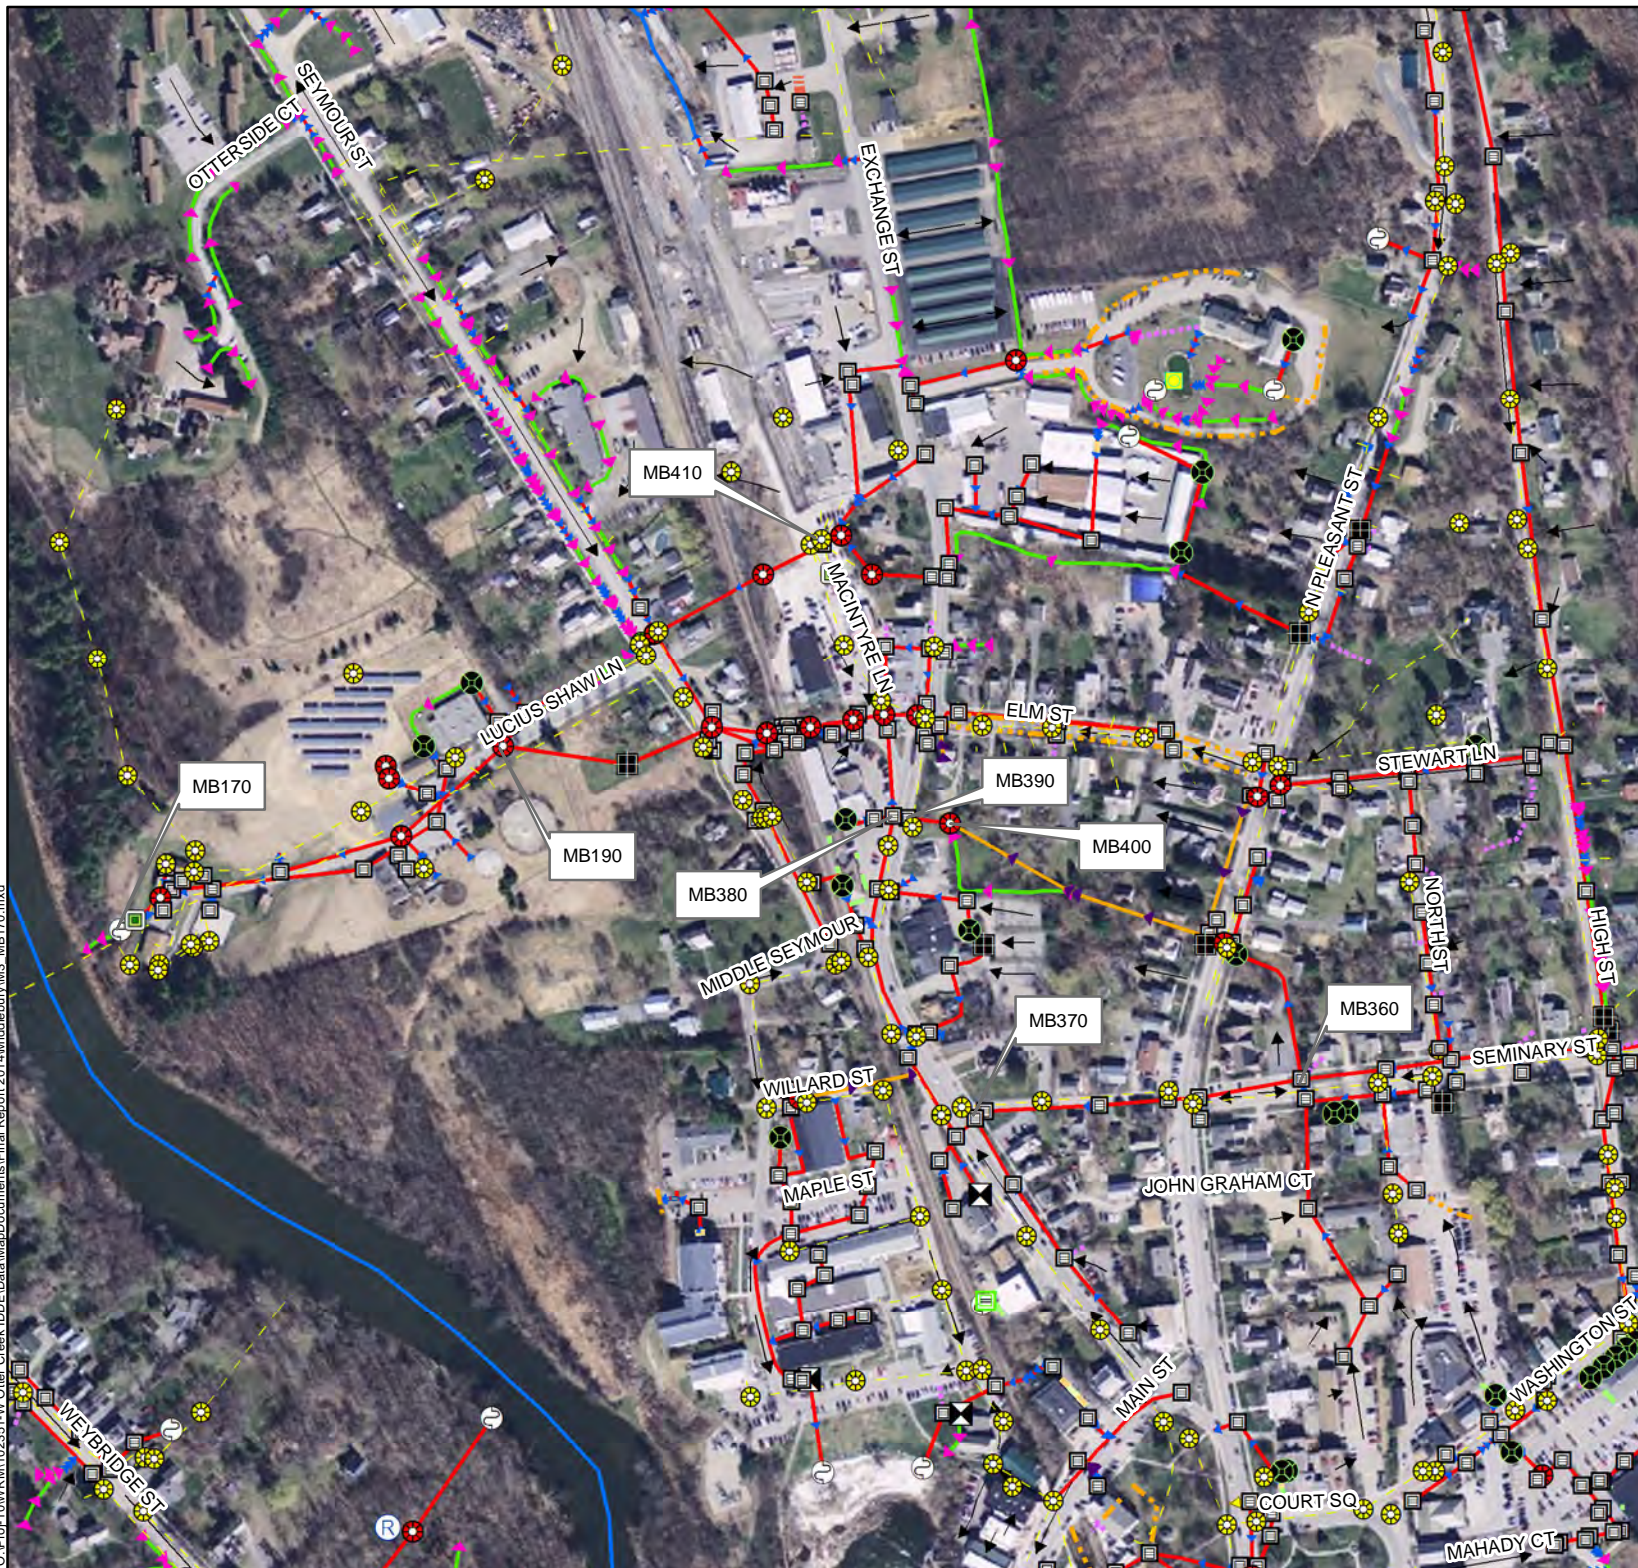
Map M3

System ID	Assessment Findings	Map
	Superintendent, Bob Wells, this stormwater system is scheduled to be replaced with a modern system as part of a major train tunnel construction project scheduled to begin in the fall of 2014. The sanitary sewer will be reconstructed or realigned as well. Direct connections to the system from floor drains should be eliminated during reconstruction. Therefore, no other action is recommended.	
MB170 system	<p>Description: Manhole MB170 is a manhole on Lucius Shaw Lane at the former wastewater treatment plant (now a pump station). This extensive drainage system discharges to Otter Creek at an outfall identified as Middlebury CSO #10. MB170 is the first structure up-pipe from the outfall, which is inaccessible.</p> <p>It appears there are contaminated non-stormwater flows entering in three segments within the contributing drainage system, identified as #1 to #3 below.</p>	M3

<p>#2: Catchbasin MB360 is located on the north side of Seminary Street in the grass next to the church parking lot. On two dates chlorine was detected in Pipe C, which crosses Seminary Street: 0.20 mg/L was measured on November 1, 2011 and 0.16 mg/L was measured on December 13, 2011. A tapwater leak is suspected in the vicinity that infiltrates the Pipe C stormline between catchbasin MB360 and the next up-pipe structure.</p> <p>Status: Small potable water leaks are essentially a municipal concern rather than sources of priority pollutants. We recommend acoustic leak detection be performed to locate the apparent leak.</p>	M3
	<p>#3: Catchbasin MB370 is located at the intersection of Seymour Street and Methodist Lane. The system in question drains the southern section of Seymour Street. During the assessment on November 2, 2011, there was small flow into the catchbasin from pipes A and B and suds in the sump. On two dates chlorine was detected in flow from Pipe B: 0.5 mg/L on November 2 and 0.09 mg/L on December 14, 2011. A tapwater leak is suspected in this vicinity that infiltrates the Pipe B stormline between catchbasin MB370 and the next up-pipe structure.</p> <p>Status: Small potable water leaks are essentially a municipal concern rather than sources of priority pollutants. We recommend acoustic leak detection be performed to locate the apparent leak.</p>	M3

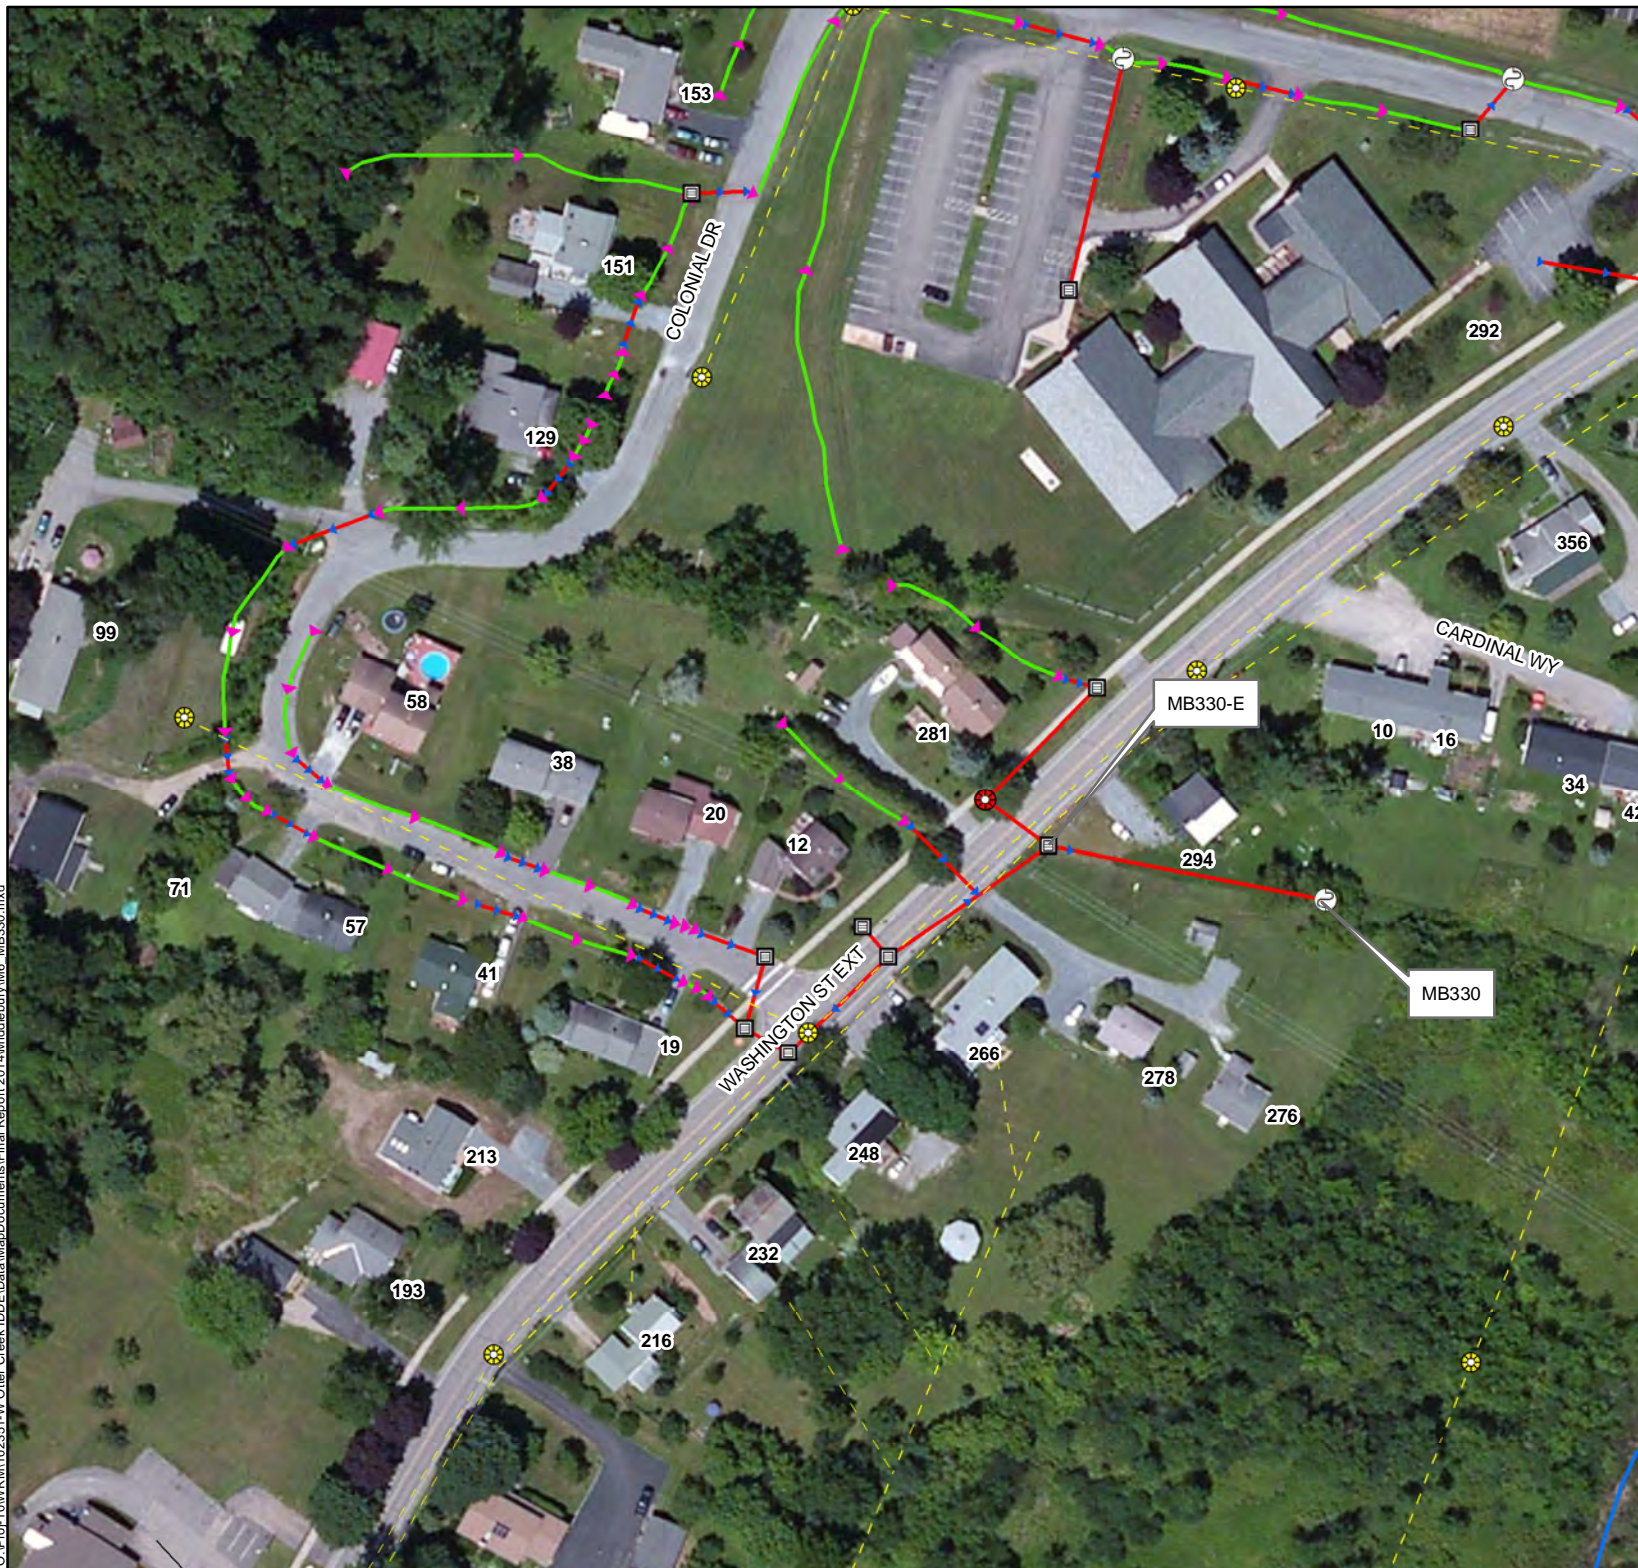
Map M6

System ID	Assessment Findings	Map
MB330	<p>Description: Outfall MB330 is a 15-inch diameter corrugated black plastic pipe that discharges into a wetland area to the south of Washington Street. The system drains a residential area from the top of the hill on the eastern section of Colonial Drive and a 200-foot section of Washington Street. Optical brightener was detected at the outfall on the first field visit, November 1, 2011. No other contaminants were detected although suds were observed.</p> <p>On November 16, 2011 monitoring pads were placed throughout the drainage system. The result at the outfall was indeterminate; however, optical brightener was detected at the next up-pipe manhole, labeled MB330-E. Two pipes discharge to catchbasin MB330-E. Pipe A is the main stormline, which was flowing when observed on November 16, 2011. Pipe B, which crosses Washington Street Extension, was not flowing when observed on November 16, 2011, but flow was entering the catchbasin beneath Pipe B. Optical brightener monitoring pads placed in Pipe A and up-pipe structures were negative. However, a pad placed in the flow stream beneath Pipe B yielded a positive optical brightener result.</p> <p>Due to the optical brightener detections in the drainage system, samples were collected from outfall MB330 for <i>E. coli</i> and total phosphorus analyses. Negligible <i>E. coli</i> (20 MPN/100 mL) and low total phosphorus (33.9 µg/L) concentrations were found in samples collected on December 1, 2011.</p> <p>Based on location of the flow entering catchbasin MB330-E and the detection of optical brightener in this flow stream, we suspect a diluted, partially renovated sanitary wastewater source. It is possible a leak in the sanitary sewer line along Washington Street Extension is infiltrating the basin in this location, after mixing with groundwater and filtering or decomposition of wastewater contaminants as effluent passes through the road base. This is speculation but we lack another explanation.</p> <p>Status: We recommend the Town of Middlebury dye test the sanitary sewer in the vicinity (east) of catchbasin MB330-E and also houses at #281 and #294 Washington Street Extension.</p>	M6

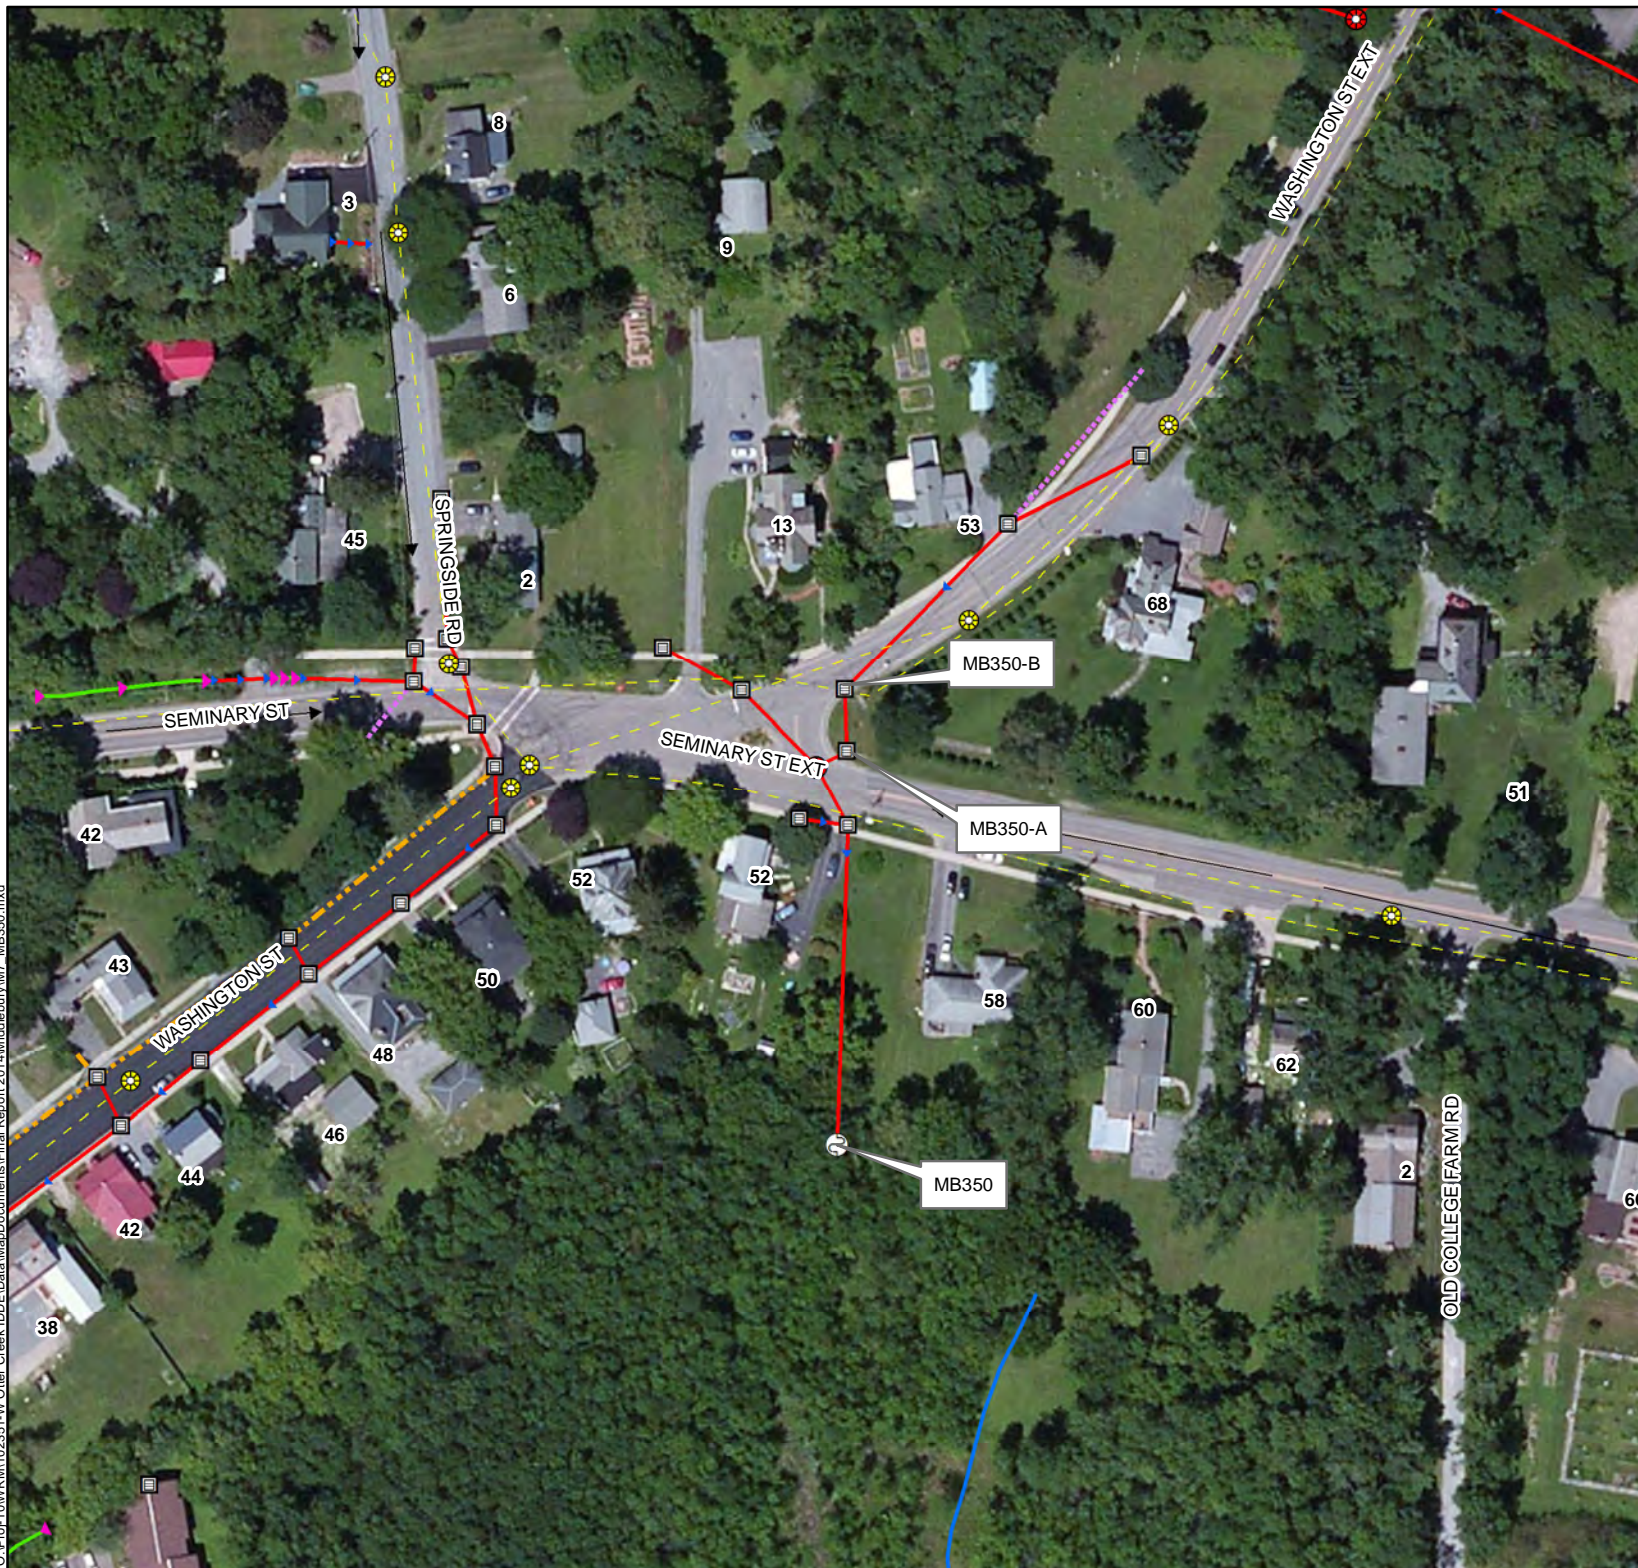
Map M7

MB350	<p>Description: Outfall MB350 is a 15-inch diameter corrugated black plastic pipe that discharges into a swale south of the "Five-Corner" intersection of Washington Street, Washington Street Extension, Seminary Street, Seminary Street Extension, and Springside Road. The system drains a small area surrounding the Five Corner intersection, including the driveway for the Sunshine Children's Center. Optical brightener was detected at the outfall; the monitoring pad deployed on November 1 and retrieved November 8 tested positive. There were no other indications of contamination. A second monitoring pad, placed on November 16, 2011, was also positive, as was the pad placed in the next up-pipe structure, catchbasin MB350-A, in the driveway of the house located near the outfall. The optical brightener test in catchbasin MB350-B was indeterminate.</p> <p>Due to the repeated detections of optical brightener in the drainage system, on December 1, 2011 samples were collected from outfall MB350 for <i>E. coli</i> and total phosphorus analyses, both of which were low (110 MPN/100 mL and 48.8 µg/L).</p> <p>Status: Based on the detection of optical brightener and the absence of other tested contaminants, we suspect either a direct laundry wastewater (graywater) source or a diluted, partially renovated sanitary wastewater source. To rule out the possibility of a direct graywater connection, the Town of Middlebury proposed inspecting wastewater piping in the neighboring buildings. The current status of this inspection is unknown.</p>	M7

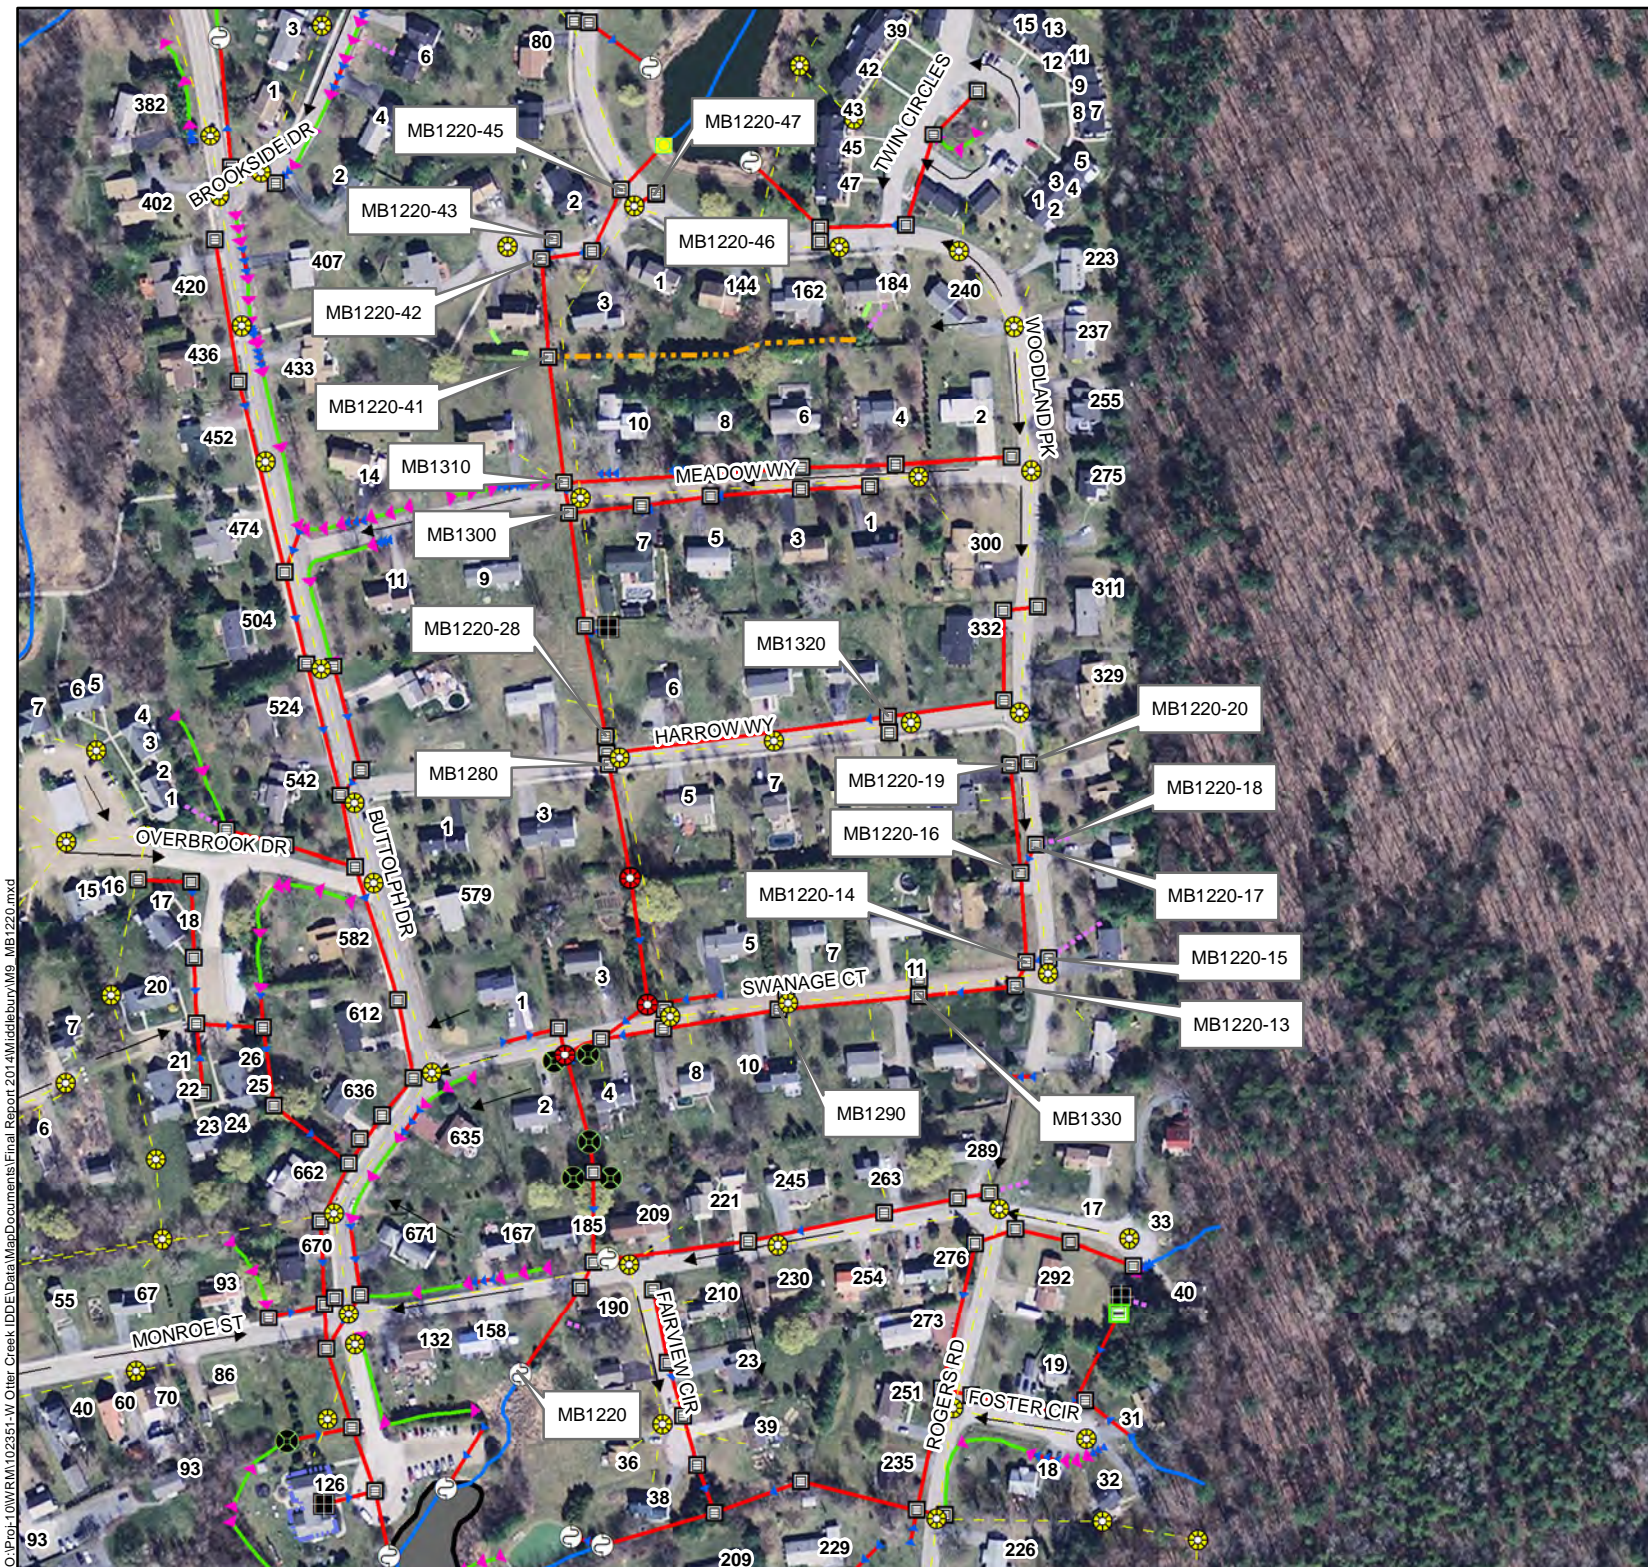
Map M9

System ID	Assessment Findings	Map
MB620	<p>Description: Outfall MB620 is a 12-inch corrugated metal pipe that discharges to an open channel at the main entrance of Middlebury High School. Elevated chlorine concentrations were detected when the system was assessed on November 2, 2011 (0.11 mg/L) and again on December 14, 2011 (0.08 mg/L). No other contaminants were detected. We suspect there is a leak in the municipal water distribution system in this vicinity.</p>	NA
	<p>Status: Small potable water leaks are essentially a municipal concern rather than sources of priority pollutants. We recommend acoustic leak detection be performed to locate the apparent leak.</p>	
MB1220 system	<p>Description: Outfall MB1220 is a 30-inch diameter corrugated metal outfall discharging to a wetland area south of Monroe Street. The system drains the entire residential area to the south of Woodland Park including Meadow Way, Harrow Way, Swanage Court, and the east end of Monroe Street. The stormwater pond located north of Woodland Park also discharges into this system. Given the large extent of the system, multiple structures were tested during the initial assessment on November 7-8, 2011.</p> <p>Due to the detection of optical brightener at six of the seven structures assessed, on December 13, 2011 pads were deployed in all accessible structures in this system. All six structures testing positive for optical brighteners in November were again positive. Intensive optical brightener monitoring narrowed the source to two locations. We suspect a direct laundry washwater connection to the storm sewer system in both areas. In a third location, a potable water leak is suspected. These discharges/locations are identified as #1 to #3 below.</p>	M9

<p>#1: Catchbasin MB1220-14 is located at the top of Swanage Court at the intersection with Woodland Park. Optical brightener was detected at MB1220-14 but not in any up-pipe catchbasins, including MB1220-15 and MB1220-16. Therefore, a source of optical brightener must exist very close to MB1220-14. The most likely source is #394 Woodland Park.</p> <p>Status: We recommend that the Town of Middlebury inspect, and dye test if necessary, the houses (starting with #394 Woodland Park) surrounding catchbasin MB1220-14 in order to identify any direct connections. If no direct connections are found, then there may be a leak in the sanitary sewer system in this vicinity.</p>	M9
	<p>#2: The second location is catchbasin MB1220-45, at the intersection of Woodland Park and Heritage Circle. This catchbasin is the first structure down-pipe from the pond outlet structure. Therefore, it is uncertain whether the source of the optical brightener is near catchbasin MB1220-45 or is the pond. All accessible outfalls discharging to this pond were assessed during the November monitoring and no contamination was detected; however, there was at least one outfall on posted private property that could not be assessed.</p> <p>Status: We recommend that the Town of Middlebury inspect, and dye test if necessary, the houses surrounding catchbasin MB1220-45 in order to identify any direct connections.</p>	M9

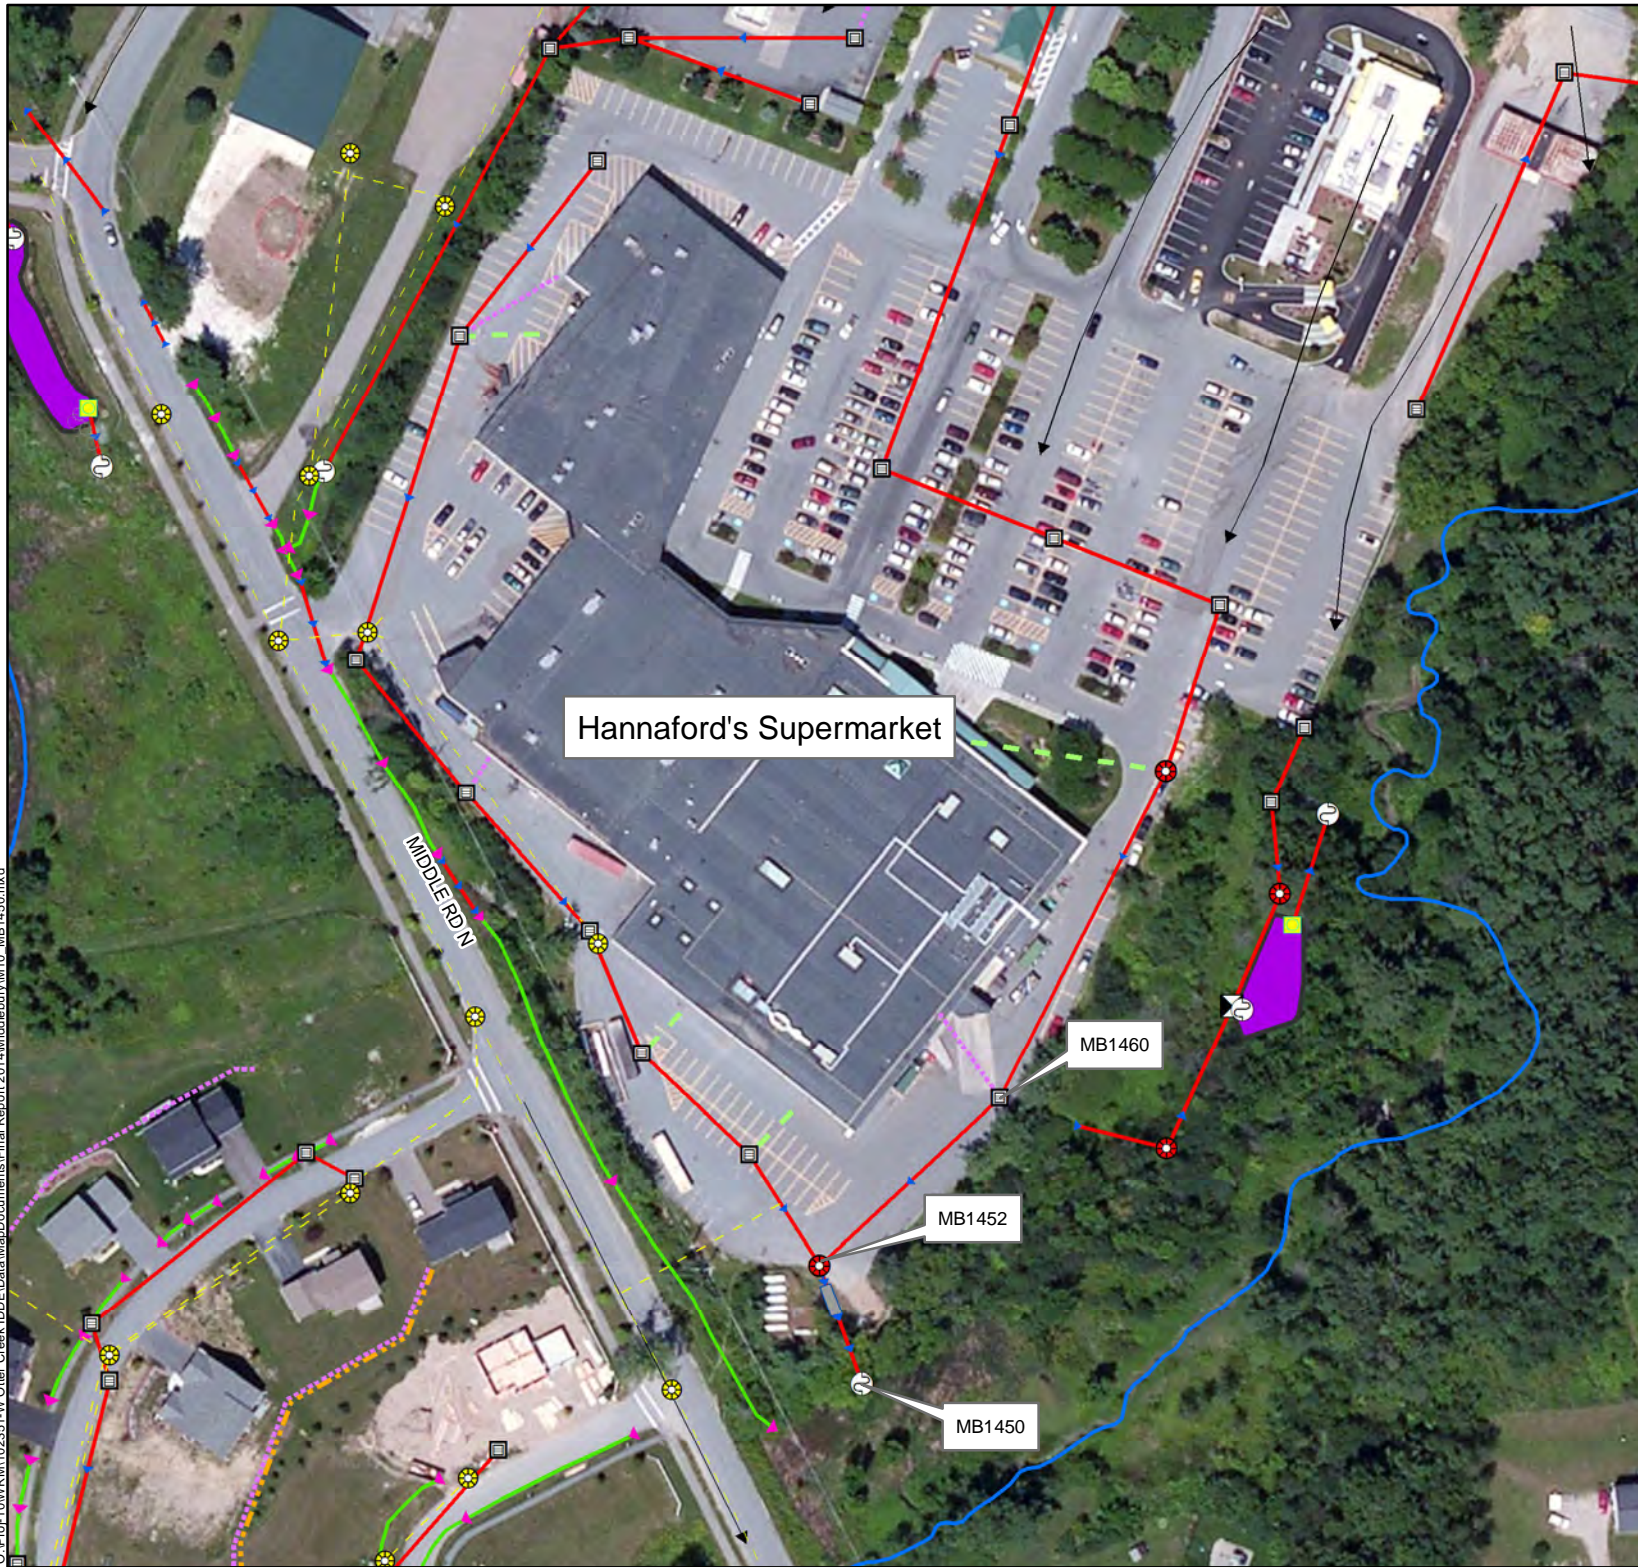
Map M10

<p>#3: Catchbasin MB1320 is located on Harrow Way. On November 8, 2011, 0.20 mg/L of chlorine was measured in flow from Pipe B. The structure was retested on December 15, 2011, yielding a chlorine concentration of 0.23 mg/L. On both dates organic matter was present in the sample, which can interfere with the chlorine analysis.</p> <p>Status: Small potable water leaks are essentially a municipal concern rather than sources of priority pollutants. We recommend the Town of Middlebury perform acoustic leak detection in the vicinity to locate the suspected water leak.</p>	M9
MB1450	<p>Description: Outfall MB1450 is a 10-inch diameter smooth plastic pipe that discharges to a wetland south of Hannaford's Supermarket on Route 7. The system drains parking areas south and east of the supermarket. On November 8, 2011, chlorine (0.26 mg/L) was measured in the manhole (MB1452) immediately up-pipe from the outfall. The majority of the flow in the system was from a 4-inch PVC pipe discharging to catchbasin MB1460 from the direction of the supermarket. There was no flow in the line from the south side of the lot. The flow from the 4-inch diameter pipe in catchbasin MB1460 had a comparable chlorine concentration, 0.25 mg/L.</p> <p>Status: The Department of Public Works contacted the property owner who quickly fixed the water leak, which was estimated at 35 gallons per minute.</p>	M10
