Otter Creek Basin Illicit Discharge Detection and Elimination Project

FINAL REPORT

May 31, 2014

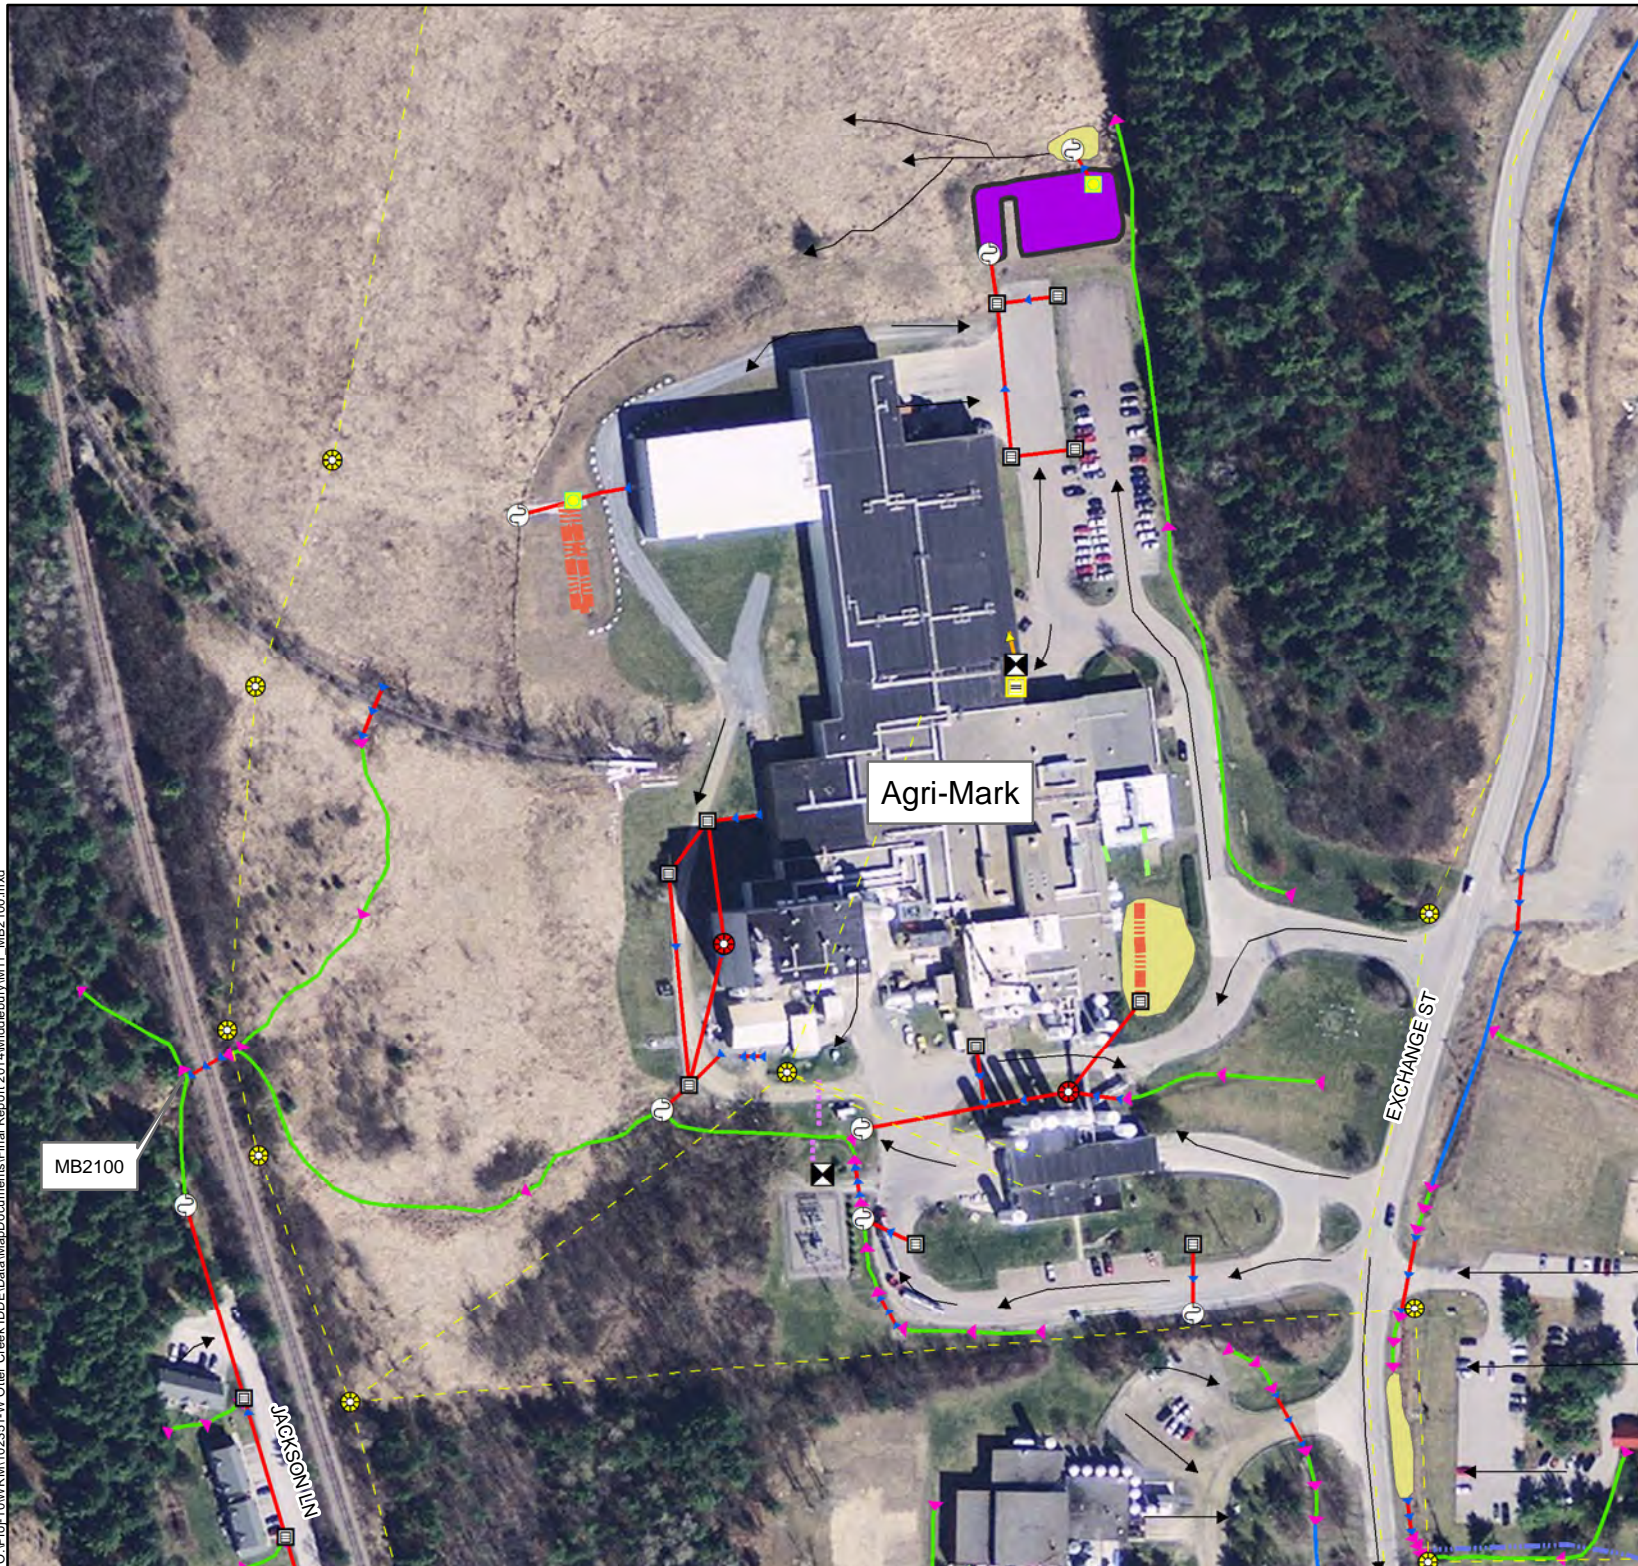
Map M11

MB2100	<p>Description: Culvert MB2100 crosses the train tracks west of the Agri-Mark facility on Industrial Avenue. A system of swales on the Agri-Mark property drains to this culvert. A sample collected at the culvert on December 15, 2011 had a moderately high ammonia concentration of 3.0 mg/L. The chlorine and MBAS detergent concentrations were below the limit of detection. No ammonia was detected in a sample collected on May 27, 2014.</p> <p>Status: We recommend repeated sampling for ammonia at the culvert.</p>	M11

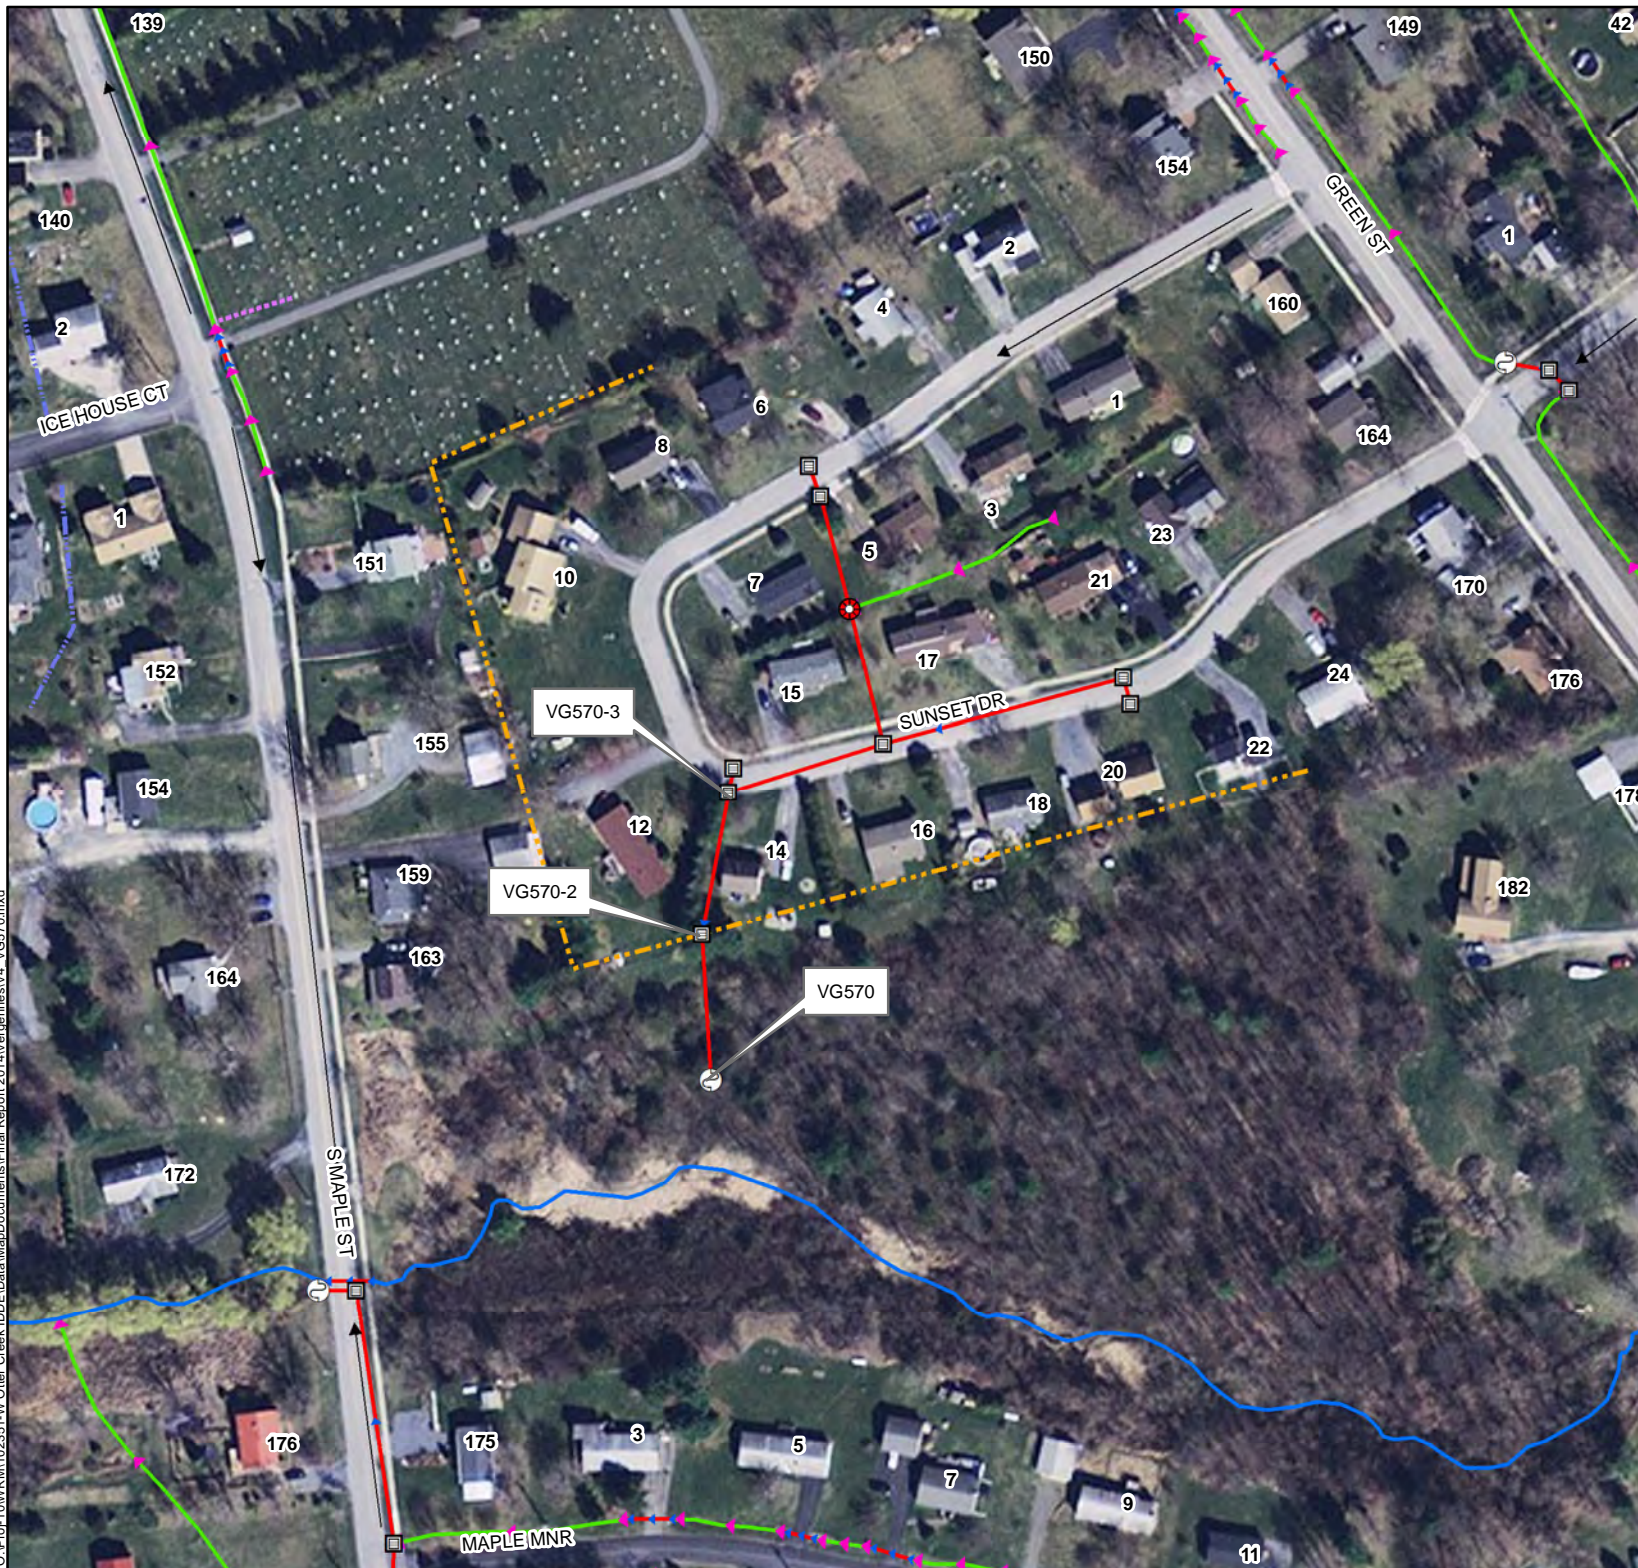
Map V4

System ID	Assessment Findings	Map
	<p>the outfall and at catchbasin VG480. On December 14, 2011 optical brightener monitoring pads were deployed throughout the system to bracket the source of the optical brightener. The source was effectively narrowed to the catchbasin VG470-6 at the intersection of South Maple Street and Roberts Street.</p> <p>Status: We recommend that the Vergennes Department of Public Works Dye test several houses on South Maple Street: #45, #46, #48, #51, #53, and #54.</p>	
VG570	<p>Description: Outfall VG570 is a 15-inch smooth plastic pipe located behind #12 Sunset Drive. The system drains all of Sunset Drive and discharges to a rip-rapped gully leading to a swampy area. Dry weather flow sampled on November 28, 2011 had no detectable ammonia, chlorine, or MBAS detergent; however, optical brightener was detected at the outfall. On December 14, 2011, the tests were repeated and an optical brightener monitoring pad was placed in every accessible structure in the system. Optical brightener was detected at the outfall and at the second catchbasin up-pipe from the outfall labeled VG570-3. The pad placed in the first catchbasin up-pipe from the outfall labeled VG570-2 (a drain in the backyard) was negative, which is an inconsistency with the detection in catchbasin VG570-3. Outfall VG570 is a 15-inch diameter smooth plastic pipe located behind a house on Sunset Drive. Optical brightener was detected at the outfall and at the second catchbasins up-pipe from the outfall.</p> <p>Status: The source of the optical brightener has been bracketed as closely as possible using monitoring pads. We recommend that the Town of Vergennes inspect, and dye test if necessary, the houses (#12, #14, and #16 Sunset Drive) surrounding the second catchbasin in order to identify any direct connections. If no direct connections are found, then there is probably a leak in the sanitary sewer system in this vicinity.</p>	V4
