# Missisquoi River Basin Advanced Illicit Discharge Detection and Elimination (IDDE) Study

**FINAL REPORT**

**October 10, 2014**

Aldrich + Elliott, PC  
6 Market Place, Suite 2  
Essex Junction, VT 05452  
Tel. / 802.879.7733  
Fax / 802.879.1742

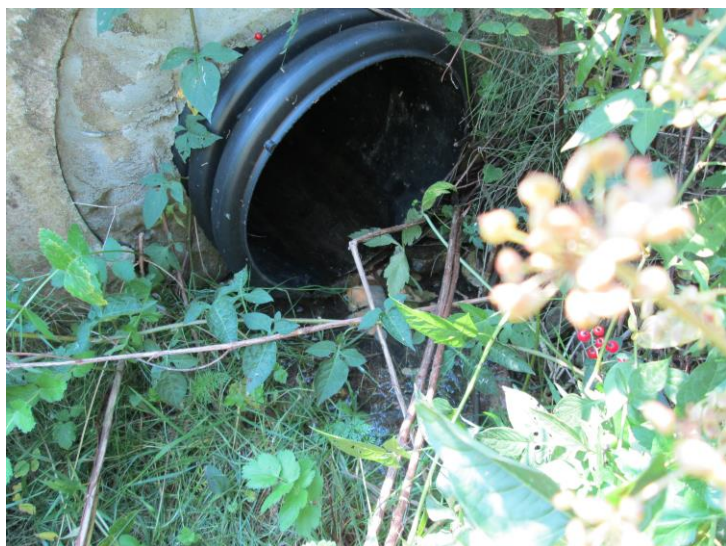
In 2013, the water quality of outfall T149C was tested on August 21 and September 18. Water quality tests on these dates yielded high levels of conductivity, 5,500 µS and 4,442 µS, respectively. Optical brightener testing was inconclusive but orange foam or suds were observed below the outfall during both occasions. Catch basins T149.CBA and T149.CBB were inspected and confirmed what was observed in 2009. A small PVC inlet pipe from the Mylan building is the only visible source of potential discharge.

Due to the presence of orange foam or suds, the illicit discharge is most likely from an interior floor

drain/sink used during cleaning or iron oxide from groundwater infiltration.

**Based on this information provided from the property owner, no further investigation is recommended and the high conductivity is most likely due to road salt and the orange foam/suds observed at the outfall may have been from an intermittent cleaning, or iron oxide from groundwater infiltration.**

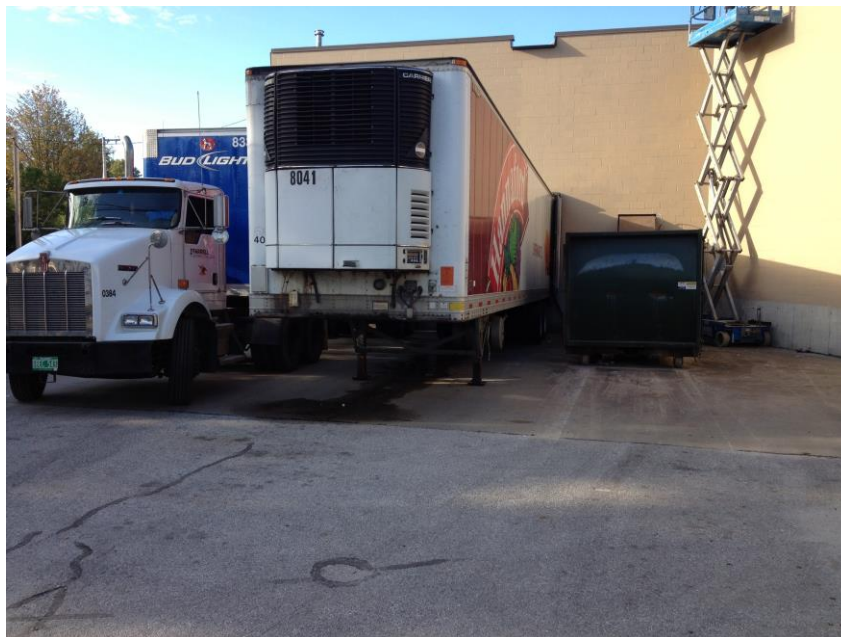
The outfall was investigated further to determine potential sources. The sump water in catch basin T16.CBA yielded ammonia levels in excess of 5.0 mg/L. Catch basin T16.CBB yielded ammonia levels of 0.46 mg/L. During dry weather investigation, the field technicians observed leakage from the trash compactor entering catch basin T16.CBA.

Follow up investigation in 2013 was conducted by A+E. During the investigation, specific conductivity was found to be less than observed in 2012, and OB pad tests were inconclusive. The outfall was tested for both E. Coli (<1 MPN/100 mL) and ammonia (0.1 mg/L) on October 30, 2013. Based on observations the trash compactor was not leaking and did not display evidence of a potential waste stream entering catch basin T16.CBA. Catch basin T16.CBA and T16.CBB were observed to have no inflow but the catch basins had significant accumulation of material.

**Based on this information, no further investigation was conducted and we do not believe there is an ongoing illicit discharge present in this system, so no further actions are recommended.**

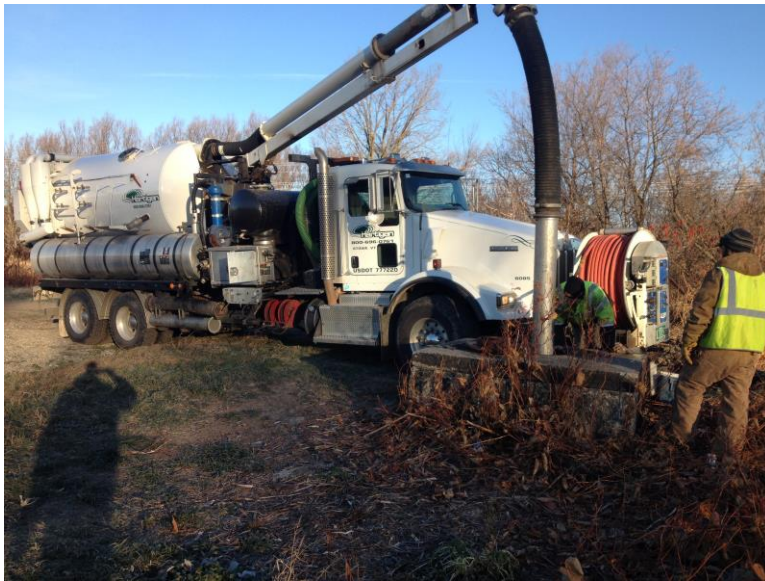
suited for the job. A+E contacted Hartigan of Middlesex, VT to perform the cleaning and televising of the trunkline. The City paid for this cleaning out of the Wastewater Department budget. Beginning on November 20 thru the 21<sup>st</sup>, Hartigan cleaned the trunkline by jetting the line and vactoring out any accumulated debris and sediment between the Briarwood Trailer Park and Lower Welden Street (TL-6). The City of St. Albans provided Hartigan with on-site water and disposal, and assisted in observing the cleaning and vactoring in the field. The picture below shows the Hartigan vector truck on-site cleaning the trunkline at manhole TL-8.

On November 25, 2013, Hartigan televised the trunkline with the assistance of the City. Video logs of the camera inspection and a report by Hartigan can be found in Appendix G. Hartigan approached the trunkline from three (3) different directions. The first began in back of SB Collins near the old CVPS cooling ponds. Hartigan began televising upstream of TL-8 towards the Briarwoods Trailer Park. The camera inspection went a total distance of 140' before it encountered an underground

structure which it could not navigate through and the structure is not accessible without excavation. Prior to the obstruction, the camera investigation found a couple of fractures and pieces of broken pipe within the 15" vitrified clay pipe. No wyes or junctions were found prior to the underground structure. Hartigan attempted to inspect downstream of TL-8 toward Lower Welden Street. The camera inspection made it approximately 10' prior to encountering another similar buried underground structure which the camera could not navigate through. At the underground structure, the 18" vitrified clay pipe transitioned to ductile iron. The camera did pick up an abandoned, partially obstructed vitrified clay pipe to the left (west). Hartigan attempted televising the trunkline from TL-6 upstream toward TL-8. Due to significant sediment and debris the camera was not able to pass through and conduct the investigation.

**Based on observation and conclusions provided by Water Consulting Associates, LLC in 2012 and investigation provided by A+E, the source of the ammonia may be due to ground water infiltration into the stormlines as evidence by excessive iron deposits and oxidation found within the trunkline. The other reason to speculate that groundwater infiltration is the source is due to the fact that TL-7 (catch basin) continues to have high concentrations of ammonia. TL-7 has no inlet pipe and is located in a grass swale. It can be concluded that overland flow is not the contributing factor to the catch basin as concentrations would be lower after passing through the surrounding grass. It is recommended that TL-7 be referred to the Vermont DEC Site Management Division for further investigation.**
