**Monitoring of stormwater system outfalls in Cabot, VT
September/October 2013**

**Friends of the Winooski River
P.O. Box 777
Montpelier, VT 05601**

**Stone Environmental
535 Stone Cutters Way
Montpelier, VT 05602**

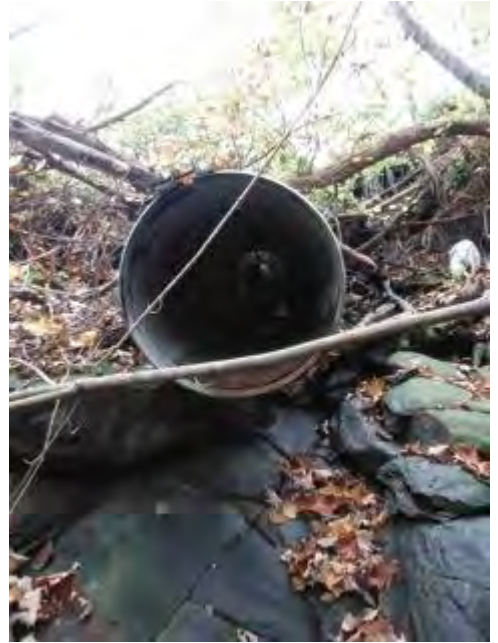
Cabot outfall C-O-190 (Main Street across from Cabot Creamery)

The assessments found one damaged public outfall. The bottom of outfall C-O-190, located across Main Street from Cabot Creamery, was severely corroded. This outfall was flowing at the time of the assessments, but the discharge did not make it to the end and instead flowed out below the pipe. Outfall C-O-170 may also have been damaged to the extent that it was unrecognizable. We were unable to locate this outfall, but did find sections of rusted corrugated metal in the riprap on the slope in the vicinity of its mapped location.

Damage: This corrugated metal outfall pipe is severely corroded along the bottom a few feet from the end of the pipe. Flow to this outfall is running through the holes left by the corrosion and goes underneath rather than to the end the pipe. No water sample could be obtained since the flow seeps directly onto the ground.

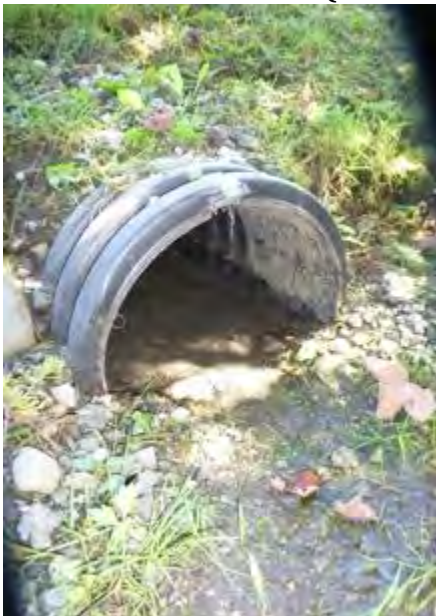
Cabot outfall C-O-020 (Route 215 at the Post Office)

Obstruction: The outfall pipe is approximately $\frac{1}{4}$ full of sediment. Drains Route 215 and the residential driveway across Route 215 from the Post Office. The 2nd catch basin (situated at the bottom of this driveway) up the stormwater system line

from this outfall was also partially full of

sediment.

- Remove the sediment partially obstructing outfalls C-O-020 and C-O-030 (and the stormwater lines above them) near the post office if flow through these outfalls seems to be slowed or backs up.

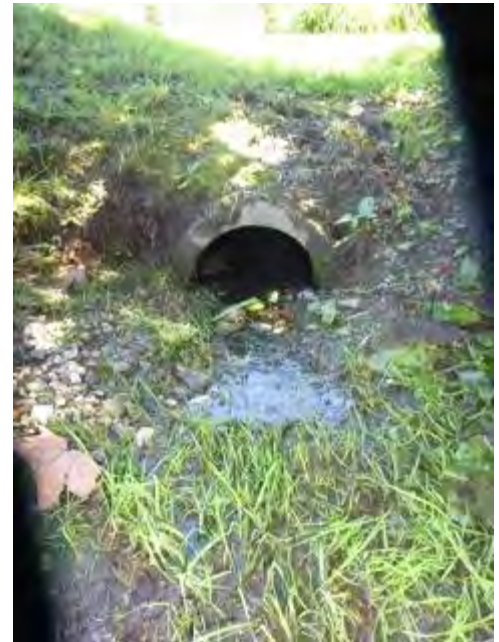
Cabot outfall C-O-030 (Main Street at the Post Office)

Obstruction: Outfall is about half-full of sediment.

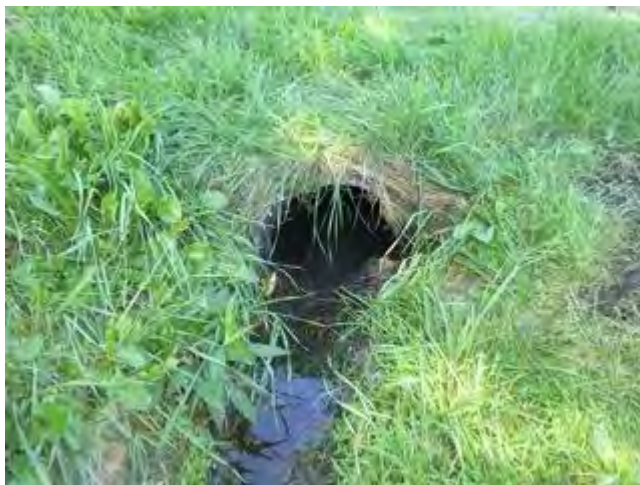
Cabot outfall C-O-010 (Southeast side of Route 215 north of Cabot Village)

Description: 15-inch smooth plastic pipe that drains the driveway in front of Larry's Garage and a section of Route 215. Submerged in outflowing water; could not be sampled for water quality.

Erosion description: Incision through the field below the outfall.

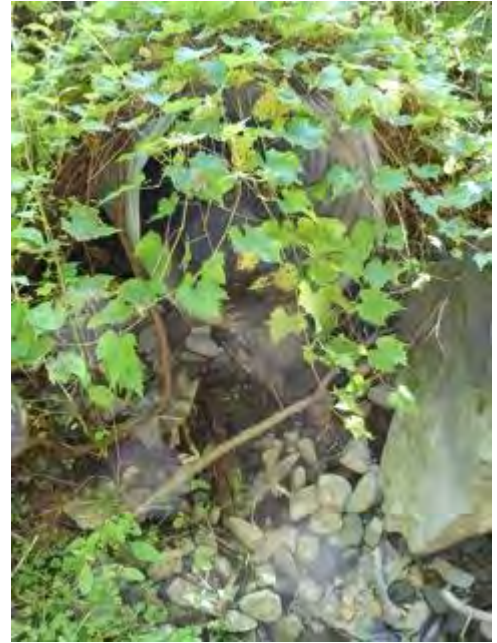
Cabot outfall C-O-060 (Whittier Hill Road and Main Street)

Erosion description: Some scouring below this outfall and some sediment deposit below that.

C-O-060	Northwest side of Main Street northwest of the Whittier Hill Road intersection.	Scouring under the outfall may be contributing sediment to the river.	Encourage property owners on the opposite side of Main Street to reduce flow into the stormwater system. Install a water-dissipating apron below the outfall.
C-O-070	Northwest side of Main Street west of the Whittier Hill Road intersection.	Erosion beneath the outfall may be contributing sediment to the river. Chlorine test was slightly pink despite colorimeter reading of 0.	Encourage property owners on the opposite side of Main Street to reduce flow into the stormwater system. Install a water-dissipating apron below the outfall. Reinforce the bank below if necessary. Retest for water quality.
C-O-080	Northwest side of Main Street northeast of Elm Street	Could not be located. May be under debris piled on the slope or may have been removed.	Remove pile of debris, see if outfall still exists, and assess if so.

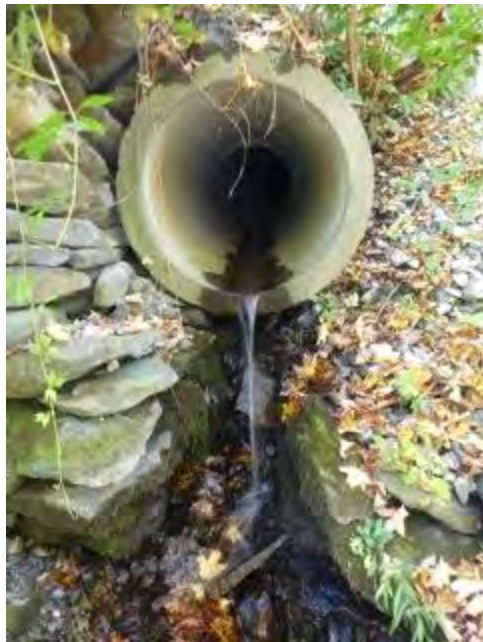
Cabot outfall C-O-070 (Whittier Hill Road and Main Street)

Erosion description: Small incision below outfall plus some scouring.

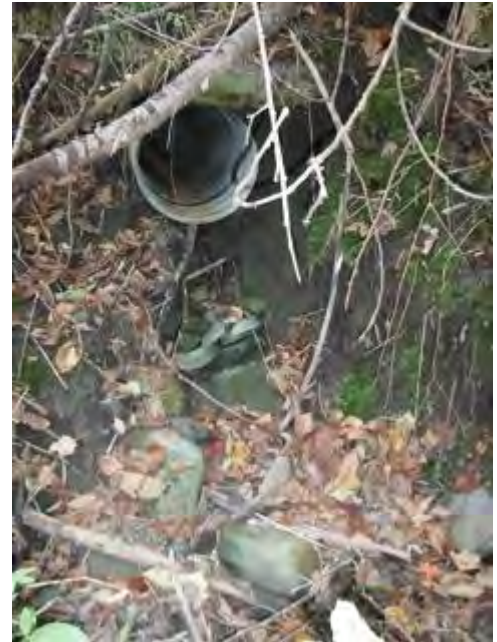
Cabot outfall C-O-150 (Main Street near Elm Street)

Erosion description: Substantial gully on the steep slope below the outfall.

Four outfalls appeared to be causing erosion, particularly outfall C-O-150. This outfall, located directly above the Winooski River, appeared to be associated with the formation of a gully in the riverbank below it. Sediment from eroded banks carries phosphorous into streams and rivers, which in turn transport it to lakes and ponds. Elevated phosphorous reduces water quality of streams, rivers, ponds, and lakes and can cause algal blooms that further reduce water quality. Both sediment transport and erosion can be addressed by stemming the amount and velocity of stormwater running through a stormwater line. Stormwater flow can be reduced by encouraging property owners and the town to reduce paved and bare areas, convert lawn to perennials or woody plants, install rain gardens, disconnect gutters and footing drains from the stormwater system, and redirect gutters to vegetated areas and away from pavement.

C-O-150	Northwest side of Main Street west of its intersection with Elm St.	A significant gully has formed beneath this outfall.	Encourage property owners on the opposite side of Main Street to reduce flow into the stormwater system. Reinforce the bank below to stem erosion.
C-O-170 and C-O-180	Main Street across from Cabot Creamery	Could not be located. May be crushed or covered by riprap.	Revisit in Spring to find these outfalls (esp C-O-170, which should be large and flowing), replace or repair if damaged, and do water quality assessment.
C-O-190	Northwest side of Main Street near Cabot Creamery Building "B".	Metal outfall pipe is severely corroded on the bottom. Flow through the ground below this pipe.	Replace this outfall pipe and test the flow for water quality.

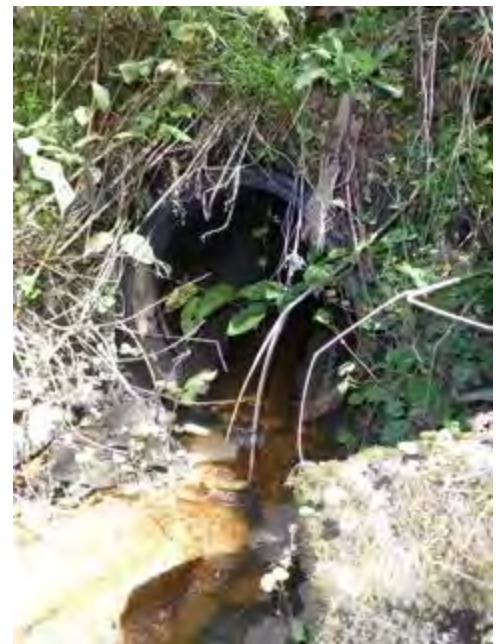
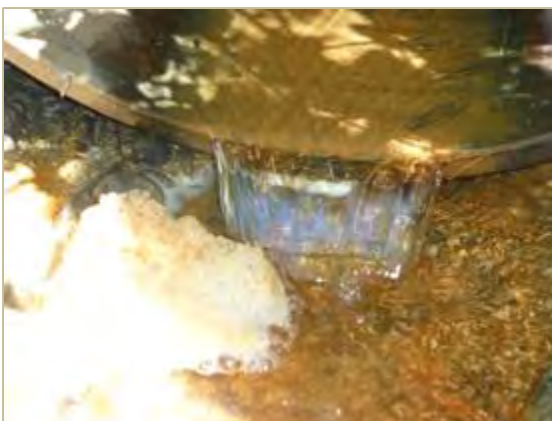
Cabot outfall C-O-040 (Main Street)

Reason for flag: Discharge from this steadily flowing outfall had a strong musty/faintly organic chemical odor and exhibited iron staining, possibly from iron-reducing bacteria. Conductivity of the sample taken from this outfall was higher than normal at 1065 micro-Siemens per centimeter ($\mu\text{S}/\text{cm}$). Foam was observed in the river below. OB and other water quality tests were normal. This outfall is at the end of a long, complicated line that drains the Cabot school grounds.

Foam in the water below outfall C-O-040

- Revisit C-O-040 for further water quality monitoring.
- Encourage community and property owner efforts to reduce stormwater flow, especially in areas drained by outfalls with erosion and sediment problems. Methods for reducing stormwater runoff involve increasing stormwater infiltration on individual properties. Examples of strategies to enhance infiltration are reducing bare and paved areas, converting lawn to perennial gardens or woody shrubs and trees, redirecting gutters away from bare or paved areas and toward vegetation, and disconnecting gutters from the stormwater system. Erosion can also be reduced by retrofitting outfalls.
